DESCRIPTIVE REPORT

Registry No. ... H-10274

General Locality Alaska Peninsula

Sublocality Northern Chiginagak Bay

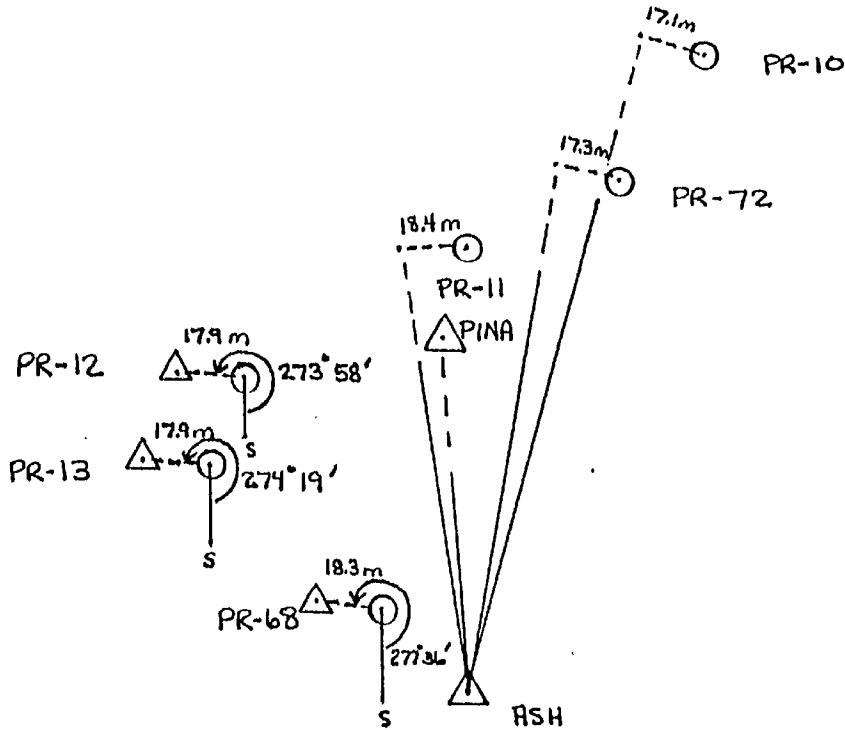
ATTACHMENT A - Displacement of Stations

To verify the location of station PR-12, launch critical system checks were accomplished using theodolite intersection. Differences of 15 to 20 meters from the Mini-Ranger baseline correctors were found. To verify other photo stations, a First-Order geodetic station (ASH) was occupied with horizontal angles (four-plate settings) turned from a First-Order station (PINA) to PR-72, PR-10, and PR-11. Using the computed distances from ASH to the aerotriangulated stations, differences between the observed and computed angles leads to positional errors of 17 to 18 meters (see Attachment A).

Third-Order, Class I positions were then determined for PR-12, PR-13, and PR-68. All three geodetic positions are approximately 18 meters west of the aerotriangulated positions (see Attachment A). This is the same error that was found with stations PR-72, PR-10, and PR-11, discussed above.

It is recommended that Job CM-8200 be reviewed as an 18-meter error to the east is suspected in both the aerotriangulated positions and the shoreline. FAIRWEATHER will not attempt to use any photogrammetric station positions from this project until the problem is resolved. Geodetic control has been extended south to Cape Providence as of this time.
