DESCRIPTIVE REPORT

Registry No. H-10280

Sublocality Aiugnak Columns and Vicinity

OPR - P180 - RA
 HYDROGRAPHIC SURVEY
 SOUTHERN ALASKA PENINSULA
 MAY 21 - AUGUST 31, 1988
 NOAA SHIP RAINIER
 JOHN C. ALBRIGHT, CAPT., NOAA
 COMMANDING
 SCALE OF CHART 16568

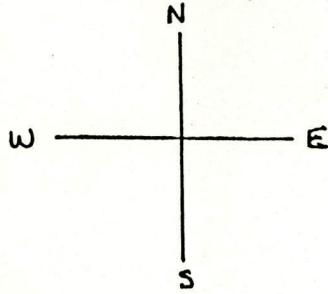
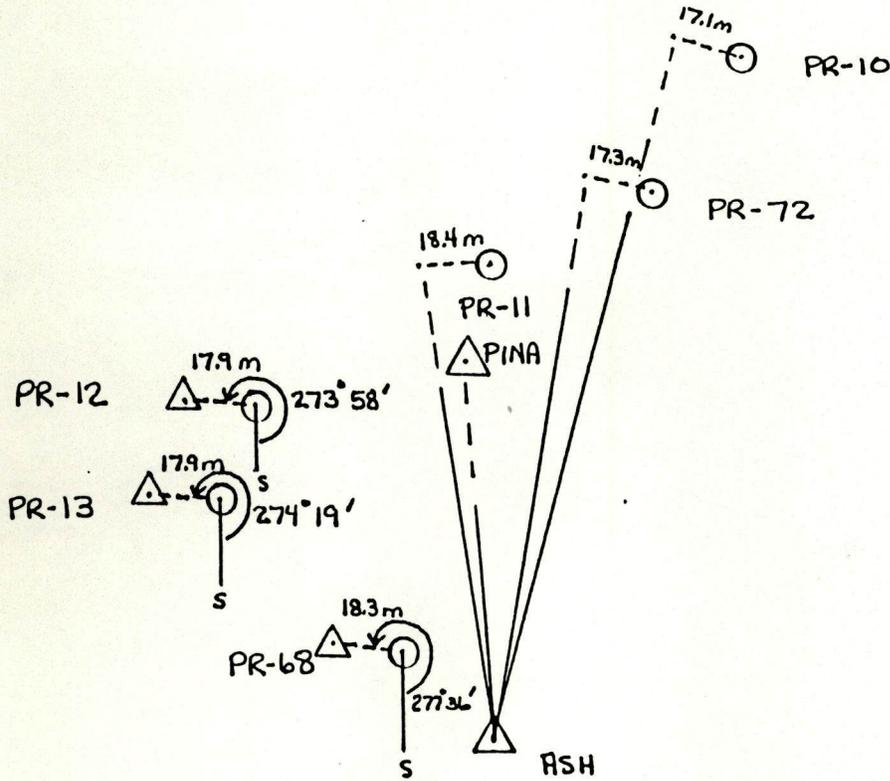
ATTACHMENT A - Displacement of Stations

To verify the location of station PR-12, launch critical system checks were accomplished using theodolite intersection. Differences of 15 to 20 meters from the Mini-Ranger baseline correctors were found. To verify other photo stations, a First-Order geodetic station (ASH) was occupied with horizontal angles (four-plate settings) turned from a First-Order station (PINA) to PR-72, PR-10, and PR-11. Using the computed distances from ASH to the aerotriangulated stations, differences between the observed and computed angles leads to positional errors of 17 to 18 meters (see Attachment A).

Third-Order, Class I positions were then determined for PR-12, PR-13, and PR-68. All three geodetic positions are approximately 18 meters west of the aerotriangulated positions (see Attachment A). This is the same error that was found with stations PR-72, PR-10, and PR-11, discussed above.

It is recommended that Job CM-8200 be reviewed as an 18-meter error to the east is suspected in both the aerotriangulated positions and the shoreline. FAIRWEATHER will not attempt to use any photogrammetric station positions from this project until the problem is resolved. Geodetic control has been extended south to Cape Providence as of this time.
