DESCRIPTIVE REPORT

Type of Survey . . . Navigable Area Hydrographic . . .

Registry No. . . . H-10282

Sublocality Sweeper Cove

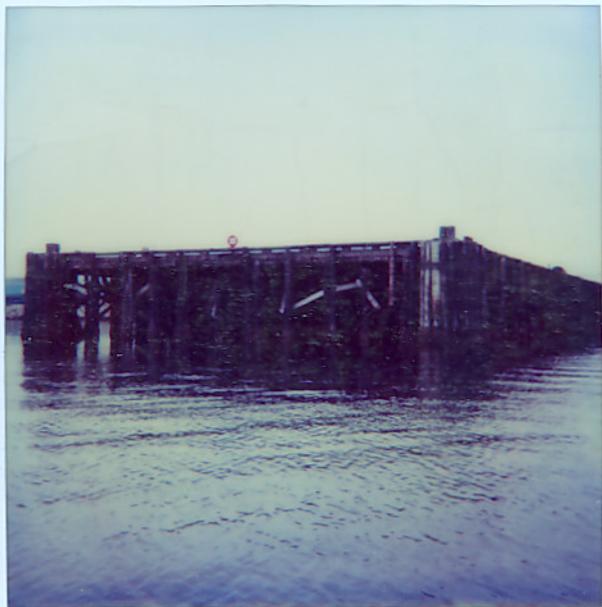
Pier 3's position was verified by sextant fixes (positions 3000-3003). The pier, built with wood decking and supported by wood piles, did not appear to have been rebuilt. It is recommended that pier 3's position be updated with the fixes taken from this survey. *Do not concur, fixes verify charted position of Pier 3, retain as charted.*

PIER NO. 3, LOOKING NW
JD 224 1988

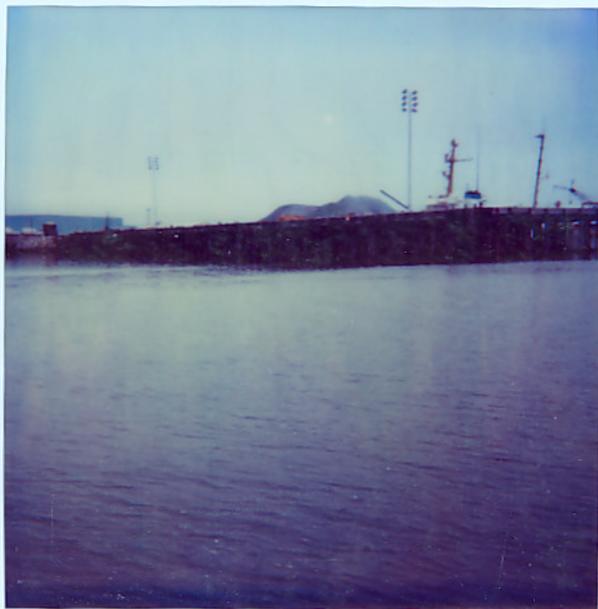
Pier 5 is now a concrete pier supported by concrete piles. This pier has been rebuilt on the same site as the wooden pier previously charted. It is recommended that sextant positions, 3008-3015 be used to chart the pier. *concur, Pier 5 is shown in red on the smooth sheet, chart according to smooth sheet*

PIER NO. 5, LOOKING NE,
JD 224 1988

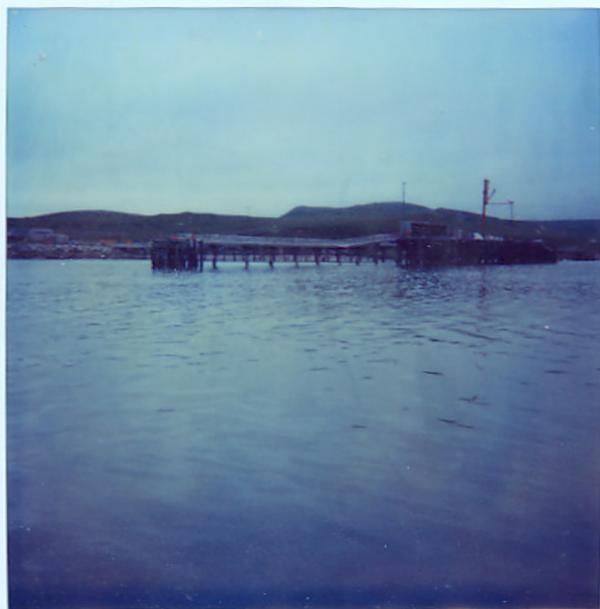
The fuel pier position was verified by sextant fixes. Position fixes 3024-3029 verified the position of the seaward face within 5 meters of the charted position. There did not appear to be any new construction or pier modifications since the original construction. DAVIDSON recommends that the fuel pier remain as charted.

FUEL PIER, LOOKING NW.
JD 224 1988

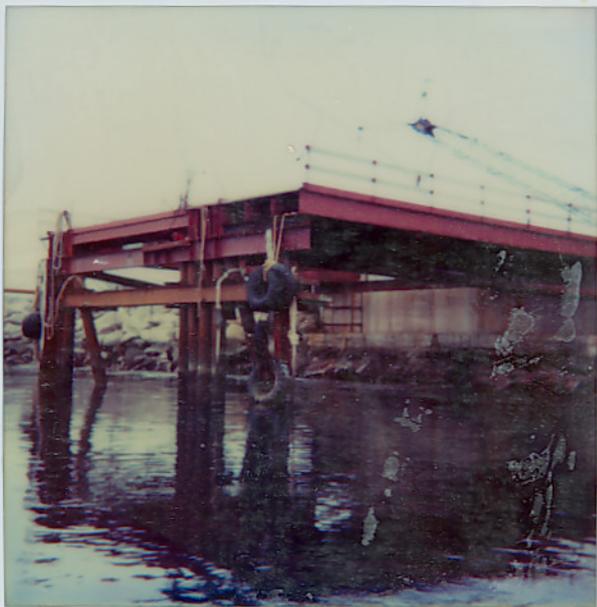
A rectangular barge ramp is located to the west of pier 5. The ramp was positioned by sextant (positions 3016, 3018-3019). The southwest corner of the pier could not be positioned due to lack of visible control stations. It is recommended that the ramp be charted using the positions and measurements taken from this survey. *concur, chart according to smooth sheet*

BARGE PIER, LOOKING NW
JD 224

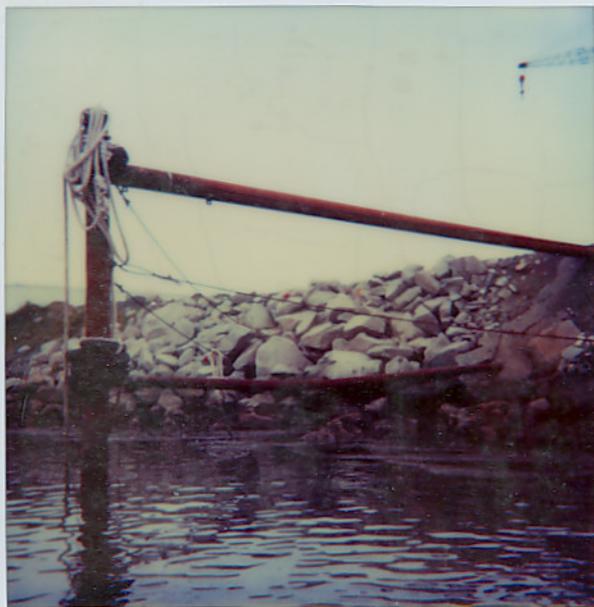
STEEL DOLPHIN (1 of 4) BESIDE
BARGE PIER, LOOKING NW
JD 224

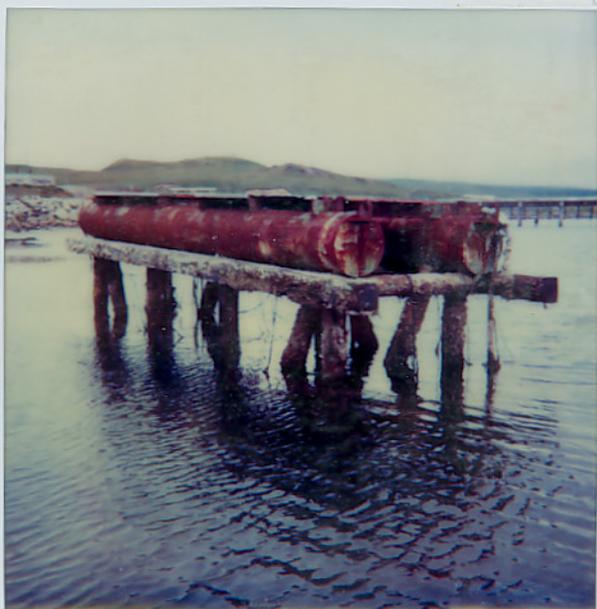
PLATFORM ROW, LOOKING NW.
JD 224 1988

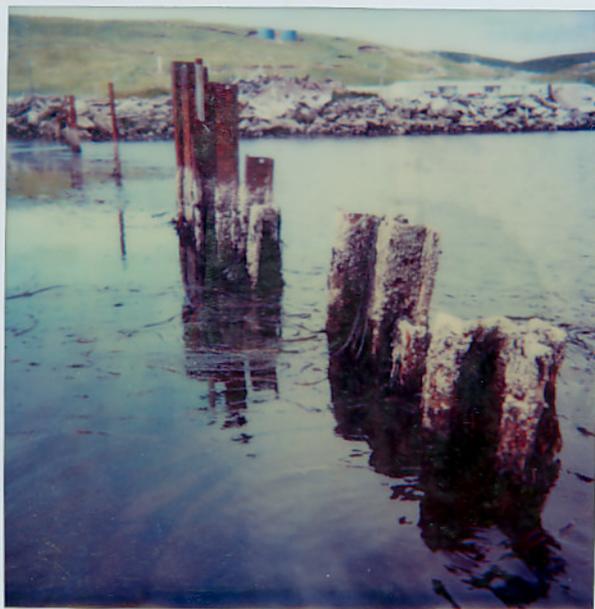
SEA WALL ROW, LOOKING W.
JD 224 1988

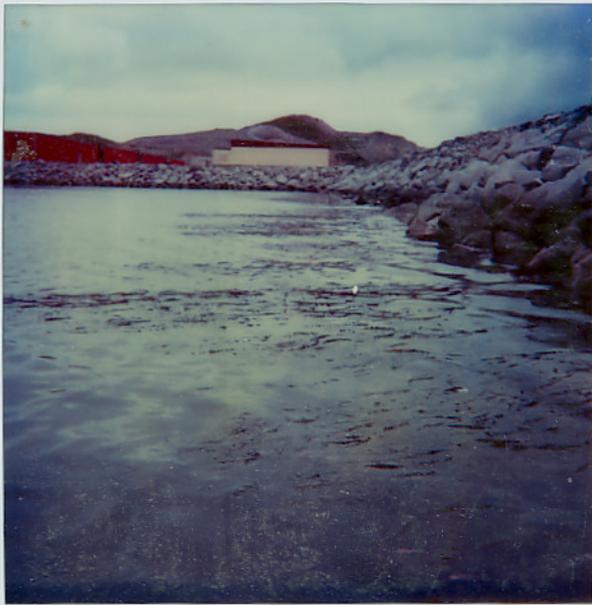
1988 BREAKWATER KELP, WEST SIDE,
LOOKING NORTH ID 234
H-10282

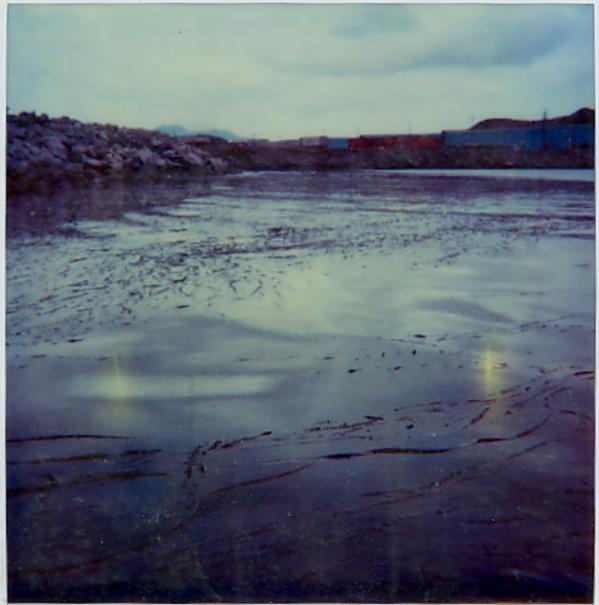
1988 TYPICAL KELP ID 234
W. SIDE OF PIER BASIN, LOOKING N.
H-10282

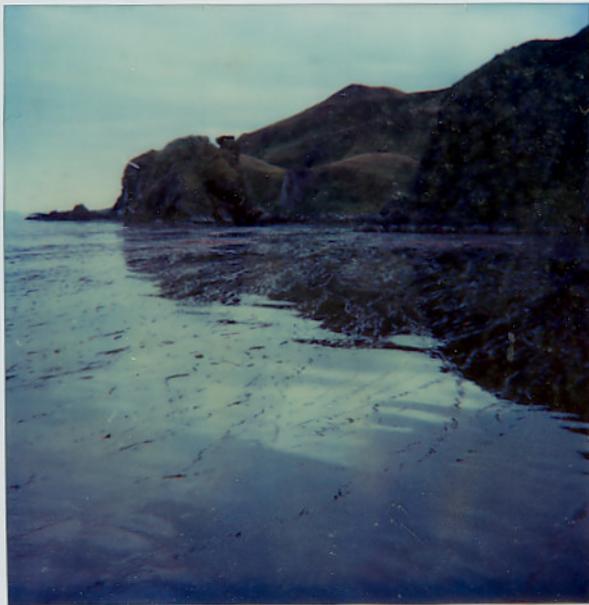
1988 TYPICAL KELP ID 234
LOOKING E. FROM STATION BAK
H-10282
