DESCRIPTIVE REPORT

Type of Survey ... Basic Hydrographic
Field No. PHP-10-6-89
Registry No. H-10317

State California
General Locality ... Suisun Bay
Sublocality Snag Island to Van
..... Sickle Island
..... 19 89-90
CHIEF OF PARTY
LT D.J. Nodine

HYDROGRAPHIC TITLE SHEET

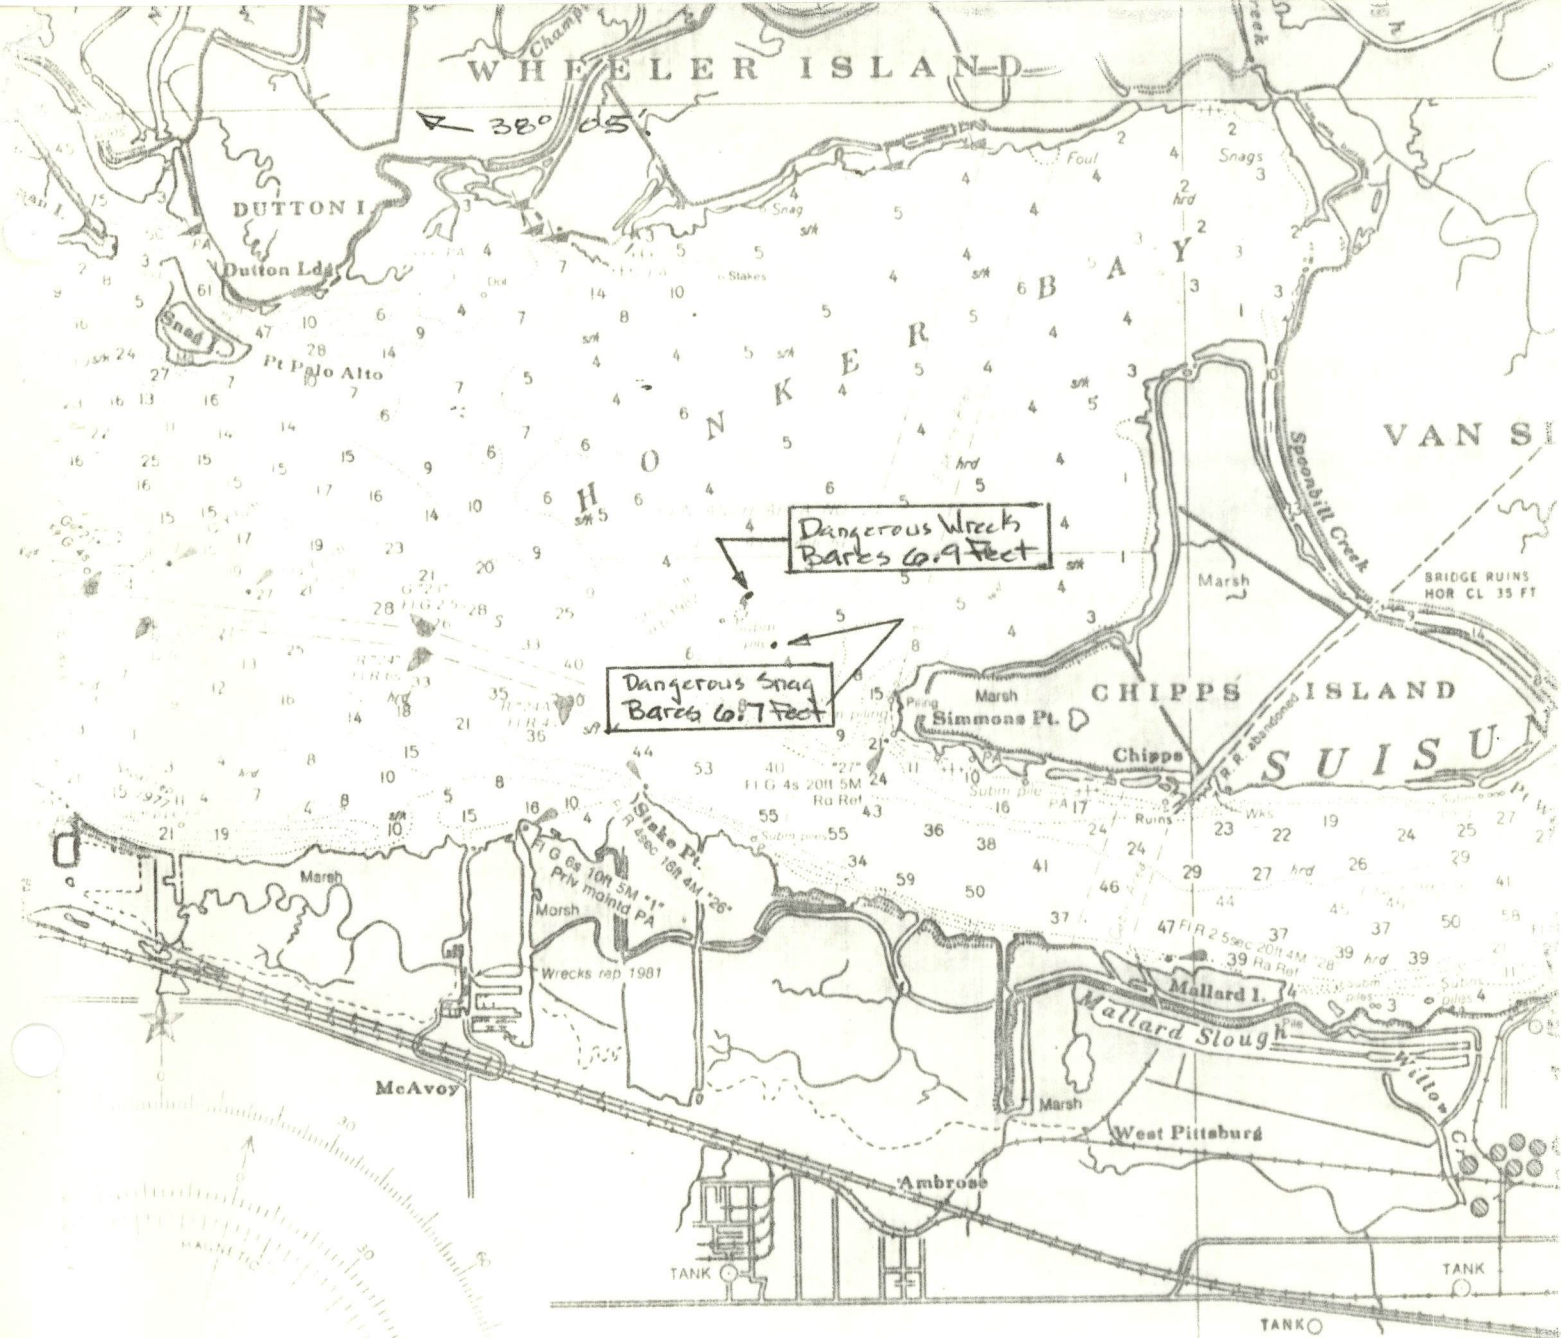
WHEELER ISLAND

Dangerous Wreck
Bars 6.9 Feet

Dangerous Snag
Bars 6.7 Feet

It is recommended that the enclosed Report of Danger to Navigation be included in the Local Notice to Mariners.
