DESCRIPTIVE REPORT

Type of Survey Hydrographic
Field No. RA-10-6-92
Registry No. H-10431

State Alaska
General Locality Cook Inlet
Sublocality Knik Arm Shoal & Vicinity

Descriptive Report to Accompany Hydrographic Survey H-10431
Knik Arm Shoal

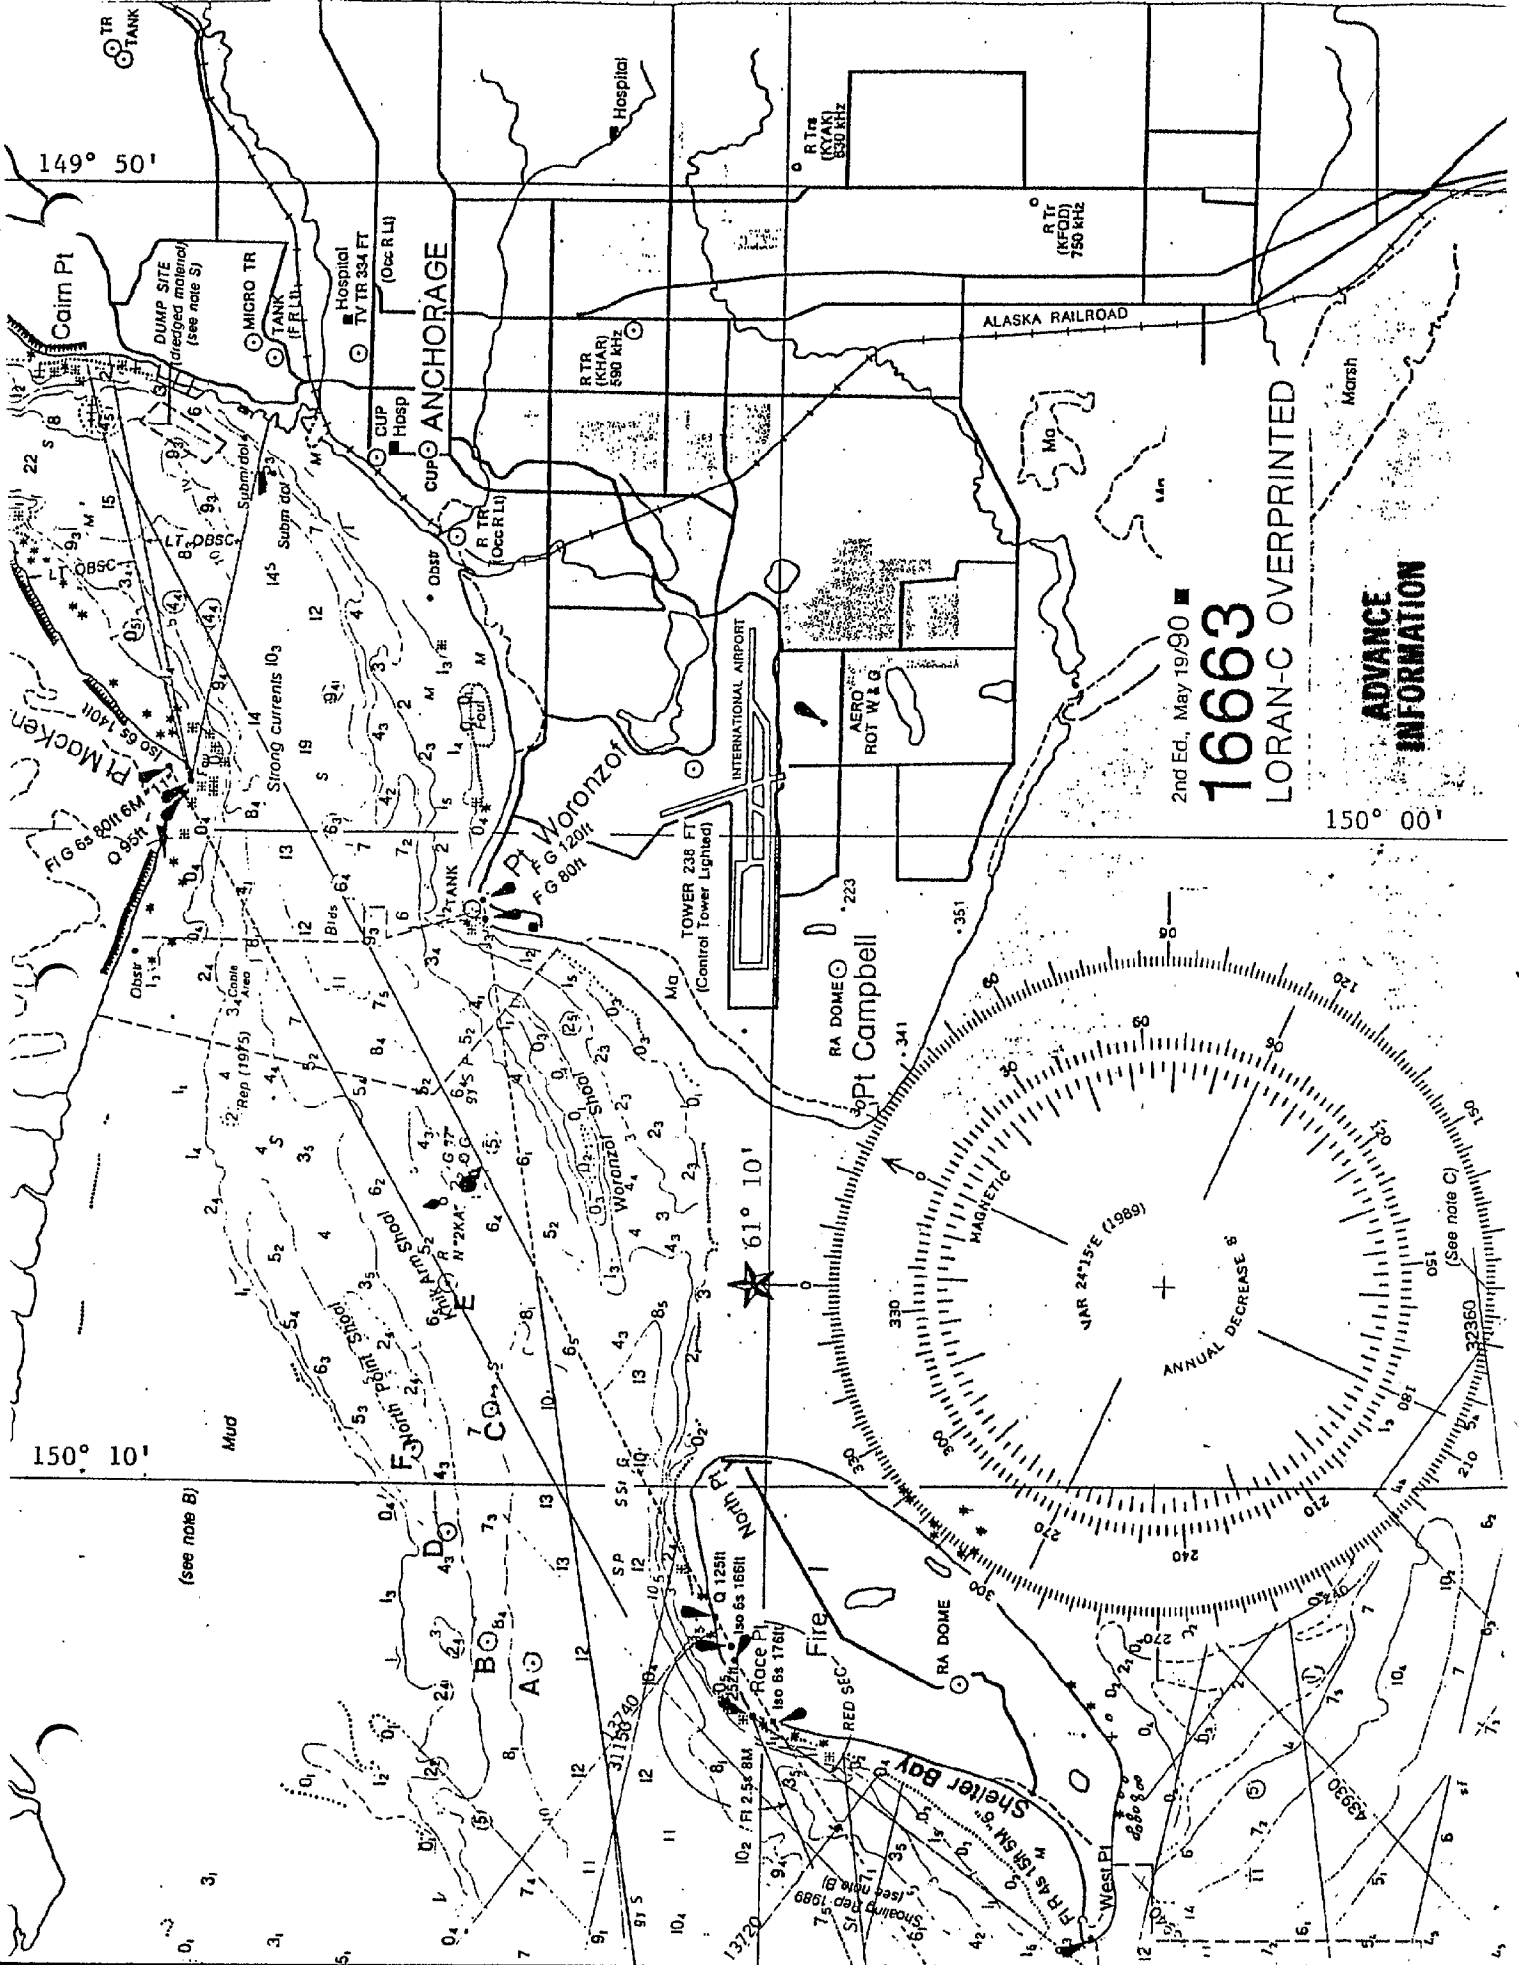
NOAA SHIP RAINIER FOUND THE FOLLOWING DANGERS TO NAVIGATION WHILE
CONDUCTING HYDROGRAPHIC SURVEY OPERATIONS IN COOK INLET, ALASKA.

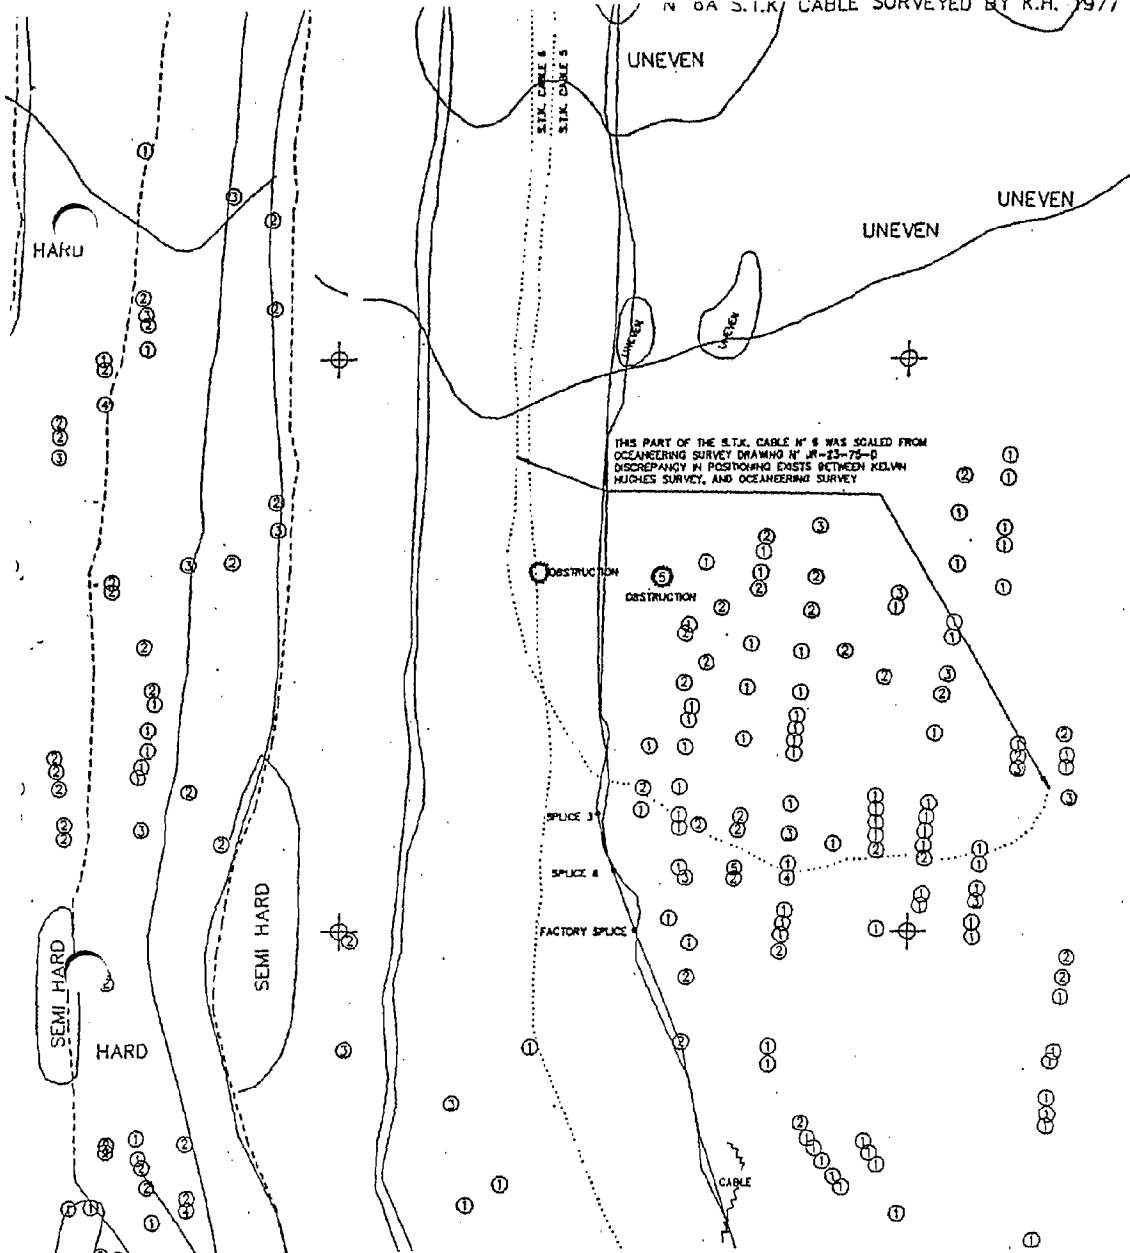
ALASKA
ANCHORAGE
 BELUGA PROJECT

CHART SHOWING INTERPRETATION OF SEABED, ROCKS,
 EMBEDDED CABLES AND EXPOSED CABLES

The presently charted limits of the cable area between Point MacKenzie and Point Woronzof were based on the results of the Beluga Project (Port of Anchorage) accomplished by Kelvin Huges surveying company in 1977. The excursion was drawn to include the remaining portion of the "disused cable" shown on the project plan. It is recommended that the charted cable area be retained as charted.
