NOAA FORM 76-35A	
U.S. DEPARTMENT OF COMMERCE NATIONAL OCEANIC AND ATMOSPHERIC ADMINISTRATION NATIONAL OCEAN SURVEY	
DESCRIPTIVE REPORT	
Type of Survey	Hydrographic
Field No.	PHP-5-2-94
Office No.....	H-10587
LOCALITY	
State	Washington
General Locality	Strait of Juan de Fuca
Locality	Port Angeles Harbor
1994-95	
CHIEF OF PARTY LT Richard A. Fletcher, NOAA	
LIBRARY & ARCHIVES	
DATE	MAY 30 1996

HYDROGRAPHIC TITLE SHEET

General locality Strait of Juan de Fuca

Locality Port Angeles Harbor

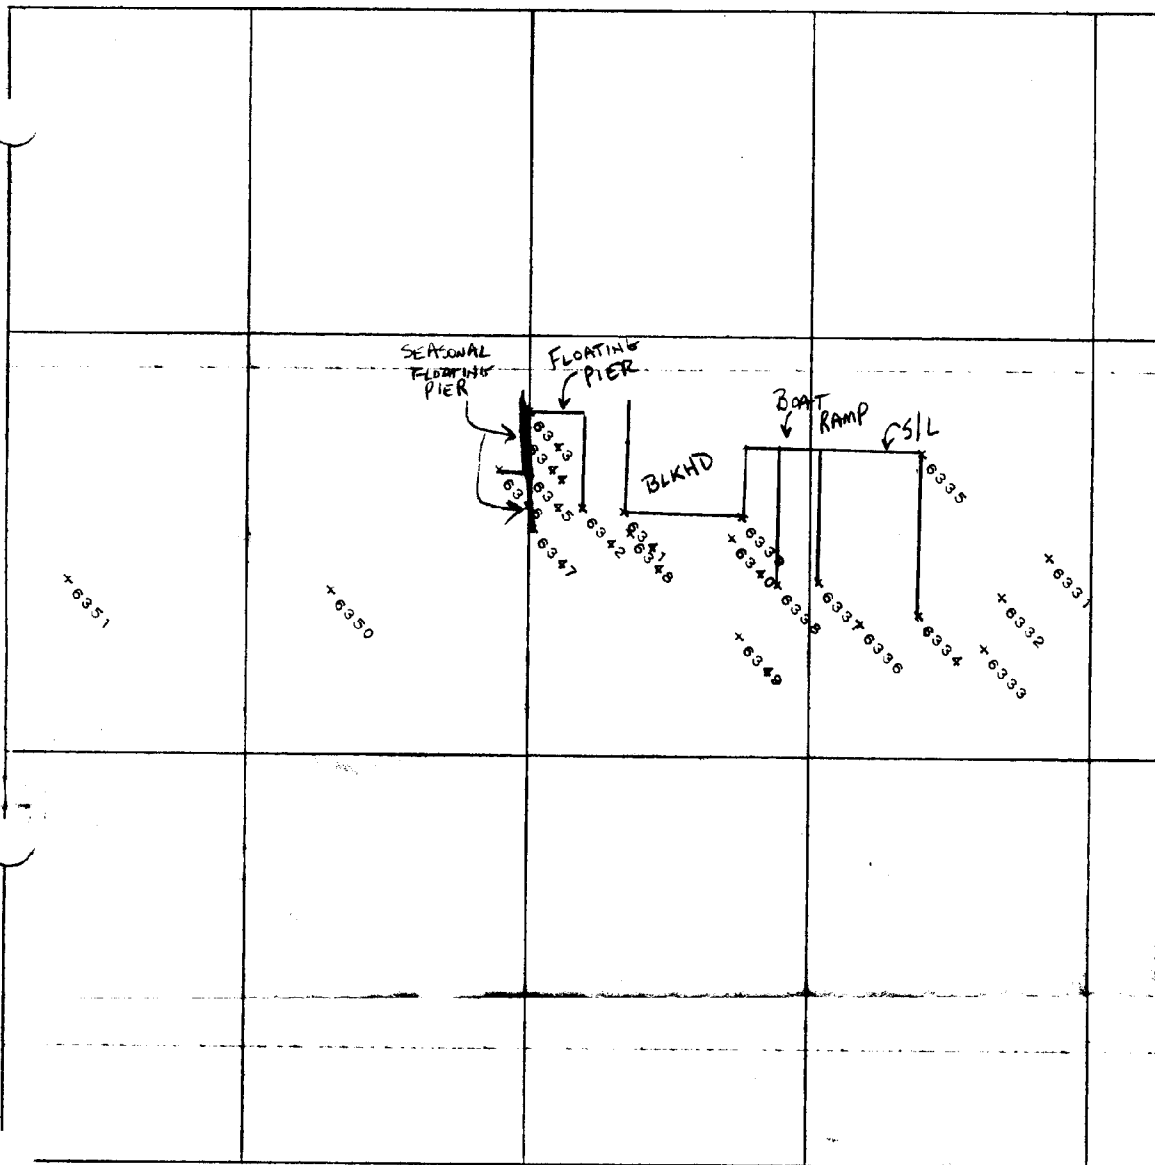
AWOIS INVESTIGATION-N8 ✓

LATITUDE	LONGITUDE	POSITION#
CHARTED:	048°08'28.00"N	123°25'41.00"W	Offshore end
OBSERVED:	048°08'28.84"N	123°25'40.11"W	6344
	048°08'28.39"N	123°25'40.00"W	6345
	048°08'28.42"N	123°25'40.54"W	6346
	048°08'27.72"N	123°25'39.92"W	6347

CHARTING RECOMMENDATIONS: "Chart as depicted on digital map at latitude 048°08'28.00"N, longitude 123°25'41.00"W." *do not concern* Delete charted pier in ruins. chart this area as shown on the smooth sheet.
