DESCRIPTIVE REPORT

Type of Survey HYDROGRAPHIC
Field No. AHP-10-1-95
Registry No. H-10588

State TEXAS
General Locality GALVESTON BAY
Sublocality RED FISH BAR TO
..... EAGLE POINT
..... 19 96
..... CHIEF OF PARTY
..... LT. K. N. HARRISON, NOAA

Project No. OPR-K204

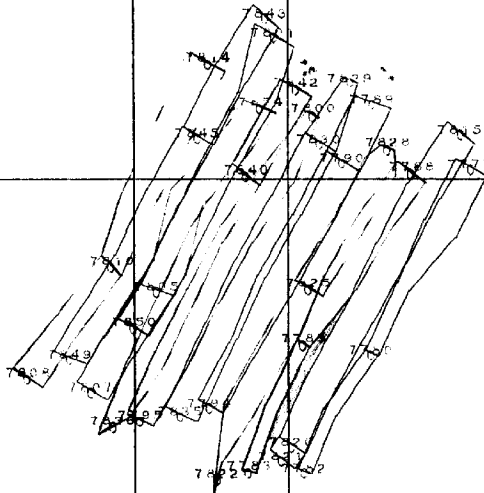
Investigation Summary: AHP divers conducted a 100m radius circle search around the AWOIS target center (PN 7471). No contacts were found. A 30-meter wide dive swath search was performed from the geographic position of PN 7471 southward towards existing piles located by positions 4873-4884 on survey H-10588. The only contact found within this swath search pattern was the existing pile positioned at PN 4878. A 100% coverage side scan sonar investigation was conducted on DN 123. Line spacing was restricted to 20 meters using the 25 meter range scale. The side scan sonar coverage primarily centered around the eastern side of the search area, as the dive investigation covered the western offshore area. Depths in the search area were less than 2.0 meters, reducing the quality of the sonagram. *See attached swath plot for coverage.

The hydrographer recommends that the charted piles be revised to the following positions:

Recommended Least Depth: -2.0m MLLW (Predicted Tides)

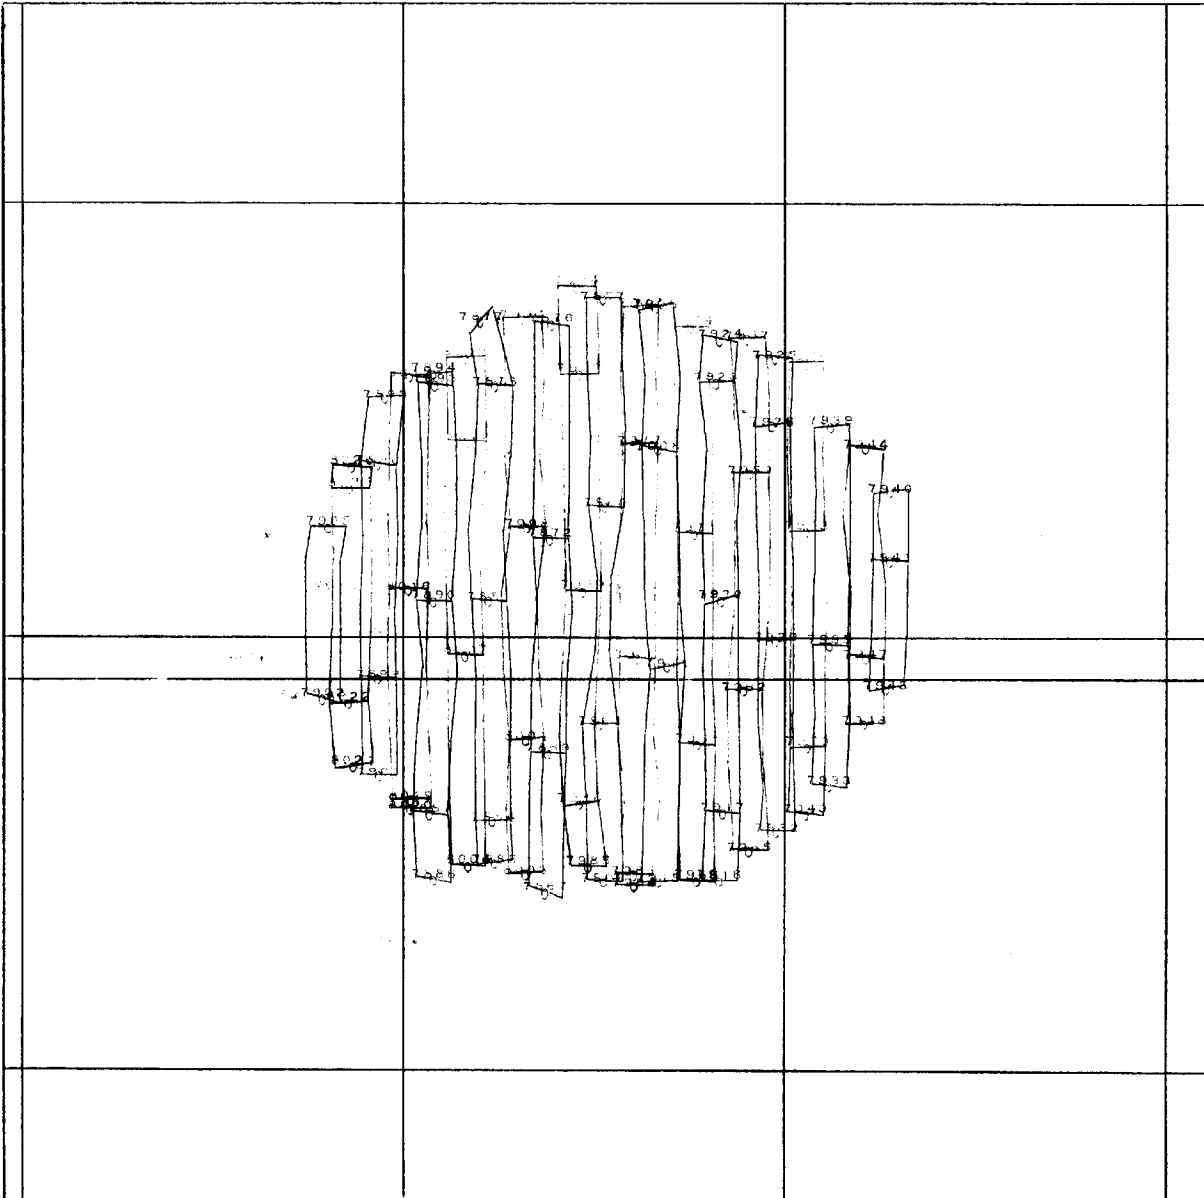
AWOIS NO: 9226

Item Description: Wreck (21-foot Pleasure Craft)

Investigation Summary: A 100% coverage side scan sonar search was conducted with 40-meter line spacing using the 25-meter range scale. The search radius was limited to 200 meters, centered around the AWOIS position. No significant contacts were found.

The hydrographer recommends that the charted wreck (21 ft pleasure craft) be deleted from the chart. *Concur*
