H-10967

DESCRIPTIVE REPORT

General Locality **TONGASS NARROWS**

Sublocality **½ NM SE OF LEWIS PT. TO PT. HIGGINS**

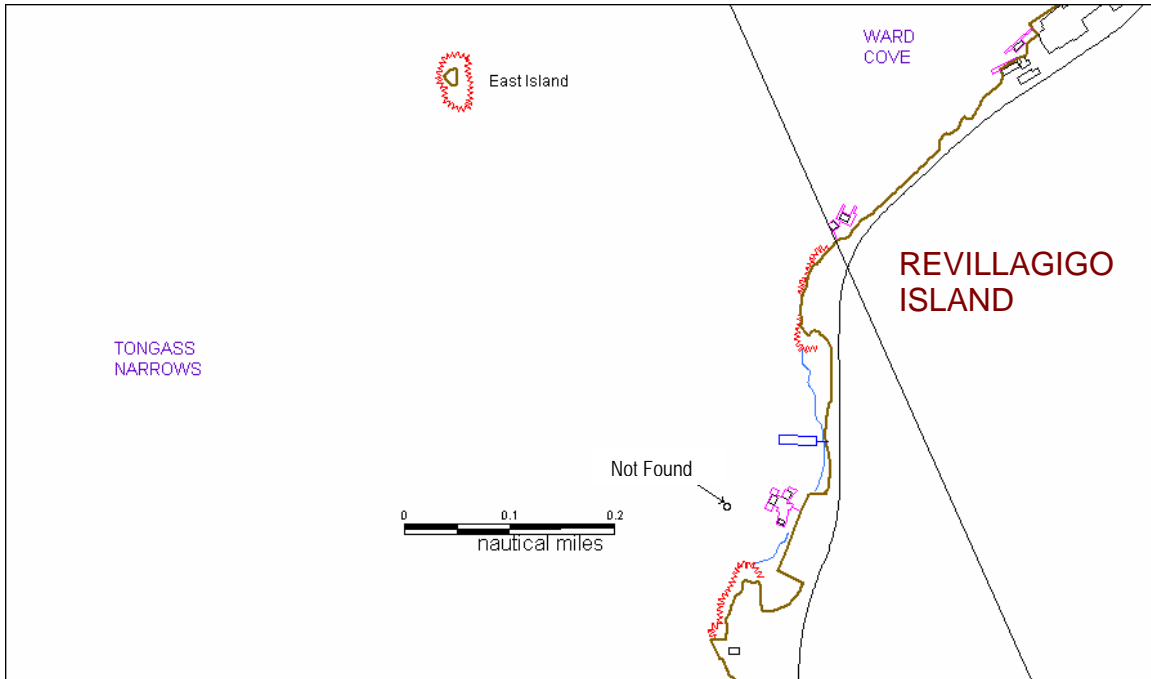
Two nearshore structures, shown in Chart 17428 and ArcInfo Coverage file “piles.e00,” were not found at charted positions. The first was a piling at latitude 55° 23’ 21.4749” north and longitude 131° 44’ 17.8512” west.⁶⁰

MapInfo Window in ASL-6 Workspace, showing charted location of piling not found in survey

The survey team's search of the area failed to show any structures at or near the given positions. Further investigation of multibeam data in Caris indicated no submerged pilings at these positions.⁶²

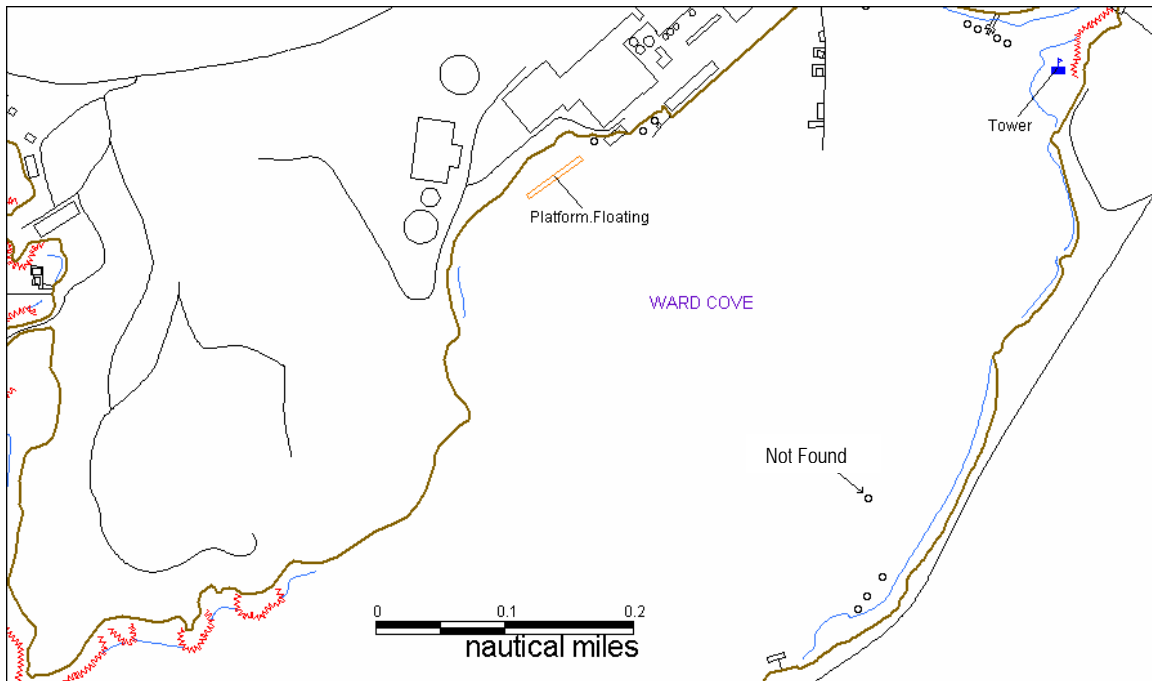
The second item not found was a piling at latitude 55° 24’ 3.4901” north and longitude 131° 43’ 24.4913” west.⁶¹

MapInfo Window in ASL-4 Workspace, showing charted location of piling not found in survey

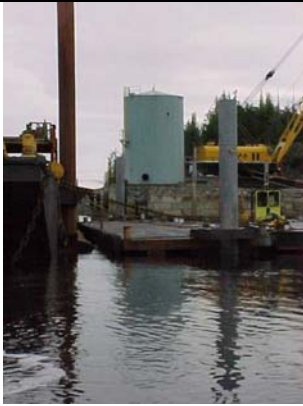
A5	ASL-11	Barge, Dock, & Tower ⁷⁴ Height MLLW: 13.28m	55°23'01.4" 55°23'01.5" 55°23'02.4" 55°23'02.2"	131°45'37.8" 131°45'37.6" 131°45'39.3" 131°45'39.5"	A5.jpg

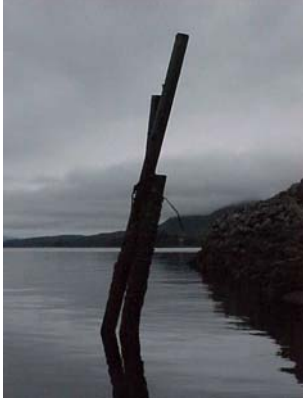
A7	ASL-7	3 Pilings ⁷⁶ Height MLLW: 16.52m	55° 23' 12.2"	131° 44' 18.5"	A7-1.jpg

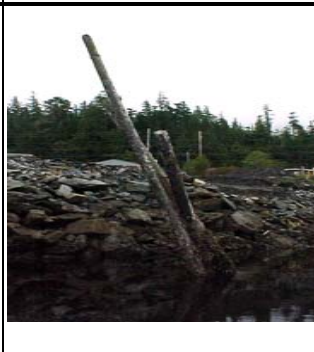
ID	SUB-SHEET	DESCRIPTION	LATITUDE N	LONGITUDE W	PHOTO FILE	IMAGE
A7	ASL-7	3 Pilings (untied) ⁷⁷ Height MLLW: 16.52m	55°23'11.7"	131°44'18.2"	A7-2.jpg

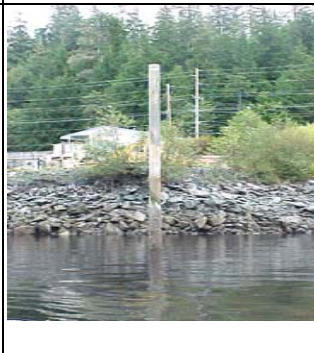
A7	ASL-7	3 Pilings (single) ⁷⁸ Height MLLW: 16.52m	55°23'10.7"	131°44'18.1"	A7-3.jpg

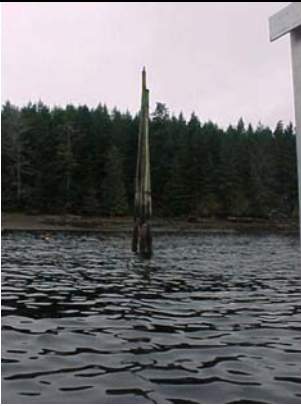
ID	SUB-SHEET	DESCRIPTION	LATITUDE N	LONGITUDE W	PHOTO FILE	IMAGE
A8	ASL-16	Dolphin ⁷⁹ Height MLLW: 14.88m	55°25'34.4"	131°50'51.4"	A8-Dolphin-2.jpg

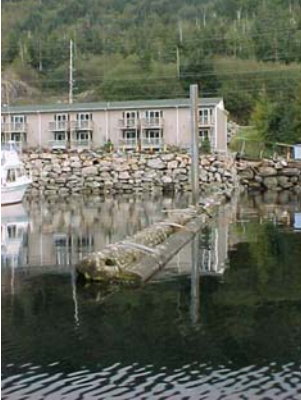
ID	SUB-SHEET	DESCRIPTION	LATITUDE N	LONGITUDE W	PHOTO FILE	IMAGE
A12	ASL-8	Logboom/floating brk.water ⁸³ Height above waterline: 0.3m	55°22'12.8" 55°22'12.0"	131°43'12.4" 131°43'15.0"	A12.jpg

-
- 82 Outside survey limit. Positioned on H10987.
 - 83 Outside survey limit. Positioned on H10987.
 - 84 Chart as mooring buoy at survey position.
 - 85 Chart as mooring buoy at survey position.
 - 86 Chart as mooring buoy at survey position.
 - 87 Chart as mooring buoy at survey position.
 - 88 Chart as mooring buoy at survey position.
 - 89 Chart as mooring buoy at survey position.
 - 90 Chart as mooring buoy at survey position.
 - 91 Chart as mooring buoy at survey position.
 - 92 It is recommended that these aids to navigation be charted with the most recent information from the USCG, District 17.
 - 93 Filed with the hydrographic data.
 - 94 Filed with the hydrographic data.
 - 95 Filed with the hydrographic data.
 - 96 Filed with the hydrographic data.
 - 97 Filed with the hydrographic data.
 - 98 Filed with the hydrographic data.
 - 99 Filed with the hydrographic data.
