**DESCRIPTIVE REPORT**

*Type of Survey* **Hydrographic / Side Scan**

*Registry No.* **H11087**

*Sub-locality* **Offshore - Approaches to  
Freeport**

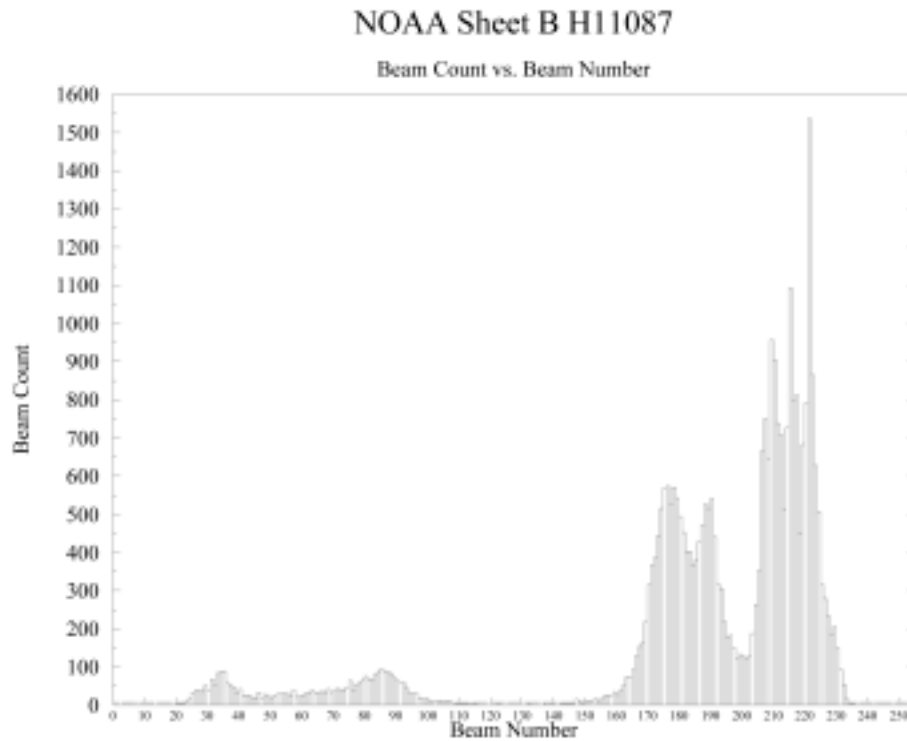
sounding distribution on the port head is dominated by the spatial distribution of soundings on the seafloor. The probability of a sounding from a particular beam making its way to the smooth sheet is inversely proportional to its corresponding density on the seafloor. The sparser soundings near the inner and outer edges of the swath are more likely to be selected because there are fewer to choose from.

The sounding distribution on the starboard head is more complex. An outstanding peak appears near beam 221, caused by a consistent 2 - 3 cm shoal bias in that portion of the swath in conjunction with extremely flat seafloor topography. Because only the shoalest of the shoals are selected for the smooth sheet, very minor biases in areas of swath data can lead to uneven beam distributions.
