DESCRIPTIVE REPORT

Type of Survey: Hydrographic Multibeam & 200% Sidescan

Registry No. : H11671

General Locality: Approaches to Vermillion Bay

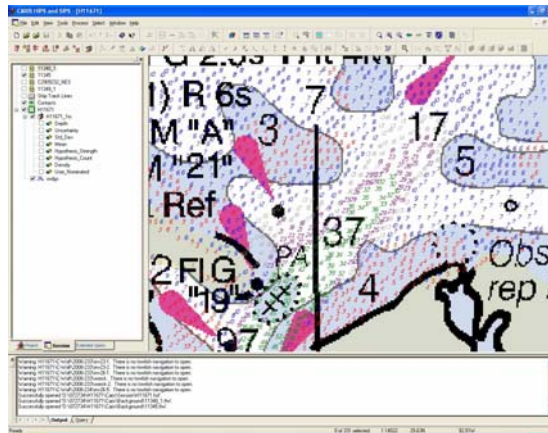
The shape of the 6-foot contour shoals found in Vermillion Bay have changed.

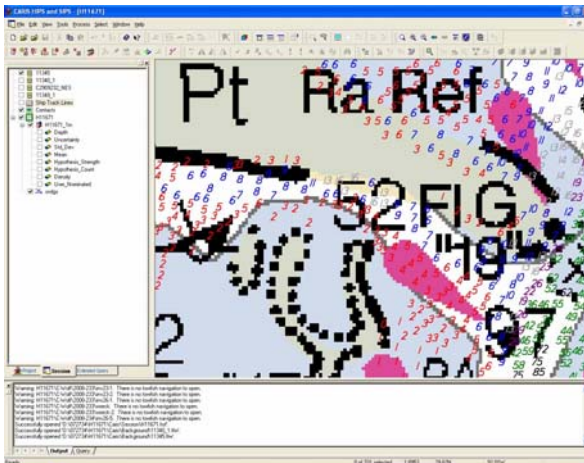
There are discrepancies found in the two side channels inside the Southwest Pass, which extend to the west from the main channel. Both have shoaled.

Concur with above remarks concerning shifting shoals.

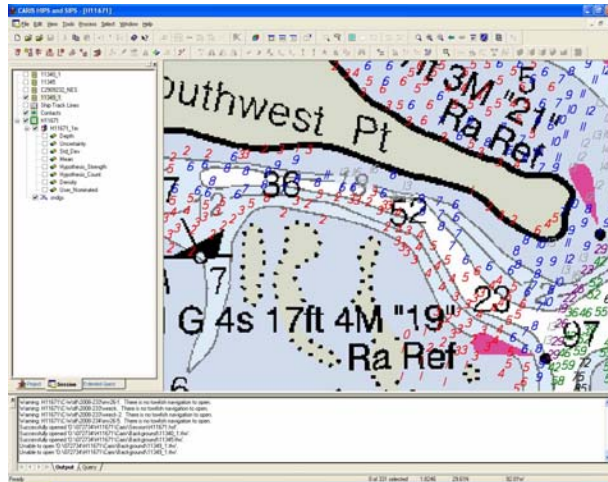
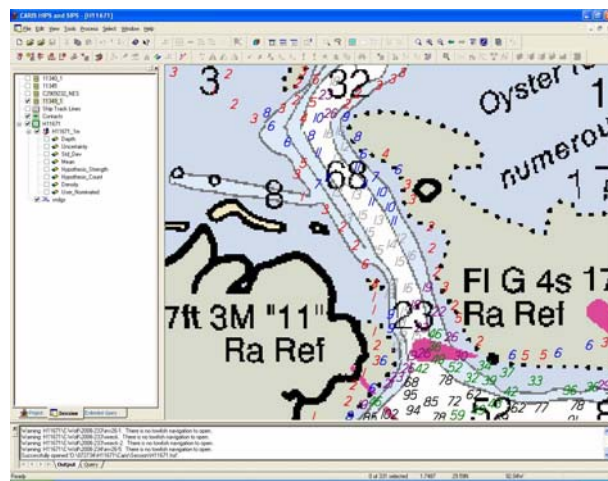
Do not concur due to examples given below.

There are discrepancies found in the two side channels inside the Southwest Pass, which extend to the west from the main channel. Both have shoaled.

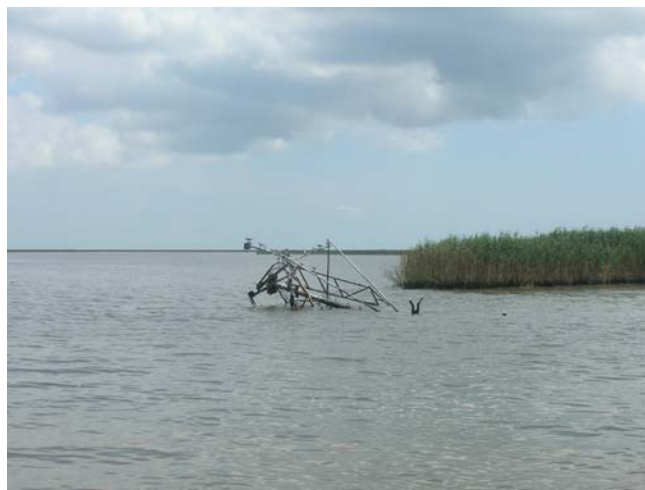
There are two uncharted visible wrecks within the survey area. The first wreck is located along the shoreline of Marsh Island in Vermillion Bay at 29°36'43.925"N, 91°59'17.663"W. This wreck is exposed approximately 4 feet at MHW. This wreck was not considered dangerous because of its proximity to the shoreline. Its charted position on chart 11349 falls on the land. The following image displays this wreck. *Do not concur. Chart visible wreck at surveyed position. S-57 updated to include SORIND, SORDAT. Height value given negative sign.*

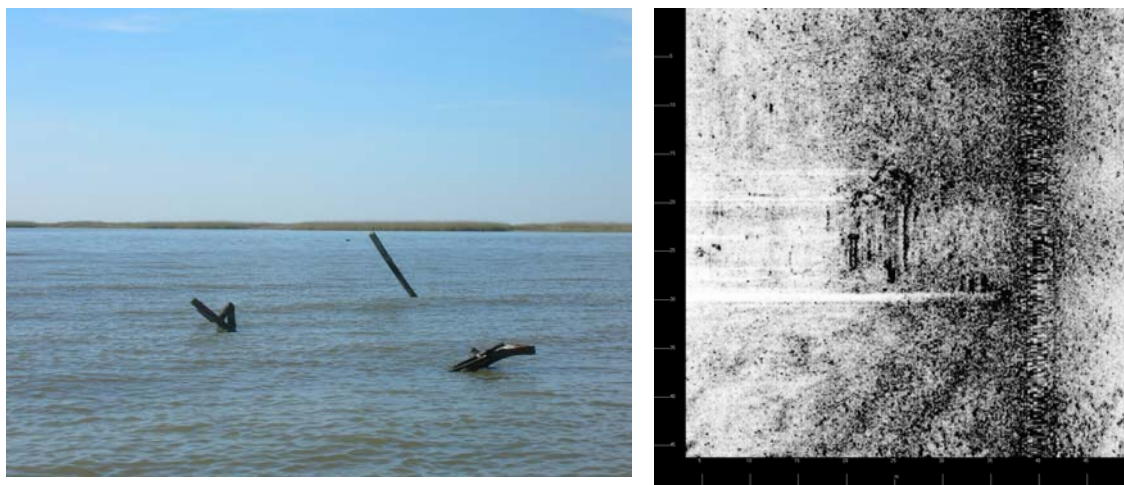
The second uncharted visible wreck is at the tip of currently charted oyster reefs at 29°36'46.490"N, 92°01'01.874"W. This wreck lies in water that is approximately 0 – 3 feet deep, and is exposed approximately 1 foot at MHW. The following images display the visible portion of the wreck, and the side scan data collected of the wreck at high tide. *Concur with clarification. Chart visible wreck at surveyed position. S-57 attributes updated.*

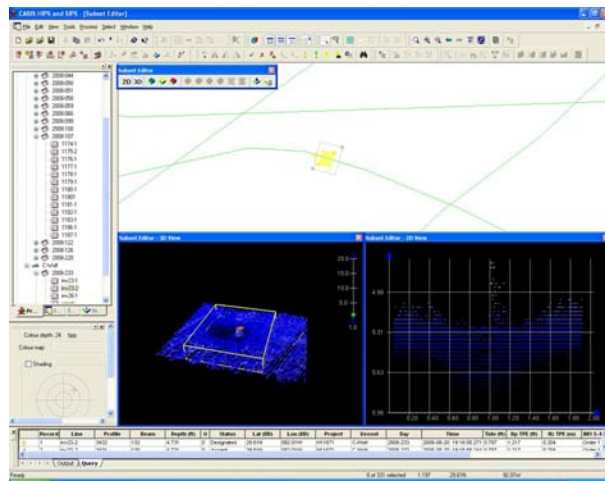
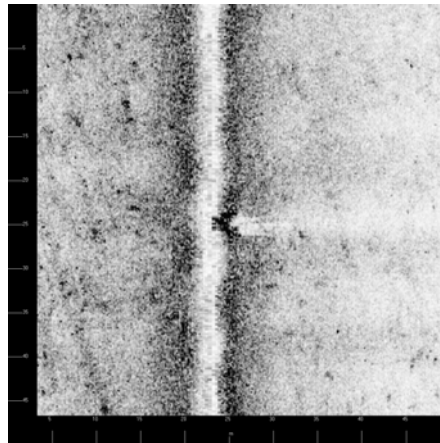
Item 1

Least Depth: 4.731ft

Hydrographer's recommendations: This contact has been marked as a designated sounding within the H11671 Caris project submitted in conjunction with this report. It is recommended that this contact be charted as a 5-foot submerged obstruction at 29° 36' 33.152" N, 92° 00' 47.576" W (WGS84).

Do not concur. Current surrounding depths in this area have changed drastically from the chart and are in the 4-ft range. Chart current surveyed soundings.

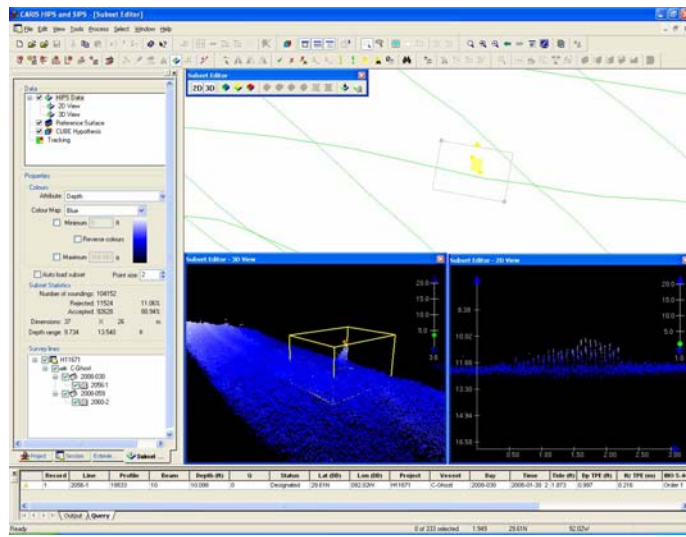
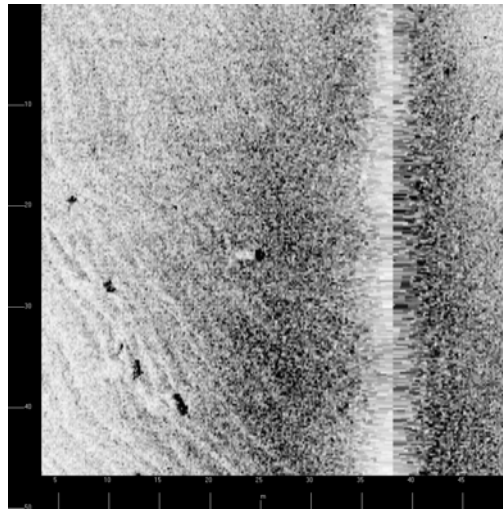
Item 2

Hydrographer's recommendations: This contact has been marked as a designated sounding within the H11671 Caris project submitted in conjunction with this report. It is recommended that this contact be charted as a 10-foot submerged obstruction at 29° 36' 48.982" N, 92° 00' 57.334" W (WGS84).

***Do not concur. Current surveyed soundings preclude item's significance.
Chart current soundings.***

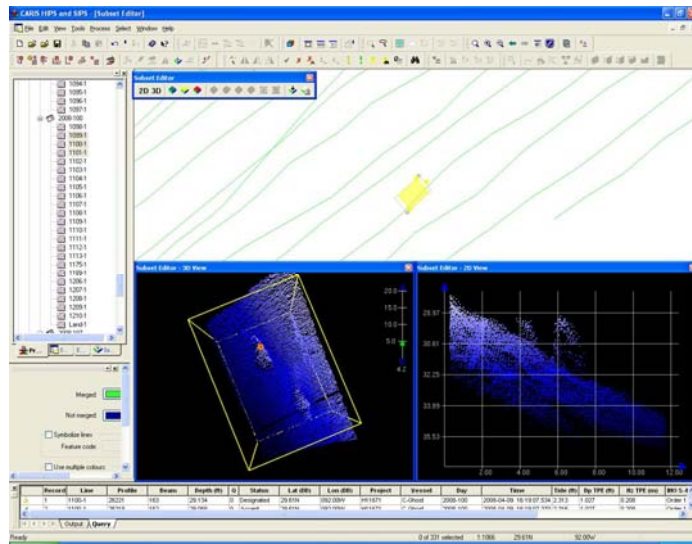
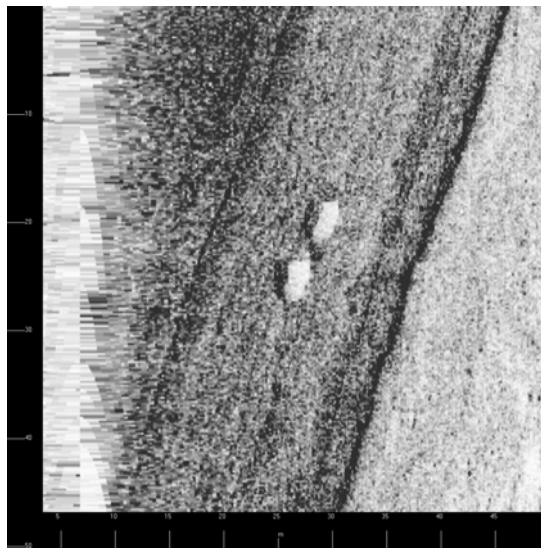
Item 3

Hydrographer's recommendations: This contact has been marked as a designated sounding within the H11671 Caris project submitted in conjunction with this report. It is recommended that this contact be charted as a 29-foot submerged obstruction at 29° 36' 23.392" N, 92° 00' 12.719" W (WGS84).

Do not concur. Shoaler depths in the vicinity of this item precludes it's significance. Chart current soundings.

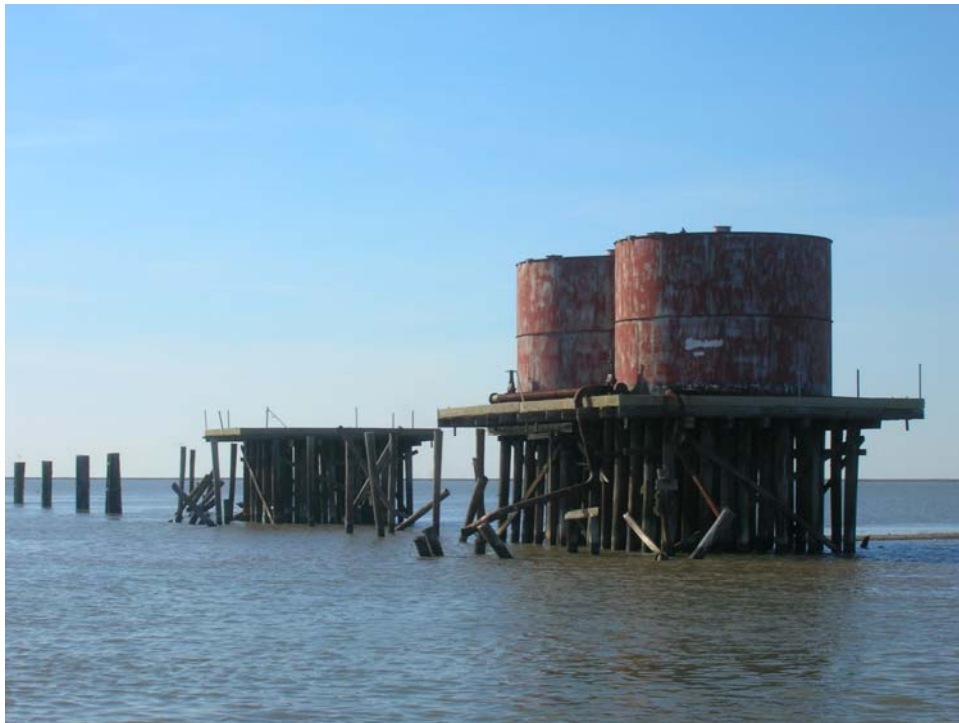
There are two large storage tank structures, standing on piles, found in the following locations that are currently uncharted. ***Concur.***

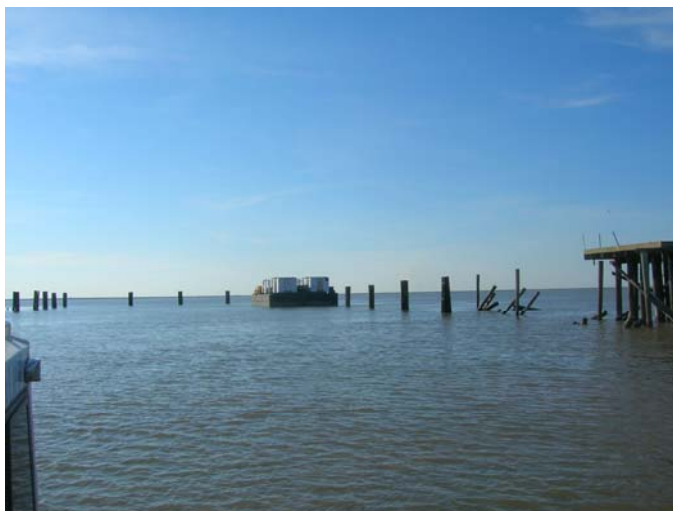
There are twenty-one piles surrounding a barge terminal area.

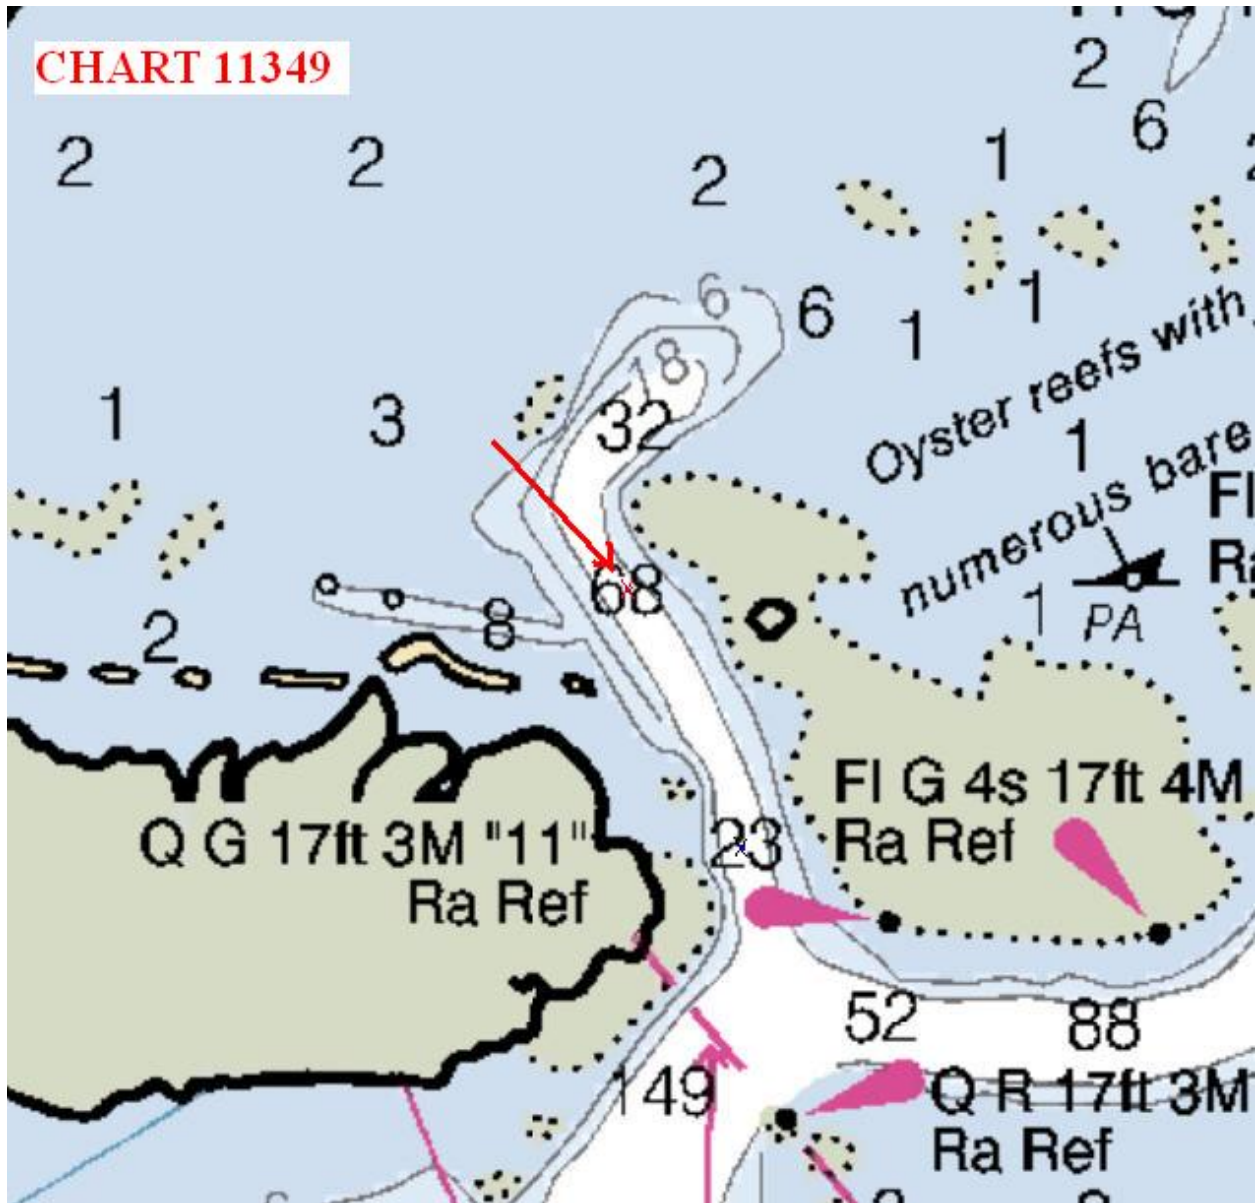
Figure 1.1.1

Geo object 1: Sounding (SOUNDG)
Attributes: EXPSOU - 1:within the range of depth of the surrounding depth area
INFORM - 12-ft sounding on a charted 68
OBJNAM - DtoN#1
QUASOU - 6:least depth known
SORDAT - 20080821
SORIND - US,US,nsurf,H11671
TECSOU - 3:found by multi-beam

This sounding is being sent as a DtoN. It is recommended that this west channel spur be closed off.

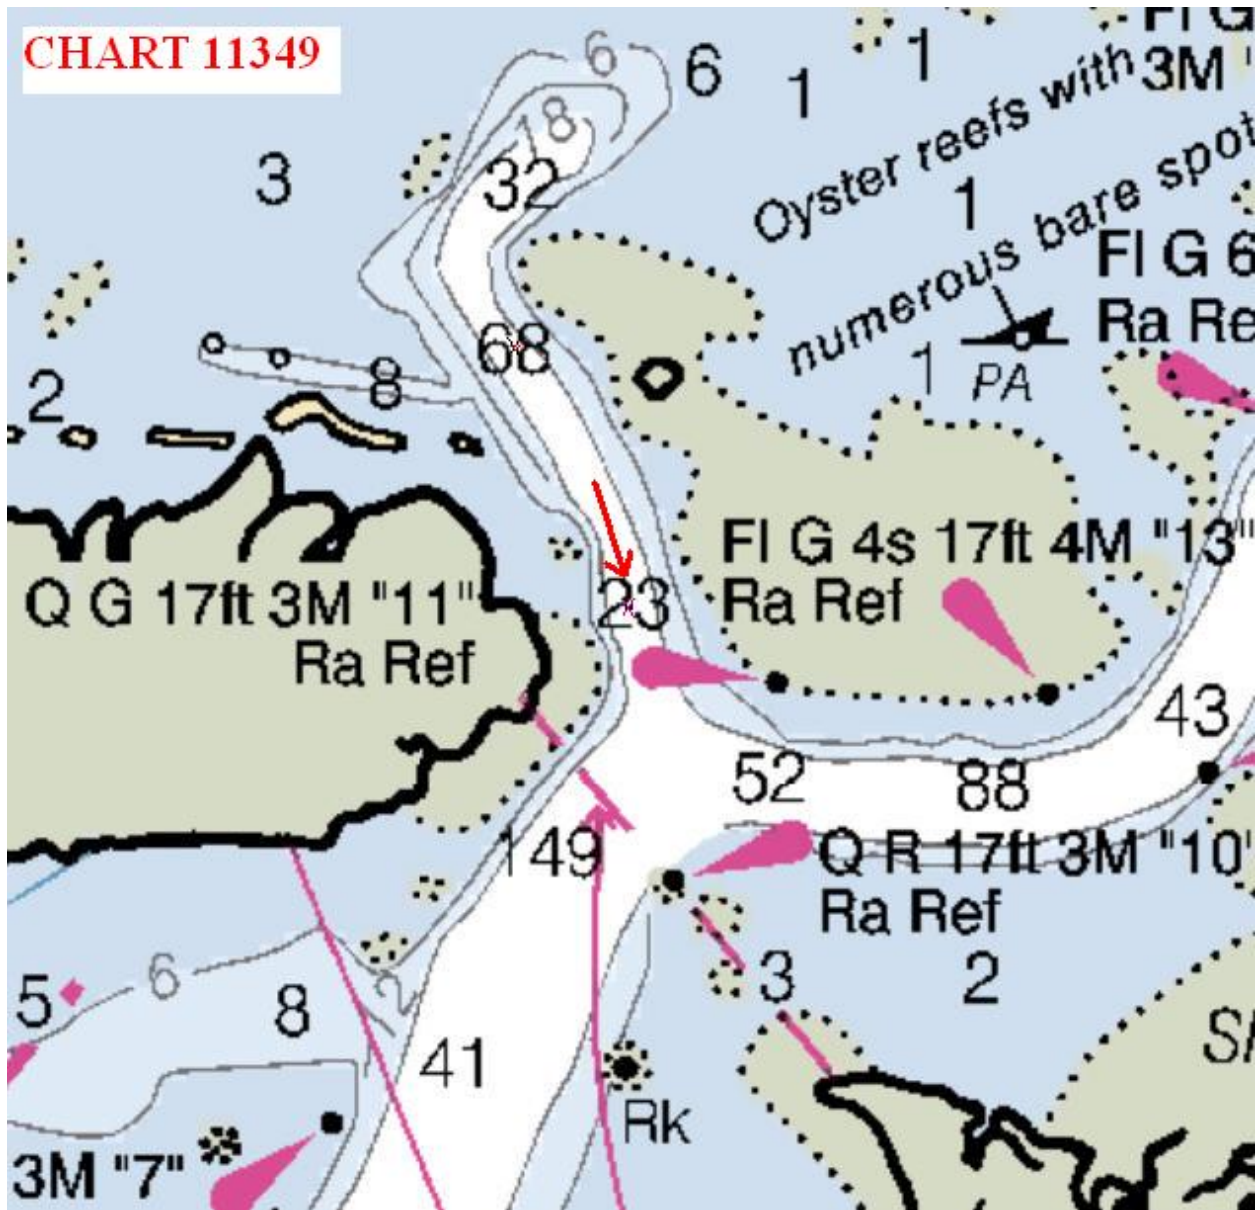
Figure 1.2.1

Geo object 1: Sounding (SOUNDG)
Attributes: EXPSOU - 1:within the range of depth of the surrounding depth area
 INFORM - 14-ft sounding on a charted 23
 OBJNAM - DtoN#2
 QUASOU - 6:least depth known
 SORDAT - 20080821
 SORIND - US,US,nsurf,H11671
 TECSOU - 3:found by multi-beam

This sounding is being sent as a DtoN. It is recommended that this west channel spur be closed off.

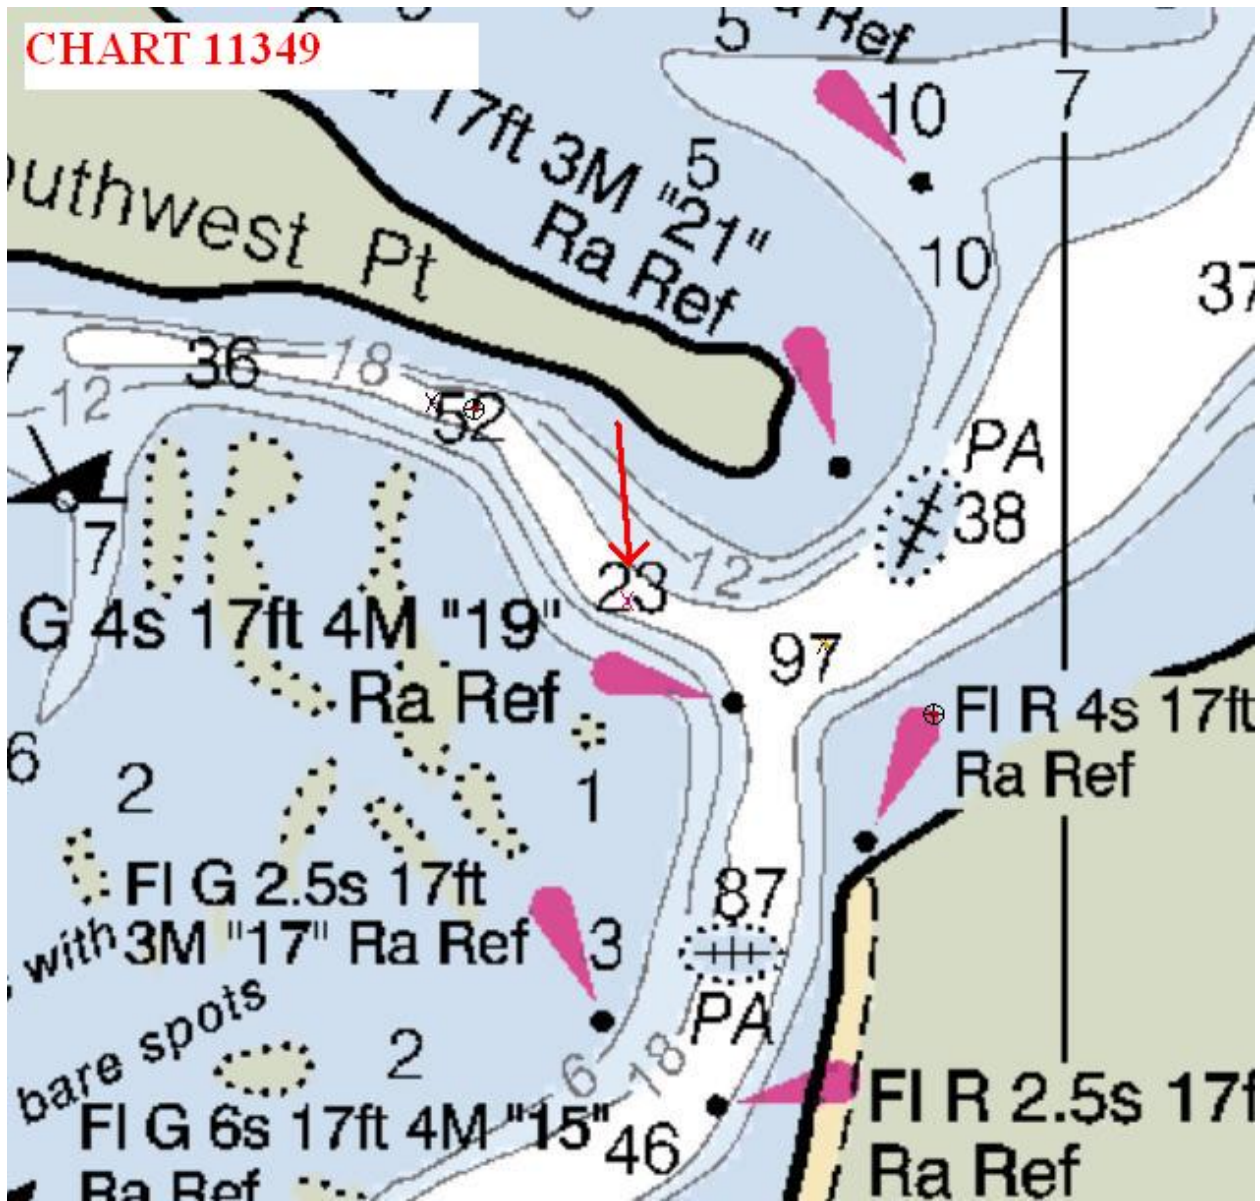
Figure 1.4.1

Geo object 1: Sounding (SOUNDG)
Attributes: EXPSOU - 1:within the range of depth of the surrounding depth area
 INFORM - 3-ft sounding on a charted 23
 OBJNAM - DtoN#4
 QUASOU - 6:least depth known
 SORDAT - 20080821
 SORIND - US,US,nsurf,H11671
 TECSOU - 3:found by multi-beam

This sounding is being sent as a DtoN. It is recommended that this west channel spur be closed off.

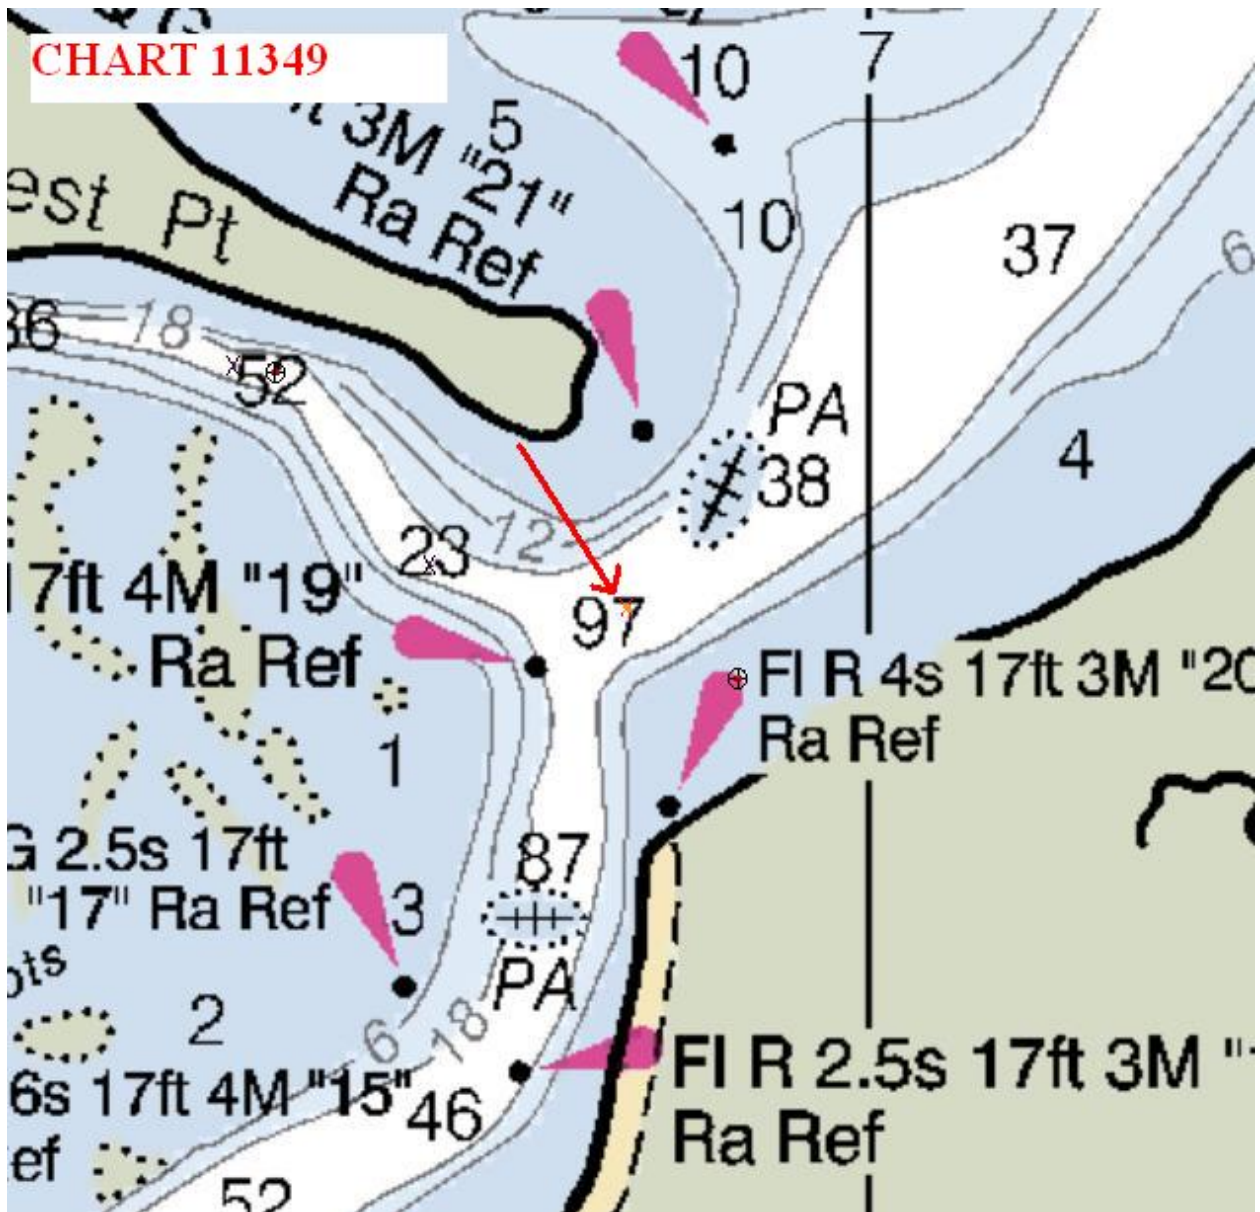
Figure 1.5.1

A 39-ft sounding (final tides applied) with surrounding soundings of 39-41 feet were found on the charted 97. Significant shoaling has occurred, especially into the western spur.

This sounding is being sent as a DtoN. Depths corrected with final tides show the vicinity of charted 97 ft to be 39 - 41 ft.

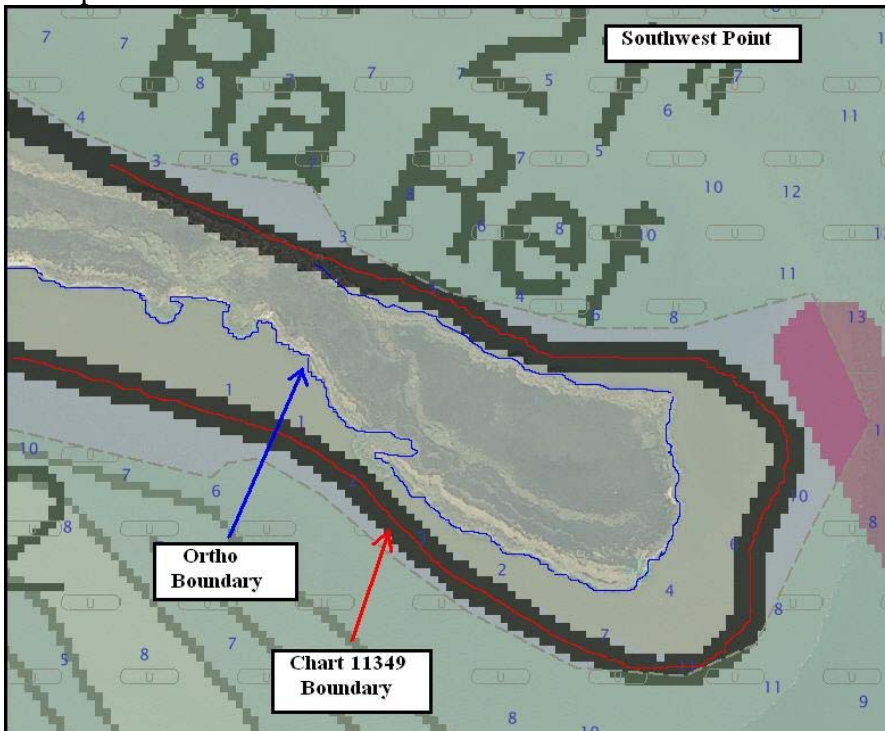
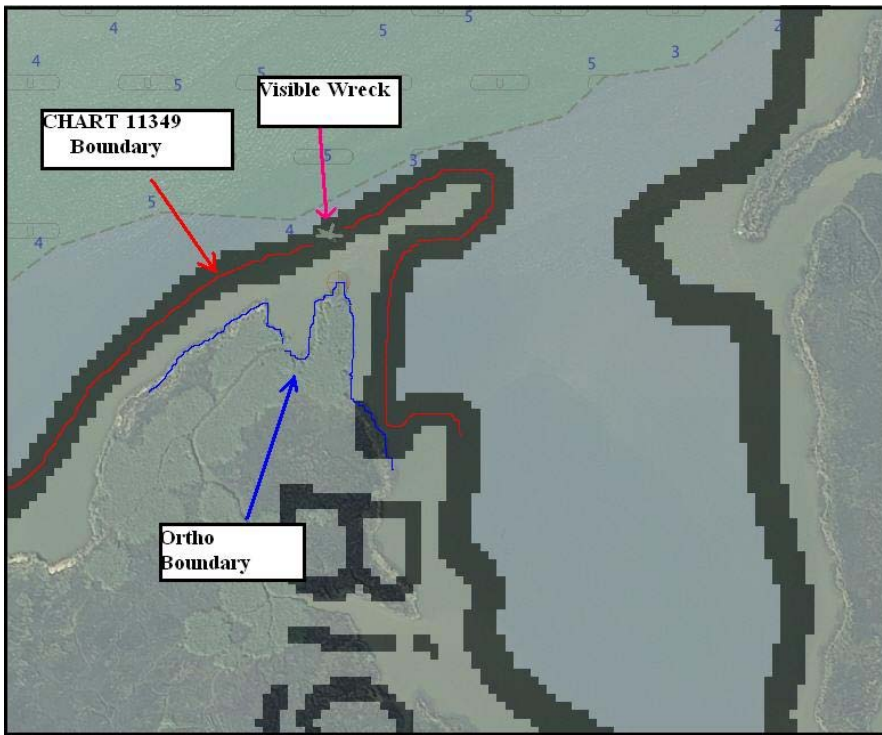
The following screen grabs shows in detail the charted shoreline and ortho imagery discrepancies:
