Type of Survey HYDROGRAPHIC
Field No.
Registry No. H11859

Descriptive Report to Accompany Hydrographic Survey H11859

Project *OPR-N338-KR-08*

Columbia River, Oregon

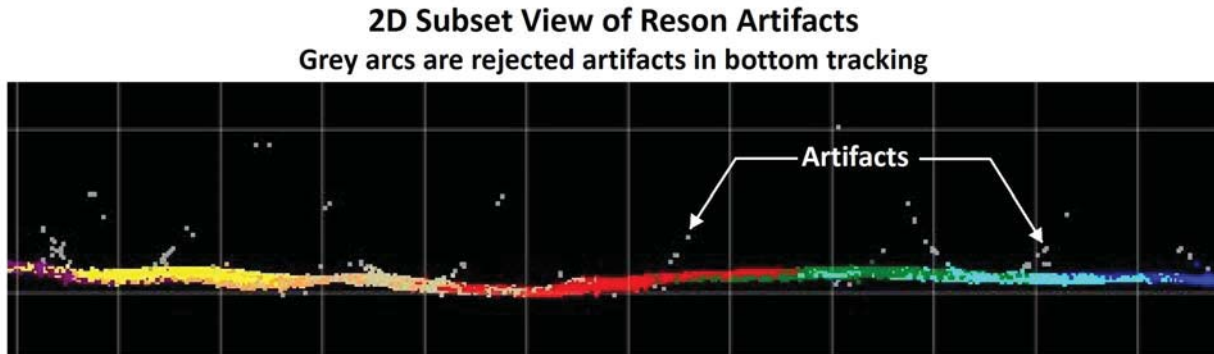
Figure 2. Artifacts in Reson 7125 Bottom Tracking Algorithm

There is an error in the Reson 7125 bottom tracking algorithm that causes bottom detection (beams 86-115 and 140-168) to lock on to stronger sonar returns bleeding over from more nadir returns. This may be related to the amplitude bottom detection used near nadir and the bottom detection locking on to the strong nadir return signal, rather than the actual bottom return for that designated beam area. These artifacts occur in two areas near nadir and are more prevalent on a hard bottom, when the amplitude of the nadir return is the strongest. The artifacts run along track and can exceed 20 centimeters in the raw soundings, but are reduced to 5 to 10 centimeters in the CUBE surface (Figure 2).⁵ Attempts to remove these artifacts during survey operations with

changes in sonar settings were unsuccessful. Reson is aware of this issue and is working towards a resolution with a different bottom tracking algorithm.

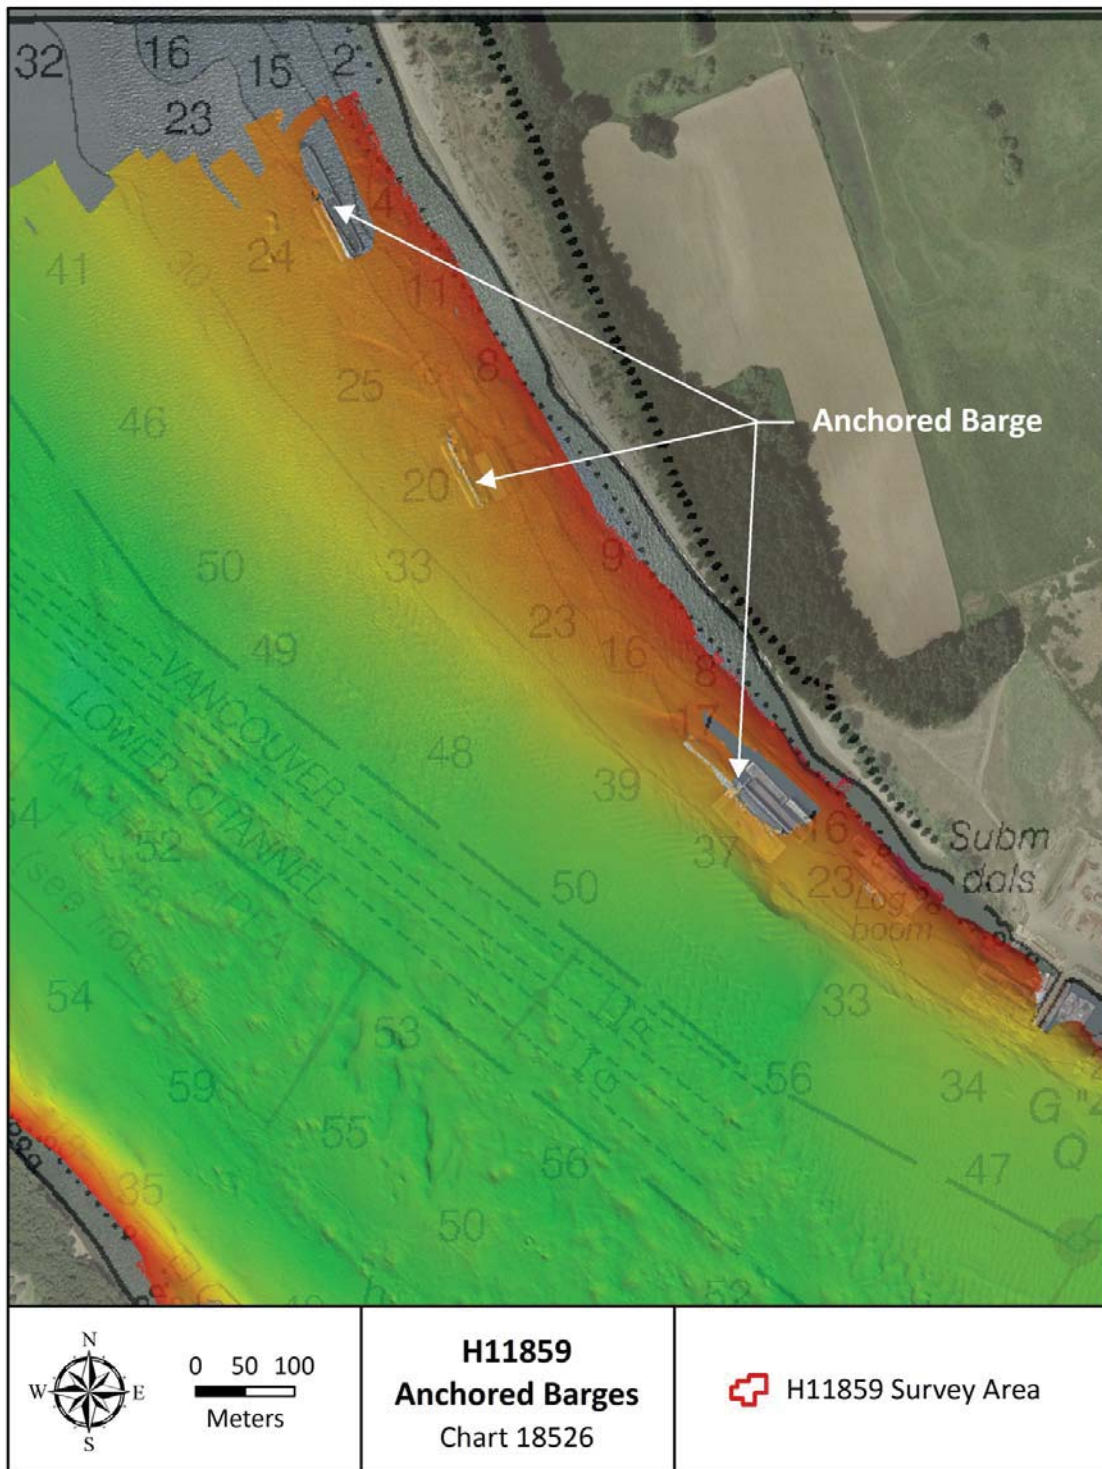
Figure 3. Anchored Vessels in Survey Area

There are holidays in the multibeam coverage in the Columbia River where barges were anchored (Figure 3).⁸ Survey crews attempted to acquire data as close to the barges as possible and returned repeatedly in order to fill in data gaps. In areas where it was not possible to obtain complete coverage a HYPACK target was taken and the area was noted in the log.

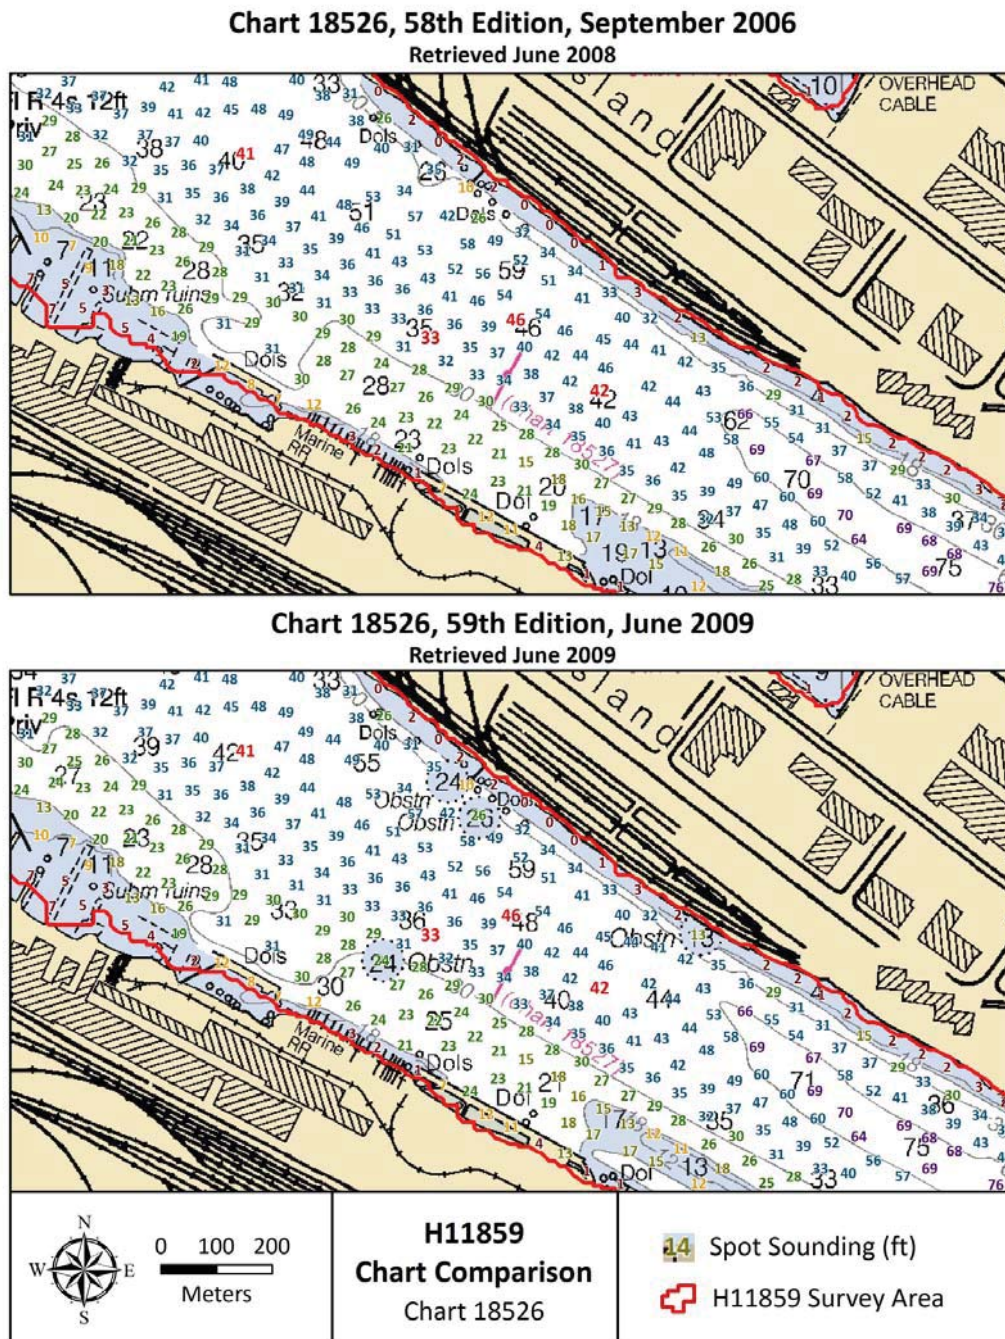
Figure 4. Current Bathymetry on Different Versions of RNC 18526

deeper soundings depicted on the chart by 2 feet which is approximately the difference observed in Edition 59 of chart 18526. The hydrographer recommends immediate evaluation of chart 18526, as there are navigationally significant variations between this and previous versions of the chart.¹⁵ The hydrographer also recommends that the current bathymetry for H11859 supersede charted soundings in all common areas.¹⁶ It appears that the largest scale chart 18527 (1:5,000), which shares a common area in the Willamette River around Swan Island has not been updated.

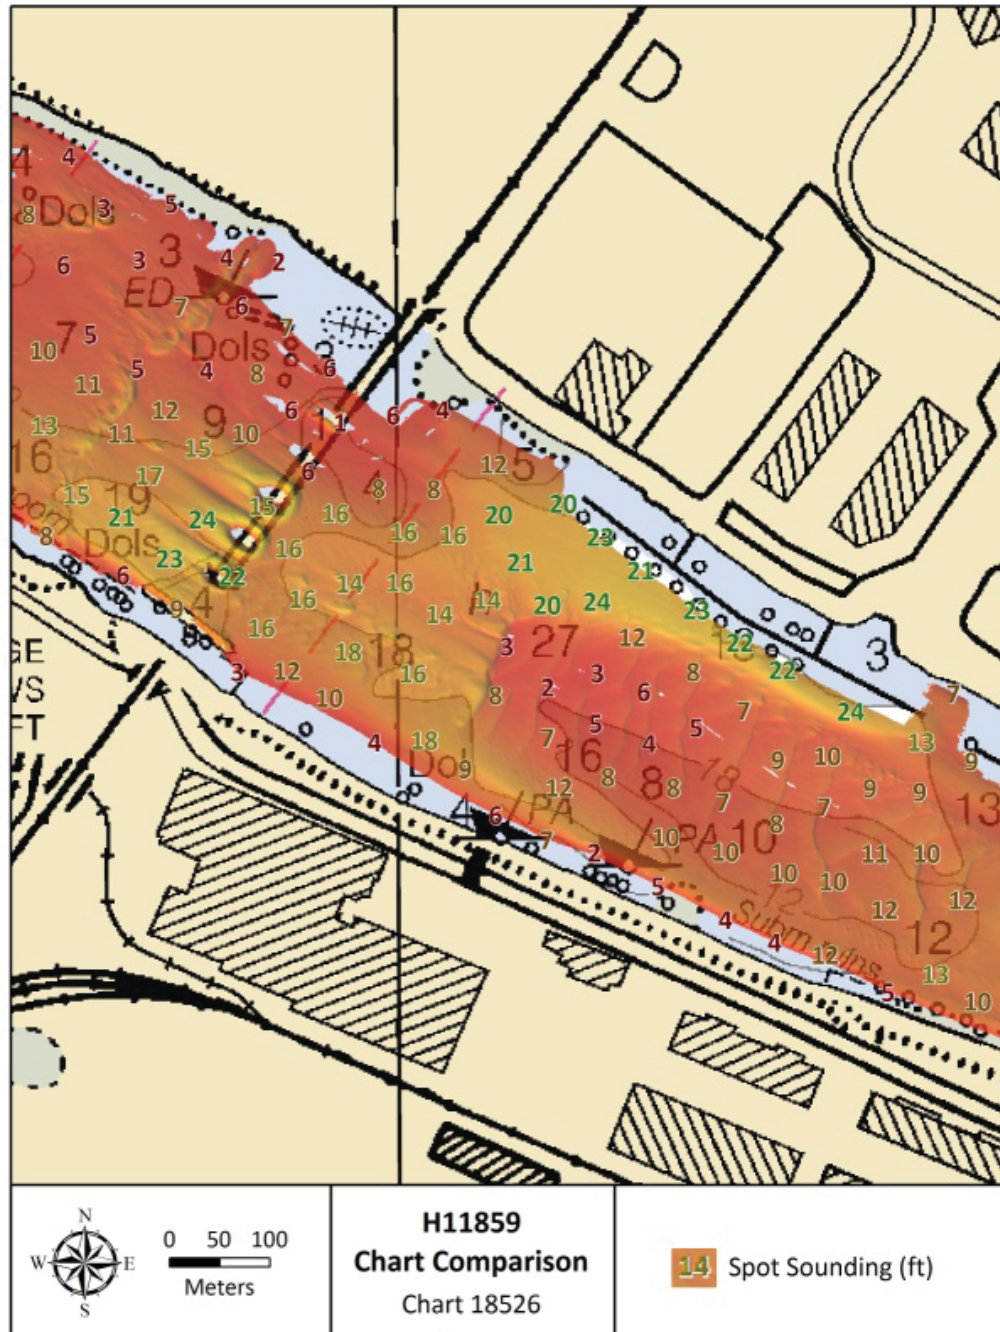
Figure 5. Significant Shoaling in the North Portland Harbor of the Columbia River

Significant shoaling from sand wave migration has occurred up river of the Burlington Northern Swing Bridge (Figure 5) in North Portland Harbor. The surveyed shoal reduces the depth of the middle of the river, south of Hayden Island, to 2.34 feet (0.71m). Charted depths in this area range from 17 to 30 -feet (5.4 to 9.1m).¹⁷

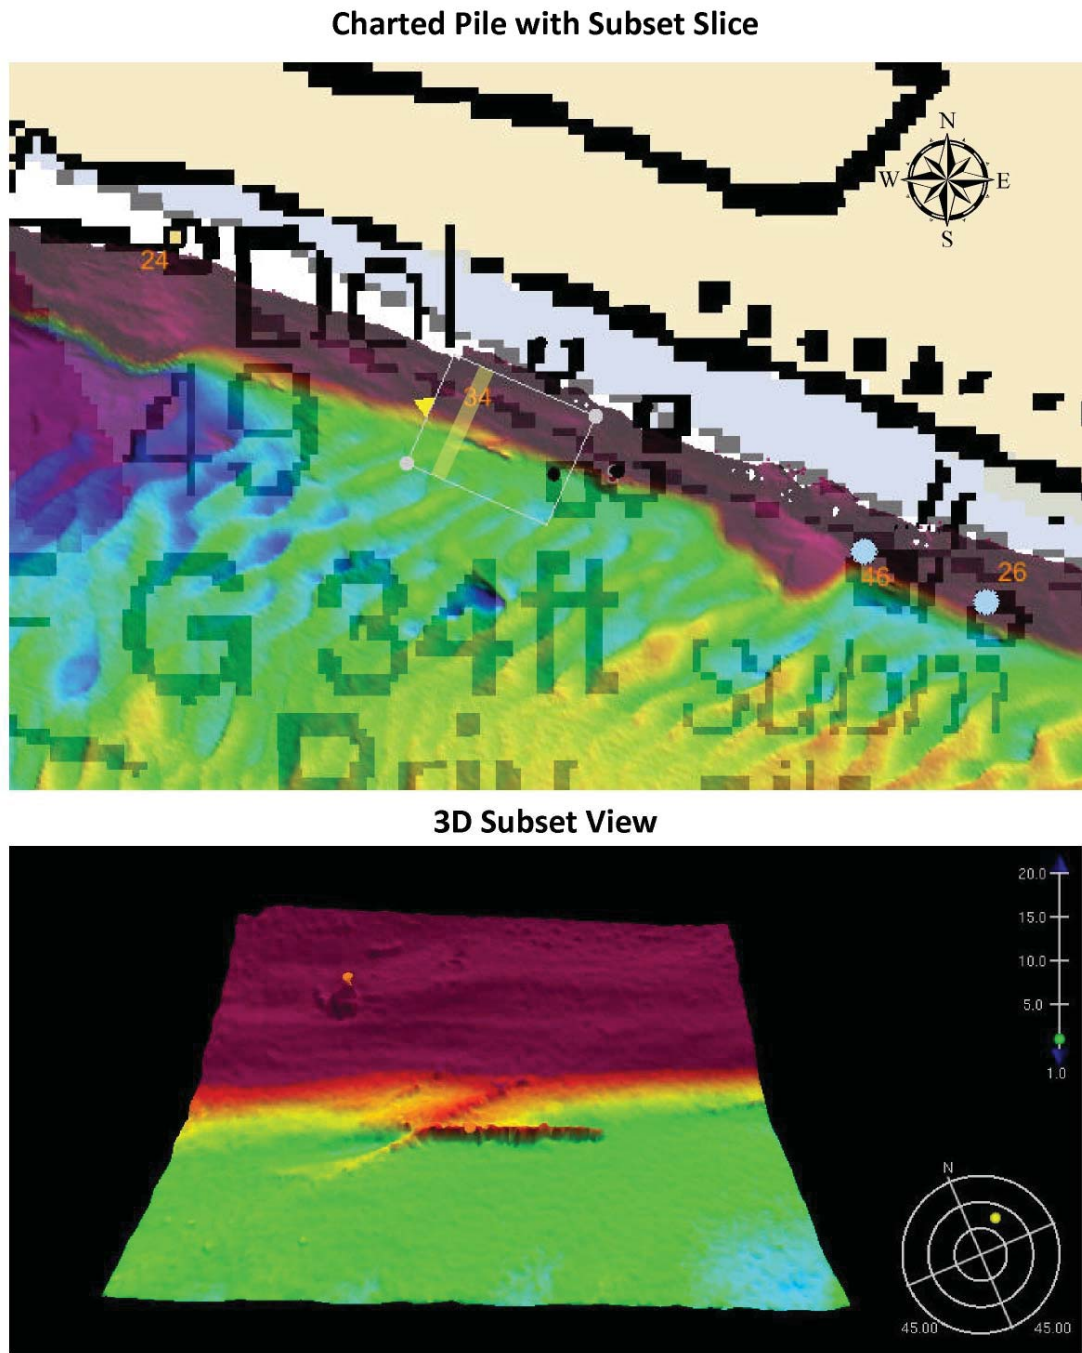
Figure 9. Submerged Features Near Charted Pile (Chart 18526)

The charted pile in the Columbia River outside of Vancouver Range at 45-38-41.40N, 122-43-52.48W was disproved with 100% multibeam. All disproved charted features are listed in Appendix II *Survey Feature Report*. Two features (Figure 9) were located nearby; one is likely a sunken log and the other is a snag or submerged pile. The hydrographer recommends charting this area as depicted in the S-57 feature file.²⁵

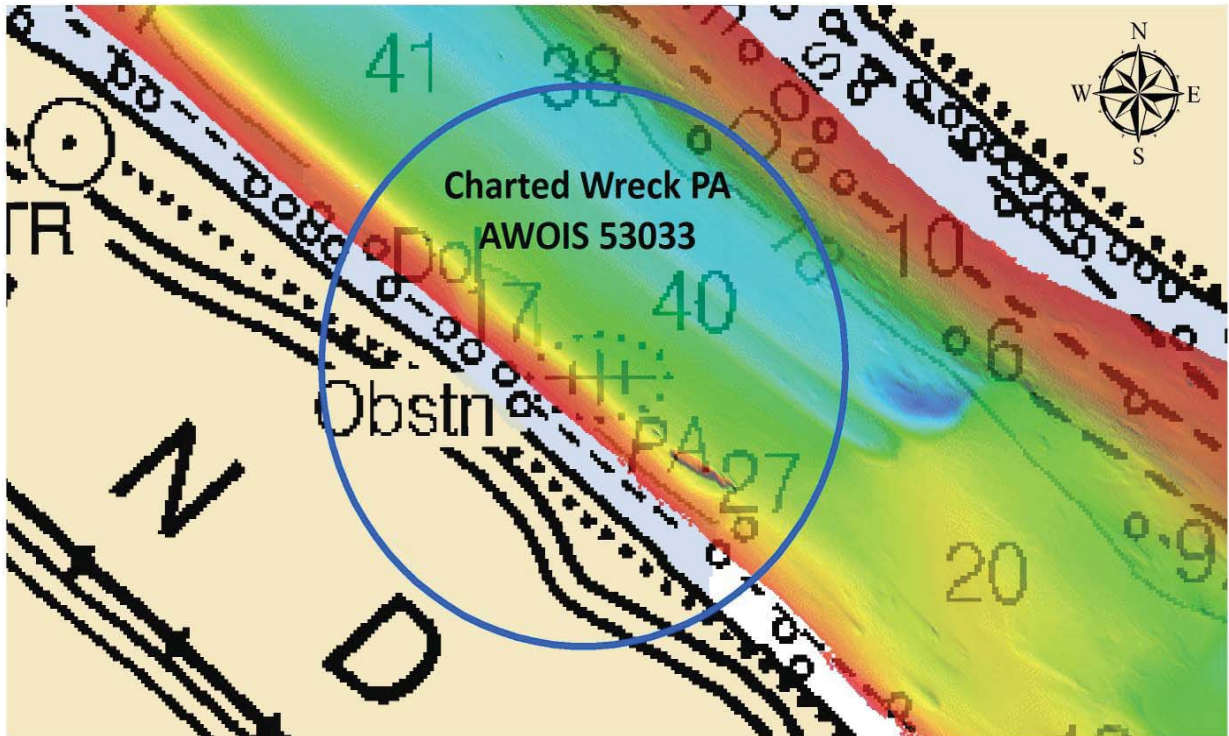
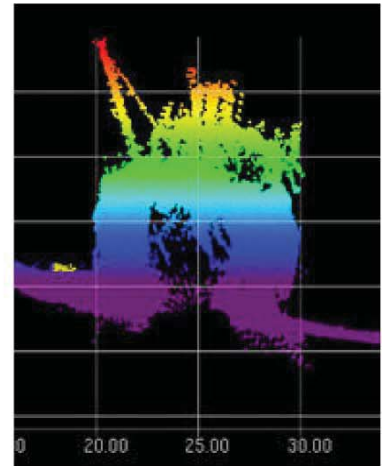
Figure 10. Wreck PA (AWOIS 53033) Located with Shallow Water Multibeam

The PA Wreck (AWOIS 53033) was located with 100% shallow water multibeam coverage at 45-37-20.91N, 122-43-15.7W (Figure 10). Multibeam acquisition on the wreck was done at a high stage of tide, which allowed for an accurate least depth of -3.68 feet (-1.1 meters) above CRD to be obtained. The hydrographer recommends charting the wreck as depicted in the S-57 feature file and removing the PA annotation from the raster chart.³⁰

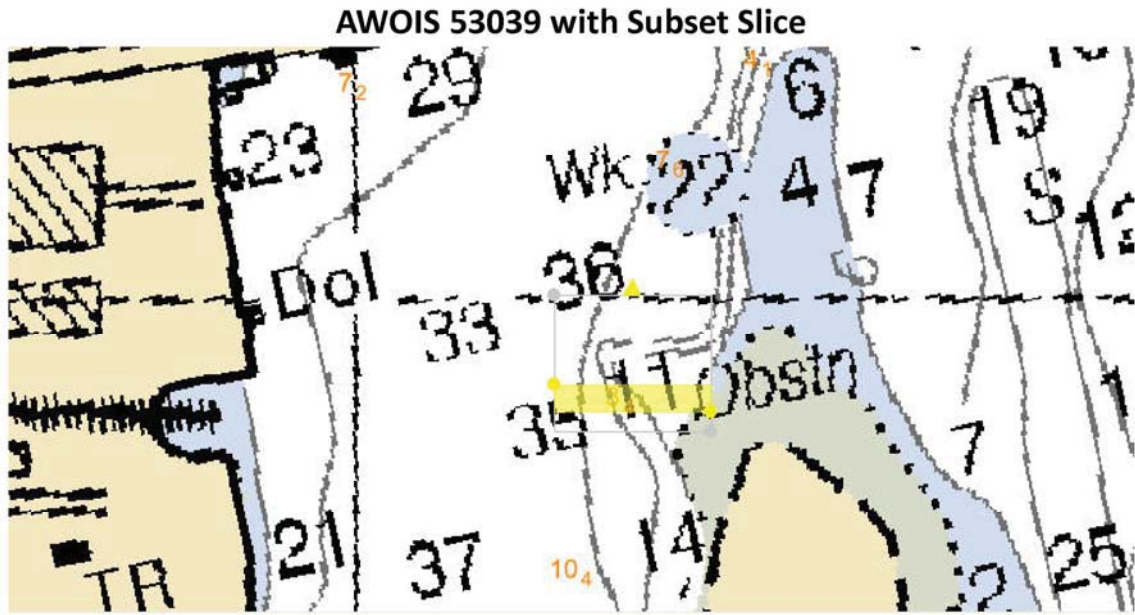
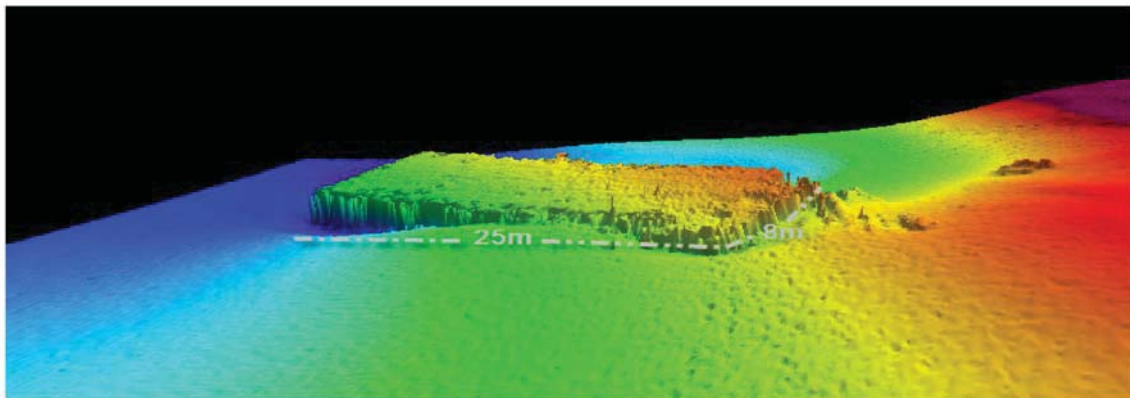
Figure 12. AWOIS 53039 and Charted Wreck

An uncharted Obstrn (AWOIS 53039) was found at 45-29-58.90N, 122-39-54.09W (Figure 12), approximately 33-feet (10 meters) downstream of the AWOIS database position. A recently charted wreck (Dton #2), which is most likely a capsized barge with dimensions similar to AWOIS 53039, is located approximately 300-feet (94 m) down river. Both features stand approximately 9.8-feet (3 m) proud from the river bottom. The survey did not extend far enough inshore to cover the charted obstruction with unknown depth located in the intertidal area at 45-29-59.49N, 122-39-51.278W. The hydrographer recommends charting both the Obstrn (AWOIS 53039) and wreck (Dton #2) as depicted in the S-57 feature file.⁴⁷

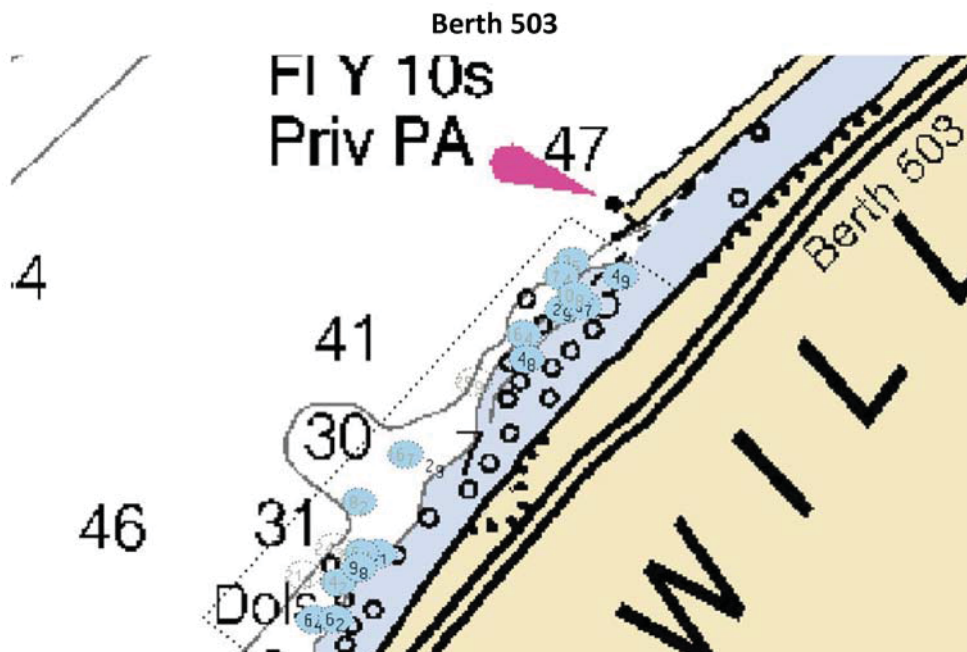
Figure 15. Area Foul with Submerged Dolphins and Piles

Numerous submerged dolphin and pile ruins were located southeast of Berth 503 (Figure 15) in the Willamette River in the vicinity of 45-38-10N, 122-46-55W. Survey lines were run in such a way that nadir or near nadir beams allowed for least depths determination on the submerged features. The hydrographer recommends charting this area foul with submerged obstructions.⁵³

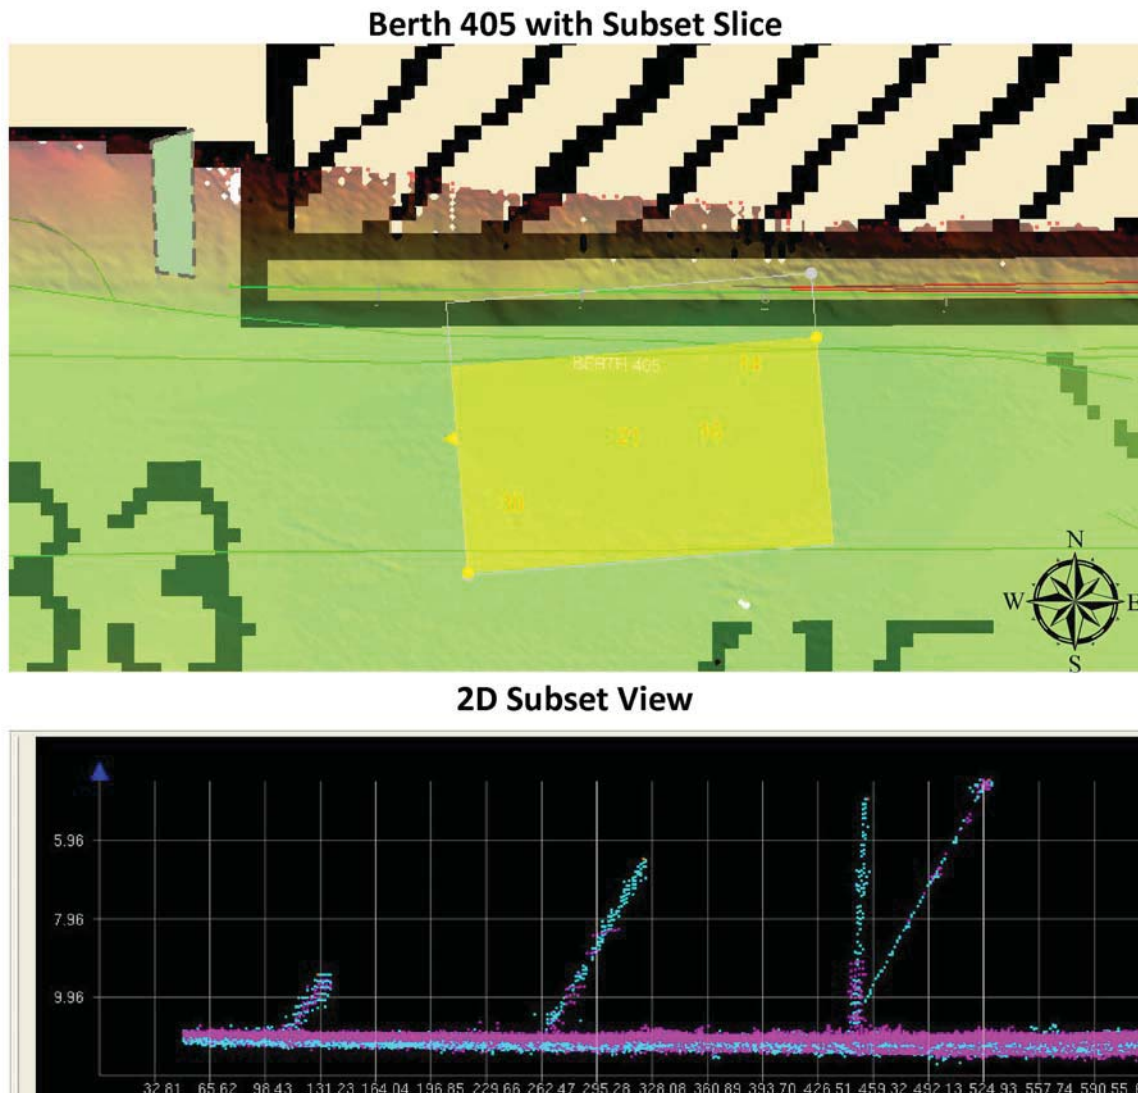
Figure 16. Uncharted Submerged Piles Near the Approach to Berth 405

Submerged piles ruins or snags were located near the approach to Berth 405 (Figure 16) at 45-36-15 N, 122-46-30 W.⁵⁴

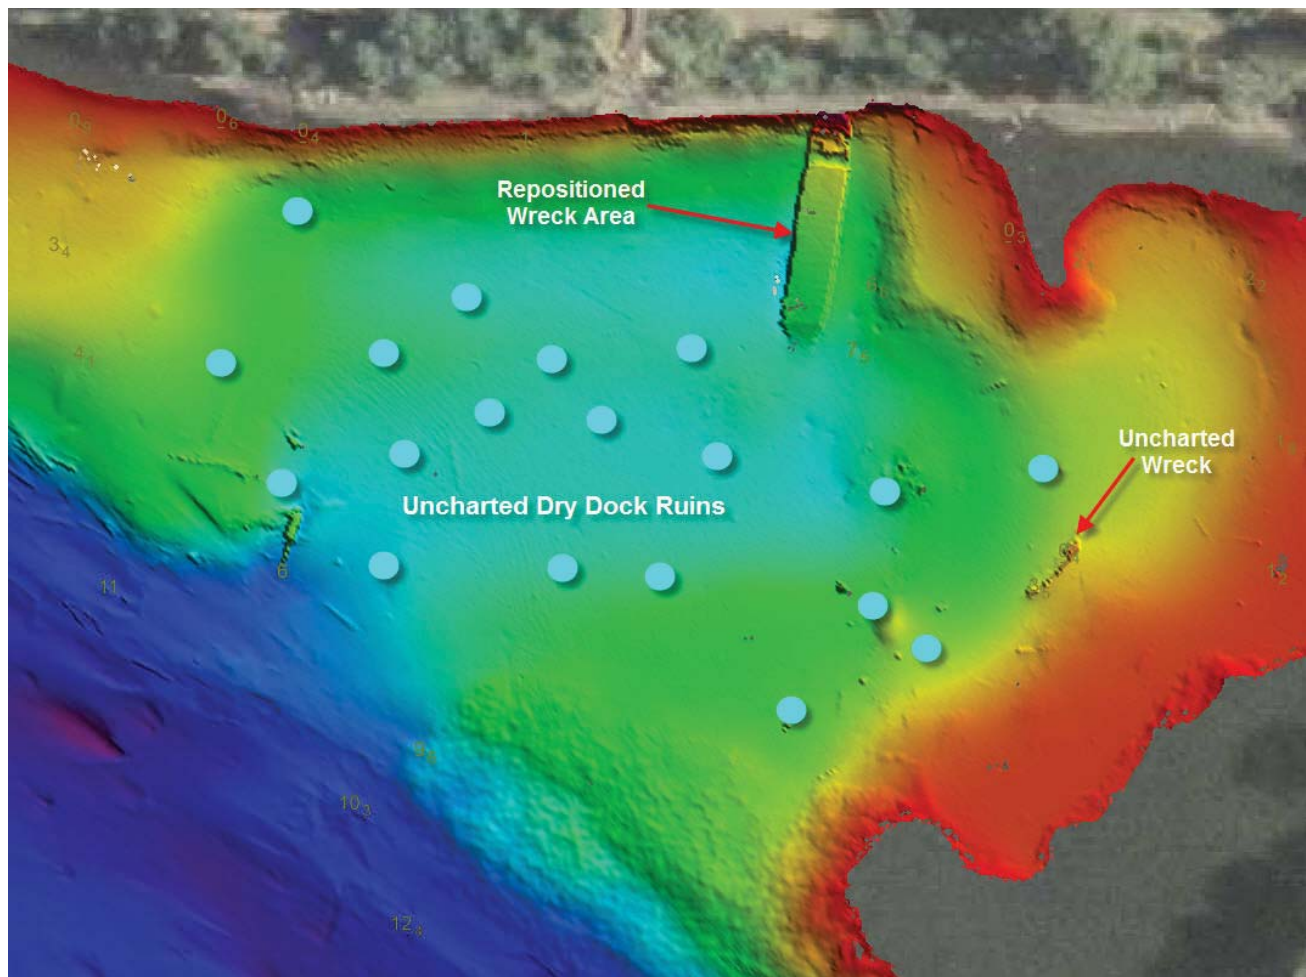
Figure 17. Uncharted Dry Dock Ruins and Wrecks

Numerous submerged features were located in the bay at 45-34-49N, 122-44-51W as shown in Figure 17. The hydrographer believes that the submerged pile ruins are associated with the historic St. John's Shipyard Dock Structure circa 1950. One charted obstruction area and two charted wrecks (point and area) were partially outside of the survey limits and not fully investigated due to the shoal nature of the area. The charted wreck area was surveyed downriver of its charted position and the hydrographer recommends charted as depicted in the S-57 feature file.⁵⁶ Although no indications of the obstruction area or wreck (point) were observed in the multibeam or visually on shore, the Hydrographer recommends retaining these features until disproved by a thorough shoreline feature investigation.⁵⁷ An uncharted obstruction and wreck were also located in the bay and are also included in the S-57 feature file.⁵⁸

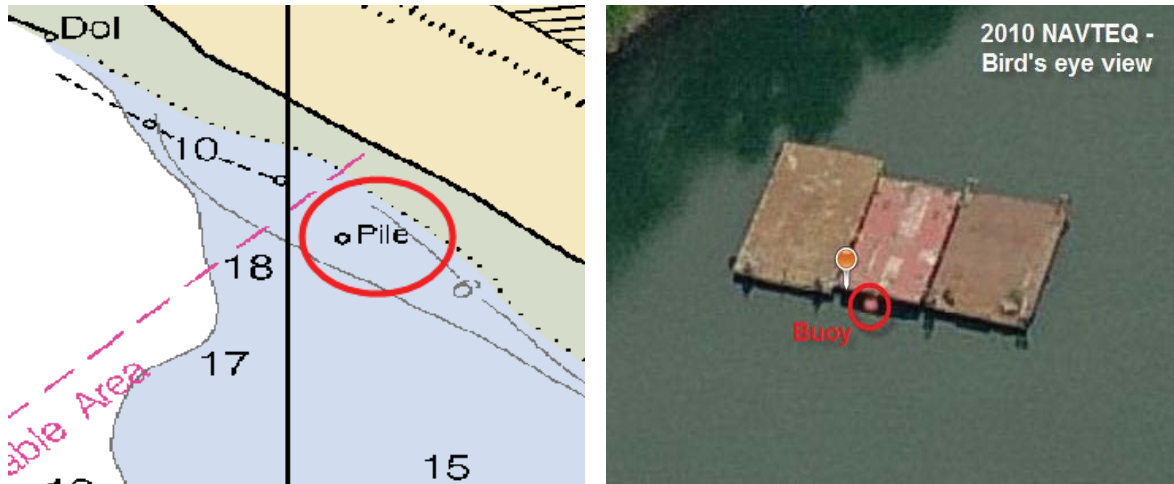
Figure 20. PHB DtoN #1.1 Disproved

Upon further review and based on several aerial images in both Google Maps© and Bing Maps©, PHB DtoN #1.1 was determined to be a buoy chain that extends from a work platform. Figure 20 shows this feature currently charted as a pile and also includes an oblique perspective of this work platform from Bing Maps© Bird's Eye View. The hydrographer recommends removing this feature from the charts.⁷⁸

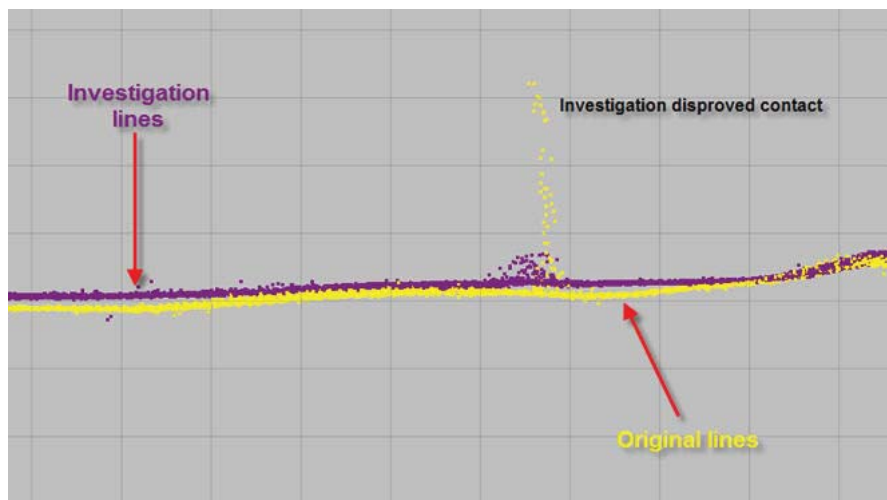
Figure 21. PHB DtoN #1.2 Disproved

The feature identified as PHB DtoN #1.2 was originally identified and disproved by multibeam investigation during survey operations (Figure 21). Disproval of this item, which was possibly transient and knocked down by currents, was unclear in the original submission and has been remedied in the revised submission.⁷⁹

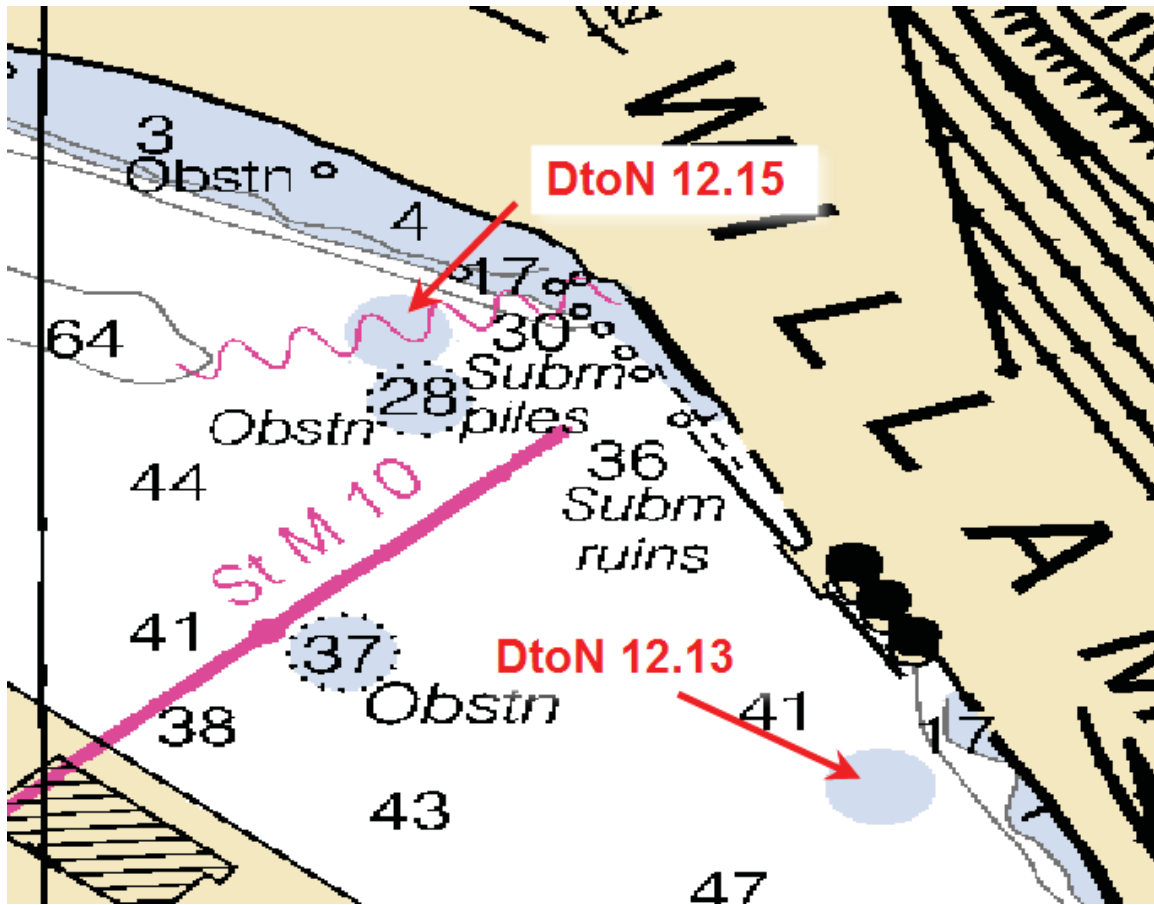
Figure 22. Incorrect Depiction of DtoN 12.13 and 12.15 on Chart 18526

Additionally, Dangers to Navigation 12.13 and 12.15 are incorrectly charted on 18526. Blue obstruction circles have been added to the chart without any least depth information (Figure 22). DtoN 12.15 which also falls within the extents of chart 18527 is depicted correctly on the large scale chart of this area.⁸¹

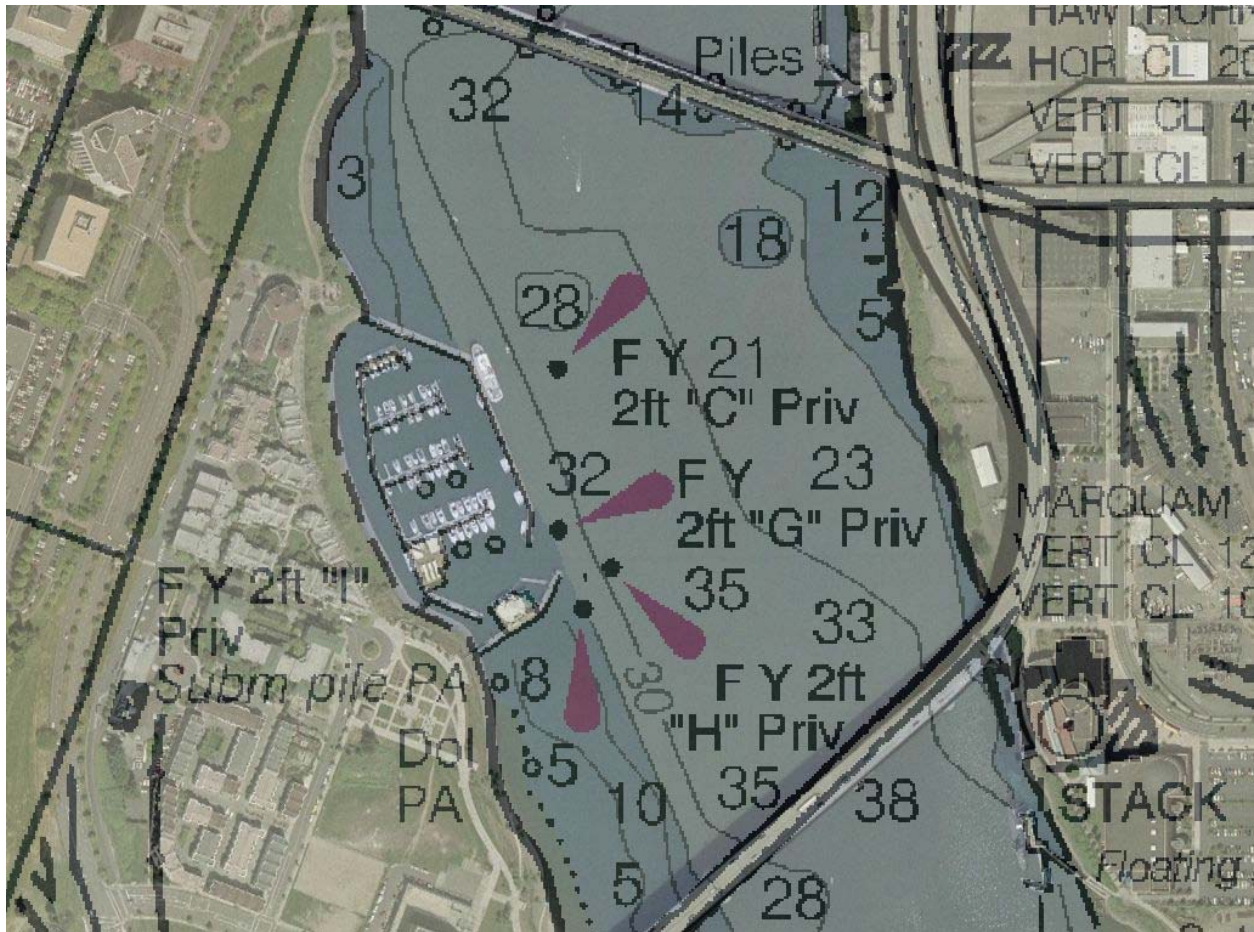
Figure 23. Chart 18526 Overlaid on Google Maps© of River Place Marina; Private Aids on Breakwater

Private aids, shown on RNC 18526 only, in the vicinity of 45-30-40N, 122-40-17W are incorrectly charted. The aids are located on the River Place Marina breakwater and are not, as charted, in the Willamette River (Figure 23). The Hydrographer recommends updating the position of these private aids on both the raster and electronic versions of all applicable charts.⁸⁷

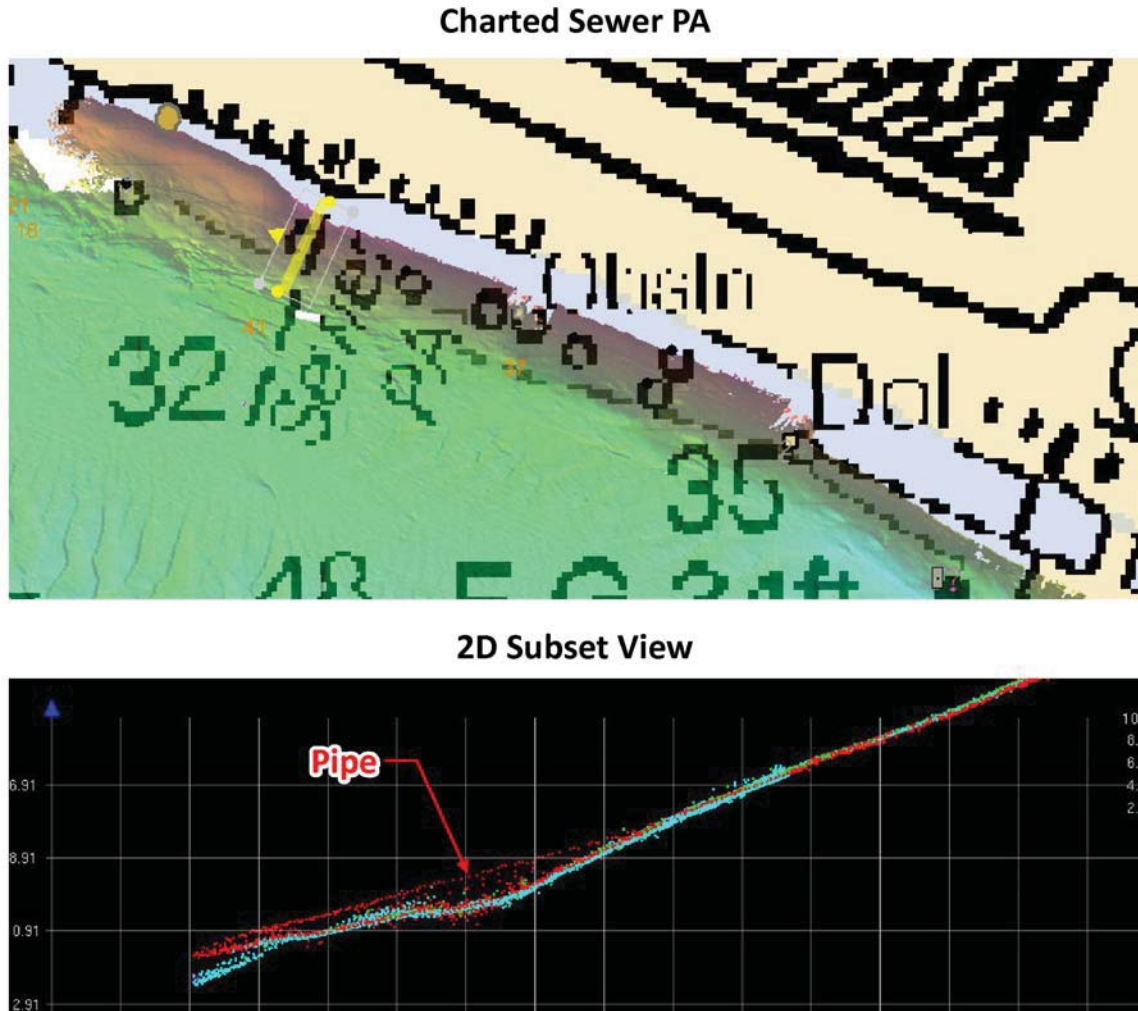
Figure 25. Sewer PA on NOAA Chart 18526

The charted Sewer PA (Figure 25) was located at 45-38-48.4N, 122-44-18.9W. The hydrographer recommends removing the PA annotation and charting as depicted in the S-57 feature file.⁹⁴

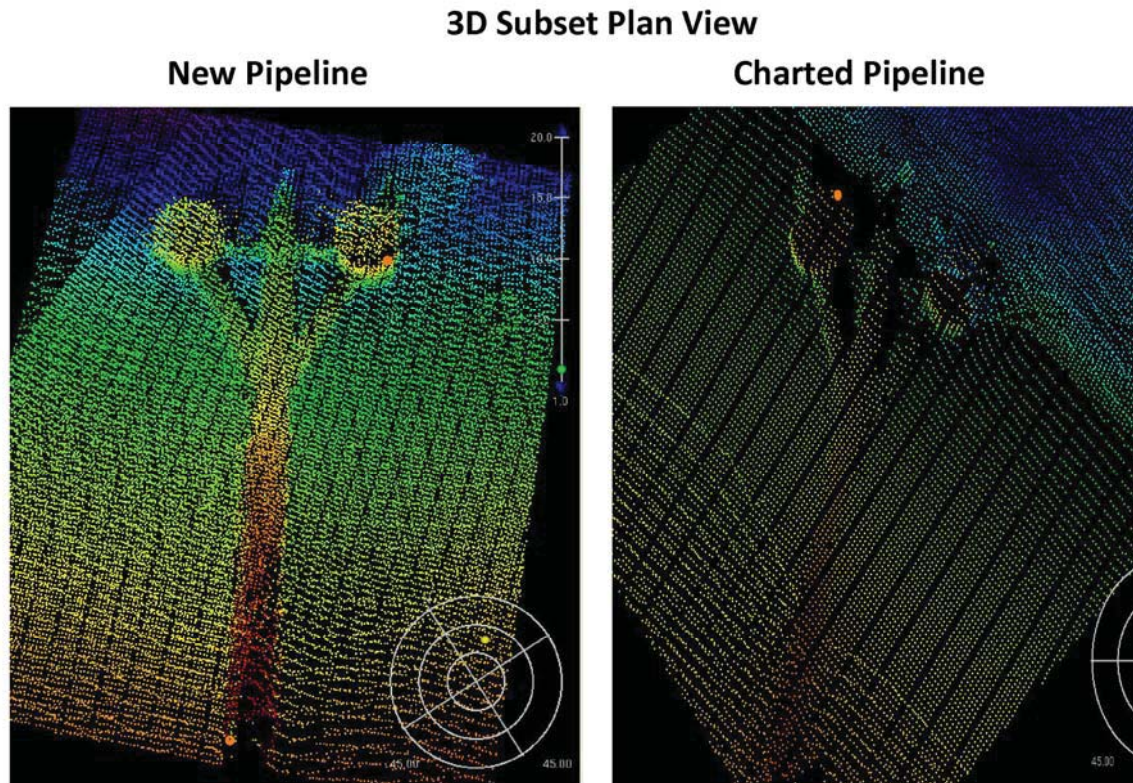
Figure 26. Pipeline Structures

The pipelines, shown on ENC USOR15M only, at 45-34-13.913N, 122-44-28.615W, and 45-34-22.66N 122-44-42.67W were verified. An uncharted pipeline was located nearby at 45-34-18.62N, 122-44-33.51W. The shape of this pipeline is identical to the structure of the charted pipeline (Figure 26). The hydrographer recommends charting the pipeline as depicted in the S-57 feature file.¹⁰⁰

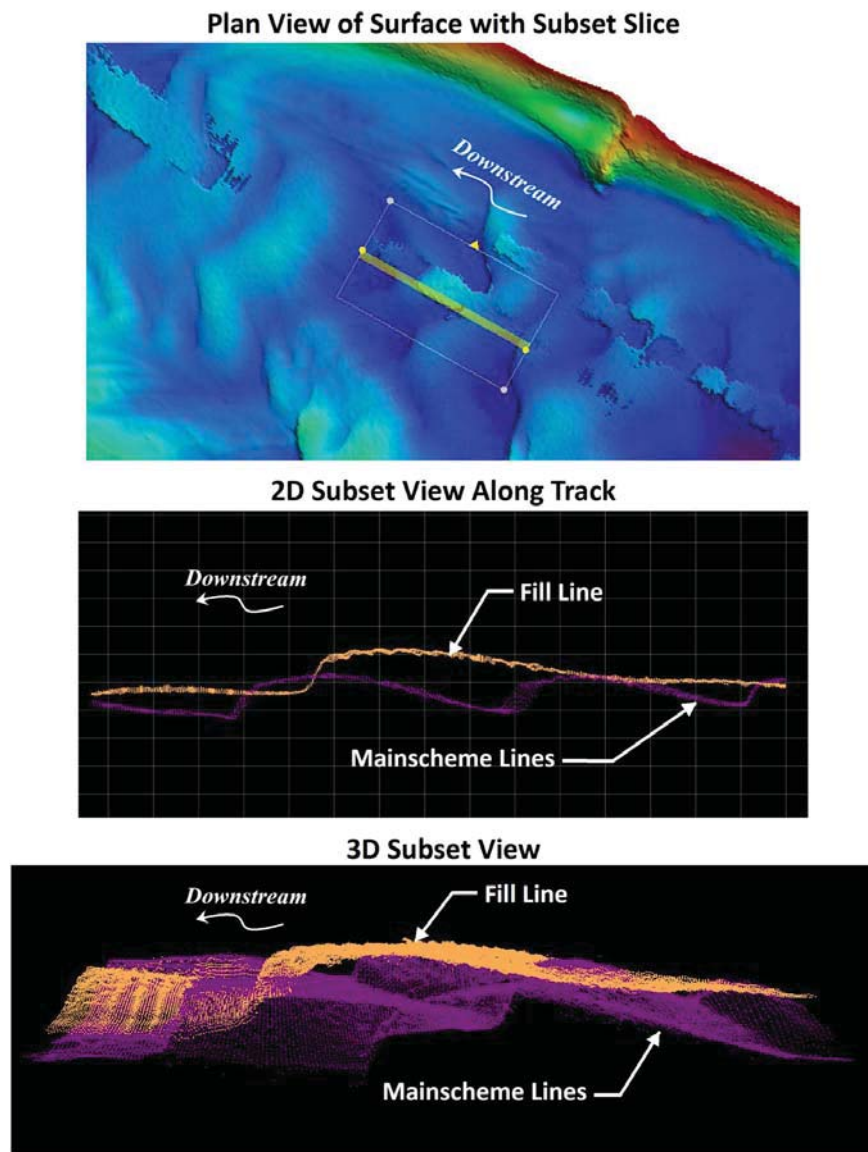
Figure 27. Sand Wave Migration

The difference in offset varies over the survey, depending upon the local sand wave formation and the time between fill and main scheme data collection. Figure 27 shows an example of downstream sand wave migration impacting agreement between main scheme and fill data.

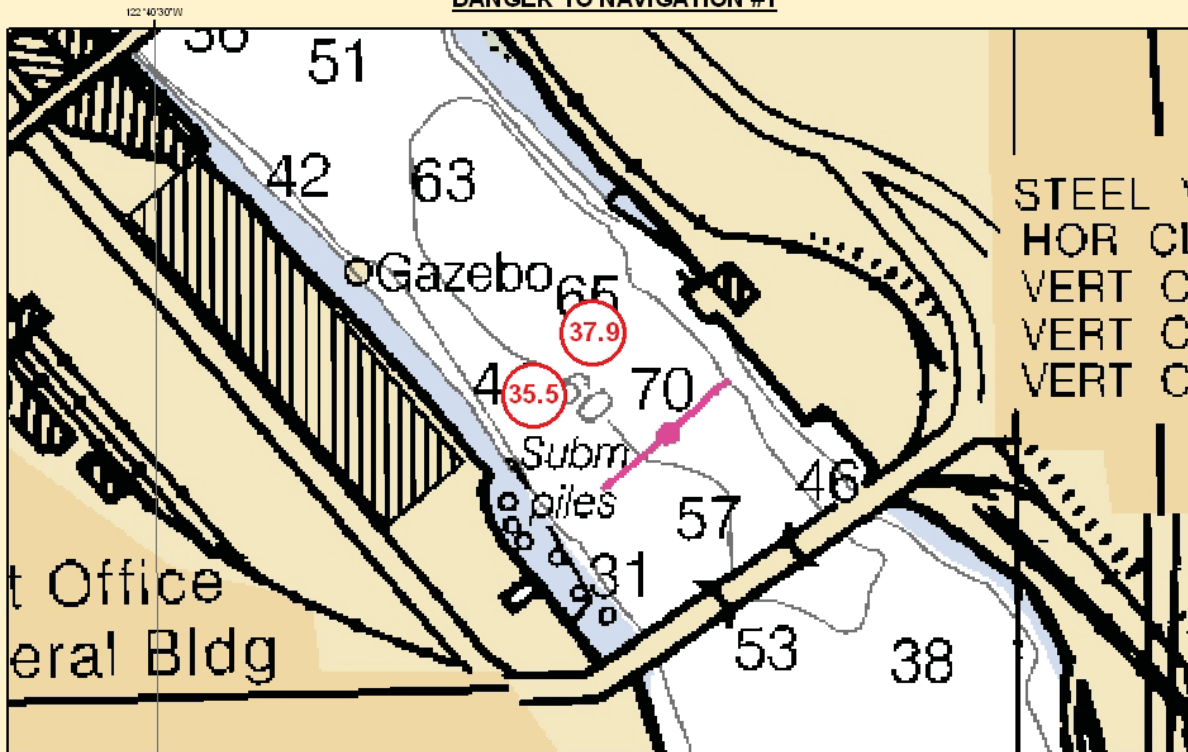
DANGER TO NAVIGATION #1

Large mounds in highly navigated waters. Approximate dimensions of 34m x 34m x 9.5m

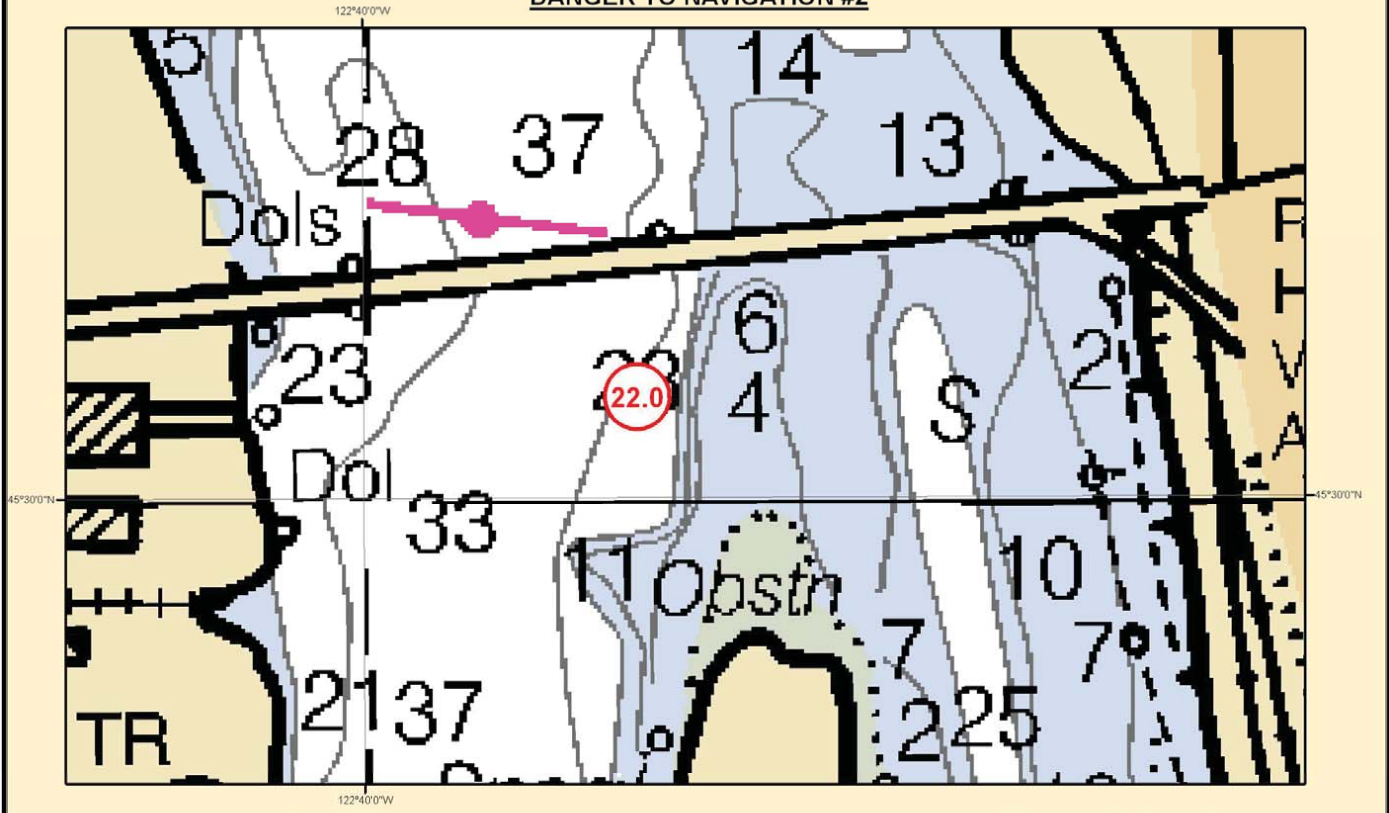
DANGER TO NAVIGATION #2

Barge. Approximate dimensions of 25m x 8m x 2.3m.
