Type of Survey HYDROGRAPHIC
Field No.
Registry No. H11859

Descriptive Report to Accompany Hydrographic Survey H11859

Project *OPR-N338-KR-08*

Columbia River, Oregon

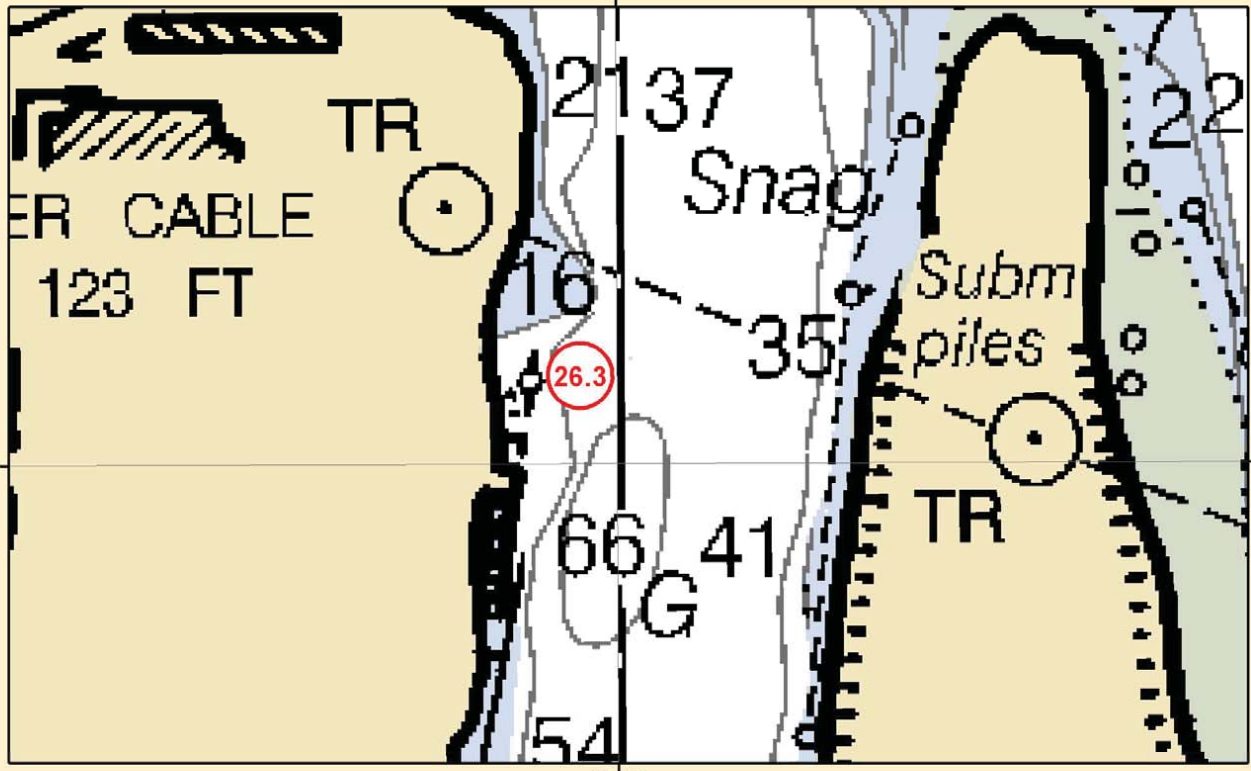
DANGER TO NAVIGATION #3

Sailboat. Approximate dimensions of 22m x 20m x 3.6m

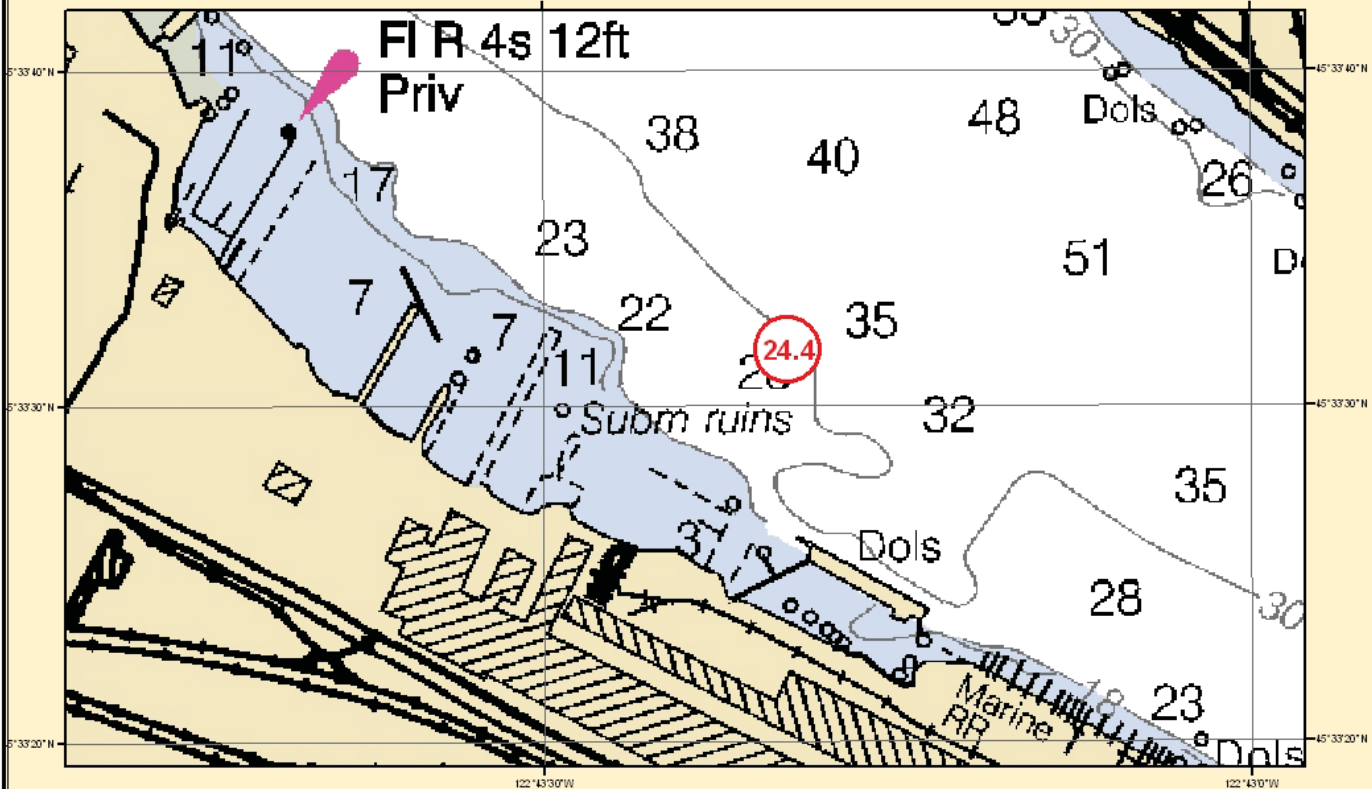
DANGER TO NAVIGATION #4

Linear object. Approximate dimensions of 10m x 2m x 1m

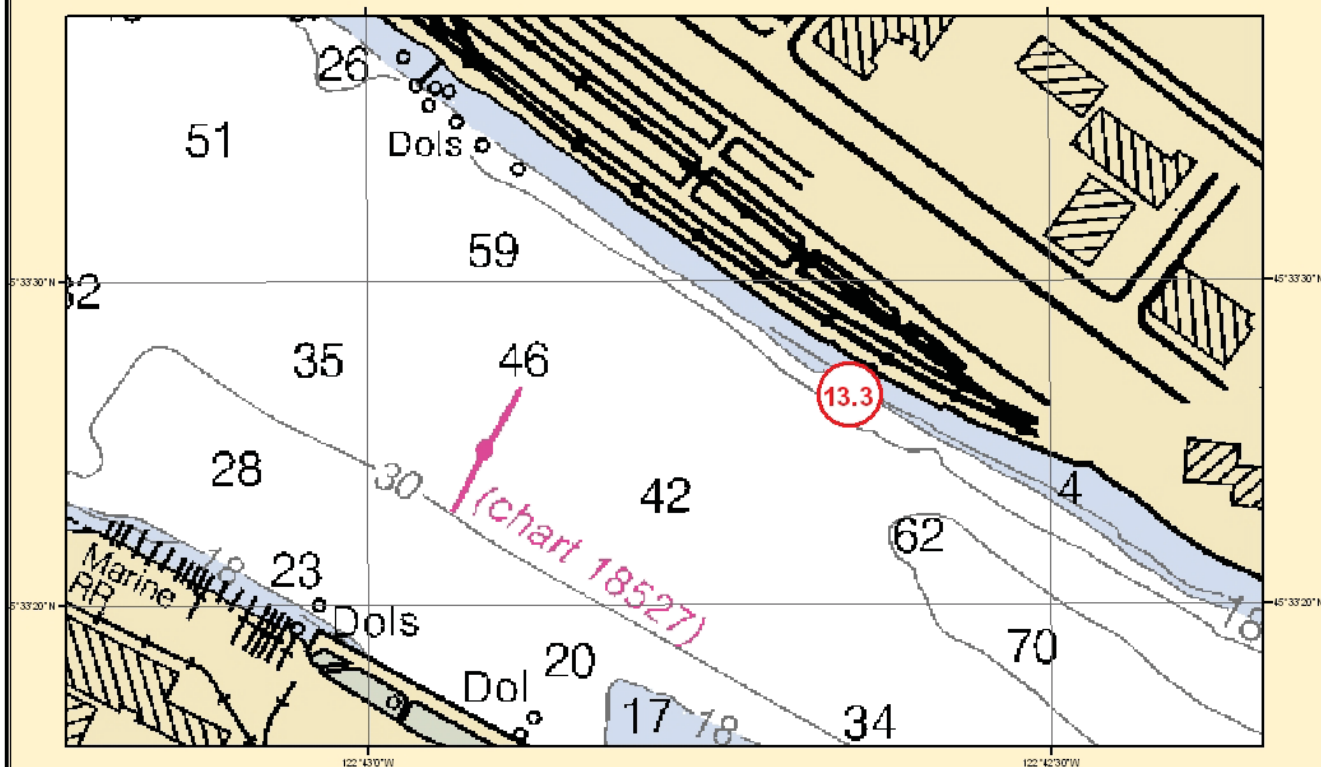
DANGER TO NAVIGATION #5

Debris. Approximate dimensions of 5.5m x 2m x 1m

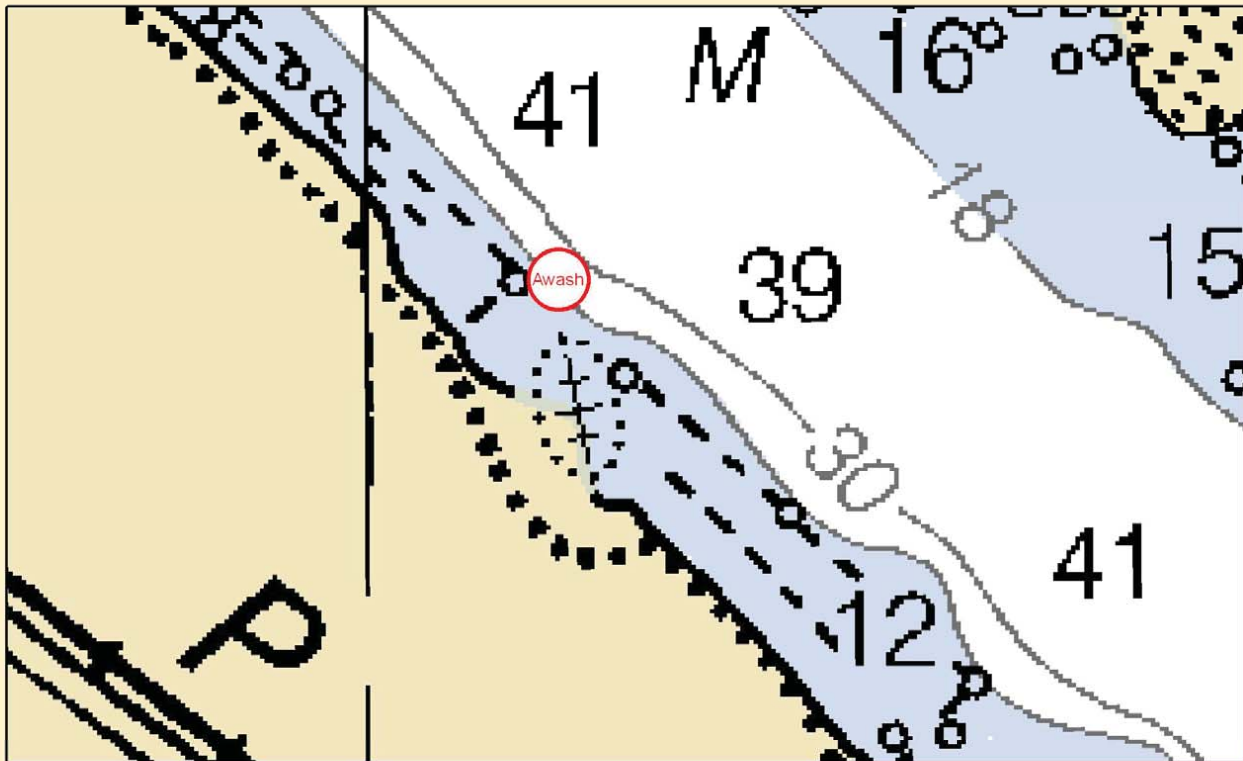
DANGER TO NAVIGATION #6

Wreck awash.
