# H12740

Type of Survey: Basic Hydrographic Survey

Sub-locality: 15 NM East of Pass a Loutre

Project Number: **OPR-J377-KR2-15**

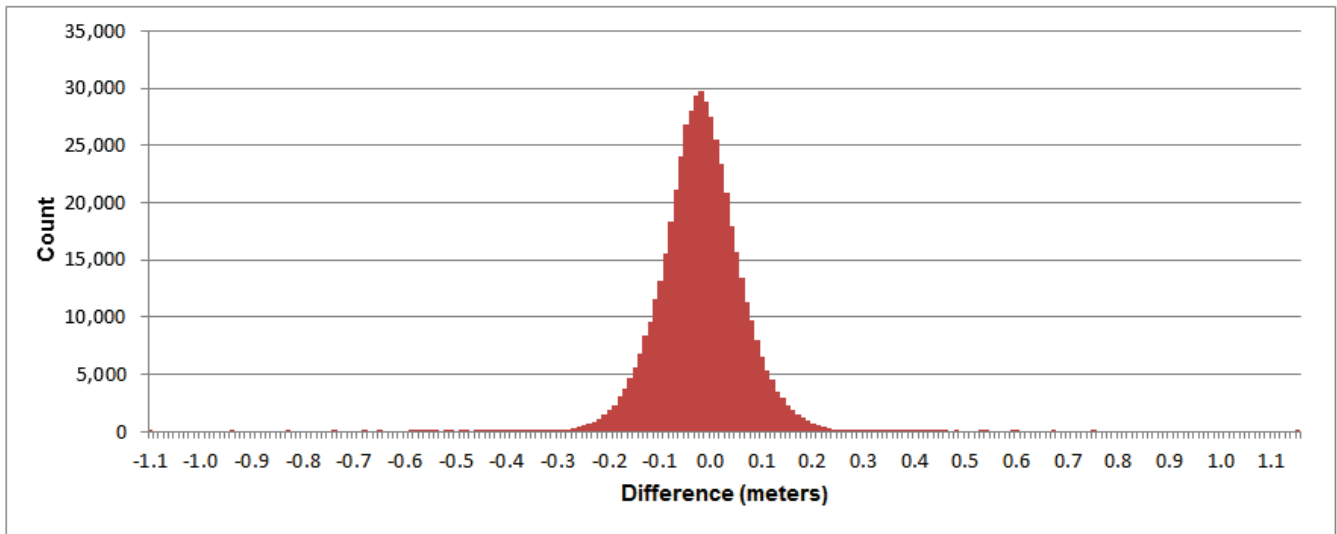
Figure 4: H12740 Crossline Differences

Results from the crossline to mainscheme difference analysis are depicted in Figure 4. Outliers from the difference analysis were reviewed in HIPS subset editor and found to result from a combination of tide and sound velocity artifacts or occur over depressions in the seafloor which were not completely represented in the crossline surface.

Mean:	-0.006 m	Standard Deviation:	0.078 m
Minimum:	-1.090 m	Bin size:	0.01 m
Maximum:	1.169 m	Number of Nodes:	505,847

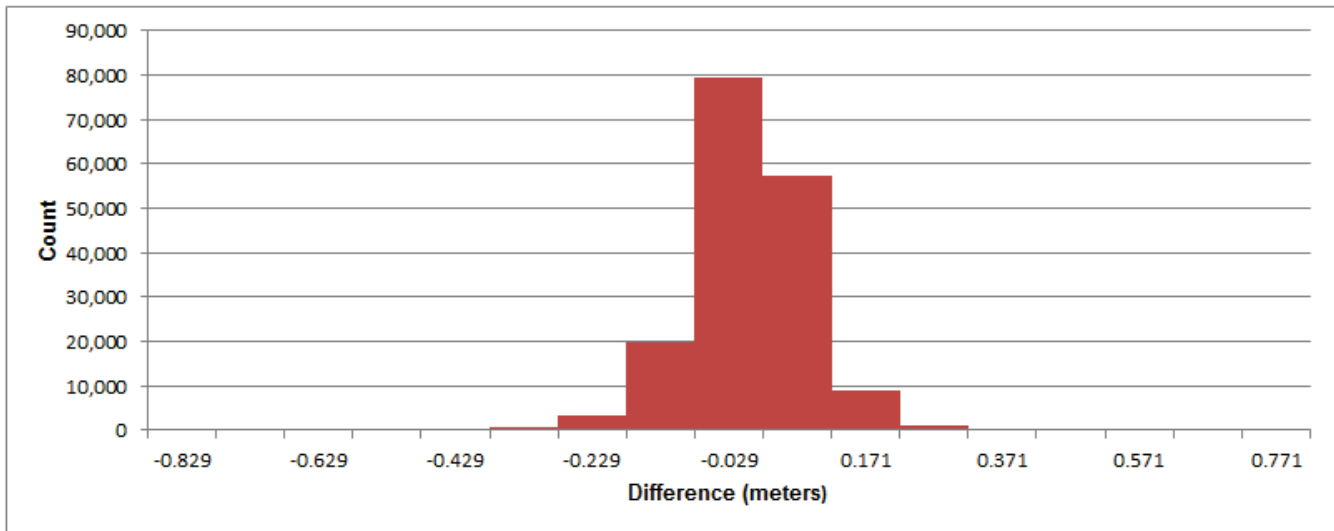
*Figure 5: Junction results between H12740 and H12739 4-meter bathy grids*

Results from the junction analysis are shown in Figure 5. The largest outliers occur over deep pock marks which were not consistently represented between the two surveys. Other differences are associated with sound speed and tide zoning artifacts.

Mean:	-0.00 m	Standard Deviation:	0.082 m
Minimum:	-0.766 m	Bin size:	0.1 m
Maximum:	0.808 m	Number of Nodes:	170,615

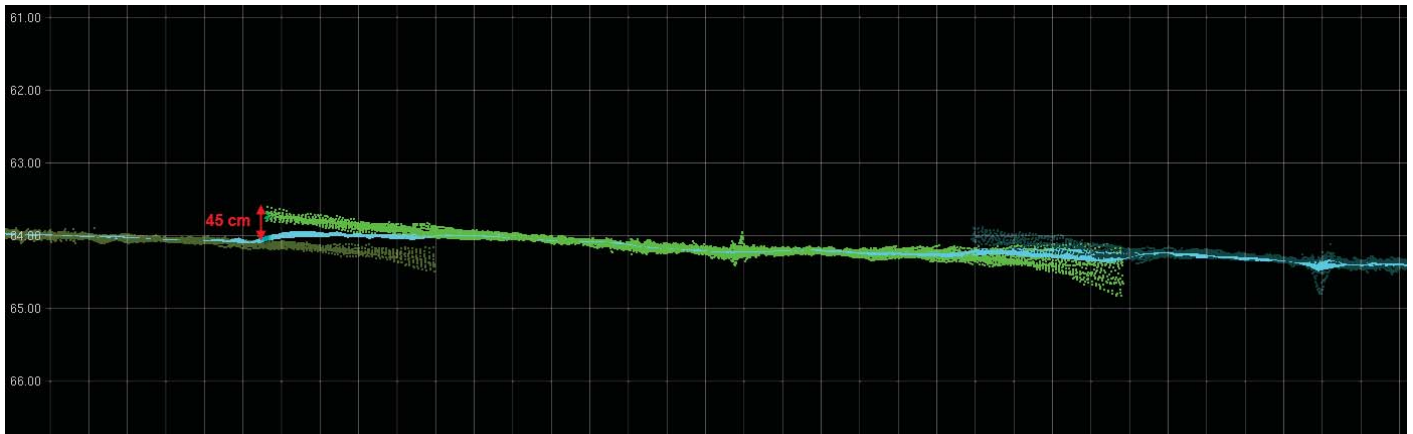
*Figure 6: Example of Sound Speed Artifact*

Refraction artifacts caused by extreme variability in water column sound speed are present throughout the survey. Sound speeds could vary by as much as 10 meters per second over just a few meters in the upper water column with more extreme changes occurring throughout the profile. In some areas the sonar swath exhibited a tilt artifact with the upslope facing beams always mapping shoaler than beams from the opposite side of the swath regardless of vessel heading during acquisition. This tilt artifact typically occurred during a flood tide.

This artifact has been thoroughly investigated with further tests pending. There is a strong correlation with the large variation in surface sound speed during a flood tide and no apparent relationship with crab angle. Sound speed measured at the sonar head during flood tides at times was significantly lower than the trailing MVP sensor. This was attributed to a shallow fresh water lens at the surface during the flood tide. The SSP sensor at the head was still in undisturbed water as it is deployed through a moon pool in the center of the S/V Blake sponsons while the towed sensor at the same depth was in more mixed water in the prop wash of the vessel. Various applications of sound speed were tried (using SSP at the head when applying casts, etc.) but no specific application removed the resultant artifacts.

When present, the artifacts can be as large as 20 to 45 centimeters peak-to-peak in the outer ranges of the swath with the actual error being 10 to 20 centimeters. The impact to the final deliverable surfaces is less extreme and in some cases nonexistent. In all cases the magnitude of the artifact is less than the allowable total vertical uncertainty. In the example graphic (Figure 6) the allowable uncertainty at a depth of 64 meters is 0.97 meters.

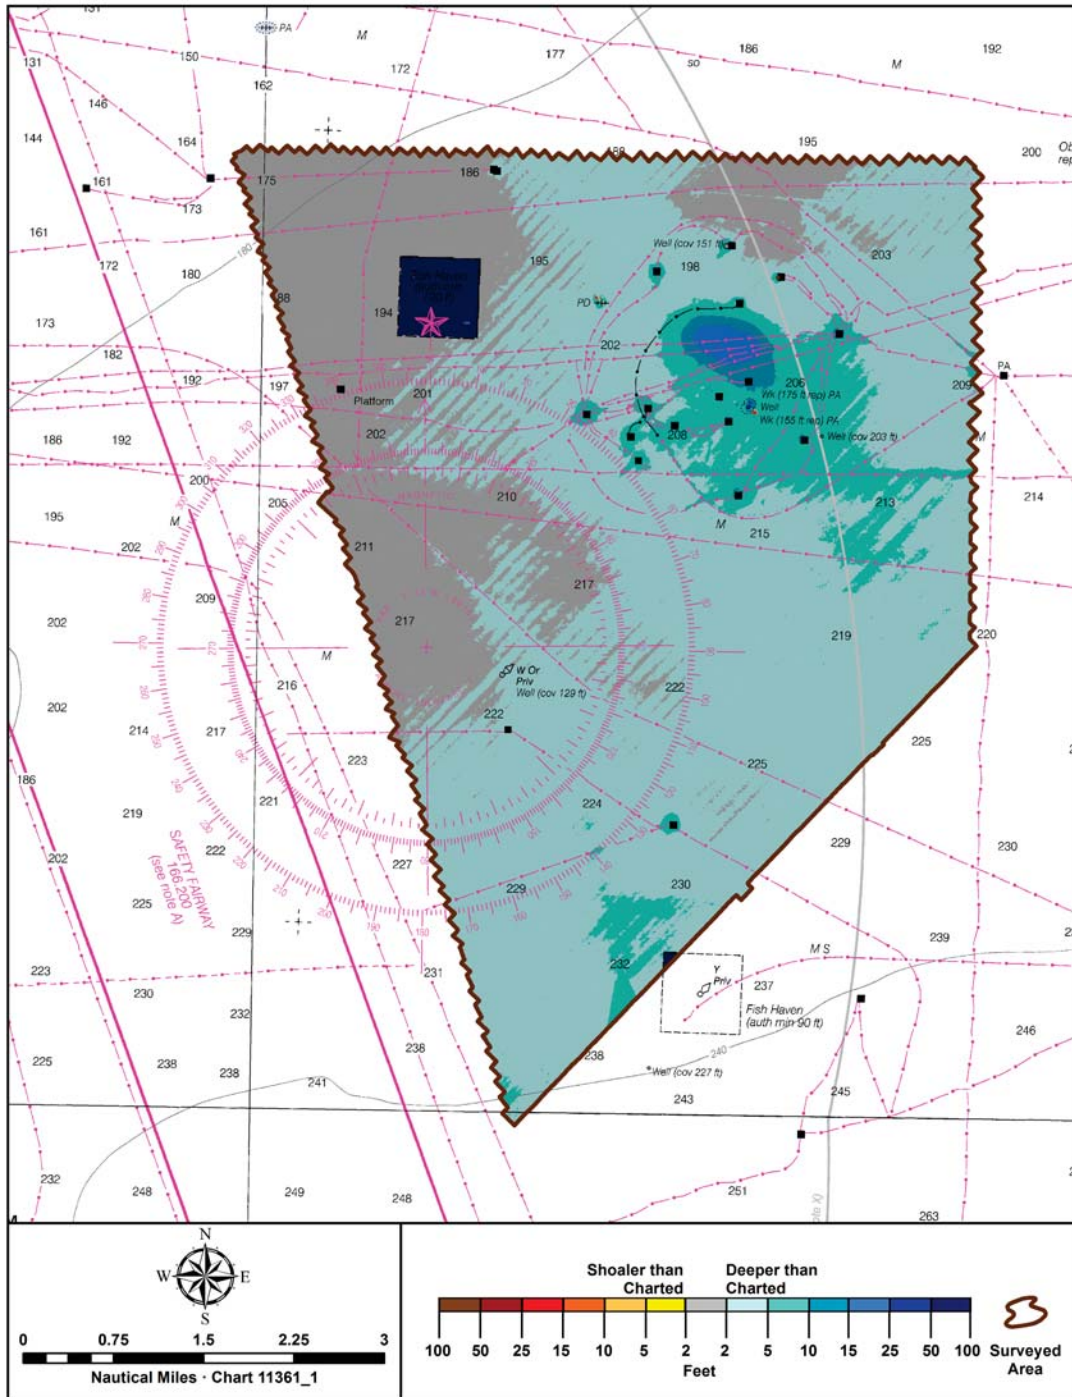
Figure 7: Depth Difference between H12740 and chart US4LA33M

Surveyed depths are generally deeper than charted on ENC US4LA33M with differences ranging from 0 to 5 feet. Maximum differences fall within a charted fish haven with an authorized minimum depth of 120 feet. Surveyed depths within this fish haven range from 126 feet to 205 feet. Surveyed depths are up to 20 feet deeper than charted within a kilometer wide depression in the northern portion of the survey area. Numerous pipelines are charted in the vicinity of this depression. Absolute maximum differences are associated with charted features which were found in a new location.

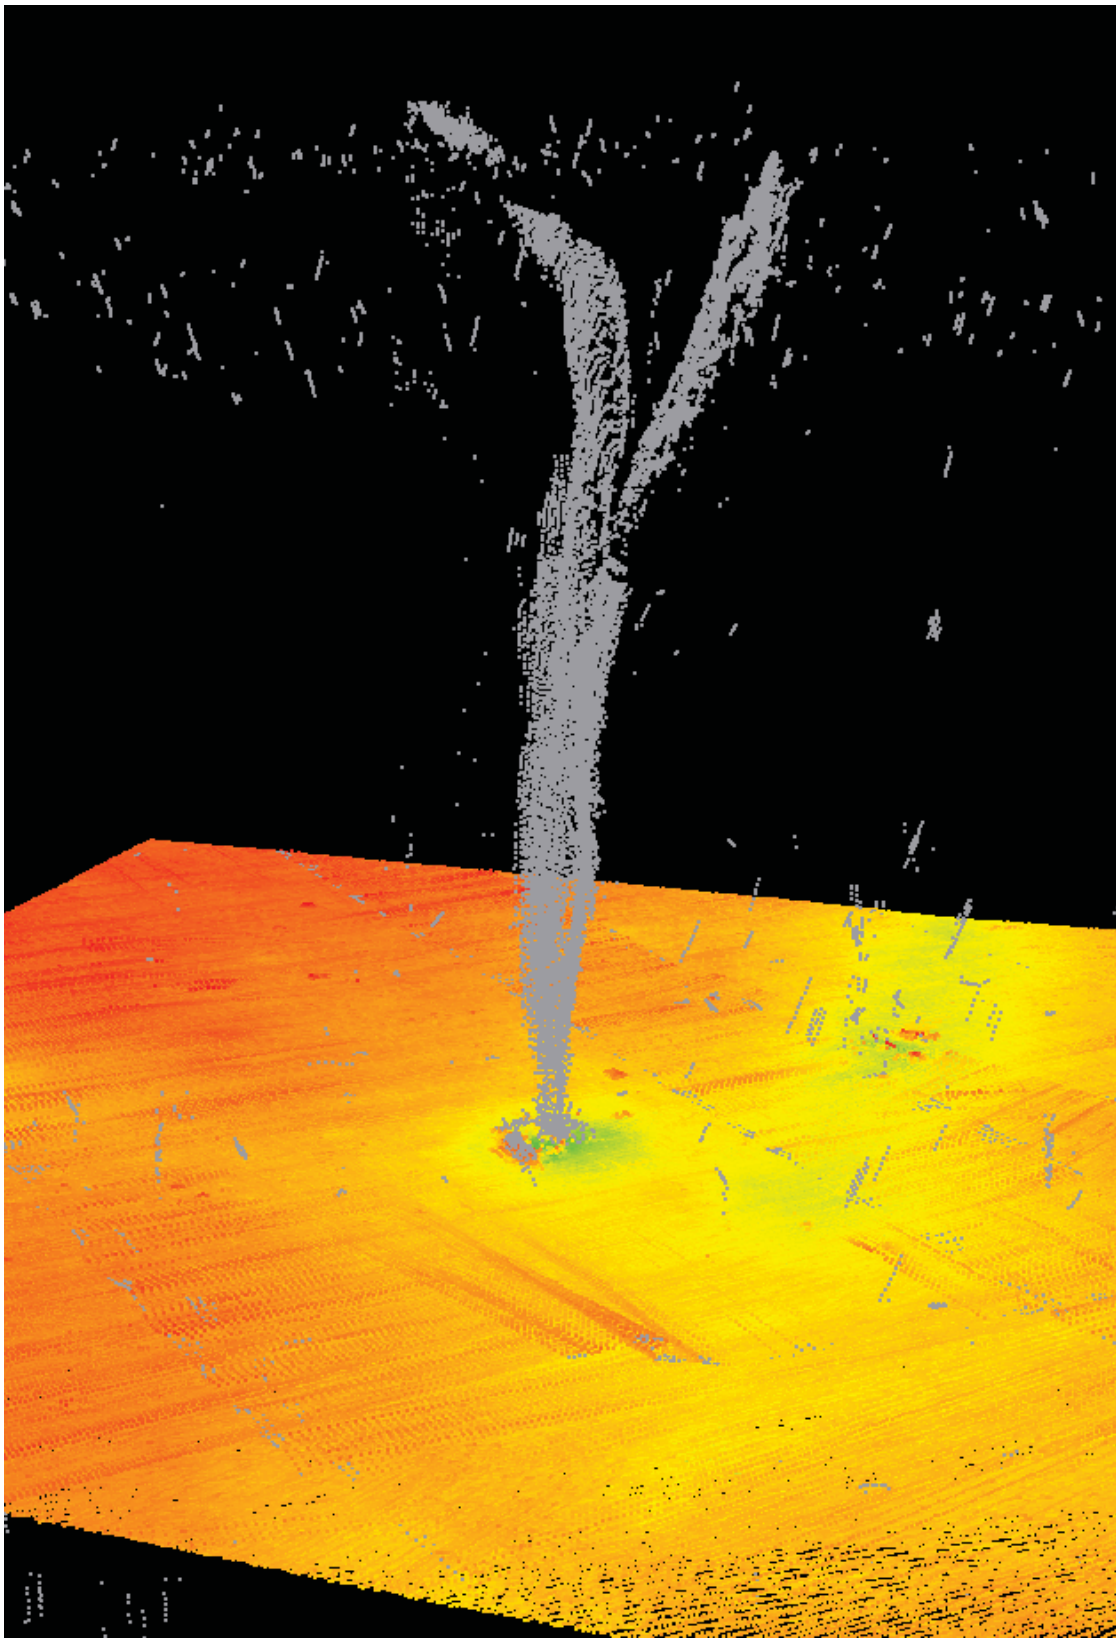
*Figure 8: MBES Data on Reported Gas Discharge from the Seafloor*

A large gas discharge from the seafloor was observed within the H12740 survey area during survey operations on July 11, 2015. This gas discharge, which was visible in the MBES data, was emanating from the seafloor in close proximity to a charted pipeline. A large area of bubbles was also observed at the water surface. DEA immediately reported the gas discharge to the NOAA Gulf Coast Navigation Manager, the

project COTR, USCG and Louisiana Department of Natural Resources personnel, as well as Shell, the owner of the nearby pipeline. After an ROV investigation, Shell was unable to determine if the gas discharge was from a natural seep or from the pipeline. It was later determined that the nearby pipeline transports oil and not gas, therefore it was not the source of the gas discharge. Email correspondence on this issue is included in Appendix II. As shown in Figure 8, all MBES returns on the plume have been rejected in order to accurately depict the seafloor.

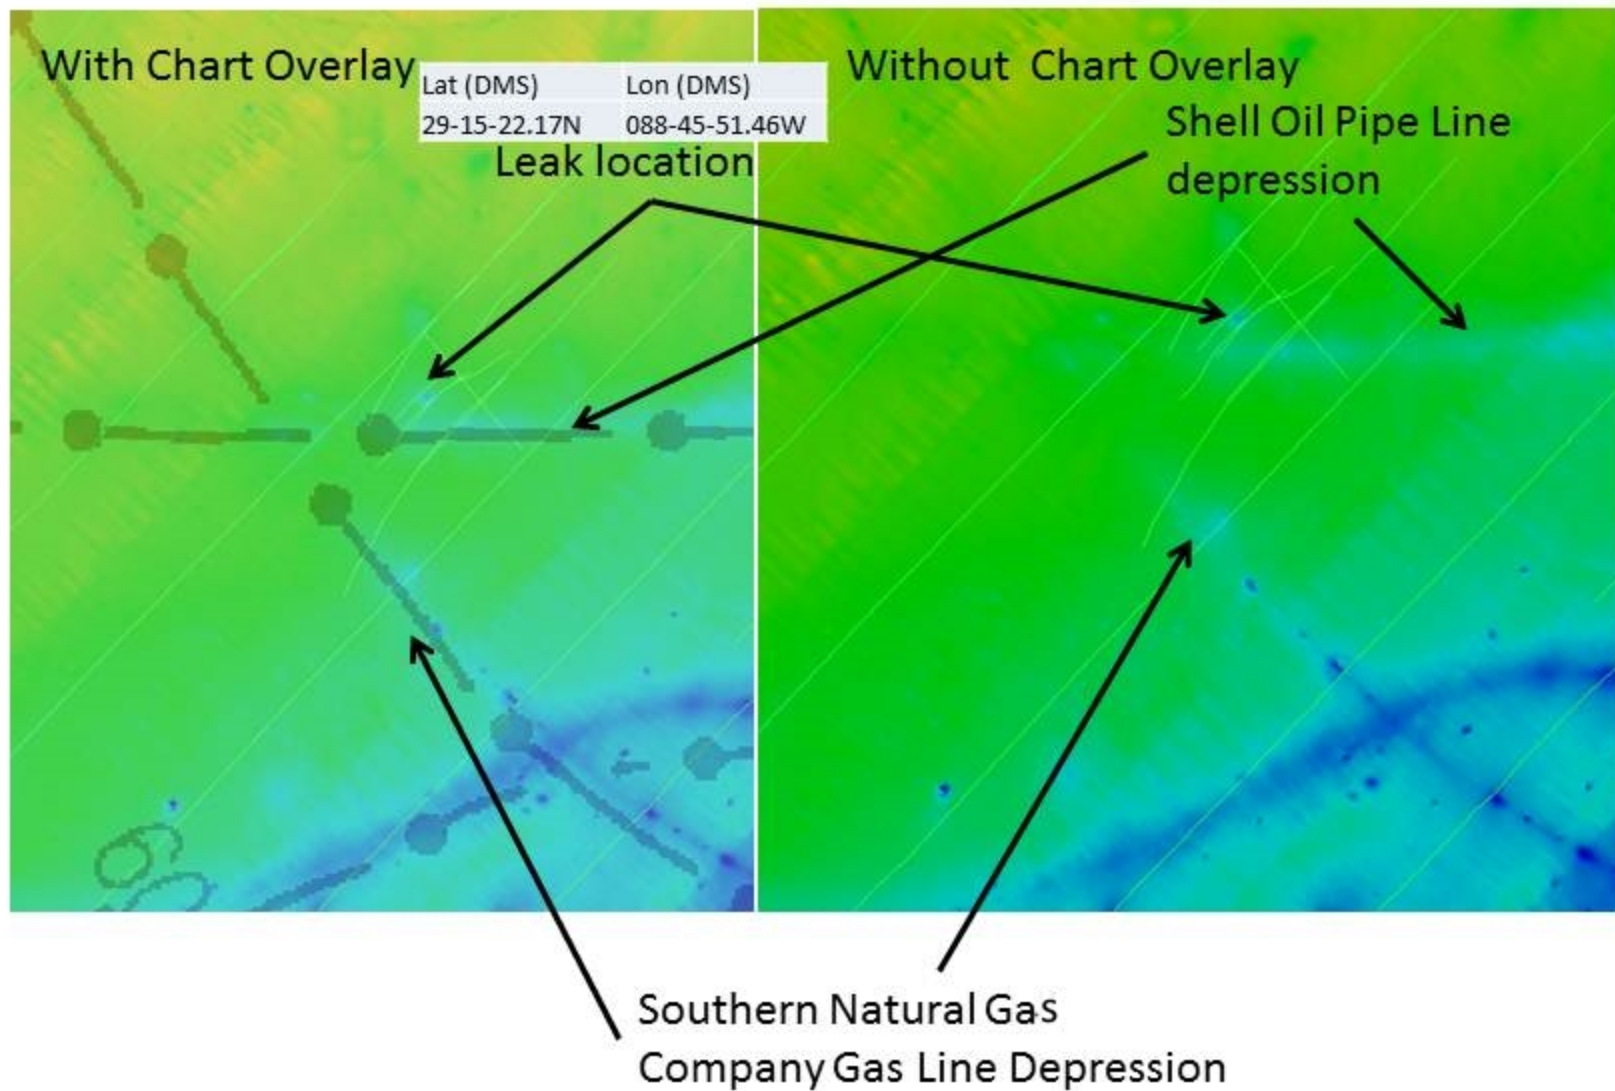
The pipeline depressions on the seafloor match almost perfectly with the charted locations of those pipelines.

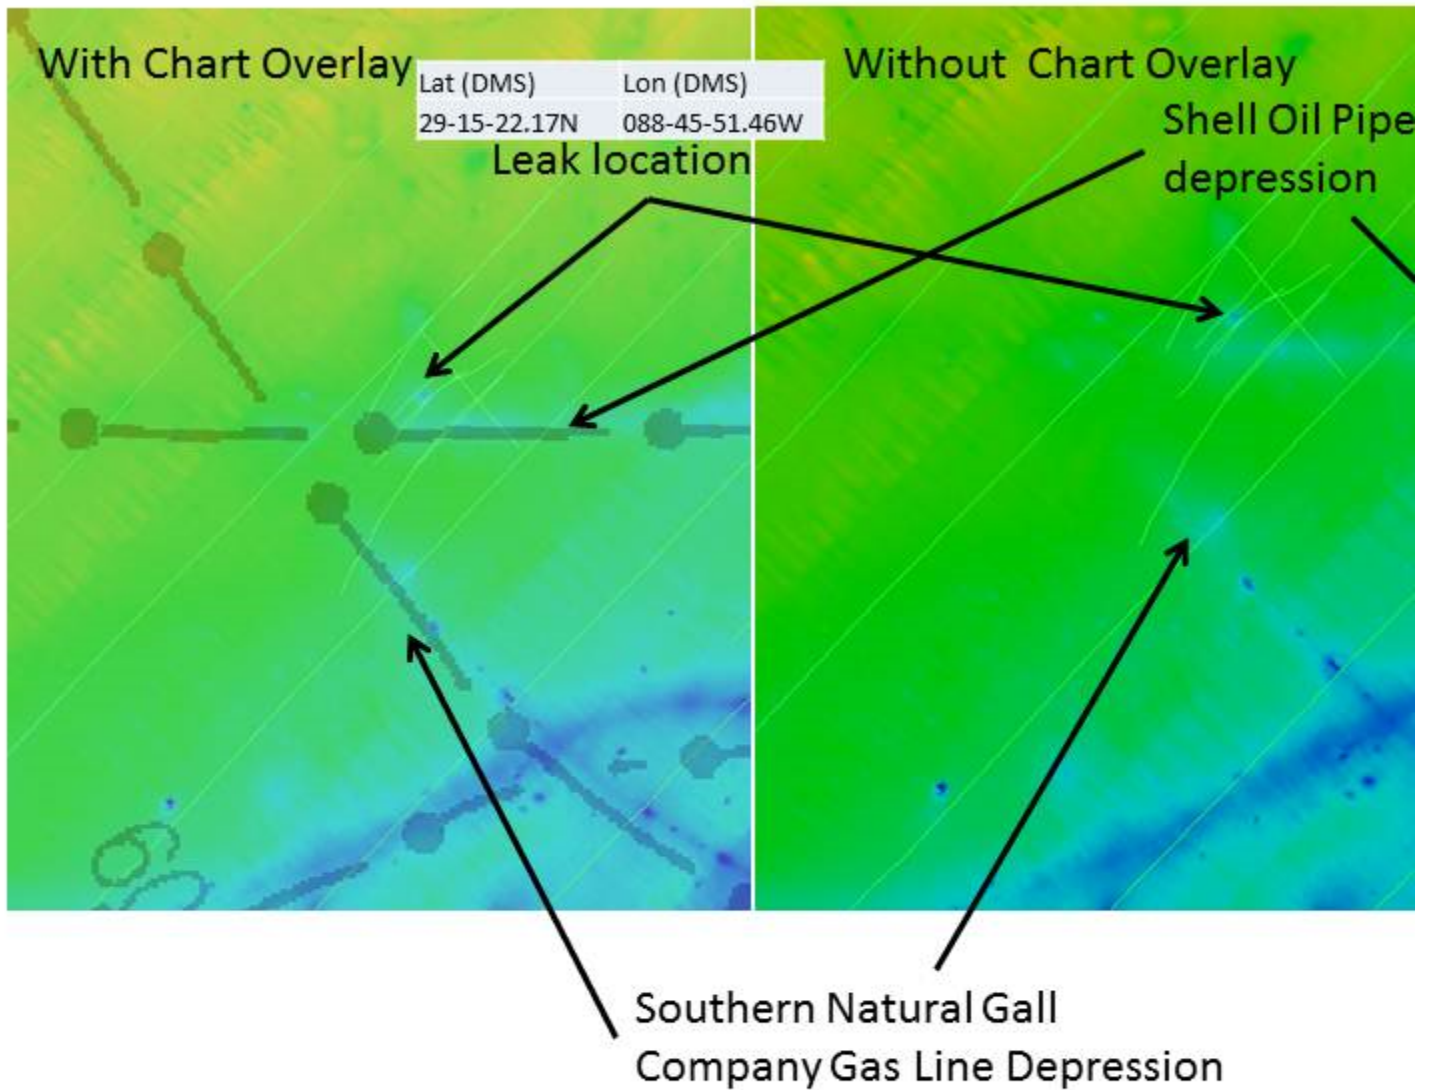
The gas discharge is 200 meters east of an abandoned 8" gas pipeline owned by Southern Natural Gas (details in BOEM query below and image attached). It is possible that line is not positioned correctly in the BOEM data base. The Blake is sediment sampling in the area today and I asked them to use their 12 kHz deep ocean echosounder as a subbottom profiler to see if they can identify a buried pipeline running northeast of the seep and also see if they can detect the Shell oil pipeline. The gas seep is in Block MP 299 (image attached).

The pipeline depressions on the seafloor match almost perfectly with locations of those pipelines.

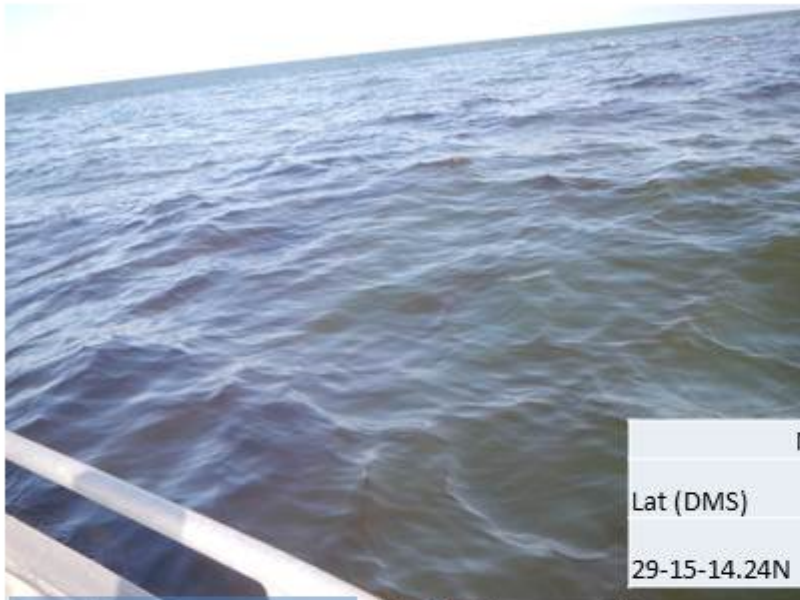
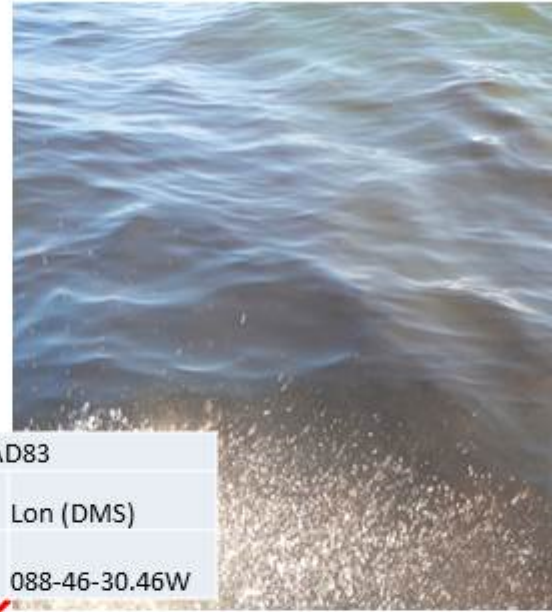
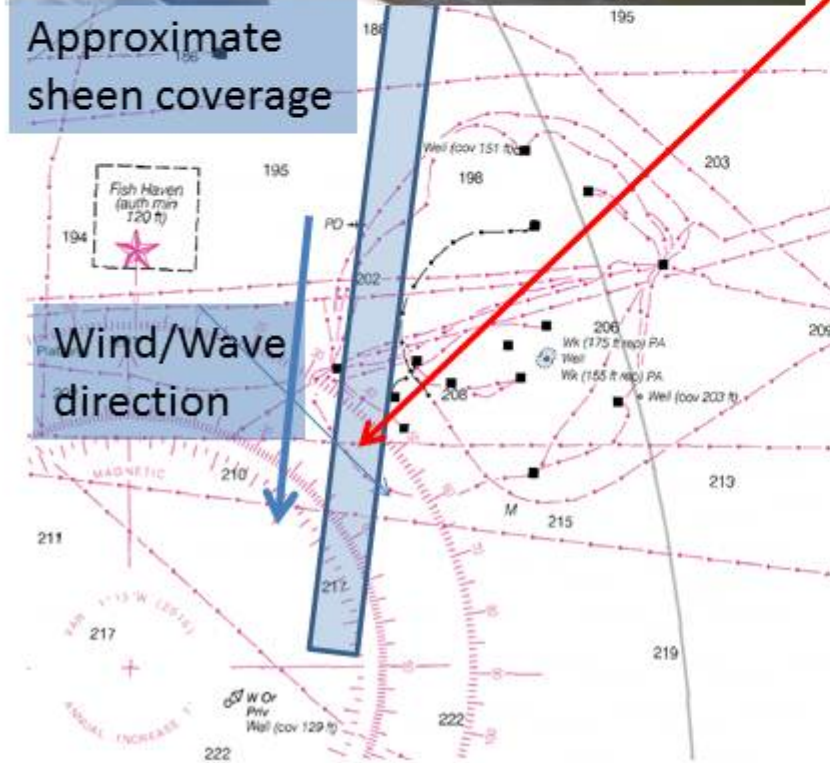
NAD83	
Lat (DMS)	Lon (DMS)
29-15-14.24N	088-46-30.46W

Sheen on surface approx 500m wide, small patches of visible oil and strong odor approximately 2pm C. Shortly after taking the photos the weather deteriorated and the sheen and smell went away completely. The source was not from the platforms in the area and is thought to be coming from the
