B.2.6 Factors Affecting Soundings

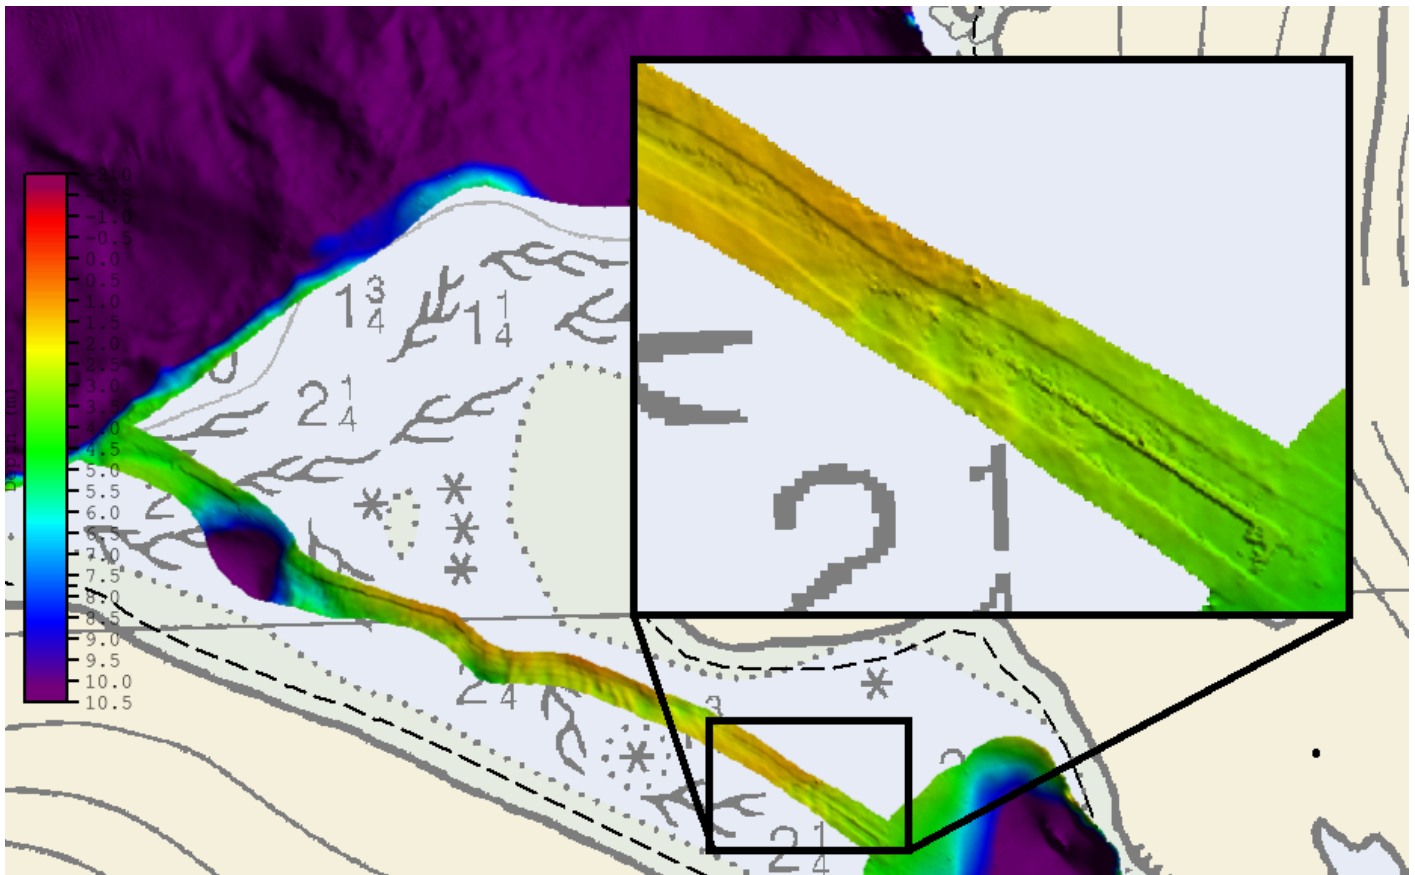
Three lines running through a narrow channel along the west side of Ruth Island exhibited issues with vertical control. The exact source of the error was not determined however it appears to be related to the SBET from that day. Due to the navigation insignificance of the area the issue was not investigated and further and a solution was not found.

Figure 12: Overview of narrow channel exhibiting vertical control issues. Note surface is shown at five times vertical exaggeration.
