## Data Acquisition & Processing Report

Project No. OPR-P384-KR-17.....

**OPR-P384-KR-17**

**Pavlof Islands and Vicinity**

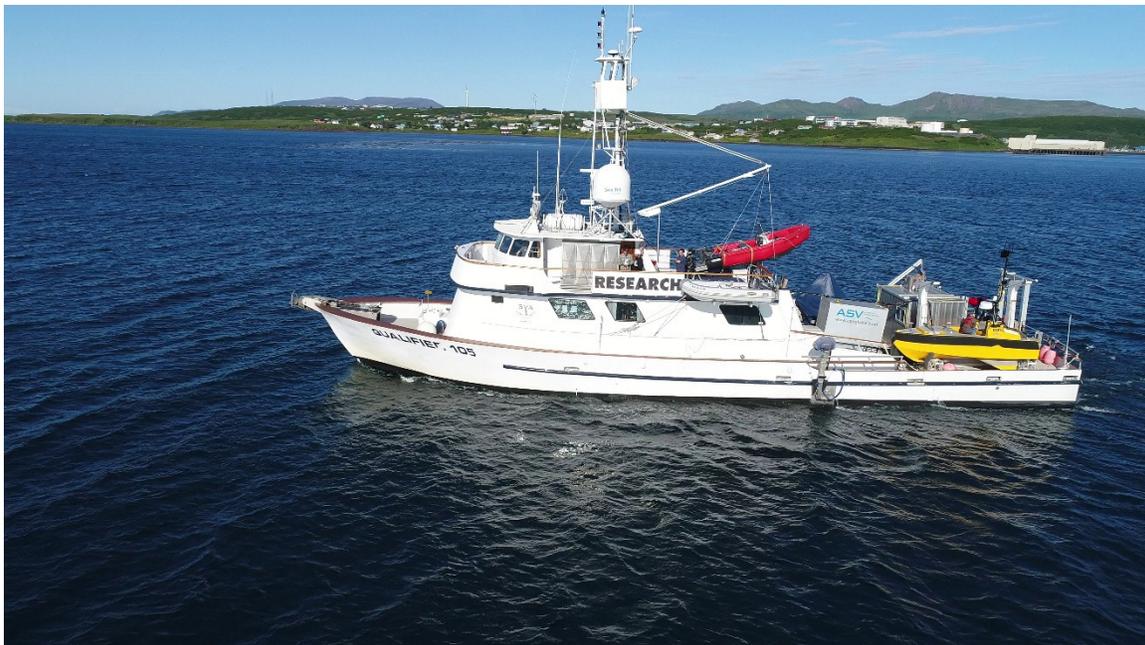
The *Q105* is 32 m in length with an aluminum hull, a 9.1 m beam, and a 1.8 m draft. The vessel is powered by three Detroit D-60 engines. AC electrical power was provided by a 103 KW generator.

*Figure 1 – The Q105 during survey operations outside of Sand Point, 2017.*

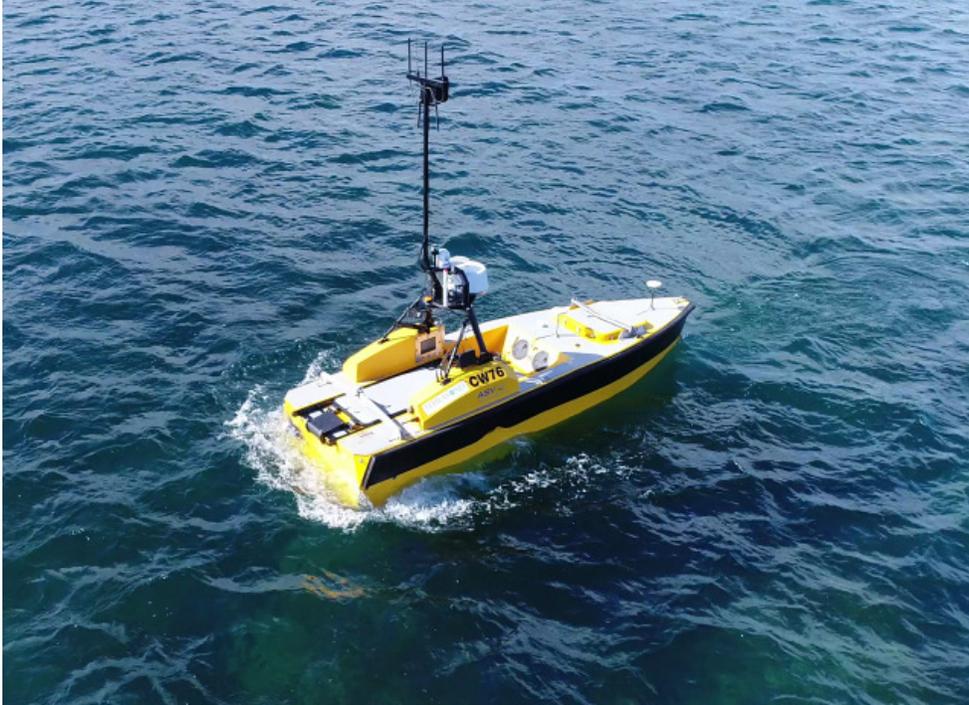
The ASV-CW5 is an aluminum, unmanned vessel manufactured by ASV Global. It is 5.5 m in length with a 1.7 m beam and 0.9 m draft. The vessel is propelled by a direct drive, fixed propeller, 1 x Yanmar 57 HP diesel engine.

*Figure 2 – ASV-CW5 on this project.*

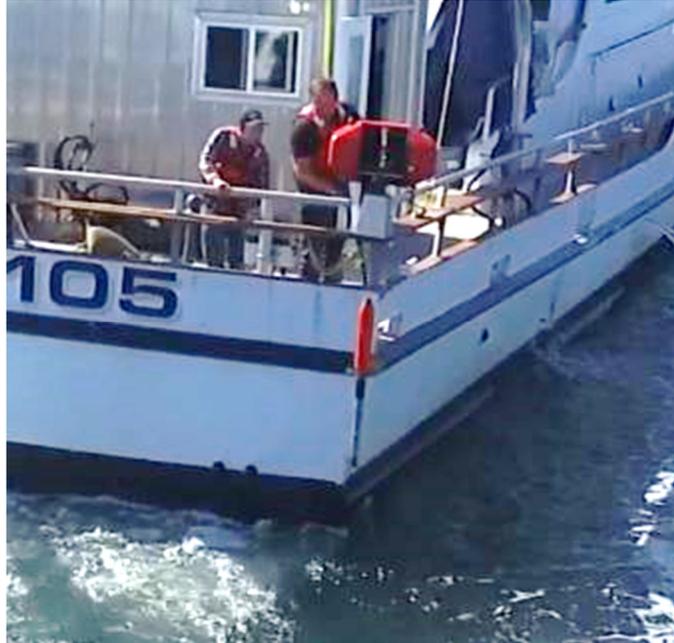
An Oceanscience RapidCAST system – equipped with a Valeport Rapid SV sensor – was utilized aboard the *Q105* for collection of sound speed profiles. Profiles or “casts” were collected as deep as possible while underway, targeting at least 80% of the surveyed water depth during each cast, and reaching 95% minimally once per day.

***Figure 3 – Valeport Rapid SV sensor aboard the Q105.  
Deployment of the Oceanscience RapidCAST.***

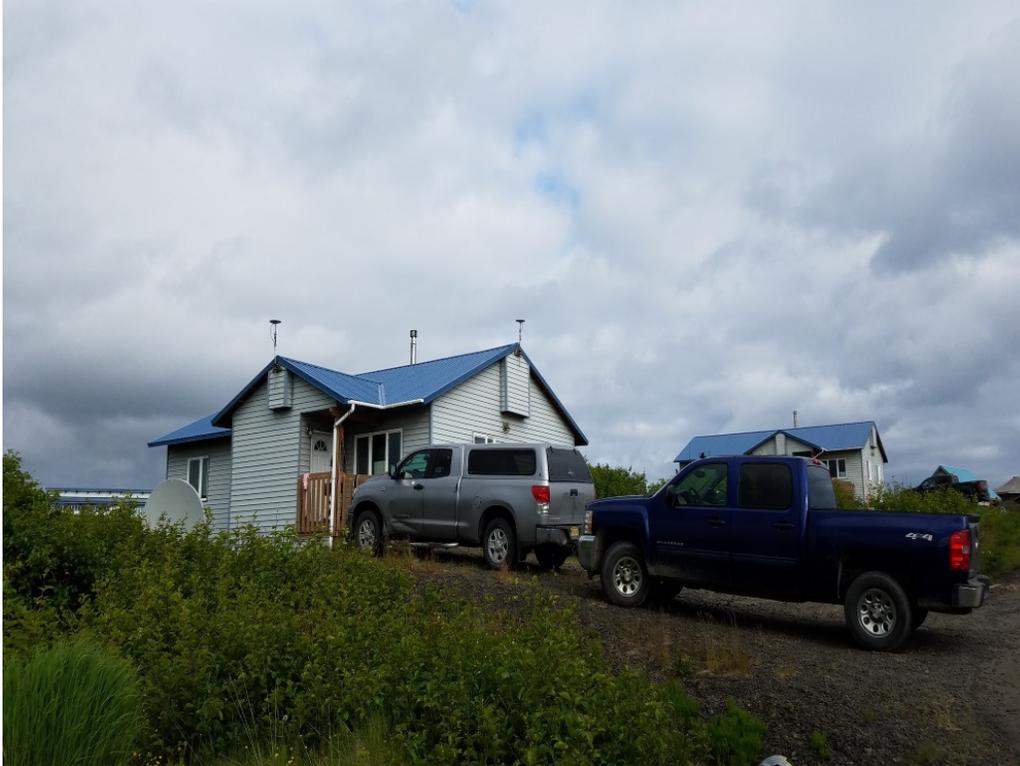
*Figure 4 – Project GPS base station at Sand Point. Zephyr GPS antennas are visible on the roof.*

Trimble 5700 (T5700) GPS receivers with dual-frequency Trimble Zephyr Geodetic antennas were utilized. These were configured to log raw GPS data continuously to data card at a rate of 1 Hz.

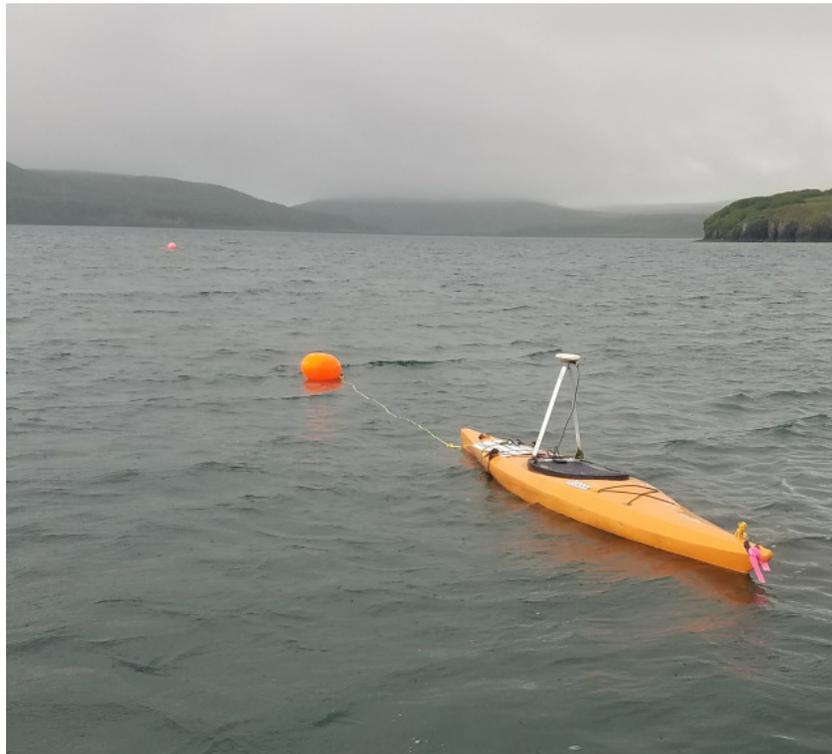
Additionally, a custom GPS Tide Buoy “Apple Jack” was attached to the Sea-Bird BMPG’s auxiliary anchor mooring line. This GPS buoy was fabricated by TerraSond and consisted of a sea kayak outfitted with a T5700 GPS receiver set to log kinematic GPS data, powered by two 12V batteries recharged via a 20w solar panel. The T5700 utilized a Trimble Zephyr antenna with a phase center elevated 0.824 m above the waterline. The GPS buoy remained deployed for the entire duration as the Sea-Bird deployment. GPS buoy data was post-processed in POSGNSS software and used for quality control and comparison purposes only.

Figure 5 – GPS Tide Buoy in Zachary Bay, moored to the BMPG’s auxiliary anchor.

The BMPG tide equipment performed well with no major equipment-related issues or outages encountered. The GPS buoy experienced power outages due to insufficient solar input on the solar panel during long stretches of cloudy/foggy weather, but this had no effect on final tidal data because its data was used for quality control and comparison purposes only.

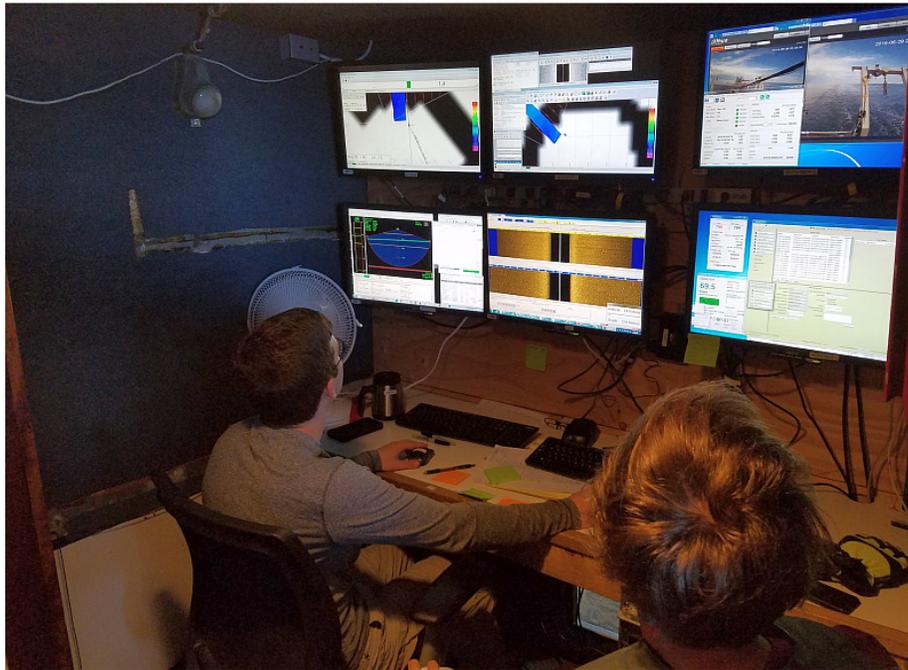
*Figure 7 – Q105 data acquisition station, with direct interfaces to survey hardware.*

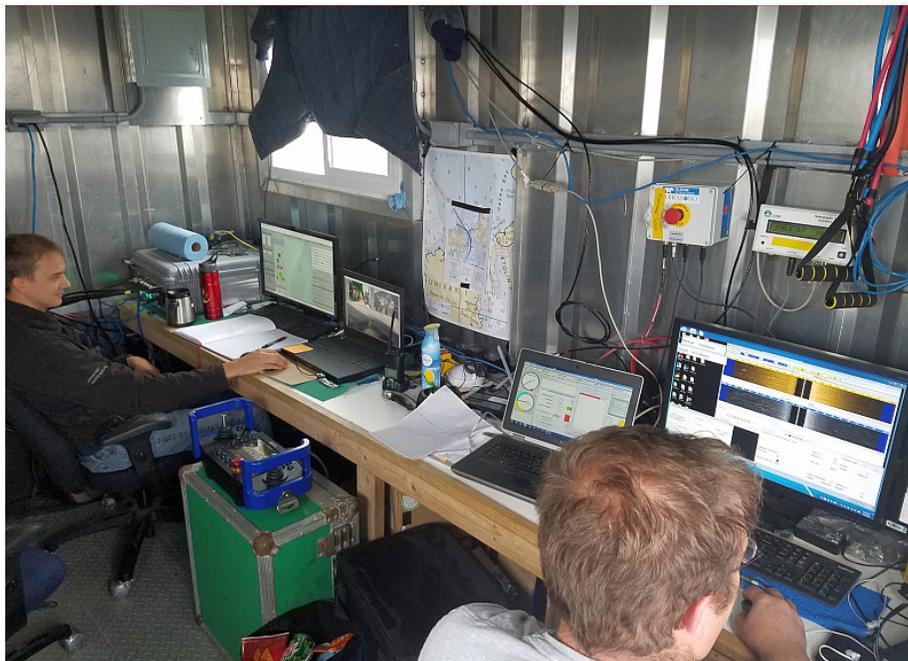
*Figure 8 – Station aboard the Q105 for remotely controlling and monitoring the ASV-CW5. Displays are transmitted wirelessly from the unmanned vessel.*

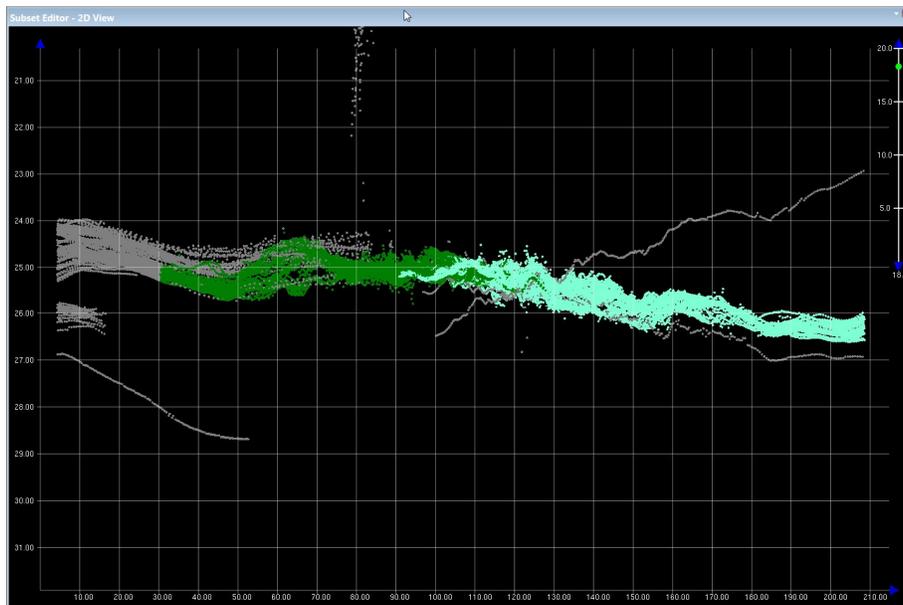
Errant or bad pings are evident periodically in the multibeam swath data. This occurred regularly on both vessel 7101 systems. The issue manifests as a single ping, or swath, that is skewed (or rolled) from the seafloor at an angle. The cause is unknown, and does not correlate to any spikes in attitude data. These were normally rejected manually during swath edit review, resulting in small along-track gaps as viewed in swath editor plan view. However, since only single pings were affected, and ping rates were high (10 pings/second if range scale allowed) there was no significant detrimental effect on data density. During surface review in CARIS subset editor, remaining errant pings were rejected if they adversely affected the surface. Un-rejected errant pings in the dataset may remain, but do not have significant detrimental effect on final surface quality.

**Figure 9 – Errant pings, skewed single swaths (rejected, in grey) shown in CARIS subset mode**

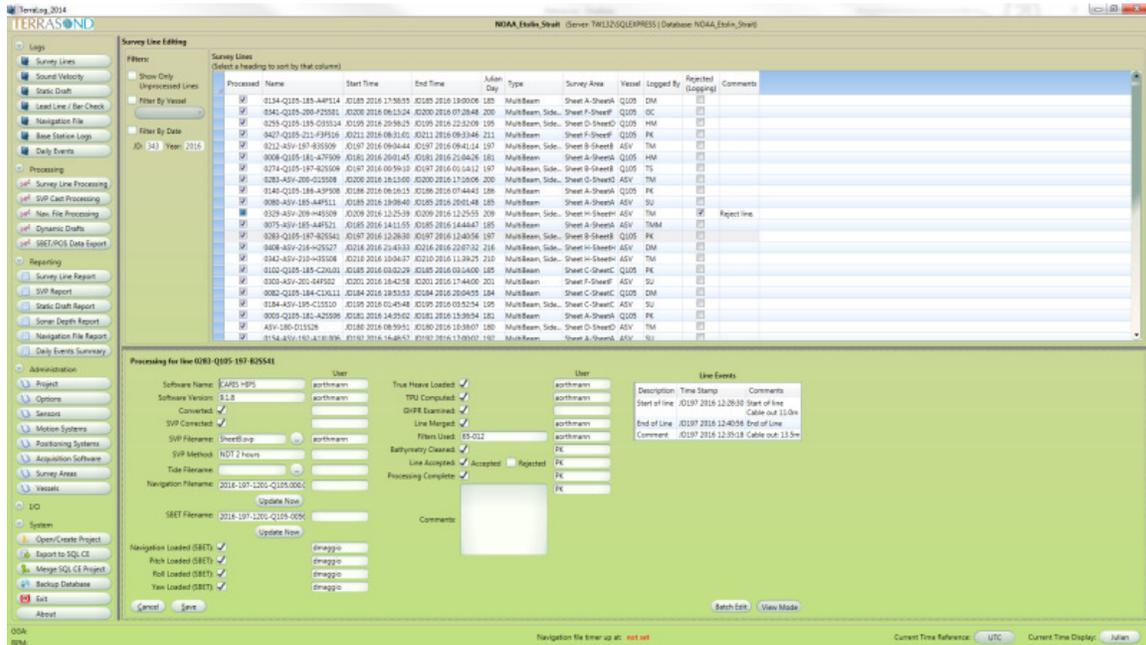
TerraLog was designed to replace Excel-based logsheets for common log keeping tasks. Its primary purpose is to simplify acquisition and processing logsheet entries, provide a more seamless and consistent flow of user-entered log data from acquisition to processing, and output standardized logsheets in PDF format. Since TerraLog automatically records time- and position-tag (with GGA input) events, it largely eliminates errors associated with manually entered time and position. On this survey (on the Q105 only), *TerraLog* was configured to receive a GGA data string from the POSMV, enabling the software to position-tag events.

Figure 10 – TerraLog interface for line processing.

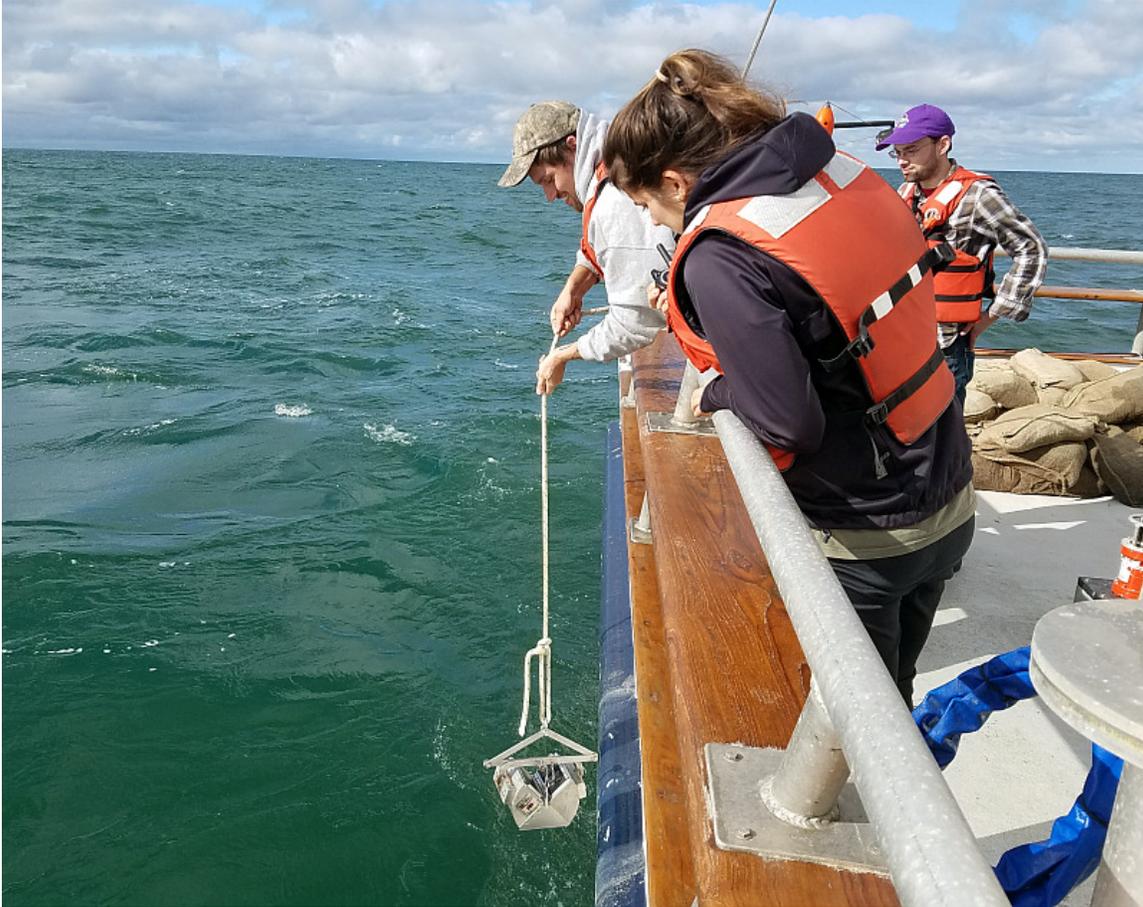
To collect the samples, the *Q105* would navigate as close as possible to each assigned location. With the vessel at full stop, the survey crew on the back deck would set a spring-loaded Van Veen grab sampler and lower it quickly to the seafloor. A GPS position fix was taken when then sampler was noted to touch bottom. Back on the surface, the sampler was opened, and the contents analyzed to determine its “SBDARE” (Seabed Area) S-57 attributes including “NATSUR” (nature of surface), “NATQUA” (qualifying terms), and “COLOUR”. Time of acquisition was noted, and a photo was taken of each sample. Following analysis, the sample was discarded overboard.

*Figure 11 – Bottom sample collection with Van Veen sampler on back deck of the Q105.*

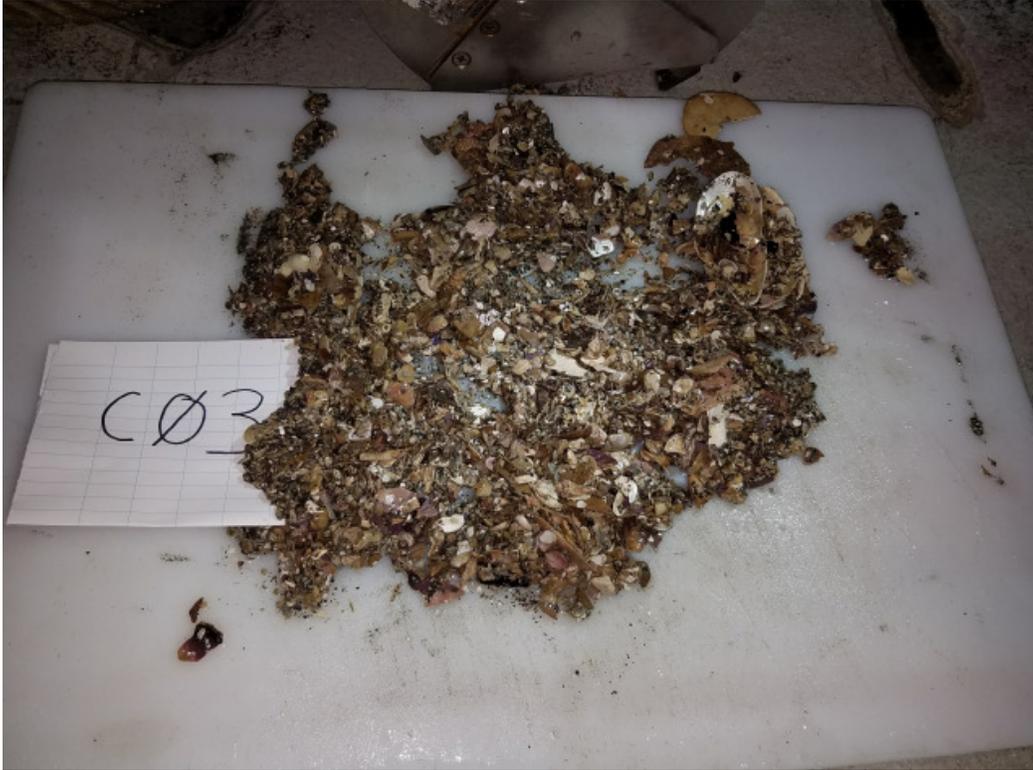
If multiple constituents were present in the sample, only the three most prevalent were noted. Constituents were encoded in order of most predominant first.

*Figure 12 -- Example bottom sample from this survey – 1st constituent broken brown shells, 2<sup>nd</sup> medium black sand, 3<sup>rd</sup> fine brown pebbles.*

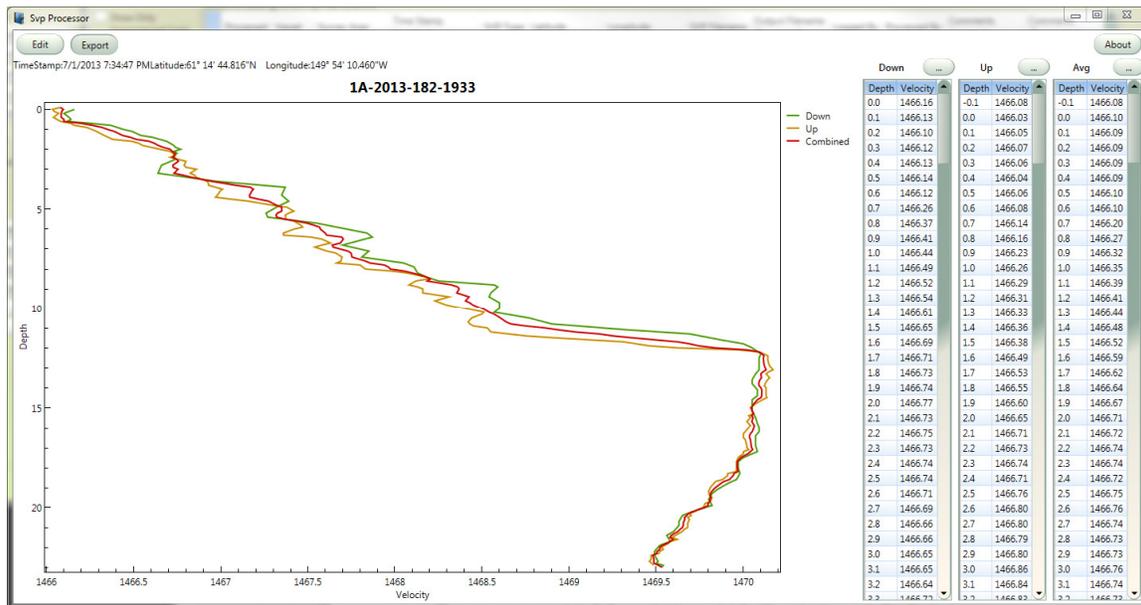
During processing, TerraLog separated the profile into its up and down components and graphed the data points, allowing erroneous points to be rejected by data processing personnel. Once checked and cleaned, the software exported the combined (average of up and down components) profile to CARIS HIPS SVP format at a regular 0.10 m interval. The output was checked for incorrect timestamps and positions, and appended to the appropriate master CARIS HIPS SVP file based on the survey sheet.

**Figure 13 – Example SVP profile editing interface in TerraLog.**

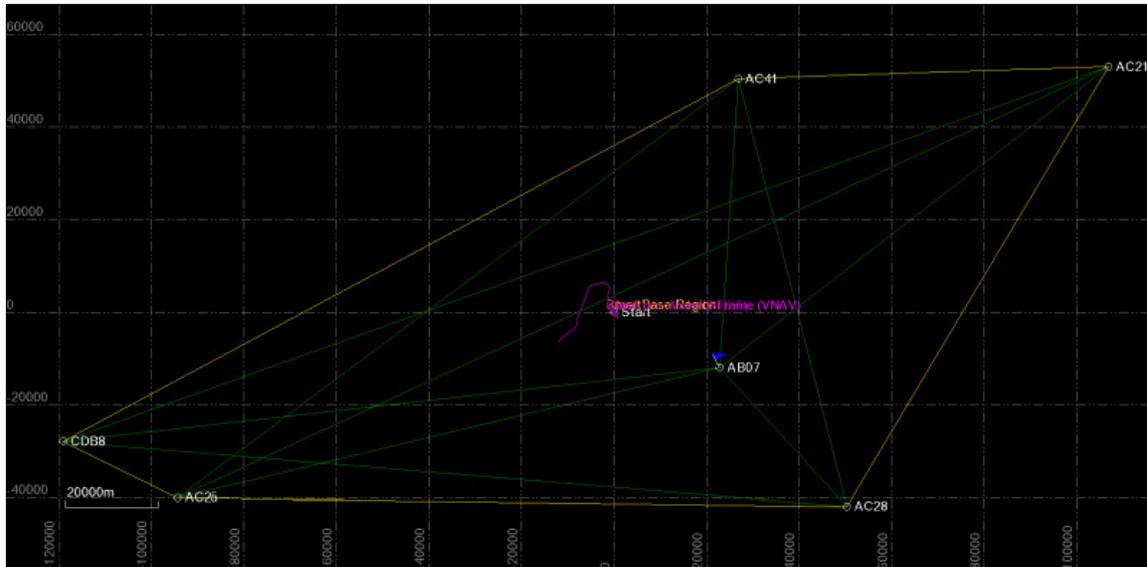
In ASB processing, POSpac typically utilized AB07 (Sand Point) as the primary base station. Neighboring stations up to 100 km away were used in the ASB network, with sites ranging from Cold Bay and Sanak Island to Port Moller and Perryville. A common ASB network is shown in the figure below.

*Figure 14 – Typical ASB network for PPK. Vessel trackline is purple. AB07 (Sand Point) is flagged.*

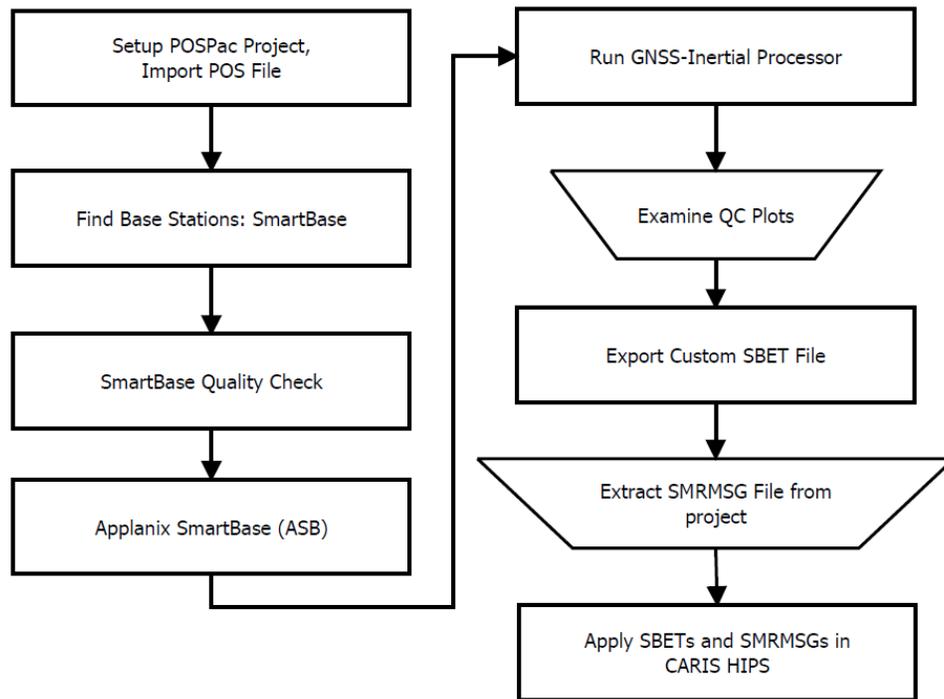
The flow chart shown below is a generalized overview of the POSPac workflow used on this project. Steps are similar for projects that used single-base mode, with the exception that single-base options were used in place of SmartBase options.

*Figure 15 – Flow chart overview of POSPac workflow used on this project.*

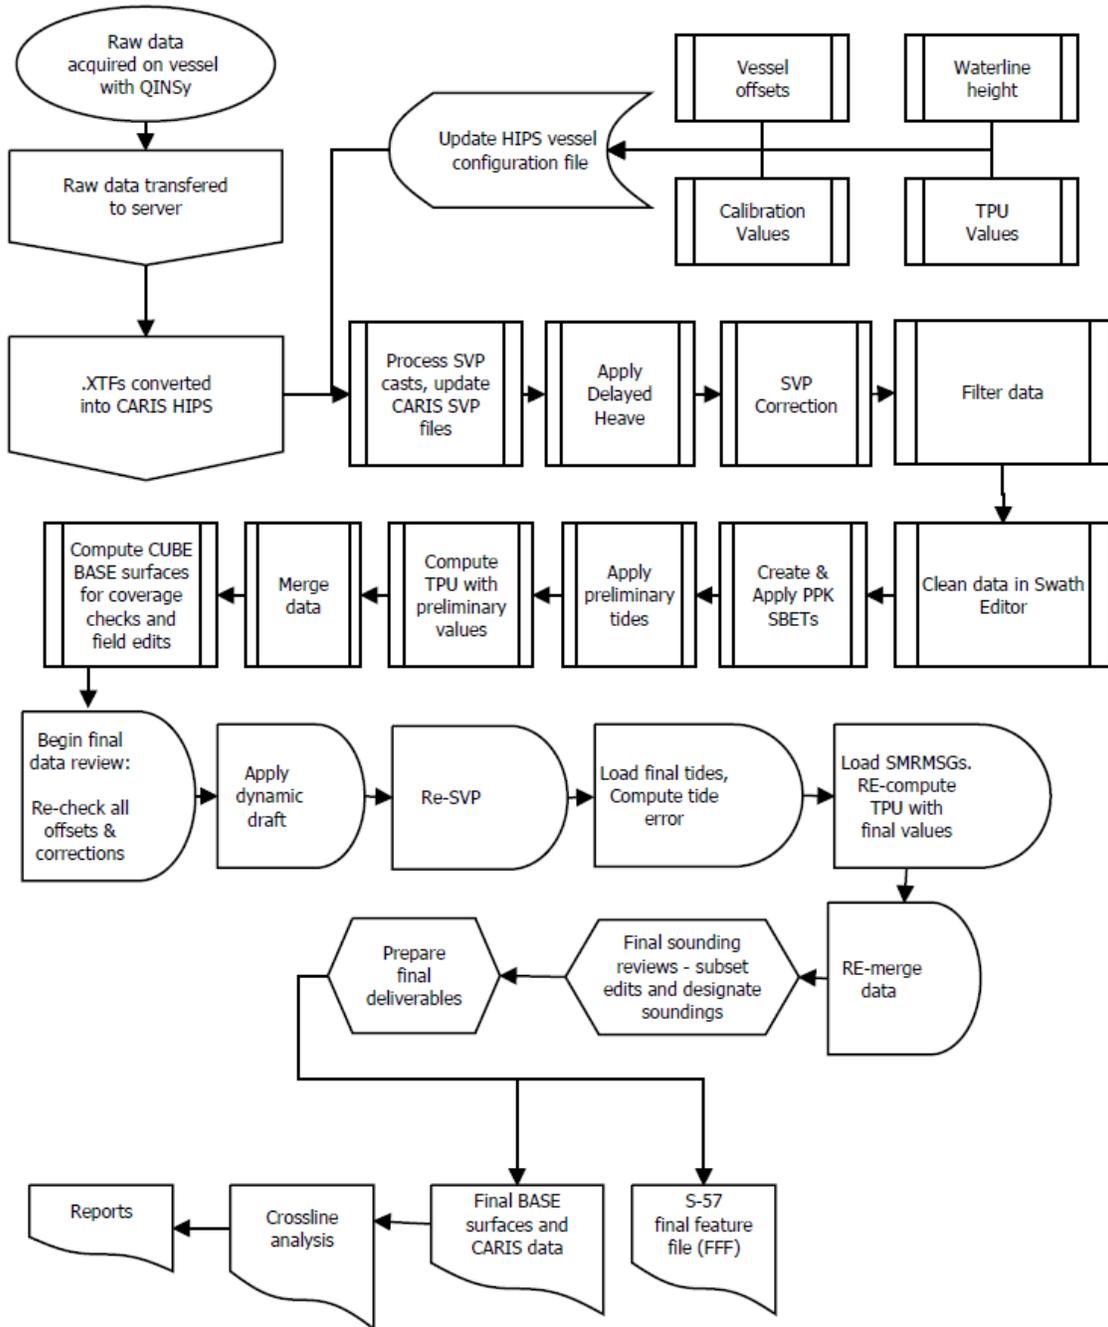
**B.3.17. Bathymetric Processing Flow Diagram**

Figure 16 – Generalized flow chart of processing steps used on this project.

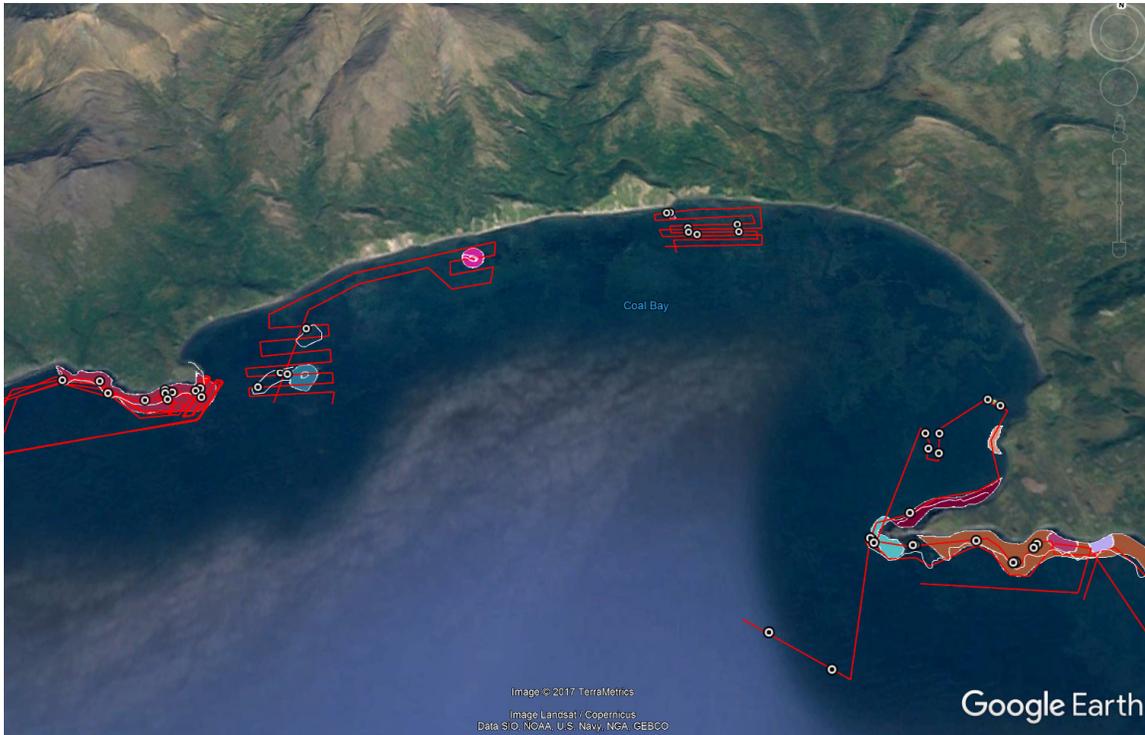
To investigate features with UAS, "missions" of approximately 1 to 2 nautical miles of coastline were first pre-defined. Missions routes were best-fit to intersect assigned features, with consideration for photo coverage and overlap. Altitudes were set to 400' or less and speeds were limited to allow at least three high-resolution (20 megapixel) geotagged photos to be taken on each feature and surrounding seafloor.

*Figure 17 -- Pre-defined mission routes over assigned features shown in Google Earth.*

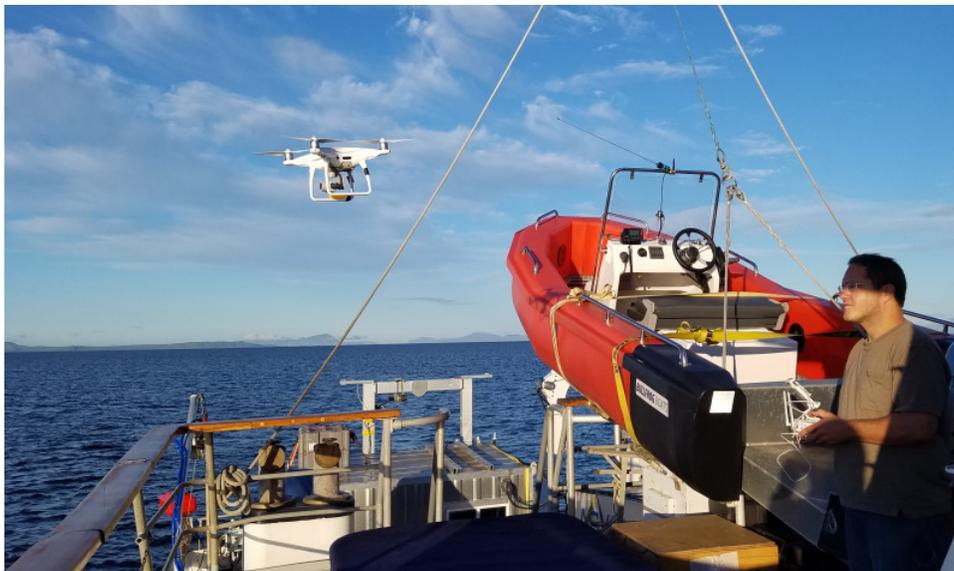
When conditions were favorable for shoreline verification (low tide, good visibility, and winds of 20 knots or less), the missions were carried out. With the *Q105* in the general proximity of the features requiring investigation, the UAS was launched from the top deck and sent on the pre-defined mission. Camera angle was usually set to a straight-down (nadir) orientation, and the UAS was set automatically take high-resolution (typically 20 megapixel), geo-tagged JPG images every 2 seconds. Images were saved to an on-board SD card for later processing.

*Figure 18 -- A P4P drone (UAS) is launched from the *Q105* to investigate shoreline features.*

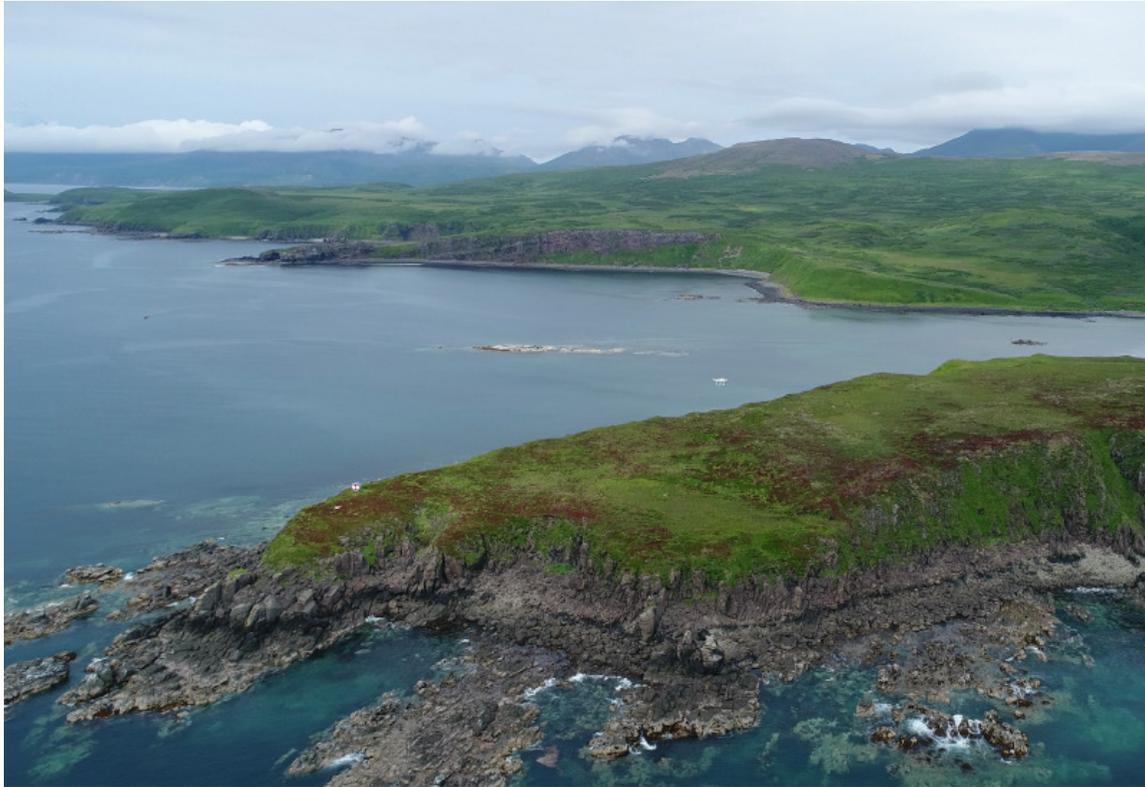
*Figure 19 -- UAS (center of image, white) in flight photographing assigned features (ledges and rocks), including ATON inspection (lower left corner)*

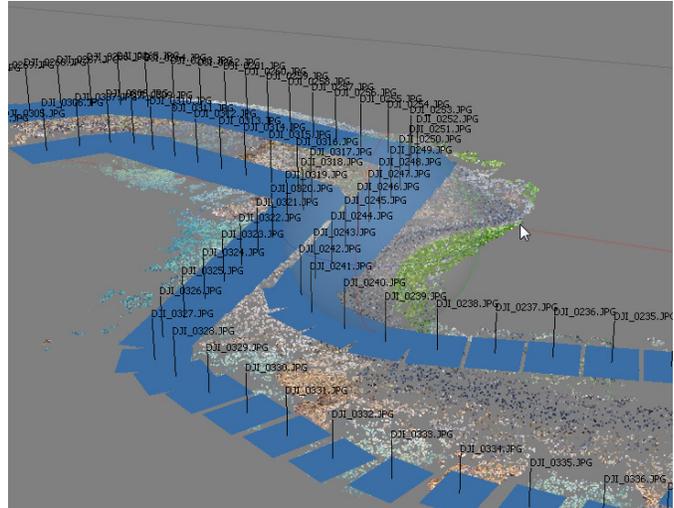
Initial field processing in PhotoScan was done immediately after each mission to ensure coverage and data quality. During this initial processing, PhotoScan was run with reduced quality settings to rapidly verify integrity of acquired data. Processing was separated into ‘chunks’ that represented UAS missions. Since SfM processing can be time intensive, lower quality settings for aero-triangulation and point cloud generation were used to compile a scene for the mission within a suitable timeframe (usually within the available tide window). Preliminary orthophotomosaics (as georeferenced TIF images) were then output and compared to assigned features to ensure coverage.

**Figure 20 -- Aero-Triangulation Tie Points showing photo locations along the pre-defined mission route.**

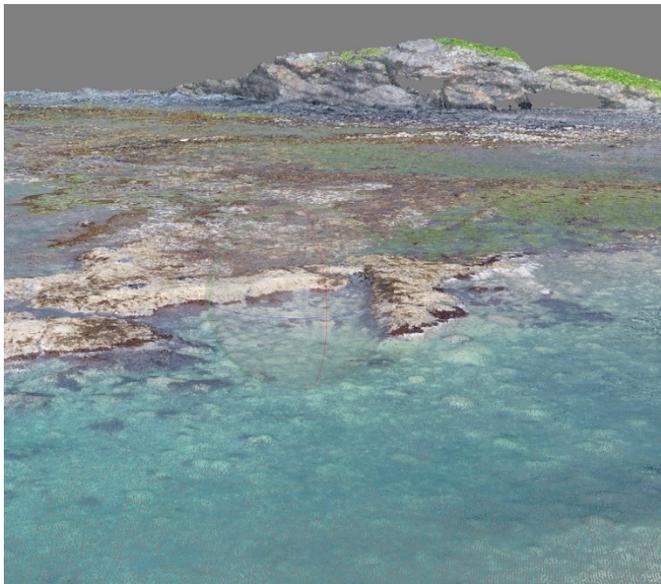
**Figure 21 -- Dense Point Cloud generated through SfM**

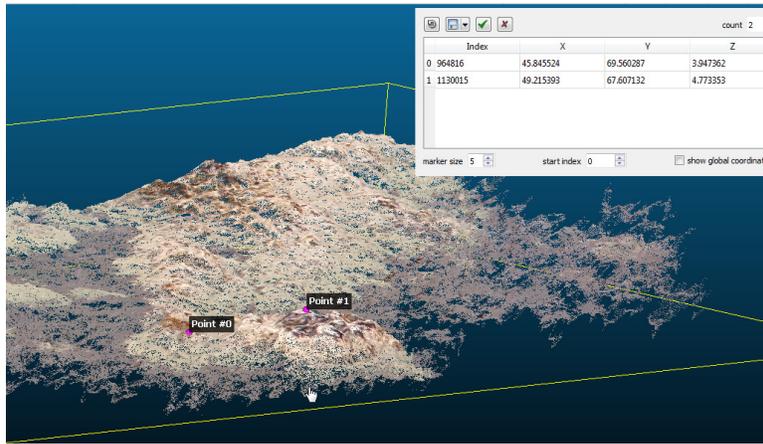
**Figure 22 -- Manual height measurements in dense point cloud**

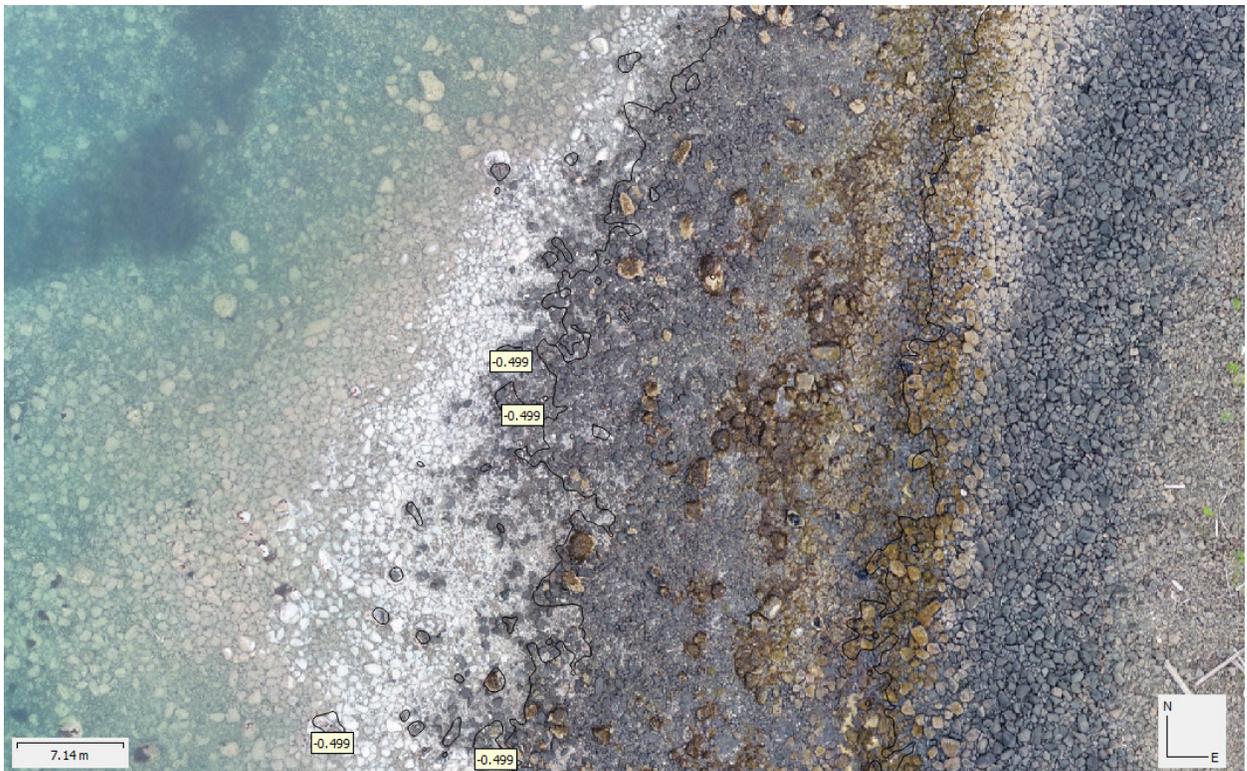
In final office processing following availability of final tides, tide corrections were applied in PhotoScan to bring point cloud data to MLLW. A tide value was first computed for each mission, based on the average time of acquisition of the mission using zone-corrected tide data from the NWLON station in Sand Point. Next, vertical control points were created along the recognizable water line. The tide value was then used to shift the entire mission’s point cloud and associated DEMs to MLLW for height determination.

**Figure 23 -- Waterline contour corrected for MLLW overlaid on DEM generated photo-mosaic in PhotoScan. A tide of -0.499 m at this mission time was assigned to the shoreline-water interface to adjust the final DEM to MLLW.**

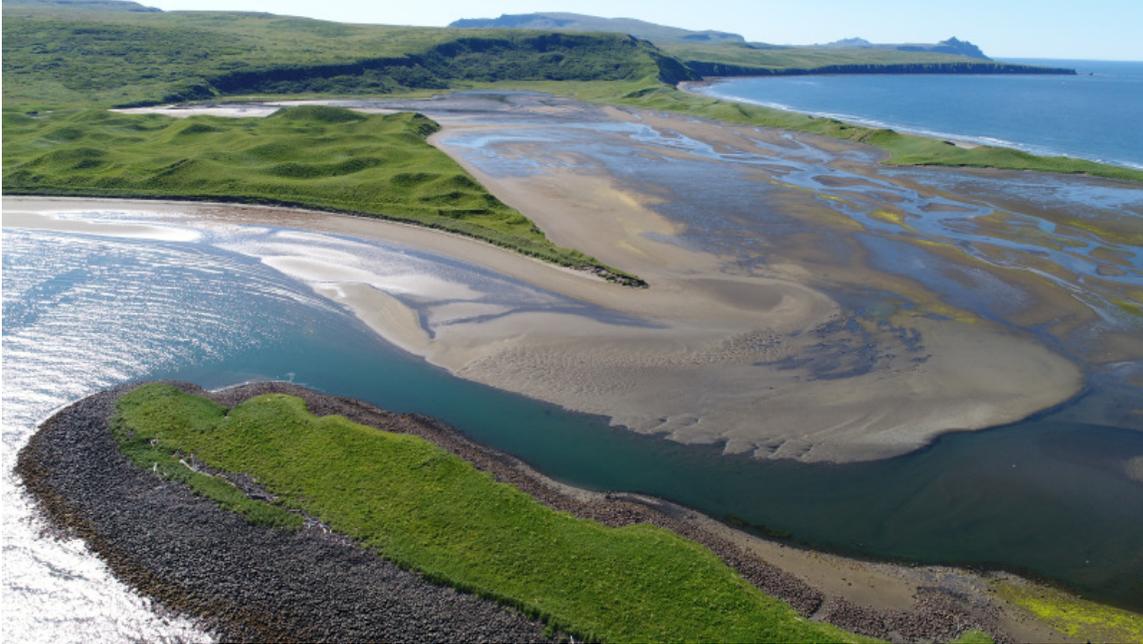
On occasion, missions were flown as “oblique”, with a camera angle of approximately 45 degrees relative to the shoreline, instead of straight down. This was advantageous when examining expansive area features, including foul coastline or ledges. An example image form one of these missions is shown below.

*Figure 24 -- Oblique photo to show foul area in shallow bay at low tide.*

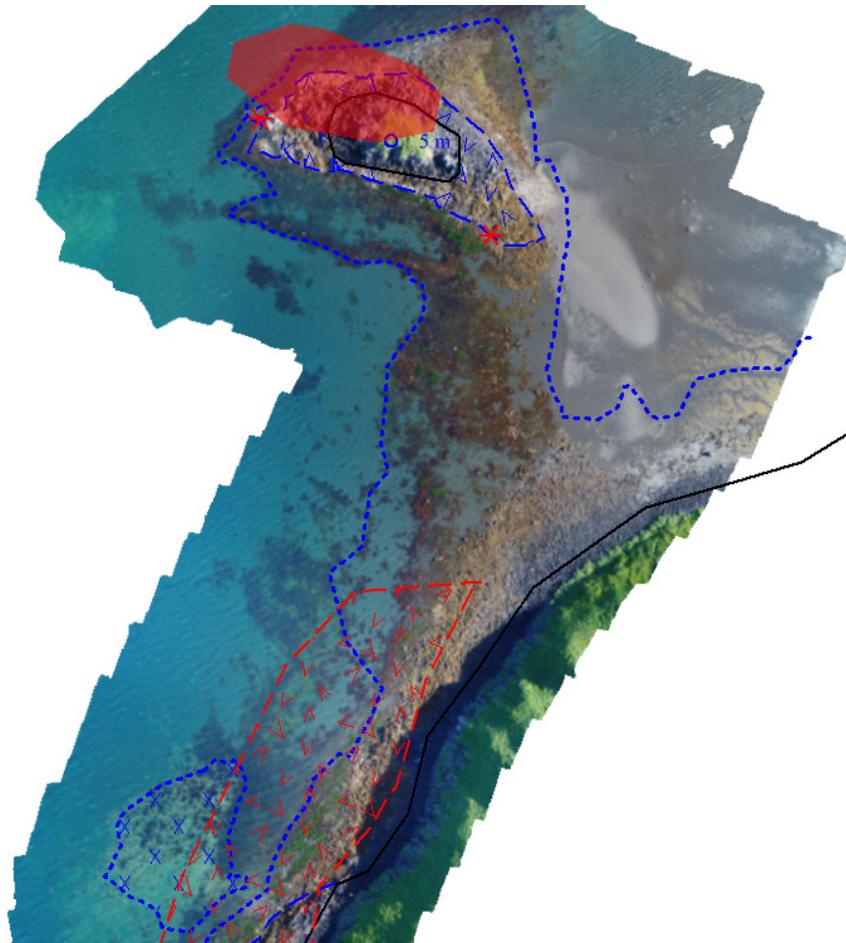
Most features could be readily identified within the required 80 m. However, per guidance in the “New/Delete vs Update” section (7.5.2) of the HSSD, the better positions obtained by this survey frequently required position updates for features. The increased accuracy as well as high level of detail available with the low-altitude aerial imagery led to extensive re-digitization of chart as well as GC-sourced line and area features. For this reason, many assigned features were noted in the FFF to be “verified but mispositioned” with a recommendation of “delete”, to be replaced by an associated “new” feature defined nearby in the FFF.

*Figure 25 -- Example of shoreline feature processing -- assigned features (red) overlaid on ortho-photomosaic and correlated. New features, including a MHW height on the island derived from the SfM DEM, are shown in blue. MHW from the CSF is black.*

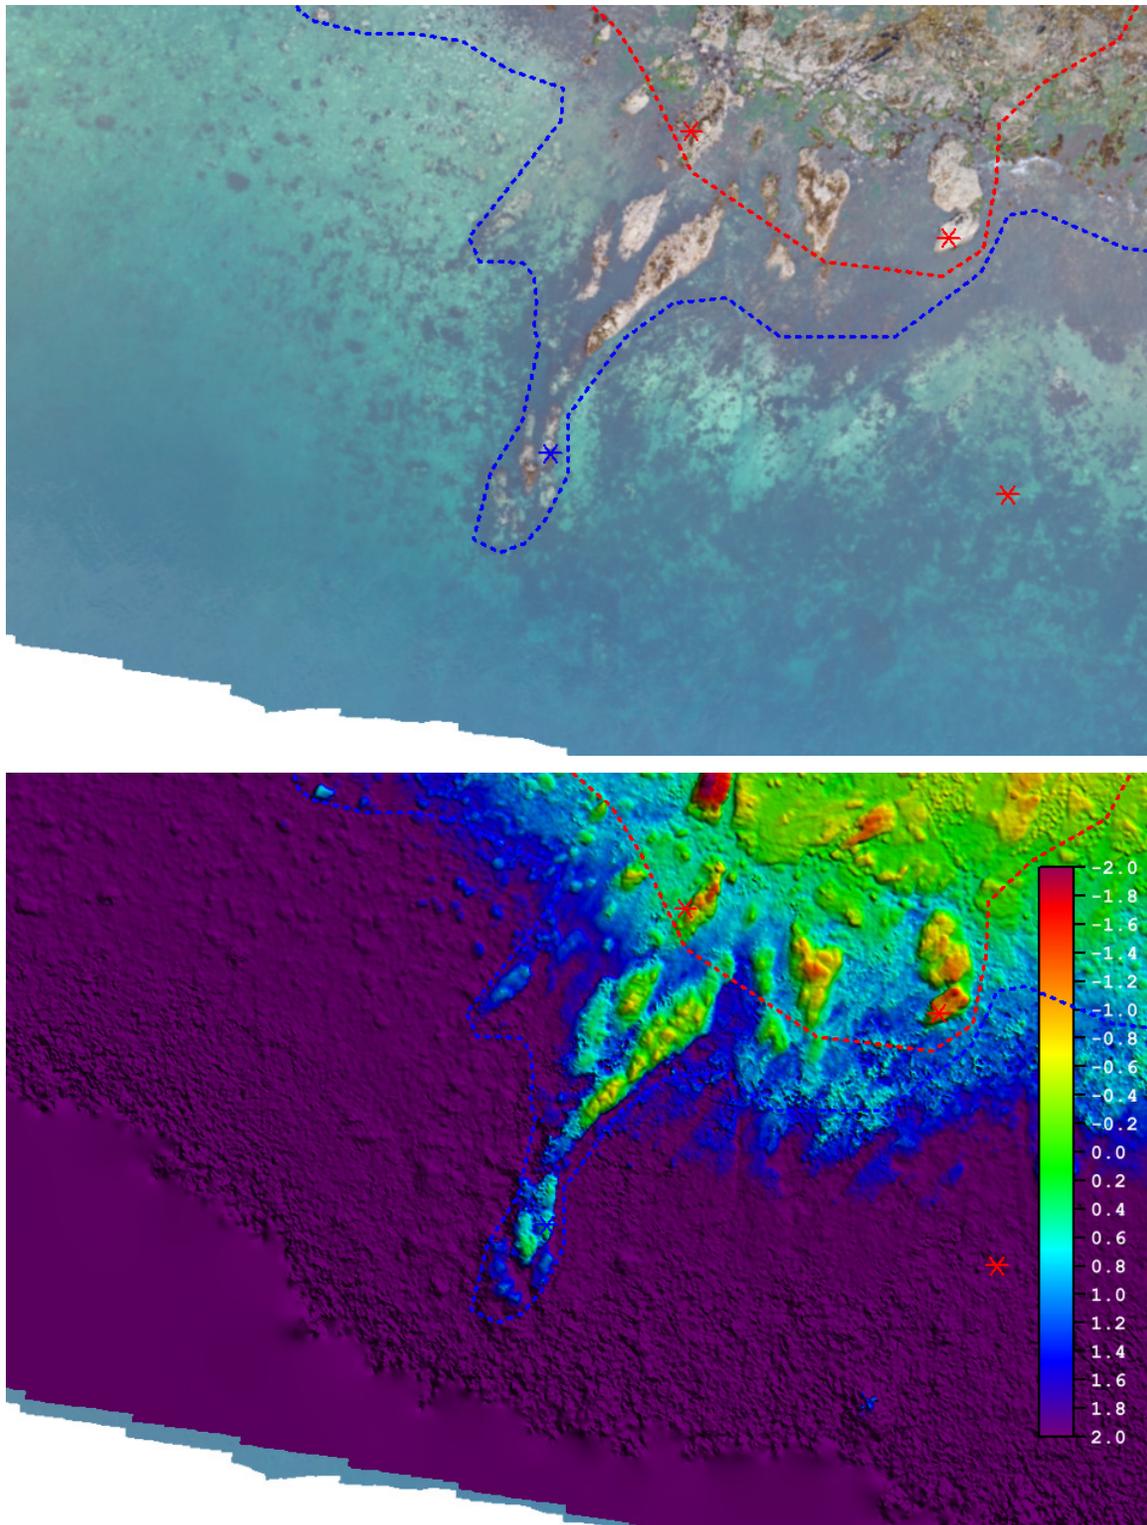
Heights for most features were pulled from the associated DEM output from PhotoScan. DEM heights were adjusted to MLLW prior to height extraction, as described previously. PhotoScan was able to generate 3D heights for exposed features in most cases, and in some cases submerged features as well--though DEM quality rapidly degraded with increasing water depth. An example is shown below.

*Figure 26 -- Example of DEM usage for height extraction – SfM ortho-photomosaic (top) clearly shows shoreline detail. DEM (bottom, scale in meters relative to MLLW) shows heights. Note smooth-appearing area in lower part of DEM is where heights could not be computed by the SfM algorithm due to water depth.*

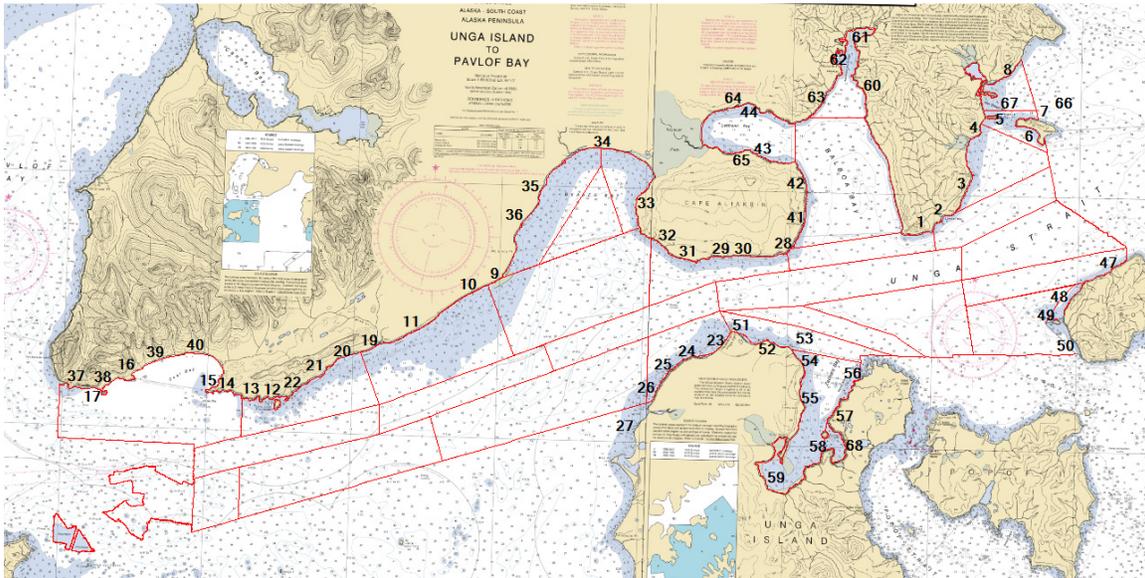
Figure 27 -- Mission number locations relative to the project area
