## Data Acquisition & Processing Report

Project No. OPR-P384-KR-17.....

**OPR-P384-KR-17**

**Pavlof Islands and Vicinity**

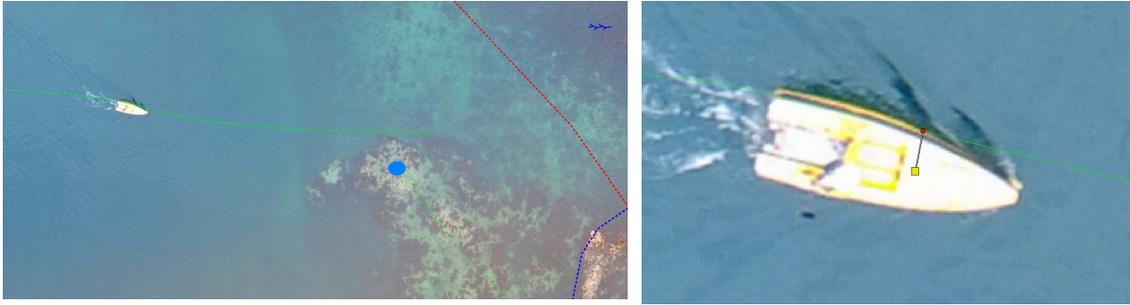
Instead, positioning results received reality checks by comparison to overlapping multibeam data on coincident features, as well as vessel track-line positions. Positions on features computed from overlapping, independent missions were also checked. These checks compared to within 5 m or better, on average. This was considered more than sufficient given that the alternative method of investigation (visual estimations based on range and bearing from skiff for most features) would result in much lower confidence for final positions. Some examples of these checks are shown below.

**Figure 28 -- Example imagery check, compared to vessel: Ortho-photomosaic computed position of ASV vessel is displaced from its actual position (green trackline in CARIS) by about 0.9 m. The navigation center is mid-ship on the vessel, so perfect alignment would place the trackline dead-center in the imagery.**

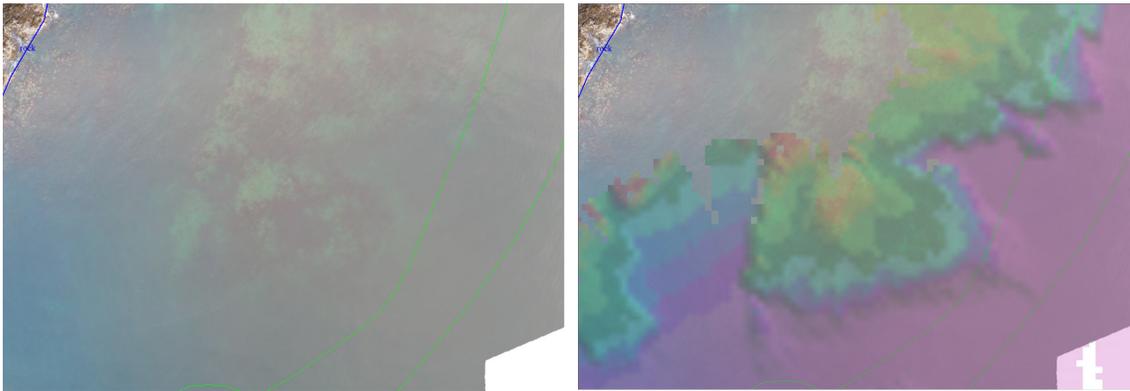
**Figure 29 -- Example of common multibeam/imagery agreement: Submerged rock in imagery (left) lines up well with multibeam (overlaid on the right), to 2 m or better in this example. Rock depth at center of image is about 6 m.**

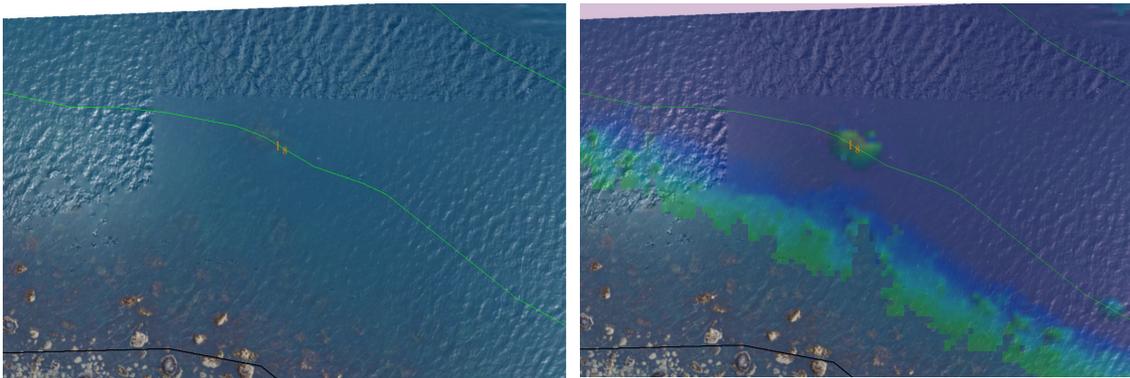
**Figure 30 -- Example of common multibeam/imagery agreement: Submerged rock in imagery (left) lines up well with multibeam (overlaid on the right), to within about 3 m in this example. Rock depth (orange designated sounding) is 1.8 m.**

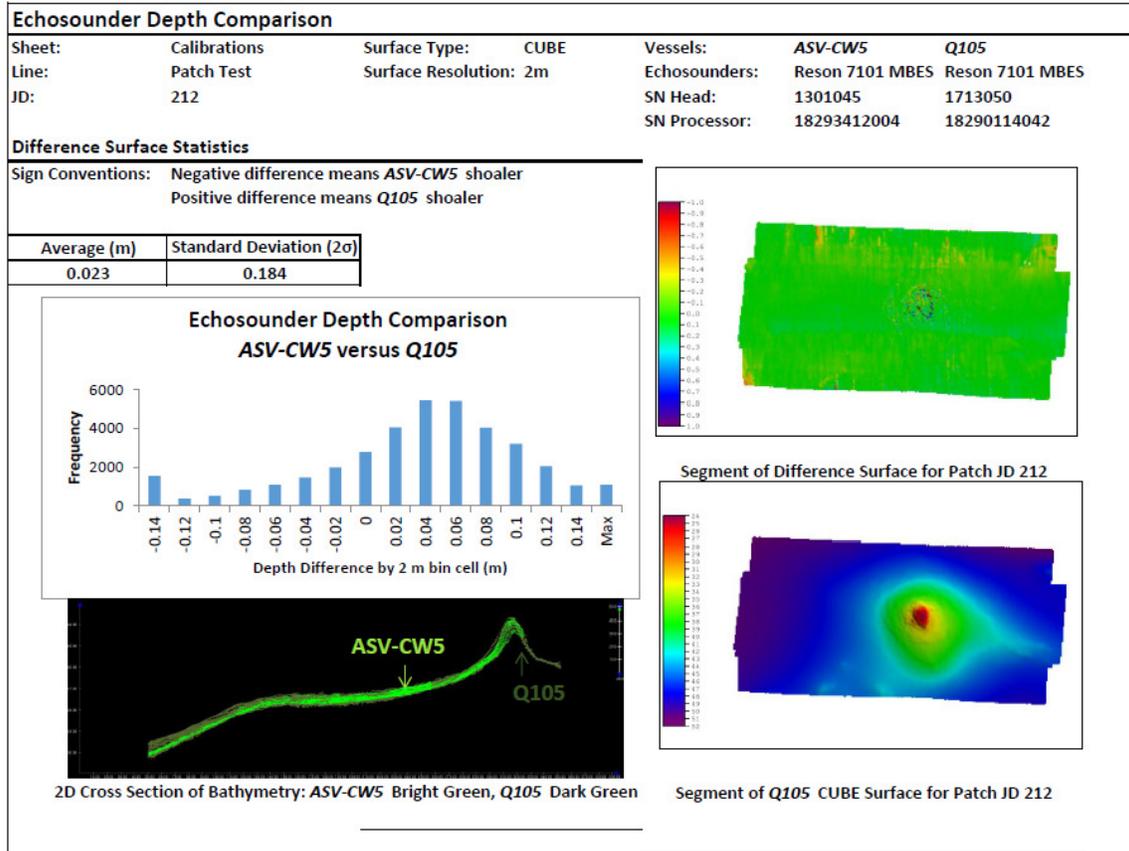
Echosounder data from the separate vessels compared well, with average results falling in a range of -0.056 m (*ASV shoaler*) to 0.021 m (*Q105 shoaler*).

*Figure 31 – Example Echosounder Depth Comparison report from this project.*

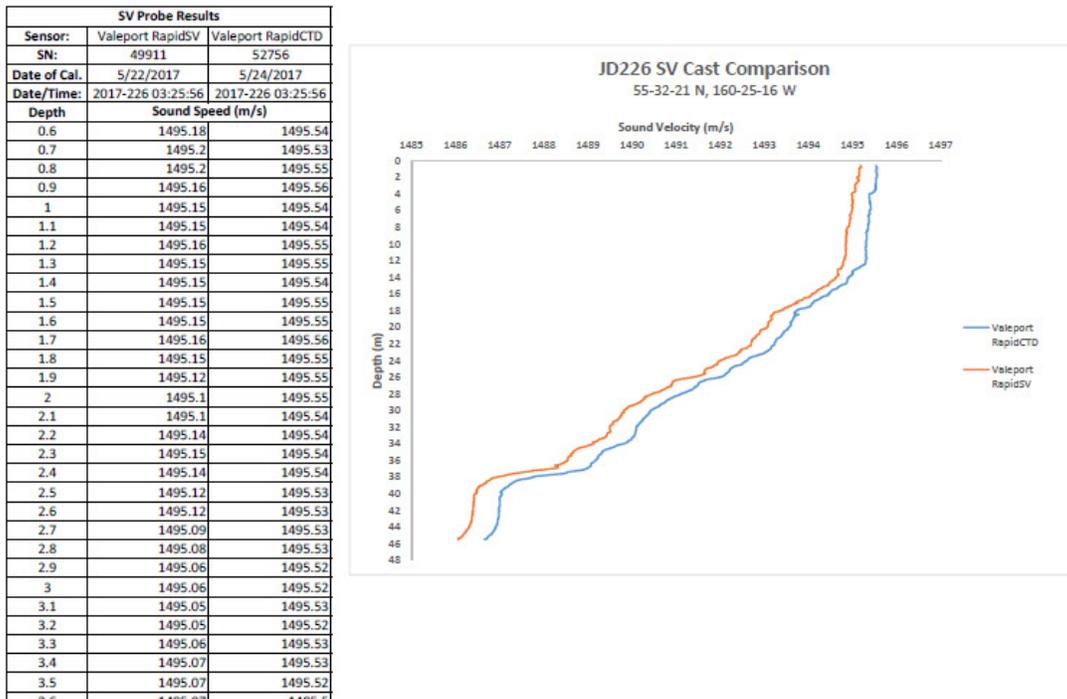
Figure 32 – Example of SVP confidence check (comparison results).

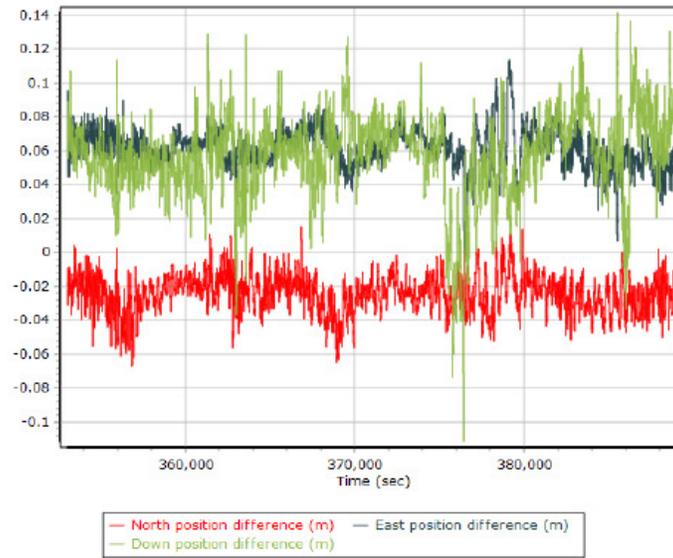
Figure 1 - Results of position difference between 2017-208-0204-Q105.POS processed with AB07 and 0056

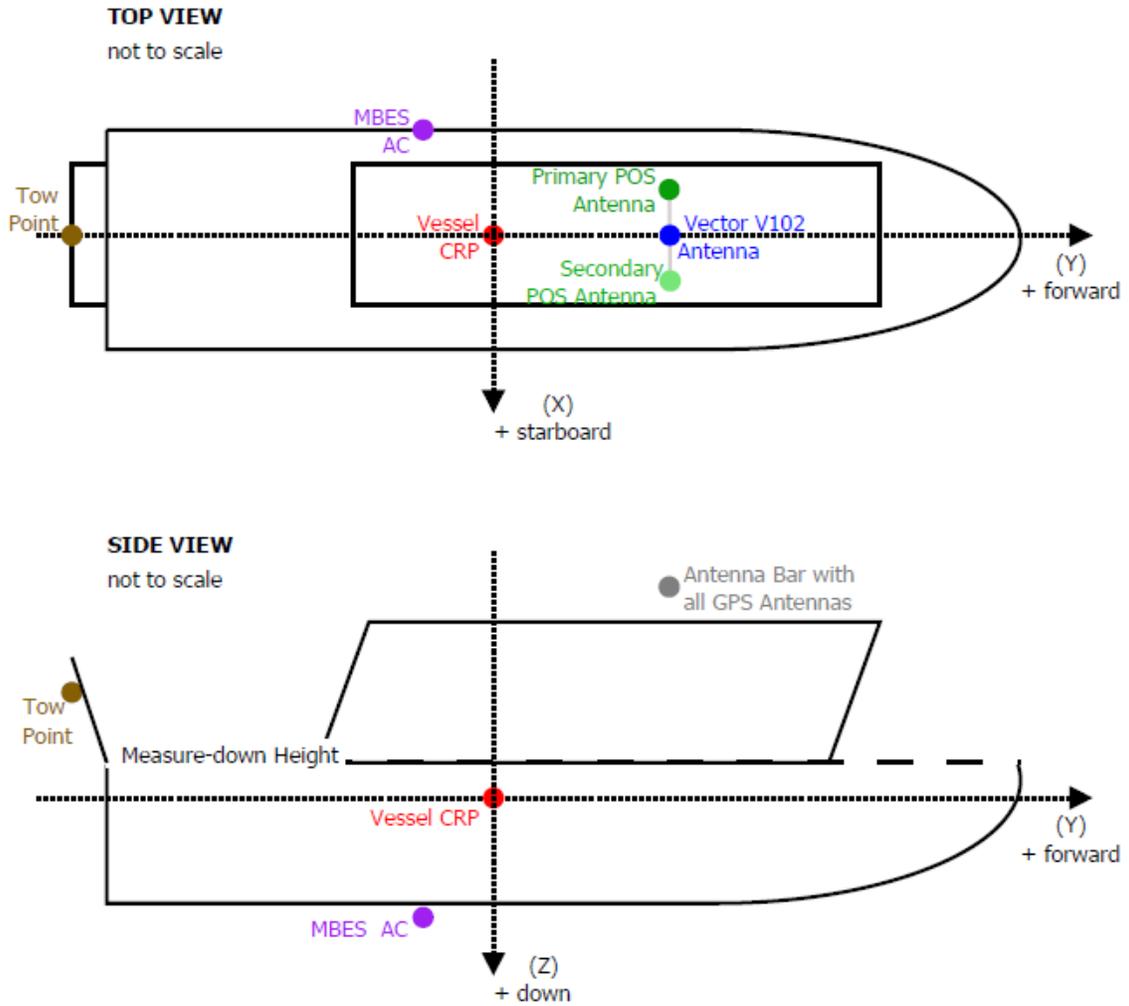
**C.1.1. Q105 Vessel Offsets**

*Figure 35 – Q105 vessel survey showing relative positions of installed survey equipment.*

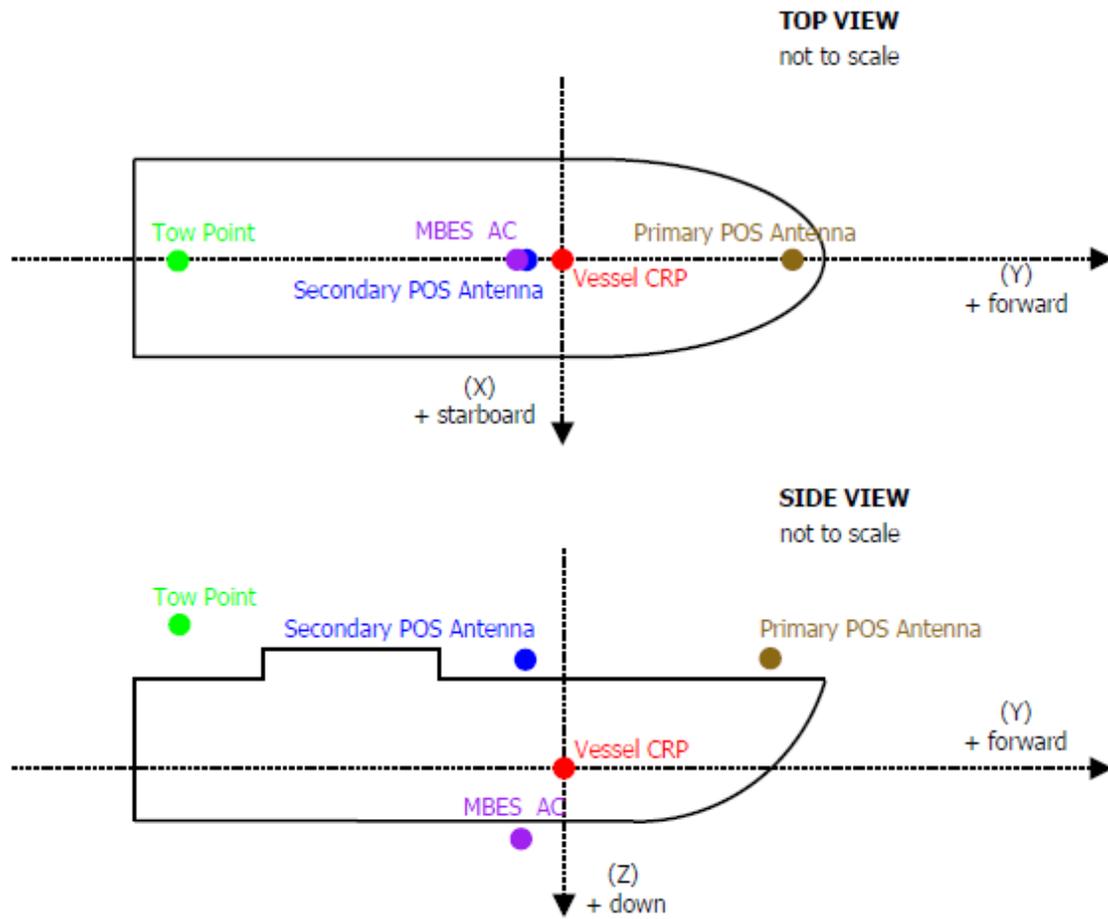
**C.1.2. ASV-CW5 Offsets**

*Figure 36 – ASV-CW5 vessel survey showing relative positions of installed survey equipment.*

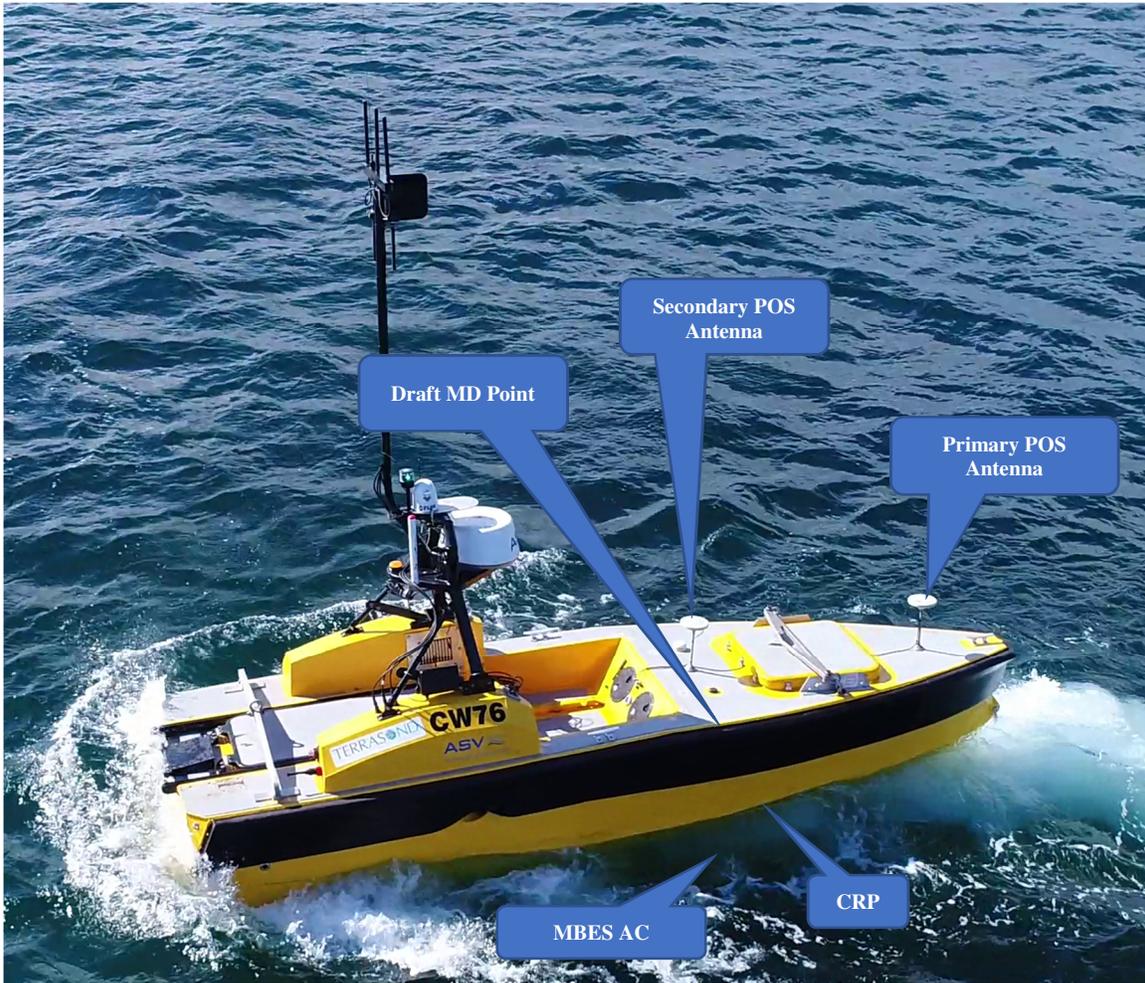
*Figure 37 – ASV-CW5 primary sensors and offset measurement points.*

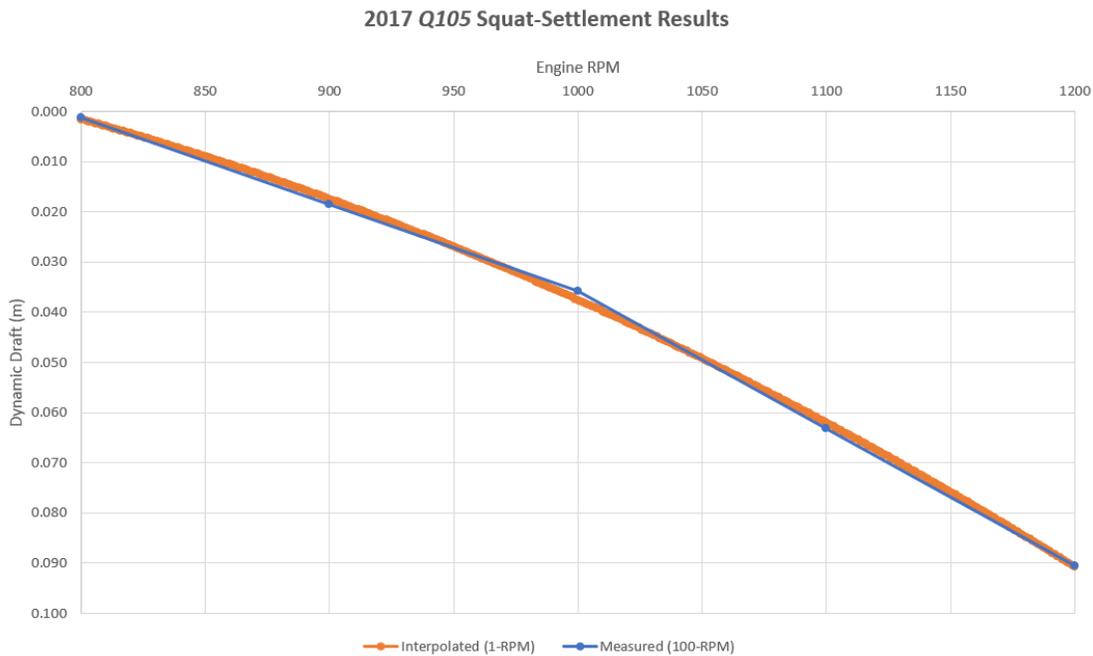
A 3<sup>rd</sup> order polynomial was used to smooth the 100-RPM results and create a correction for every 1 RPM of change, as shown in the following figure. The interpolated data—not measured data—was used for final corrections.

**Figure 38 – Q105 squat settlement results (2017).**

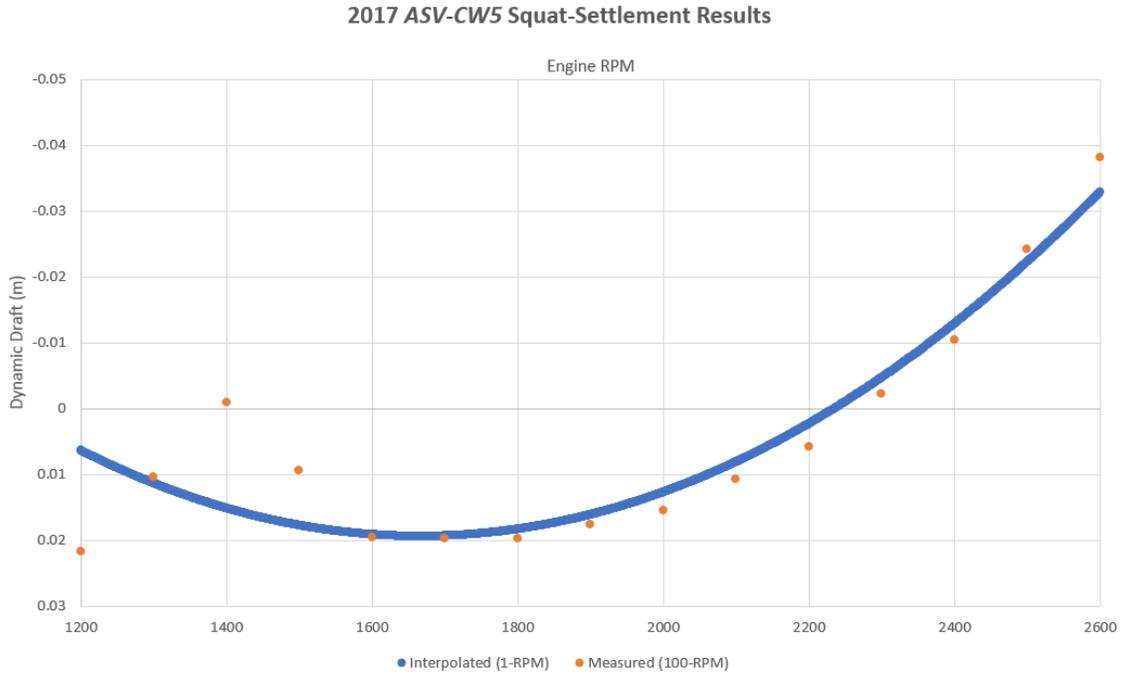
A 3<sup>rd</sup> order polynomial was used to smooth the 100-RPM results and create a correction for every 1 RPM of change, as shown in the following figure. This also had the effect of smoothing out inconsistent data points obtained for the 1200, 1400, and 1500 RPM levels that were not observed on the 2016 tests done on the same vessel. The interpolated data—not measured data—was used for final corrections.

**Figure 39 – ASV-CW5 squat settlement results (2017).**
