DESCRIPTIVE REPORT

Registry Number: D00168

Project: M-S974-FA-12

NOAA Ship *Fairweather*

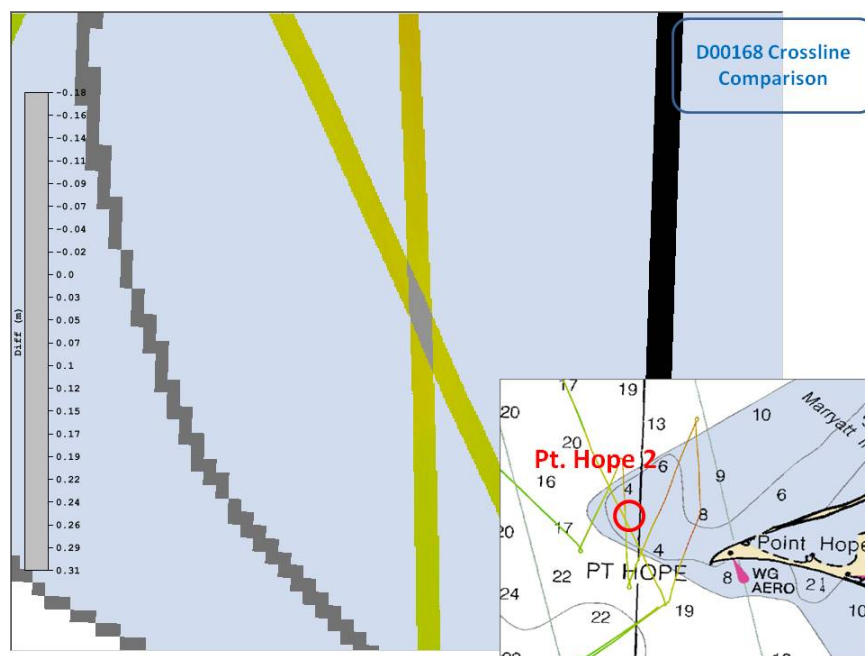
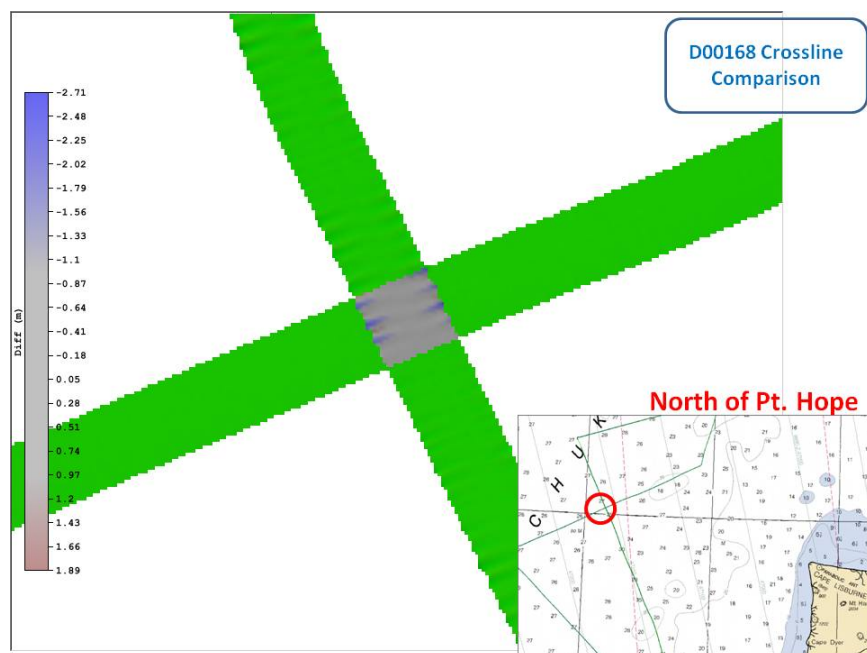
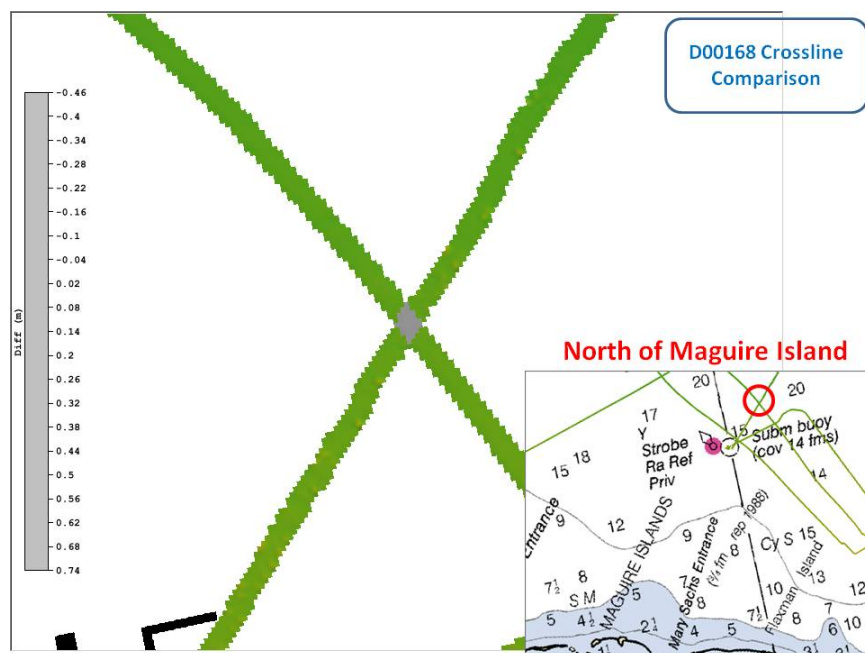
Surface differencing in CARIS Bathy Data Base was used to assess agreement between transit North and South tracklines. The Figures depict a difference surface between a 32-meter surface made with a trackline during the transit north only and 32-meter surface made with a trackline during the transit south only. This difference surface is submitted digitally in the Separates II folder. The two surfaces agree within plus or minus 2 meters, therefore the areas where the tracklines cross each other agree within the total allowable vertical and horizontal uncertainty in their common areas.

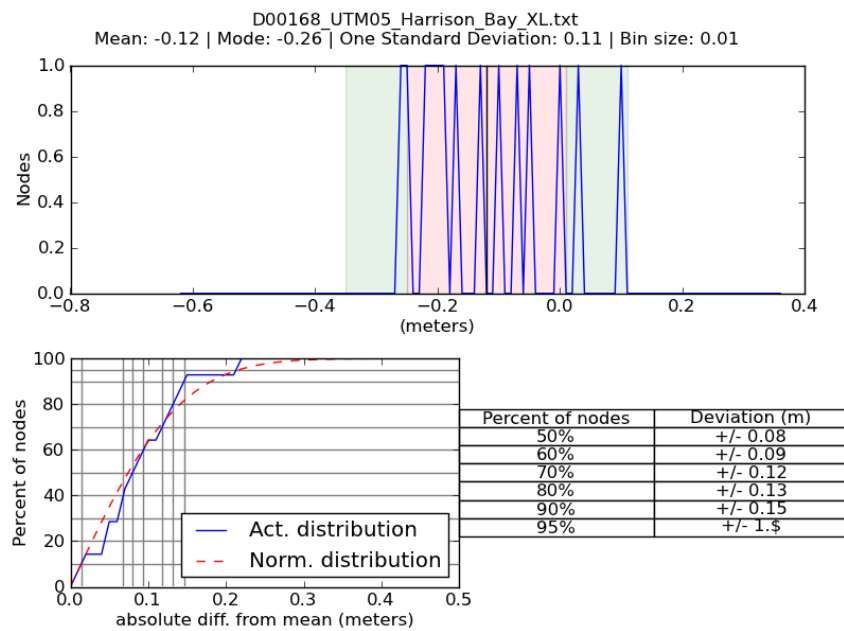
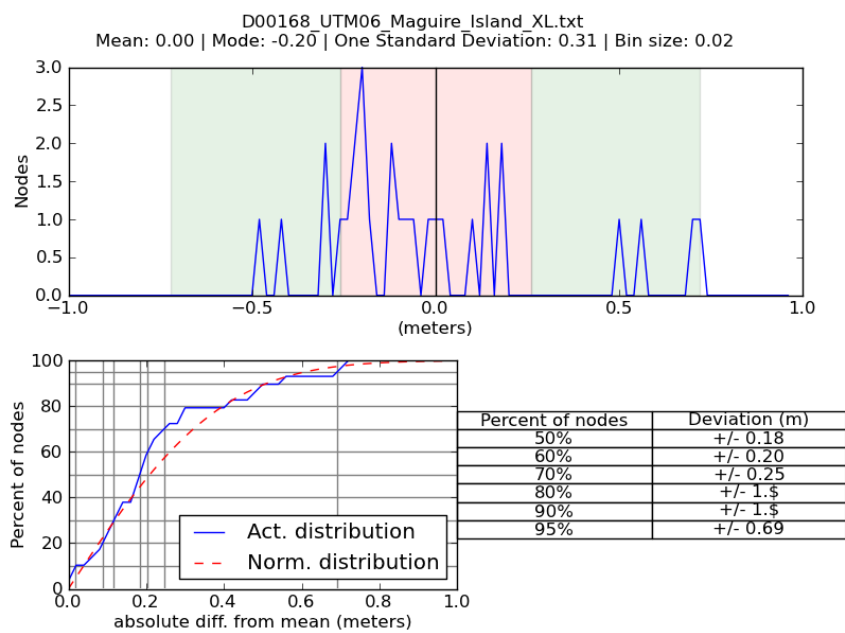
It was found that some crossline comparison partially failed the statistical computation. The graphs show deviation values (m) equal to ± 1.5 . This is due to the lack of data point in the exported file. The data is within specifications after a visual review. See figure 9, 17, 19 and 21 for graphical representation.

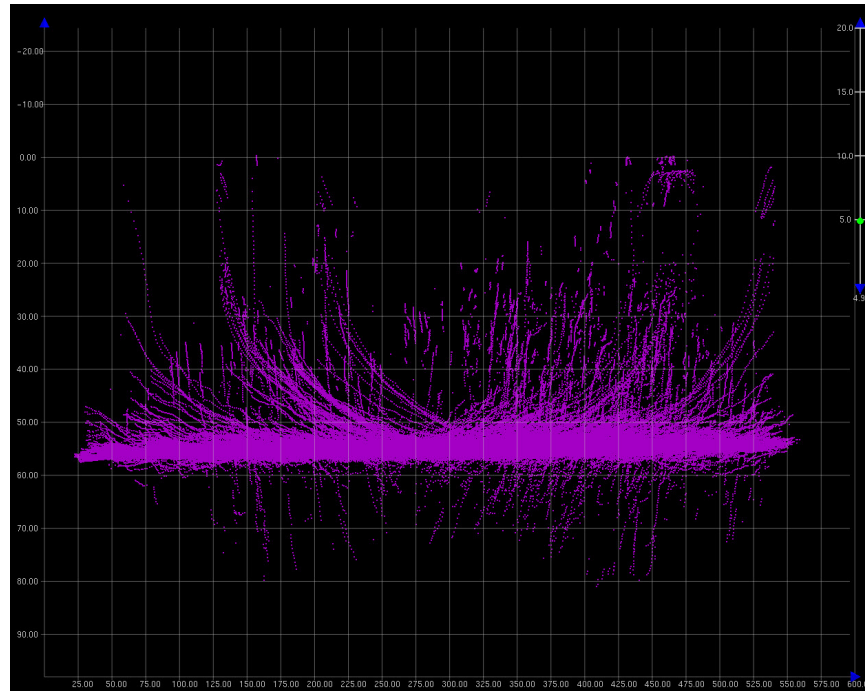
During acquisition on D00168 multiple weather events occurred during the track line survey in the Bering Sea and Chukchi Sea causing large swell conditions in the working area. All MBES data for D00168 were collected in three to nine-foot sea surface swells. Due to the swell, significant pitching with a peak magnitude of 8 to 10 degrees was experienced. In many cases, the pitching caused the Reson 8160 to entirely lose bottom tracking, see Figure 27. While the Reson 7111 did not lose bottom tracking entirely the outer beams appeared to be of unreliable quality as compared with adjacent data. The data were cleaned out where they affected the surfaces.

Figure 27: Large Swell.
