DESCRIPTIVE REPORT

Type of Survey: Natural Disaster Response

General Locality: Galveston Bay

Sub-locality: Bolivar Roads Anchorage Area A and B, Galveston Channel, Morgans Point to Turning Basin

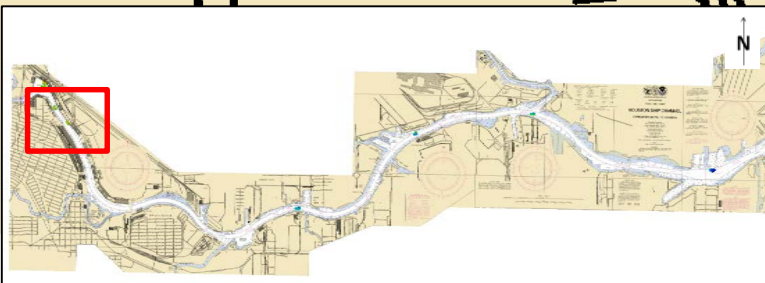
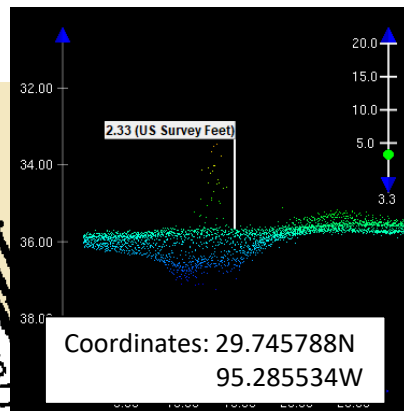
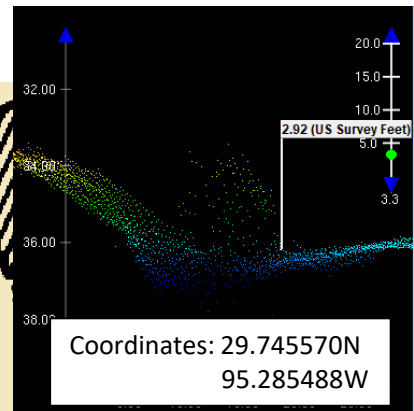
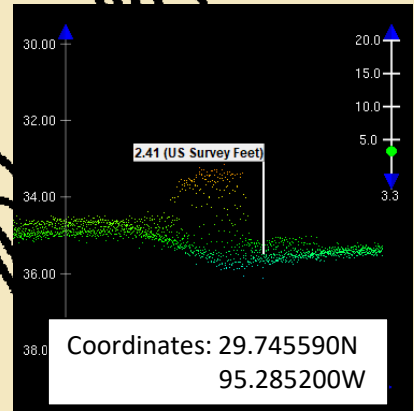
Chartlet 2 of 5: Contacts
Preliminary Data - NOT FOR NAVIGATION

Longest Length: 11ft
 Widest Width: 9ft
 Tallest Height: 2.92ft
 Least Depth: 33ft

Bathymetry data were acquired and inspected from the Lynchburg Landing to the Turning Basin. Possible obstructions were found in the channel by the R/V Manta using sidescan sonar then later developed by NRT4. Data reflects state of seafloor on the date surveyed.

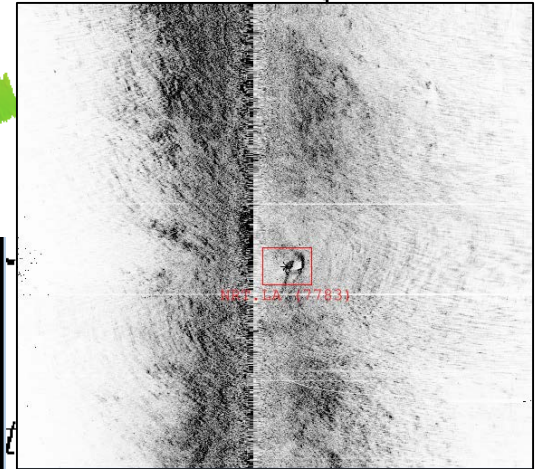
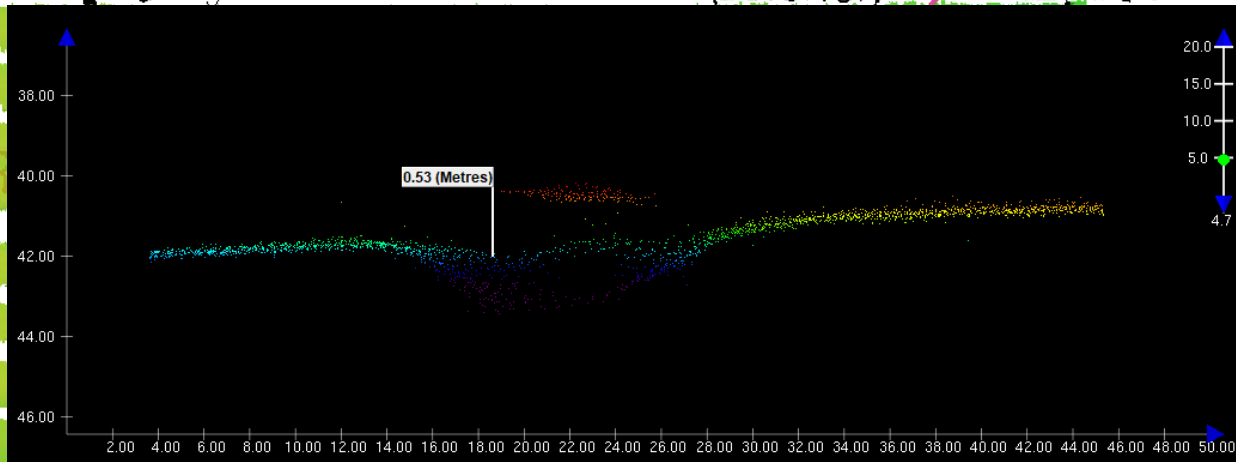
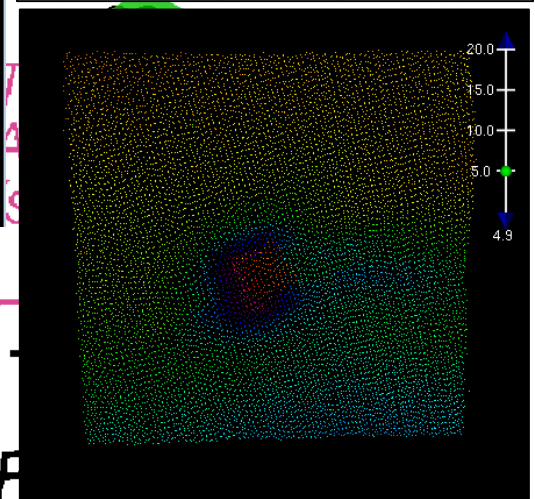
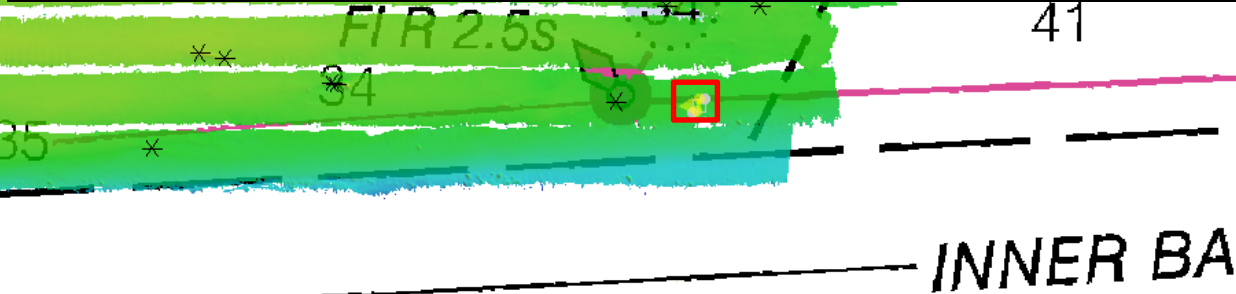
Chartlet 5 of 5: Object Detection
Preliminary Data - NOT FOR NAVIGATION

Least Depth: 111.5m (37.7ft)
 Coordinates: 29.344979N 94.751331W
 Possible abandoned buoy block.
