NOAA FORM 76-35A	
U.S. DEPARTMENT OF COMMERCE NATIONAL OCEANIC AND ATMOSPHERIC ADMINISTRATION NATIONAL OCEAN SERVICE	
DESCRIPTIVE REPORT	
Type of Survey	Field Edit
Field No.	
Registry No.	F00023
LOCALITY	
State	New York
General Locality	Long Island Sound
Sublocality	Oyster Bay
	Jakobson's Shipyard
	<u>1940</u>
	CHIEF OF PARTY
LIBRARY & ARCHIVES	
DATE

Subject: Survey in Oyster Bay, N.Y.

On July 2, 1940, the attached survey was made to locate Jakobson's Shipyard and channel at Oyster Bay, L.I. N.Y. Under separate cover is being forwarded the sounding volume.

Sketch Showing Jakobson's Shipyard

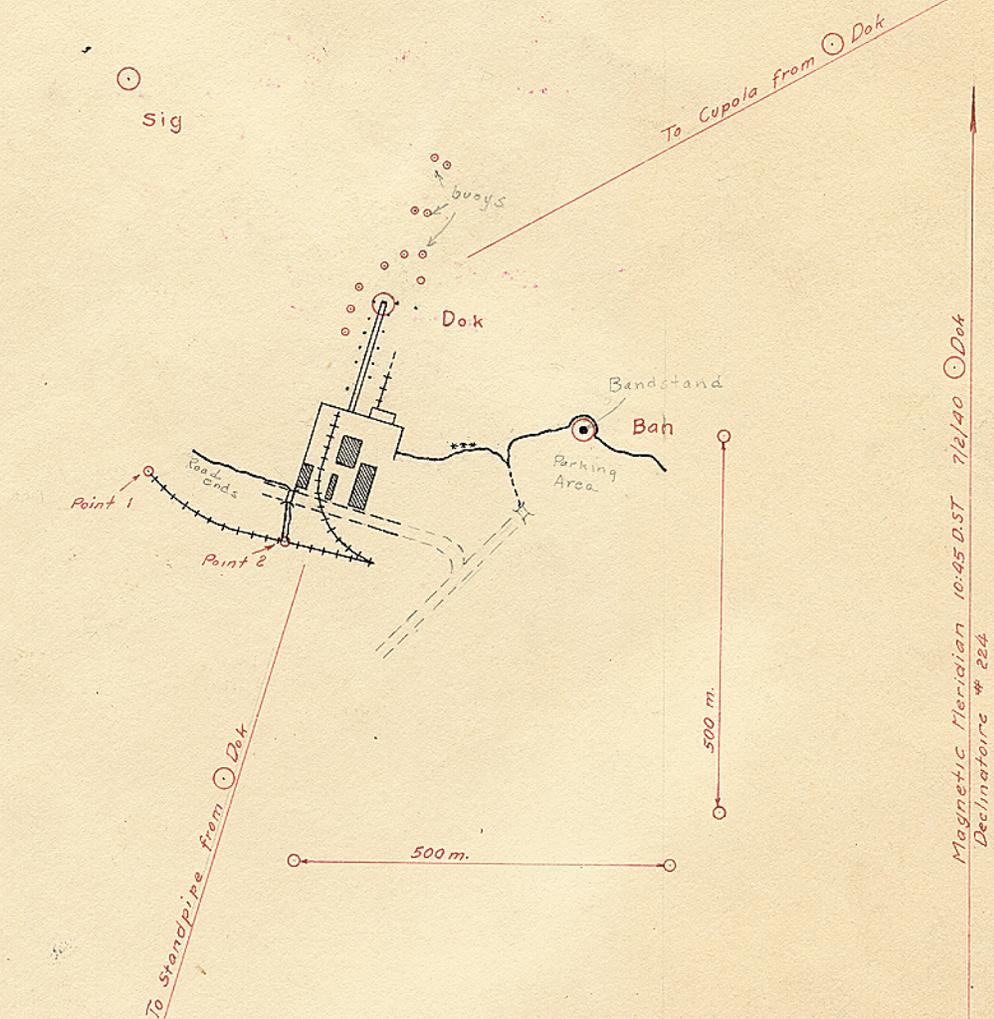
The channel is marked by barrel buoys which are maintained by the shipyard. The original intention was to have a thirteen (13) foot channel to the dock. This, however, as shown by the survey was not accomplished. The shipyard intends to improve it at some future time. There is eleven (11) to twelve (12) feet along the sides of the dock.

Oyster Bay, L.I.N.Y.

July 2, 1940

Scale 1:10,000

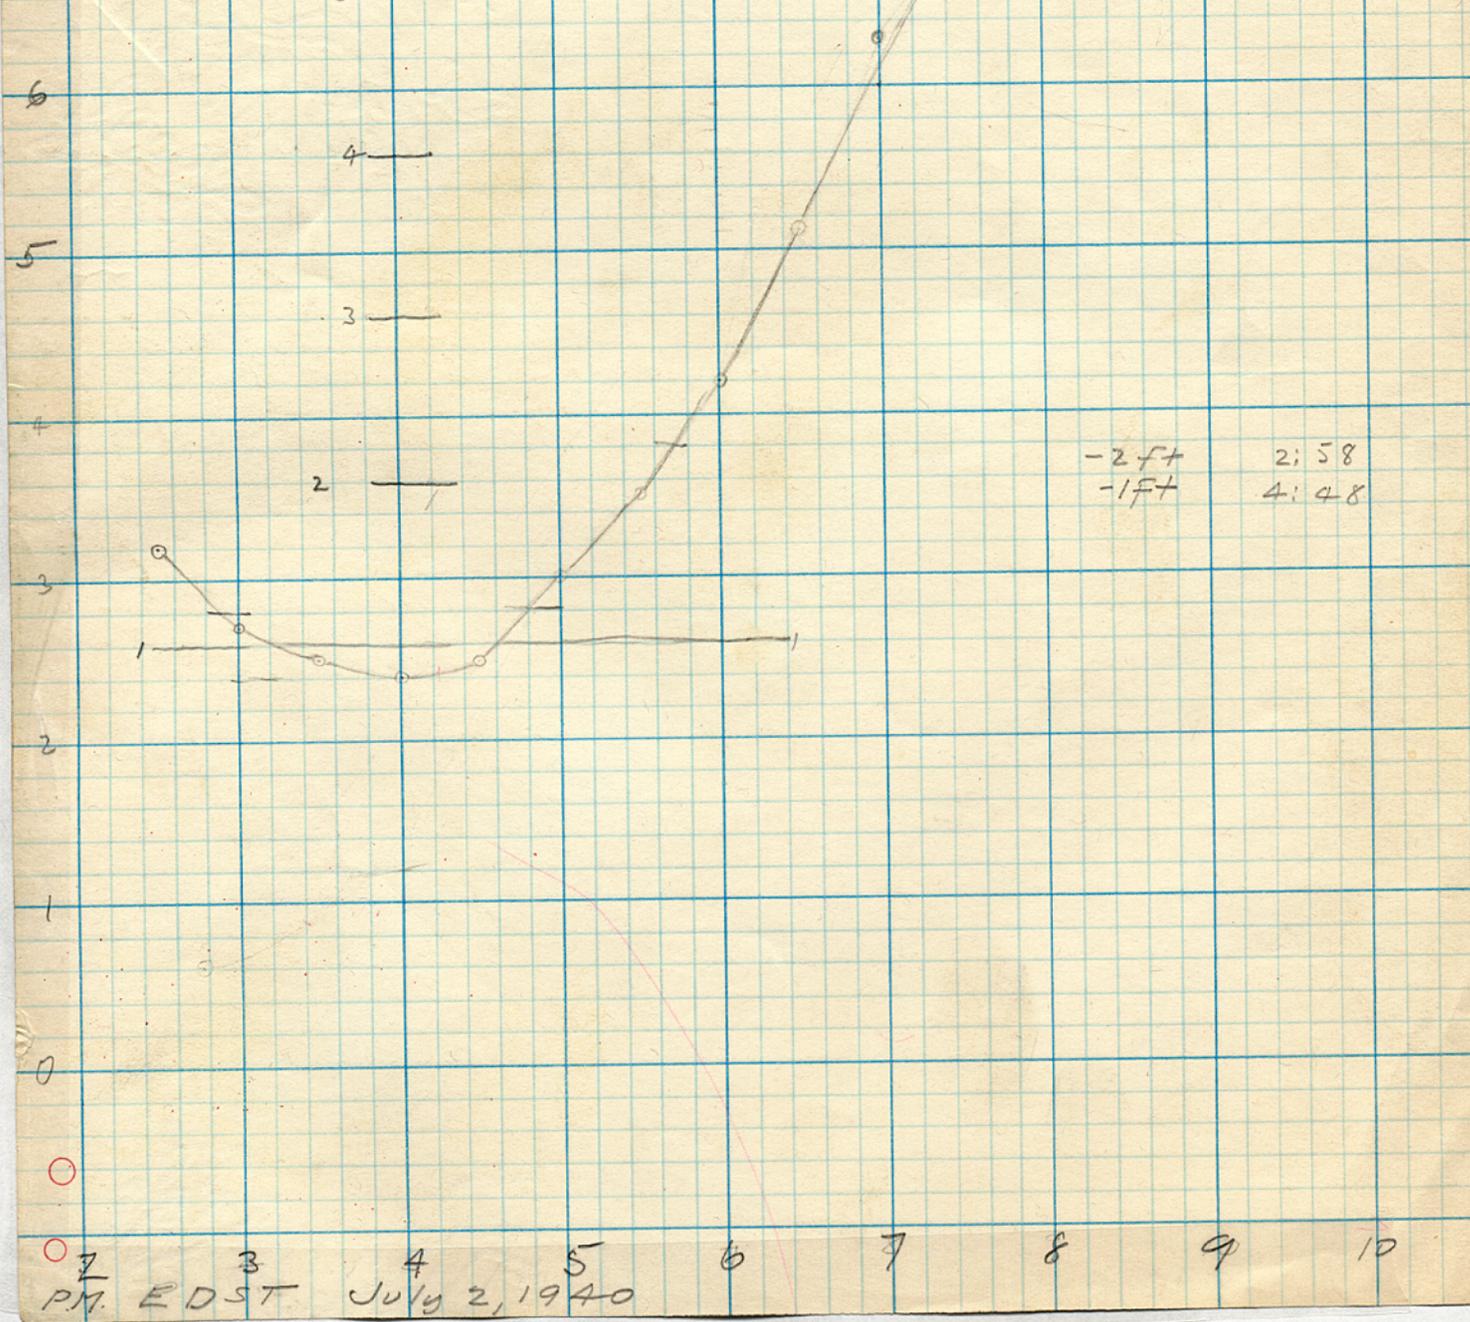
Tide Staff READINGS

TIDES A tide staff was secured to the dock (O Dok). Readings were taken half hourly and the attached curve was plotted for reducing the soundings. The low point on the curve was considered to be 0.8 as given in the tide tables.

2:30	3.2
3:00	2.7
3:30	2.5
4:00	2.4
4:30	2.5
5:00	3.0
5:30	3.5
6:00	4.2
6:30	5.1
7:00	6.3
7:30	7.0
8:00	8.0
8:30	8.7
9:00	9.3
9:30	9.5
10:00	9.6
10:35	9.4

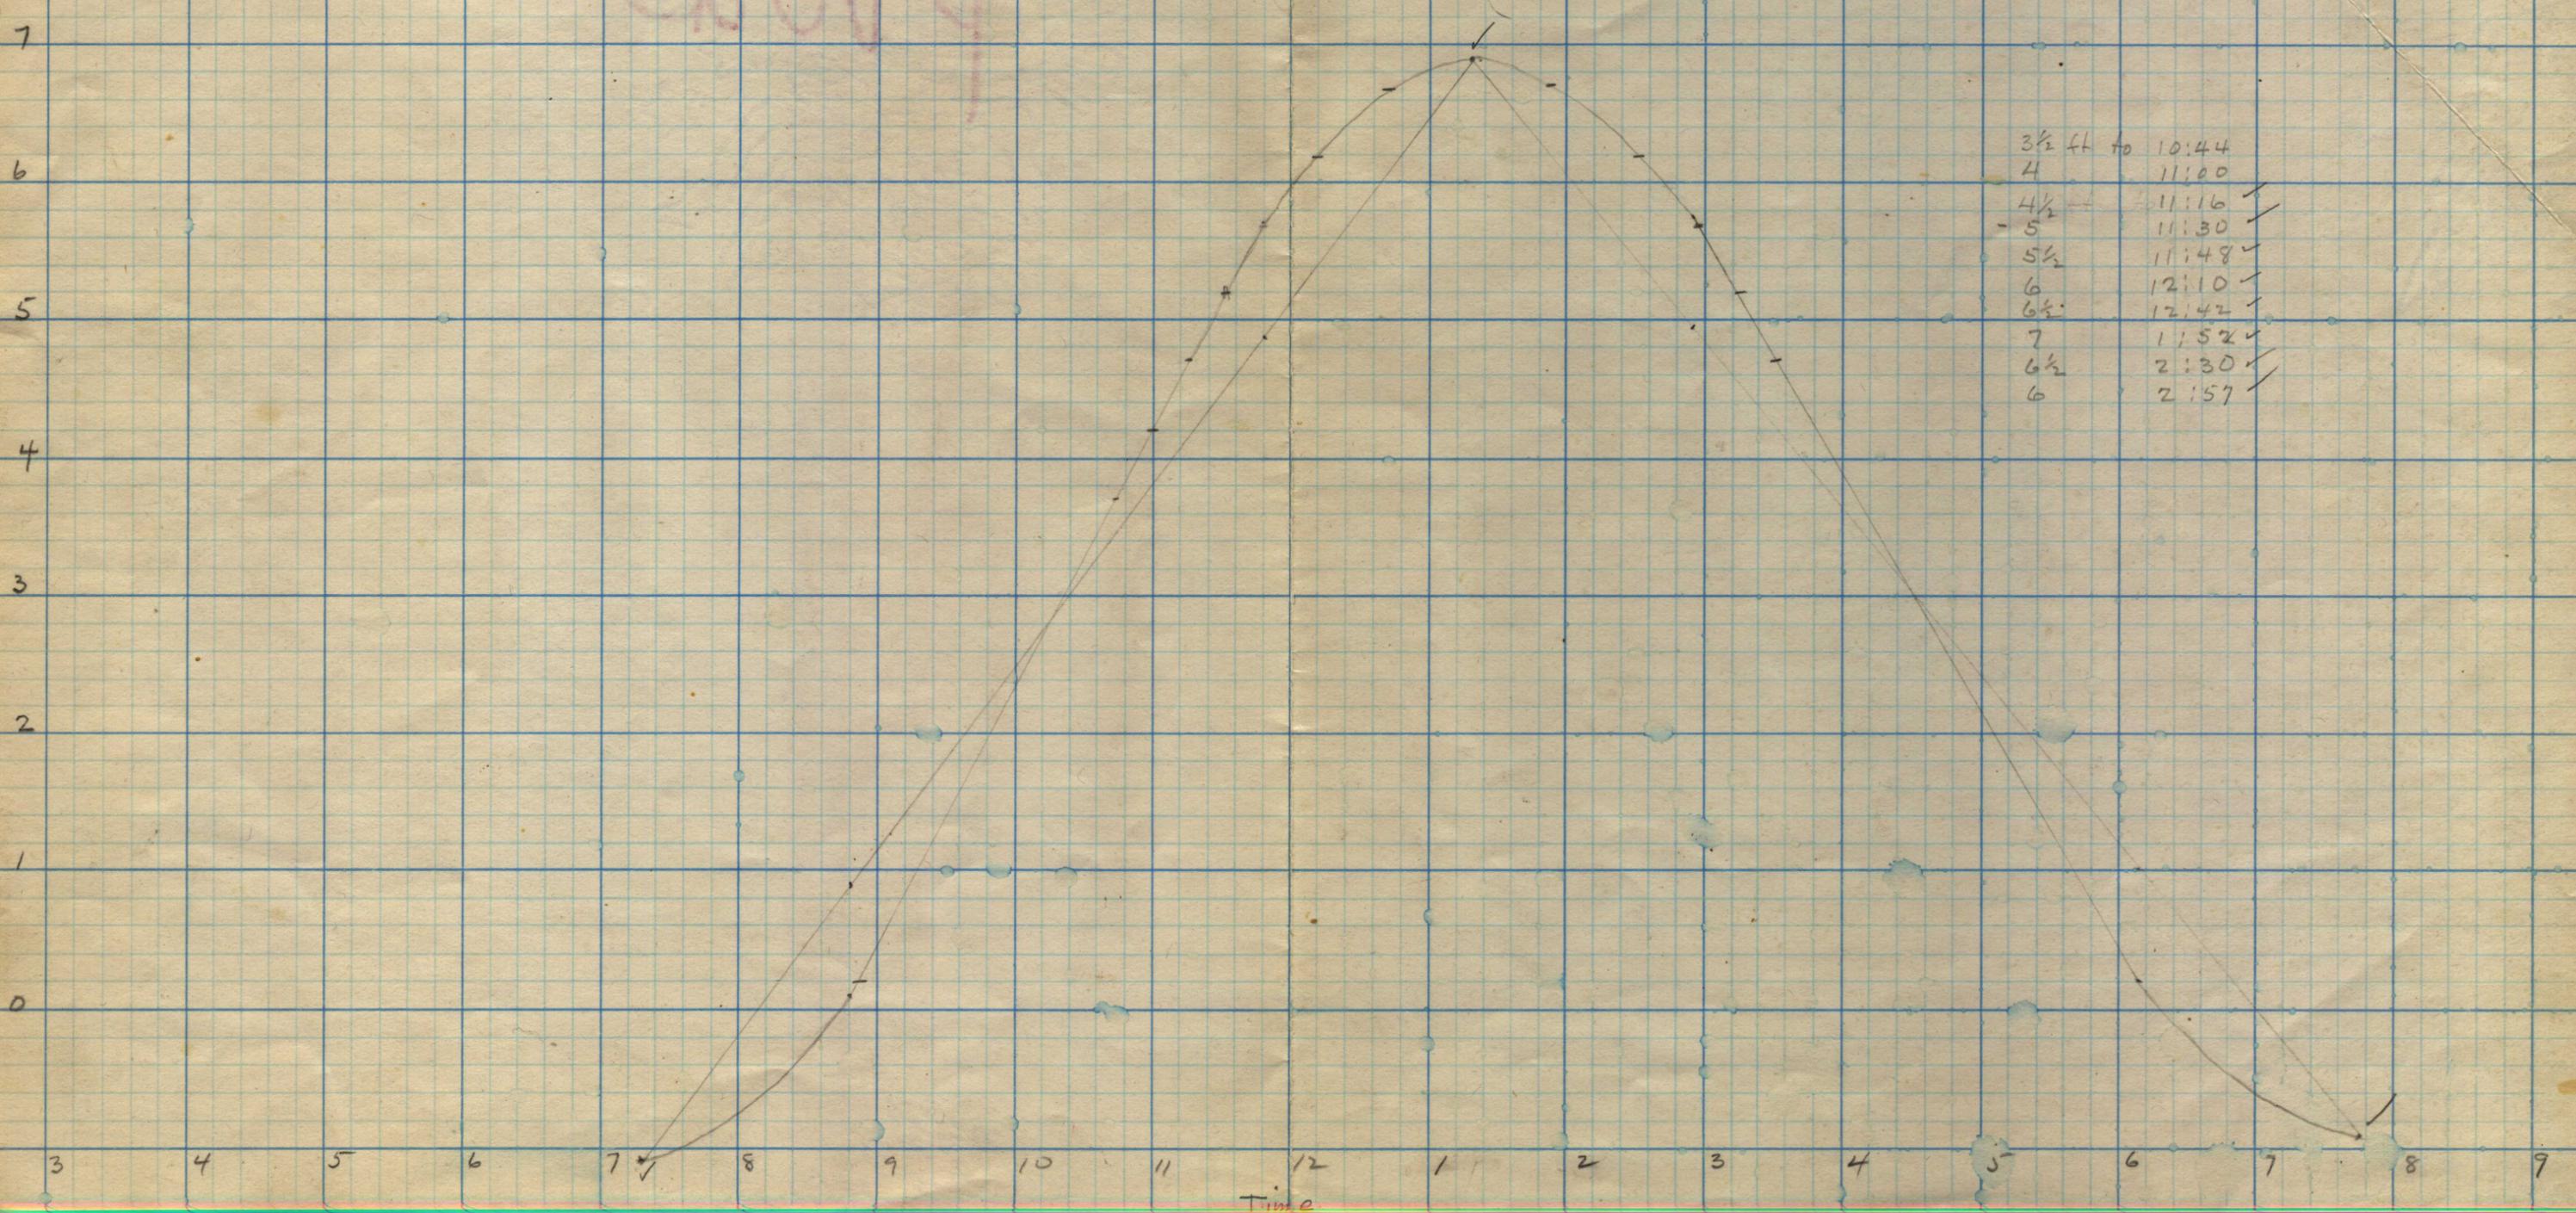
Predicted Tide Curve
 for
 Pine Orchard Harbor
 August 6, 1940
 E.D.S. Time
 Values taken at Money Id.
 Launch ELSIE III
 Fred A. Riddell, Ch. of Party.

3½ ft	to	10:44	
4		11:00	
4½		11:16	✓
5		11:30	✓
5½		11:48	✓
6		12:10	✓
6½		12:42	✓
7		1:52	✓
6½		2:30	✓
6		2:57	✓

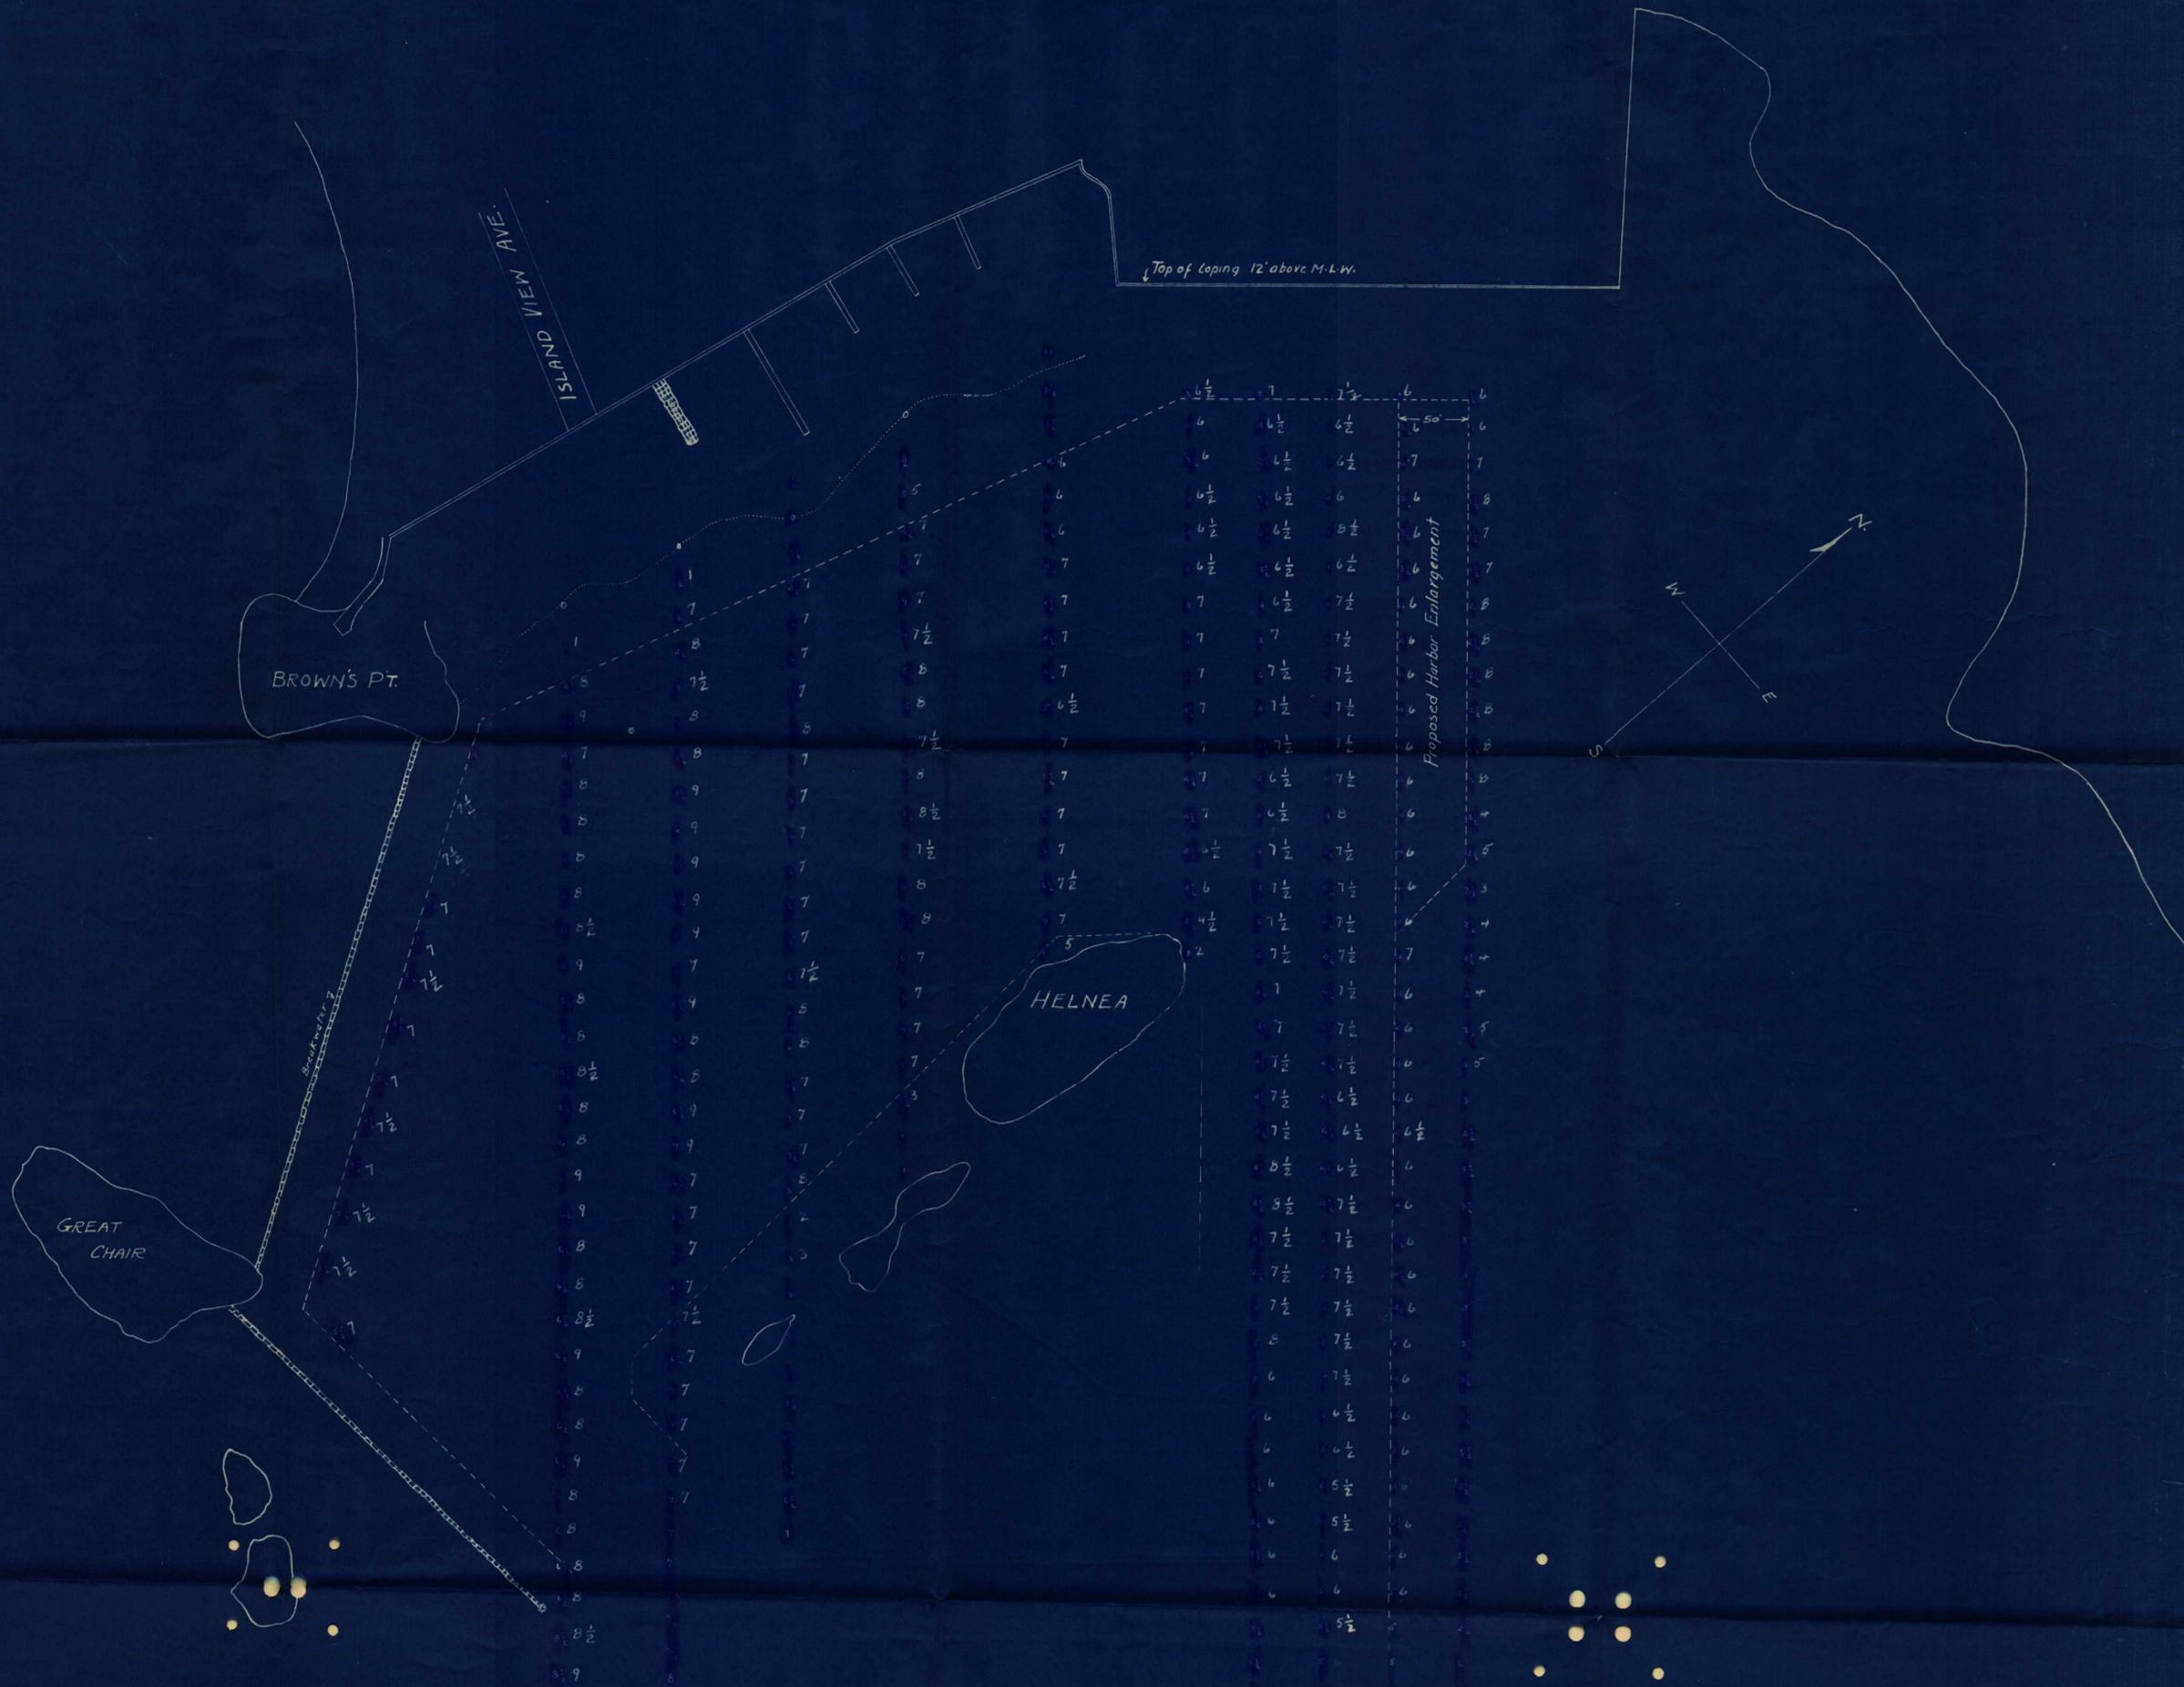
ANCHORAGE BASIN
PINE ORCHARD, CONN.

SCALE: 1" = 60'0"

Soundings in Red taken after Dredging Feb. 1931

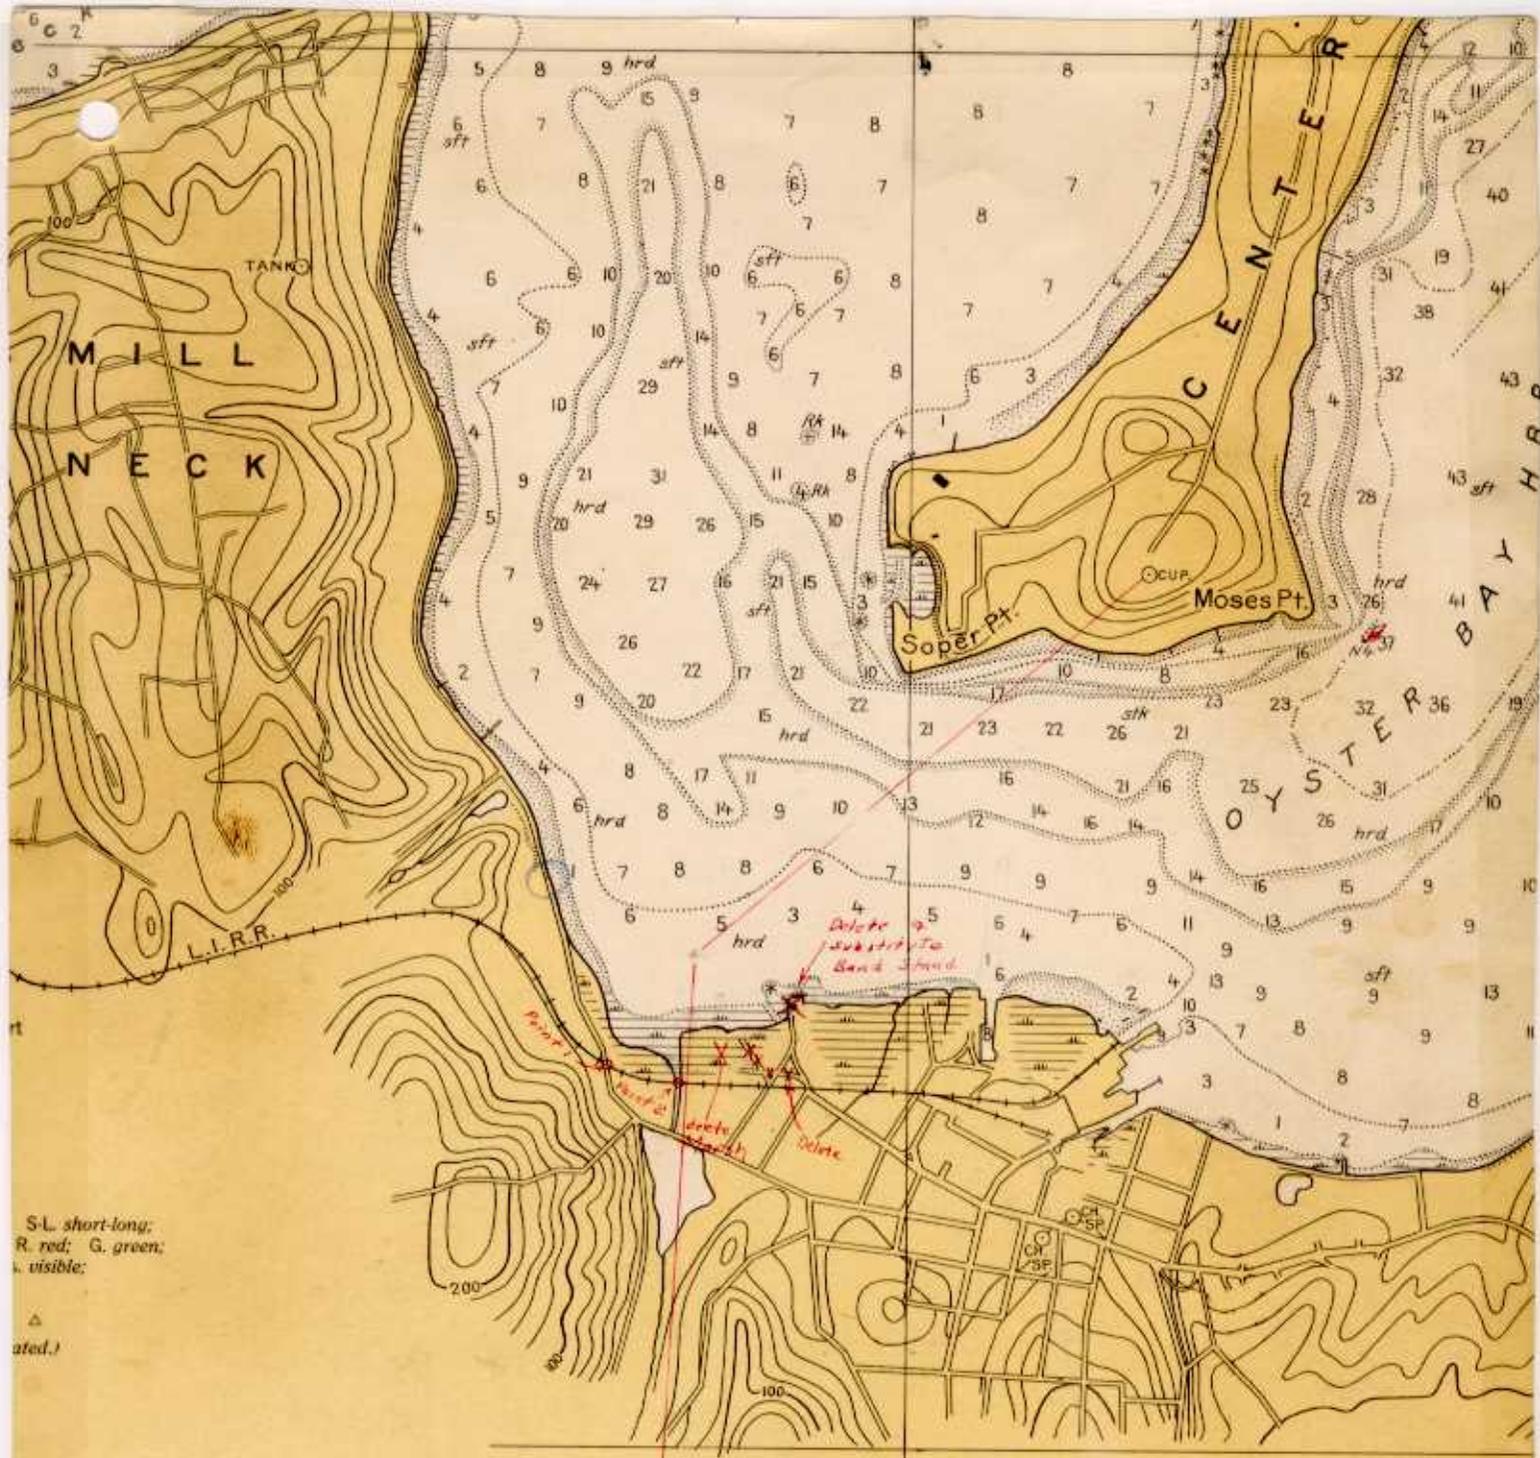
Chart 224

CONTROL The control used was natural objects as shown on the attached chart section (224), points 1 and 2, standpipe, and cupola. Point 1 was in the center of the railroad track on the East side of the highway. Point 2 was in the center of the bridge and also in the center of the railroad track.

The band stand is new and is not the building shown on the chart.
On the shore side of the bandstand is a stone semi-circular bulkhead.
