DESCRIPTIVE REPORT

Type of Survey: Navigable Area

Registry Number: F00628

Sub-locality: Key Bridge to the Woodrow Wilson Bridge

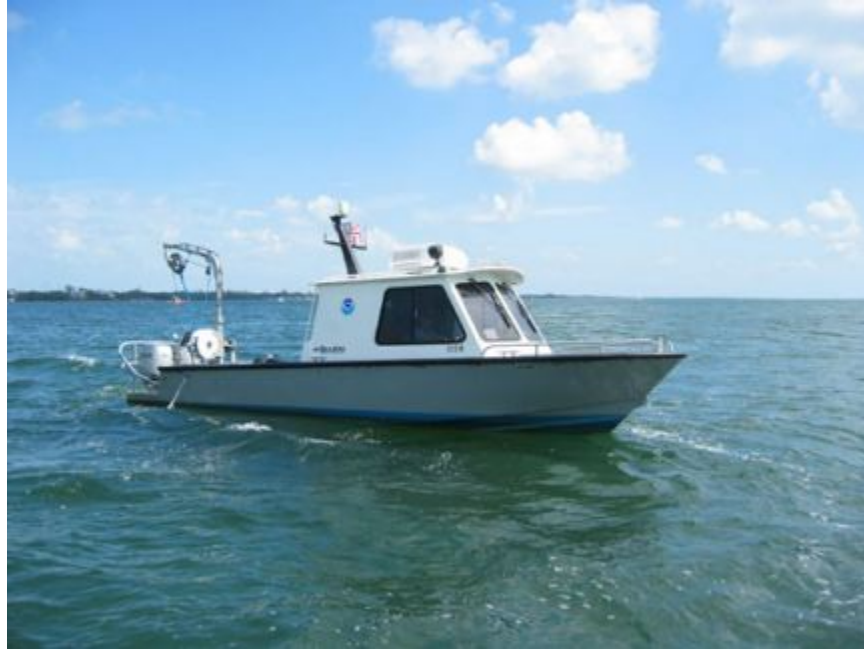
Figure 2: Survey Vessel S3002

S3002 is a 30 ft aluminum hulled SeaArk Commander, powered by twin 200hp outboard engines.

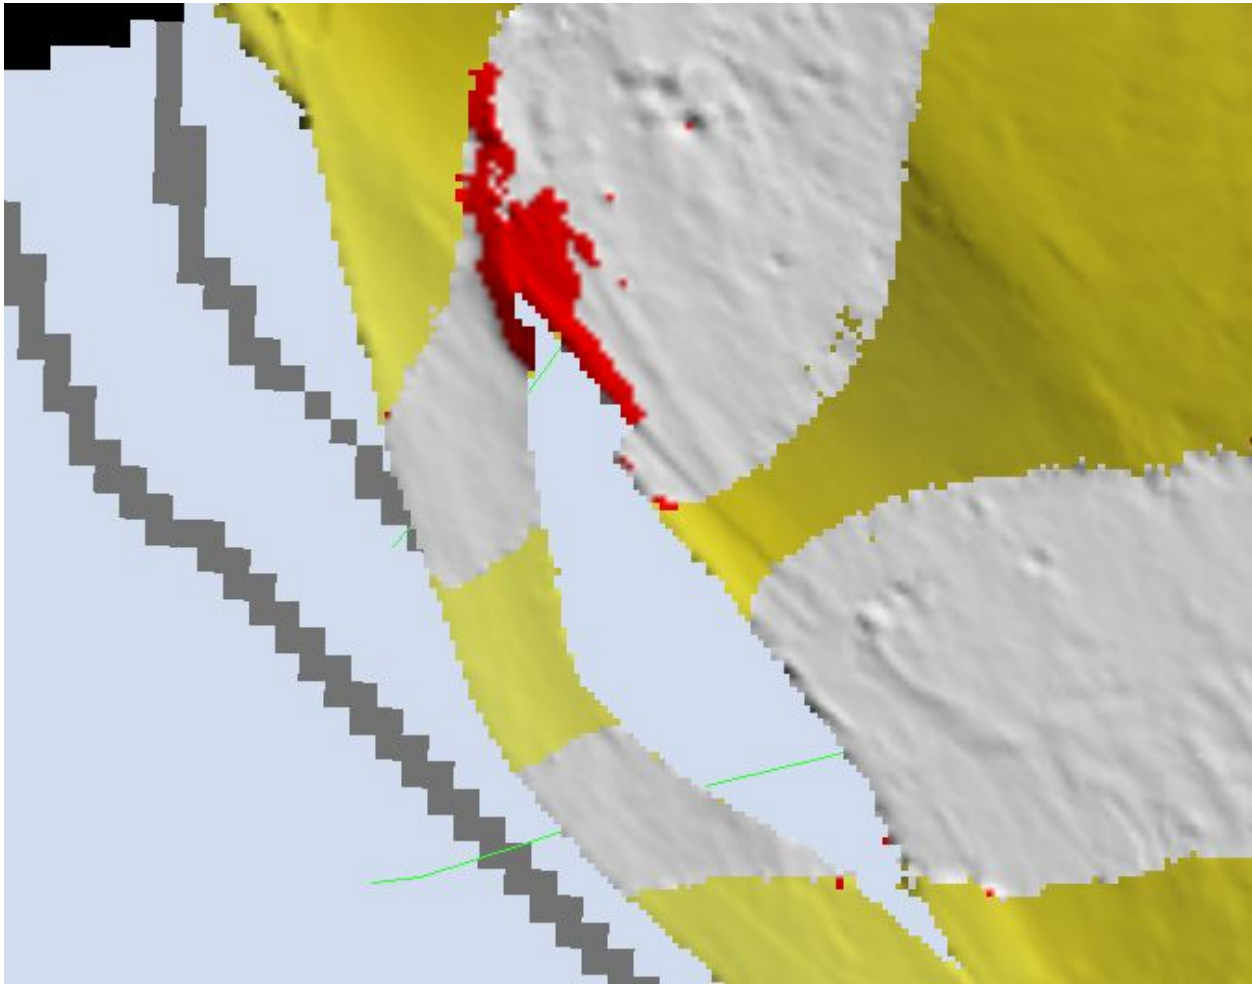
Crosslines were collected, processed and compared in accordance with section 5.2.4.3 of the HSSD. Surface differencing in CARIS HIPS and SIPS was used to assess crossline agreement with main scheme lines. Percentage of crosslines collected to main scheme lines is 19.1%. Differences between crosslines and main scheme lines were generally less than 0.5 meter. Differences in crosslines to main scheme lines greater than 0.5 meter are believed to be caused by large changes in slope that occur near the edges of the channels and in the rocky areas of the North Potomac. Figure 3 is an illustration of the surface difference greater than 0.5 meter along the edge of the channel in the north Potomac River.

Figure 3: Graphical representation of differences greater than 0.5 meter between crossline and main scheme surfaces.

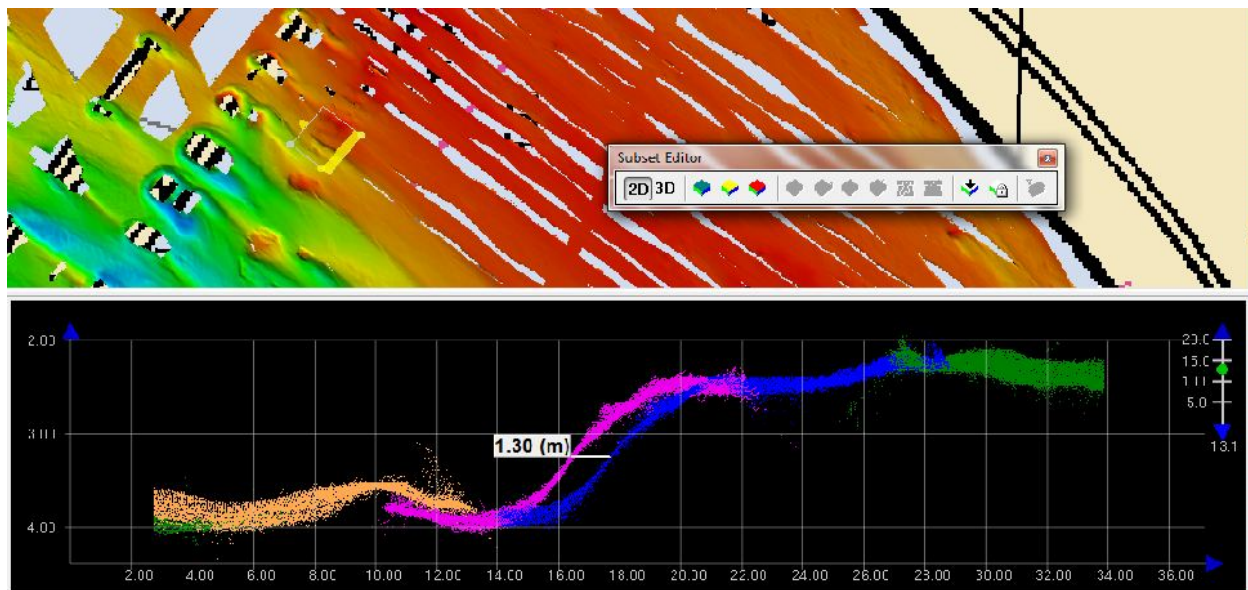
There were a number of bridges that crossed over the Potomac and Anacostia Rivers. As data were acquired near the bridges, horizontal positioning degraded considerably because of the poor visibility of satellites from the GPS antennas. All data were still within Total Horizontal Uncertainty standards, but some obvious offsets were present (Figure 4).

Figure 4: Poor positioning in North Potomac due to bridges causing poor visibility of satellites from GPS antennas.

Both horizontal and vertical offsets are evident throughout the survey area. Horizontal offsets are intermittent and range between 1m and 1.5m within uncertainty tolerances set forth in section 3.1.1 of the HSSD. Vertical offsets show up as a 0.1m vertical difference between lines throughout the survey area, and not attributed to any vertical displacements arising from horizontal offsets. These offsets are also within error budgets set forth in HSSD section 4.16 and 5.2.3.5 of the HSSD.

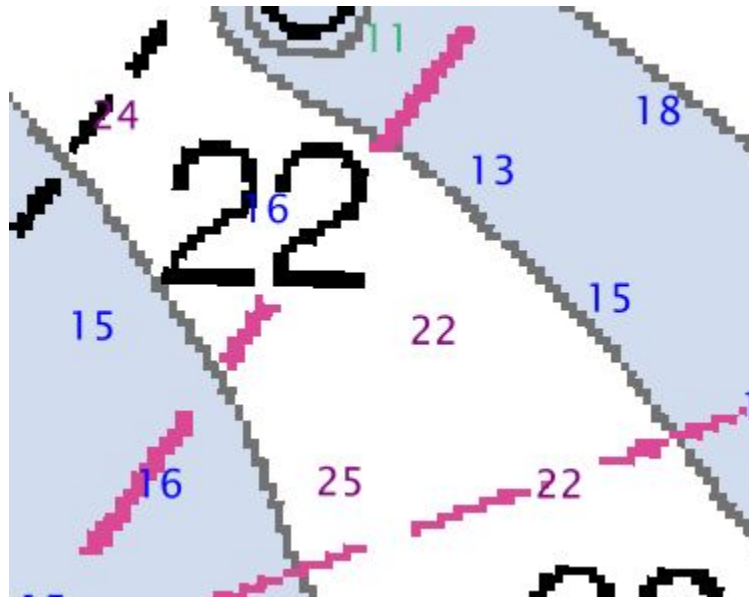
Sounding agreement between surveyed soundings on sheet F00628 were generally within 2-3 ft of chart 12289. The following are the only notable exceptions: a 16 ft surveyed sounding as compared to a 22 ft charted depth located just south of the George Mason Bridge (Figure 5) and a 21 ft surveyed sounding as compared to a 25 ft charted depth just south of the Arlington Memorial Fixed Bridge (Figure 6).

Figure 5: Chart 12289 charted depth difference between surveyed soundings just south of the George Mason Bridge. For reference, the charted 22 ft depth is located at 38/52/21.26N, 077/02/20.33W.

The deeper depths shown in Figure 5 are on the inset 12289 and have been replaced with new soundings in the chart update product.

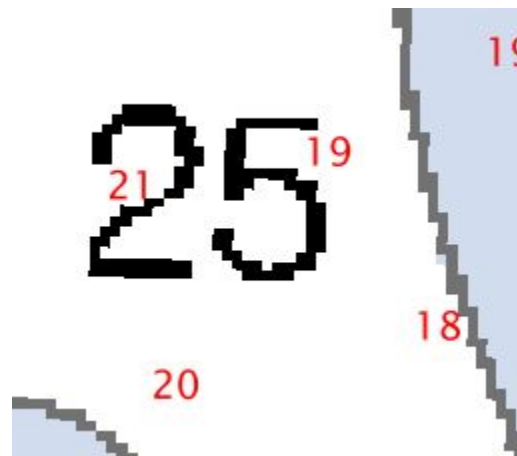
Figure 6: Chart 12289 charted depth difference between surveyed soundings just south of the Arlington Memorial Fixed Bridge. For reference, the charted 25 ft depth is located at 38/53/13.94N, 077/03/13.28W.

Sounding agreement between surveyed soundings on sheet F00628 were generally within 2-3 ft of chart 12285. The only notable exception is a 21 ft surveyed sounding as compared to a 25 ft charted depth just south of the Arlington Memorial Fixed Bridge which was also a noted discrepancy for chart 12289.

The 25 ft. sounding in Figure 6 was replaced with an 18 ft. sounding in the chart update product.

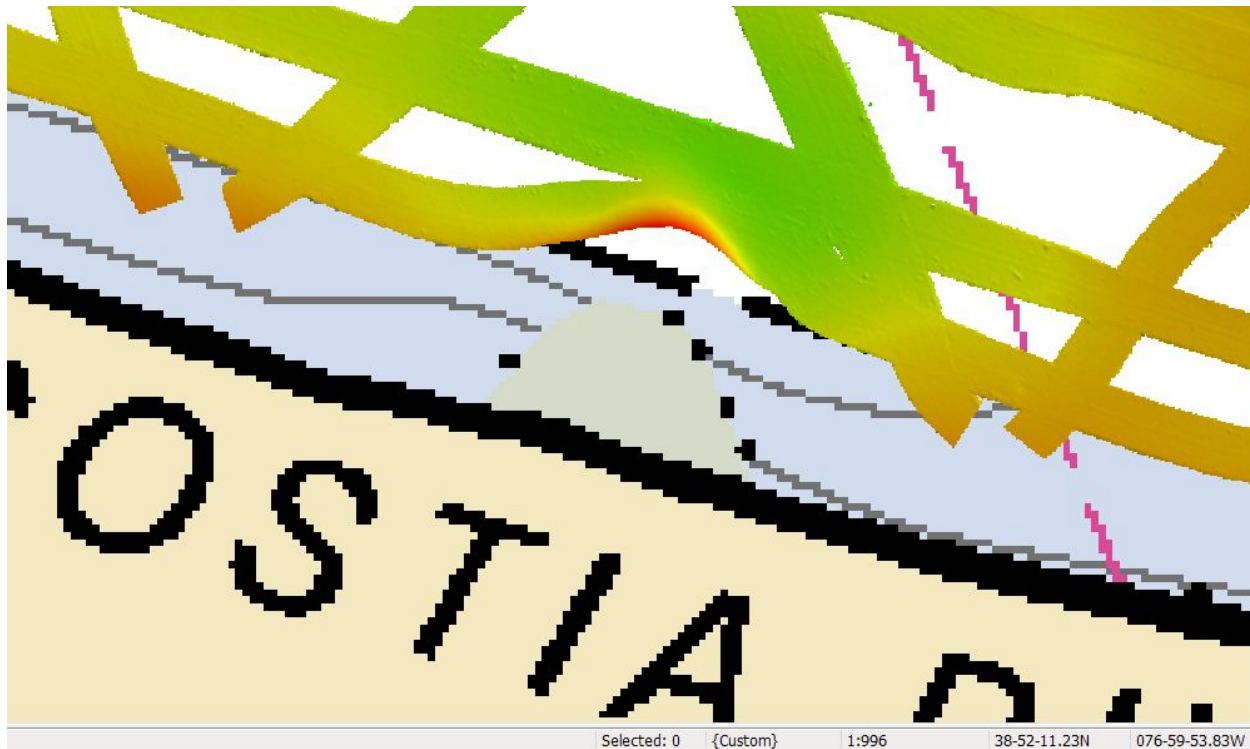
Contours generated in CARIS Bathy DataBase generally approximated the 6-ft, 12-ft, 18-ft, and 24-ft contours. The only notable exception is in northern Anacostia where a shoal on the south side of the channel (Figure 7) extends into the channel further than charted.

Figure 7: Chart 12289 shoal on the south side of the channel in the Anacostia River extends further into the channel than charted.

Contours generated in CARIS Bathy DataBase generally approximated the 6-ft, 12-ft, 18-ft, and 24-ft contours. The only notable exception is in northern Anacostia where a shoal on the south side of the channel (position 38-52-09.43 N, 076-59-48.68 W) extends into the channel further than charted. This discrepancy is also noted on chart 12289.

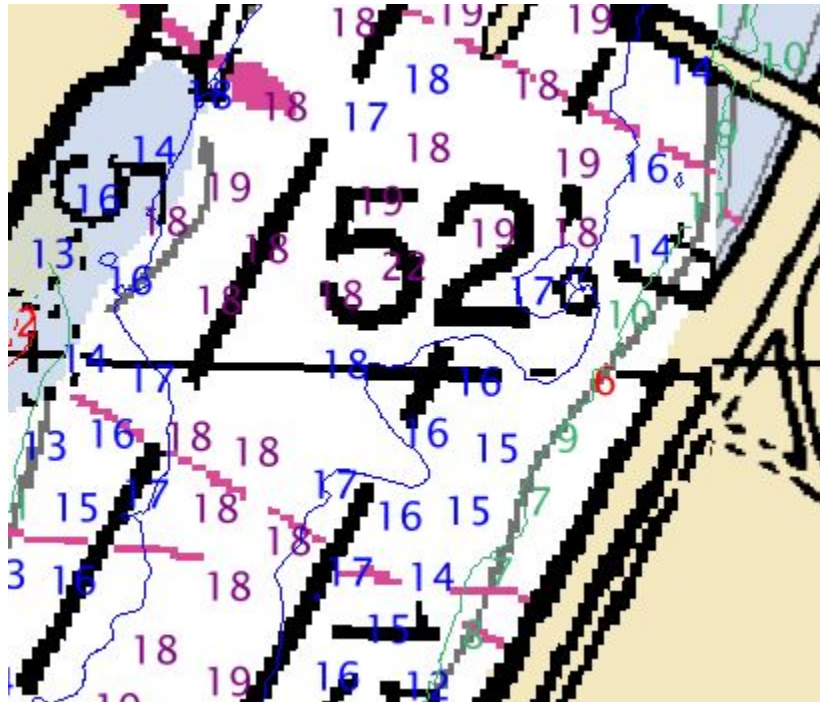
The only other issue of note for chart 12289 is a charted 52 ft air draft in the northern Anacostia River for the Frederick Douglas Bridge. Figure 8 shows that the air draft is displayed so that it is ambiguous and

Figure 8: Chart 12289 charted 52 ft air draft that is ambiguous as it is placed in the middle of the Anacostia River. For reference, the charted 52 ft air draft is located at position 38°52'02.67N, 077°00'21.38W.

Overhead features exist for this survey, but were not investigated. The only issue that was found was a 52 ft air draft for the Frederick Douglas Bridge over the Anacostia River. The 52 ft air draft was charted in the middle of the Anacostia River Channel and was ambiguous and could be confused as a depth for mariners. This issue was also noted in the chart comparison section D.1.1.

may be confused for a sounding as it is placed in the middle of the channel for the Anacostia River. It is recommended by the hydrographer that the air draft be charted on land so that it is less ambiguous.

The 52 ft. air draft does not appear on the most recent version of charts 12285 or 12289.

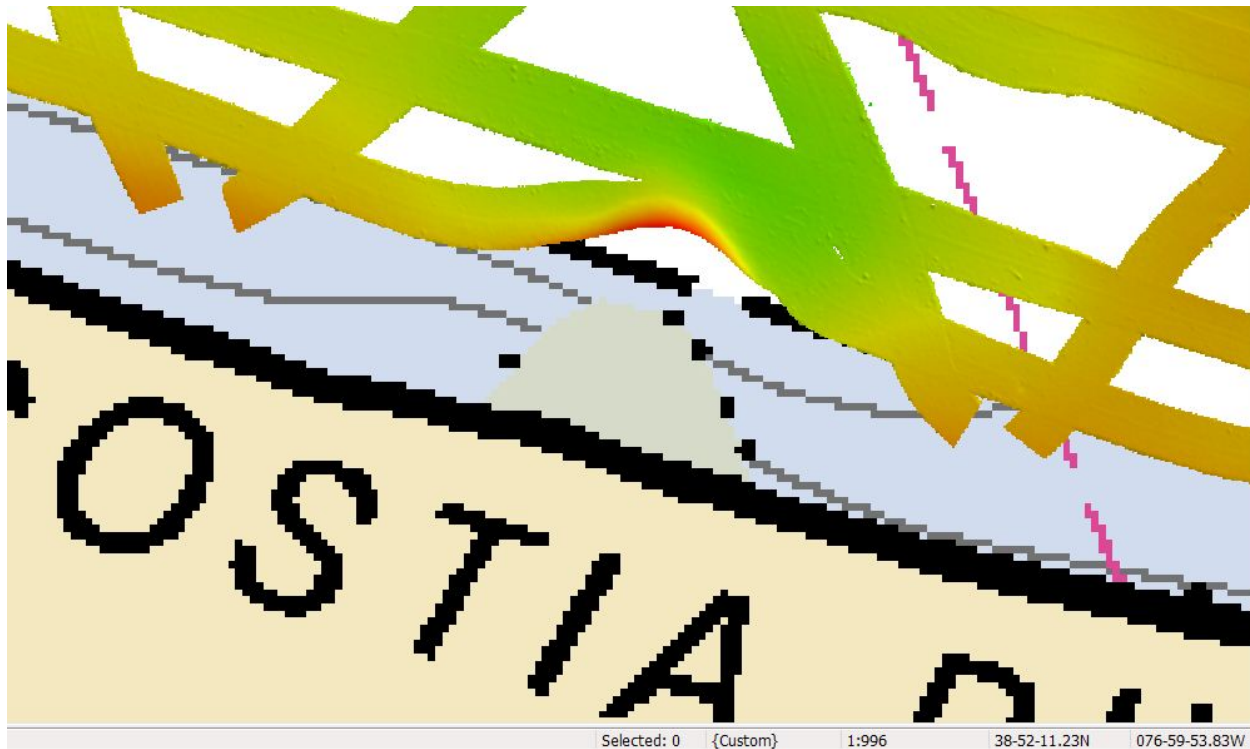
The shoal in the northern Anacostia River discussed in section D.1.1 is further into the channel than charted (Fig 9). The edge of the shoal was determined with MBES, but no least depth was found.

Figure 9: Shoal further into the Anacostia channel than charted.

The extent of the charted intertidal area was not addressed by the survey. However, the shoal extent offshore will be reflected in the chart update with the new 6 foot contour, which will extend to the edge of the Anacostia Channel. The shoalest offshore surveyed depth is 5.153 feet, just under 10 meters inside the channel, and is deeper than the shoalest depth listed in the tabulation for ROQ of the Anacostia Channel.

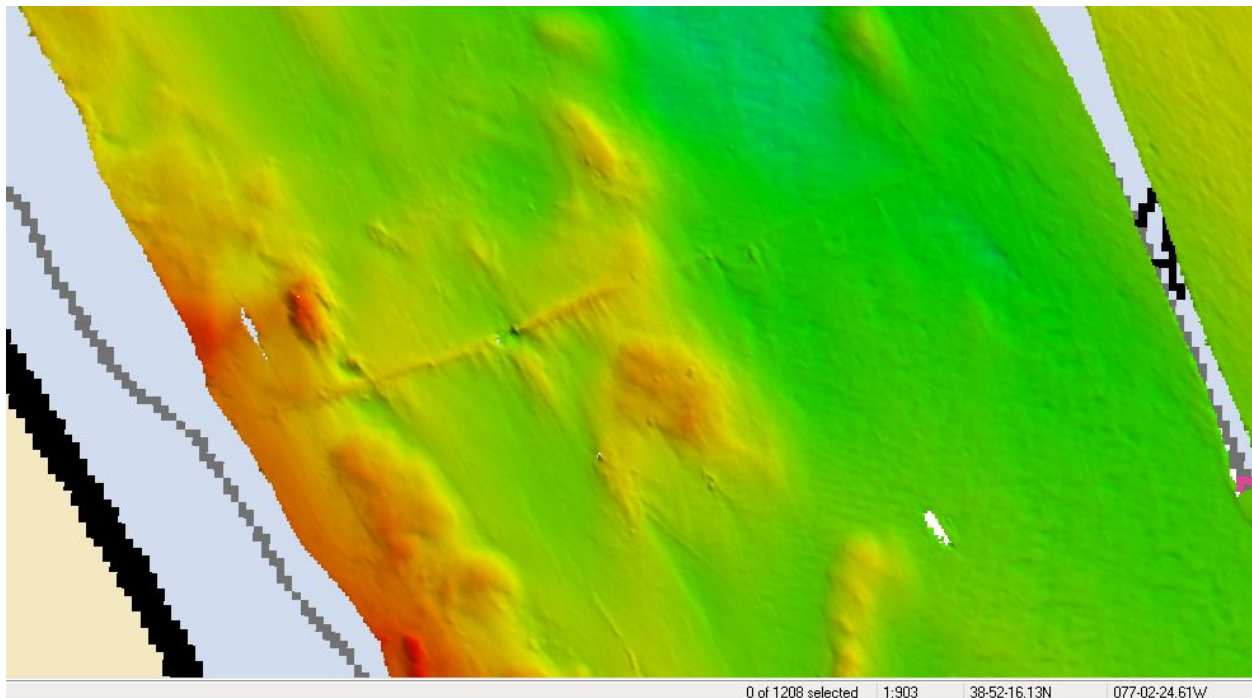
Many cable areas and tunnel areas exist throughout the survey area. The only submarine feature that was easily visible in the MBES data was in a cable area located just south of the George Mason Bridge (Fig 10).

Figure 10: Cable present in MBES data just south of the George Mason Bridge.
