DESCRIPTIVE REPORT

Type of Survey: Navigable Area

Registry Number: F00629

Sub-locality: St. Augustine Inlet and Vicinity

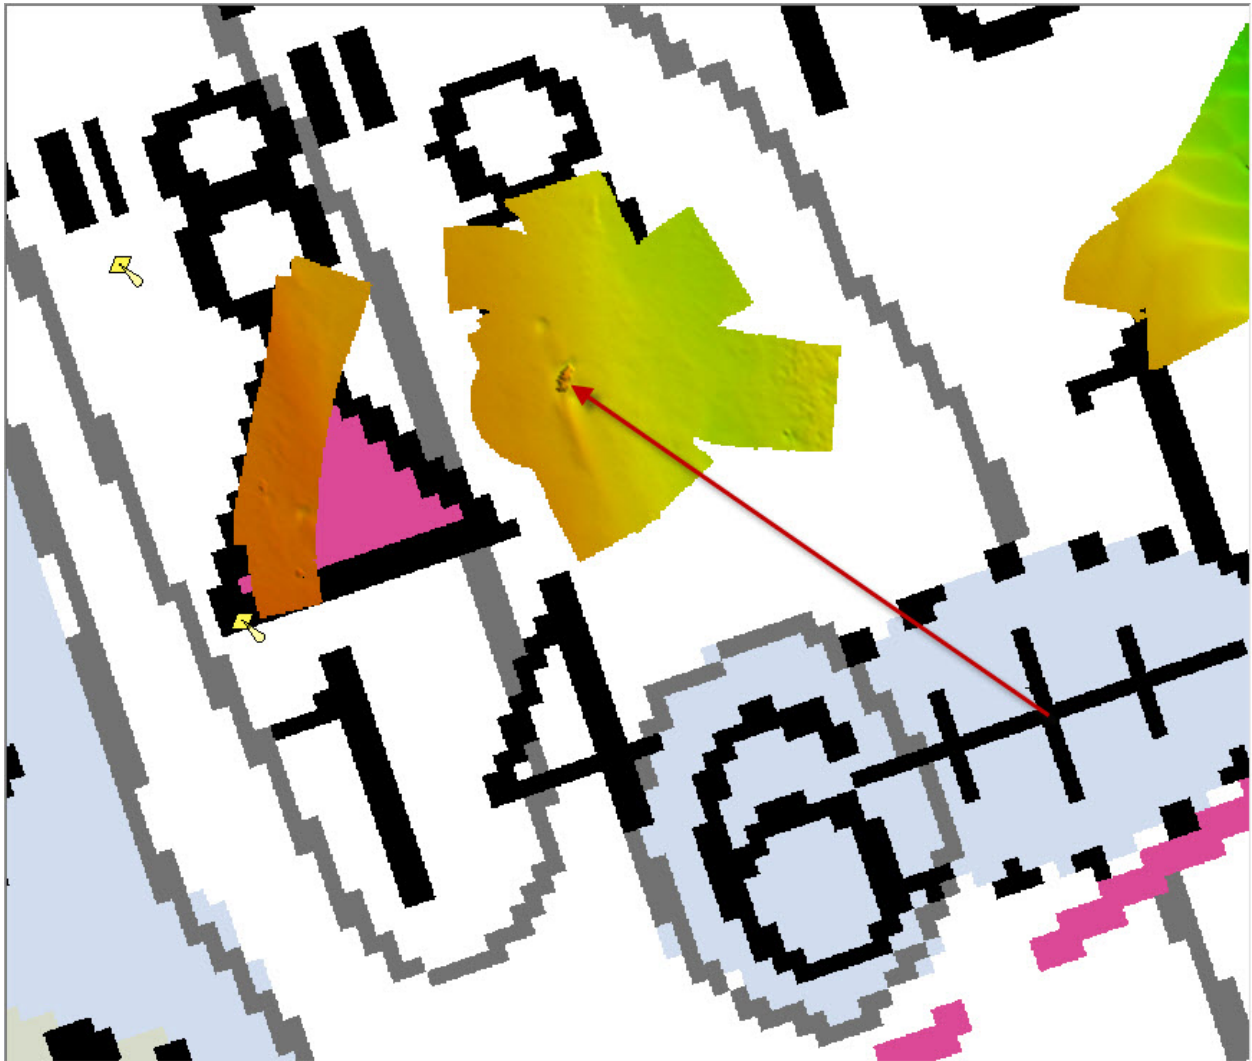
Figure 11: AWOIS 15091

--AWOIS 15091 charted as PA wreck just south of bridge of lions was found to be 130 meters NE of charted symbol. Least Depth of 4.39 meters at position 29 53 25.41N / 081 18 26.19W. Figure 13 shows position. Recommend remove PA and move symbol.

AWOIS 15091: The wreck was recommended to be charted at the new location in the chart update product.

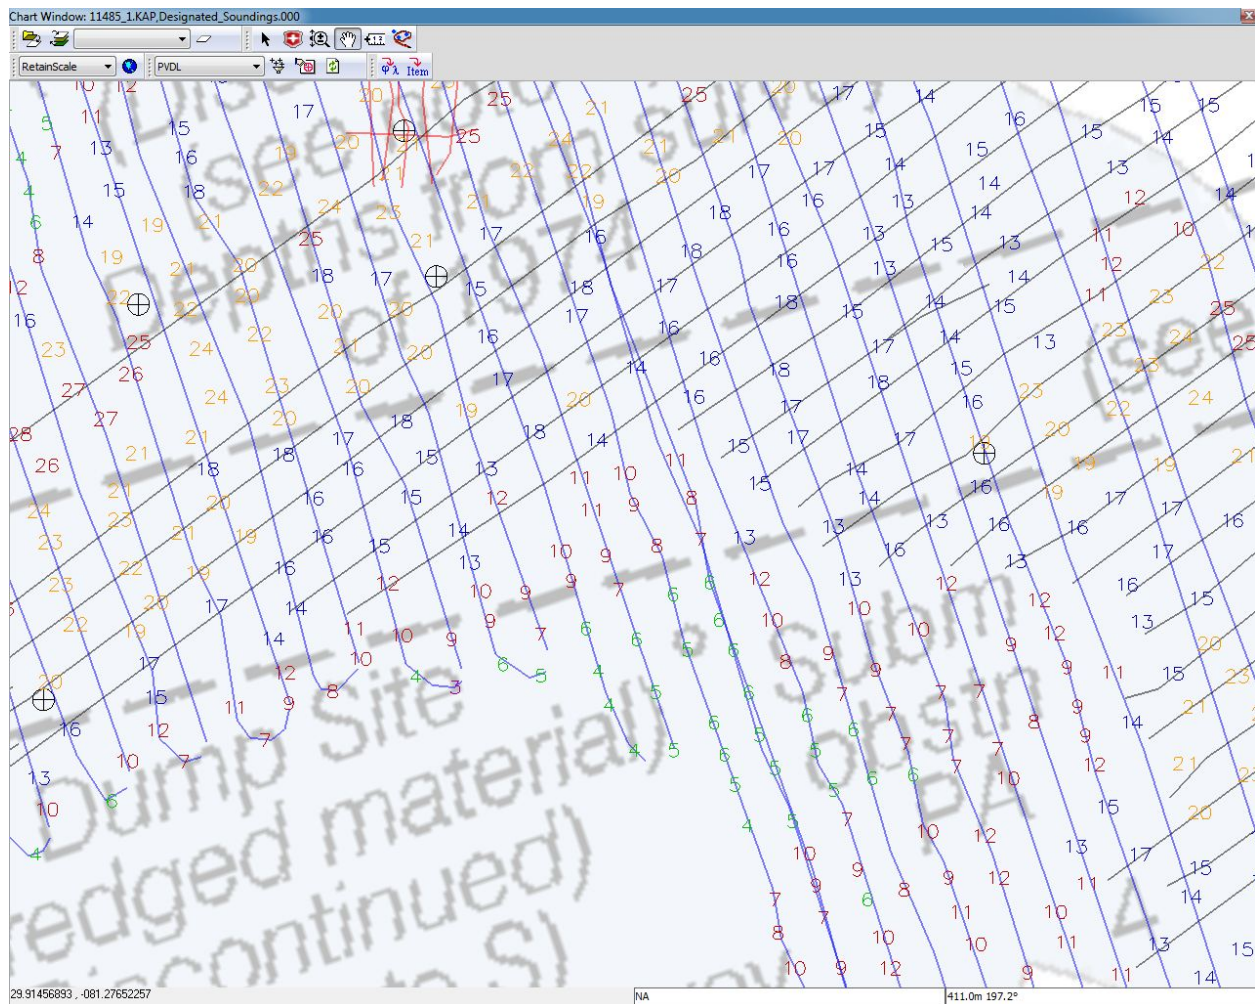
Figure 15: AWOIS 15094

--AWOIS 15094 charted as PA Subm Obstrn in south spoil area of St. Augustine Inlet. Breaking waves on sandbar and shallow water limited SSS operations to outside the search radius. Figure 17.

AWOIS 15093, 15092 and 15094: The wrecks and obstruction were recommended to be retained in the chart update product.
