DESCRIPTIVE REPORT

Type of Survey: Basic Hydrographic Survey Navigable Area Field Examination Debris Mapping Support USCG

General Locality: Kodiak, AK

Sub-locality: Womens Bay

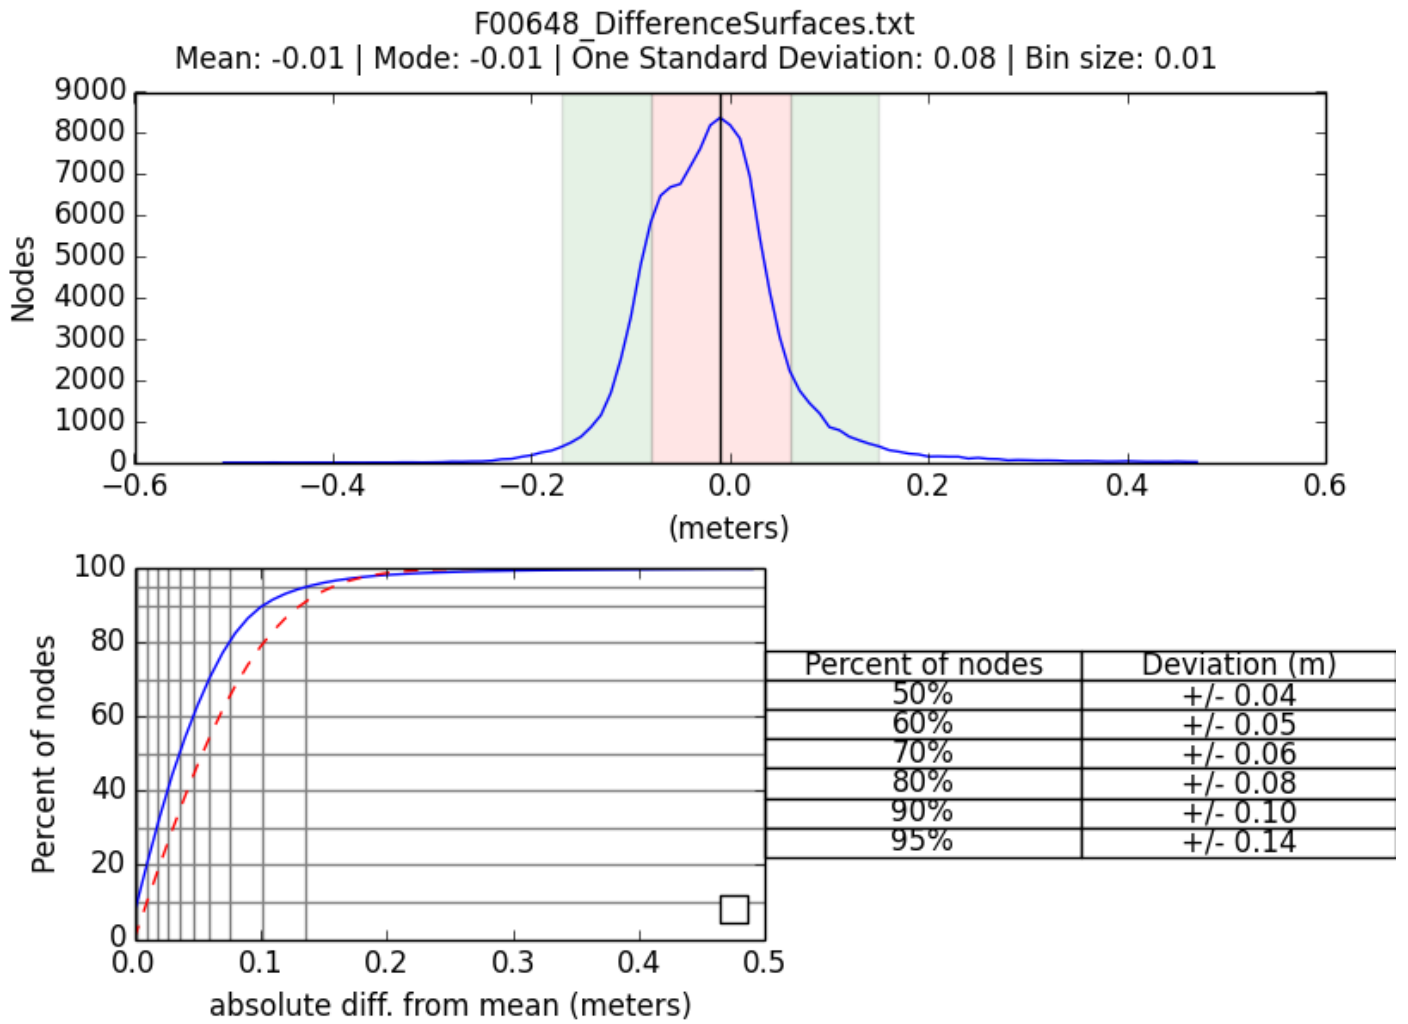
Figure 2: Crossline Comparison Statistics

Crosslines were collected, processed, and compared in accordance with section 5.2.4.3 of the HSSD. Surface differencing in CARIS Bathymetry Data Base was used to assess crossline agreement with main scheme lines. This difference surface is submitted digitally in the Separates II folder. The two surfaces agree within plus or minus 0.14m at the 95% confidence level, therefore crosslines agree with main scheme lines within the total allowable vertical and horizontal uncertainty in their common areas. The only areas where there are crosslines, but a differencing surface gap, are areas where sound speed spikes were deleted due to "frowning" data which pulled the surface down, and crosslines data was used to fill in the gaps of the surface as shown in image below (Crossline Differencing gaps due to "frowning" data). The survey met the percentage requirements for crosslines, but did not collect any crosslines in the Womens Bay entrance Channel due to the small width of the channel and vessel traffic.

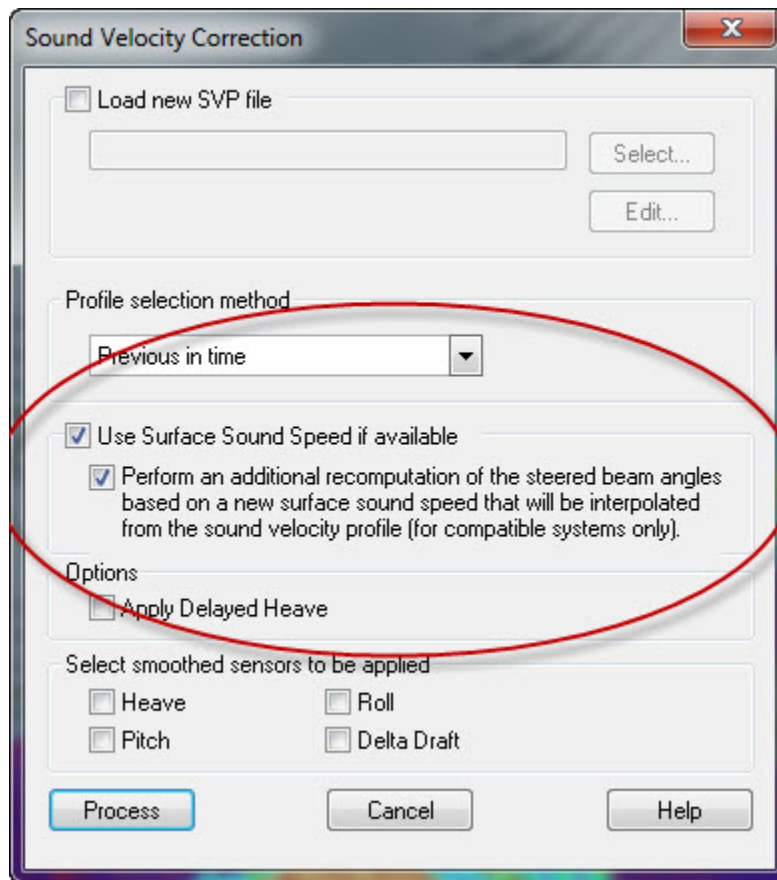
Figure 4: Additional computation

Several days of acquisition occurred during heavy rains which resulted in sound speed artifacts. The most severe artifacts appear in an area where there is an out flow of fresh water from a stream of freshwater runoff southeast of Shannon point. The MBES data were reviewed in CARIS Subset Mode with appropriate reference surfaces. The problem was discovered early and cast frequency was increased from every four hours to every one or two hours. Processing an additional interpolated recomputation of the steered beam angles from the sound velocity profile was done for the worst days, day numbers 223-227. The images below are done before and after the additional interpolated recomputation. Figure 8 and 9 are images from after the additional computation, with and without rejected data.

It should be noted that Figure 4 is an example for the 'Use Surface Sound Speed' check box and is not an indication of profile selection method used. There are also roll errors that are evident in the submitted BASE surfaces. They have been examined by the reviewer and were found to be within specifications.

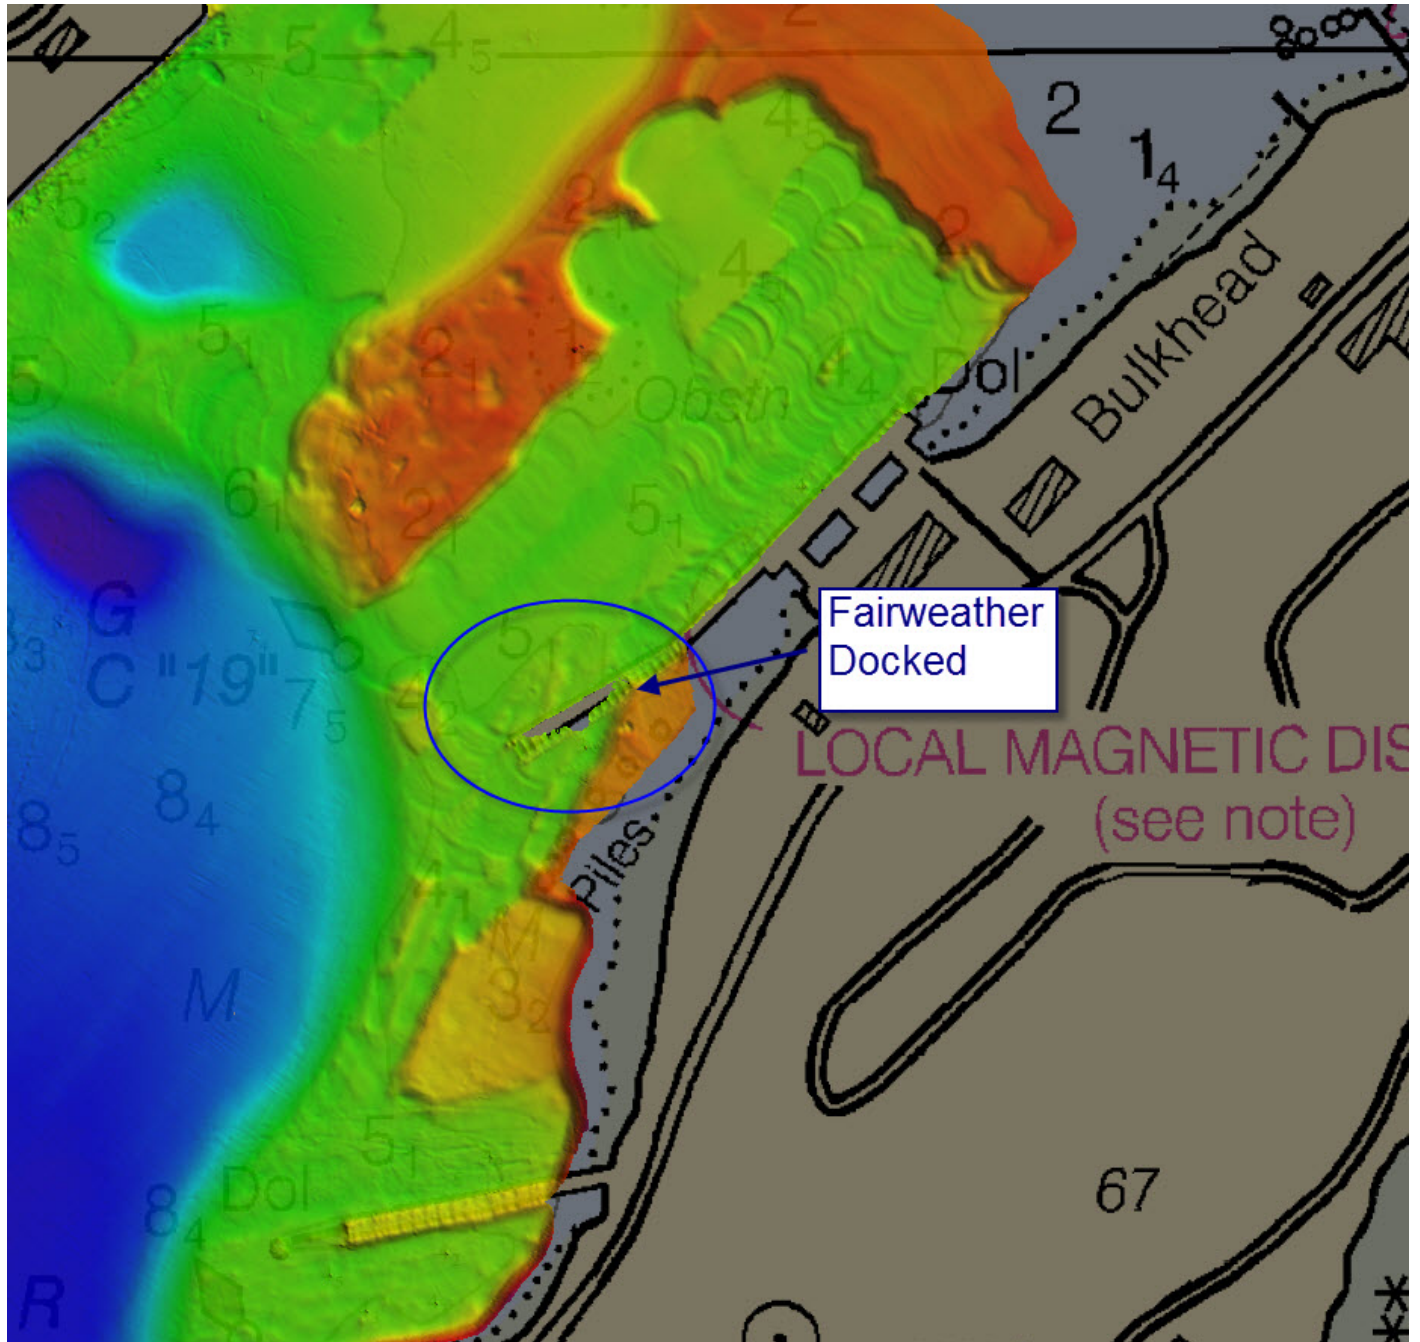
Figure 10: *Fairweather* Docked on the Pier

The only Holiday on F00648 is where NOAA ship *Fairweather* was docked on the Coast Guard Pier.

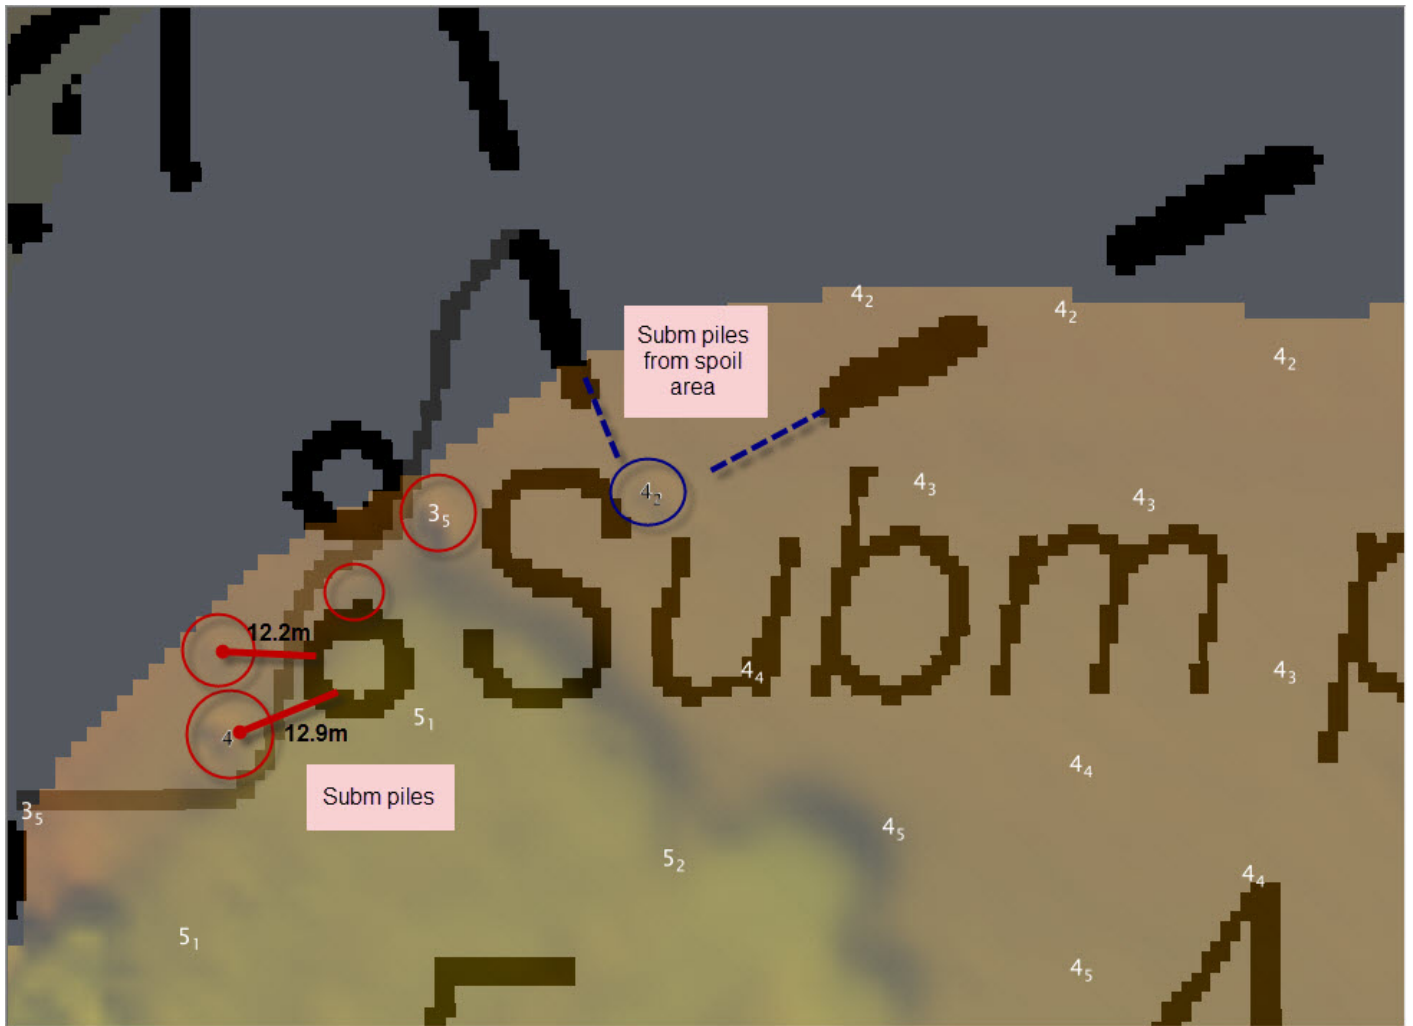
Figure 11: Disagreement between chart Submerged Pilings and surveyed soundings

Soundings from survey F00648 generally agreed within one to two meters with charted depths on chart 16595. Contours generated in CARIS HIPS and SIPS closely approximated the charted 3, 5, and 10 fathom contours. Notable exceptions to this general agreement are shown in the figures below. The 10 meter, 5 meter, and the Submerged piles contours are affected. The Submerged piles south of the Submerged piles Spoil Area on the Northwest corner of the chart show disagreements between the charted features and the MBES data. The charted soundings are accurate, but there are up to five submerged pilings in that area, but none of them are within the circled areas, Hydrographer recommends extending the Submerged piles Spoil Area to the Southwest to encompass these additional submerged piles.

Chart 16595 is not the largest scale chart for the survey area and the chart comparison should not have been done in meters. The survey should have been compared to Chart 16596, Scale 1:10,000, Edition 13, Edition Date 10/01/2012, LNM Date 10/20/2015, NM Date 10/17/2015. Upon review, surveyed depths generally agree within 2 feet of charted depths and the surveyed contours show good agreement with charted contours. The charted wreck and obstructions within the survey area were found to be accurately charted. There were also numerous uncharted obstructions that were identified and addressed during office review. As noted in the field chart comparison, the submerged piles near the spoil area in the northwest corner of the survey are mis-charted and have also been addressed during office review. SAR: It should be noted that the Spoil Area is not intended to define an area of submerged piles. There happens to be submerged piles within the Spoil Area, but they are two separate features. Therefore, it is not necessary to modify the extents of the Spoil Area to encompass the nearby submerged piles. It should also be noted that submerged piles aren't defined by contours as indicated in the chart comparison.

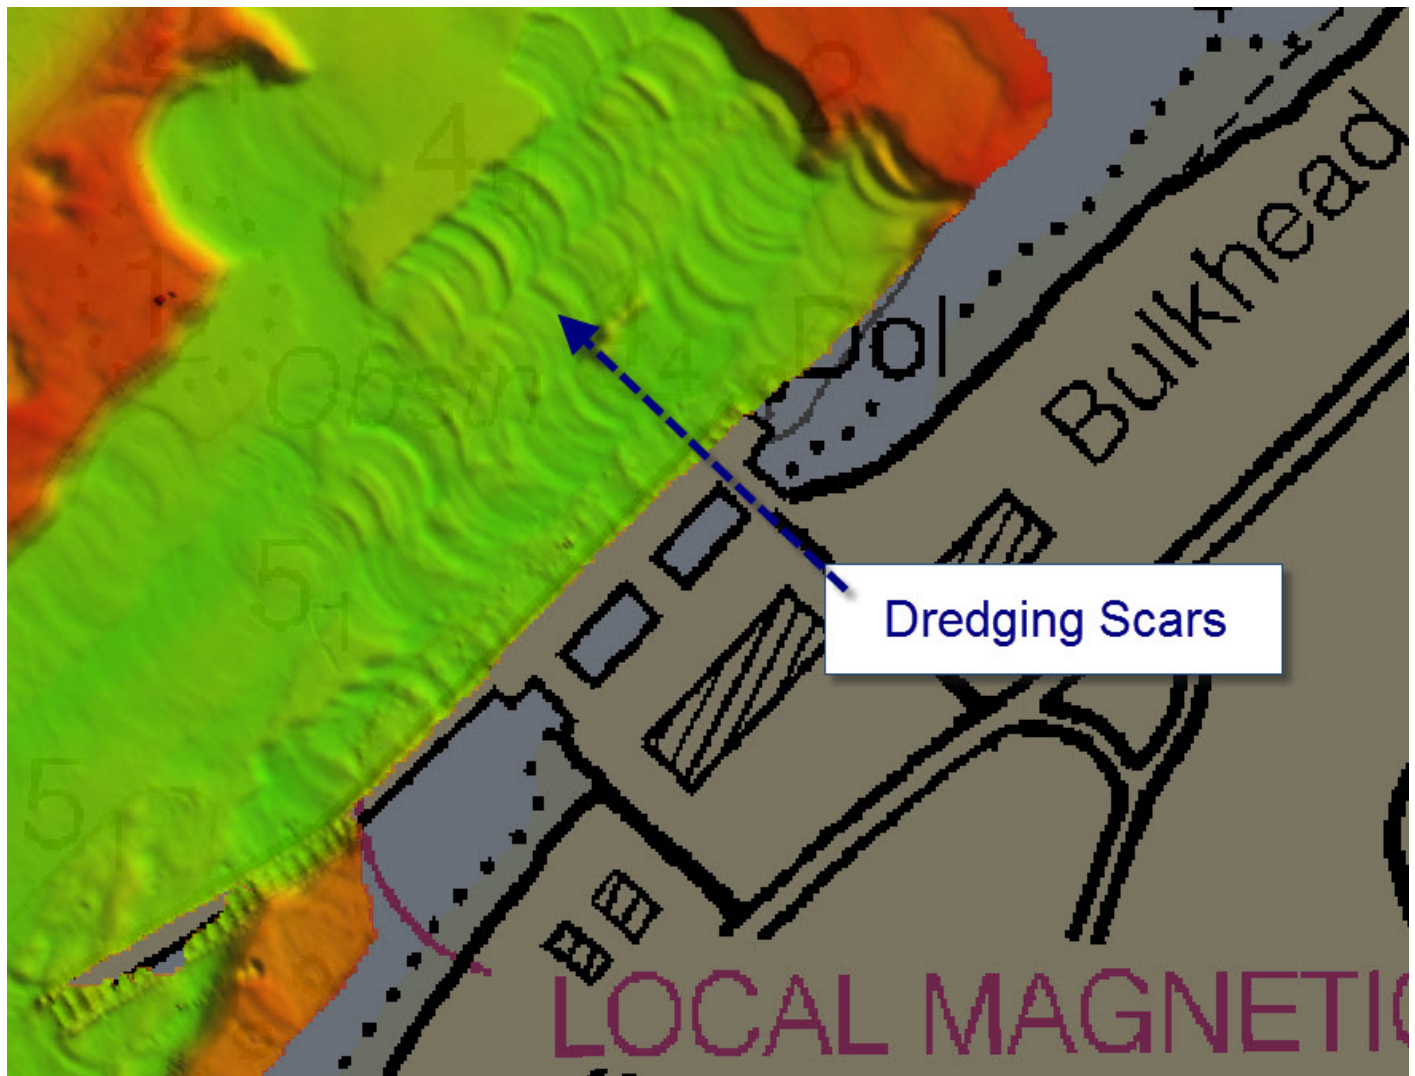
Figure 18: Dredging Scars

No present or planned construction or dredging exist within the survey limits, however past dredging has left some scars in the sediment.
