DESCRIPTIVE REPORT

Type of Survey: Navigable Area

Registry Number: F00668

Project Number: **S-D927-BH2-15**

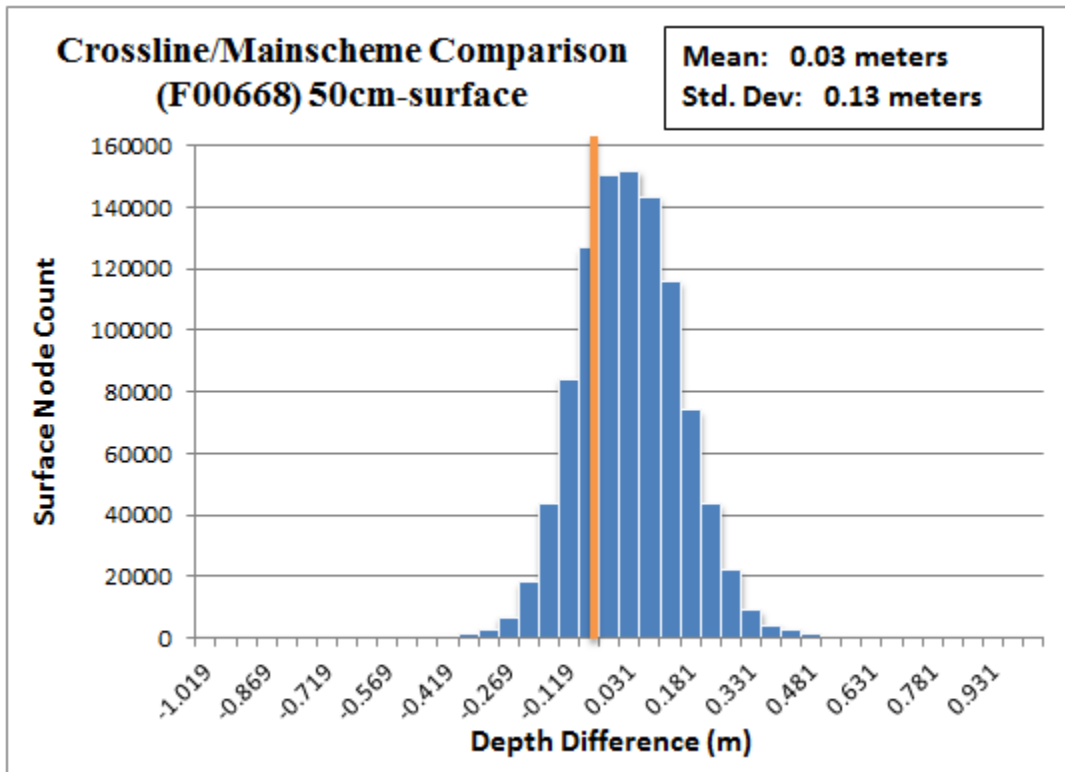
Figure 6: Mainscheme versus crossline difference comparison graph, with zero difference being represented by an orange line.

To evaluate the crosslines, a 50cm CUBE surface was created using strictly mainscheme lines, and a second 50cm CUBE surface was created using only crosslines. From these two surfaces, a difference surface was generated at a 50cm resolution. This difference surface is submitted digitally in the Separates II folder. The comparison indicated that the two surfaces had a mean difference of 0.16m and a standard deviation of 0.14m, showing good internal consistency (Figure 6). The greatest difference was found to be at the shoaling edge of dredge scours.

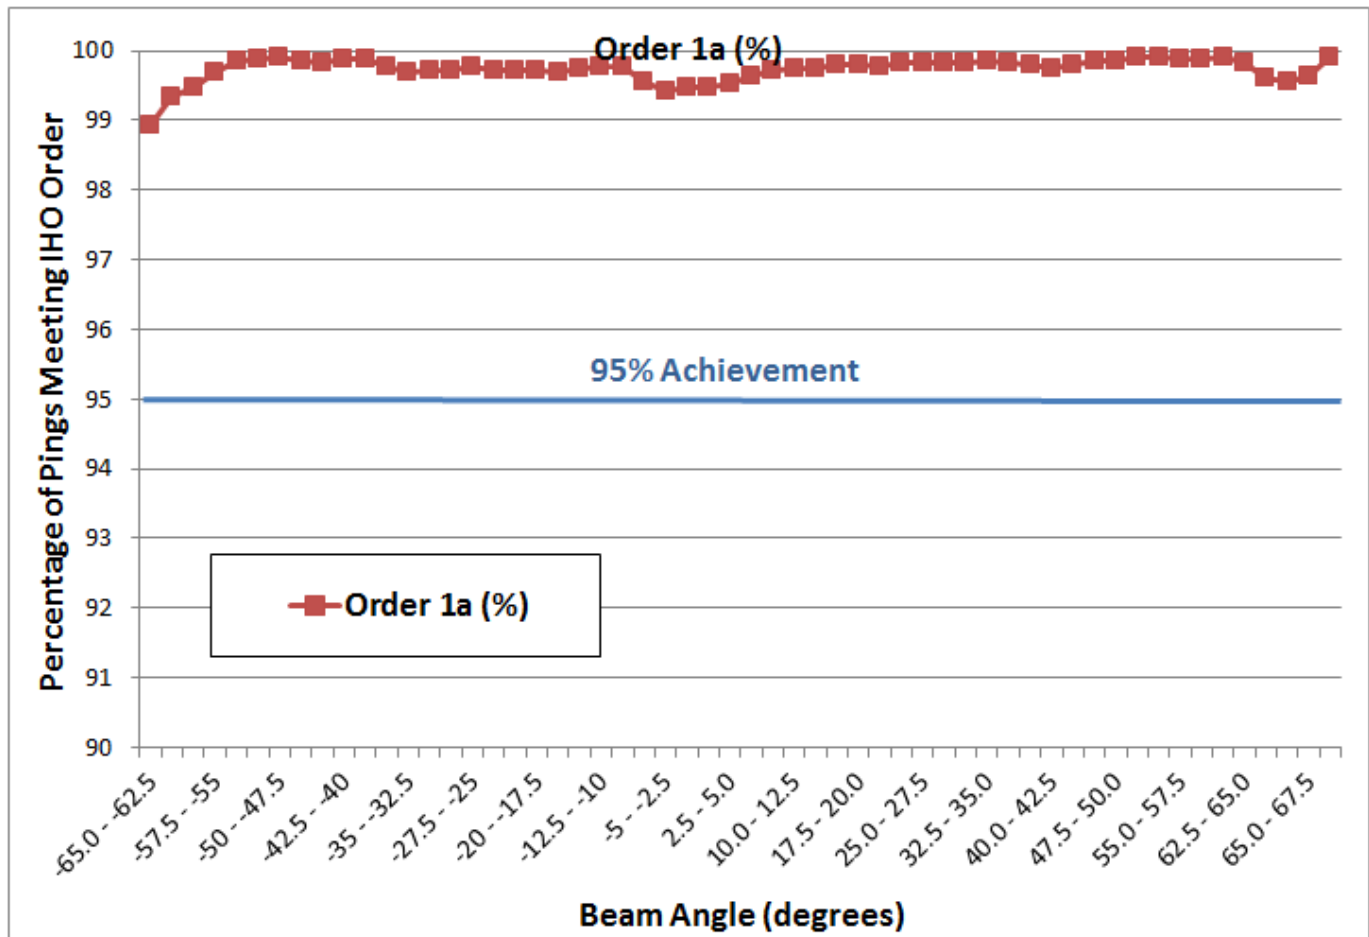
Figure 7: CARIS crossline quality control report.

In addition to performing a crossline comparison using surface differencing, the CARIS QC Report was used to compare the MBES crossline sounding to the depth estimates of the 50cm CUBE surface. The depth differences are calculated between each MBES crossline ping and mainscheme surface; and that depth difference is then compared to allowable NOAA uncertainties. The output QC Report classifies the percentage of pings meeting NOAA orders by beam angle. This table was copied and examined in Excel

(Figure 7). Over 95% of the crosslines analyzed were within NOAA Order 1a for the entire swath width. For further discussion of NOAA standards, refer to Section B.2.2, Uncertainty.

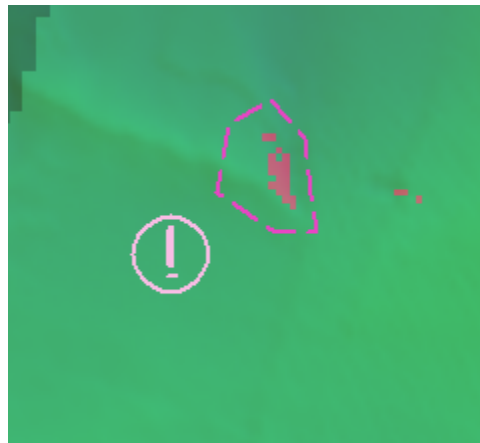
Figure 13: Density holiday, in pink, west of Delaware River Port Authority bulkhead.

The second type of holiday was a density holiday, an area where the data density did not meet the NOAA standard of five soundings per node; three of these holiday exist. The first is over the charted 39 foot obstruction, located west of Gloucester Point. In this area, there are two 0.5m by 1.0m lines, 0.5m apart, where only one or two sounding per node were collected (See Figure 12). This holiday was hypothesized to have been created as a result of the angled, linear section of the obstruction leaving a shadow behind it on the first pass over the object; then only ensonifying the object in the outer beams on the second pass. The second density holiday is located west of Delaware River Port Authority bulkhead, 24m south of the Walt Whitman Bridge (See Figure 13), and had a density of one to four soundings per node. This holiday is 5.81m long by 1.49m wide, and is located at the edge of a slope. This holiday was hypothesized to have been the result of slope effect. The third area is in the southeastern section of the Navy Anchorage (Anchorage 10). In this area, two 2.75m long density holiday line occur 10.5m apart, and are also located at the edge of a slope (See Figure 14). This holiday was also hypothesized to have been the result of slope effect. None of the density holidays were recognized to have existed until the vessel had left the area, therefore the holidays were never required.

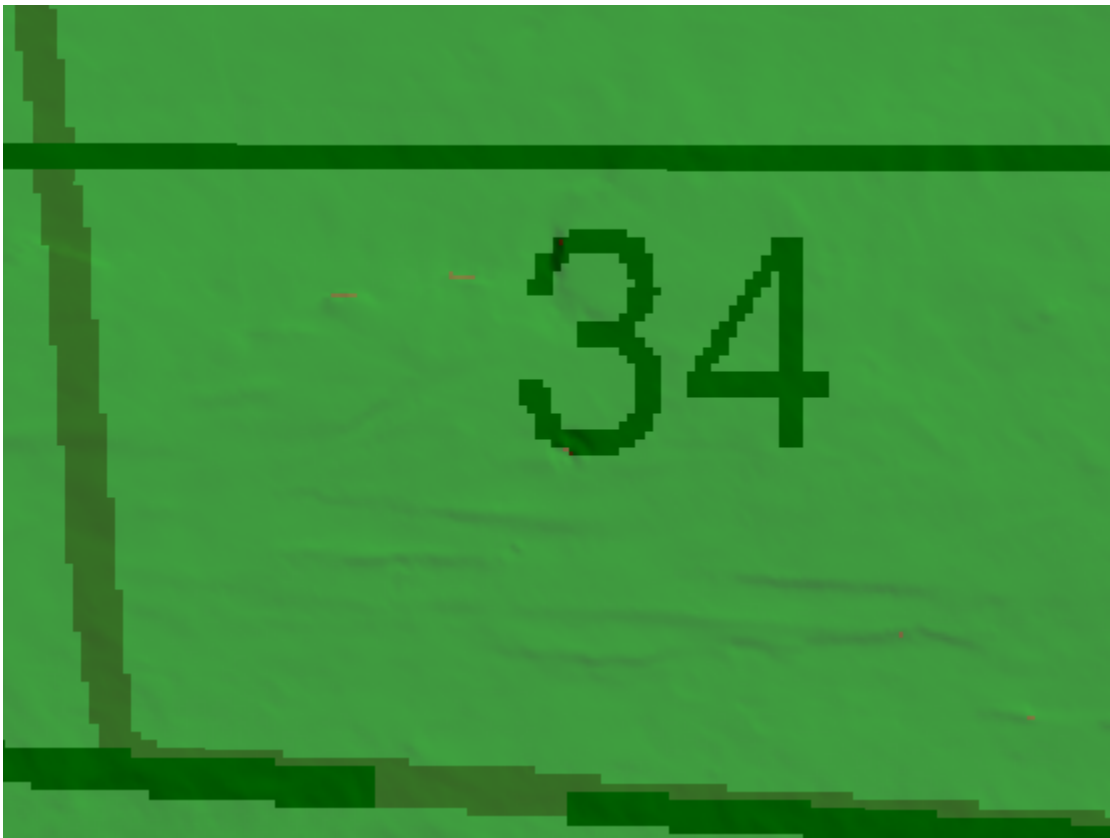
Figure 14: Density holiday, in pink, in southeastern area of Navy Anchorage (Anchorage 10).

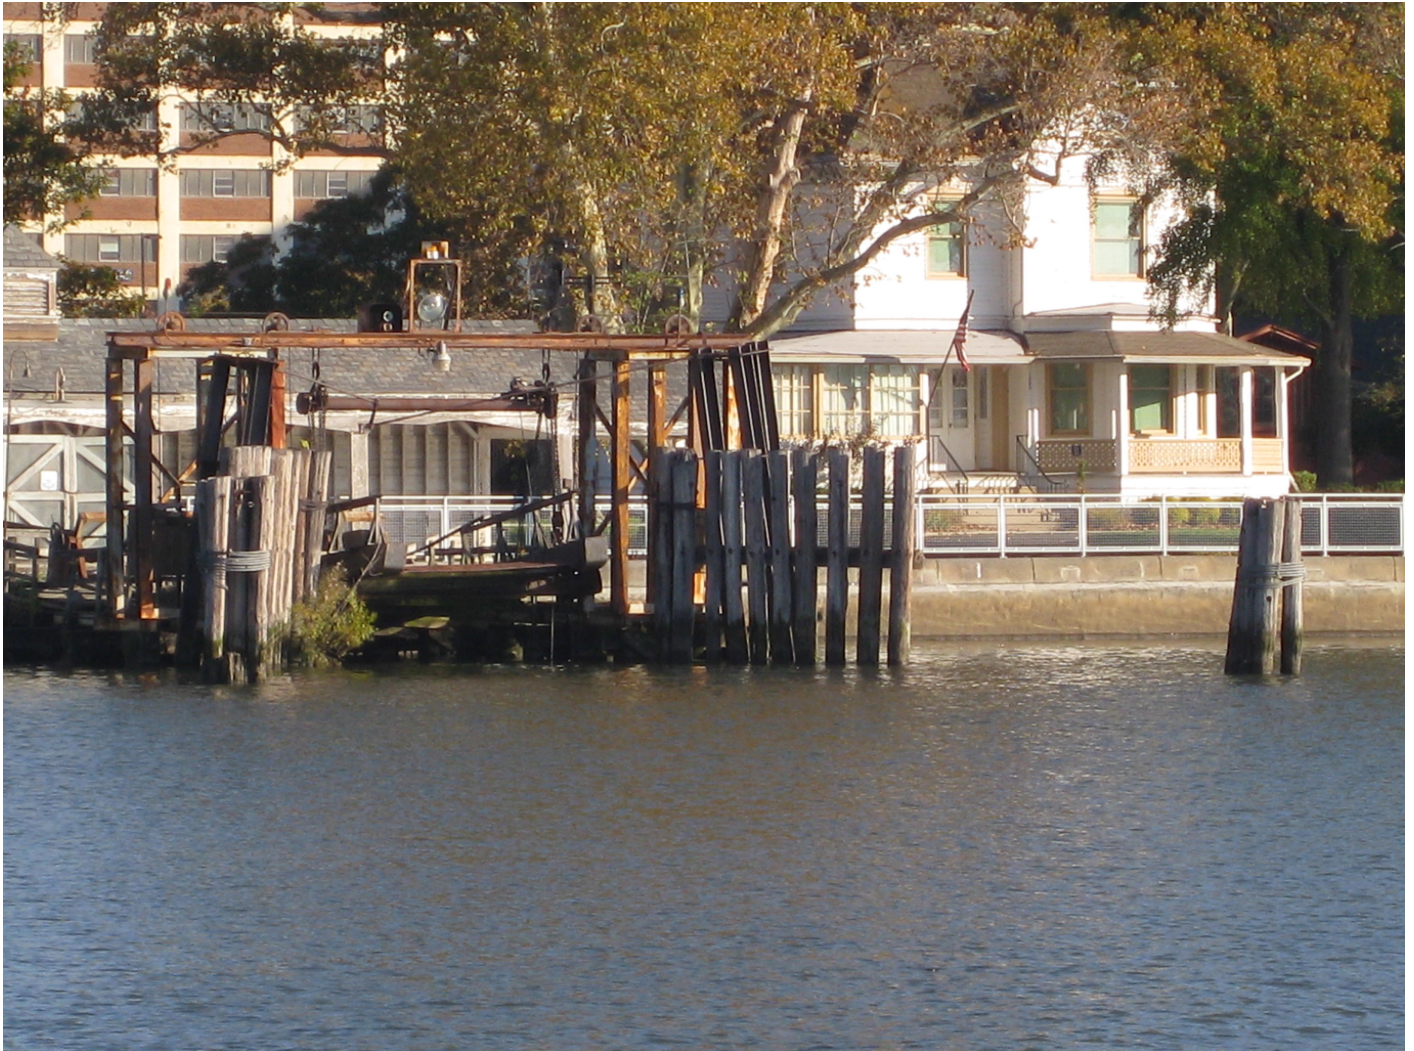
Figure 23: Chartered ferry terminal at southern edge of Navy Anchorage, Anchorage 10.

Ferry routes and/or terminals exist for this survey, but were not investigated (See Figure 23).
