**DESCRIPTIVE REPORT**

Type of Survey: Navigable Area

Registry Number: F00691

Sub-locality: West and Rhode Rivers

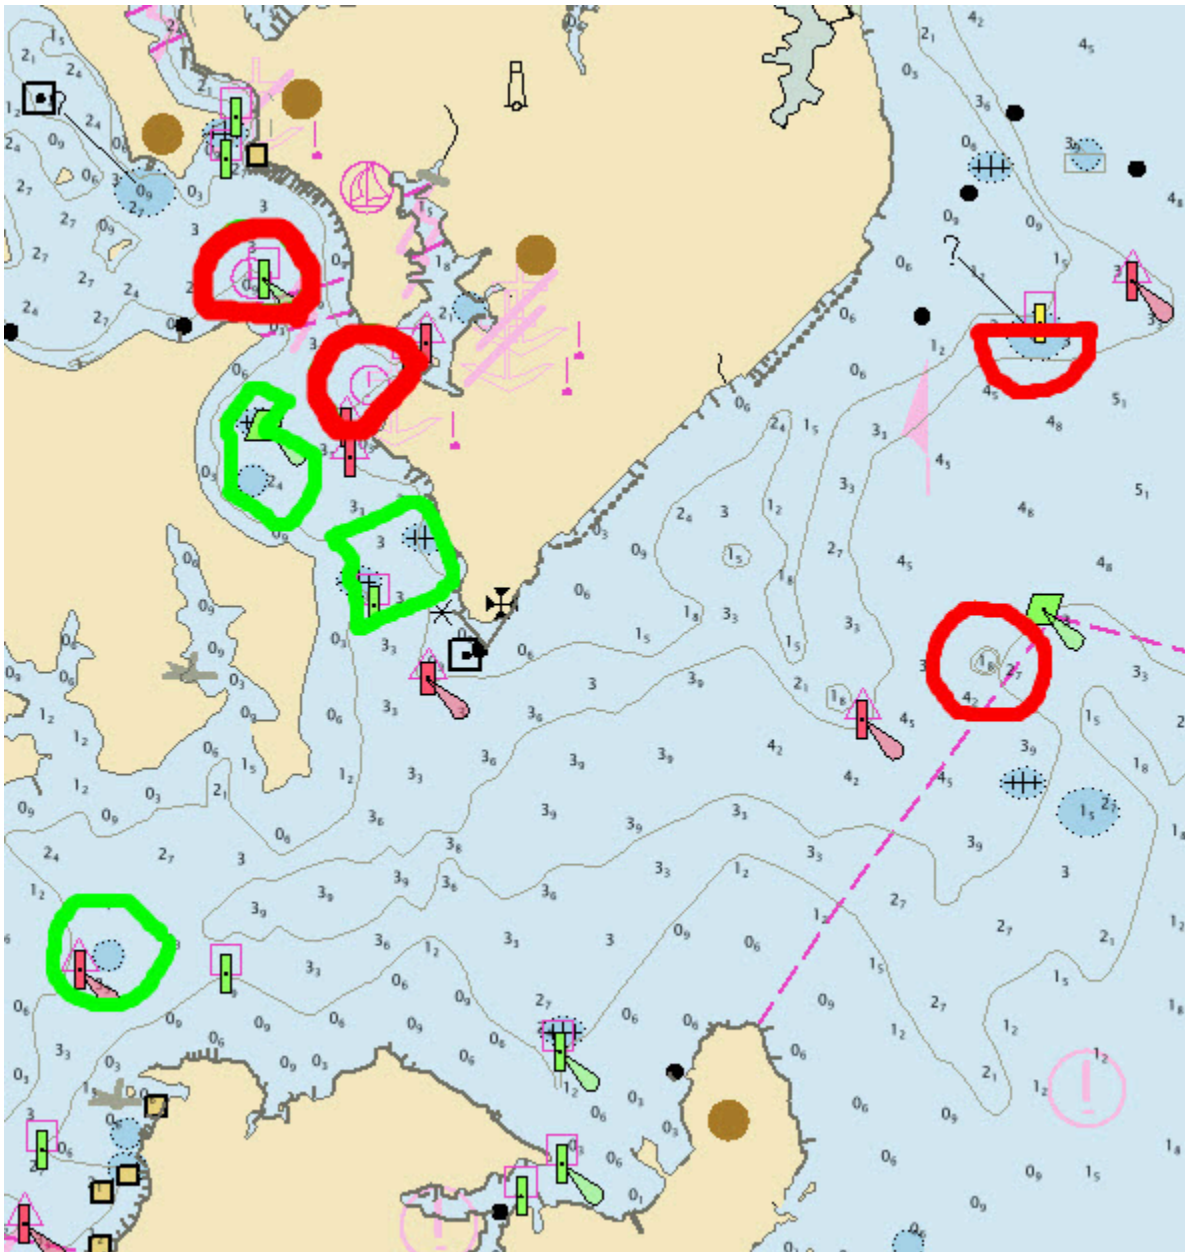
Survey data in the West River and the Rhode River are adequate and intended to supersede all prior survey data in their common areas, except for the four areas indicated in red in Figure 2. Survey data in Chesapeake Bay near the Green "1A" buoy were intended to supersede previous data, but do not meet HSSD 5.2.2.2 Object Detection Coverage for 200% Side Scan Sonar (SSS) Coverage with Concurrent Multibeam Echosounder (MBES) (See Figure 2).

Figure 2: F00691 survey areas adequate to supersede previous data. Survey data that is adequate to supersede previous data is highlighted in green and the survey data this is not adequate to supersede previous data is highlighted in red.

**Survey F00691 was found to be adequate to supersede previously charted data during review at the Pacific Hydrographic Branch. This includes the areas outlined in red in Figure 2.**

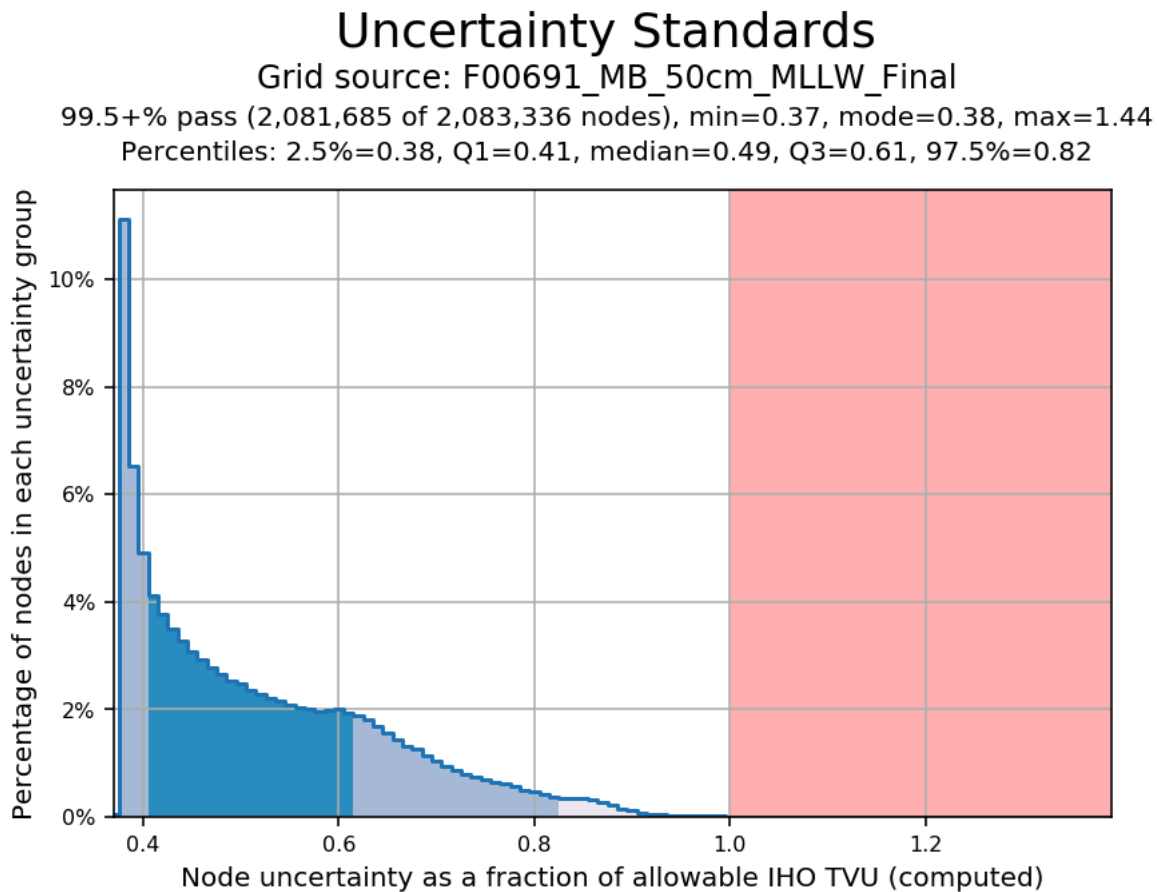
To verify that all data meets the accuracy specifications as stated in HSSD 5.1.3, a child layer titled NOAA\_Allowed\_1 was created for the 50cm surface using the equations stated in HSSD 5.1.3. The surface was then analyzed using the Pydro QC Tools Grid QA feature to determine what percentage of the surface meets specifications. Overall, 99.5% of nodes meet or exceed NOAA Allowable Uncertainty specifications for F00691 (See Figure 3). See the QC Tools Folder location in Appendix II for further detail.

Figure 3: F00691 Total propagated uncertainty statistics.

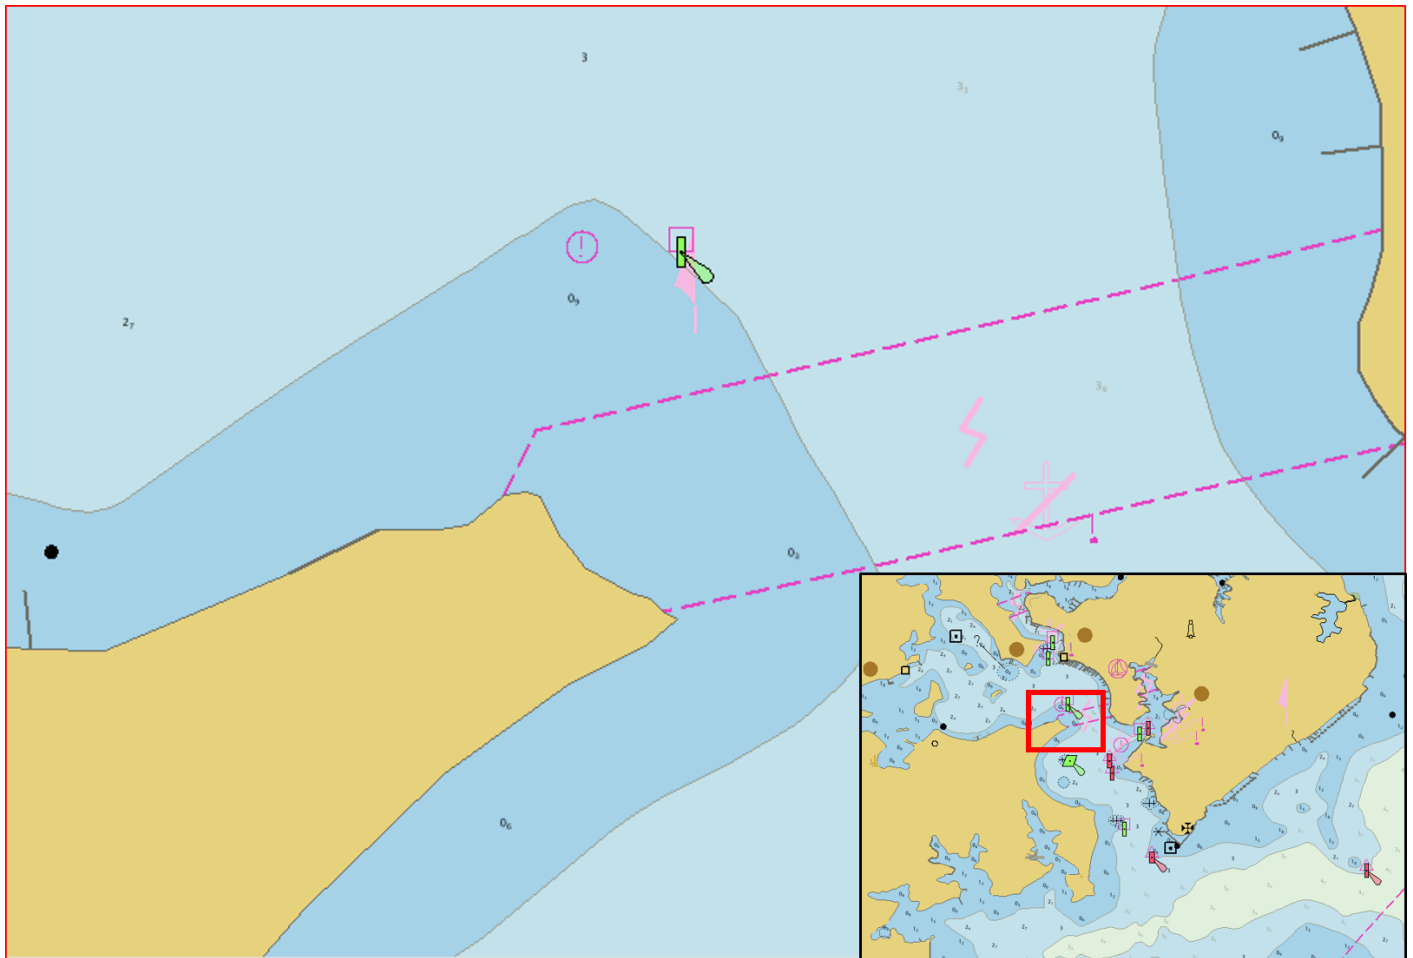
Contours from F00691 generally agree with charted contours on ENC US5MD13M, with two exceptions. The first exception is the point on the west side of the Rhode River, east of High Island, see Figure 4 for overview. The 1.8m contour around this point has migrated inshore approximately 20m along the edges of the point and to approximately 50m at the point itself (Figure 5). The second exception is in Chesapeake Bay, east of Saunders Point. In this area, the charted 3.6m contour protrudes east, indicating a submerged point, however, the data shows that this pointed contour is migrating west, and flattening out. The entire area around this contour was not surveyed, so the true extent of this change is unknown, however, in the area that was surveyed, the contour has shifted west up to 105m (See Figure 6).

Figure 4: General location of the point with the migrating 1.8m contour. Inset shows overview.

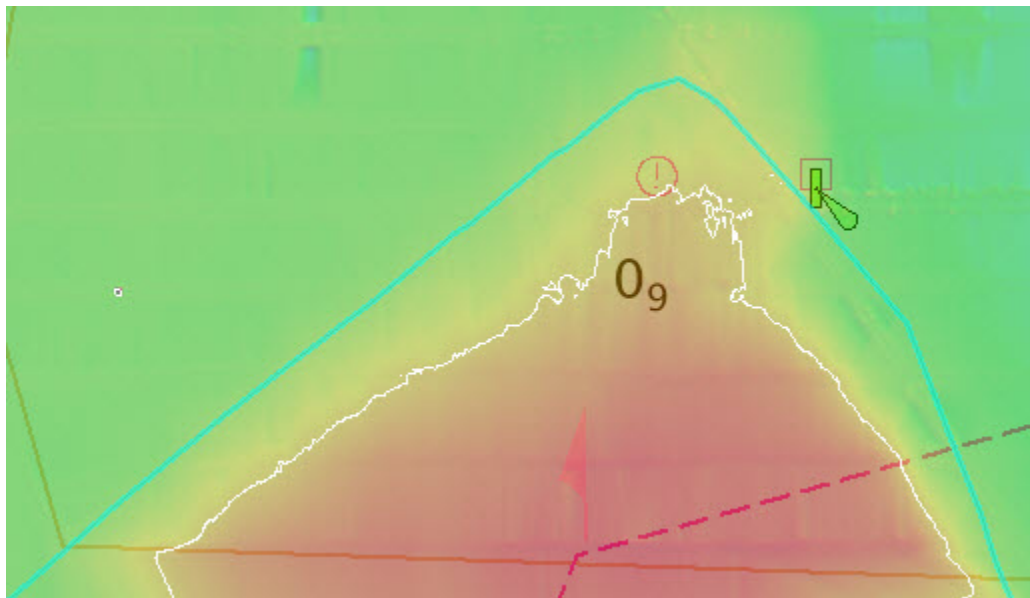
Figure 5: Western shift of 1.8m contour along the point east of High Island in the Rhode River. With the charted ENC US5MD13M 1.8m contour in blue and the surveyed 1.8m contour in white.

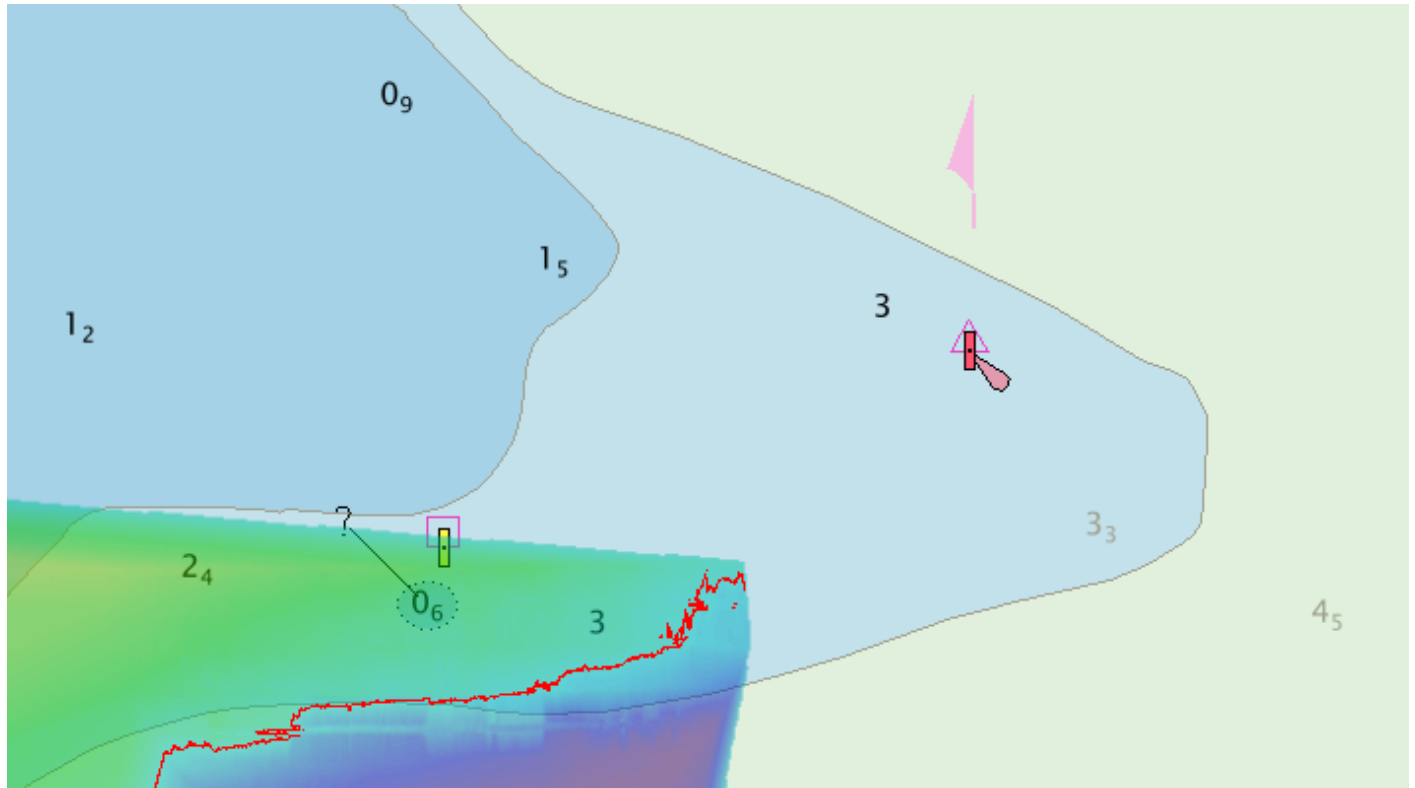
Figure 6: F00691 3.6m contour shift in Chesapeake Bay. With the charted ENC US5MD13M 3.80M contour in blue and the surveyed 3.6m contour in red.

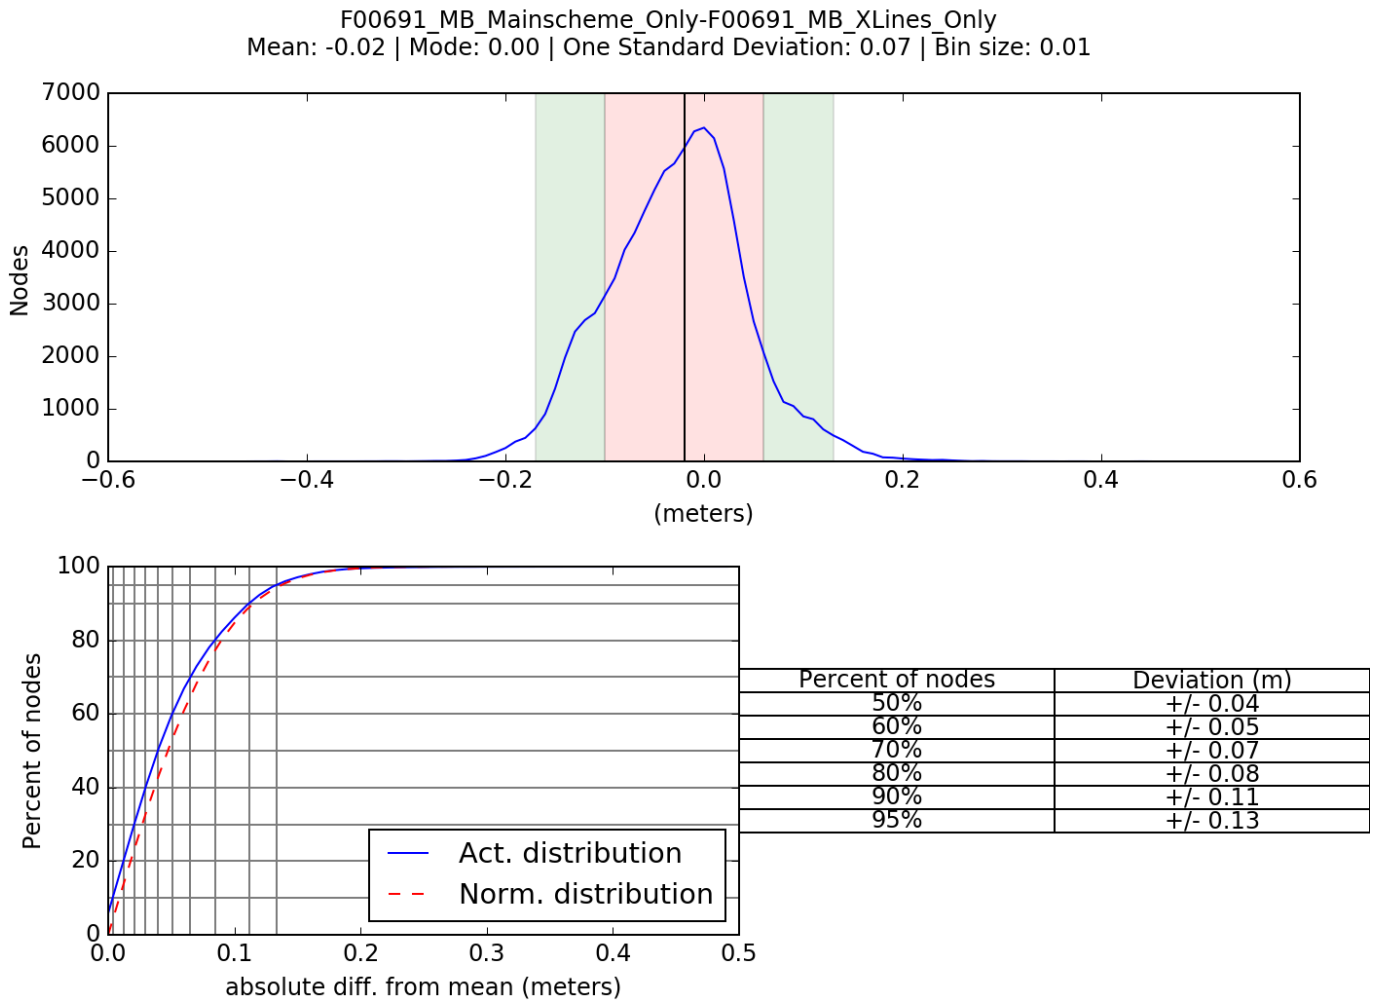
Crosslines were collected, processed, and compared in accordance with HSSD 5.2.4.3. To evaluate crosslines, a 0.5 meter CUBE surface using strictly mainscheme lines and a 0.5 meter CUBE surface using strictly crosslines were created. From these surfaces a difference surface (mainscheme - crosslines = difference surface) was generated using Pydro's Compare Surfaces tool at a 0.5 meter resolution, and are submitted in the Separates II Digital Data folder. Statistics show the mean difference between the depths derived from mainscheme and crosslines was -0.02 meters and 95% of nodes falling within 0.13 meters (Figure 7). For the respective depths, the difference surface was compared to the allowable NOAA uncertainty standards using Compare Surfaces. In total, 99.5% of the depth differences between F00691 mainscheme and crossline data were within allowable NOAA uncertainties (Figure 8).

Figure 7: F00691 Crossline statistics.

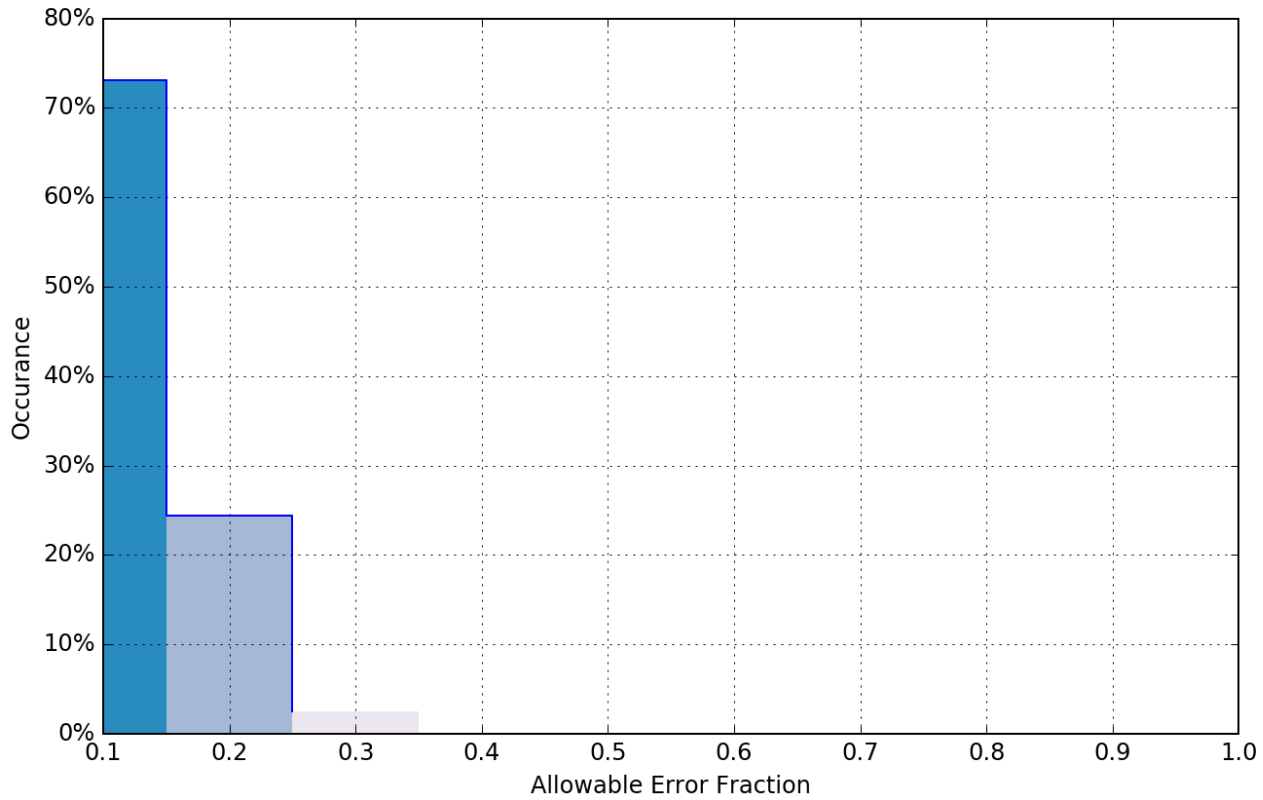
Per Grid: F00691\_MB\_Mainscheme\_Only-F00691\_MB\_XLines\_Only\_fracAllowErr.csar

99.5+% nodes pass (101464), min=0.0, mode=0.1 mean=0.1 max=1.8

Percentiles: 2.5%=0.0, Q1=0.0, median=0.1, Q3=0.1, 97.5%=0.2

Figure 8: F00691 Crossline allowable uncertainty statistics.

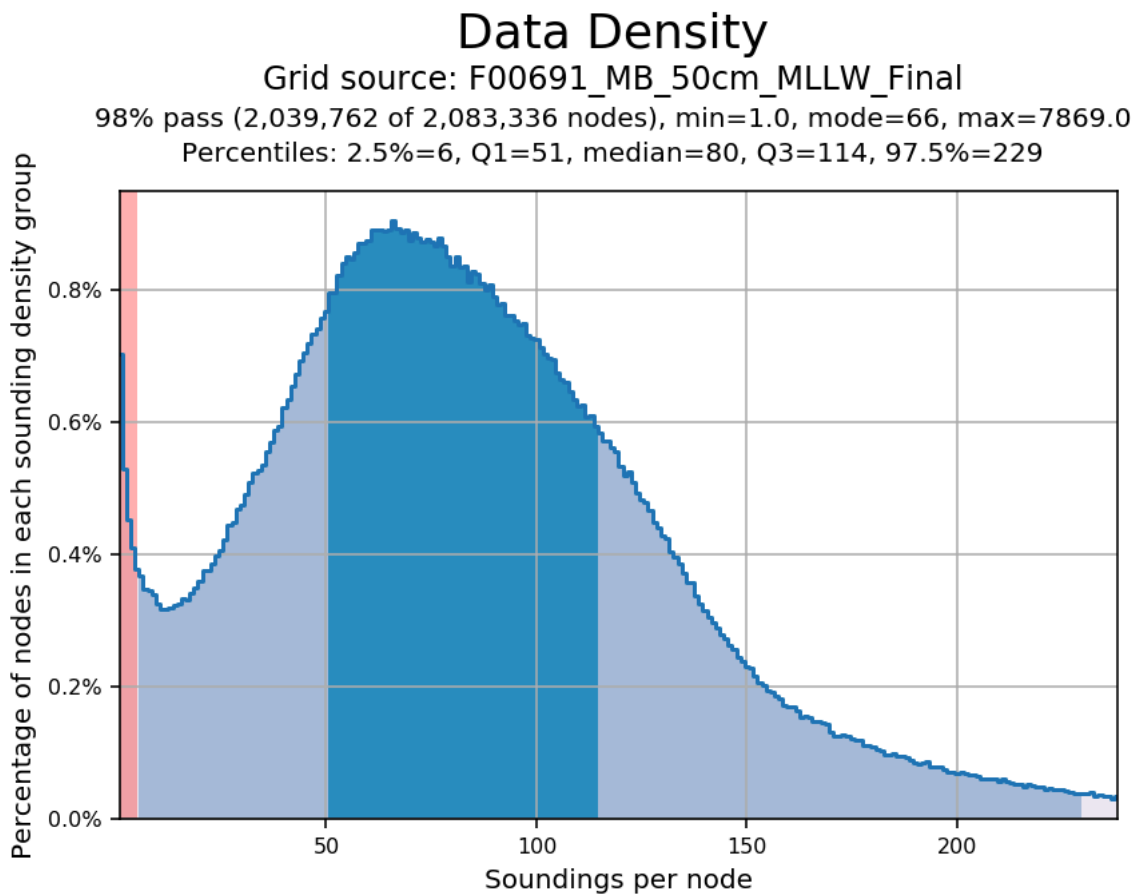
The finalized surface was analyzed using the Pydro QC Tools Grid QA feature. Density requirements for F00691 were achieved with at least 98% of finalized surface nodes containing five or more soundings as required by HSSD 5.2.2.3 (See Figure 9). For individual graphs, see the QC Tools folder located in Appendix II.

Figure 9: F00691 Density Statistics.

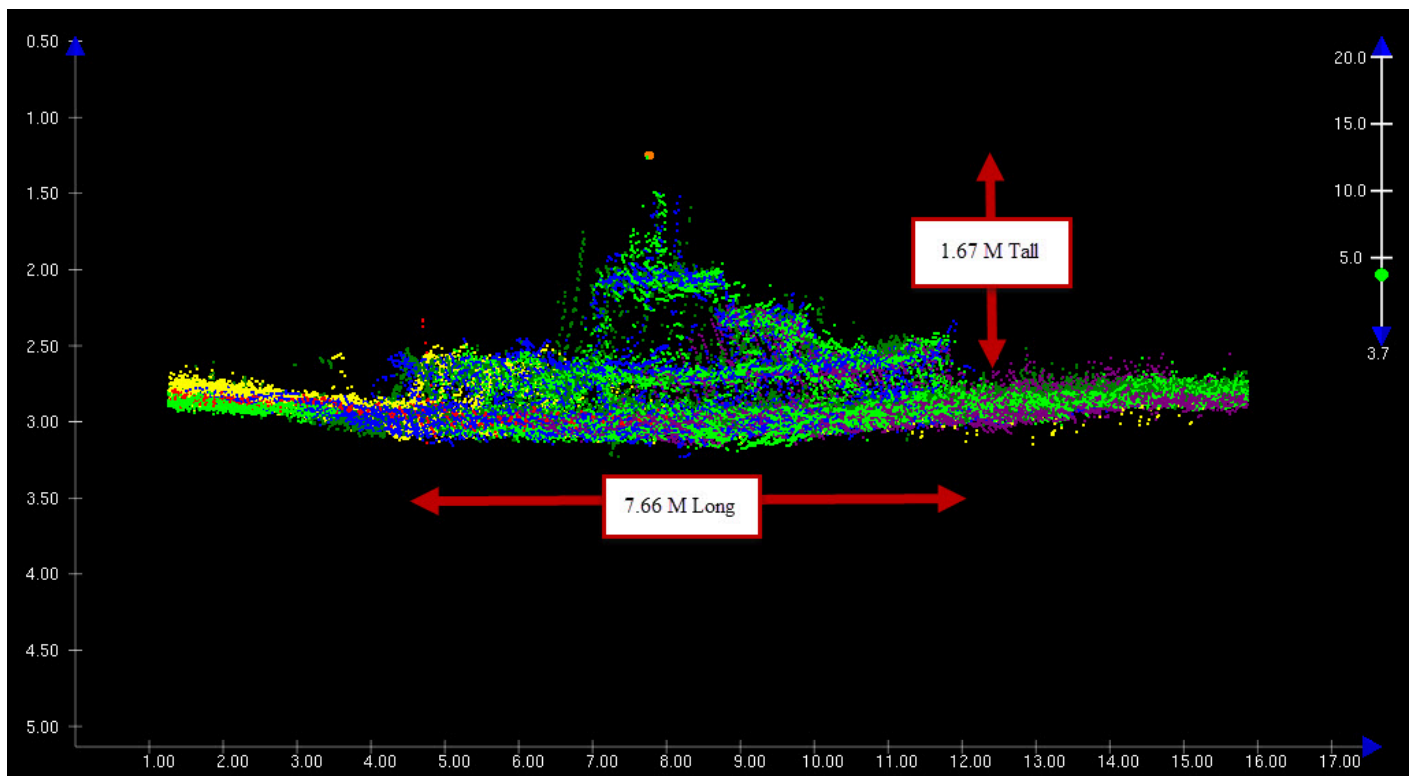
F00691 contains one designated sounding in accordance with HSSD 5.2.1.2.3. The designated sounding is included in the FFF, as it is associated with the wreck located by Buoy "WR5" in Rhode River (See Figure 10). On November 7th, 2019, the wreck associated with the designated sounding and Green Buoy "WR5" was removed by a Maryland DNR contractor (Figure 11). In the folder "II\_Supplemental\_Survey\_Records\_Correspondence," see correspondence for more information regarding the wreck removal.

Figure 10: Designated sounding on wreck.

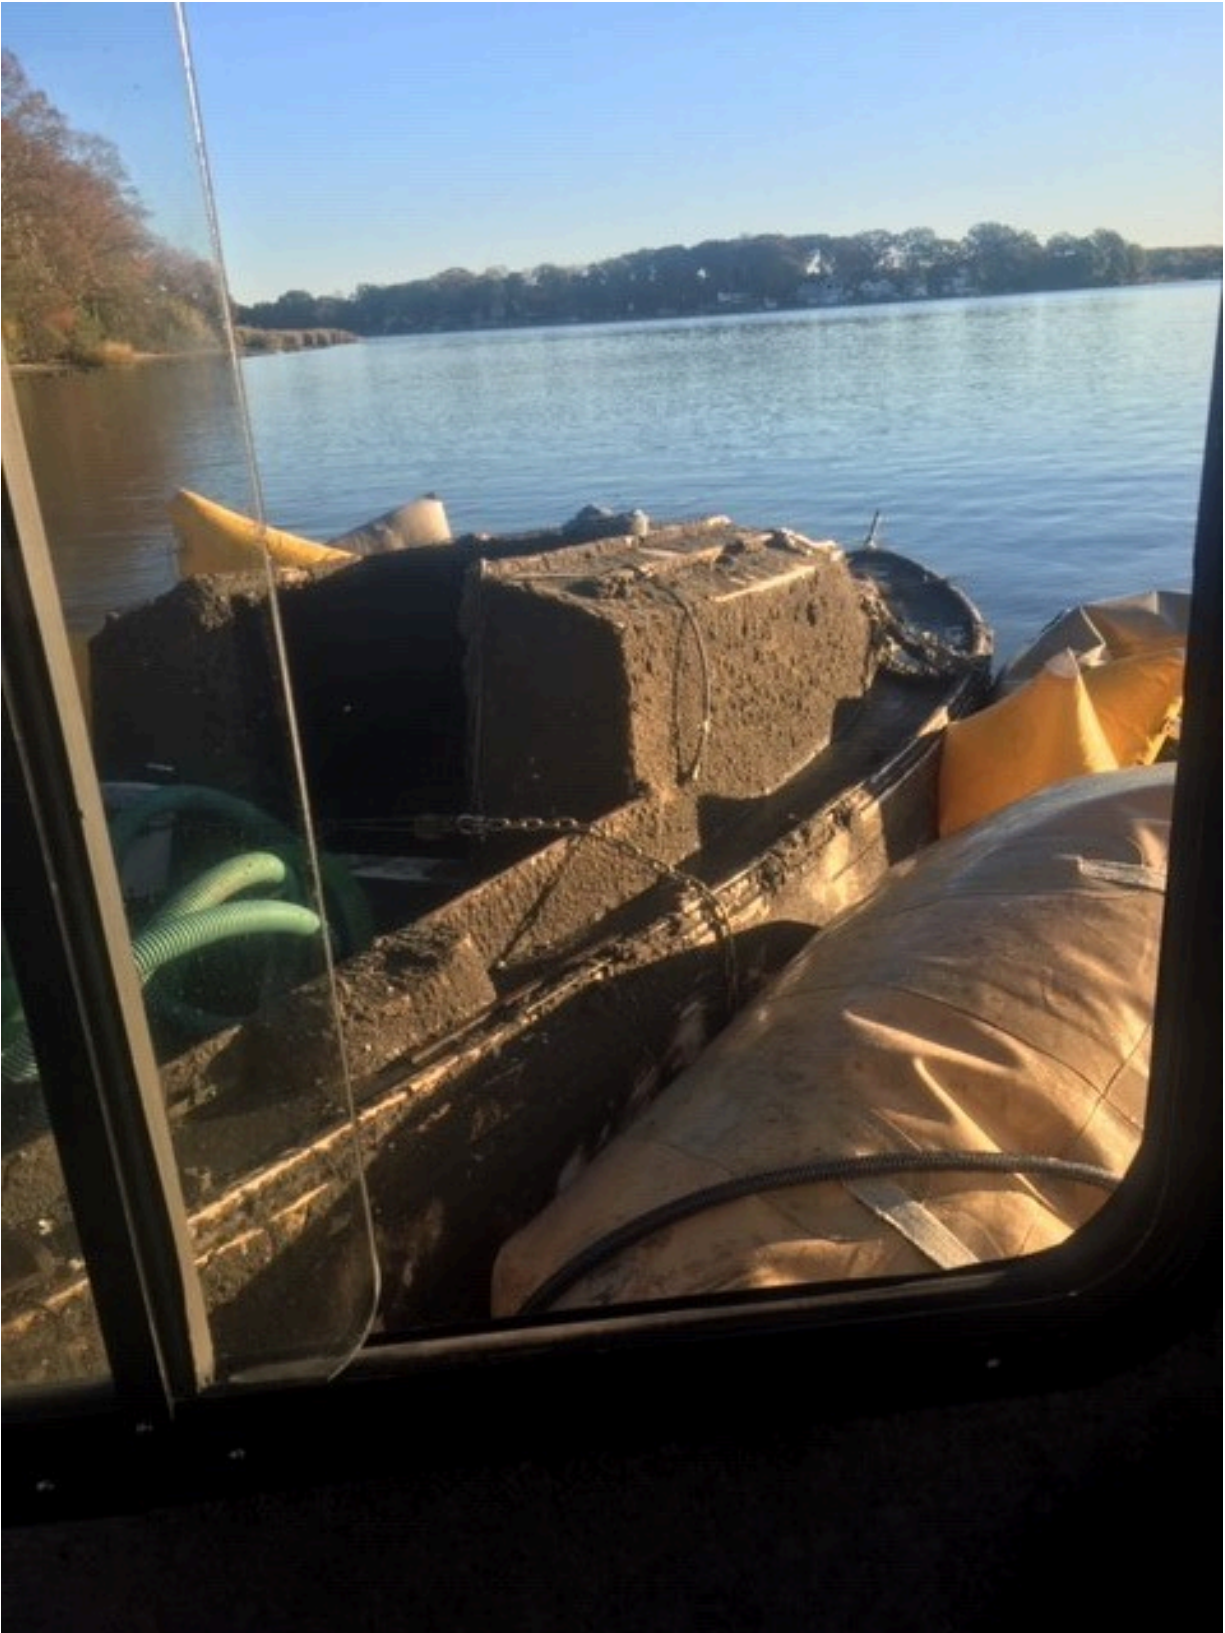
*Figure 11: Vessel after a Maryland DNR contractor floated and removed the wreck.*

On or about Nov 7th, 2019. DNR's Contractor "Pristine Marine Inc" refloated the wreck marked by WR"5" Rhode River. The vessel was removed in its entirety, and was towed away. Fiberglass is a durable material.

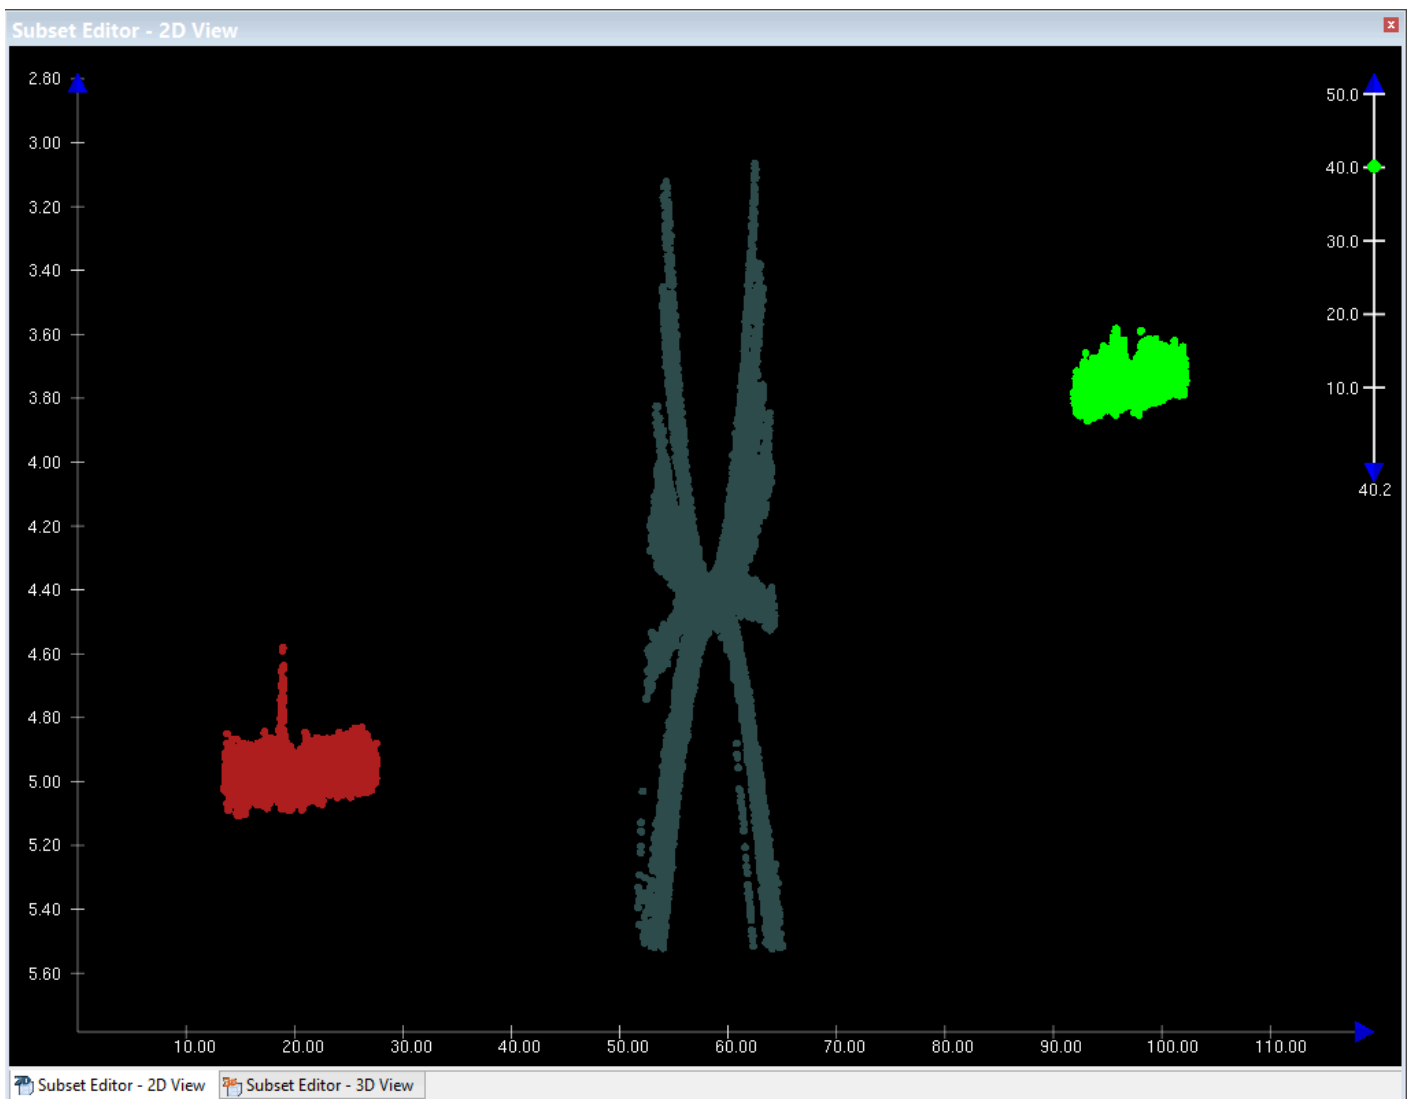
Multibeam data on F00691 contains some evident outer beam spreading (Figure 12). This is caused by sound speed variations in the area, as well as areas of soft mud and silt seafloor. In areas, such as the eastern bay side assigned locations, the beam spreading was obvious, rather than a true seafloor feature, the spurious soundings were rejected and surfaces recomputed. These soundings were either rejected manually or by filtering the lines to 50 degrees from nadir, or filtering the data deeper than 6 meters and shallower than 0.25 meters. In some area, the blowouts were egregious and data was removed down to within a few meters on either side of nadir.

*Figure 12: Example of sound speed blowout from F00691.*

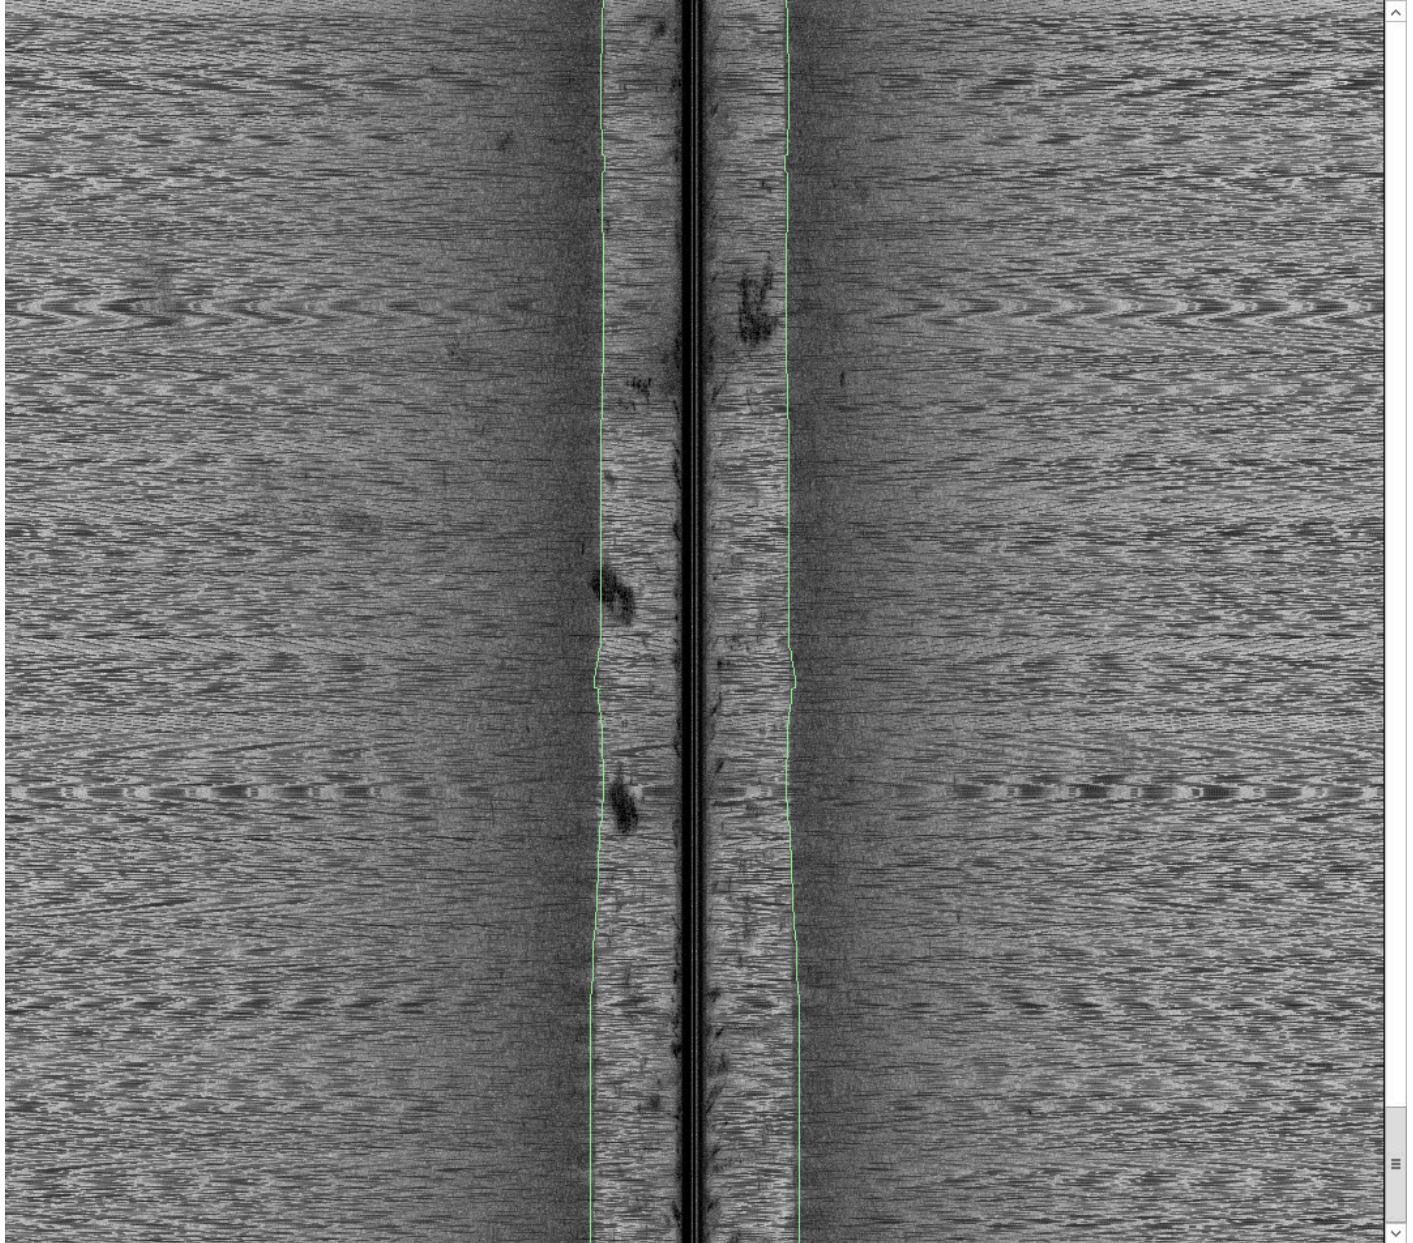
Due to the mounting configuration of the SSS control module relative to the propulsion controls within the ASV, some interference is evident in the SSS data (See Figure 13). This interference does not obscure objects from being found by the hydrographer and does not degrade the data beyond use.

*Figure 13: Example of side scan sonar interference.*

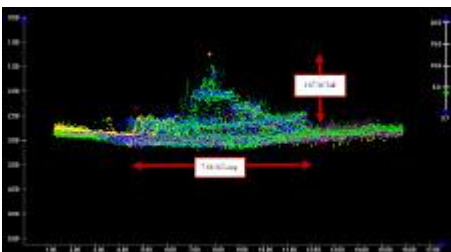
F00691\_000000683500001\_b.JPG  
107K

Please see attached picture and correspondence for the wreck that has been removed. Images are the wreck viewed in subset mode (pre-removal), and then the wreck when it was removed. Thanks for advising on this.

It can be removed with reference to the correspondence that you have from Maryland DNR being deemed an a removal report from an authoritative source. Which is in compliance with NCM (nautical chart manual) section 4.10.4a.
