**DESCRIPTIVE REPORT**

Type of Survey: Navigable Area

Registry Number: F00731

General Locality: Beaufort, NC

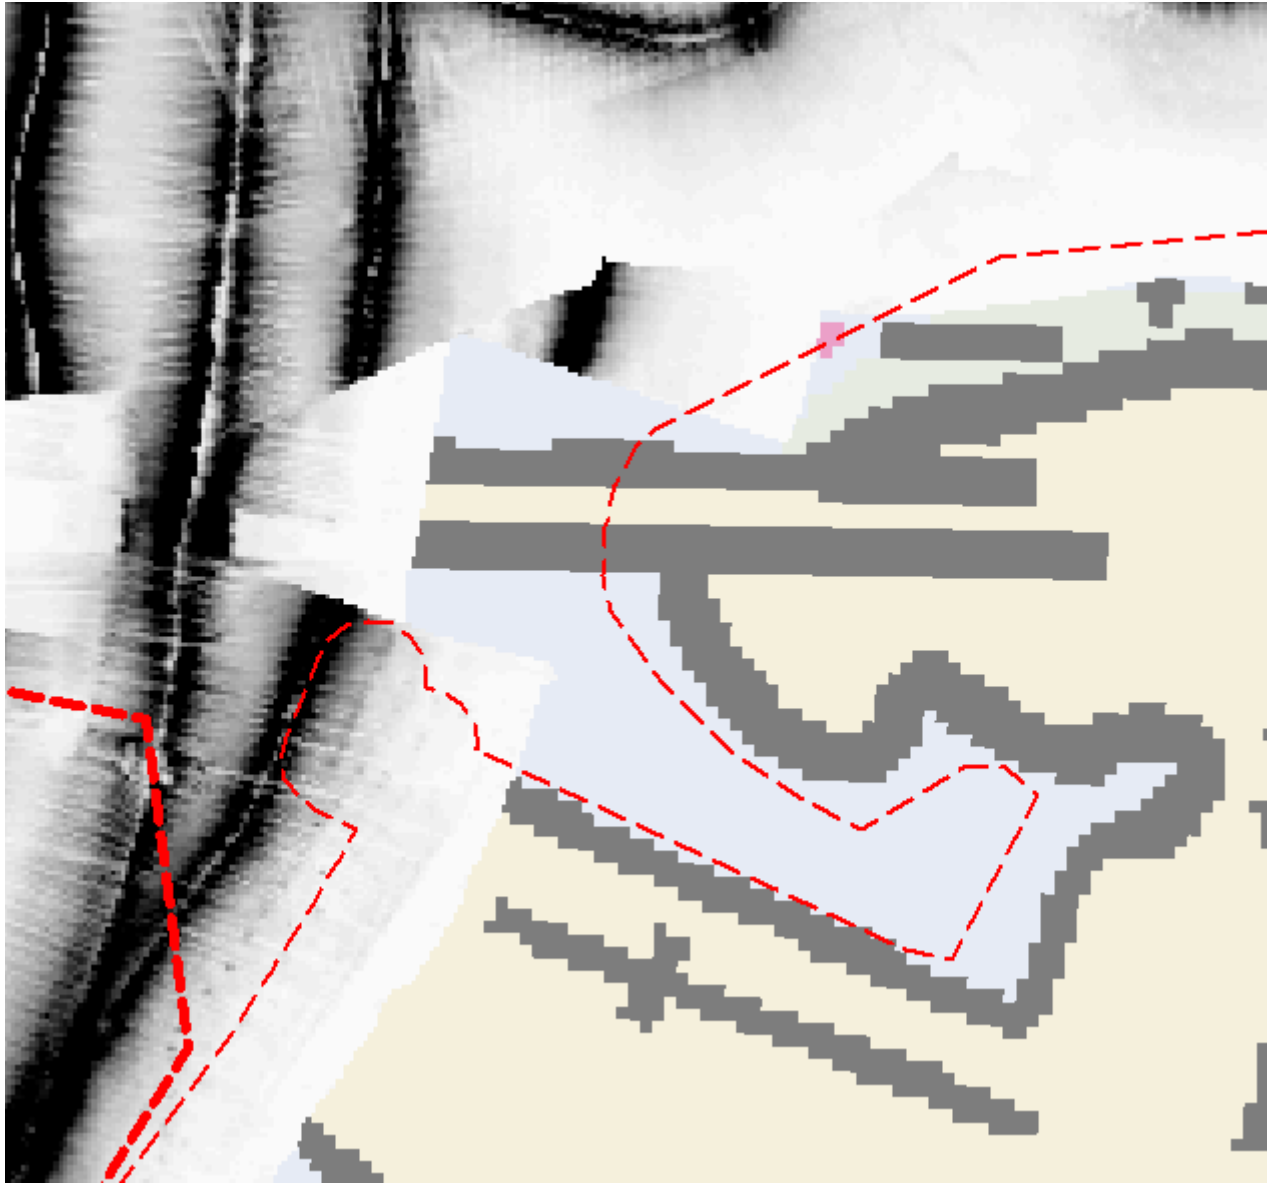
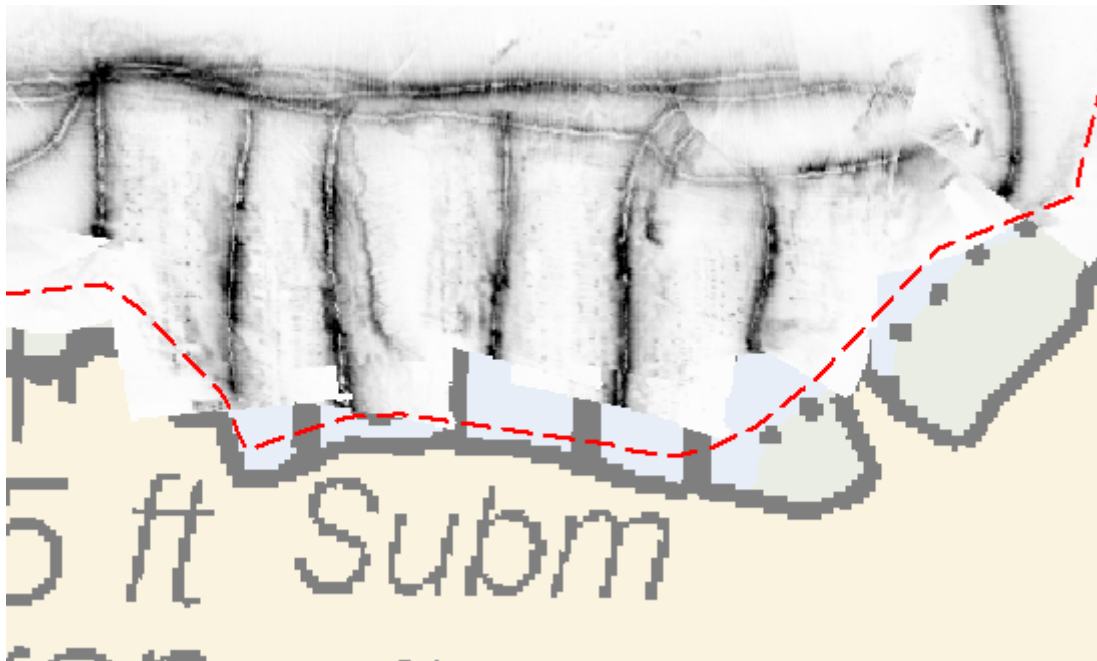
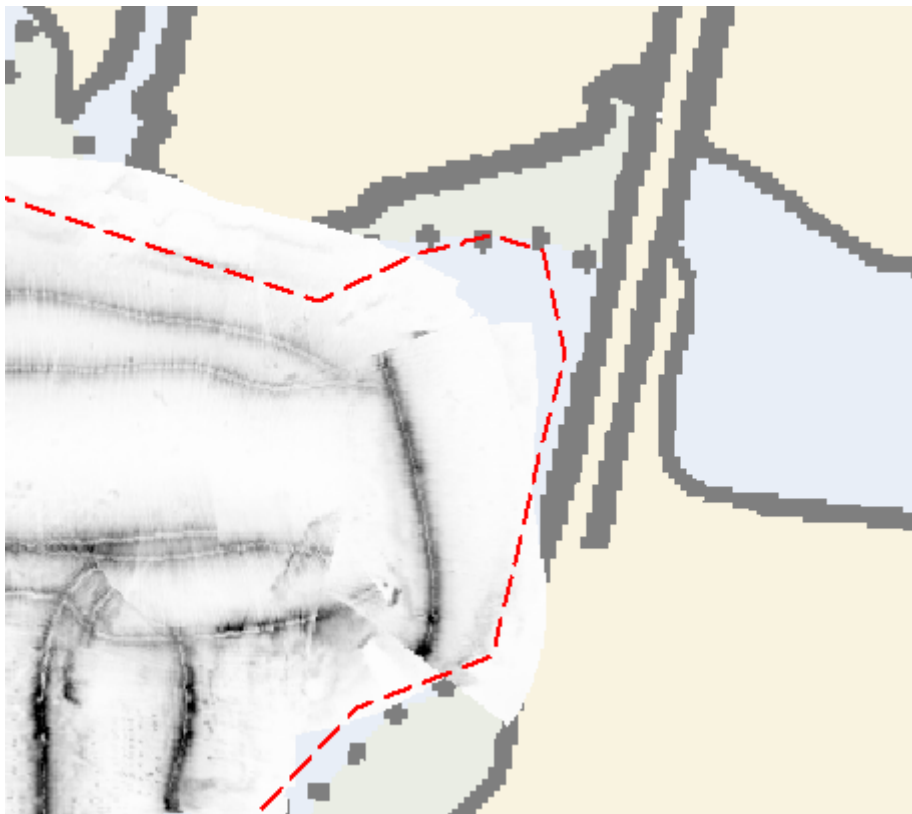
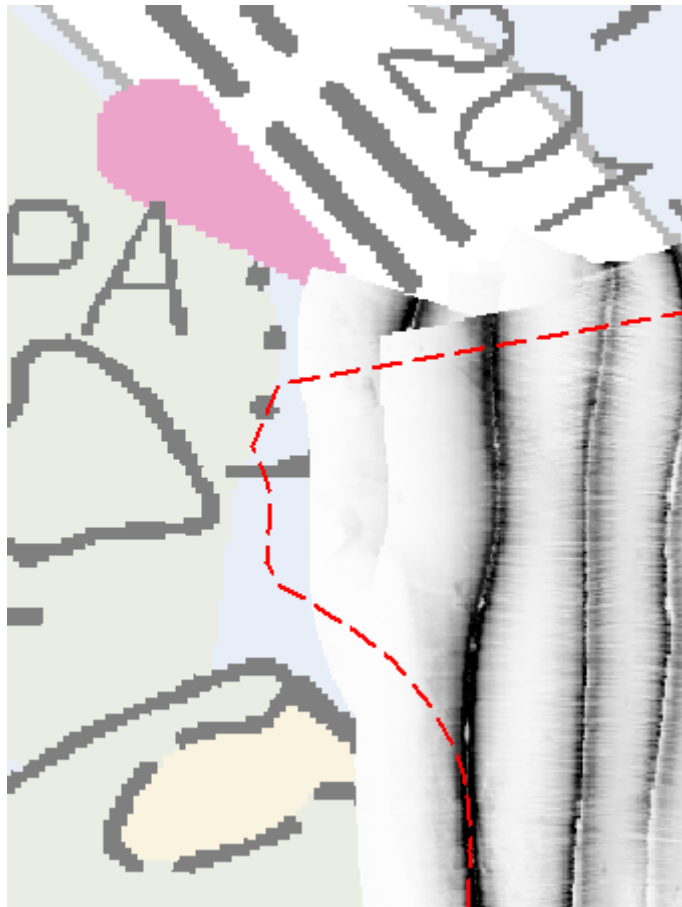
The assigned survey limits were completed with 200% SSS and concurrent MBES except for the areas listed below. These areas were determined to be too shoal for safe operations.

*Figure 3: Non object detection area 1*

*Figure 4: Non object detection area 2*

*Figure 5: Non object detection area 3*

*Figure 6: Non object detection area 4*

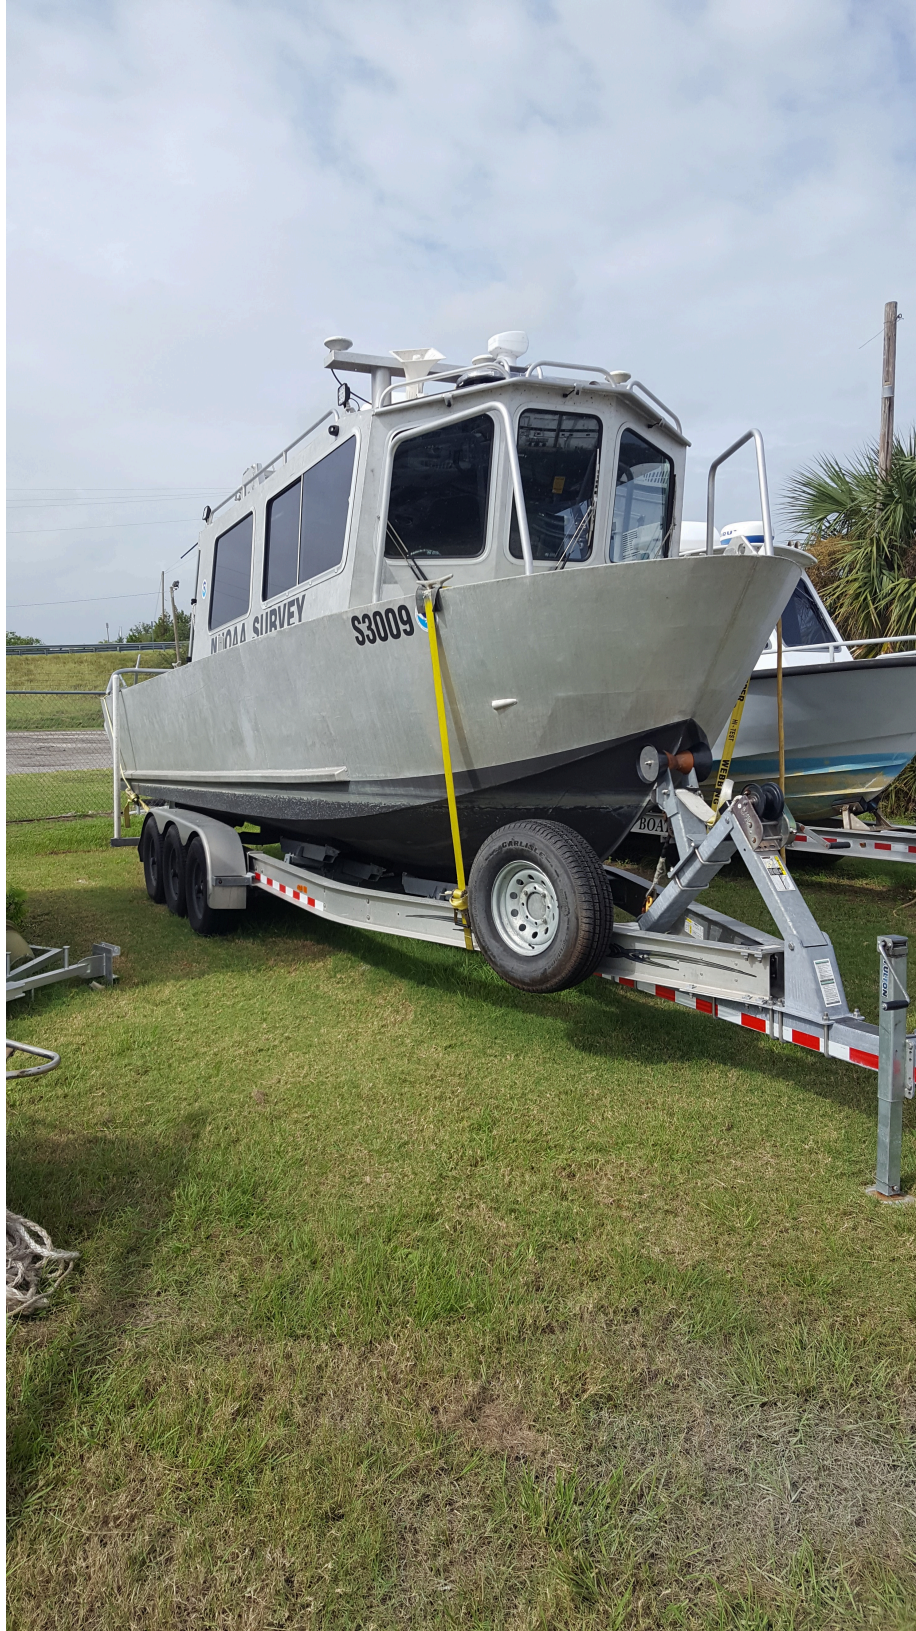
*Figure 8: S3009*

S3009 is a 30 foot survey vessel used for inshore and near shore hydrographic surveys, homeported in Fernandina Beach, FL and operated by Navigation Response Team 2.

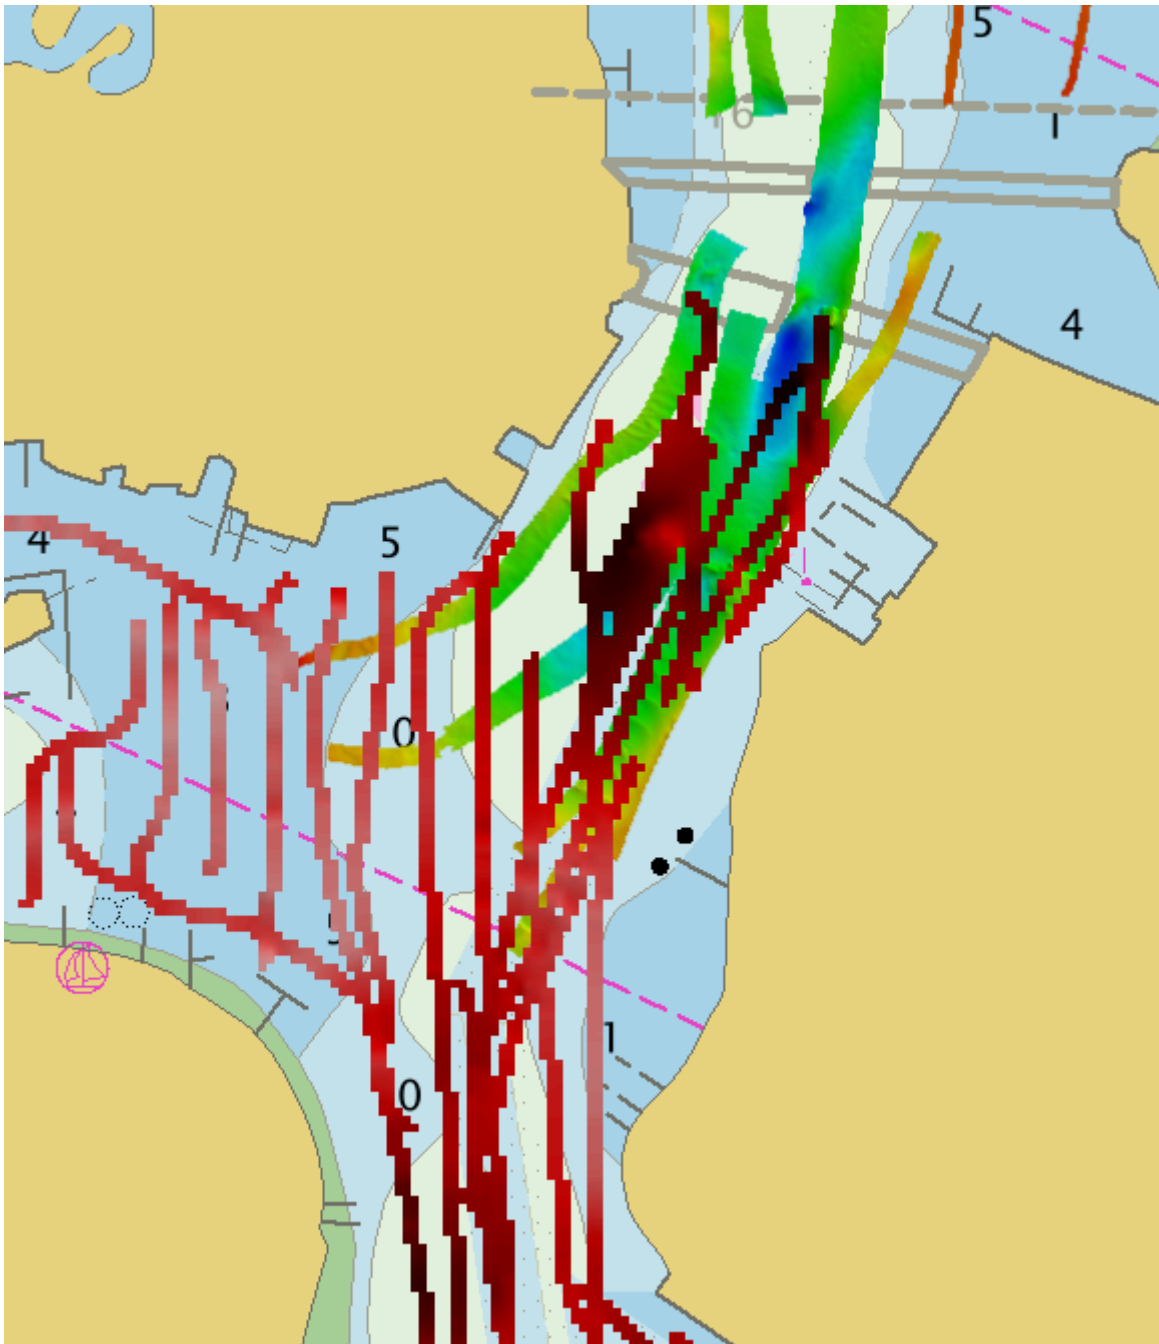
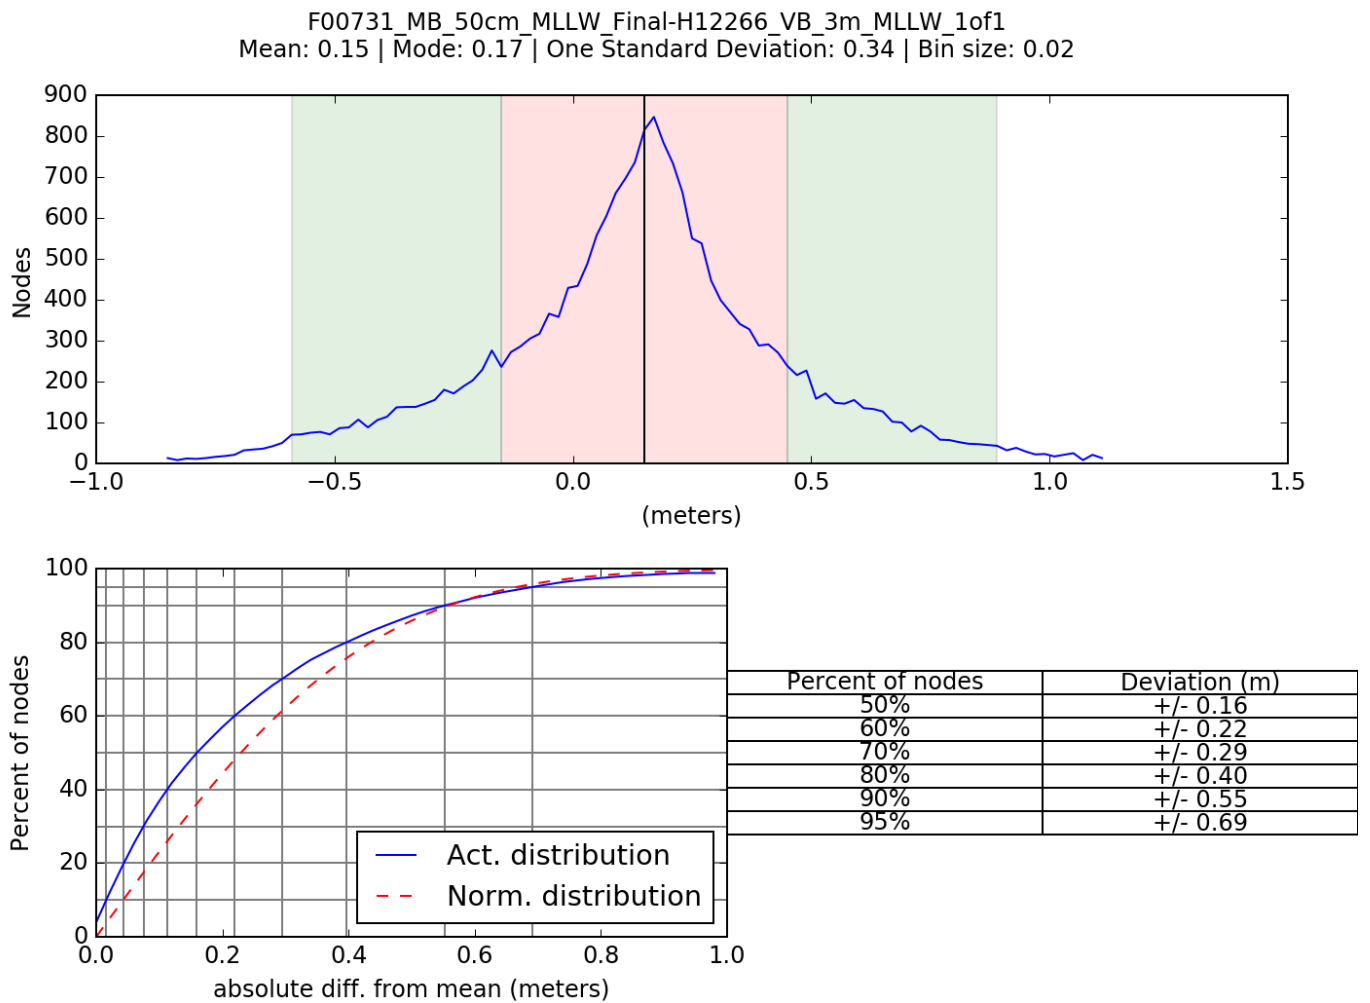
A junction from survey H12266 completed by NRT2 in 2010 overlaps the southernmost portion of the survey. A 3m singlebeam bag was created with the data retrieved from NOAA's Bathymetric Data Viewer. This 3m bag was differenced directly with F00731\_MB\_50cm\_MLLW\_Final.csar. Results were in general agreement and no significant changes to bathymetry were noted. Standard deviation between the two surfaces was calculated to be 0.3 meters.

Figure 10: Junction overlap area.

*Figure 11: Junction Depth Delta analysis.*

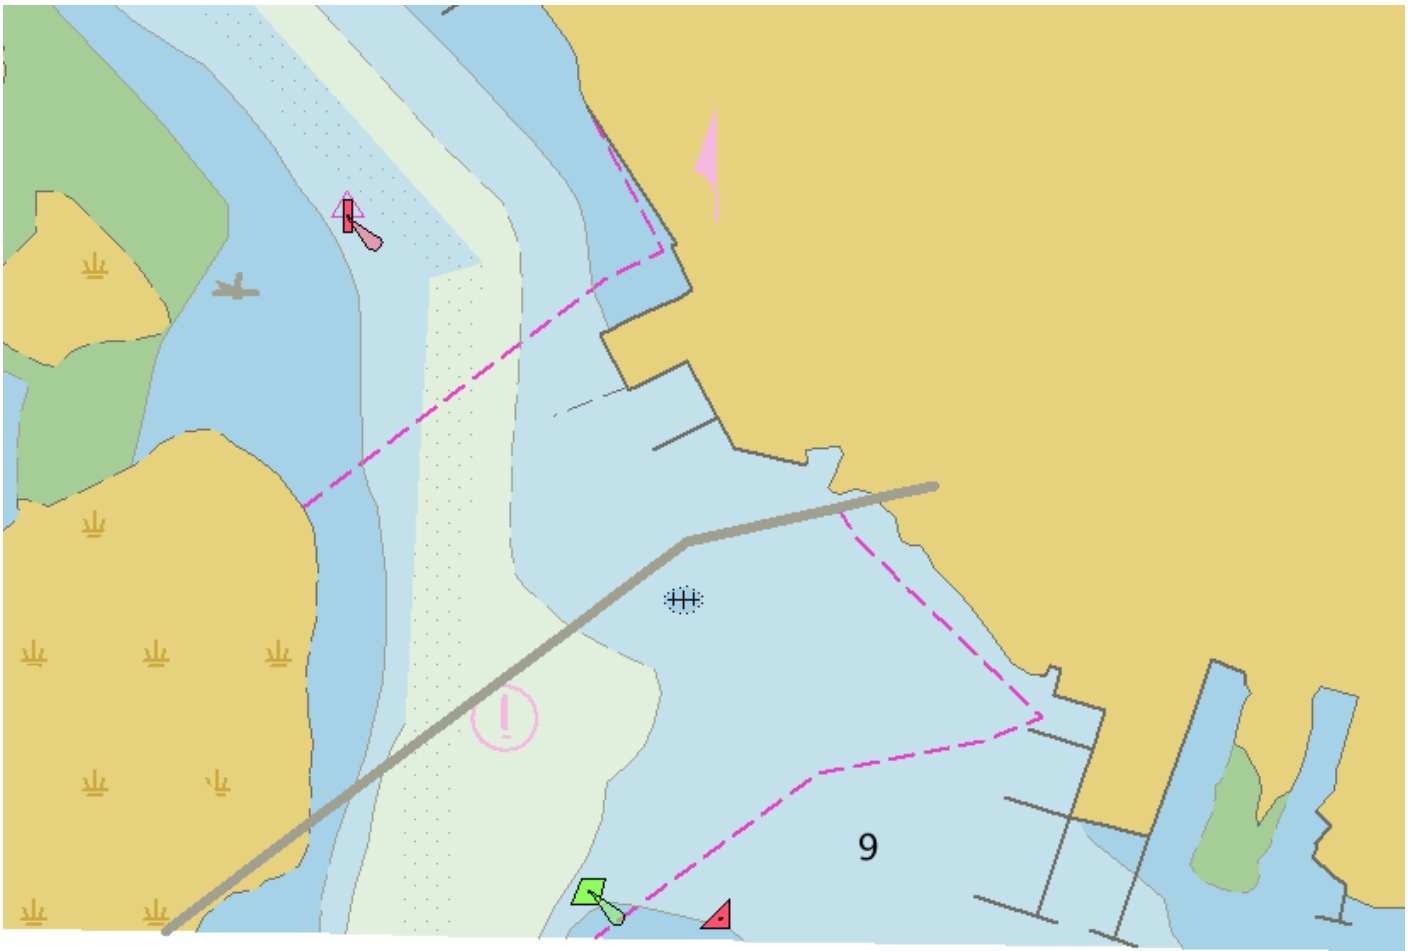
Figure 16: Survey area covered by ENC US5NC18M

US5NC18M unfortunately only contained one sounding in the survey area and it is in agreement with surveyed depths. Recommend new soundings be added to the ENC.

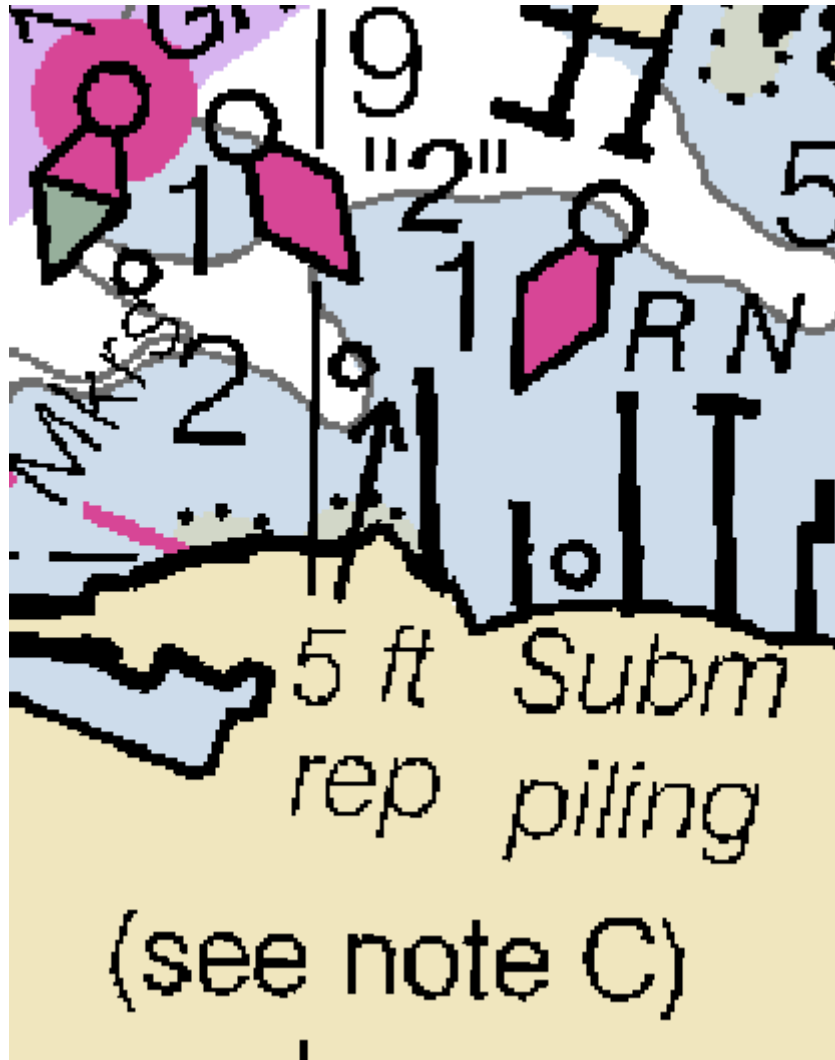
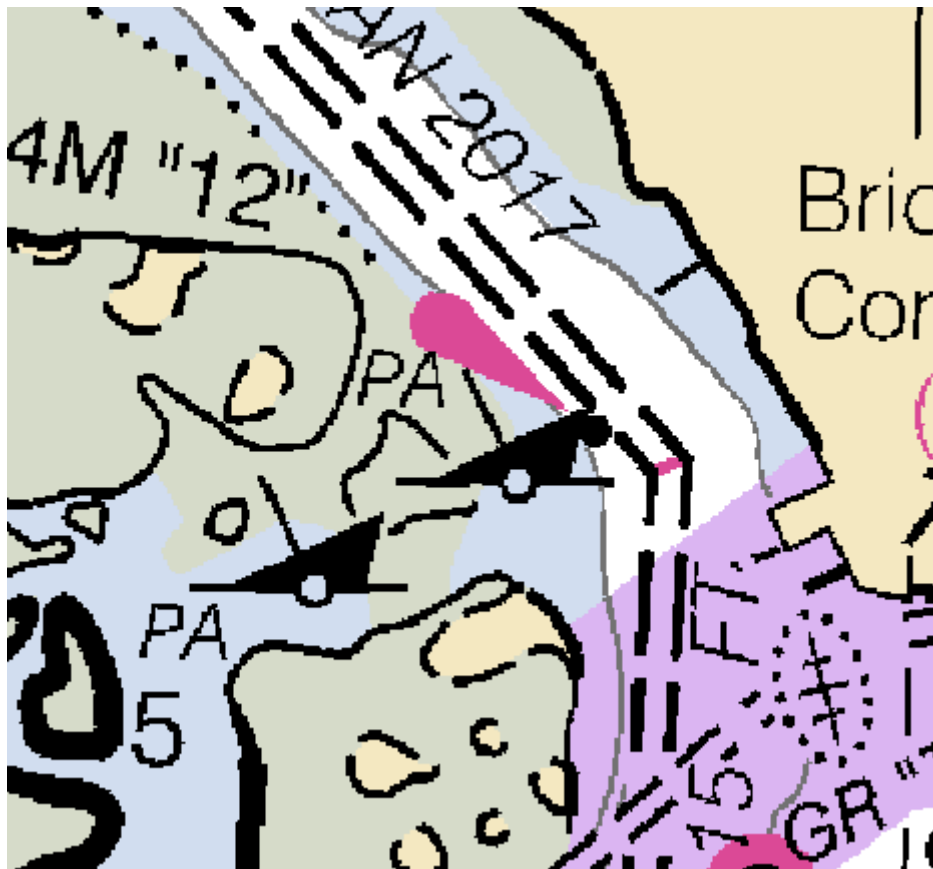
A reported 5 feet exists on Chart 11545 that is not necessary to safe navigation as it is reported under a marina slip. Recommend removing the reported 5 feet and updating bathymetry as needed. The Wreck PA on Chart 11545 and US5NC18M was not surveyed due to the shallow surrounding waters. No visual contact with the wreck was made.

Figure 17: Reported 5 feet.

Figure 18: Wreck PA.

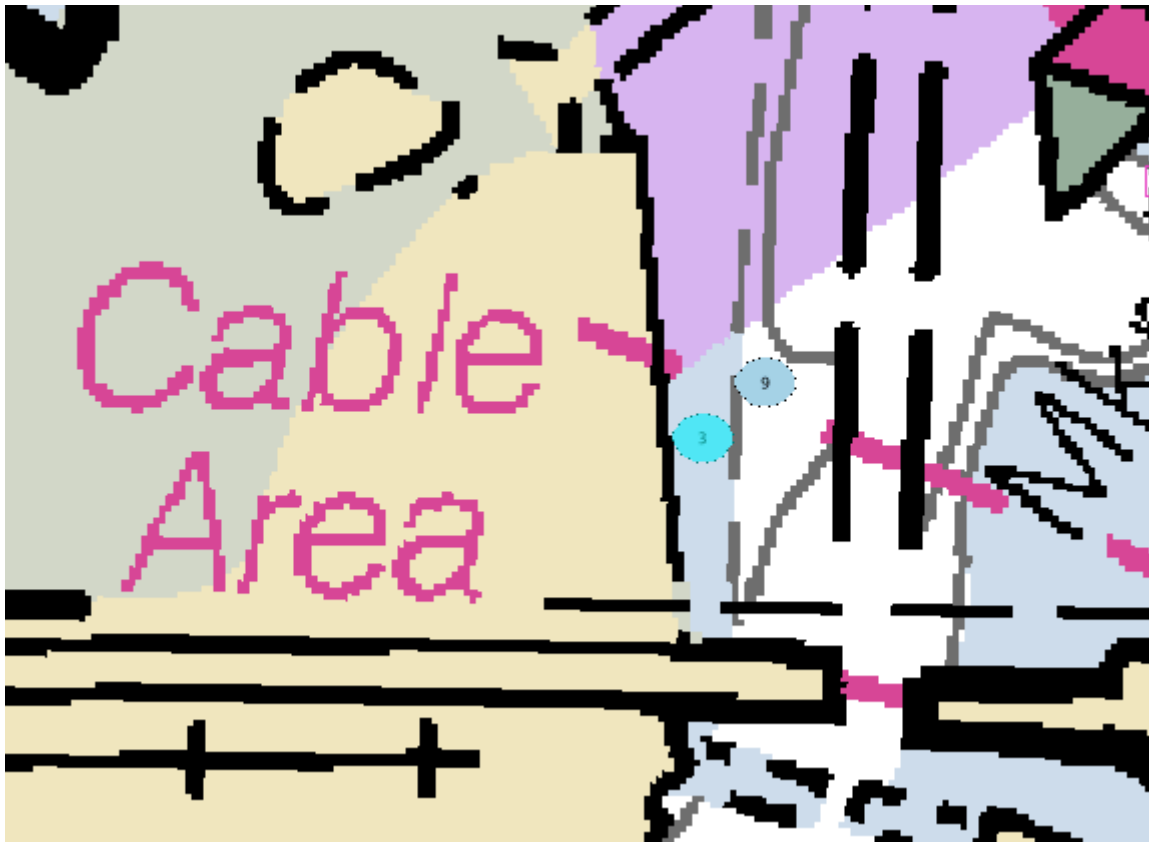
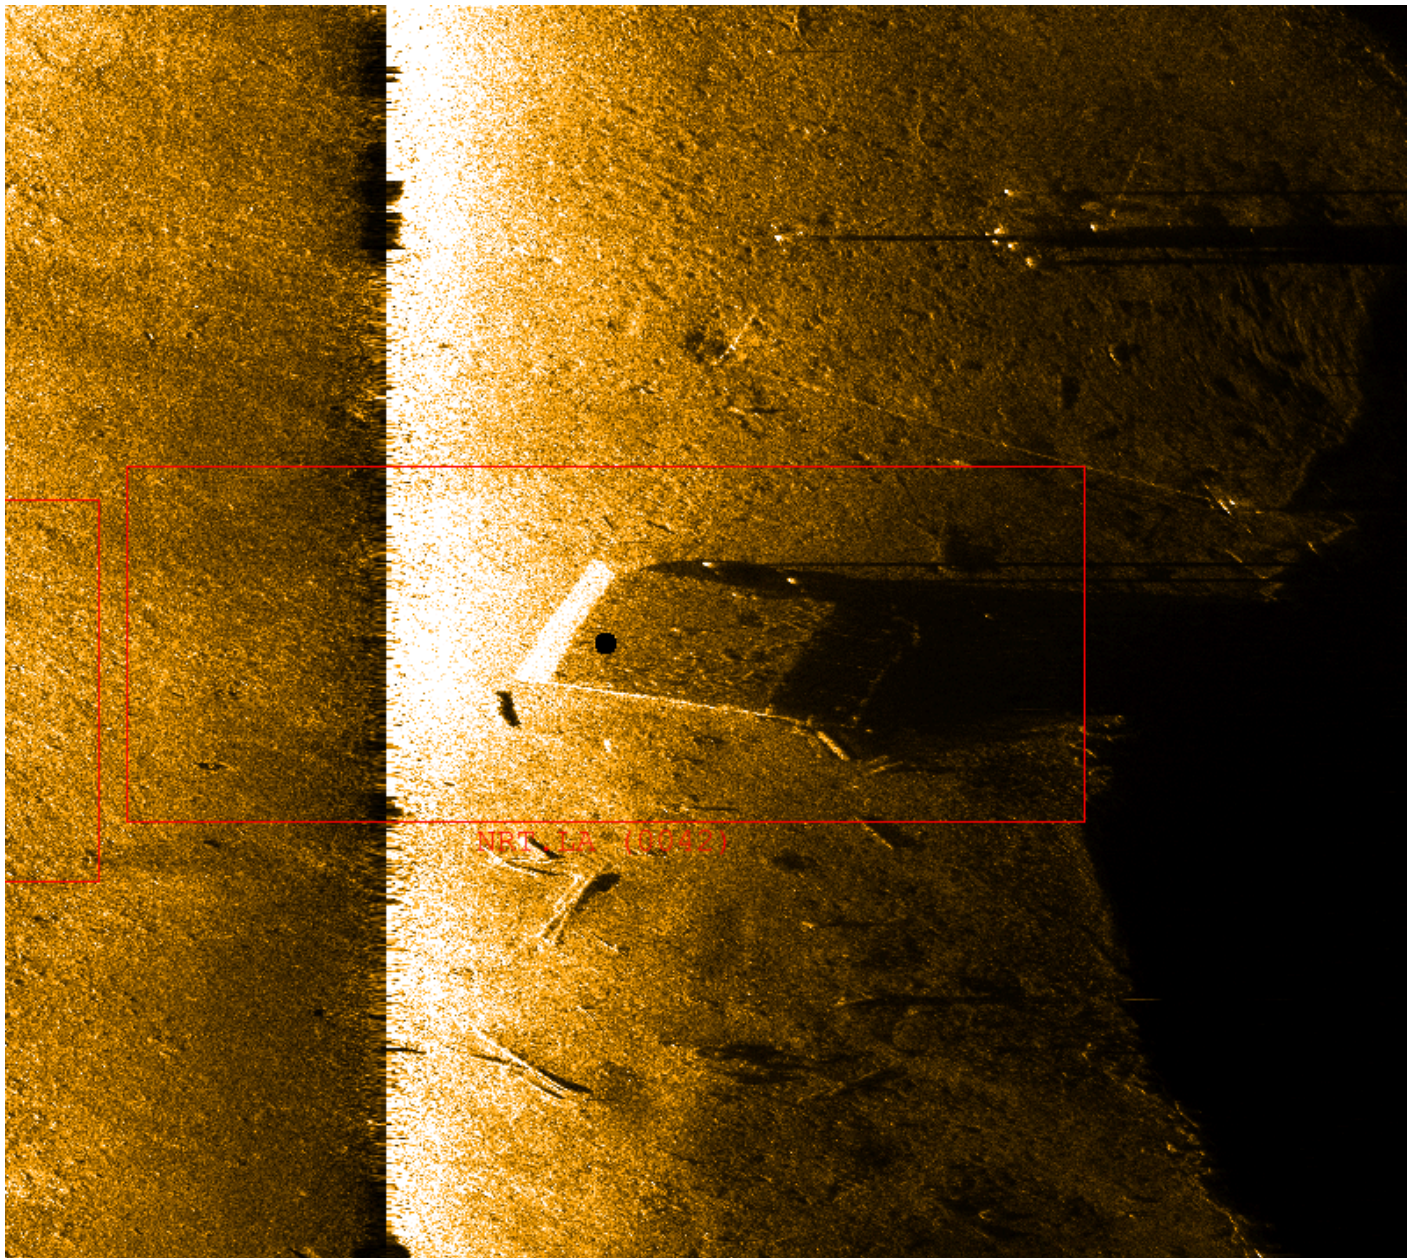
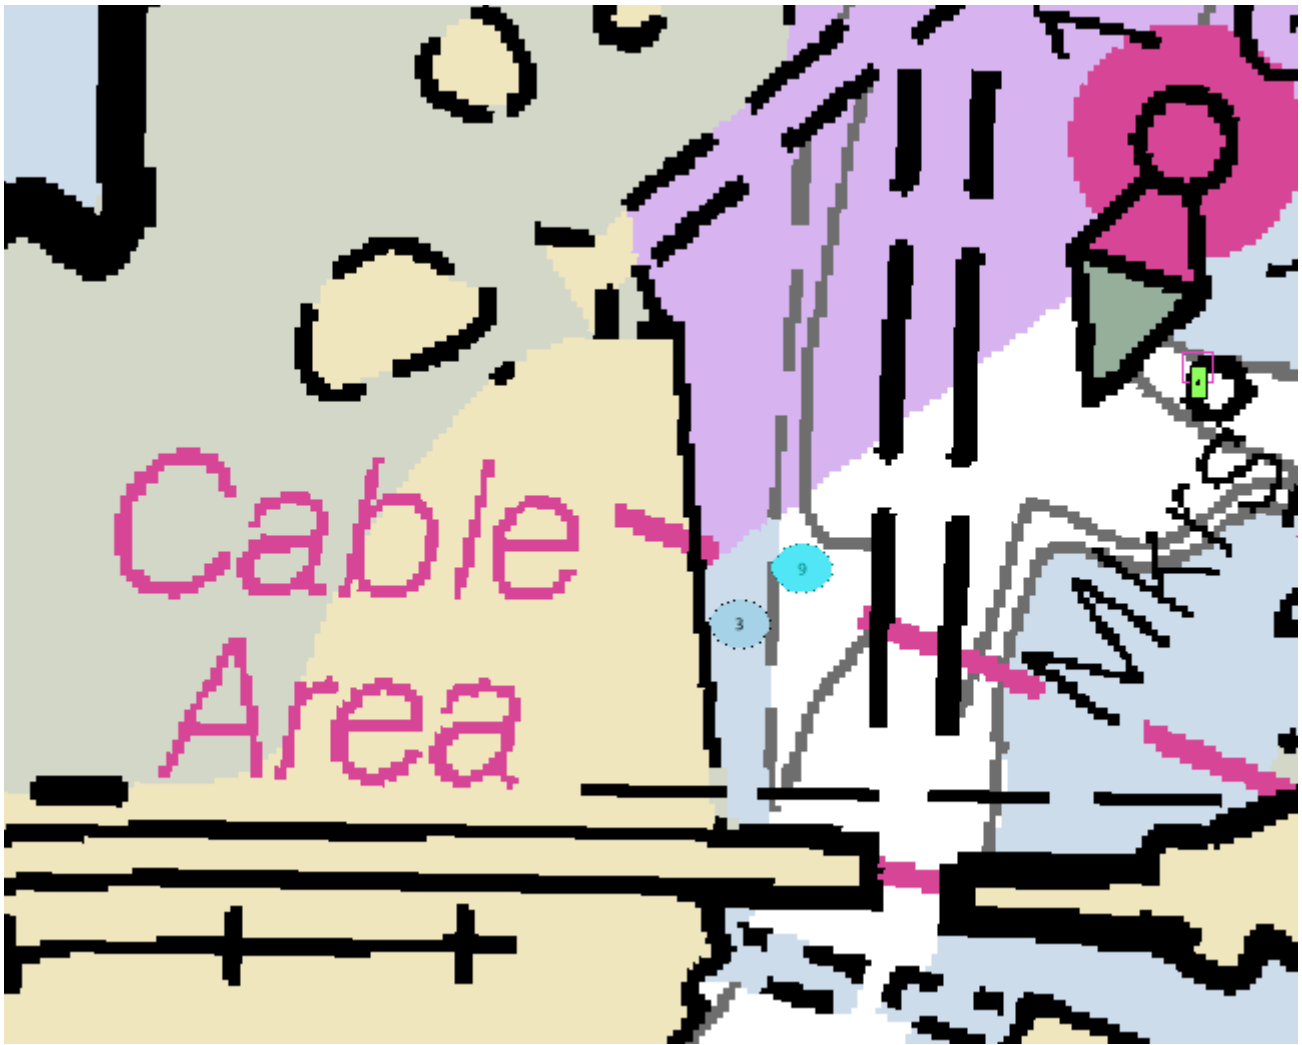
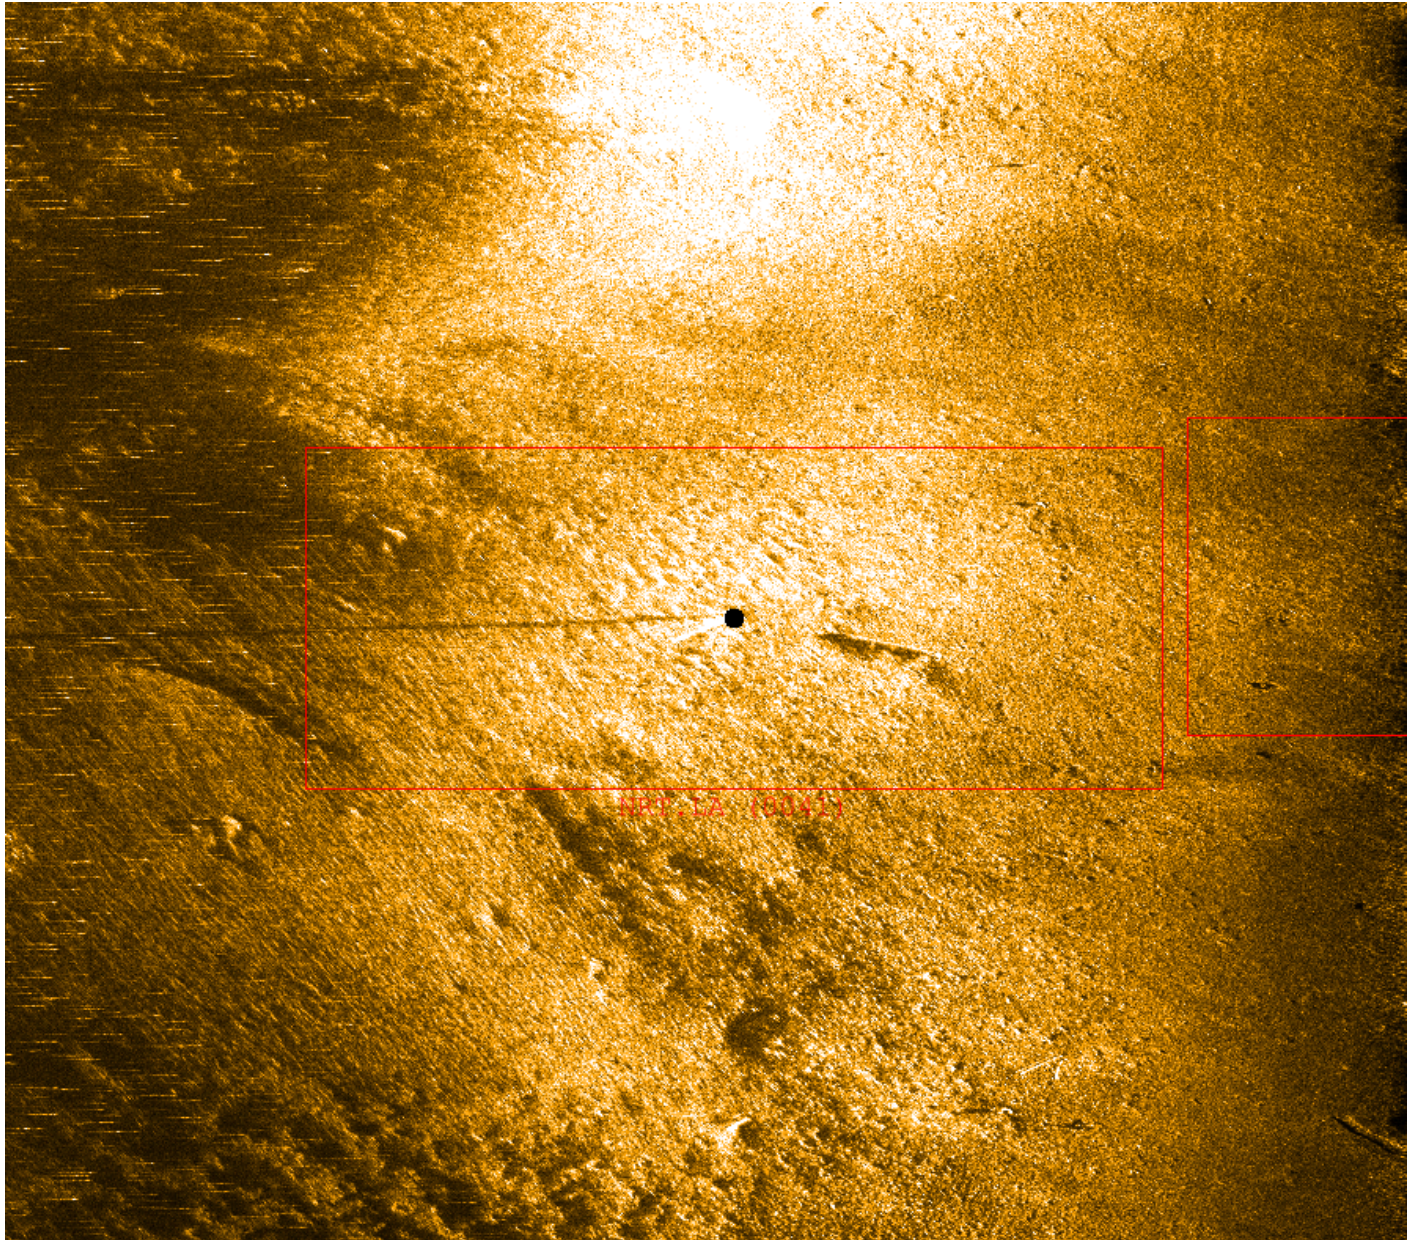
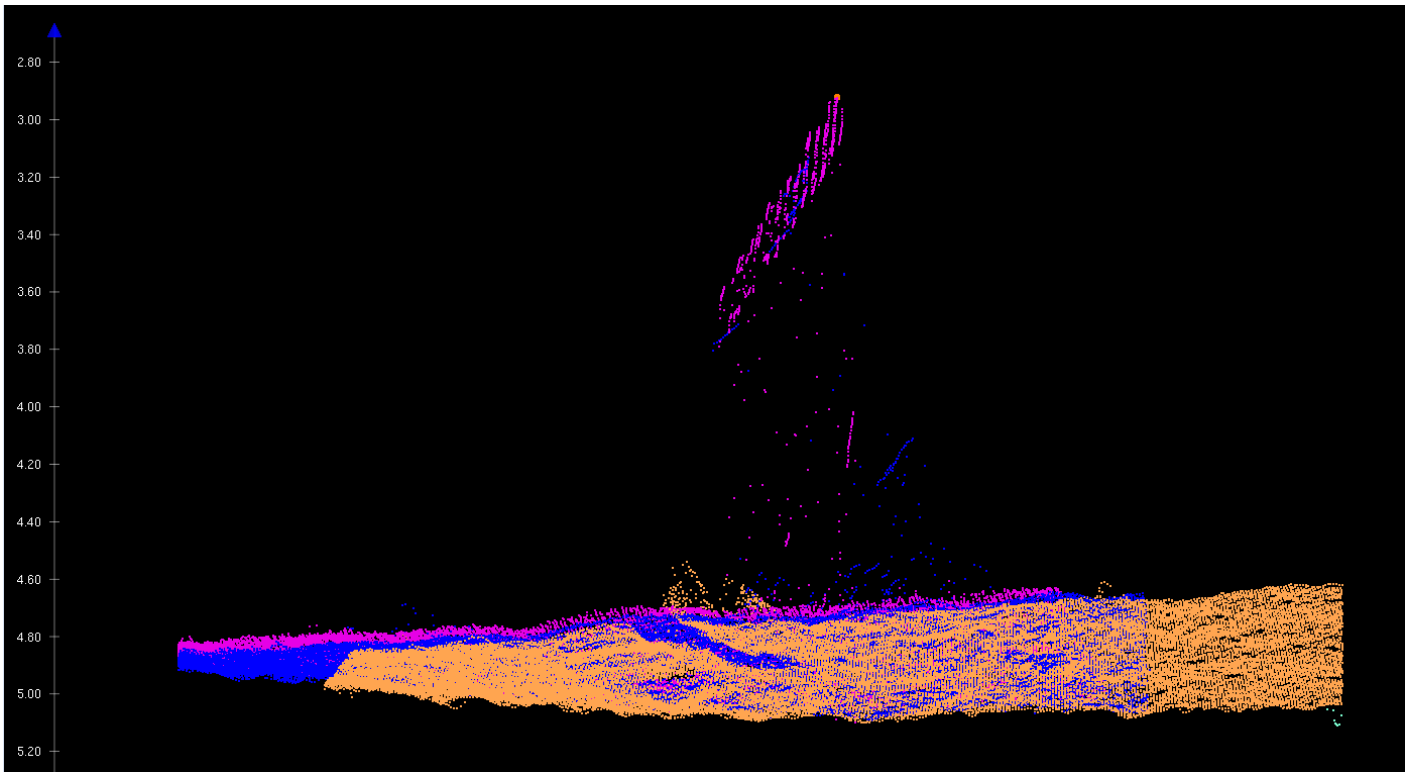
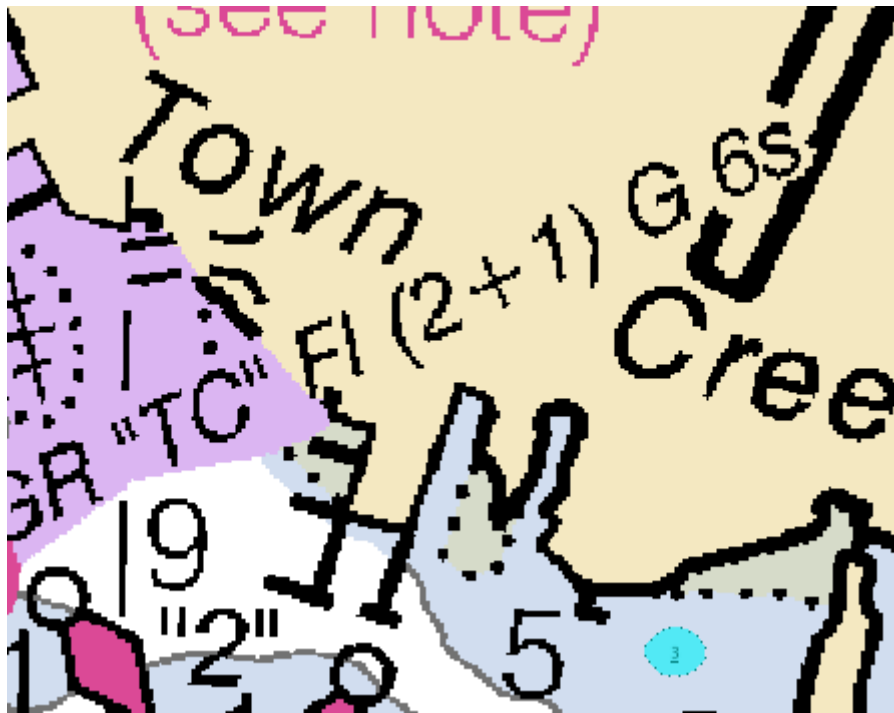
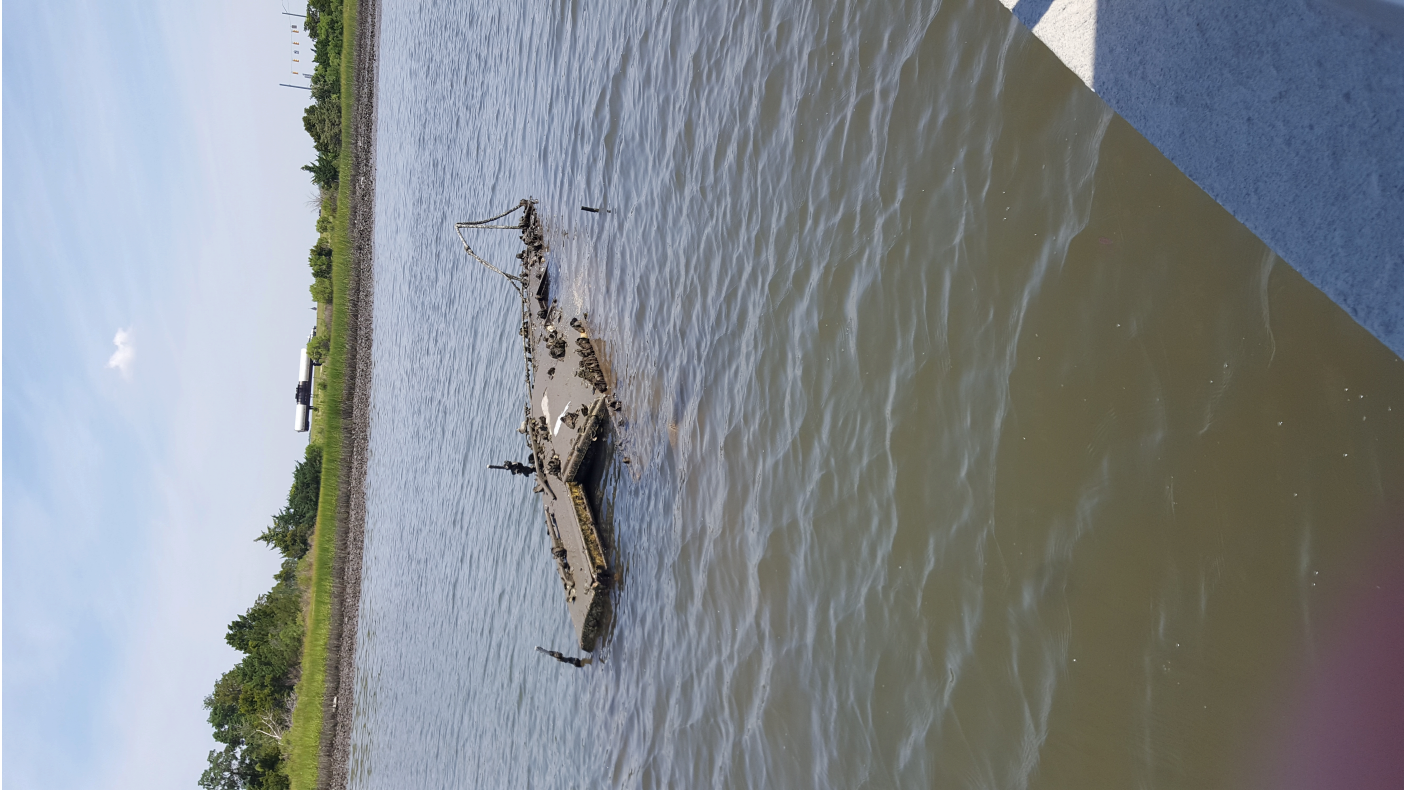
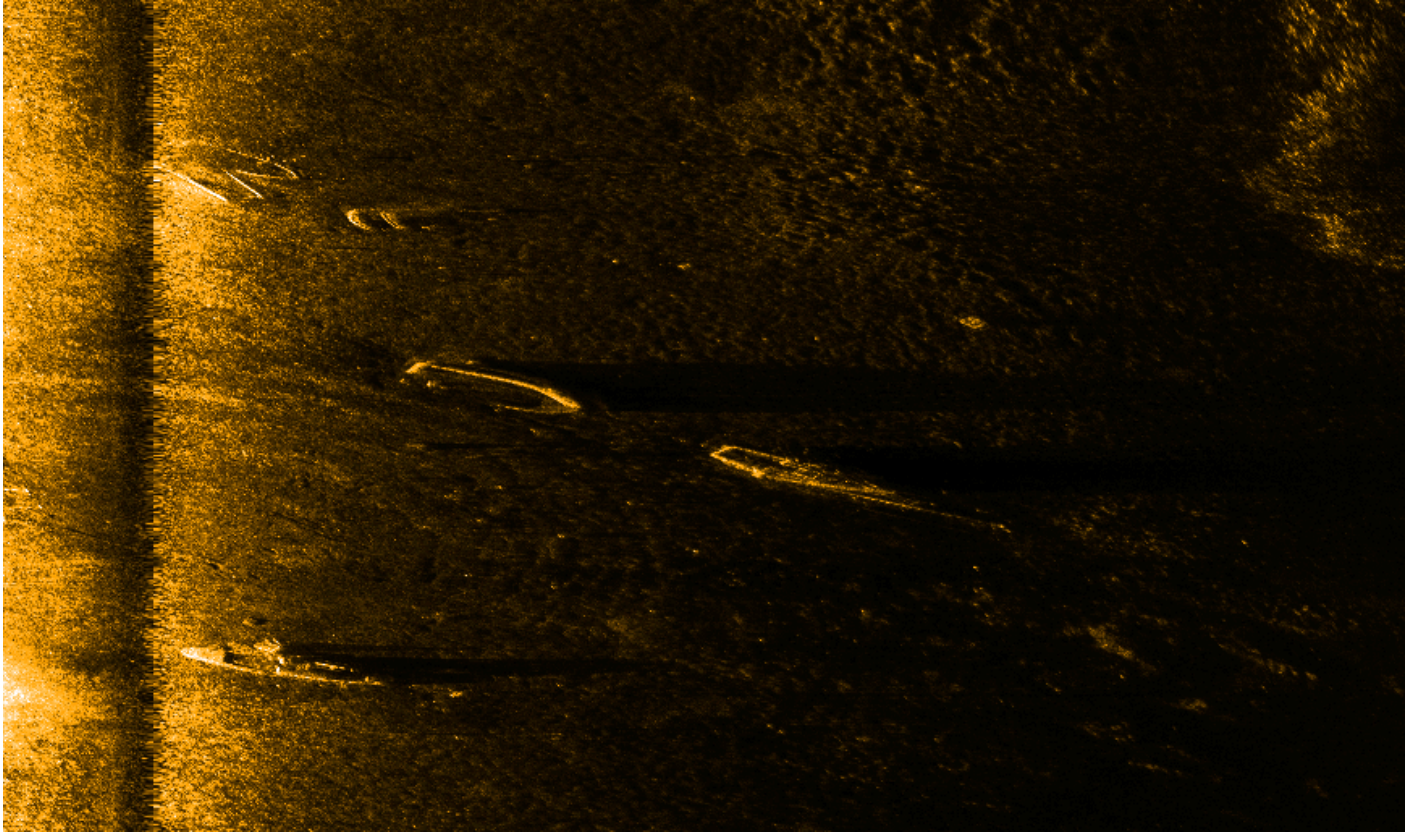
1. A large obstruction was found in the SSS imagery at position 34.723466N / 076.669970W. Due to the shallow surrounding area and potential height of the object a least depth was not determined. Using the closest bathymetry to the object and the shadow height measured in Caris Side Scan Editor an estimated depth of 3 feet was determined. This item is not considered a danger to navigation because of the proximity to shore and distance from charted channel. 2. A 9 foot obstruction was found in the SSS imagery at position 34.723677W / 076.669688W. Least depth was confirmed by 2 passes of MBES bathymetry. This obstruction is not considered a danger to navigation because no vessel with 9 foot draft could transit into the area. Recommend charting new 9 foot obstruction. 3. A new awash wreck was discovered with Side Scan imagery and visual contact at position 34.724886 / 076.662287W. This wreck is not considered a danger to navigation because it is located in a dead end portion of a shallow harbor. Recommend to chart new wreck and possibly chart large foul area because of numerous wrecks and debris in the area.

*Figure 19: 1. Large obstruction estimated 3 feet.*

Figure 20: 1. Large obstruction Side Scan image.

Figure 21: 2.9 foot obstruction.

*Figure 22: 2.9 foot obstruction Side Scan image.*

Figure 23: 2.9 foot obstruction Multibeam image.

Figure 24: 3. New awash wreck location.

*Figure 25: 3. New awash wreck image.*

*Figure 26: 3. New awash wreck Side Scan image.*
