**DESCRIPTIVE REPORT**

Type of Survey: Navigable Area

Registry Number: F00731

General Locality: Beaufort, NC

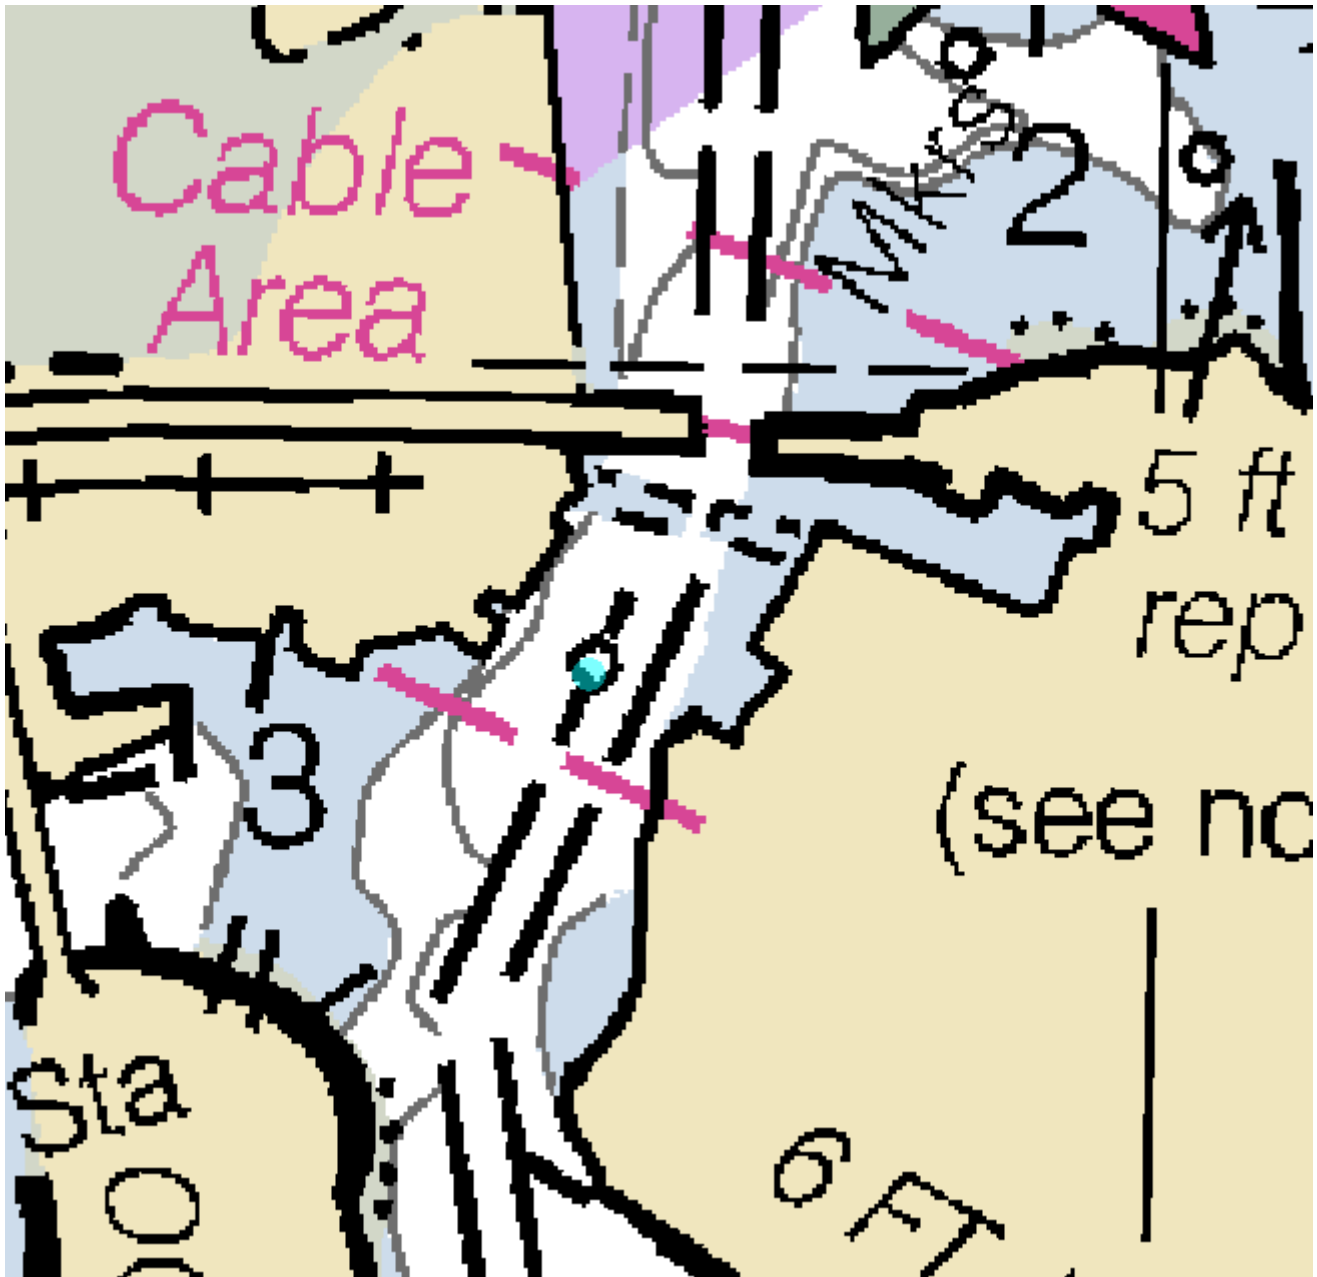
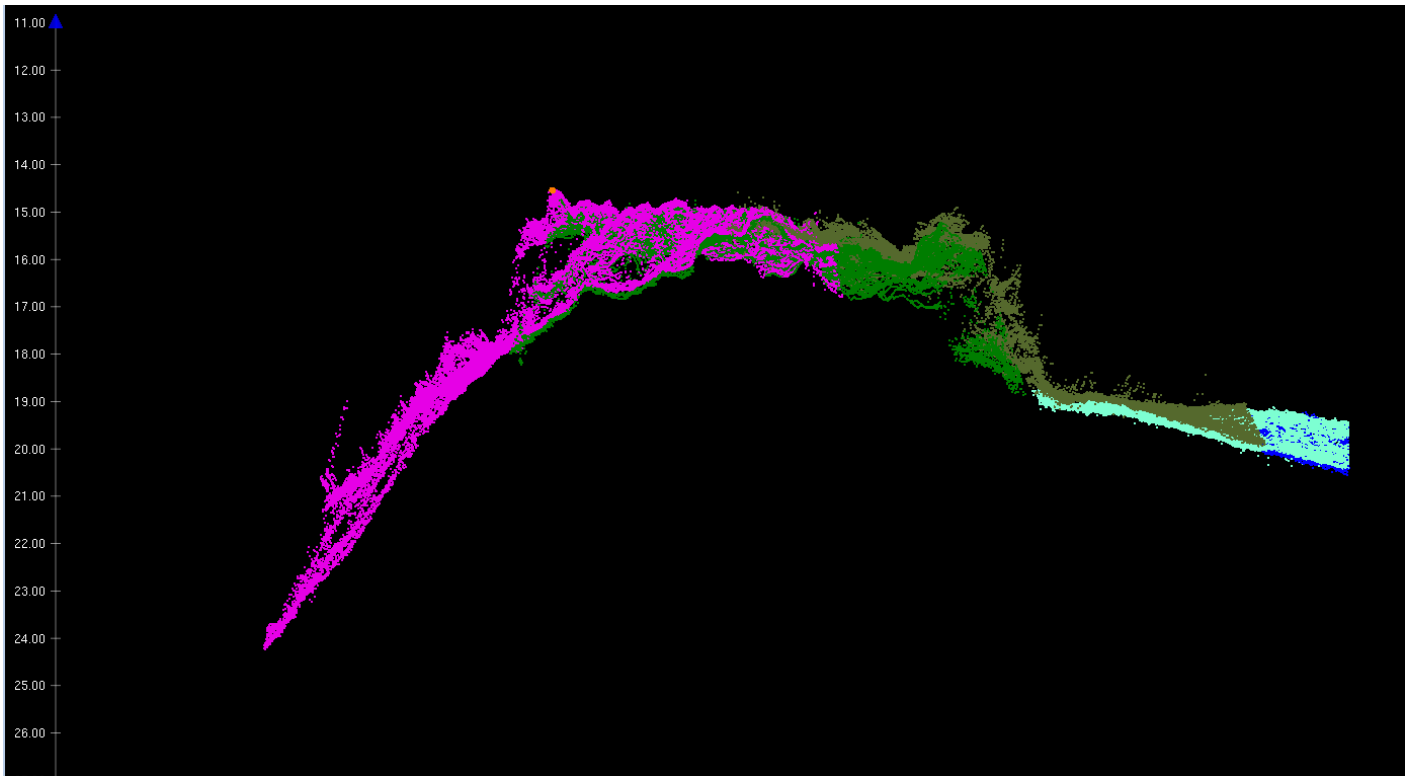
One obstruction on ENC US5NC17M at position 34.721332N / 076.669965W had no least depth reported. A least depth of 14.4 feet was confirmed by MBES. This obstruction is included in the Final Feature File as an update to chart the least depth. One DTON was submitted during F00731. The DTON report and submission email are included in the appendices of this report.

Figure 27: Obstruction recommended for update.

*Figure 28: Obstruction least depth MBES image.*

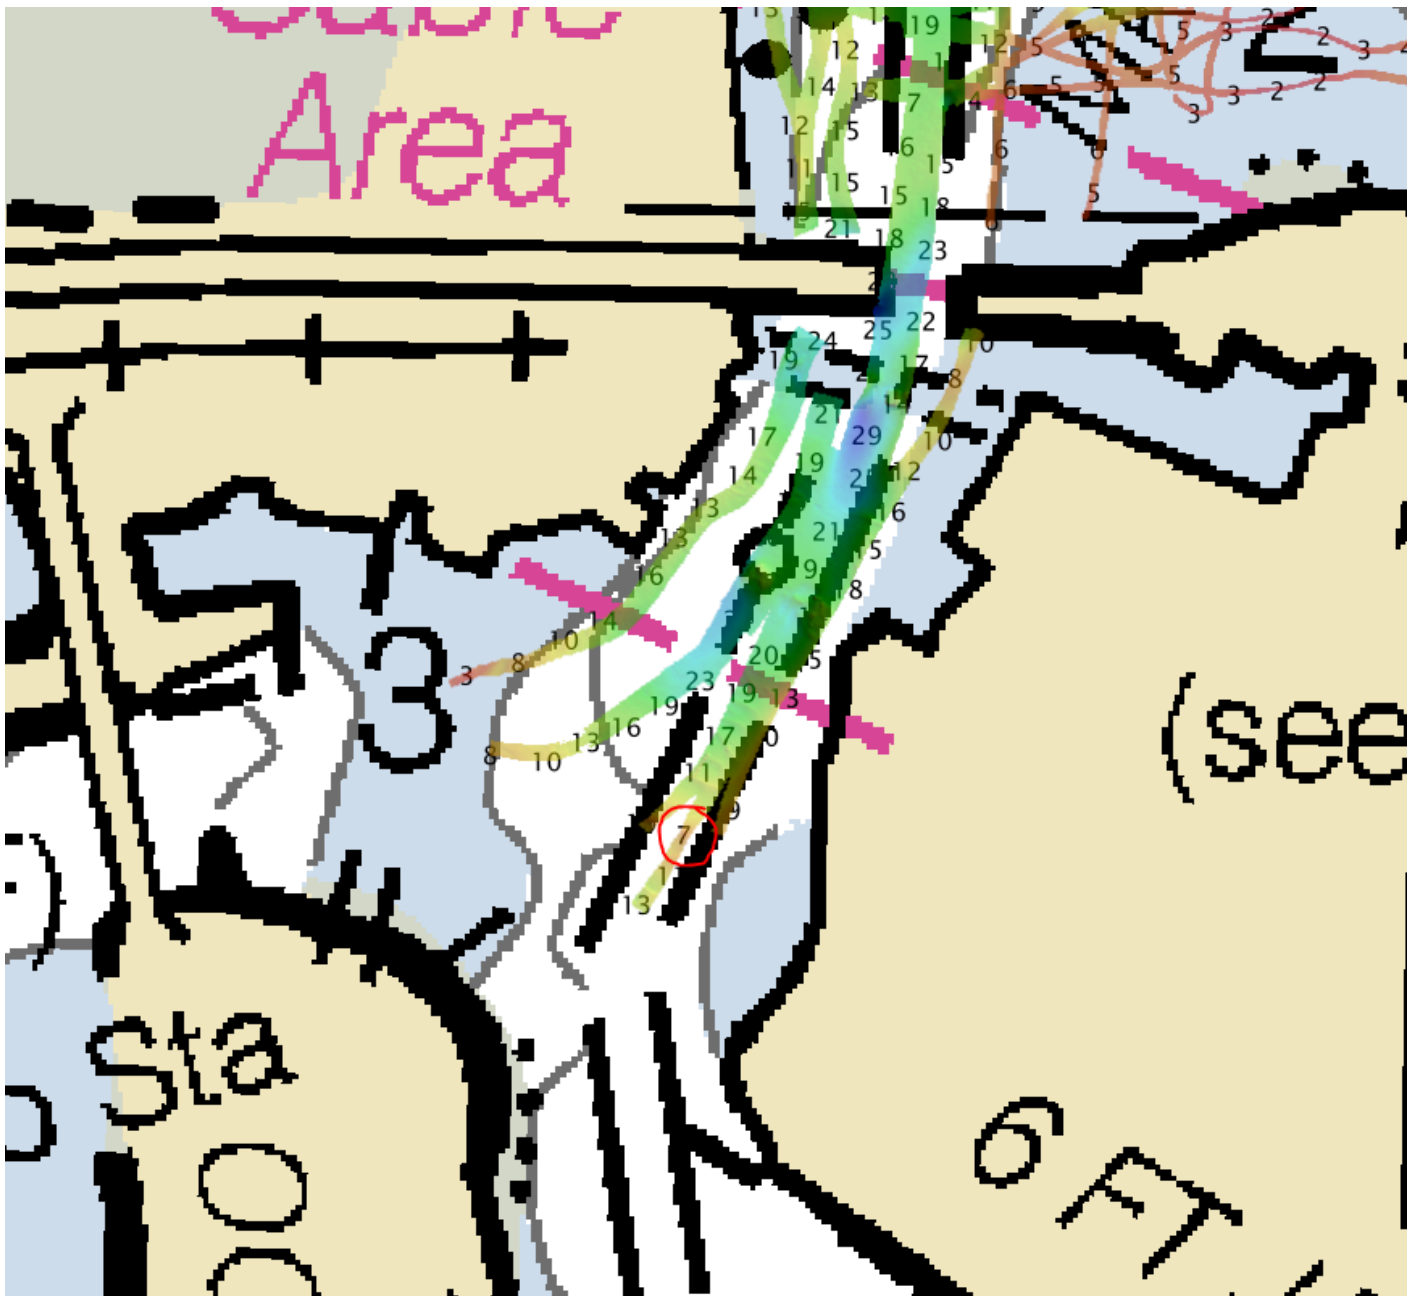
Figure 29: 7 foot sounding in Bulkhead Channel Range 6.

Bulkhead Channel Range 6 from ENC US5NC17M was partially included in F00731. Soundings in the charted channel were all deeper than the reported 7.5 feet with the exception of one sounding that measured 7.3 feet. North of the defunct bascule bridge survey soundings are not shoaler than the reported 15 feet in the channel.

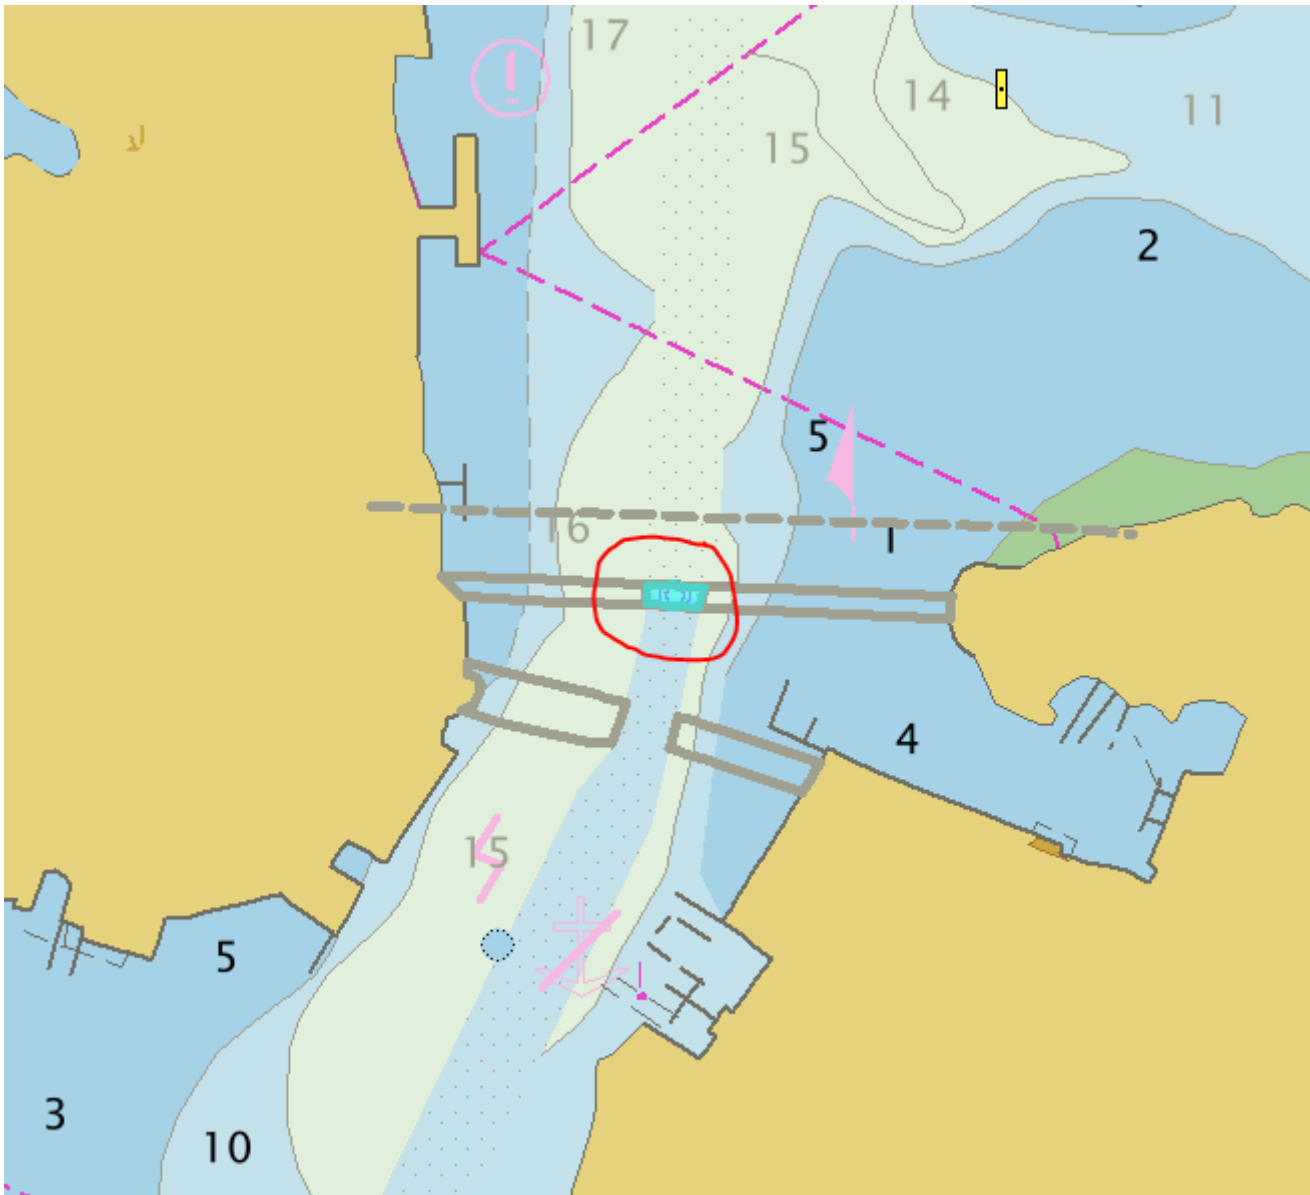
1. The bascule bridge on ENC US5NC17M is no longer operational due to the opening of the new fixed bridge to the north. Recommend removing the bascule bridge. The new Highrise Bridge has a reported vertical clearance of 65 feet at MHW and a horizontal clearance of 72 feet at the channel span. An email from North Carolina Department of Transportation is included in Project Correspondence.

Figure 30: 1. Bascule Bridge recommended for removal.

The high-rise has a vertical clearance at mean high water of 65-feet and a horizontal clearance of 72-feet. The bascule bridge is no longer in service.

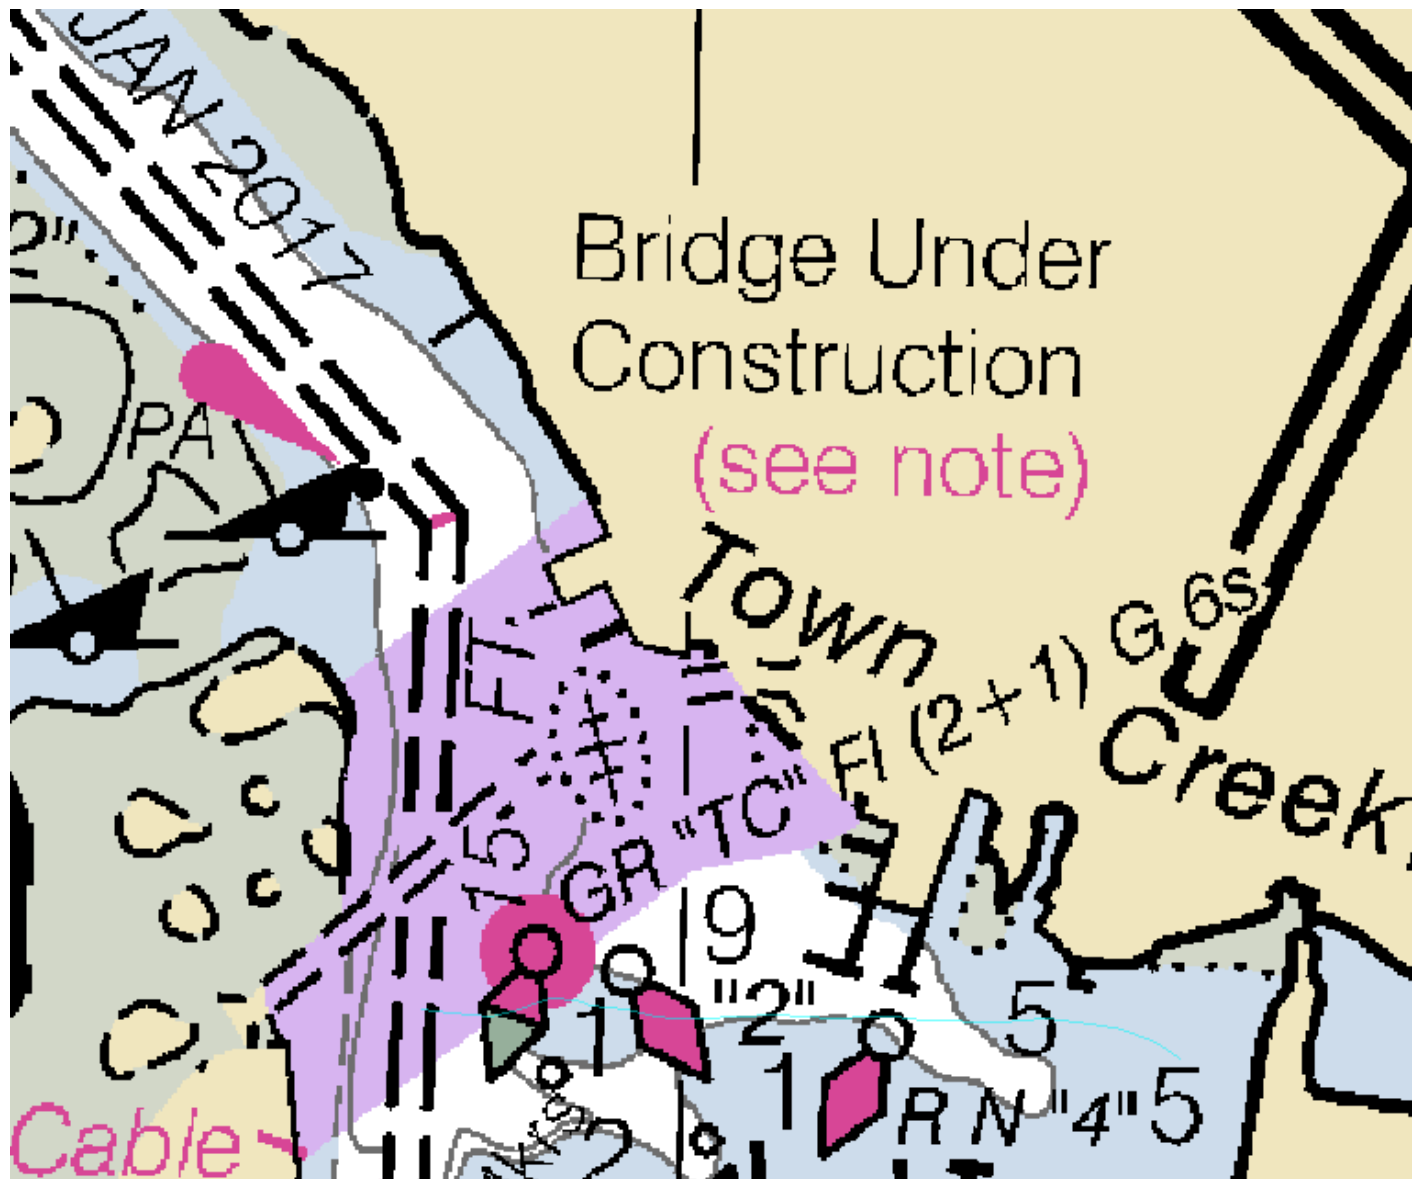
Figure 31: Bridge under construction note.

Chart 11545 still displays the Beaufort Highrise bridge in the survey area as under construction. Construction has been completed on the bridge and this note should be removed from the chart.
