**DESCRIPTIVE REPORT**

Type of Survey: Navigable Area

Registry Number: F00763

Project Number: **S-P958-KR-18**

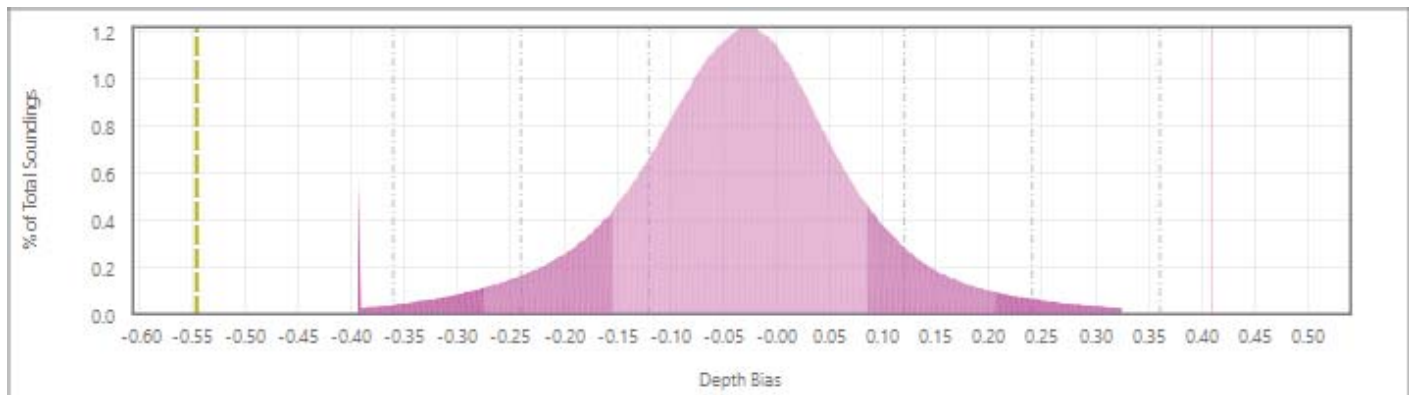
Below are histograms of the crossline comparison statistics showing IHO Order 1a compliance per beam.

*Figure 6: F00763 Crossline Comparison - Area A (1m)*

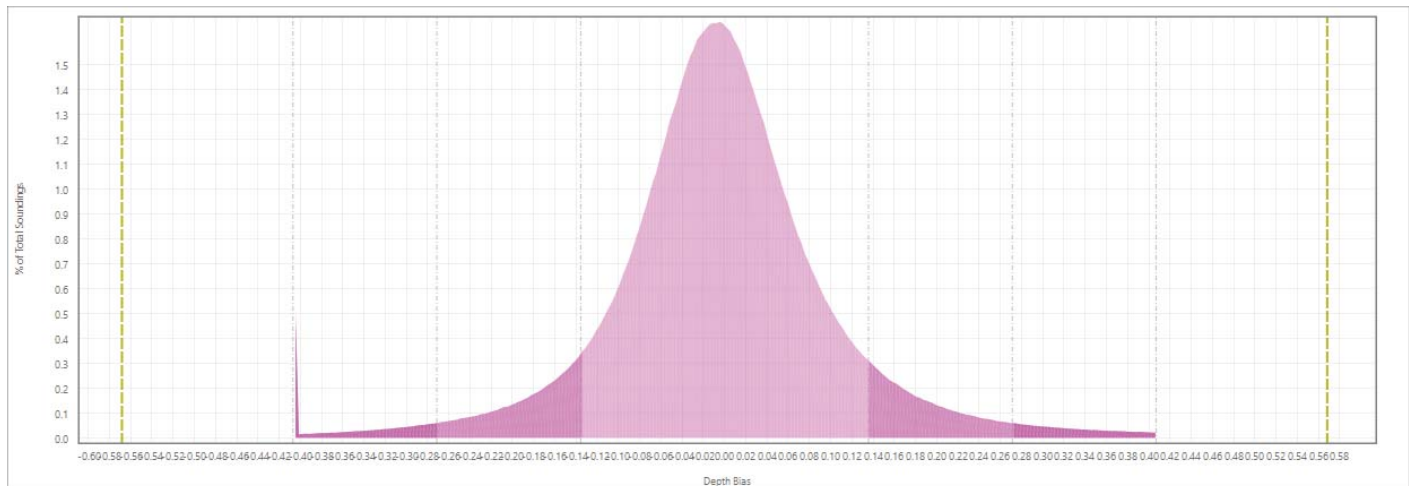
*Figure 7: F00763 Crossline Comparison - Area B (1m)*

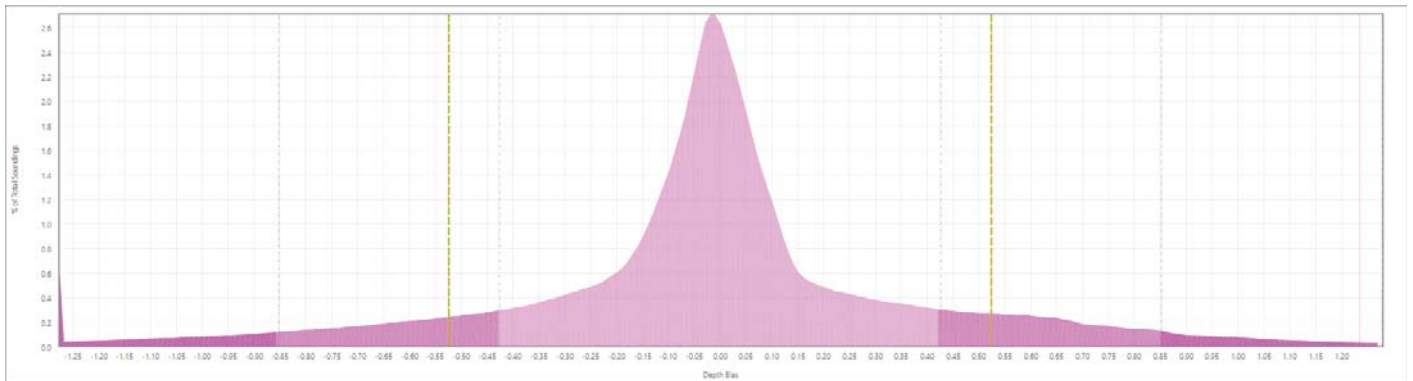
Figure 8: F00763 Crossline Comparison - Area C (1m)

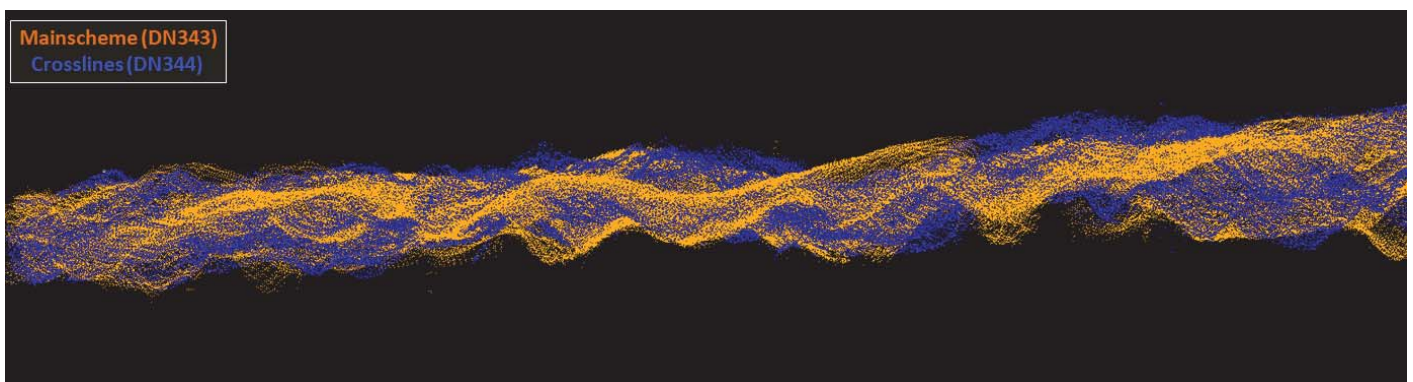
Figure 9: Small Sandwave Movement between Mainscheme and Crosslines

A beam-to-beam statistical analysis was performed using the Cross Check tool in Qimera. A 1 meter Combined Uncertainty and Bathymetric Estimator (CUBE) weighted dynamic surface was created incorporating only the mainscheme lines and excluded crosslines. The Cross Check tool was used to perform the beam-by-beam comparison of the crossline data to the mainscheme surface. Comparisons showed excellent agreement, well above 95% of the allowable TVU for areas A and B. For area C, the comparison between crosslines and mainscheme lines yielded a 85.2% for the beam-to-beam statistical analysis. The reason the percentage is lower is do to migrating sandwaves in the region. Mainschene lines were collected on DN342 and DN343 and crosslines were collected on DN344. Areas with large and small sandwaves show movement between days. Areas with no sandwaves show excellent agreement between days. Following images of the histograms for the beam-to-beam analysis of each area, there are images of the small migrating sandwaves, large migrating andwaves, and an area with no sandwaves to show the comparison between days in area C. Lastly there is an image with all three types of seafloor within one cross section. Crossline 2018RE3440651 is the crossline imaged in all four images.

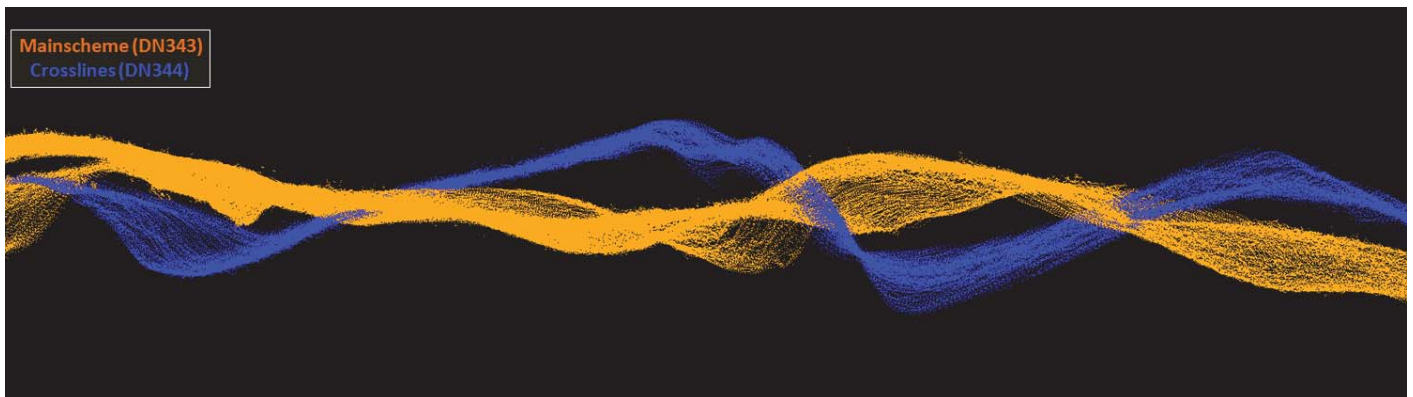
Figure 10: Large Sandwave Movement between Mainscheme and Crosslines

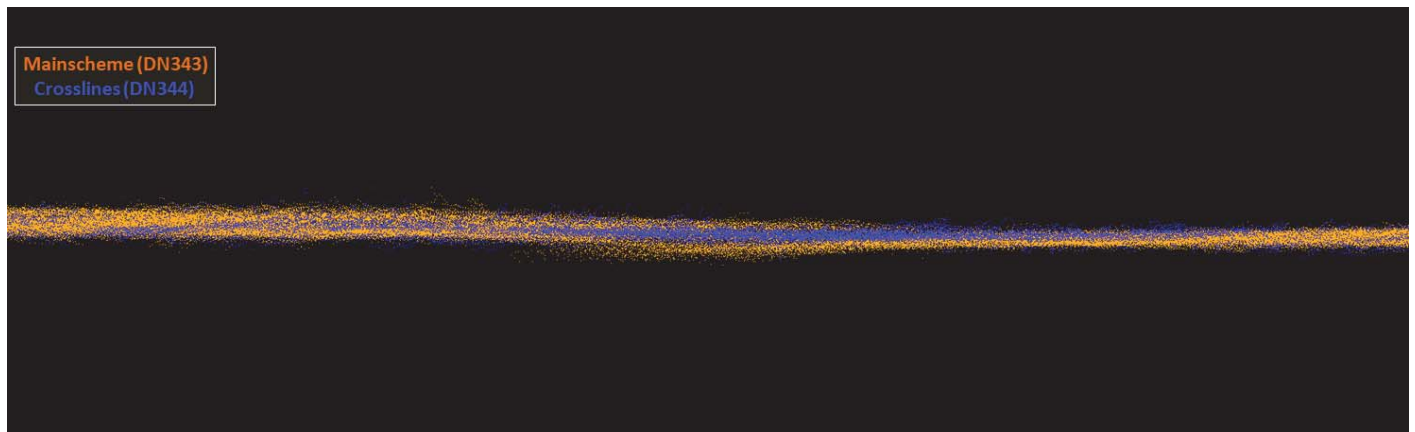
Figure 11: Areas with No Sandwave show Excellent Agreement between Mainscheme and Crosslines

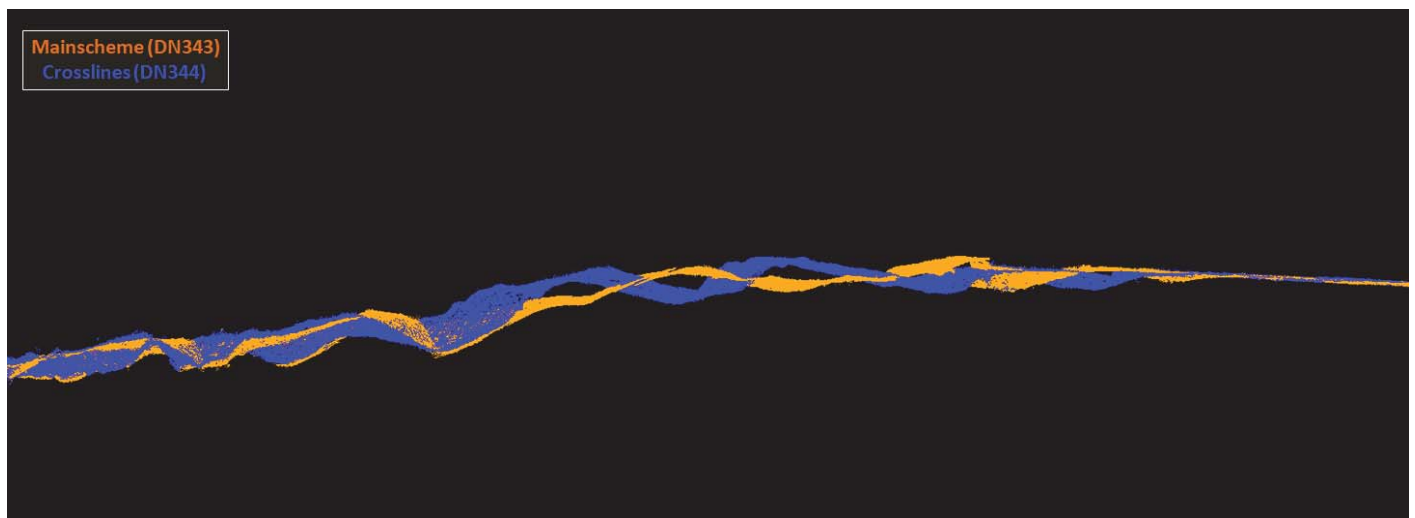
Figure 12: Cross section of sandwaves and no sandwaves between Mainscheme and Crosslines

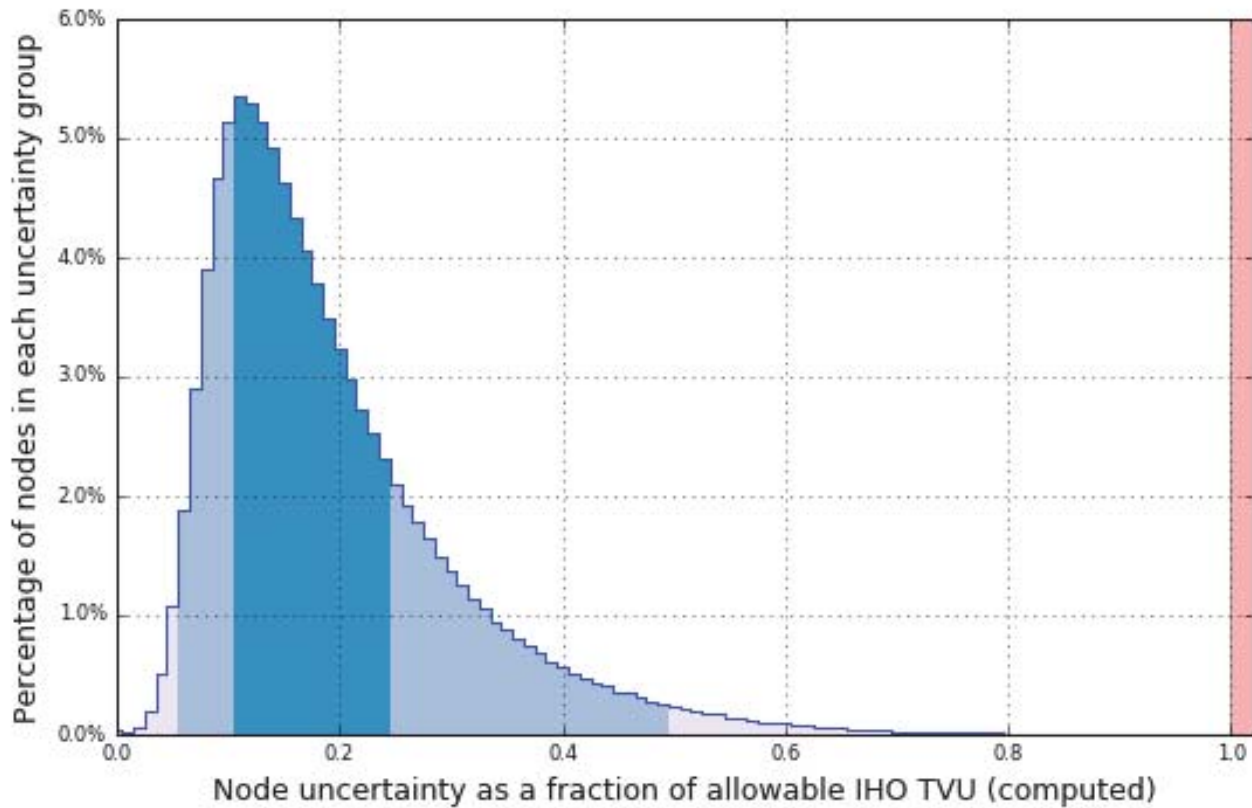
99.5+% pass (1,862,334 of 1,863,386 nodes), min=0.00, mode=0.11, max=2.87

Percentiles: 2.5%=0.06, Q1=0.11, median=0.16, Q3=0.24, 97.5%=0.49

Figure 13: Area A of F00763 Finalized 1m Complete Coverage MBES TPU Statistics (NOAA QC Tools)

Complete Coverage MBES (Finalized 1m CUBE weighted Dynamic Surface in NOAA QC Tools) = 99.5+% of nodes are within the allowable TPU.

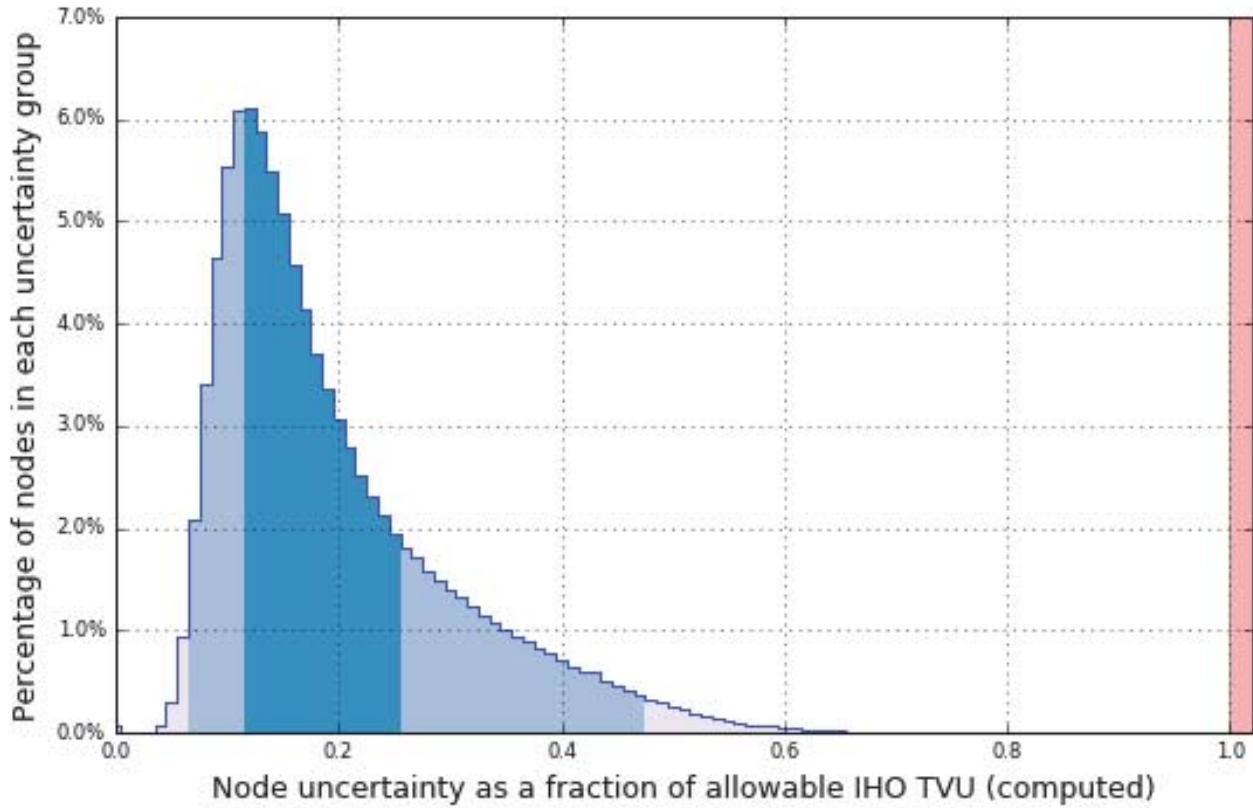
99.5+% pass (285,775 of 285,785 nodes), min=0.00, mode=0.12, max=1.61

Percentiles: 2.5%=0.07, Q1=0.12, median=0.16, Q3=0.25, 97.5%=0.47

Figure 14: Area A of F00763 Finalized 2m Complete Coverage MBES TPU Statistics (NOAA QC Tools)

Complete Coverage MBES (Finalized 2m CUBE weighted Dynamic Surface in NOAA QC Tools) = 99.5+% of nodes are within the allowable TPU.

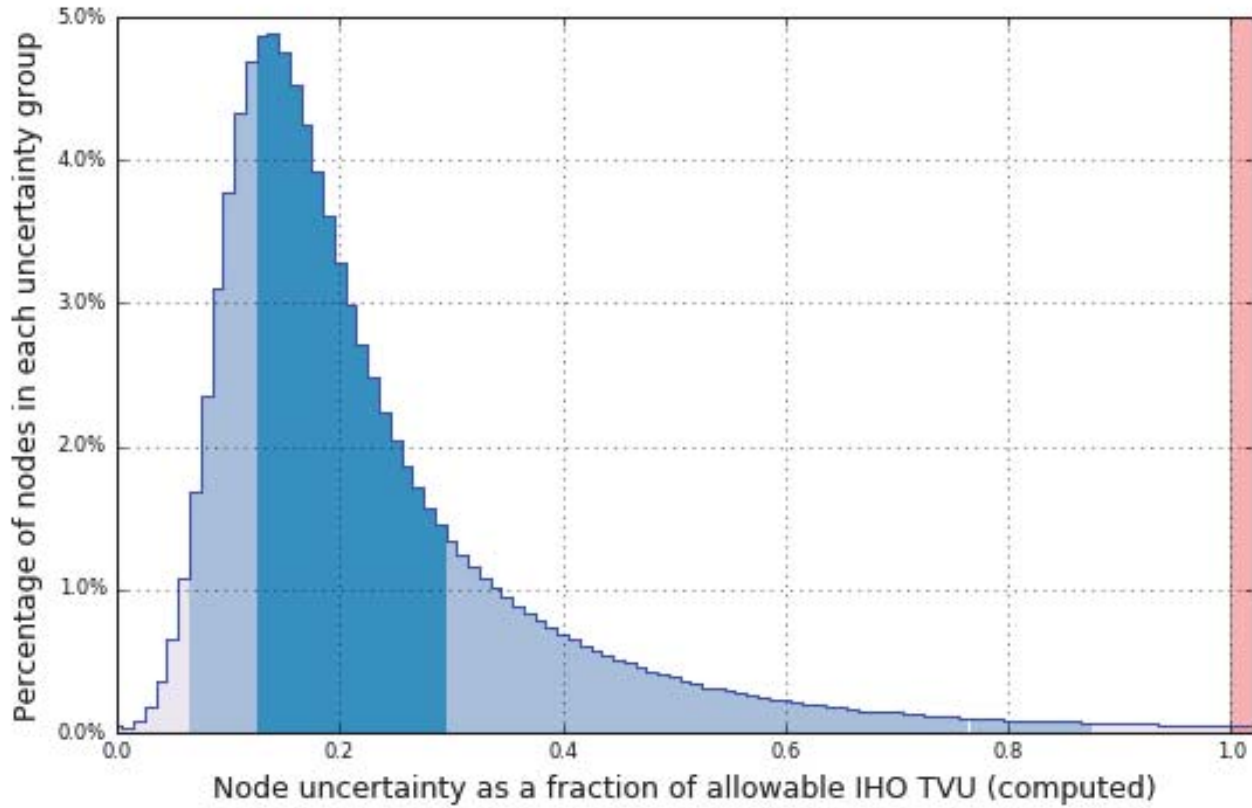
98% pass (4,330,630 of 4,407,491 nodes), min=0.00, mode=0.14, max=8.32

Percentiles: 2.5%=0.07, Q1=0.13, median=0.19, Q3=0.29, 97.5%=0.87

Figure 15: Area B of F00763 Finalized 50cm Object Detection MBES TPU Statistics (NOAA QC Tools)

Object Detection Coverage (Finalized 50cm CUBE weighted Dynamic Surface in NOAA QC Tools) = 98% of nodes are within the allowable TPU.

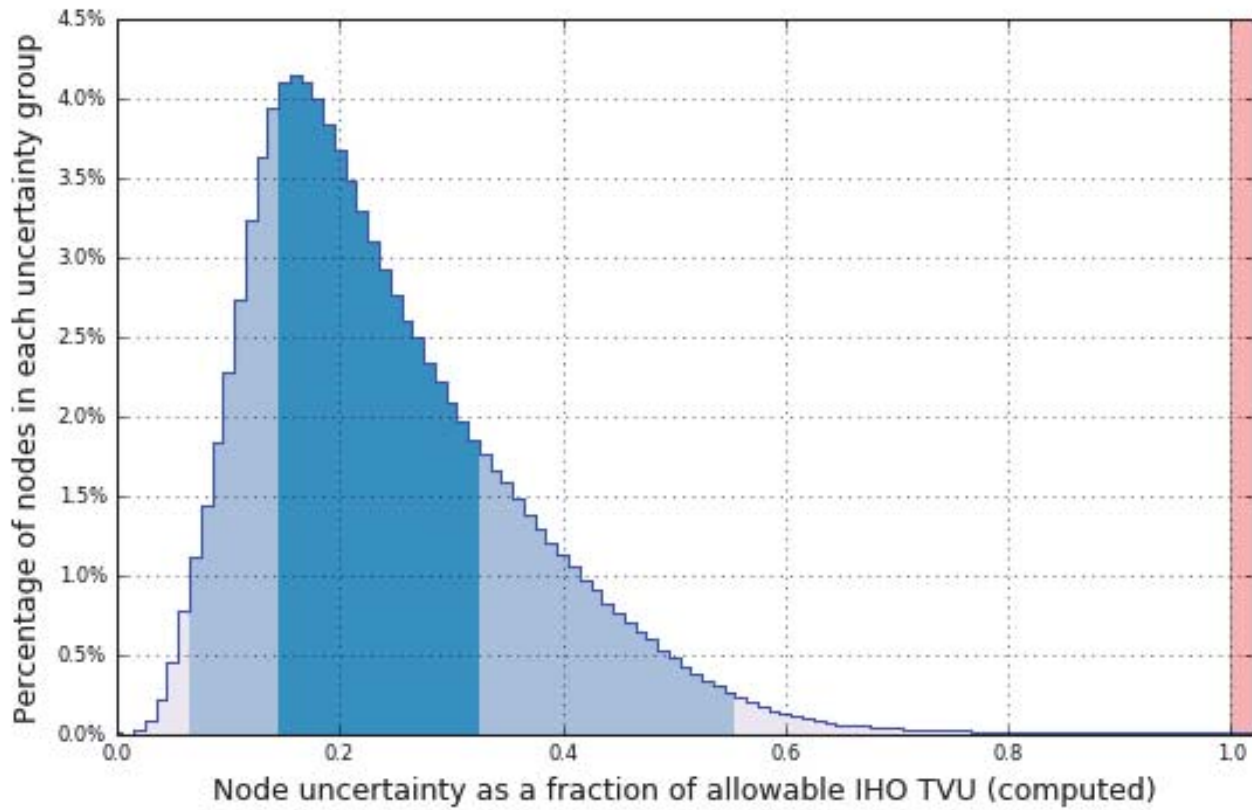
99.5+% pass (2,225,693 of 2,233,603 nodes), min=0.00, mode=0.16, max=5.38

Percentiles: 2.5%=0.07, Q1=0.15, median=0.22, Q3=0.32, 97.5%=0.55

Figure 16: Area B of F00763 Finalized 1m Object Detection MBES TPU Statistics (NOAA QC Tools)

Object Detection Coverage (Finalized 1m CUBE weighted Dynamic Surface in NOAA QC Tools) = 99.5+% of nodes are within the allowable TPU.

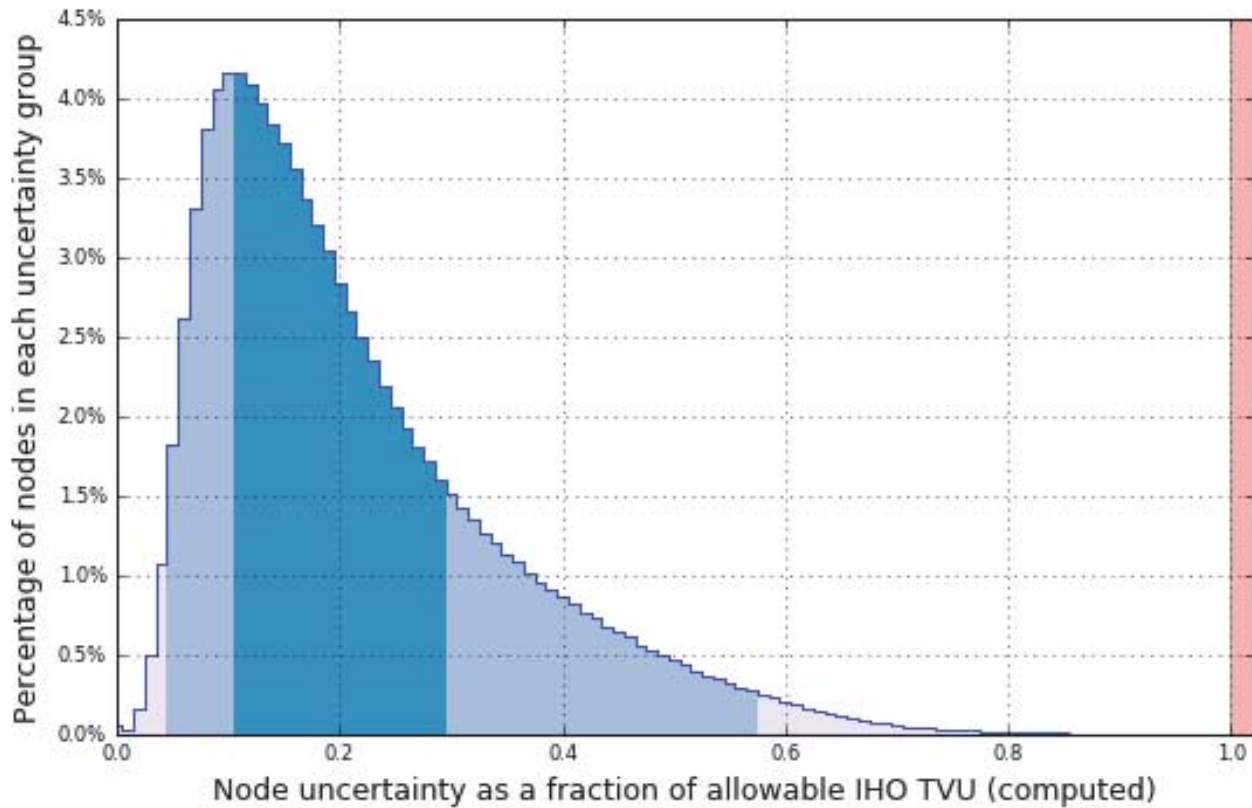
99.5+% pass (3,392,820 of 3,393,400 nodes), min=0.00, mode=0.10, max=2.00

Percentiles: 2.5%=0.05, Q1=0.11, median=0.18, Q3=0.29, 97.5%=0.57

Figure 17: Area C of F00763 Finalized 1m Complete Coverage MBES TPU Statistics (NOAA QC Tools)

Complete Coverage MBES (Finalized 1m CUBE weighted Dynamic Surface in NOAA QC Tools) = 99.5+% of nodes are within the allowable TPU.

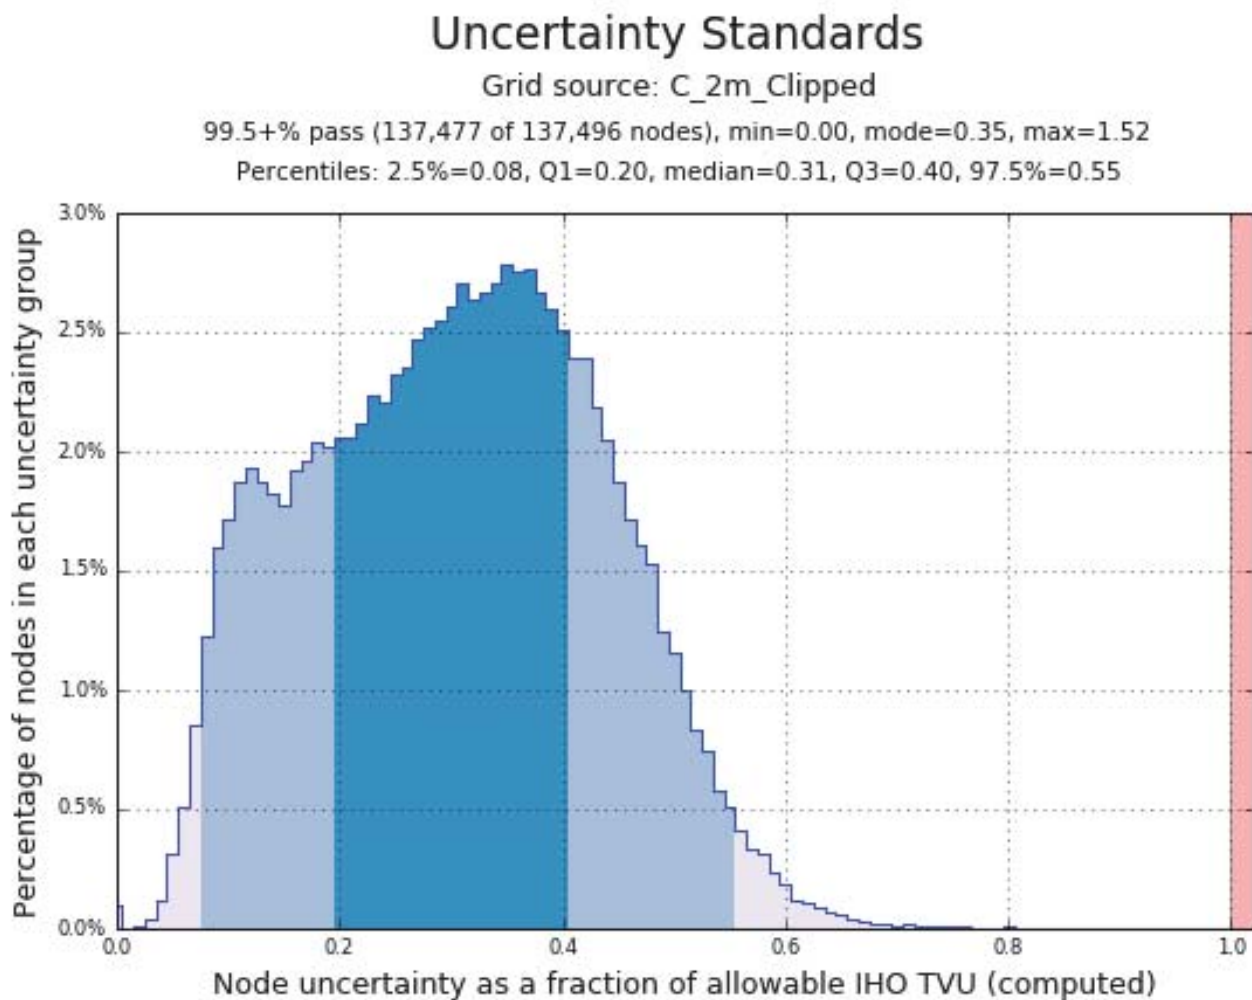
Figure 18: Area C of F00763 Finalized 2m Complete Coverage MBES TPU Statistics (NOAA QC Tools)

Complete Coverage MBES (Finalized 2m CUBE weighted Dynamic Surface in NOAA QC Tools) = 99.5+% of nodes are within the allowable TPU.

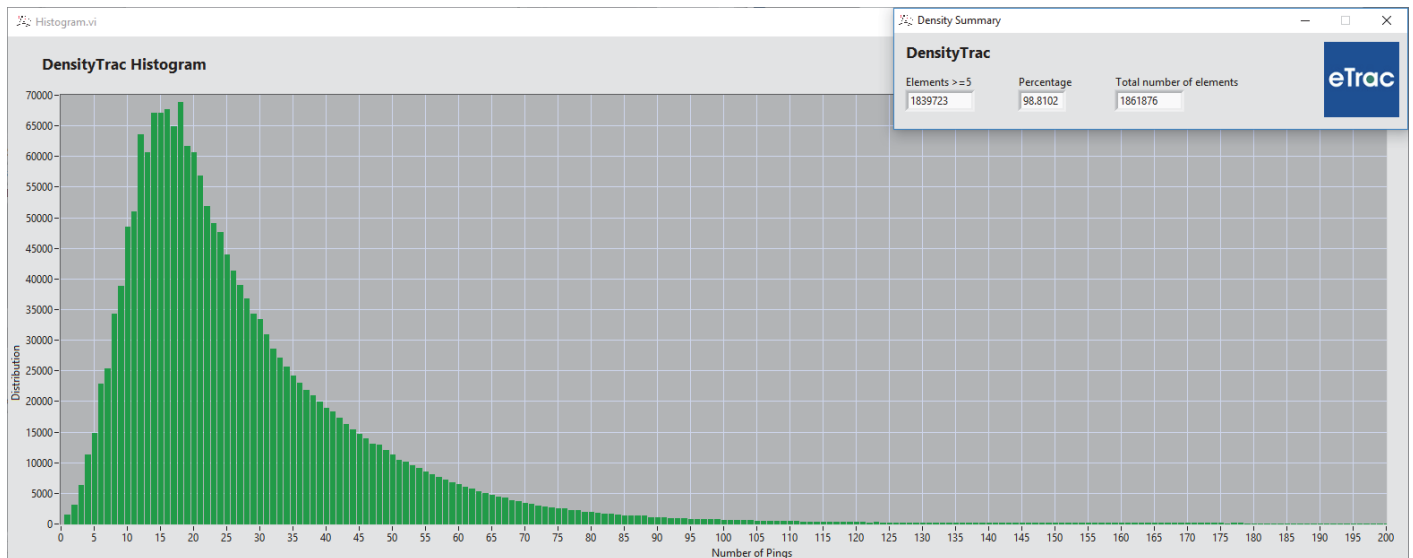
Figure 19: Area A of F00763 - Finalized 1m Complete Coverage MBES Density Distribution

Area A - Complete Coverage MBES (Finalized 1m CUBE weighted Dynamic Surface ) = 98.8102% of nodes are composed from at least 5 soundings.

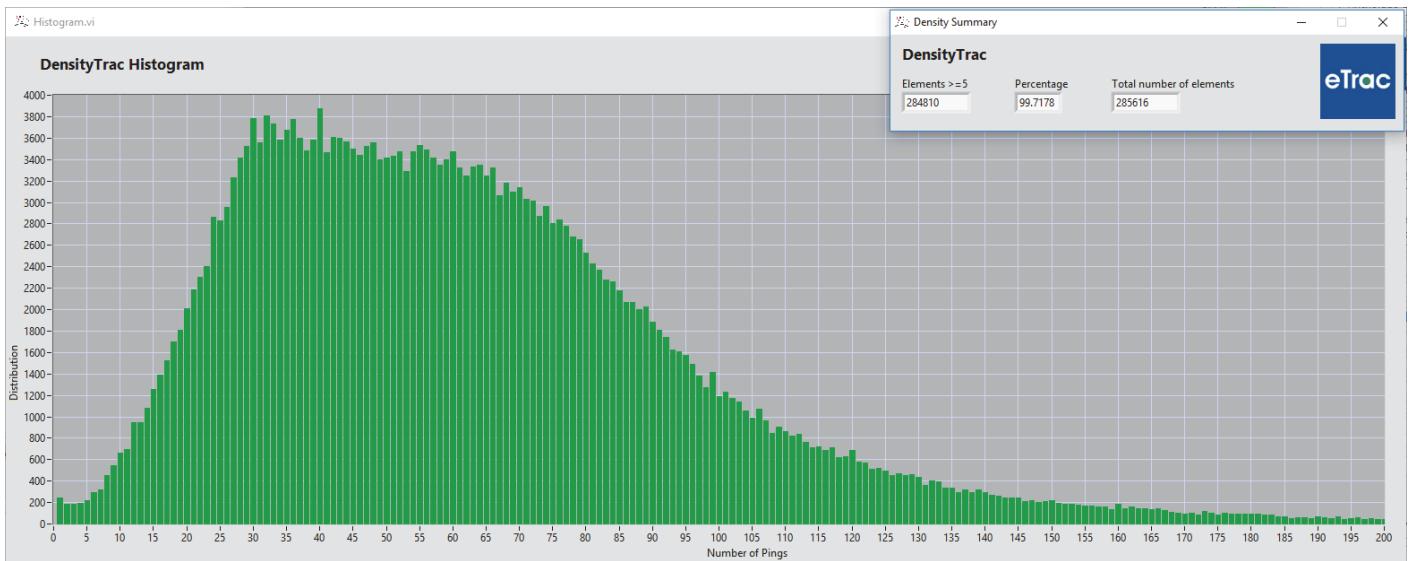
Figure 20: Area A of F00763 - Finalized 2m Complete Coverage MBES Density Distribution

Area A - Complete Coverage MBES (Finalized 2m CUBE weighted Dynamic Surface ) = 99.7178% of nodes are composed from at least 5 soundings.

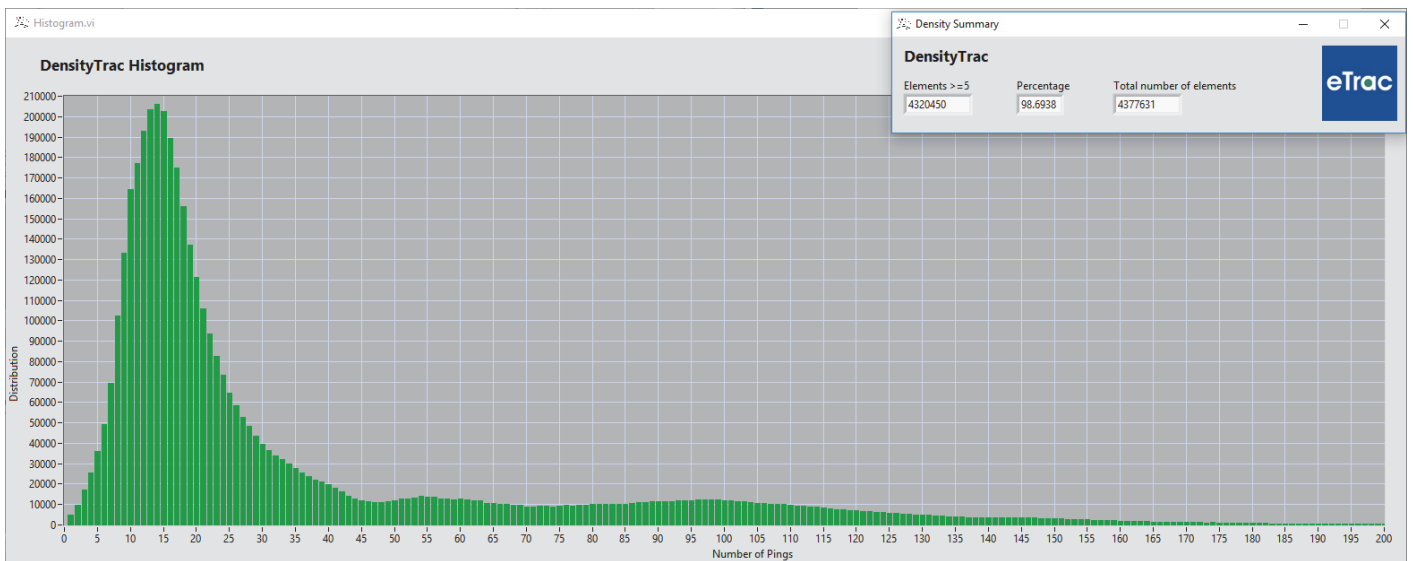
Figure 21: Area B of F00763 - Finalized 50cm Object Detection MBES Density Distribution

Area B - Object Detection Coverage MBES (Finalized 50cm CUBE weighted Dynamic Surface ) = 98.6938% of nodes are composed from at least 5 soundings.

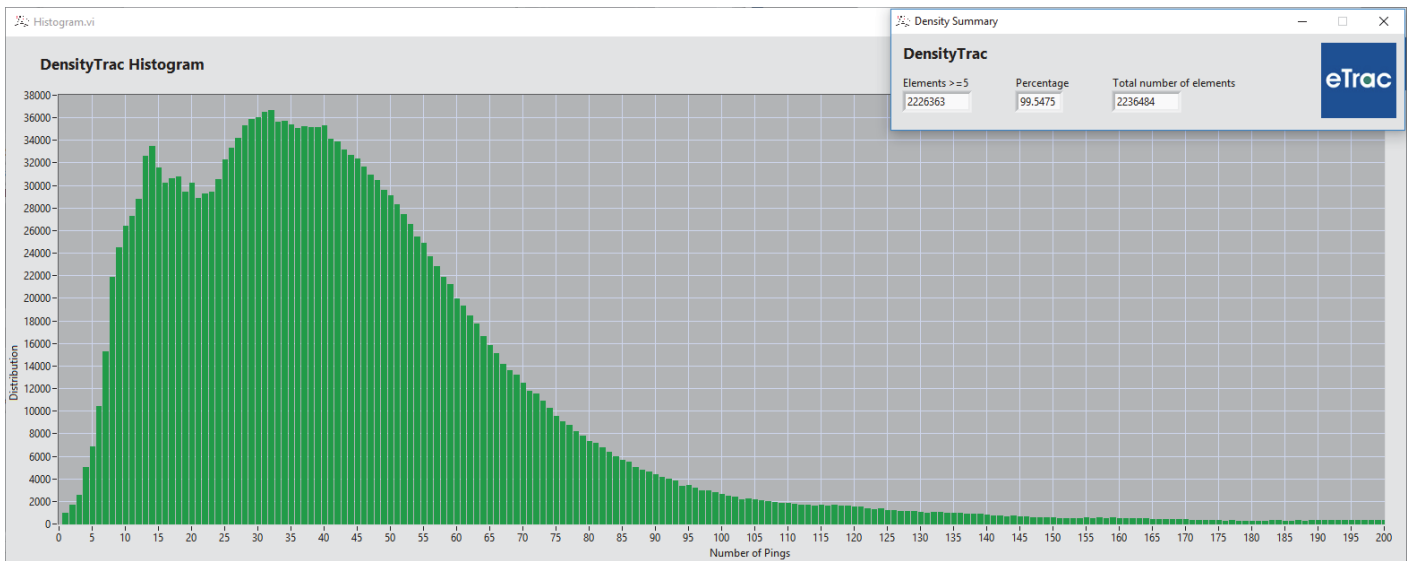
Figure 22: Area B of F00763 - Finalized 1m Object Detection MBES Density Distribution

Area B - Object Detection Coverage MBES (Finalized 1m CUBE weighted Dynamic Surface ) = 99.5475% of nodes are composed from at least 5 soundings.

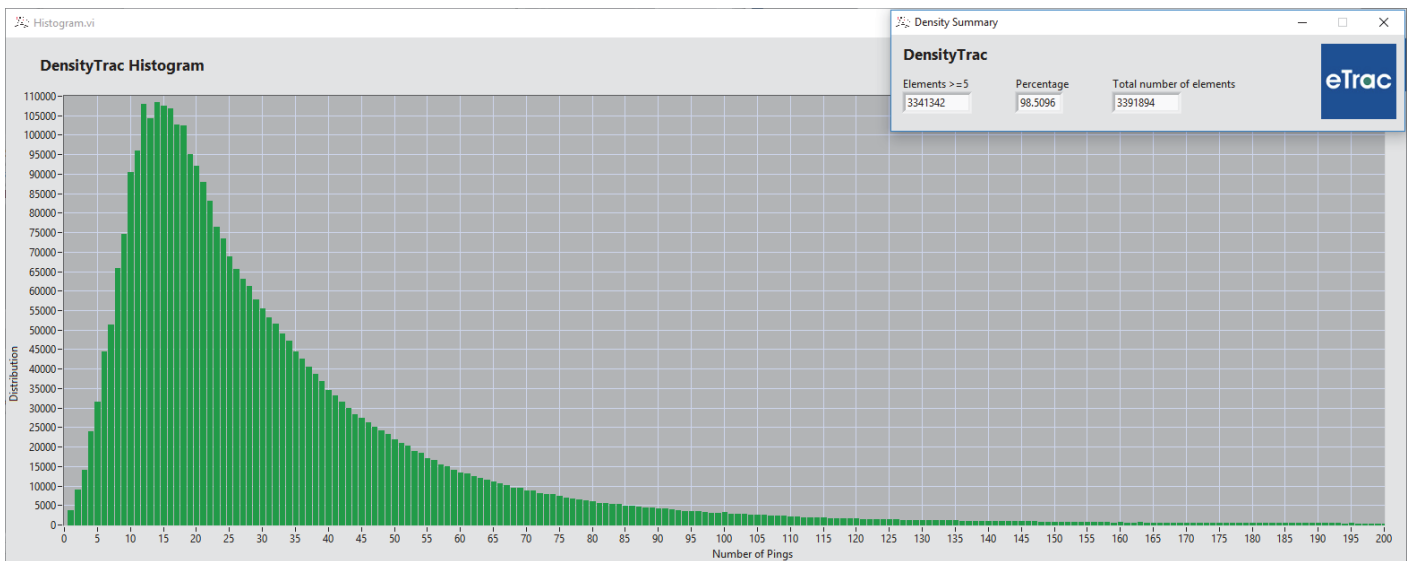
Figure 23: Area C of F00763 - Finalized 1m Complete Coverage MBES Density Distribution

Area C - Complete Coverage MBES (Finalized 1m CUBE weighted Dynamic Surface ) = 98.5096% of nodes are composed from at least 5 soundings.

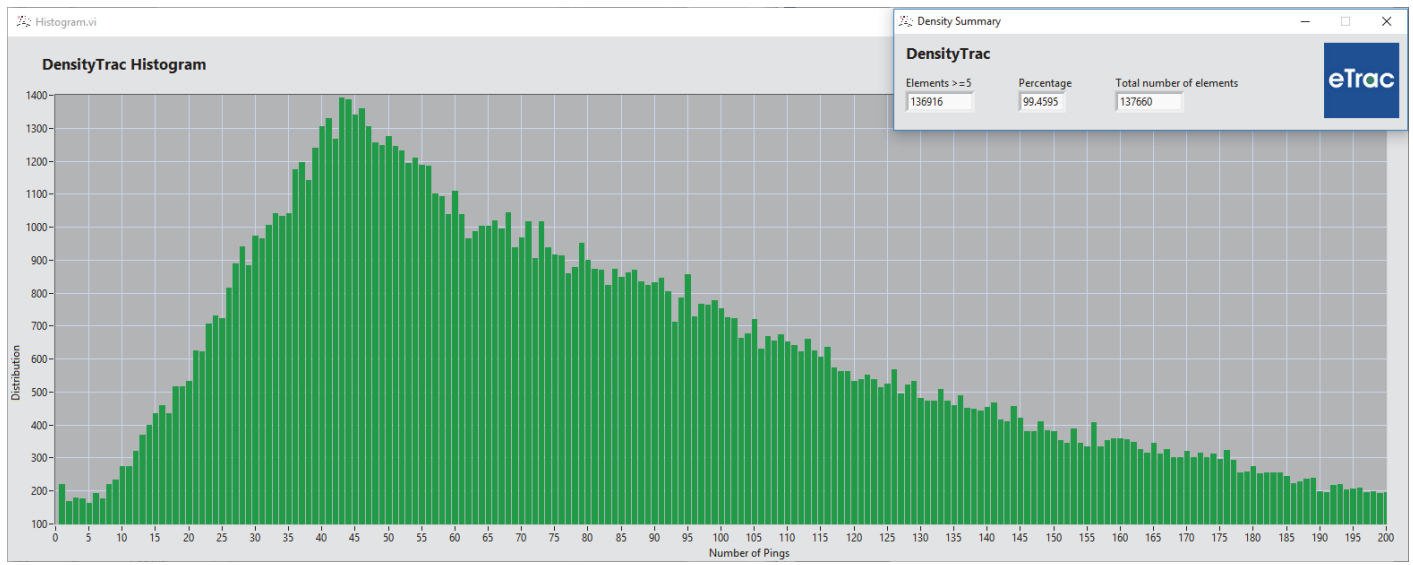
*Figure 24: Area C of F00763 - Finalized 2m Complete Coverage MBES Density Distribution*

Area C - Complete Coverage MBES (Finalized 2m CUBE weighted Dynamic Surface ) = 99.4595% of nodes are composed from at least 5 soundings

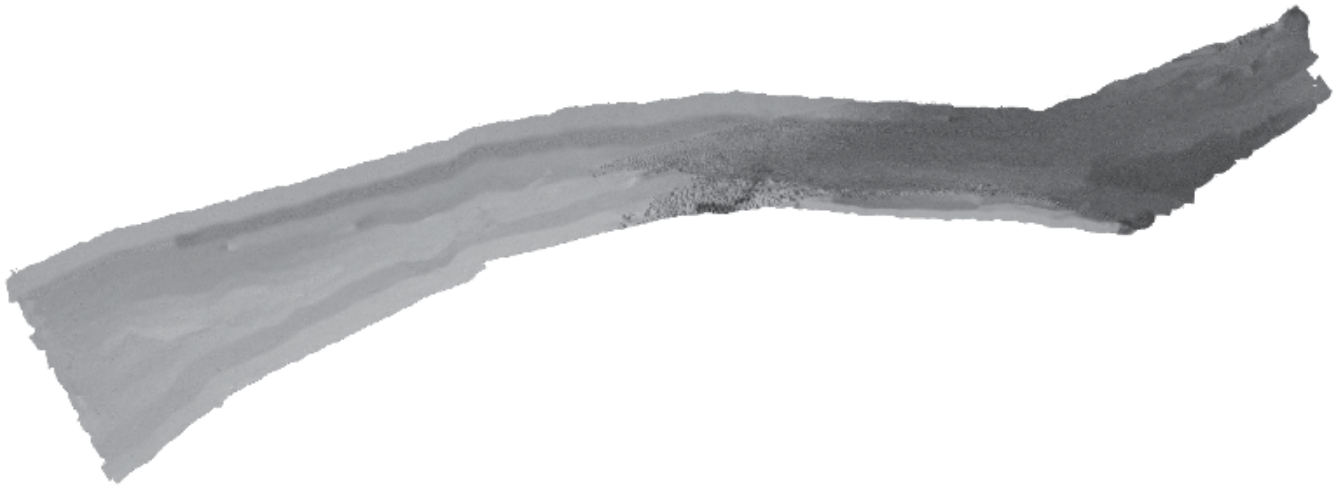
*Figure 25: Raw backscatter from Area A of F00763*

Backscatter data were collected throughout the survey and are retained in the raw DB files. Every effort was made in the field to collect quality backscatter data while maintaining the primary mandate of high quality bathymetric data. While no processing or analysis of backscatter was required, eTrac Inc. verified coverage and general quality of the backscatter data collected. A beam intensity window was monitored in Qinsy during acquisition to ensure backscatter data collection. Raw backscatter data were viewed in QPS FMGeocoder to further confirm collection criteria had been met. Shown below is an example of the unprocessed backscatter mosaic from F00763 area A, area B and area C.

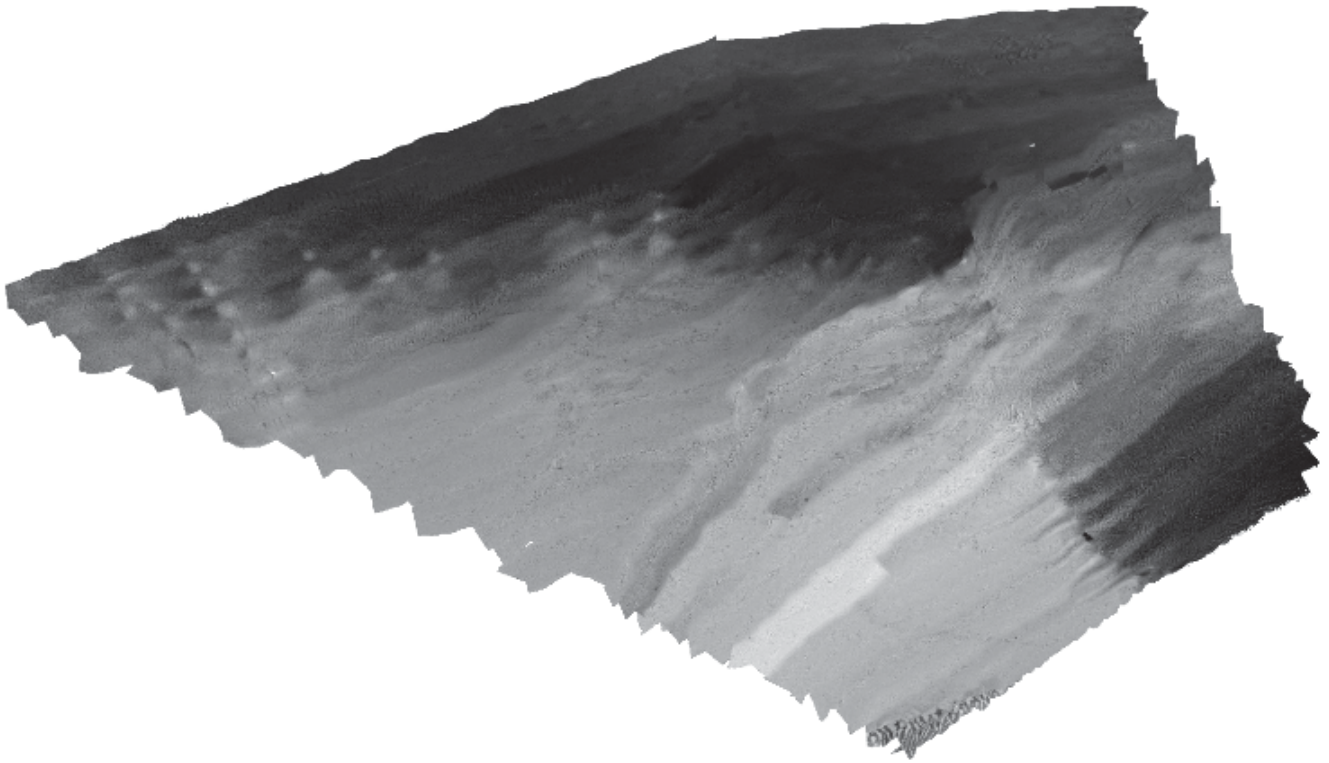
*Figure 26: Raw backscatter from Area B of F00763*

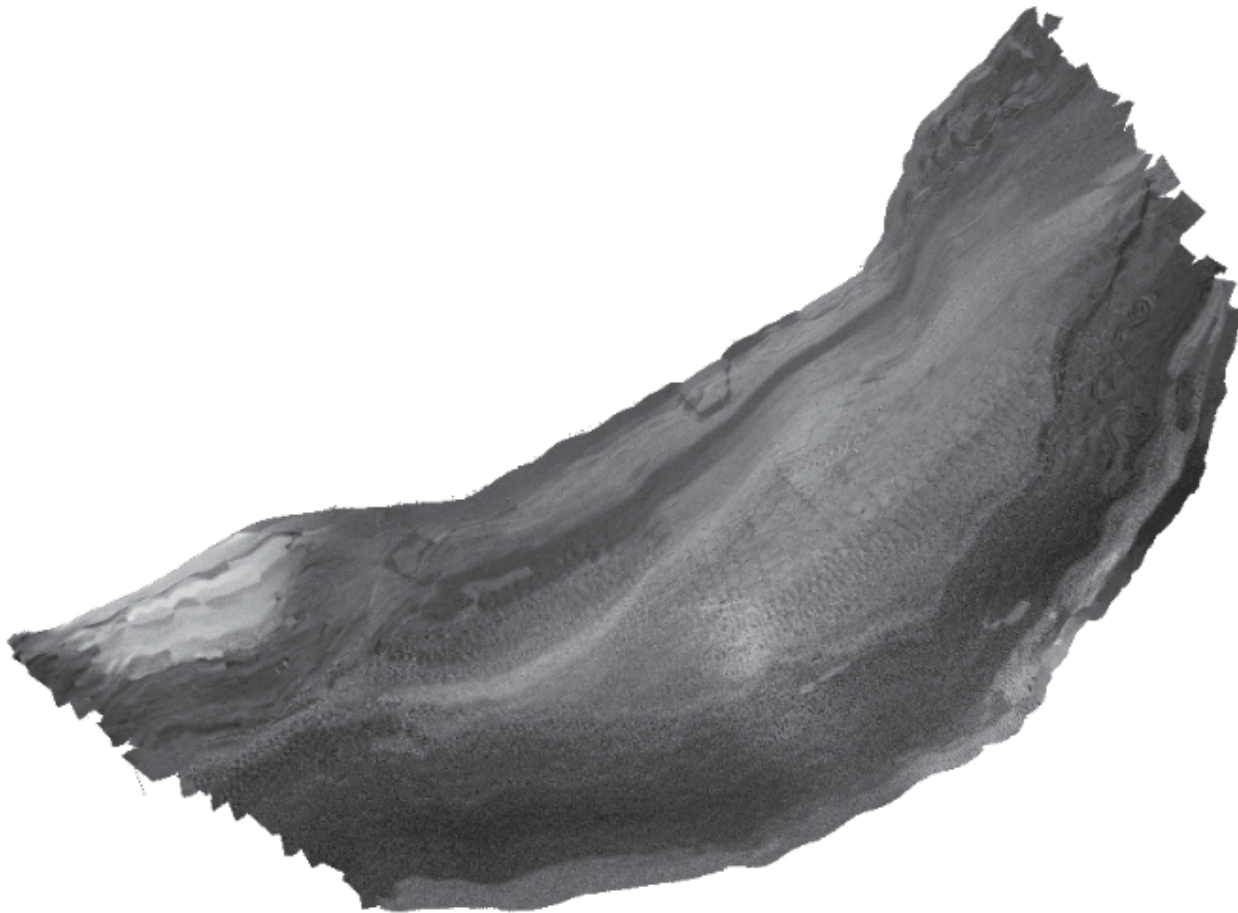
*Figure 27: Raw backscatter from Area C of F00763*

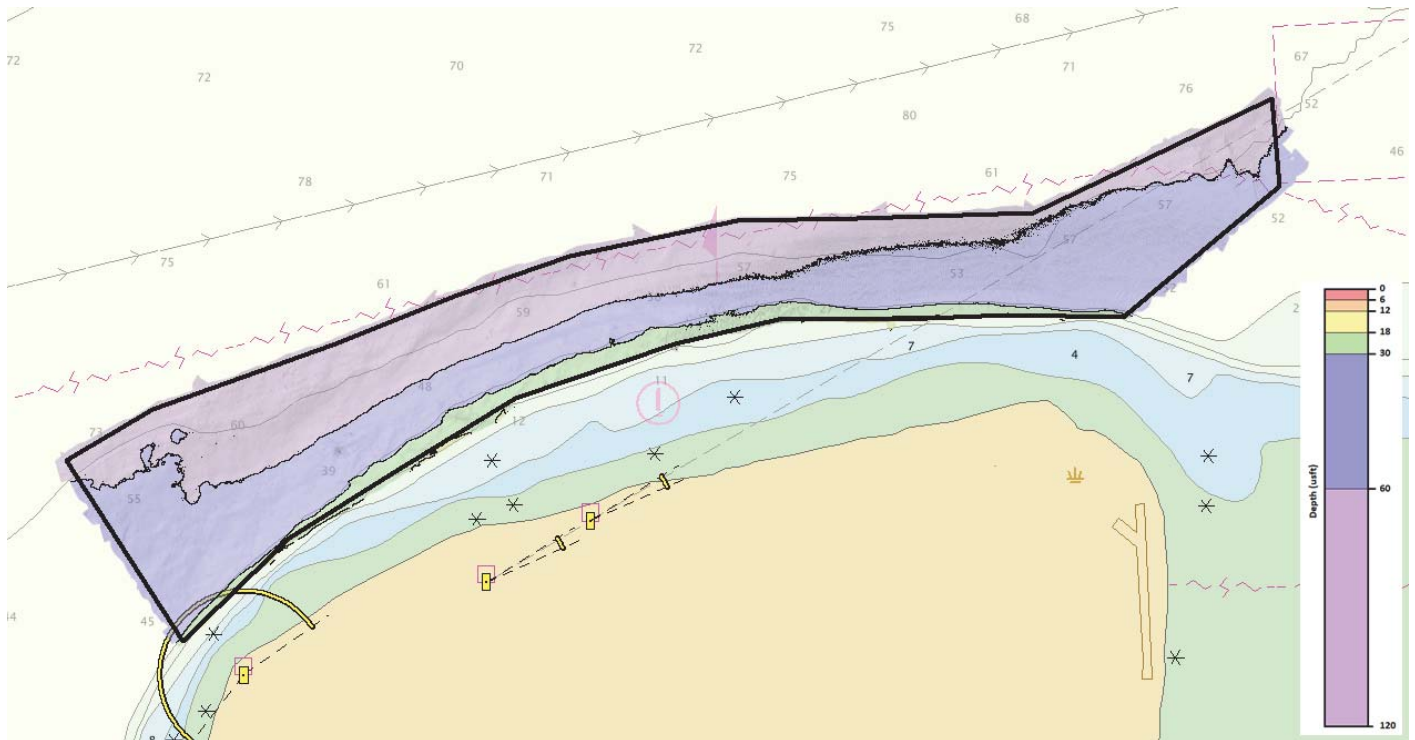
Figure 34: Area A of F00763 Contour Comparison (US5AK16M)

In areas where the contours have changed, as noted above, and where a feature was detected, soundings differ from the charted depths. In area A of F00763, soundings are generally in agreement within 1 to 5 feet of each other. Various soundings differ up to 15 feet, however these are typically areas with dynamic sandwaves. Depth differences are not biased in any particular direction to support a systematic error.

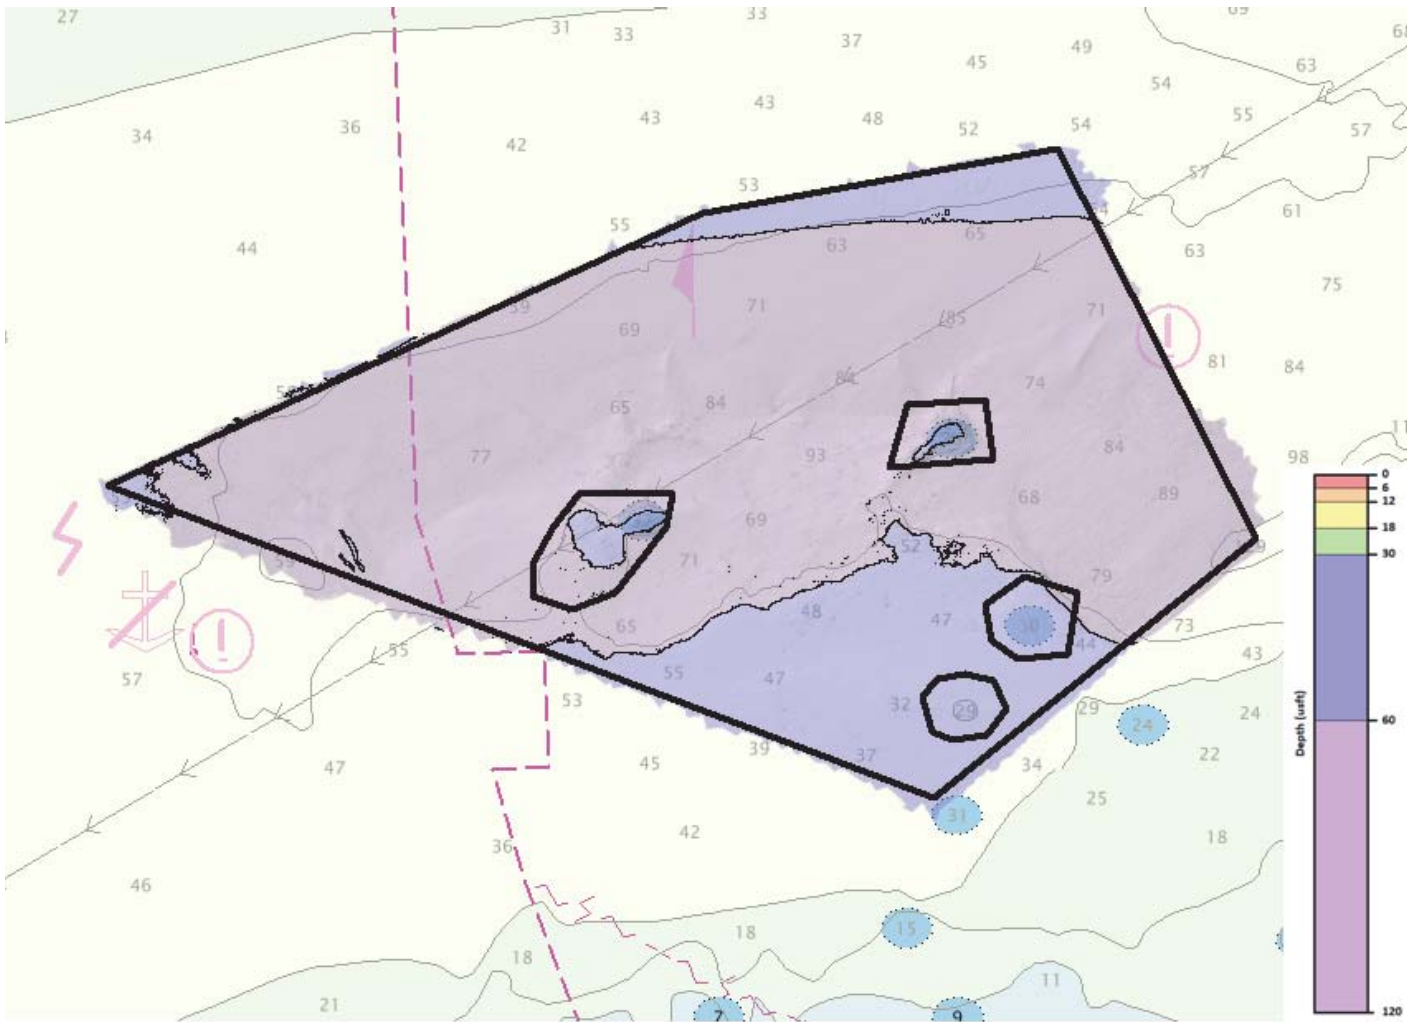
Figure 35: Area B of F00763 Contour Comparison (US5AK16M)

In areas where the contours have changed, as noted above, and where a feature was detected, soundings differ from the charted depths. In area B of F00763, soundings are generally in agreement within 1 to 5 feet of each other. Various soundings differ up to 15 feet, however these are typically areas with dynamic sandwaves. Depth differences are not biased in any particular direction to support a systematic error.
