**DESCRIPTIVE REPORT**

Type of Survey: Navigable Area

Registry Number: F00763

Project Number: **S-P958-KR-18**

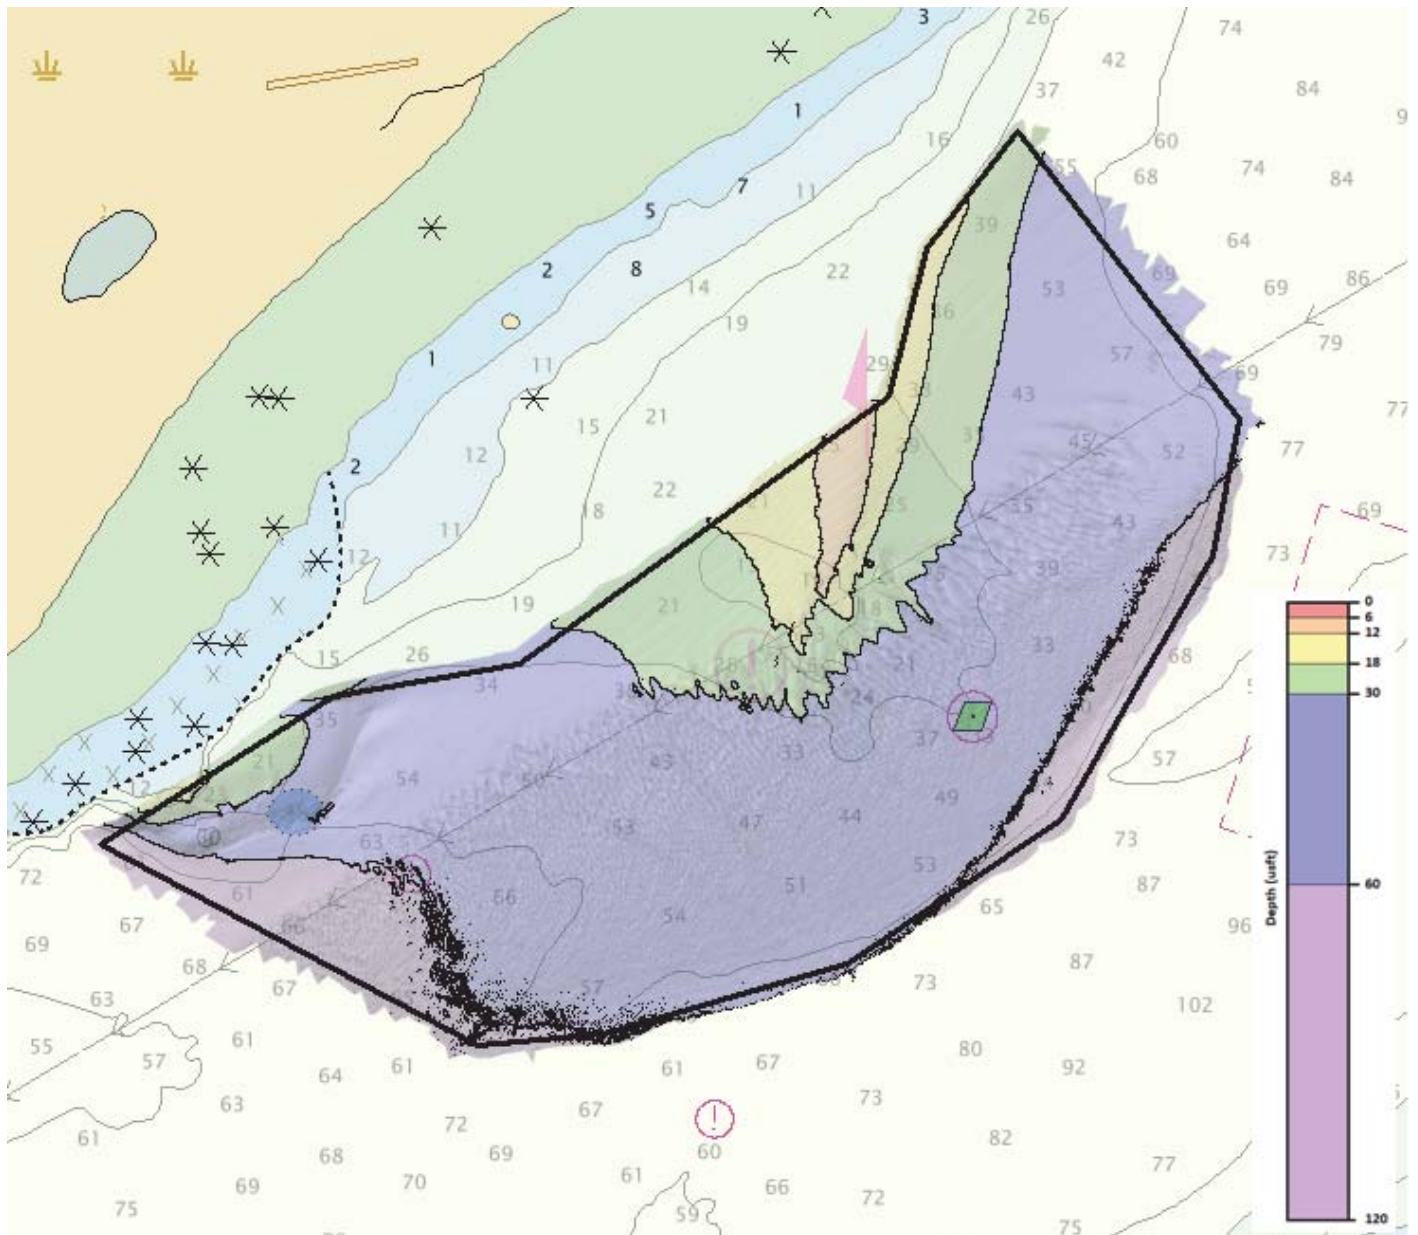
Figure 36: Area C of F00763 Contour Comparison (US5AK16M)

In areas where the contours have changed, as noted above, and where a feature was detected, soundings differ from the charted depths. In area C of F00763, soundings are generally in agreement within 1 to 5 feet of each other. Various soundings differ up to 15 feet, however these are typically areas with dynamic sandwaves. Depth differences are not biased in any particular direction to support a systematic error.

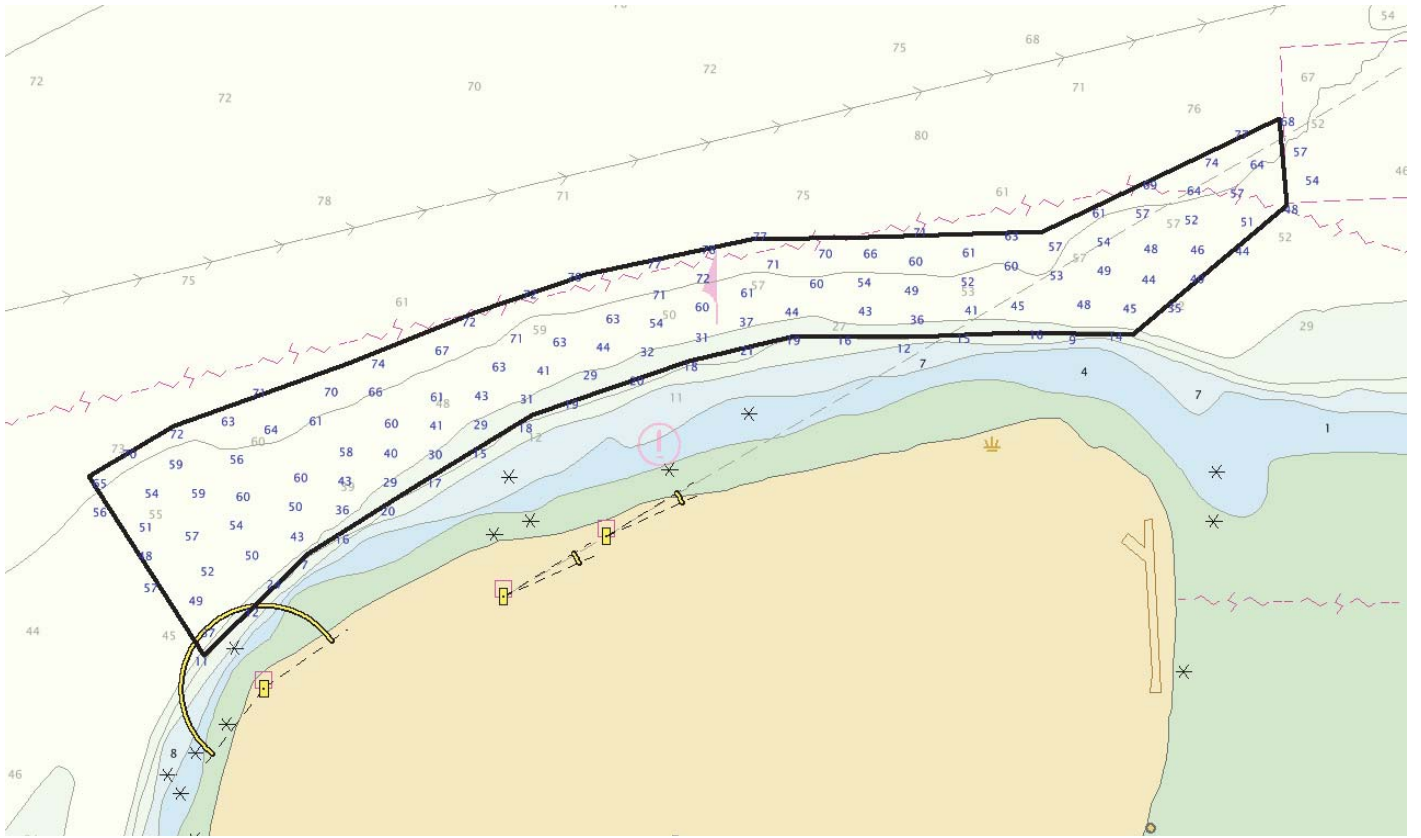
Figure 37: Area A of F00763 Sounding Comparison (US5AK16M)

In areas where the contours have changed, as noted above, and where a feature was detected, soundings differ from the charted depths. In area A of F00763, soundings are generally in agreement within 1 to 5 feet of each other. Various soundings differ up to 15 feet, however these are typically areas with dynamic sandwaves. Depth differences are not biased in any particular direction to support a systematic error.

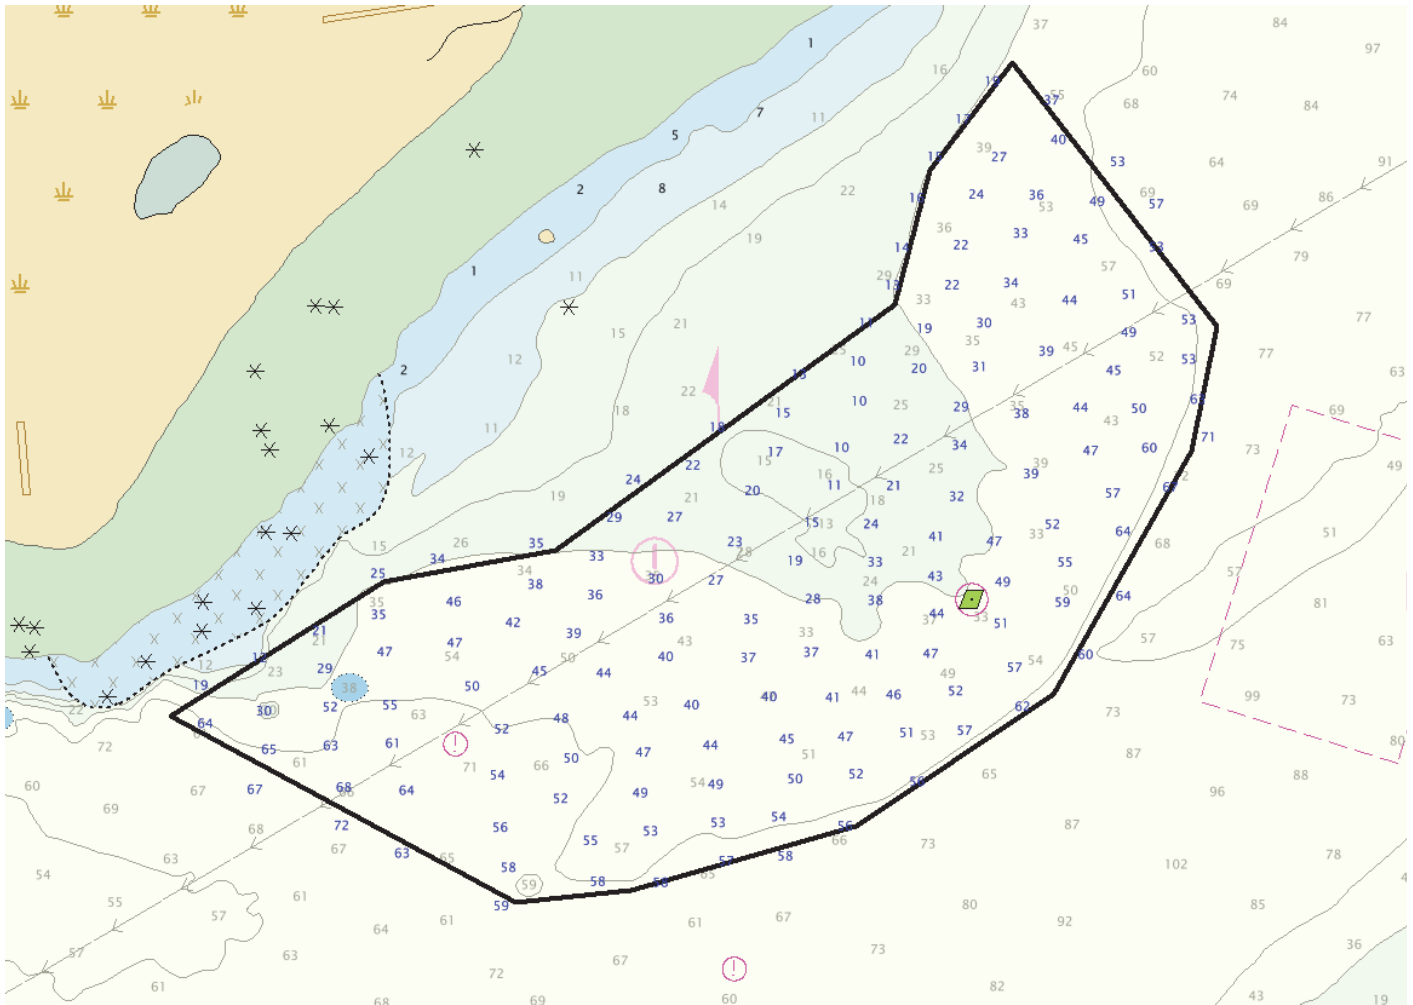
Figure 39: Area C of F00763 Sounding Comparison (US5AK16M)

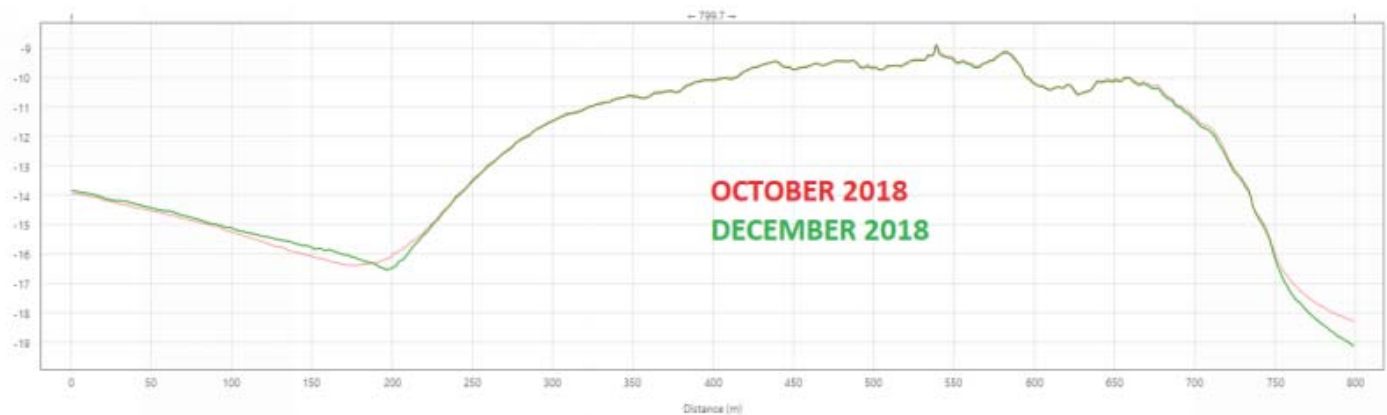
*Figure 41: Cross Section 1 over hard material*

eTrac was contracted by USACE to perform a hydrographic survey in October 2018 in the vicinity of area C of F00763. A comparison was made between datasets in Qimera. An image of the difference surface between the October dataset and area C of F00763 is located below. In the difference surface, red represents accretion, blue represents erosion, and white represents agreement between the two surfaces. Example cross sections are provided following the surface images. The first cross section across the two areas is over hard material and bedrock, which shows excellent repeatability and agreement. The second cross section across the two areas is over soft transient material. Significant accretion can be seen in the McKenzie Pt. area. The material in this section of the survey area has been observed to change significantly within a single tide cycle.

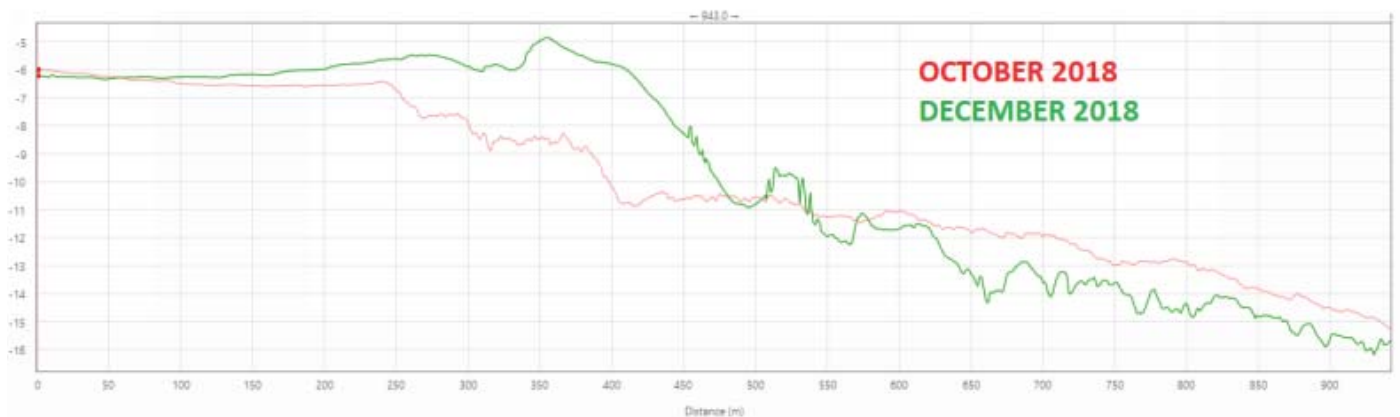
*Figure 42: Cross section 2 over soft material*

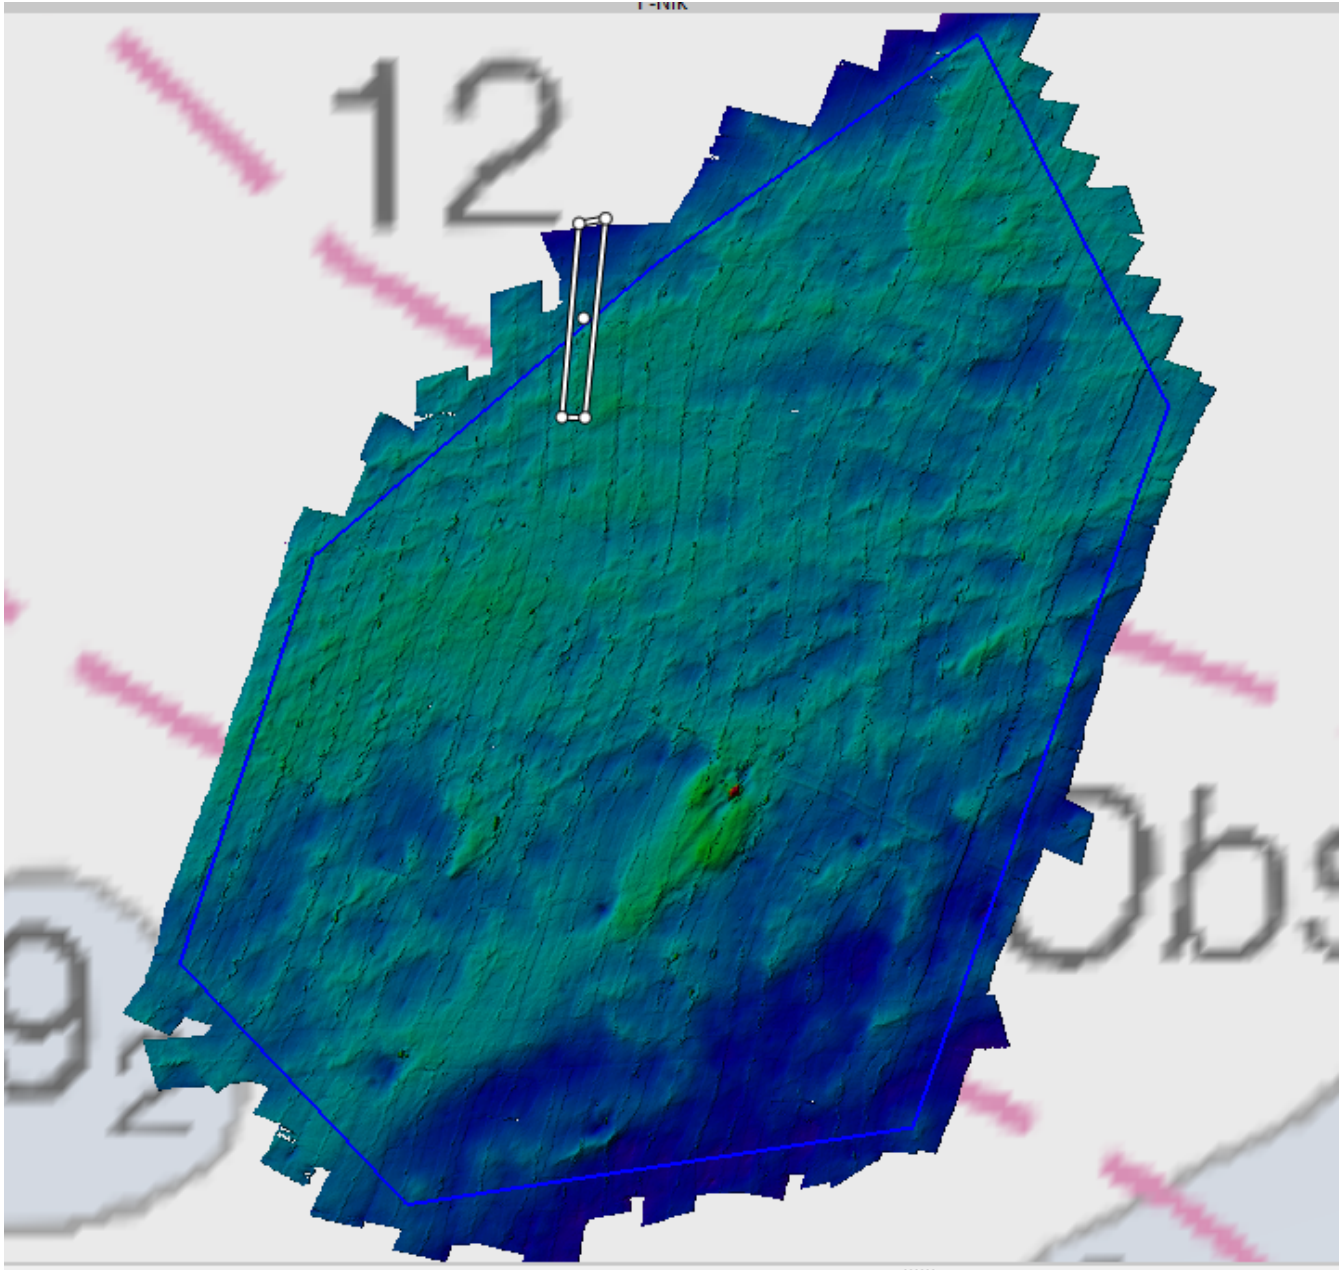
To follow up on your request in our meeting on Friday to quantify the amount of time necessary to clean out the data artifact present in a portion of our Nikiski data.

Surface Before Cleaning

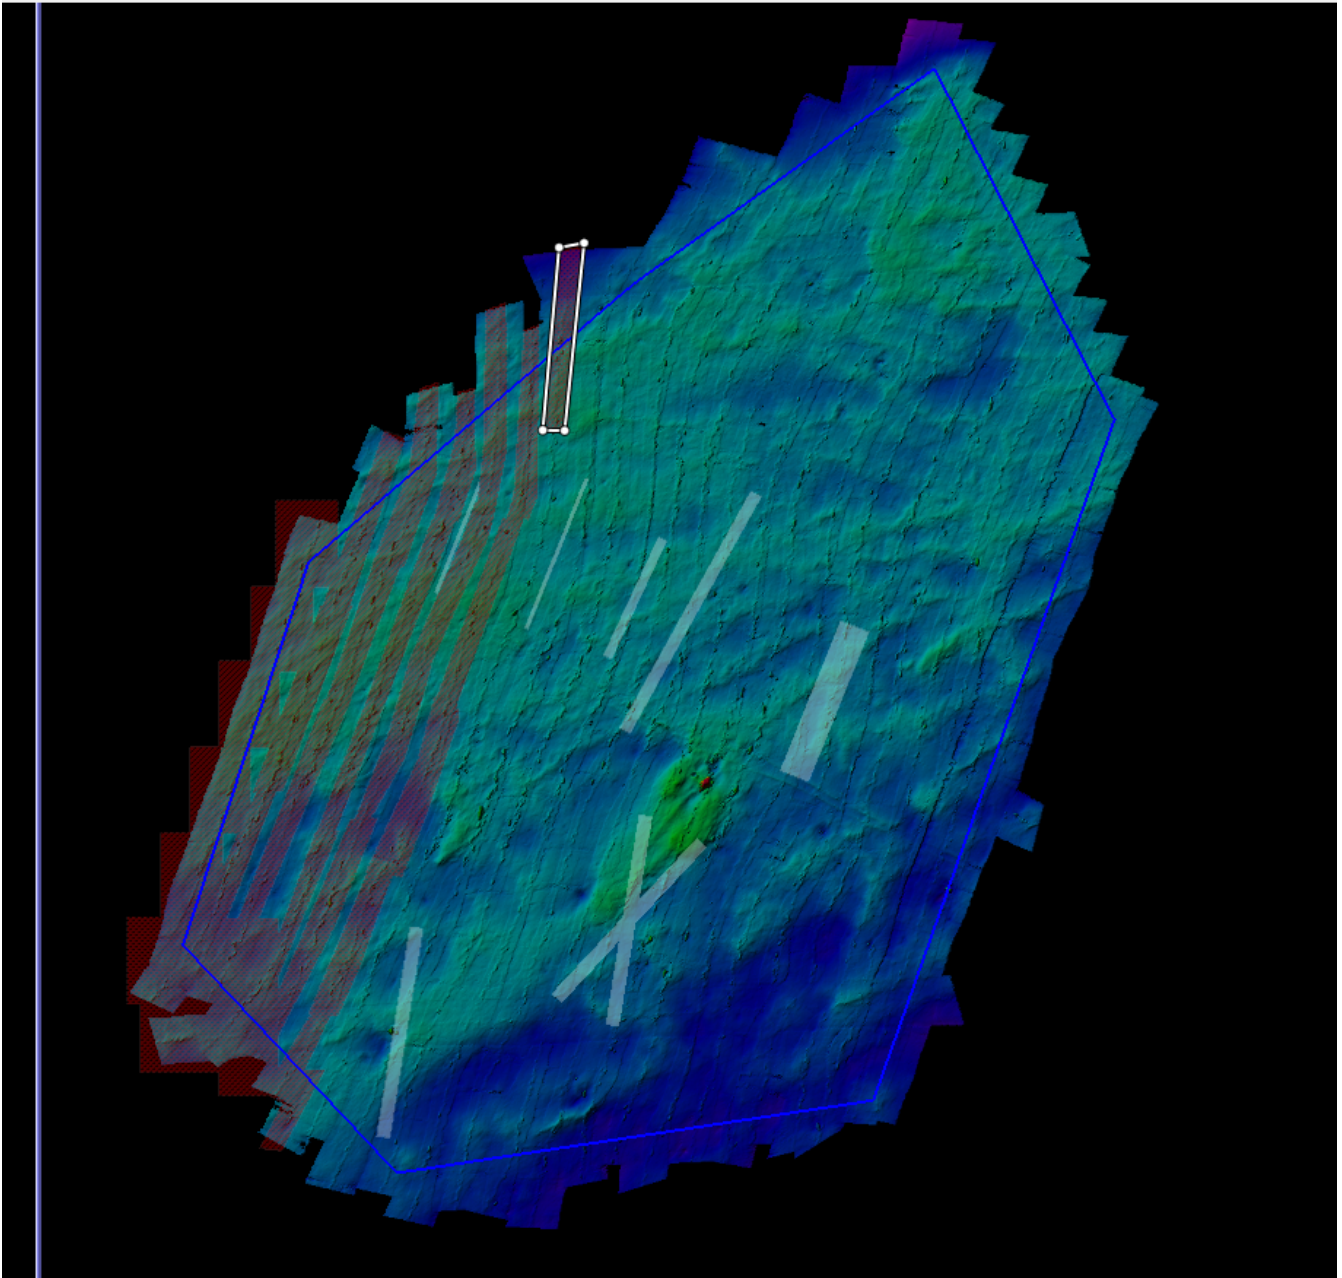
Cleaning completed after 1 hour of cleaning (Red Areas)

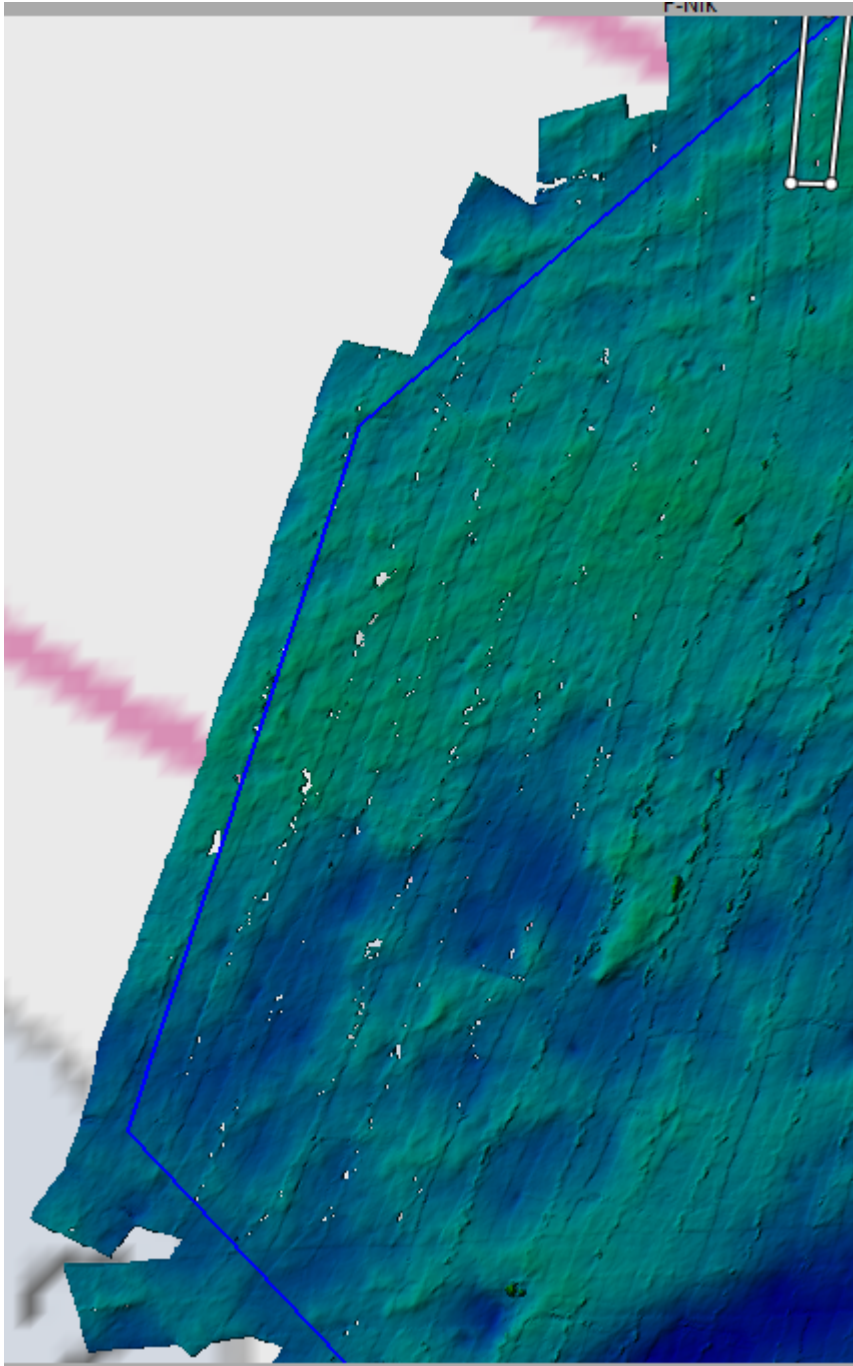
Updated surface after 1 hour of cleaning

We believe we would be able to clean out this artifact within 3 days. Not a significant undertaking.
