DESCRIPTIVE REPORT

Type of Survey: Navigable Area

General Locality: Keystone Harbor

Sub-locality: Approach to Keystone Harbor

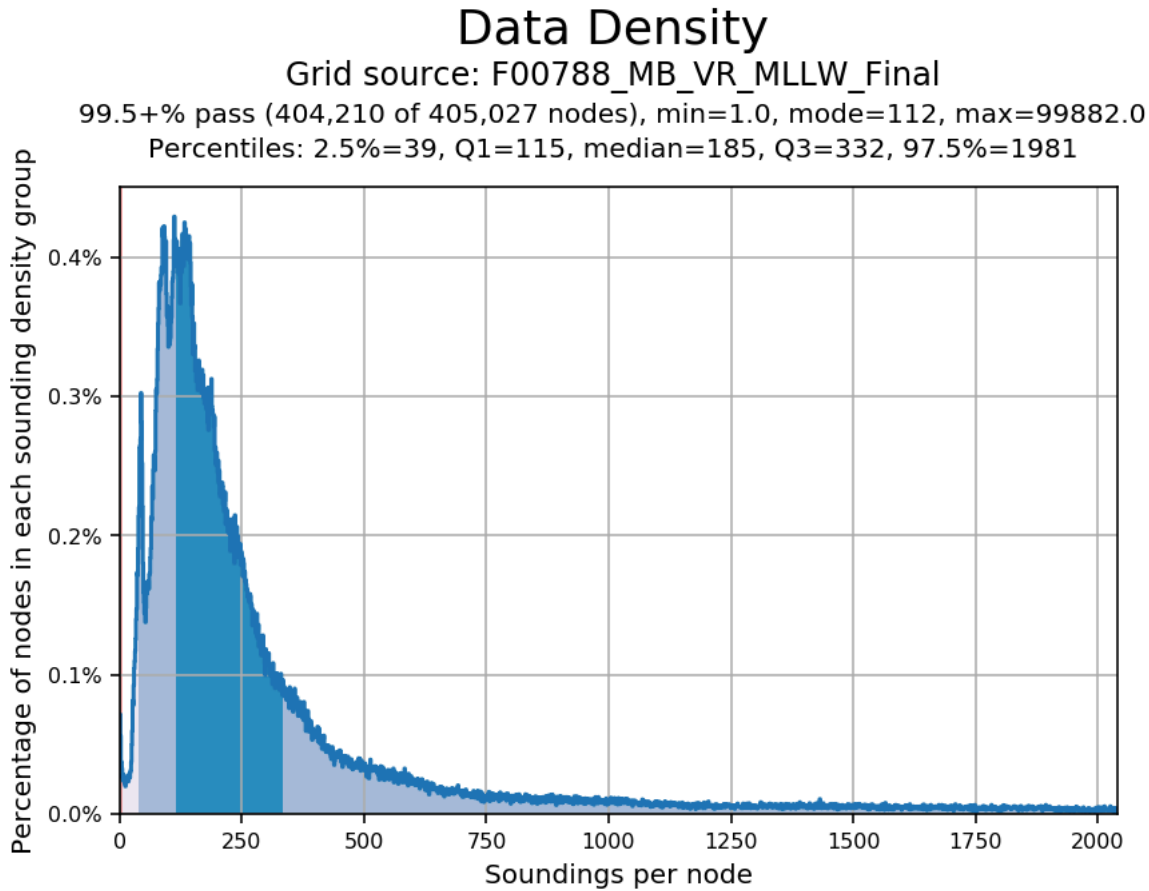
Figure 2: Pydro derived histogram plot showing HSSD object detection compliance of F00788 MBES with the finalized CUBE surface.

The surface was analyzed using the HydrOffice QC Tools Grid QA feature (Figure 2). Density requirements for F00788 were achieved with at least 99.5% of surface nodes containing five or more soundings as

required by HSSD Section 5.2.2.3. The few nodes that did not meet density requirements are due to sparse data in the outer beams, slopes and rocky areas where acoustic shadowing occurred, and at the edges of the survey limits.

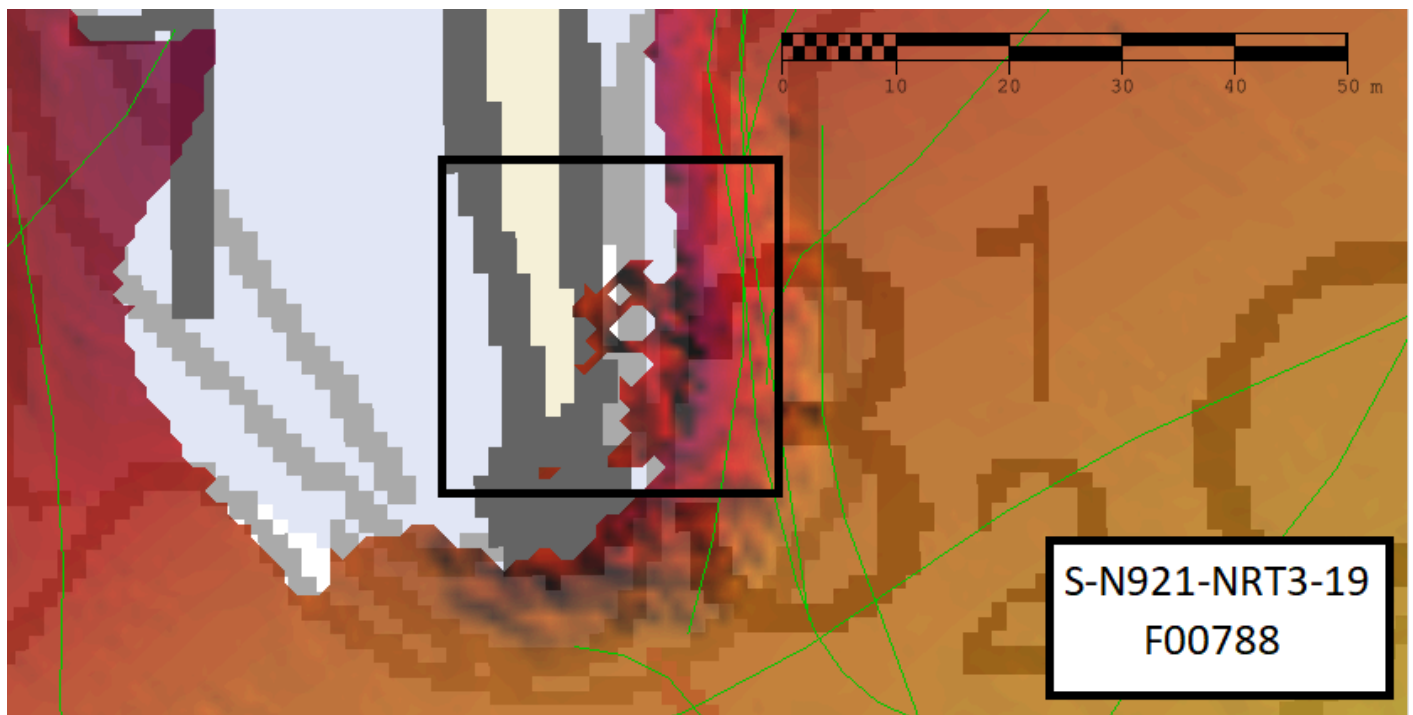
Figure 3: Two inshore holidays exist in four meters of water along the eastern sea wall approaching Keystone Harbor.

SAR: As a result of being formed by spurious soundings, the gridded data within the Figure 3 box has been rejected in review. Those spurious grid nodes no longer exist in the gridded surface.

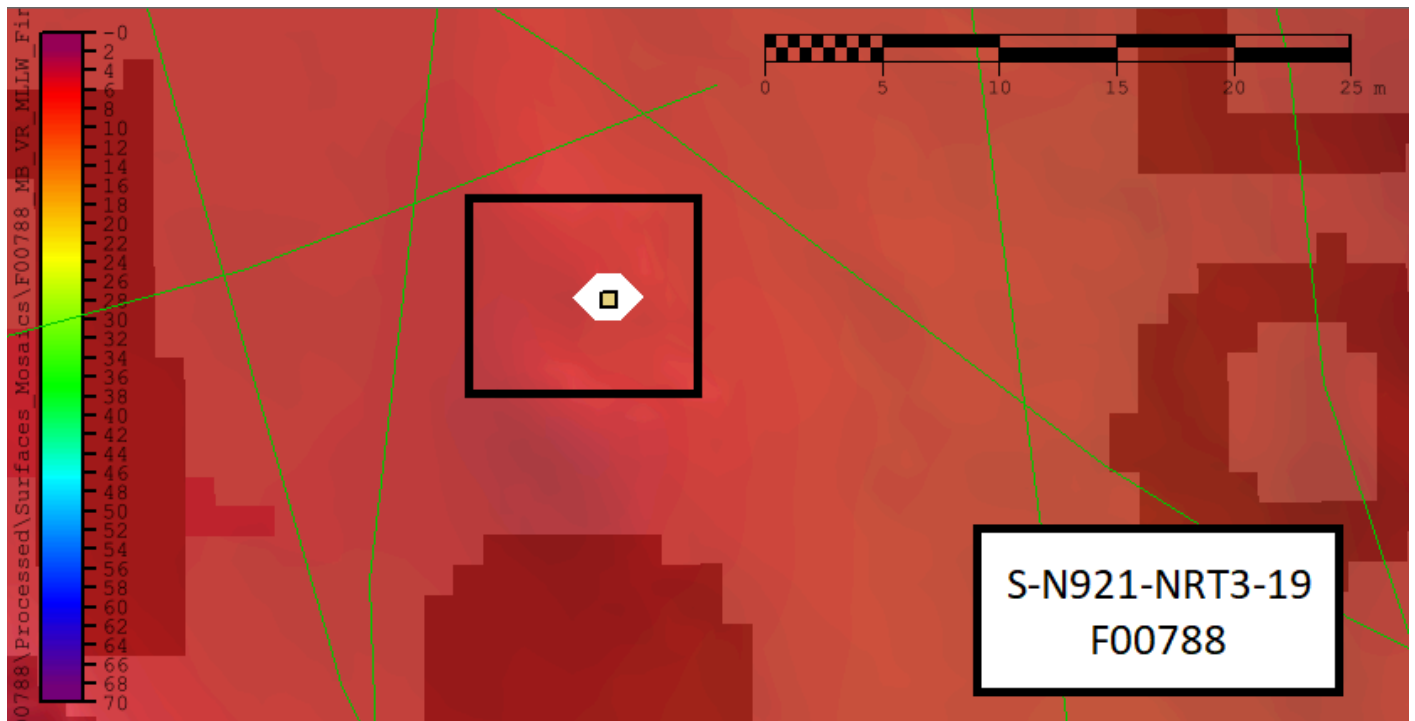
Figure 4: A data gap exists due to location of a pier piling.

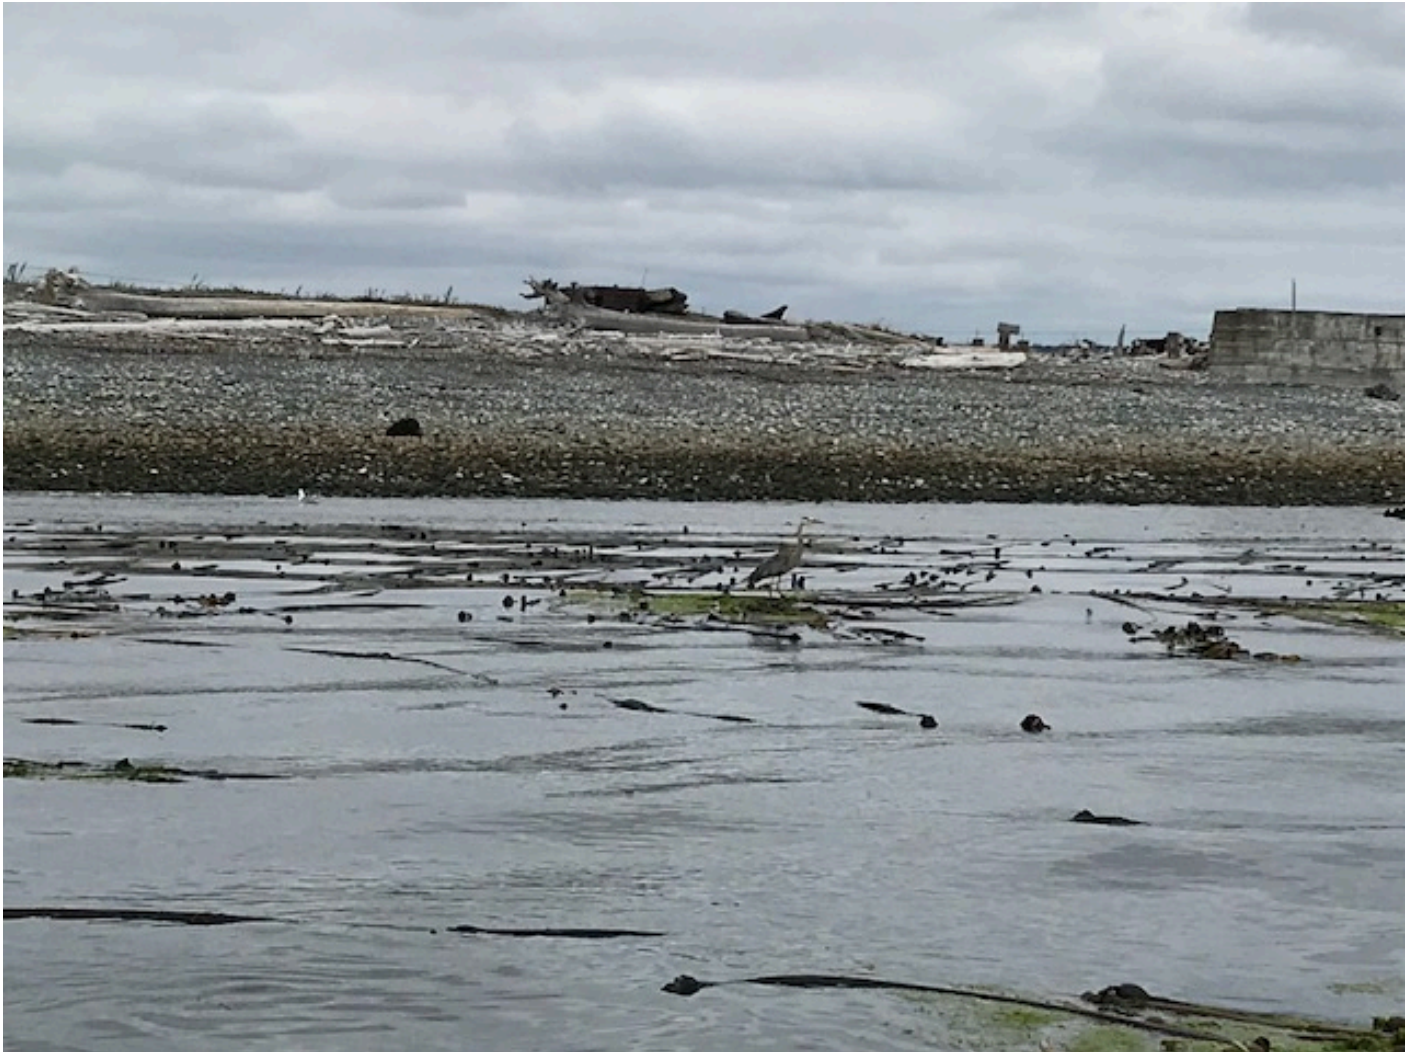
Figure 6: Dense kelp beds exist inshore of 8 meters on the north eastern and western shores of Keystone Harbor.

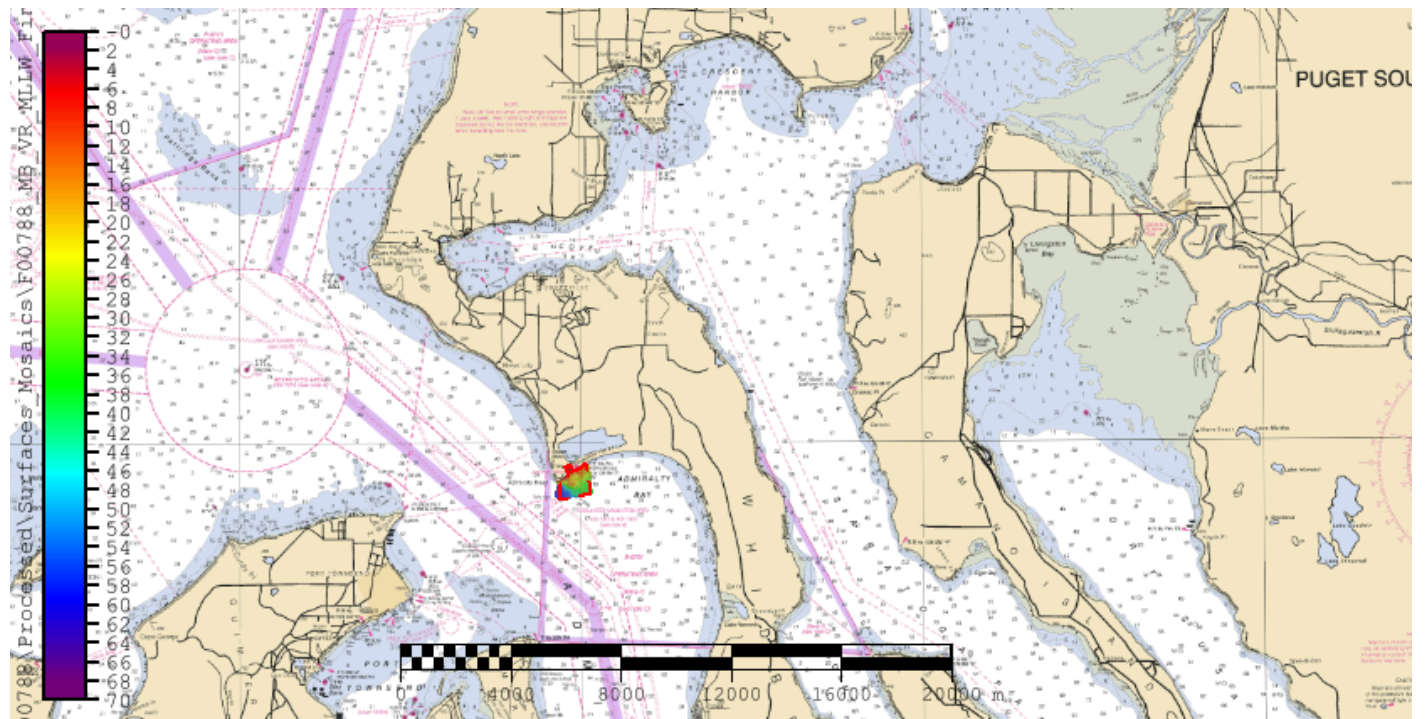
Figure 8: Survey coverage relative to northern Puget Sound on chart 18441

Complete multibeam coverage was achieved within the limits of hydrography as defined in the project instructions with some exceptions (Figure 5). In all areas where the 3.5 meter depth contour or the sheet limits were not met, the Navigable Area Limit Line (NALL) was defined as the inshore limit of bathymetry due to the risks of maneuvering the survey vessel in close proximity to the shoreline, obstructions, and kelp (Figure 6). This survey represents a small area of north Puget Sound, and is outside the channel (Figure 7 and 8).

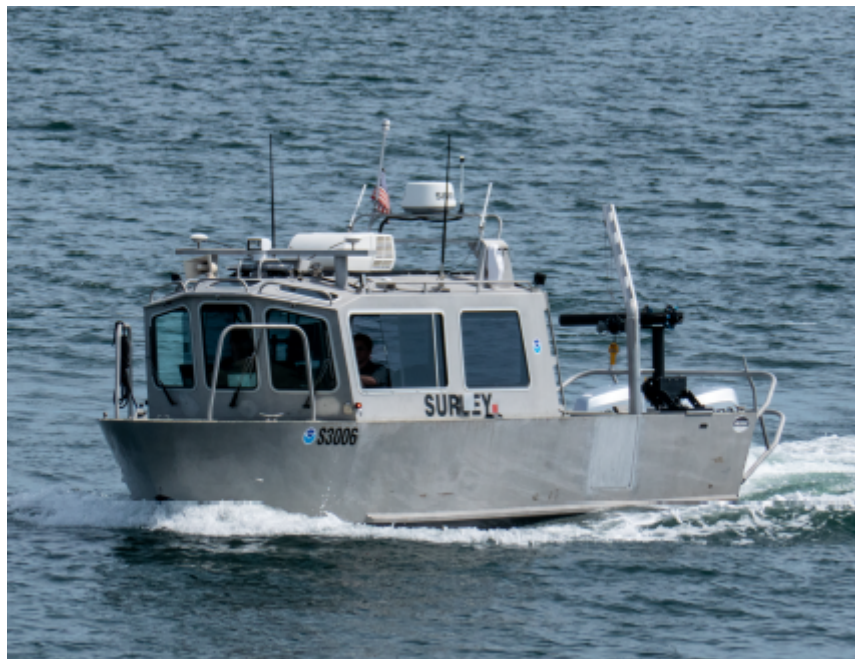
Figure 10: NRT-Seattle, S3006

S3006 is an aluminum survey boat built by Lake Assault Boats in Superior, WI (Figure 10).

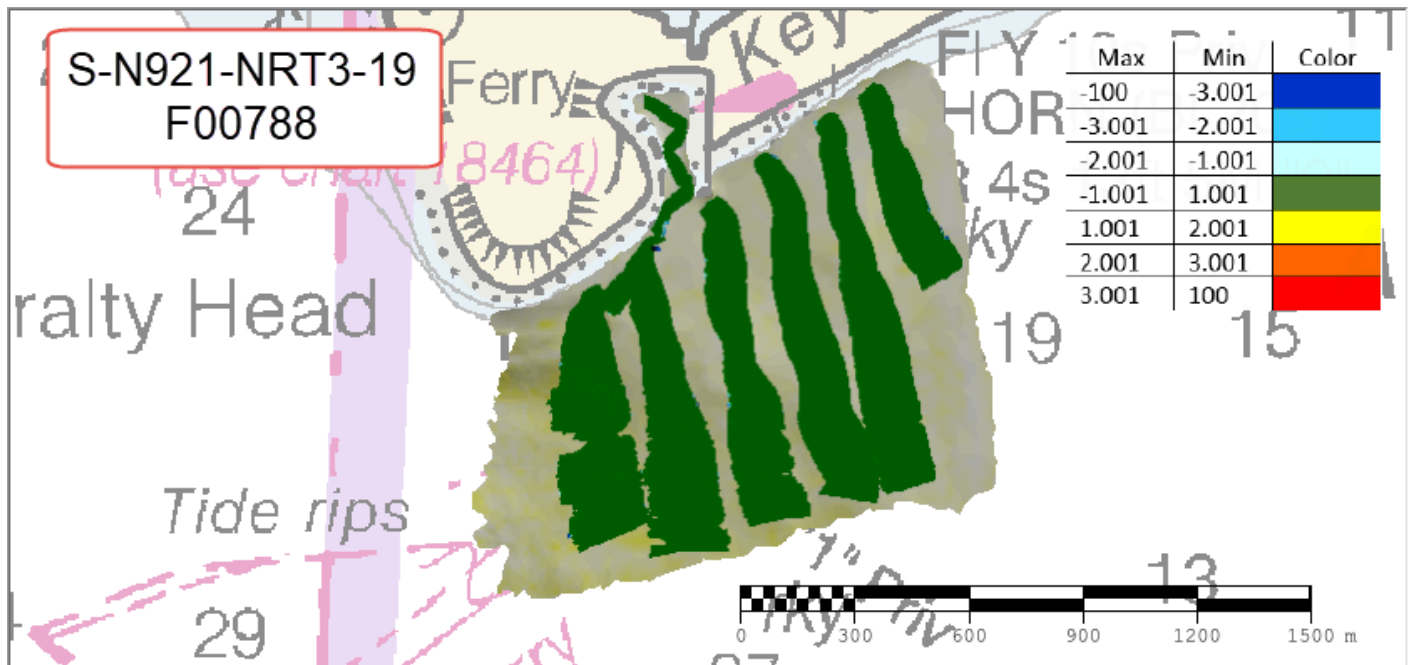
Figure 12: Depth differences between F00788 mainscheme and crossline data as compared to NOAA allowable uncertainty standards for the associated depths.

For the respective depths, the difference surface was compared to the allowable NOAA uncertainty standards. Statistics show the mean difference between the depths derived from mainscheme data and crossline data was 0.1 meters, with mainscheme being shoaler/deeper. In total, 99.5% of the total number of nodes pass the TVUmax test between F00788 mainscheme and crossline data (Figure 13-14). The coloring represents areas where the TVUmax error tolerance in exceeded; red, orange and yellow colors represent areas where mainscheme data is deeper than crossline data; the blue shades represent where crossline data is deeper than mainscheme data (Figure 12). The analysis was performed on F00788 MBES data reduced to Mean Lower Low Water (MLLW) using Ellipsoidally Referenced Survey (ERS) methods.

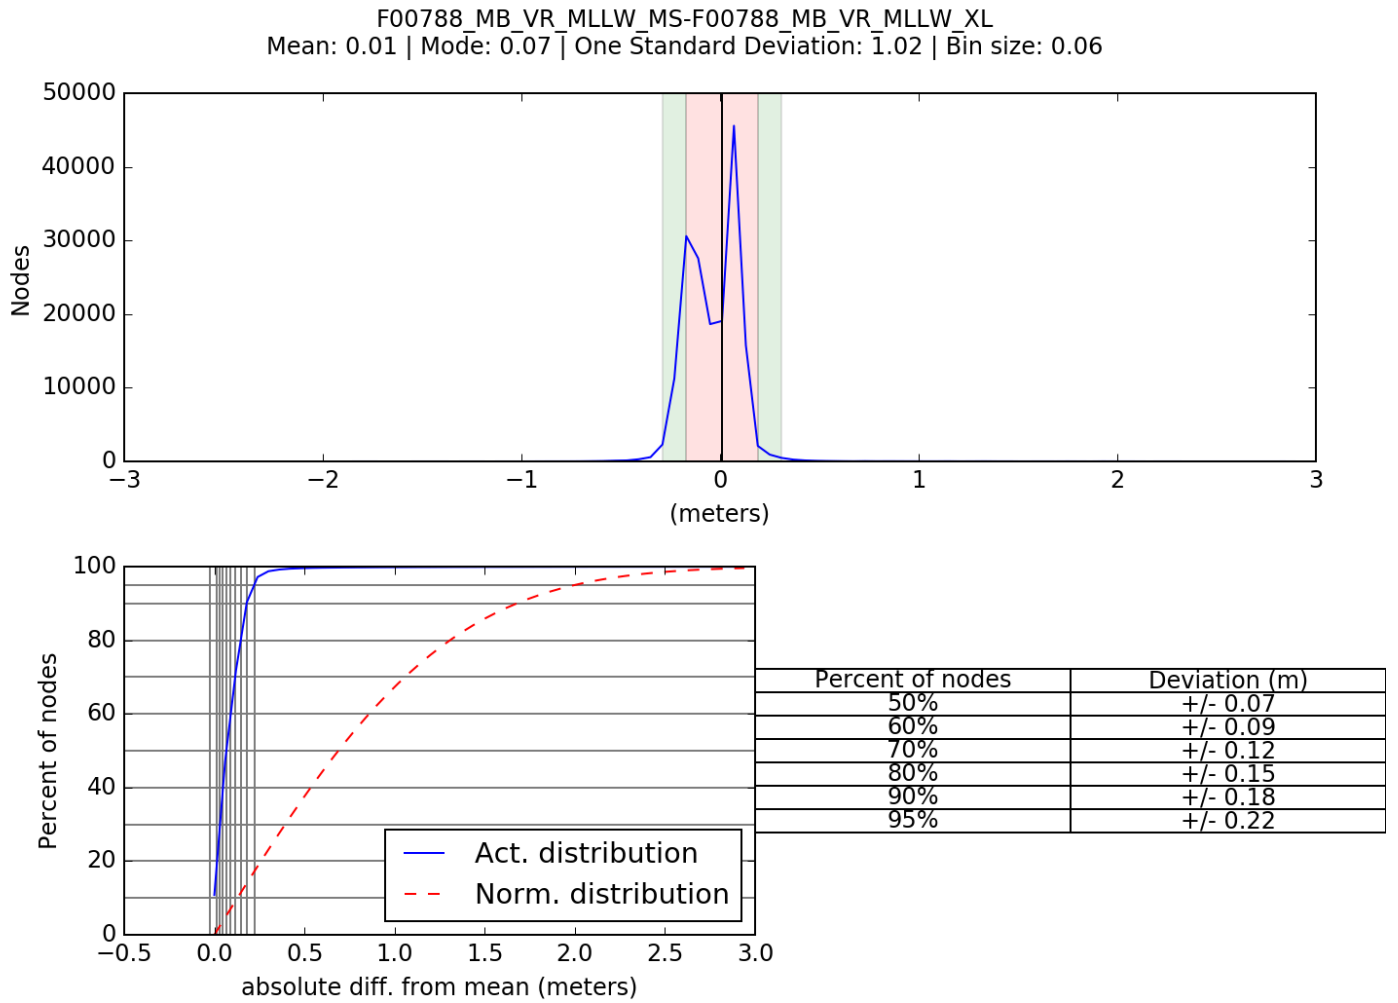
Figure 13: The statistic distribution summary plot of the difference between F00788 mainscheme and crossline data.

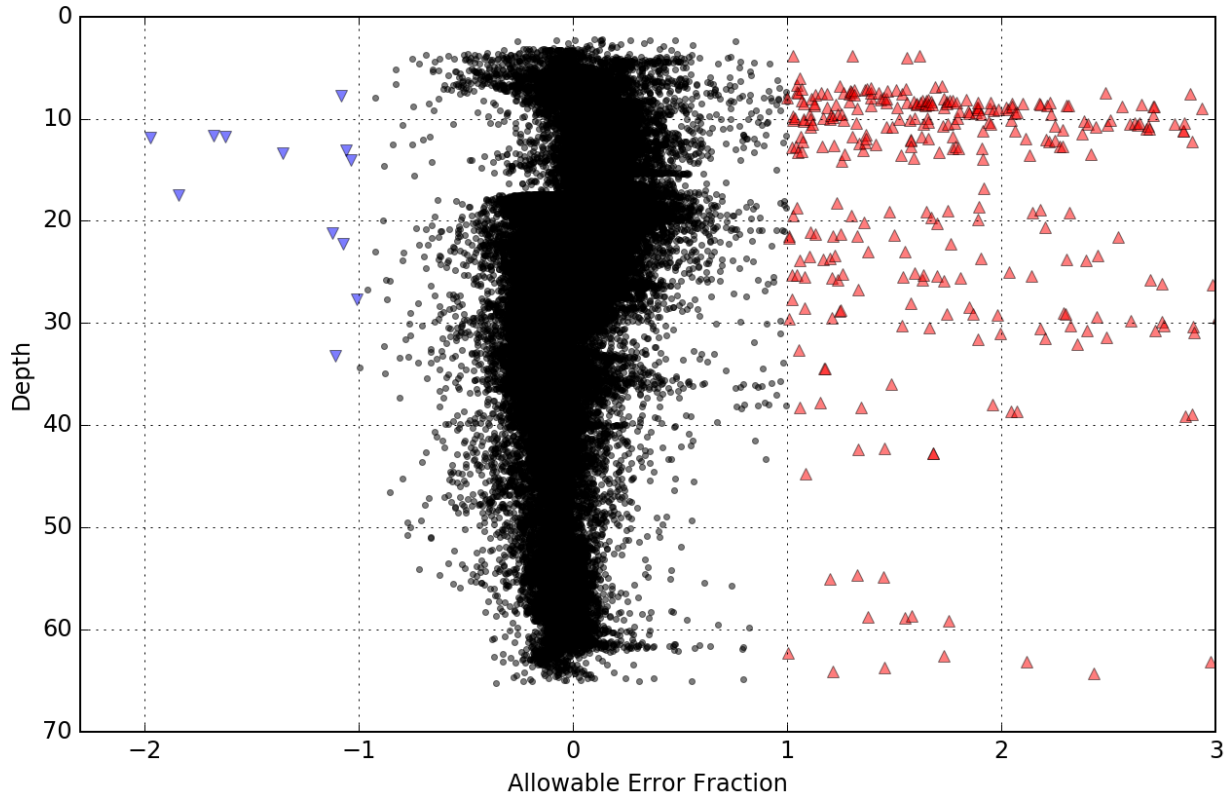
Node Depth vs. Allowable Error Fraction

F00788_MB_VR_MLLW_MS-F00788_MB_VR_MLLW_XL_fracAllowErr.csar, total comparisons 176523

Failed Stats [-inf,-1]: min=-2.3, 2.5%=-2.2, Q1=-1.7, mean=-1.4, median=-1.1, Q3=-1.1, 97.5%=-1.0, max=-1.0

Failed Stats (+1,+inf]: min=1.0, 2.5%=1.0, Q1=1.3, median=1.8, Q3=2.6, mean=8.7, 97.5%=61.5, max=63.0

Figure 14: The depth dependent plot of the Allowable Error Fraction, with values between and including +/-1 representing passing comparisons.

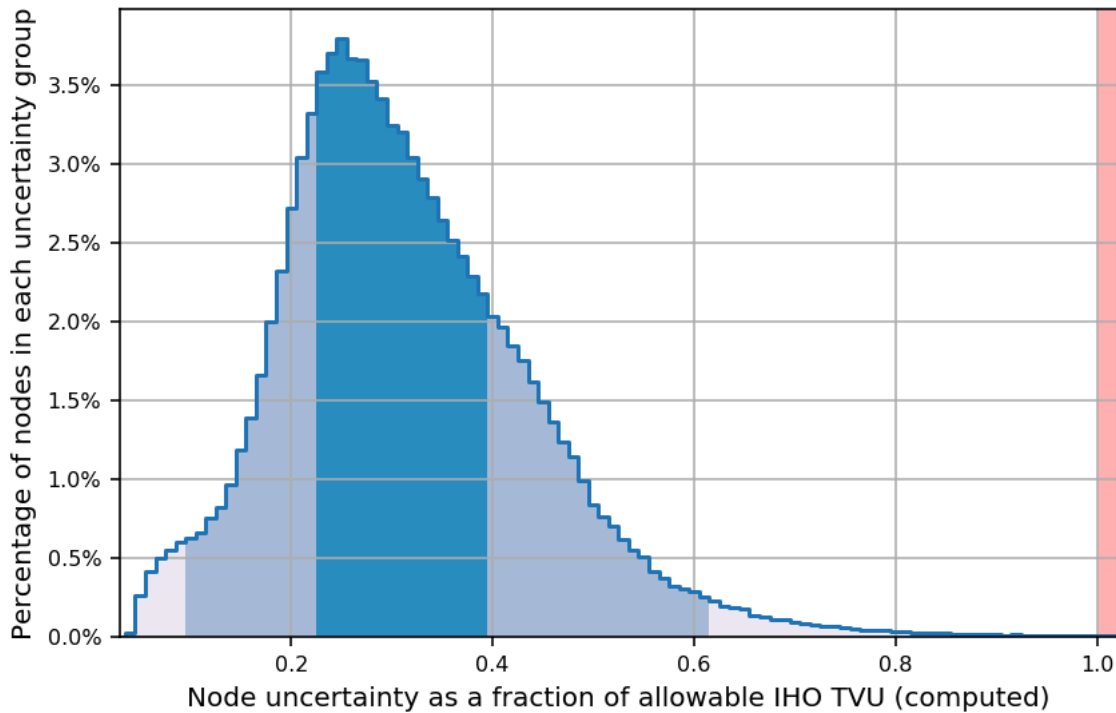
Uncertainty Standards

Grid source: F00788_MB_VR_MLLW_Final

99.5+% pass (404,382 of 405,027 nodes), min=0.03, mode=0.25, max=4.87

Percentiles: 2.5%=0.10, Q1=0.23, median=0.30, Q3=0.39, 97.5%=0.61

Figure 15: Pydro derived histogram plot showing HSSD uncertainty standards compliance for F00788 finalize VR surface.

The surface was analyzed using the HydrOffice QC Tools Grid QA feature to determine compliance with specifications. Overall, 99.5+% of nodes within the surface meet NOAA Allowable Uncertainty specifications for F00788 (Figure 15).

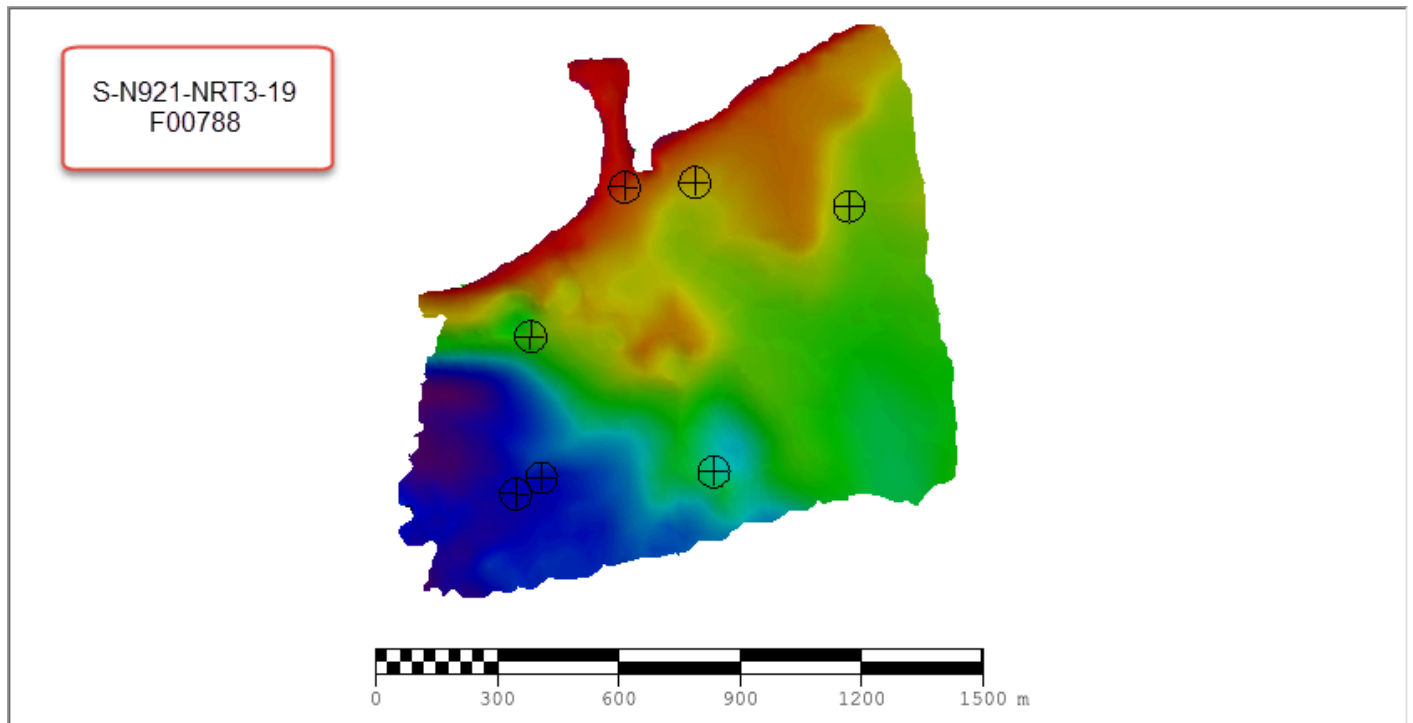
Figure 16: F00788 sound speed cast locations

Sound Velocity Profiles (SVP) casts were taken at least once every four hours in the deepest water nearest to the survey area being worked on (Figure 16). The SVP casts were applied to the MBES lines in CARIS using the "nearest in distance within time of 4 hours" method.

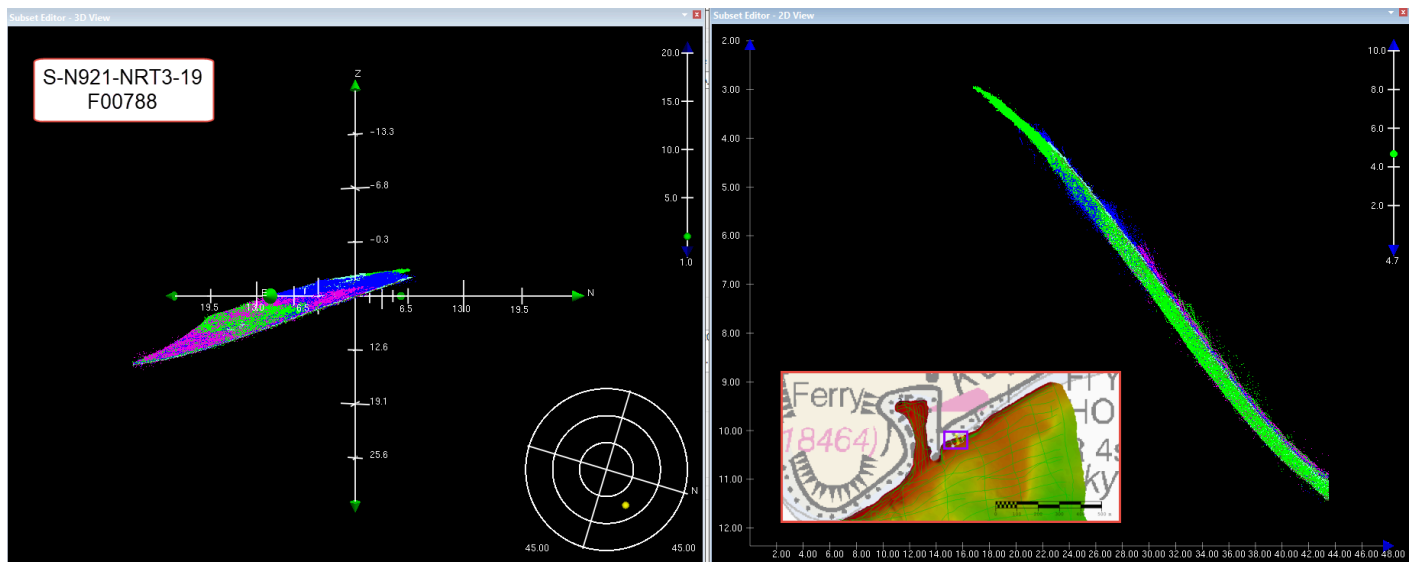
Figure 17: Example of a flier identified by QC tools over a rocky, kelp ridden shoreline.

QC Tools in Pydro Explorer was used to analyze the surfaces for fliers. There were 3 fliers identified on the finalized surface. Upon review, they were found to be primarily at the steep and rocky shoreline edges of the survey area (Figure 17).

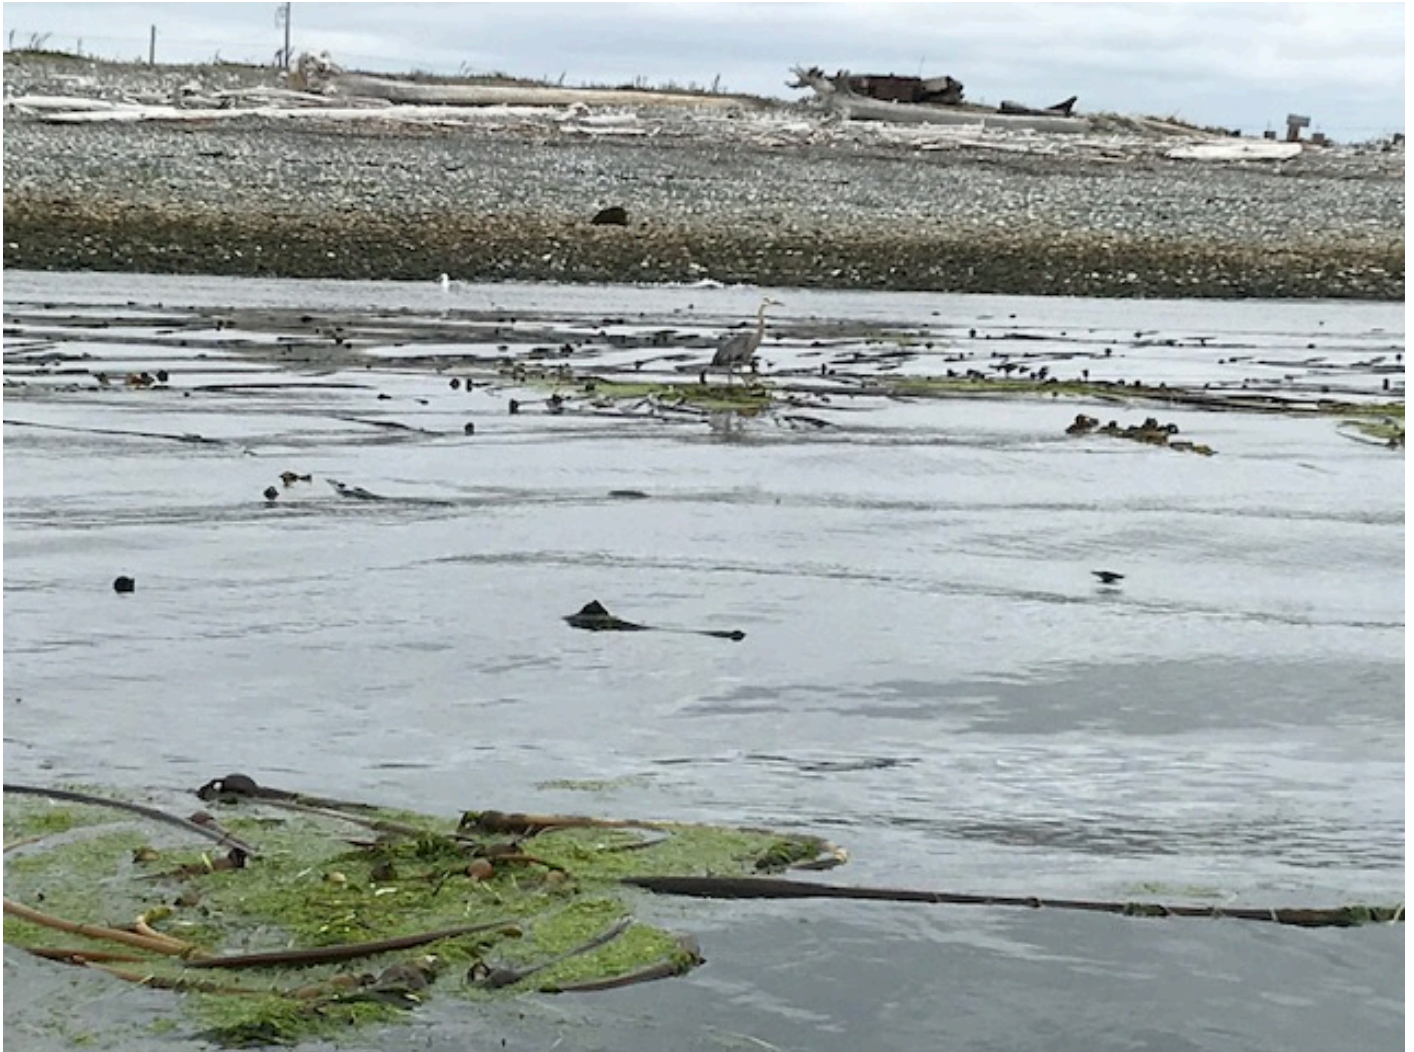
Figure 19: Example of heavy kelp observed on the shorelines of F00788.

Heavy kelp that is too thick to navigate was observed on both the western and eastern shorelines. This area has been encoded as a foul area, and provided the remarks "Foul with kelp" into the file feature file of this survey (Figure 22).
