U.S. Department of Commerce National Oceanic and Atmospheric Administration National Ocean Service		
]	DESCRIPTIVE REPORT	
Type of Survey:	Navigable Area	
Registry Number:	F00800	
	LOCALITY	
State(s):	Texas	
General Locality:	Galveston Bay	
Sub-locality:	Entrance to Galveston Bay	
	2020	
	CHIEF OF PARTY Dan Jacobs	
	LIBRARY & ARCHIVES	
Date:

## **Descriptive Report to Accompany Survey F00800**

Project: S-K924-NRT4-20 Locality: Galveston Bay Sublocality: Entrance to Galveston Bay Scale: 1:10000 February 2020 - February 2020 **NOAA Navigation Response Team 4** Chief of Party: Dan Jacobs

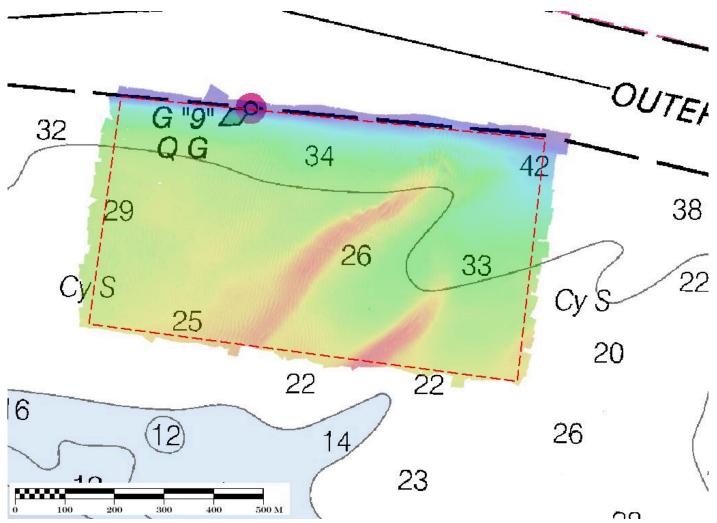
Figure 2: Survey limits (red dashed line) and Complete MBES Coverage, NOAA Chart 11324.

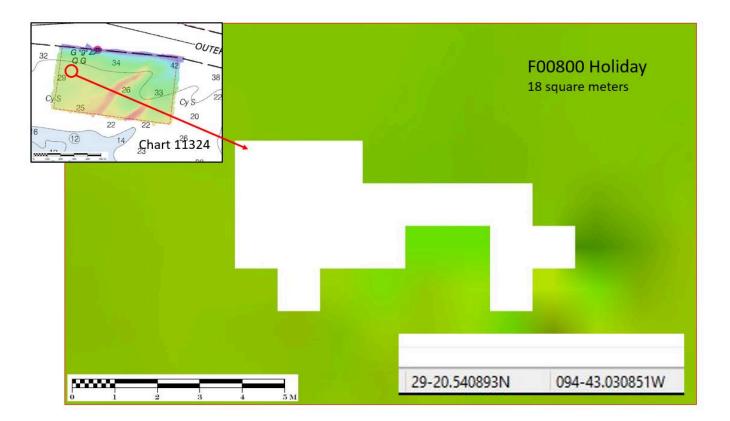
Figure 3: F00800 Holiday

1 holiday existed at 29-20.540893N 094-43.030851W. Its approximately 18 meters square.

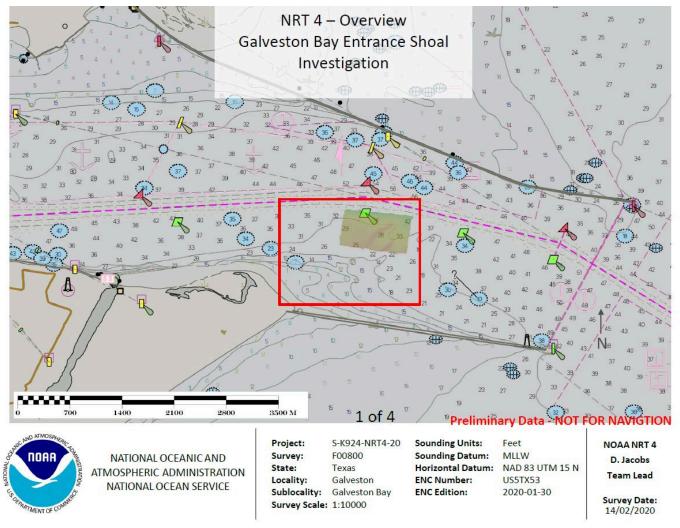
Figure 4: Overview, F00800 Survey Coverage onto ENC US5TX53M.

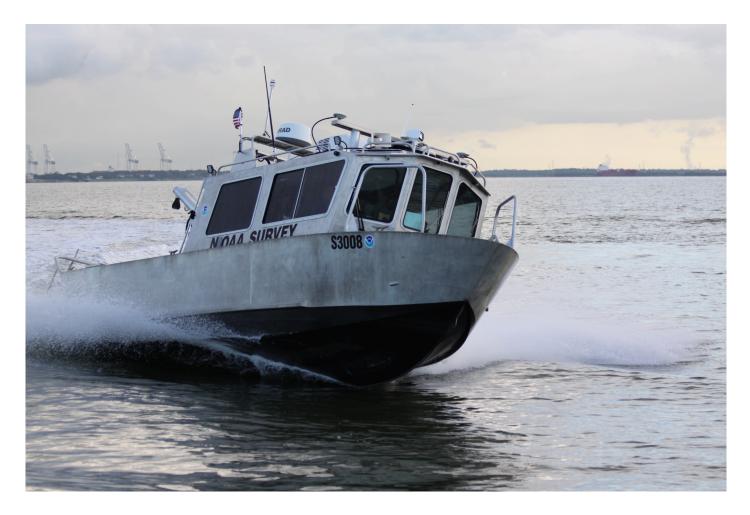
Figure 5: NOAA S3008

NOAA Survey Vessel S3008 is a 30 foot, aluminum hulled fire boat modified for NOAA hydrographic survey operations. Its powered by dual 225 horsepower Honda outboard engines. A Kohler 7.5 EKD generator supplies AC power for two workstations, 5 monitors, one POS system, one multibeam echo sounder system, and one side scan sonar system.

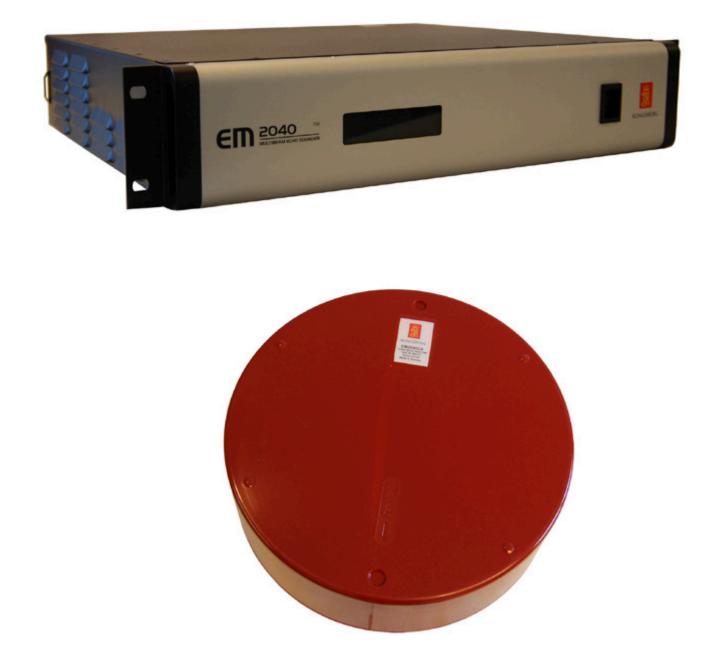
## Figure 6: Kongsberg EM2040C Multibeam Echo Sounder

The Kongsberg EM2040C system is a digital recording multibeam echo sounder which is capable of operating at 200kHz, 300kHz, 400kHz, or in a Frequency Modulation (FM) Chirp. The system is comprised of a receiver unit that is hull mounted, a Hydrographic Work Station (HWS), and a Processor Unit (PU). The EM2040C is operated through Seafloor Information System (SIS) software; version 4.3.2. The EM2040C is used to acquire full and partial bottom bathymetric coverage throughout a survey area to determine least

depths over critical items such as wrecks, obstructions, dangers-to-navigation, and general object detection. The maximum depth range for a single head system in cold ocean water is 520 m at 200 kHz with a swath width up to 580 m. The angular coverage for 200 to 320 kHz is 130° with one sonar head, allowing coverage 4.3 times water depth. For frequencies above 320 kHz the angular coverage per head is gradually decreasing to 70° at 400 kHz. The nadir beam width is 1° x 1° at 400 kHz. The system has a maximum ping rate of 50 Hz with 400 soundings per ping.

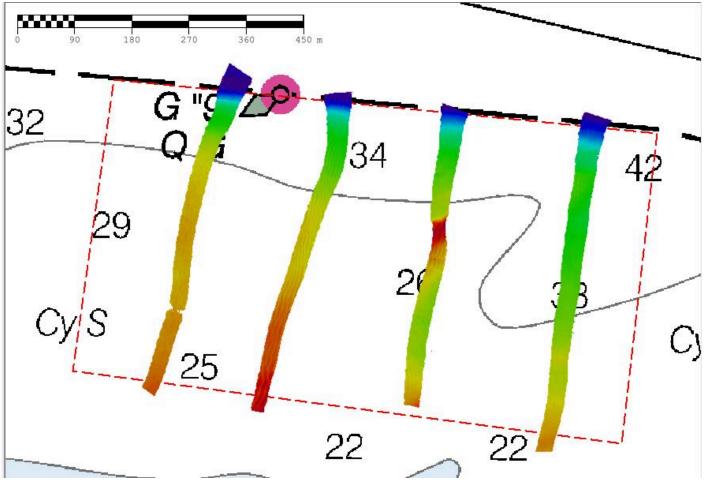
Per 2019 HSSD paragraph 5.2.4.2 lineal mileage of crosslines exceeded 4 percent of main scheme mileage. 16.4 LNM of mainscheme survey lines were collected for F00800. Four MBES crosslines totaling 1.11 LNM were acquired at the end of DN045 totaling 6.7 percent of MBES mainscheme acquisition. A 1 meter crossline surface was compared to a 1 meter mainscheme surface invoking the Pydro Compare Surfaces script. The two surfaces were in excellent agreement with each other as 99 percent of the nodes passed the allowable error fraction. The analysis was performed on MBES data reduced to MLLW using ellipsoidally referenced RTX SBET methods. Please reference the folder named Crossline\_Comparisons for all analysis outputs. See graphics, below.

Figure 7: F00800 Crossline Coverage, 1m Surface.

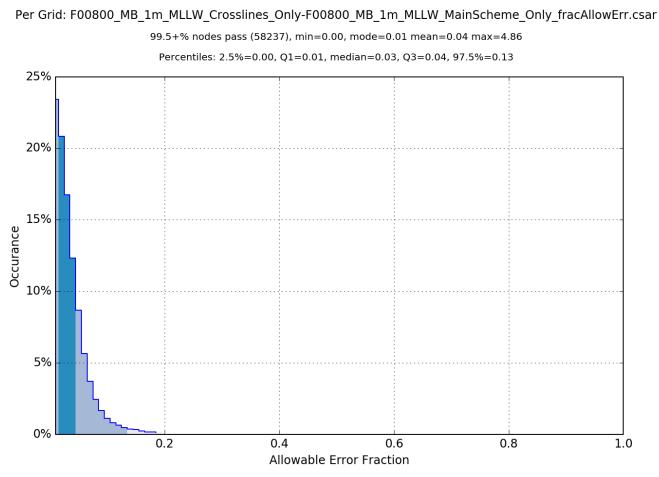
*Figure 8: F00800 Crossline Coverage, 99 percent nodes pass allowable error fraction.*

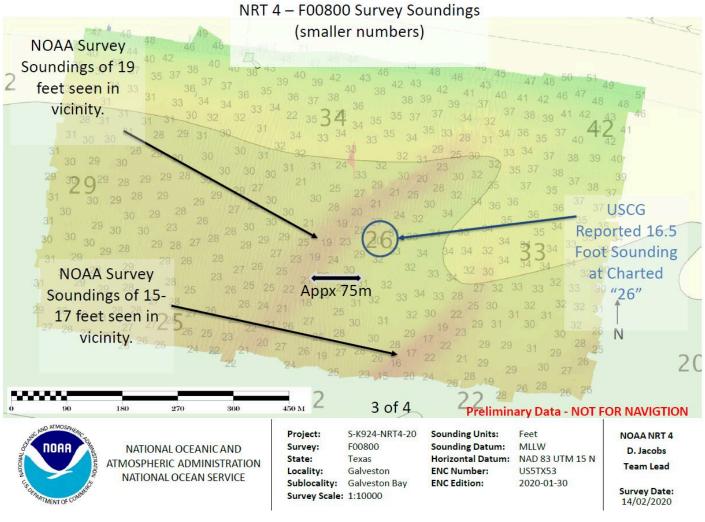
Survey soundings with depths within 3 feet of charted (11324) depths were deemed to be acceptable taking into account sand waves and hydro dynamics in this constricted entrance area. All charted soundings on ENC US5TX53M and Raster 11324 are within two feet of survey soundings. However, shoaling trends are occurring in two regions, between charting soundings. Charted (11324) depths between 25-26 feet were surveyed at 19 to 21 feet. Likewise, charted (11324) depths between 22 to 26 feet were surveyed at 15 and 20. The shoaling is not deemed a danger to navigation (DtoN) as vessel traffic bearing drafts greater than 12 feet do not occur outside of the shipping channel. Graphic of the shoals, below.

Figure 9: Shoaling occurring between ENC US5TX53M soundings.

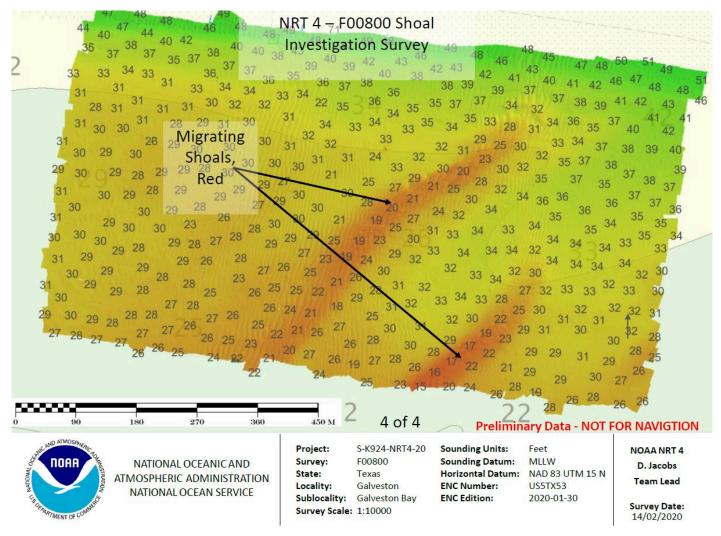
Shoaling trends are occurring in two regions inside of the sheet limits, between charting soundings. Charted (11324) depths between 25-26 feet were surveyed at 19 to 21 feet. Likewise, charted (11324) depths between 22 to 26 feet were surveyed at 15 and 20. The shoaling is not deemed a danger to navigation (DtoN) as vessel traffic bearing drafts greater than 12 feet do not occur outside of the shipping channel. Graphic shown below. Graphics were provided to Western Gulf Navigation Manager, Chief NRB, Project Manager of NRB and crew member LTJG Collin Walker. See project correspondence folder for specific communication. A USCG Local Notice to Mariners chart correction was issued for Week 8 subsequent to the discovery of the shoaling and the discovery of a non-DtoN obstruction on 17FEB2020. See "Uncharted Features" section of this descriptive report for additional information about this obstruction.

Figure 10: Shoaling in two places, ENC US5TX53M. Migrating shoals are reddish color on the 1 meter grid. Survey soundings in feet shown atop of survey grid.

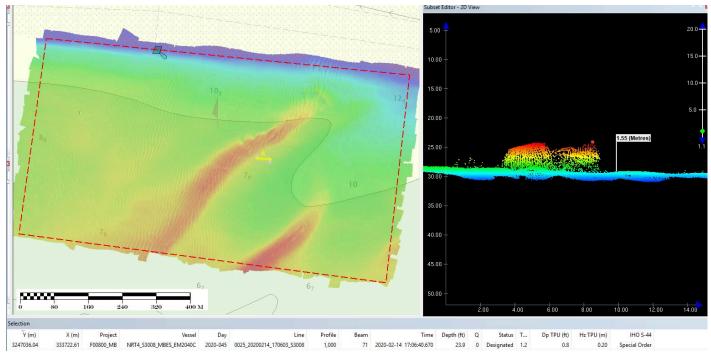
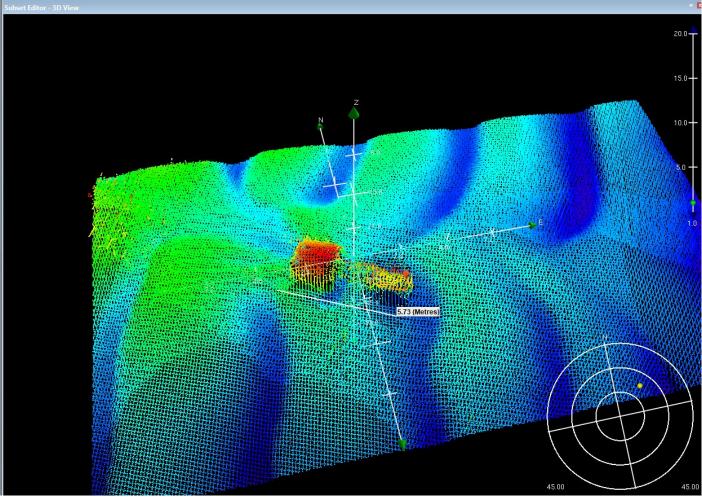
A sunken obstruction was discovered on 17FEB2020 during the cleaning phase of F00800. Conferring with USCG SFO Galveston, the object is thought to be Buoy "9" from a time not specified. The object is located at 29.-20.4878N 094-42.7612W with a height of 1.55 meters. Its least depth is 24 feet with a length of approximately 6 meters. Please reference the pdf entitled "Re\_ USCG Report, Charted Depth Galveston" for additional information pertaining to this new object. A USCG Local Notice to Mariners

Figure 12: Non DtoN object seen in F00800 1 meter Bathy, 2D.

Figure 13: Non DtoN object seen in F00800 1 meter Bathy, 3D.

chart correction was issued for Week 8 subsequent to the discovery of the shoaling and the discovery of a non-DtoN obstruction on 17FEB2020. See "Uncharted Features" section of this descriptive report for additional information about this obstruction.

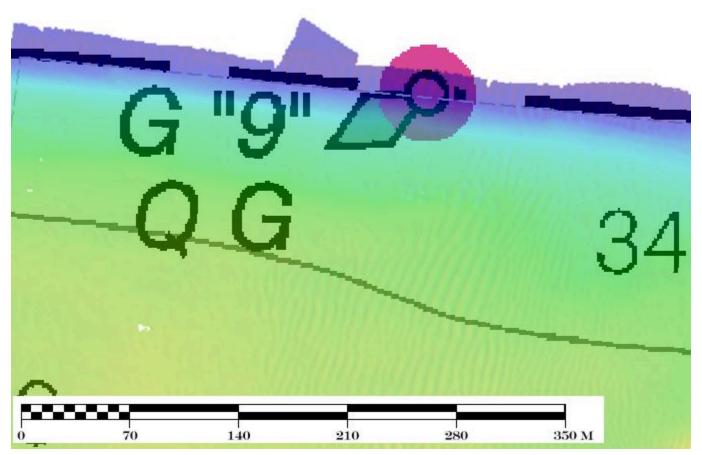
Galveston Entrance Buoy "9" resided on the edge of survey F00800. It was observed to be on station and serving its intended purpose. See the project's final feature file for additional information.

Figure 15: Buoy "9" observed to be on station and serving its intended purpose.
