DESCRIPTIVE REPORT

Type of Survey: Basic Hydrographic Survey

Registry Number: F00811

Sub-locality: Dawes Glacier and Endicott Arm

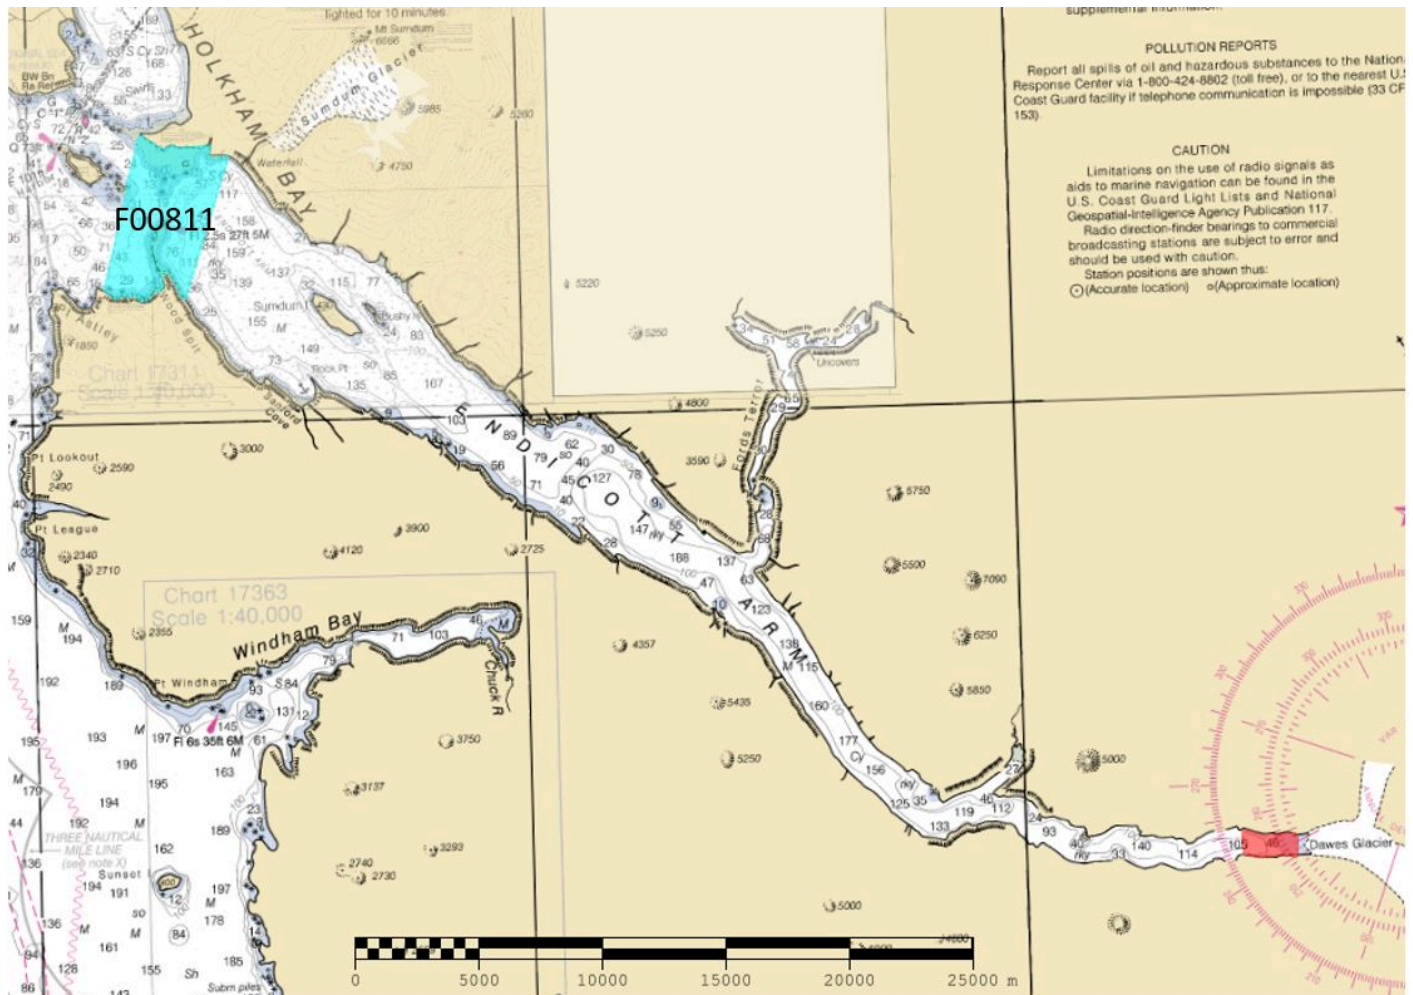
Figure 1: F00811 assigned survey area (Charts 17311 & 17360)

The survey area is referred to as F00811, "Endicott Arm and Dawes Glacier" (sheet 1) in the project instructions. The survey area is approximately 5.57 square nautical miles and located south of Tracy Arm, AK.

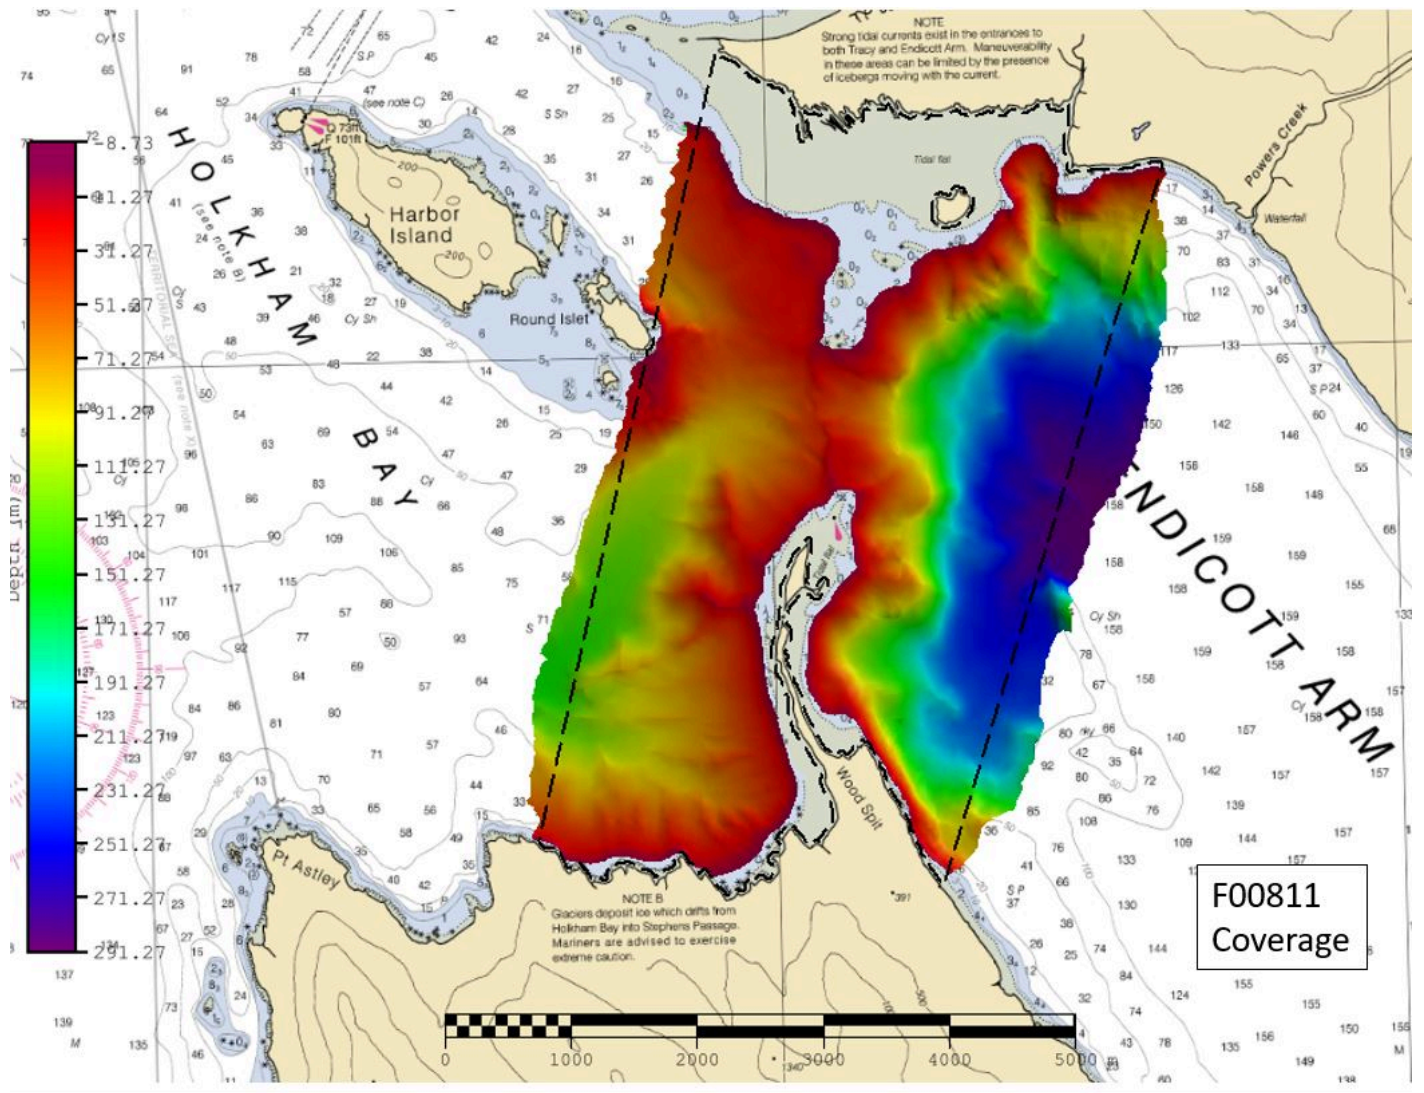
Figure 2: F00811 MBES coverage and assigned survey limits (Chart 17311)

Complete multibeam echosounder coverage was acquired to the inshore limit of hydrography, the Navigable Area Limit Line (NALL). The NALL is defined as the most seaward of the following: the surveyed 3.5-meter depth contour, the line defined by the distance seaward from the observed MHW line which is equivalent to 0.8 millimeters at chart scale (the assigned sheet limits closely reflect this) or the inshore limit of safe navigation. Areas where F00811 survey coverage reached neither 3.5 meters water depth, or the assigned sheet limits, were due to the presence of thick kelp and lack of a shoreline window to further develop the NALL.

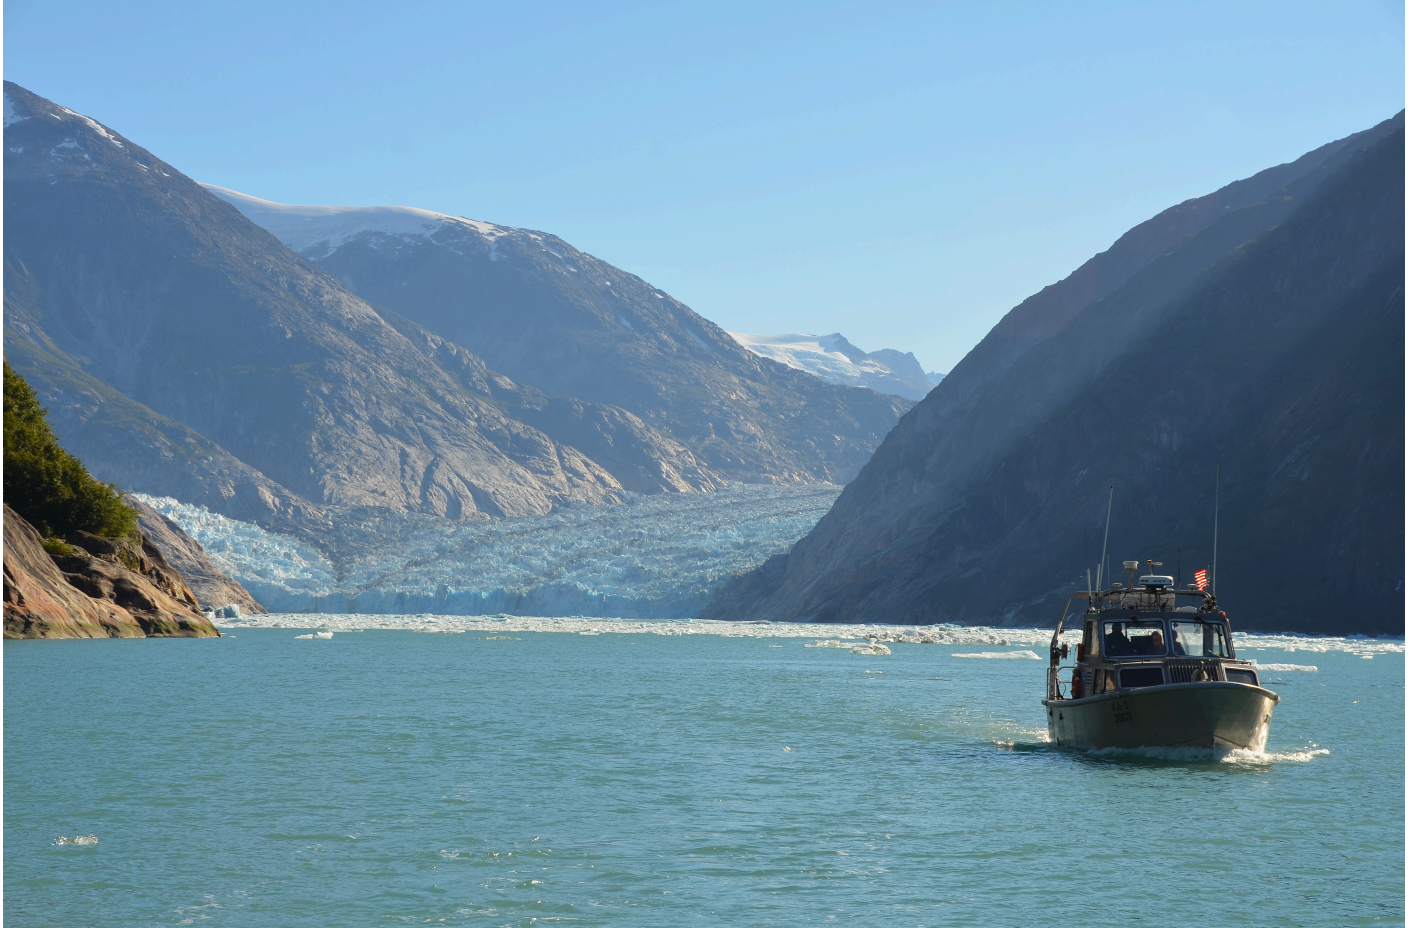
Figure 4: Example of NOAA ship RAINIER survey launch in front of ice field near the face of Dawes Glacier.

Coverage was not acquired near the face of Dawes Glacier due to ice conditions on the two days we attempted to reach this area. The ice field extended over the survey area and prevented acquisition due to safety concerns. This can be seen in Figure 4 and survey junction H11759.

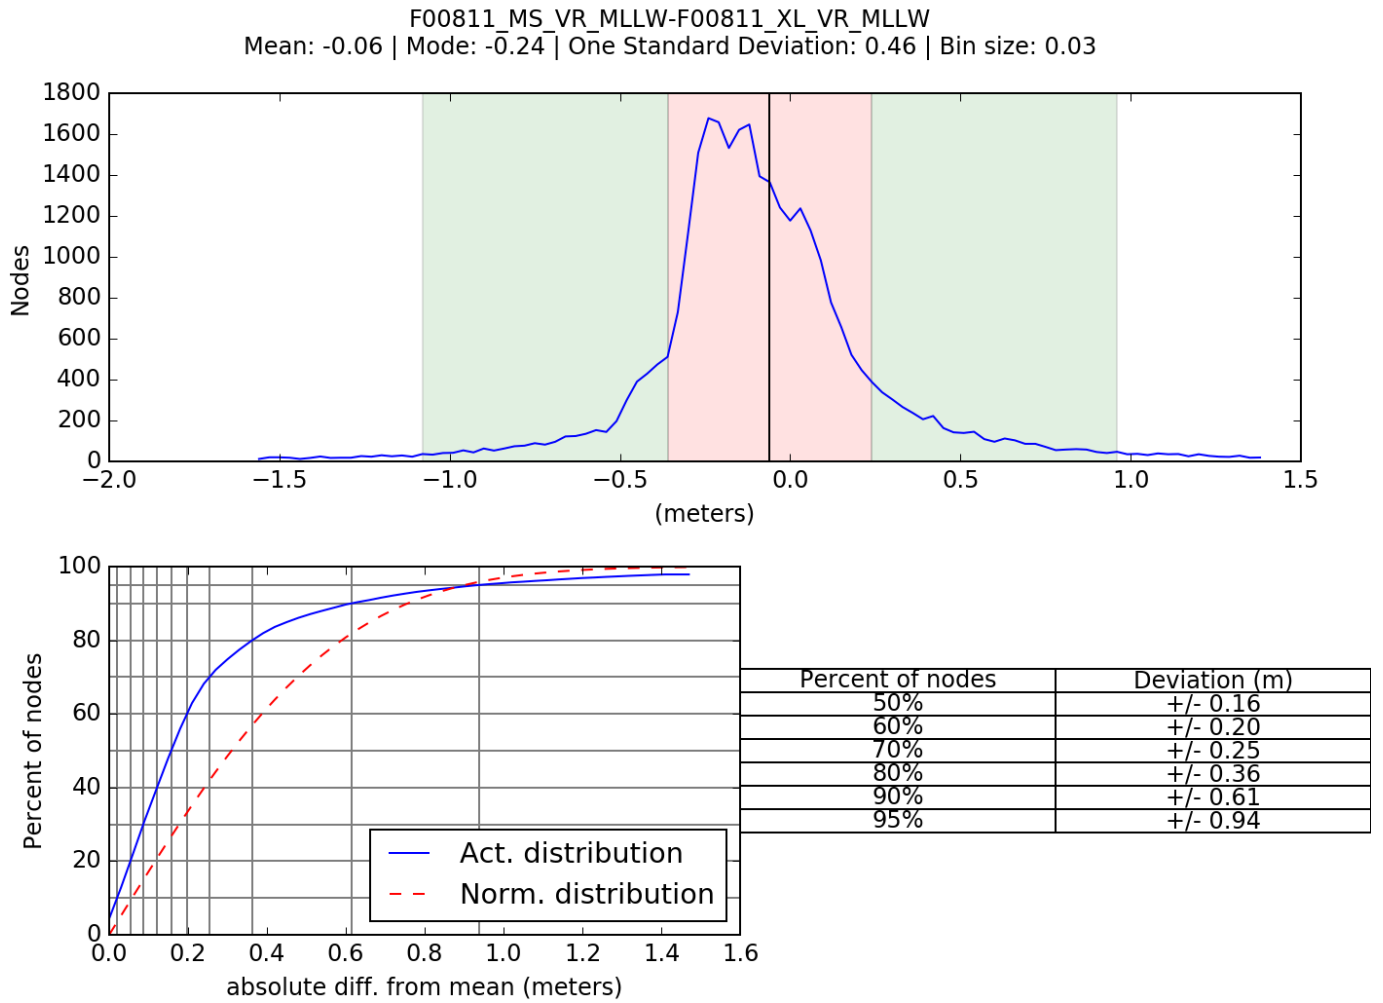
Figure 6: Pydro derived plot showing percentage-pass value of F00811 mainscheme to crossline data.

99.5+% nodes pass (31097), min=0.0, mode=0.1 mean=0.1 max=1.9

Percentiles: 2.5%=0.0, Q1=0.0, median=0.1, Q3=0.2, 97.5%=0.5

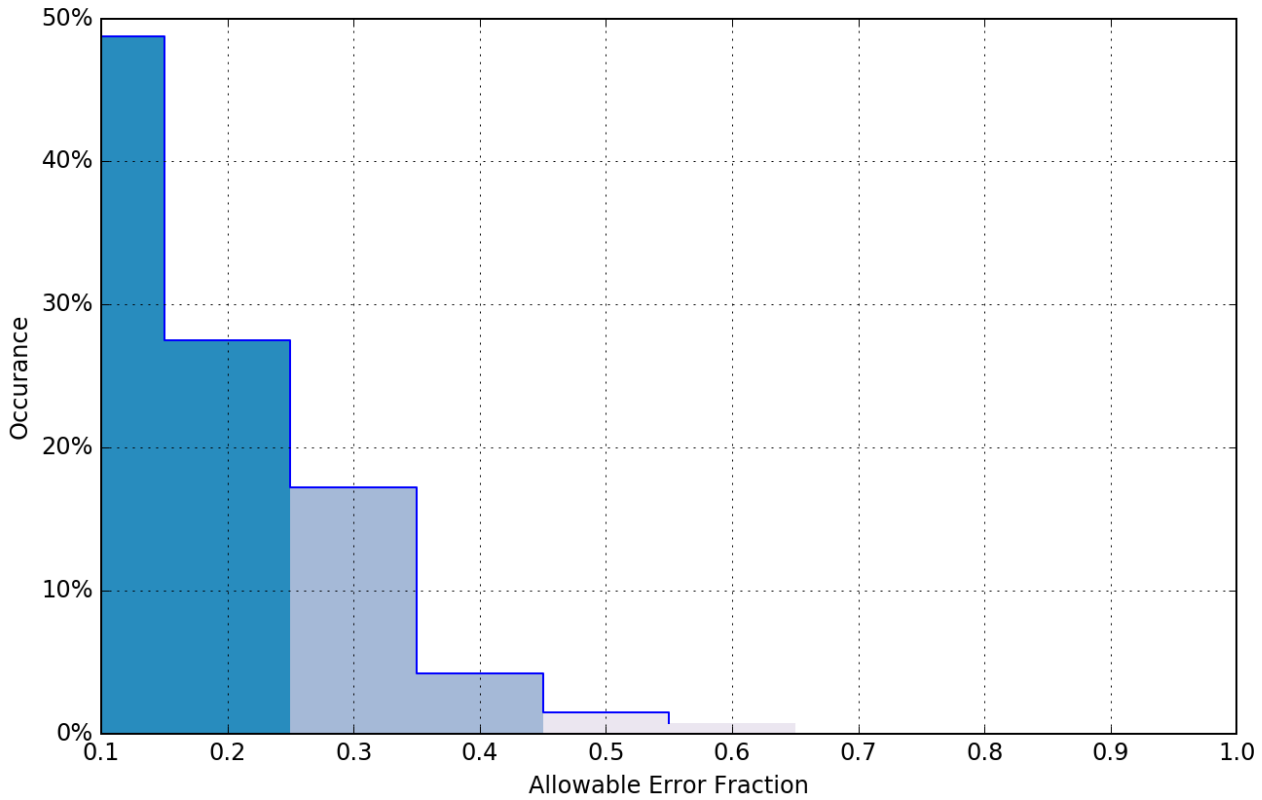
Figure 7: Pydro derived plot showing absolute difference statistics of F00811 mainscheme to crossline data.

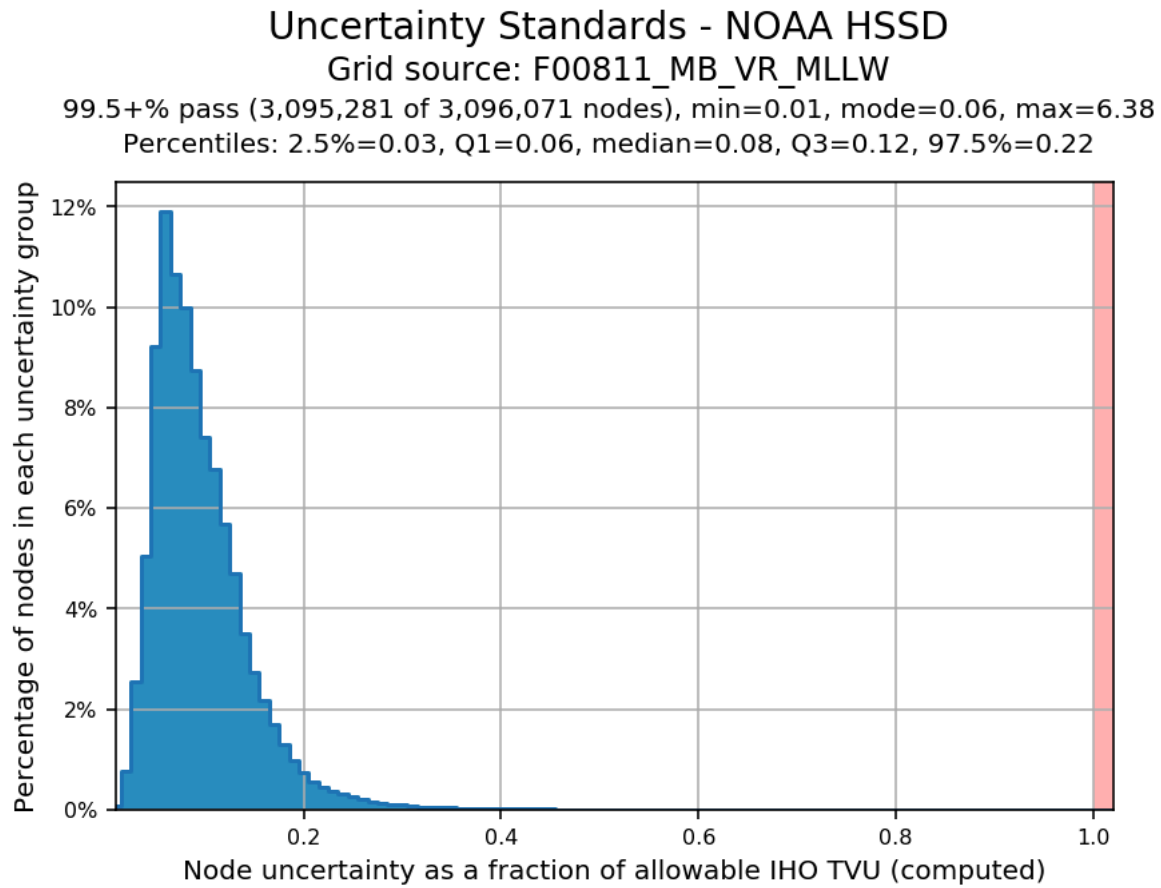
Figure 8: Pydro derived plot showing TVU compliance of F00811 finalized multi-resolution MBES data.

Uncertainty values of the submitted finalized grids were calculated in Caris using "Greater of the Two" of uncertainty and standard deviation (scaled to 95%). Grid QA v5 within Hydro QC Tools was used to analyze F00811 TVU compliance. F00811 met HSSD requirements in over 99.5 percent of grid nodes, which is shown in the histogram plot below.

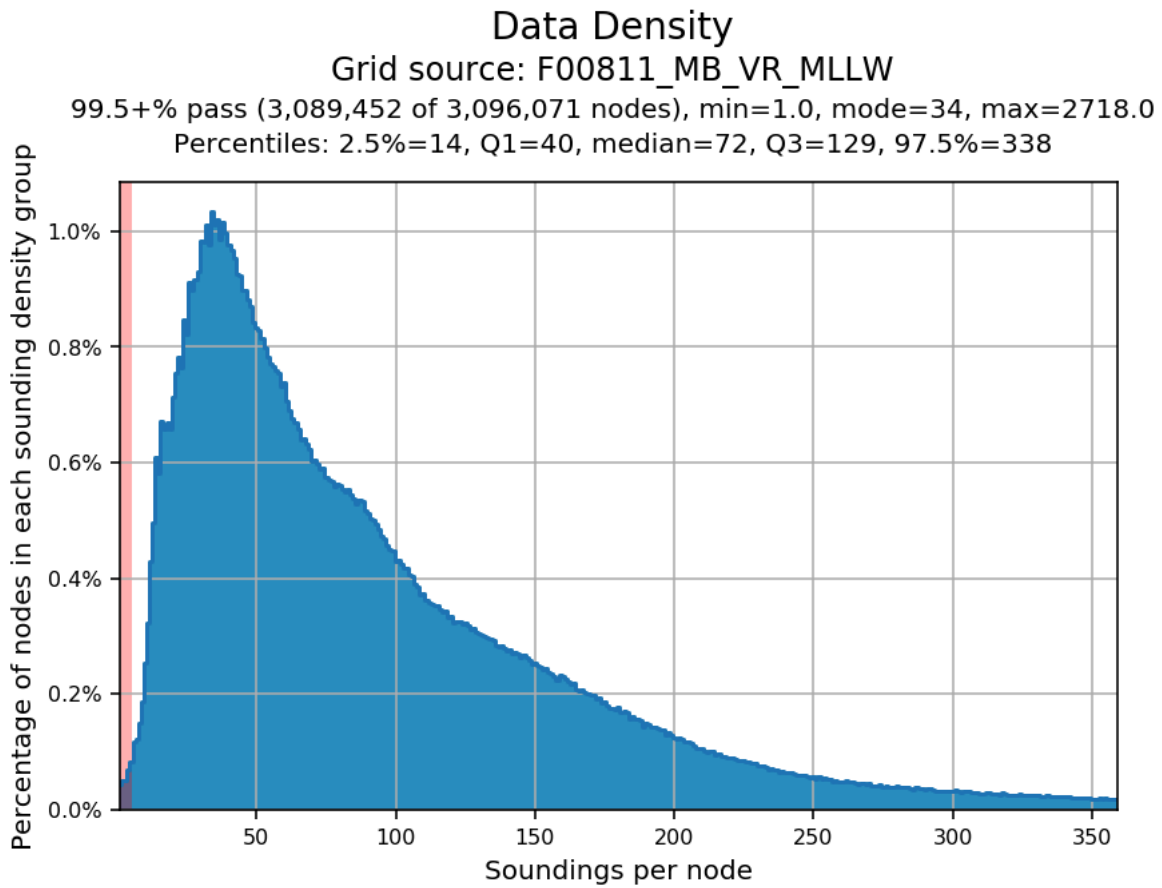
Figure 9: Pydro derived histogram plot showing HSSD density compliance of F00811 finalizd variable-resolution MBES data.

Pydro QC Tools 2 Grid QA was used to analyze F00811 multibeam echosounder (MBES) data density. The submitted F00811 variable-resolution (VR) surface met HSSD density requirements shown in the histograms below.

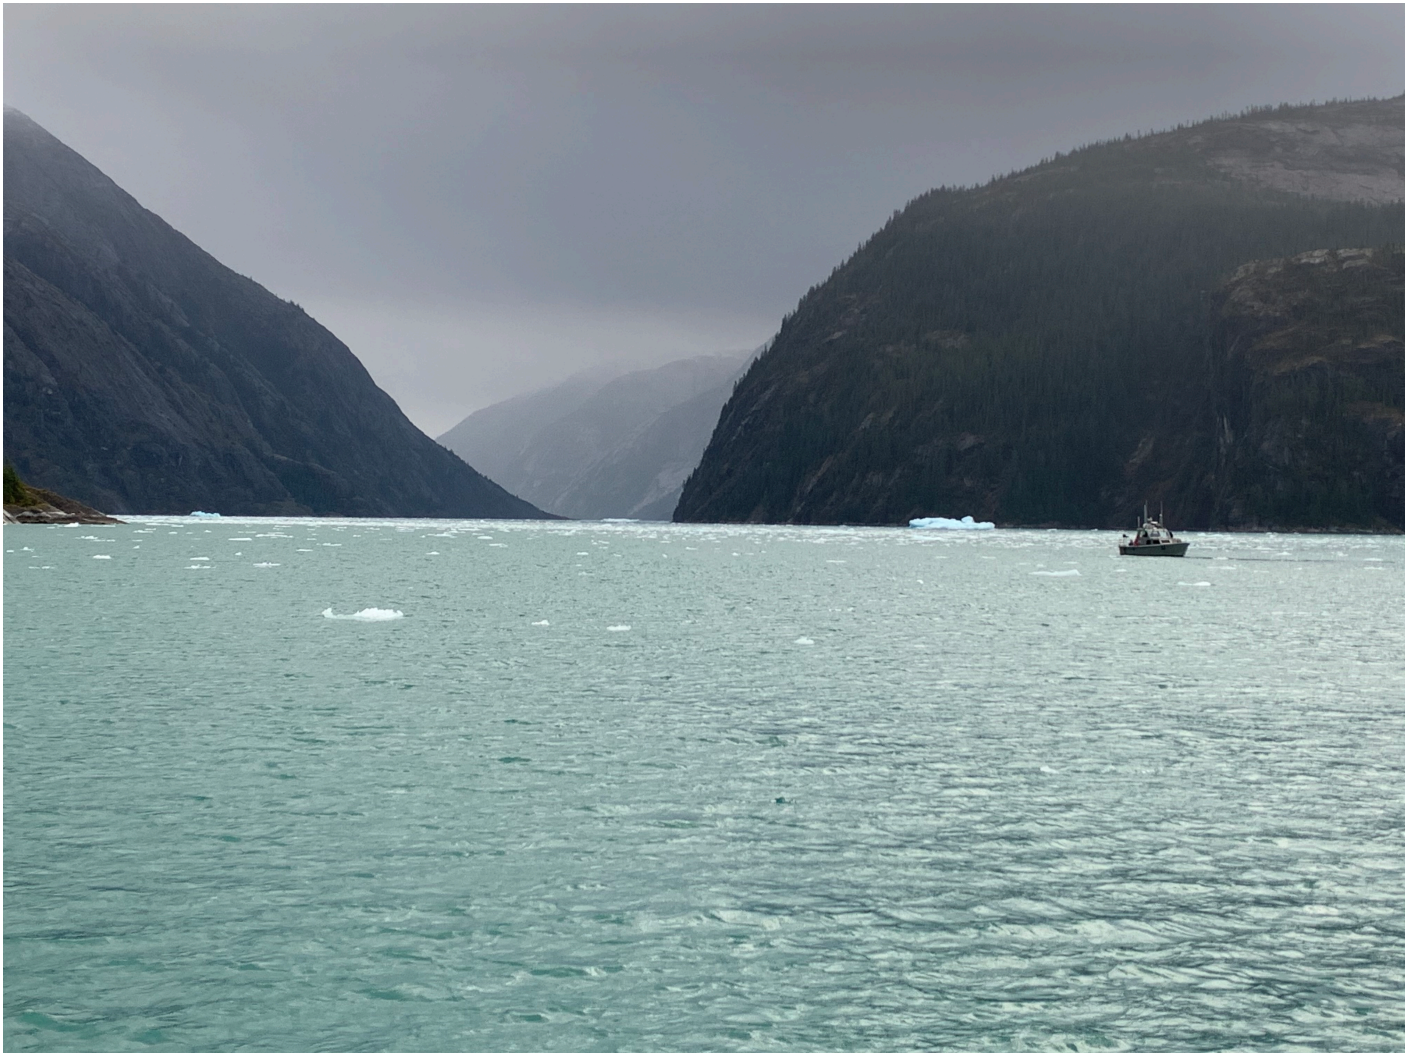
Figure 10: Example of ice field blocking survey near the face of Dawes Glacier.

Junction H11579 was not completed as assigned in project instructions due to ice conditions. Ice field coverage extended over the survey area preventing acquisition due to safety concerns.

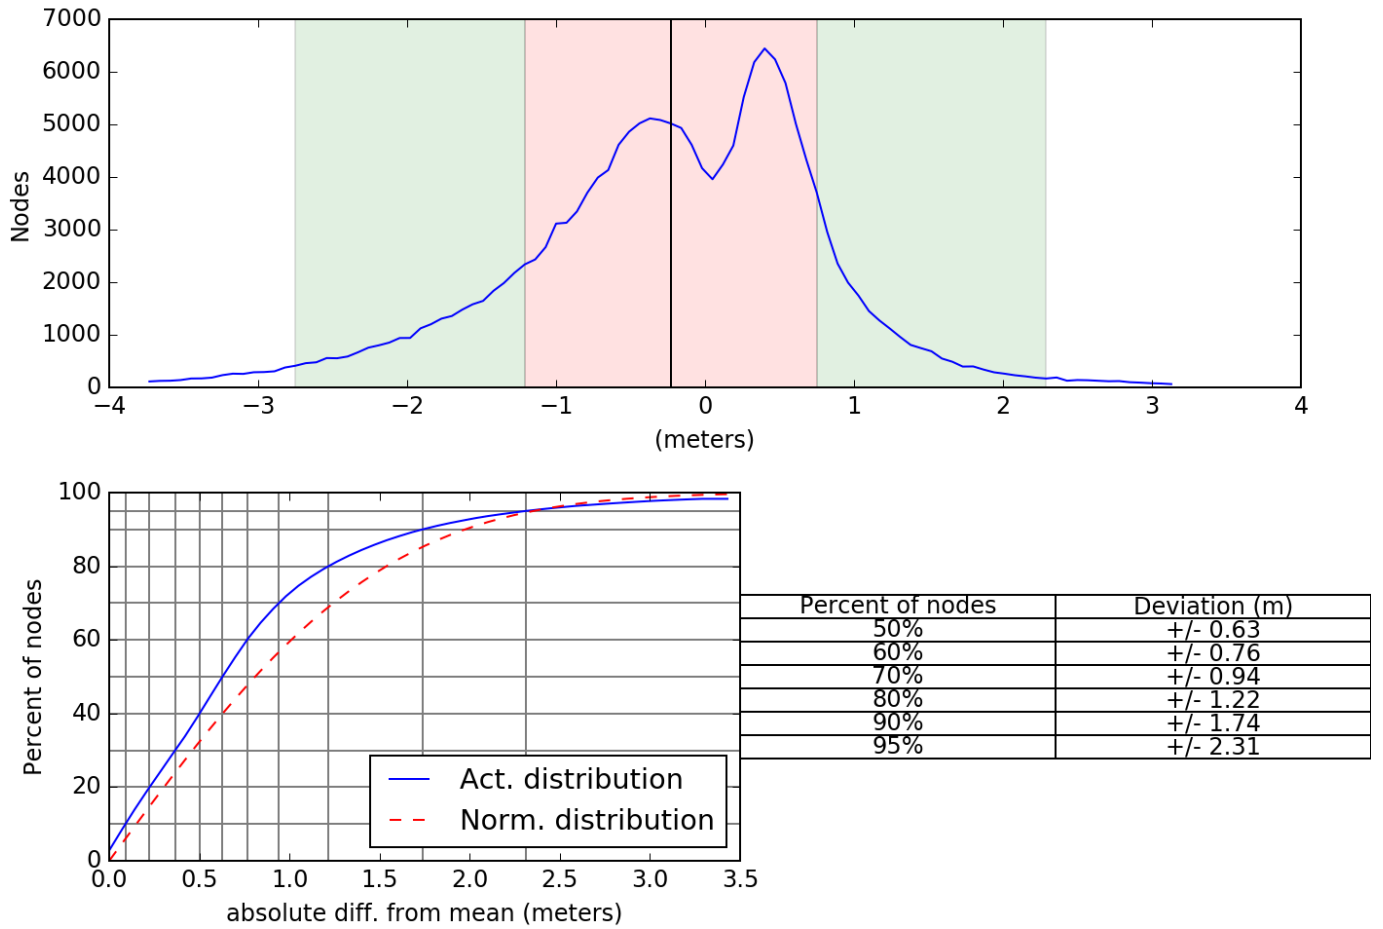
Figure 12: Pydro derived plot showing percentage-pass value of F00811 to H11998.

85% nodes pass (152416), min=0.0, mode=0.1 mean=0.5 max=14.7

Percentiles: 2.5%=0.0, Q1=0.1, median=0.2, Q3=0.6, 97.5%=2.3

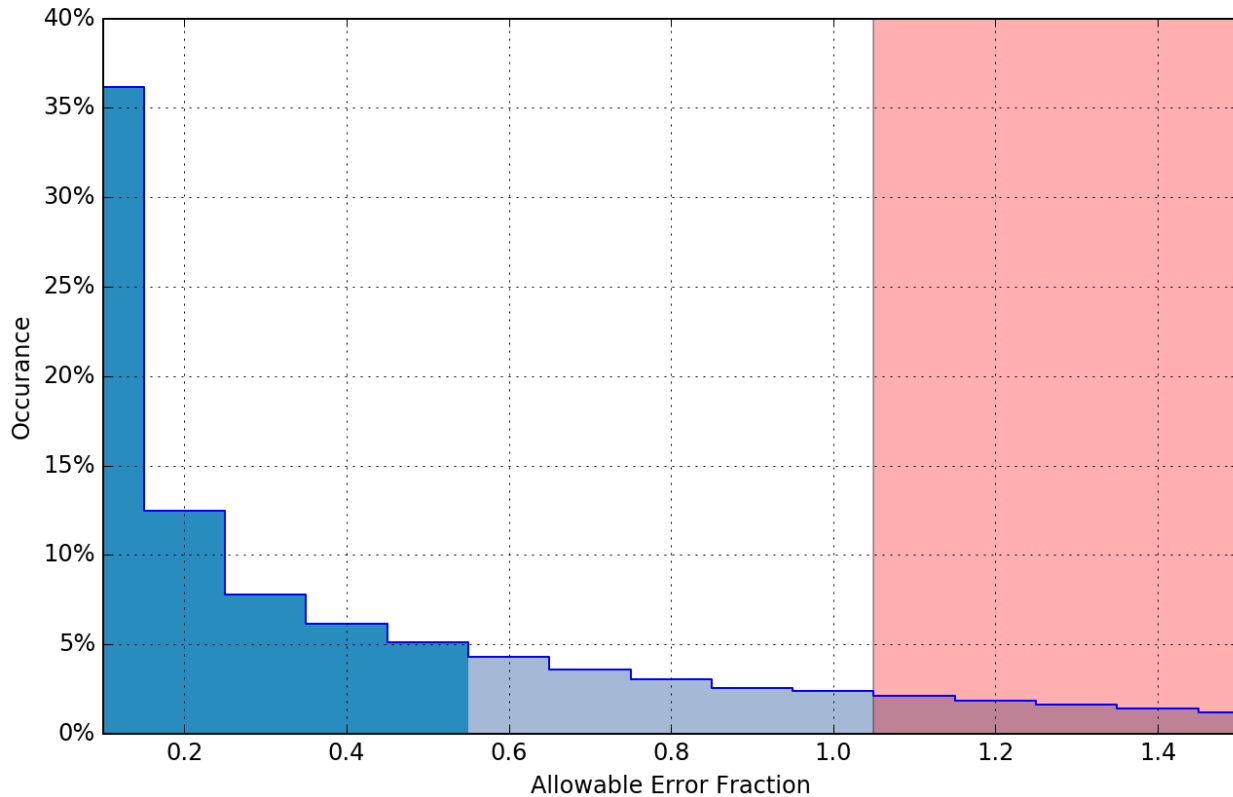
Figure 13: Pydro derived plot showing absolute difference statistics of F00811 to H11998.

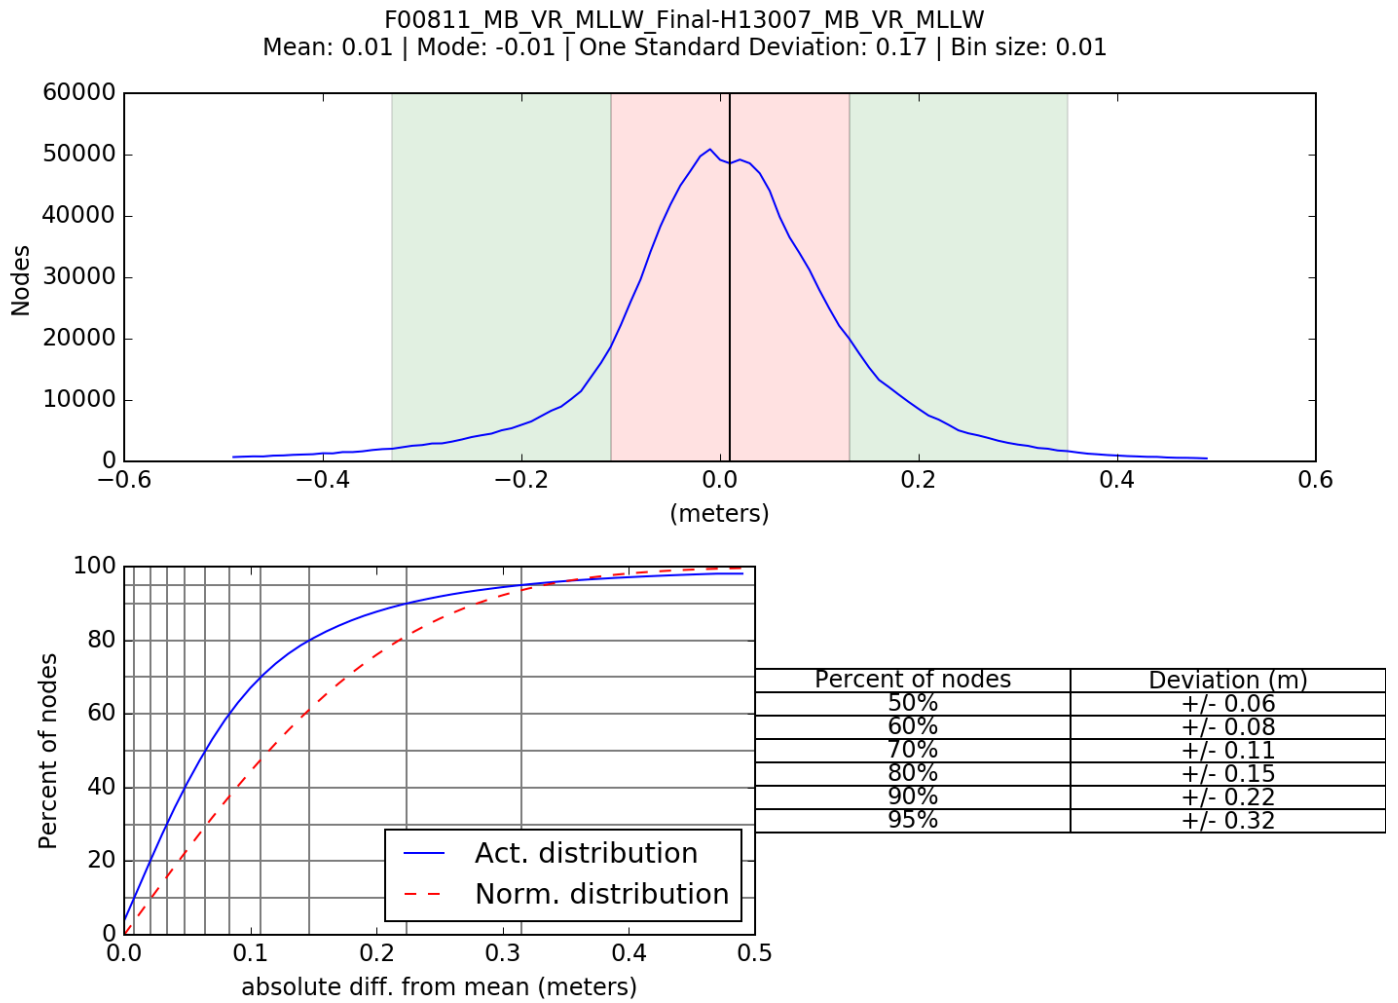
Figure 15: Pydro derived plot showing percentage-pass value of F00811 to H13007.

99.5+% nodes pass (1256284), min=0.0, mode=0.1 mean=0.1 max=5.7

Percentiles: 2.5%=0.0, Q1=0.0, median=0.1, Q3=0.1, 97.5%=0.4

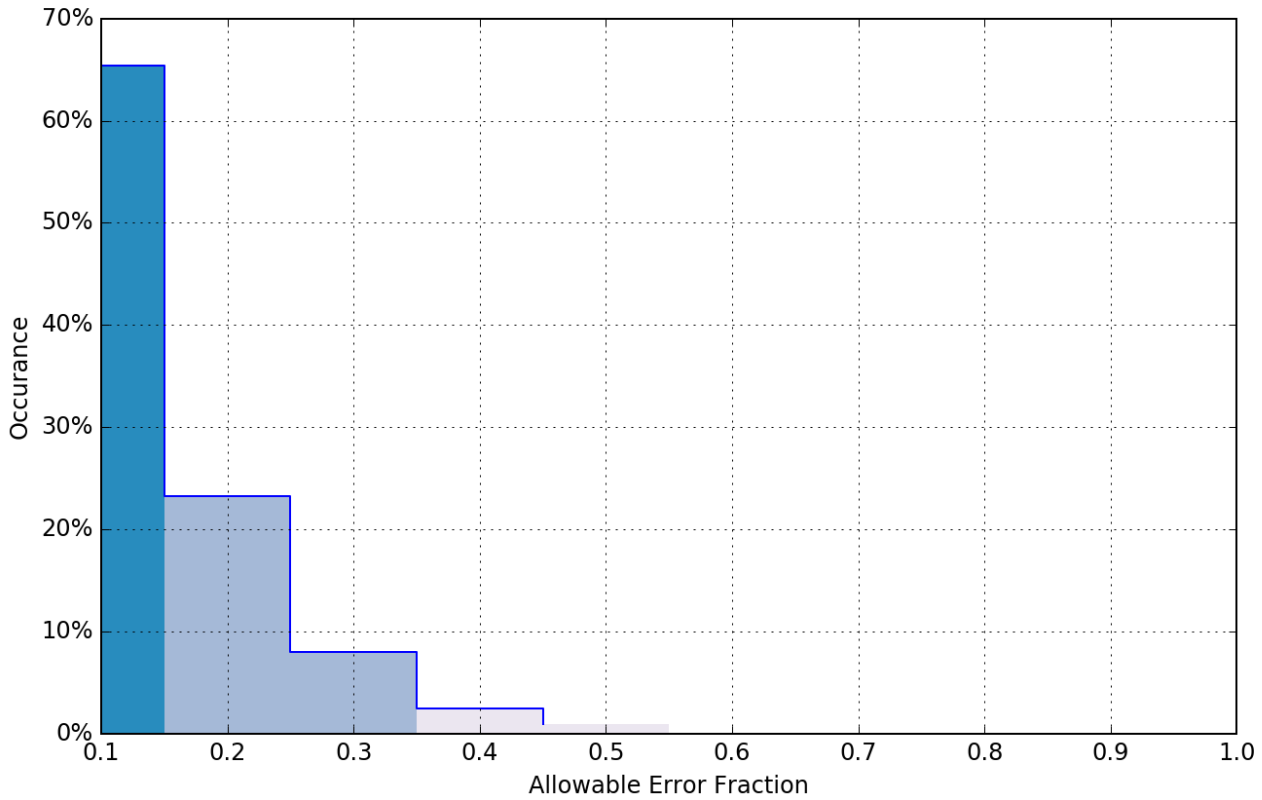
Figure 16: Pydro derived plot showing absolute difference statistics of F00811 to H13007.

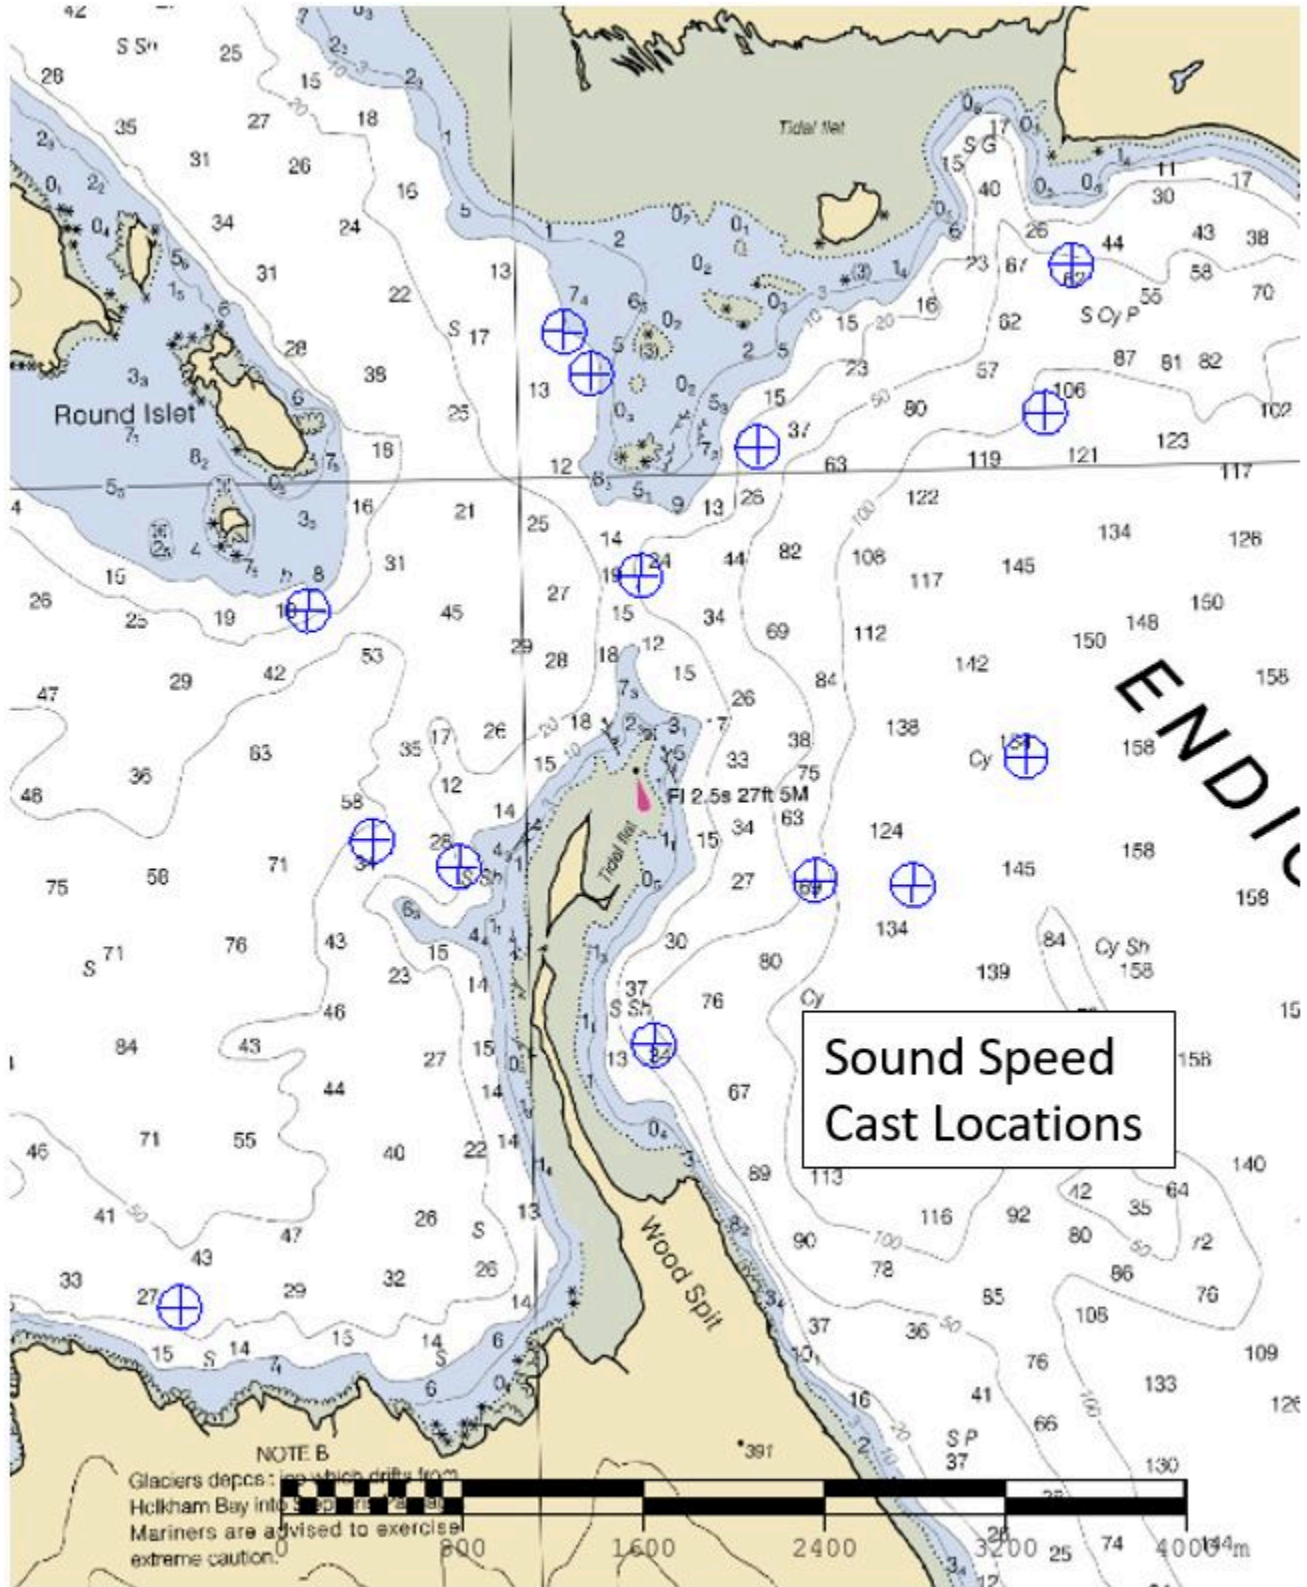
Figure 19: F00811 sound speed cast locations.

Fourteen sound speed profiles were acquired for this survey at discrete locations within the survey area at least once every four hours, when significant changes in surface sound speed were observed, or when operating in a new area. Sound speed profiles were obtained using Sea-Bird 19plus SEACAT Profilers. All casts were concatenated into a master file and applied to MBES data using the "Nearest distance within time" (4 hours) profile selection method.

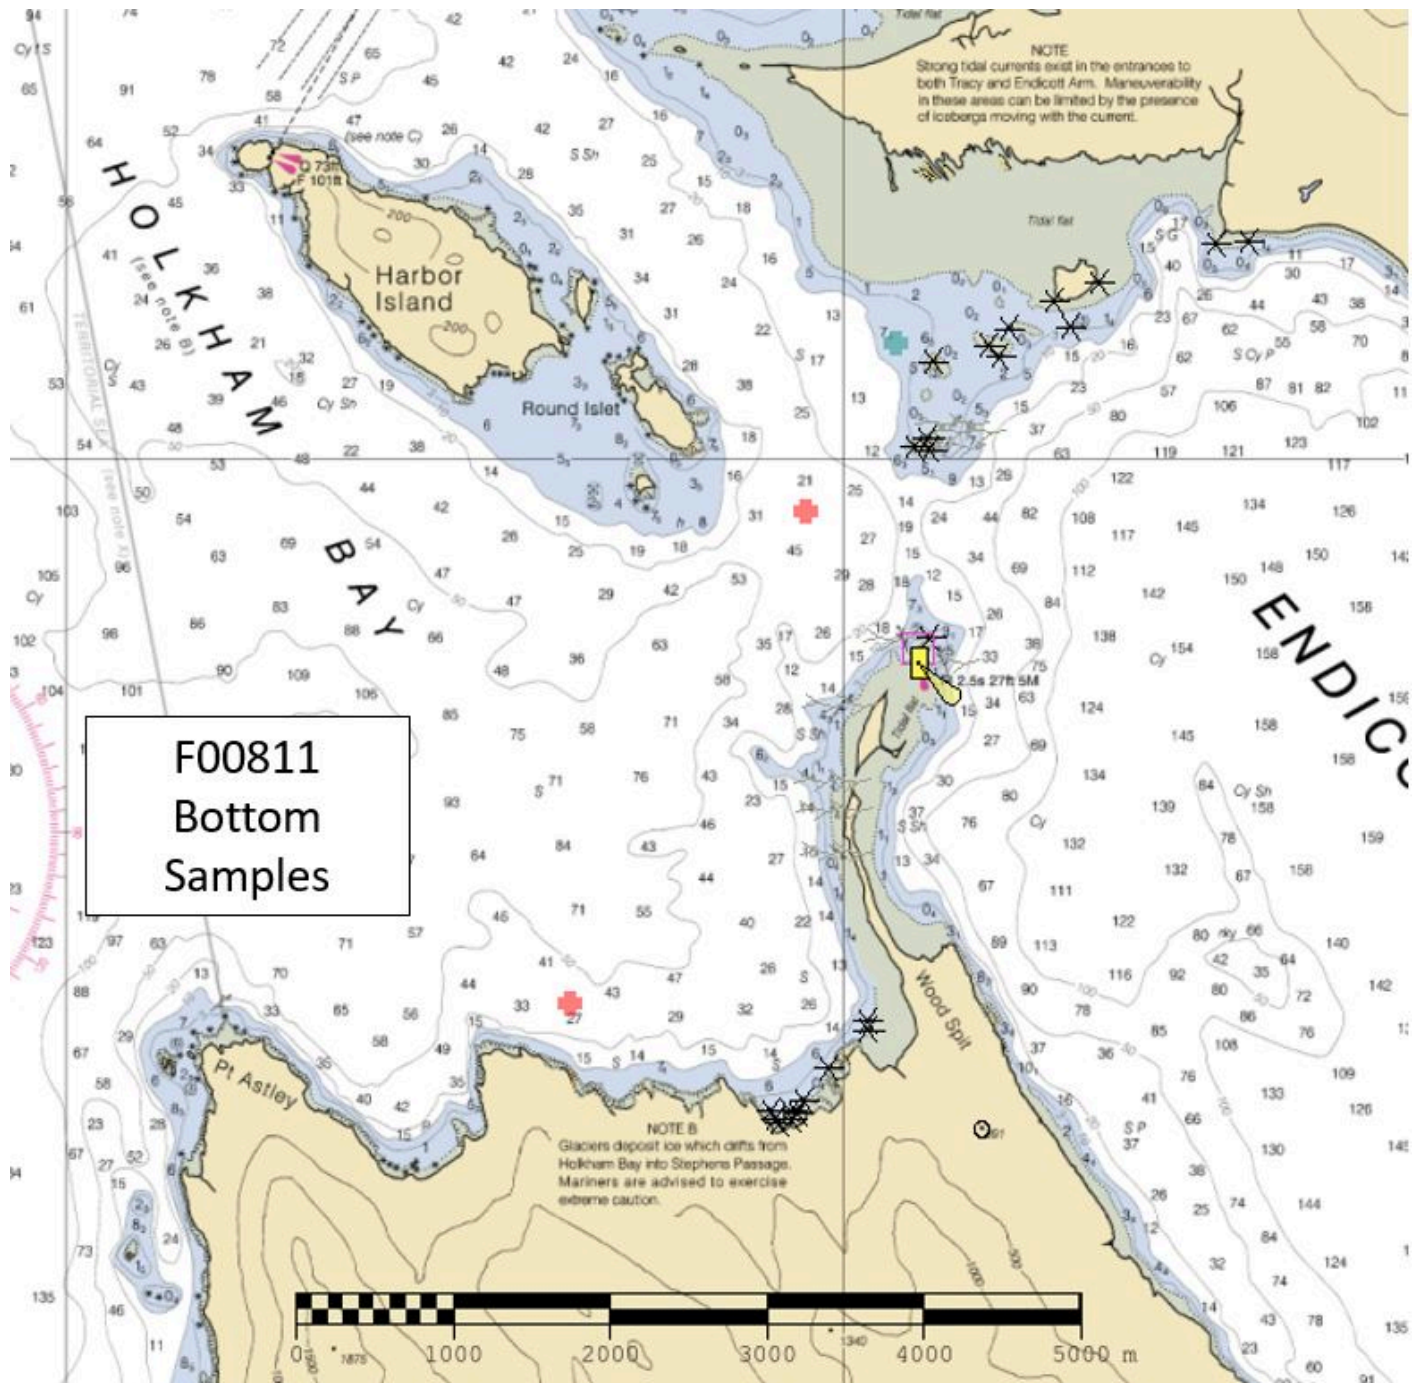
Figure 21: F00811 Bottom Samples.

Three bottom sample locations were assigned for F00811 after their positions were revised at the request of the hydrographer due to depth and the possibility of potentially new anchorage locations. There are no images to accompany bottom samples. The results of the bottom samples acquired are included in the F00811 Final Feature File submitted with this report.

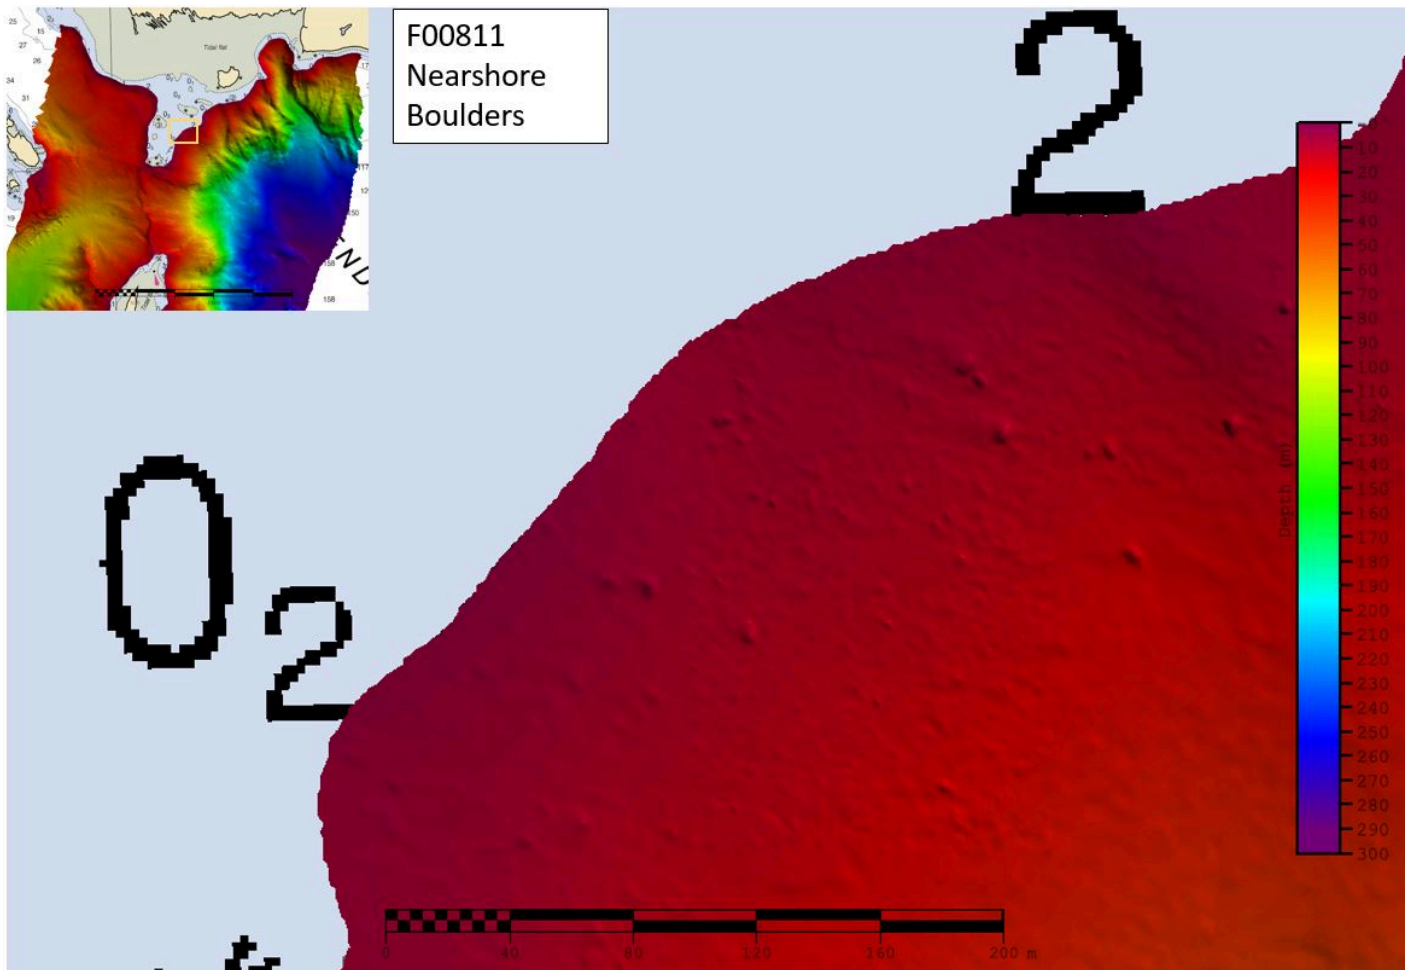
Figure 22: Example of F00811 surface, nearshore area with boulders.

Several icebergs carrying carrying large boulders or ice rafted debris were observed in the area of the survey grounds. It was also observed that several icebergs were stranded in shallow water in the survey area. This means that icebergs could be depositing large boulders in shallow water.

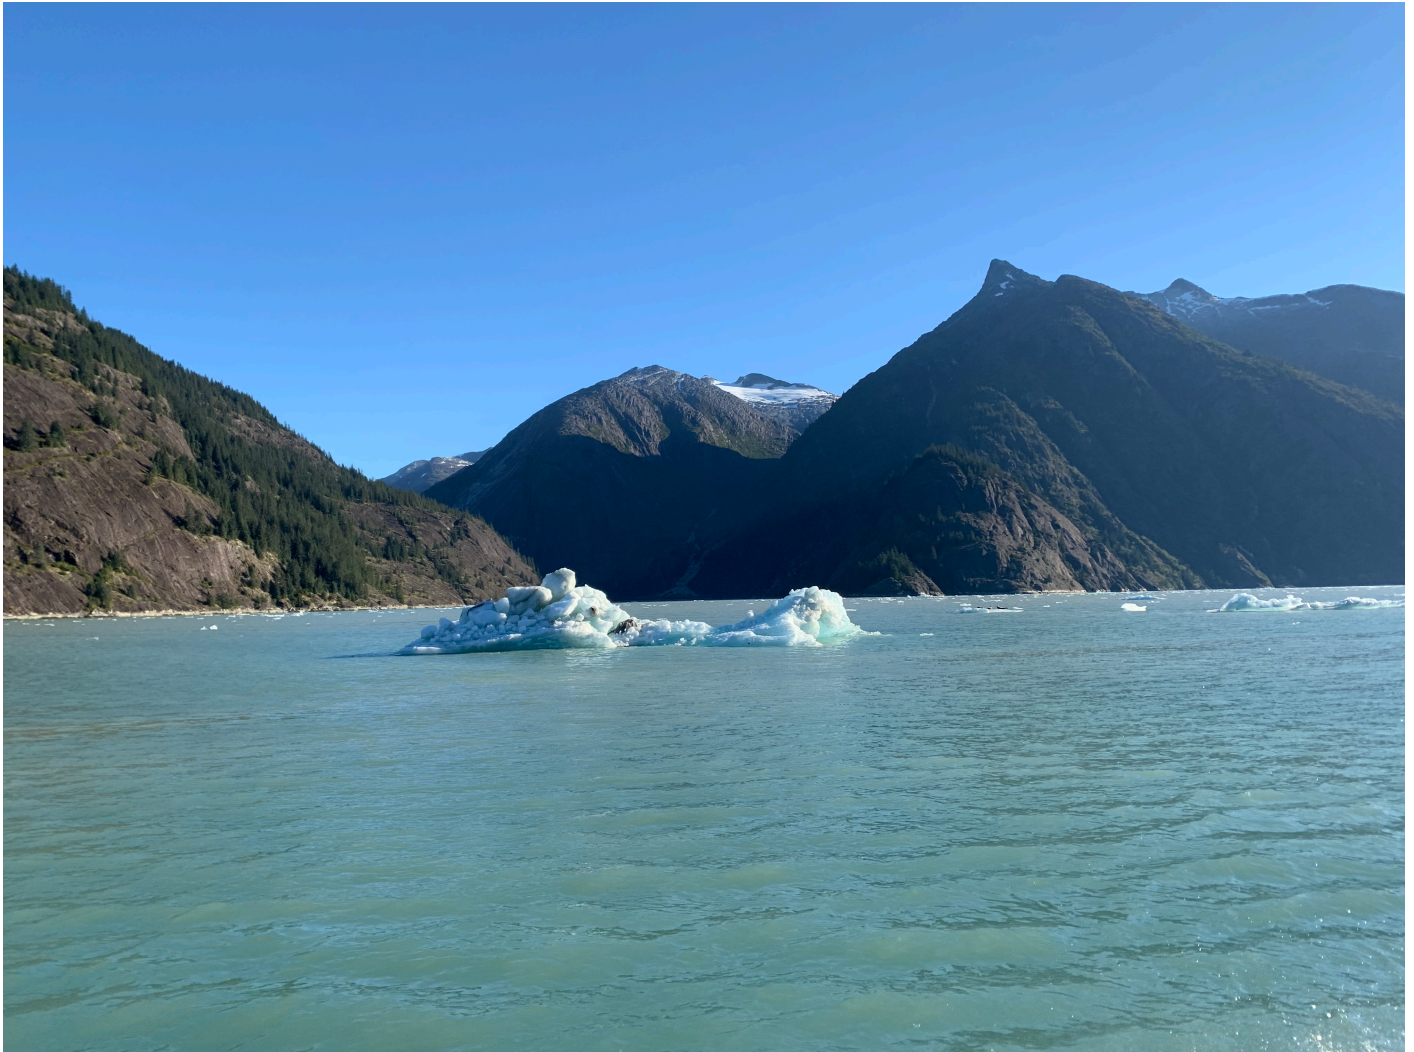
Figure 23: Image of iceberg carrying sediment taken on transit to survey grounds.
