DESCRIPTIVE REPORT

Type of Survey: Navigable Area

Registry Number: F00836

General Locality: East River, NY

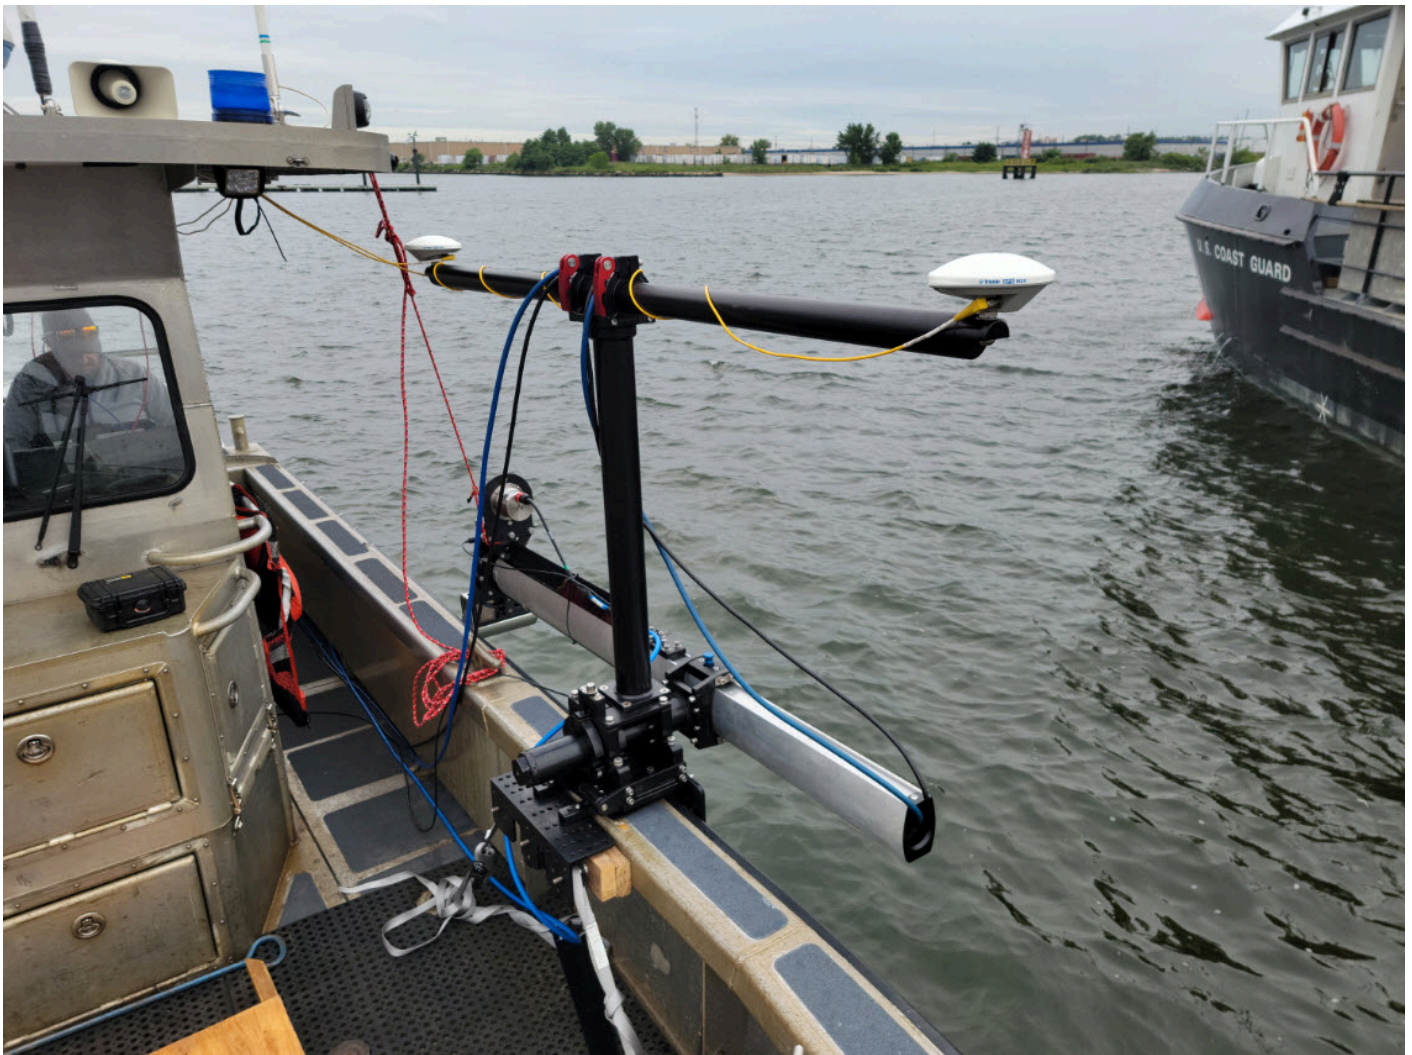
Figure 1: Survey equipment installed on TANB.

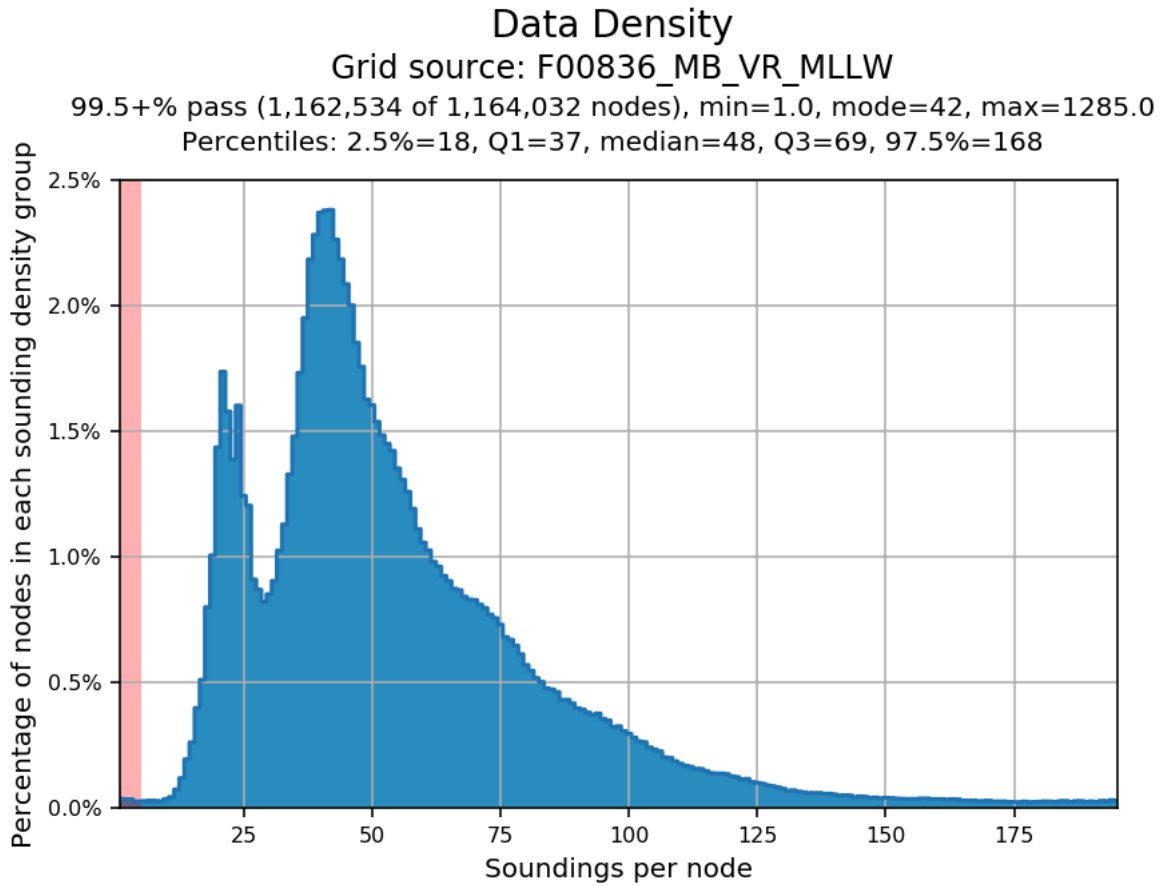
The Grid QC tool within QC Tools was used to analyze multibeam echosounder (MBES) data density. The MBES surface meets the HSSD data density requirement.

Figure 2: Pydro derived histogram plot showing HSSD object detection compliance of F00836 MBES data within the VR CUBE surface.

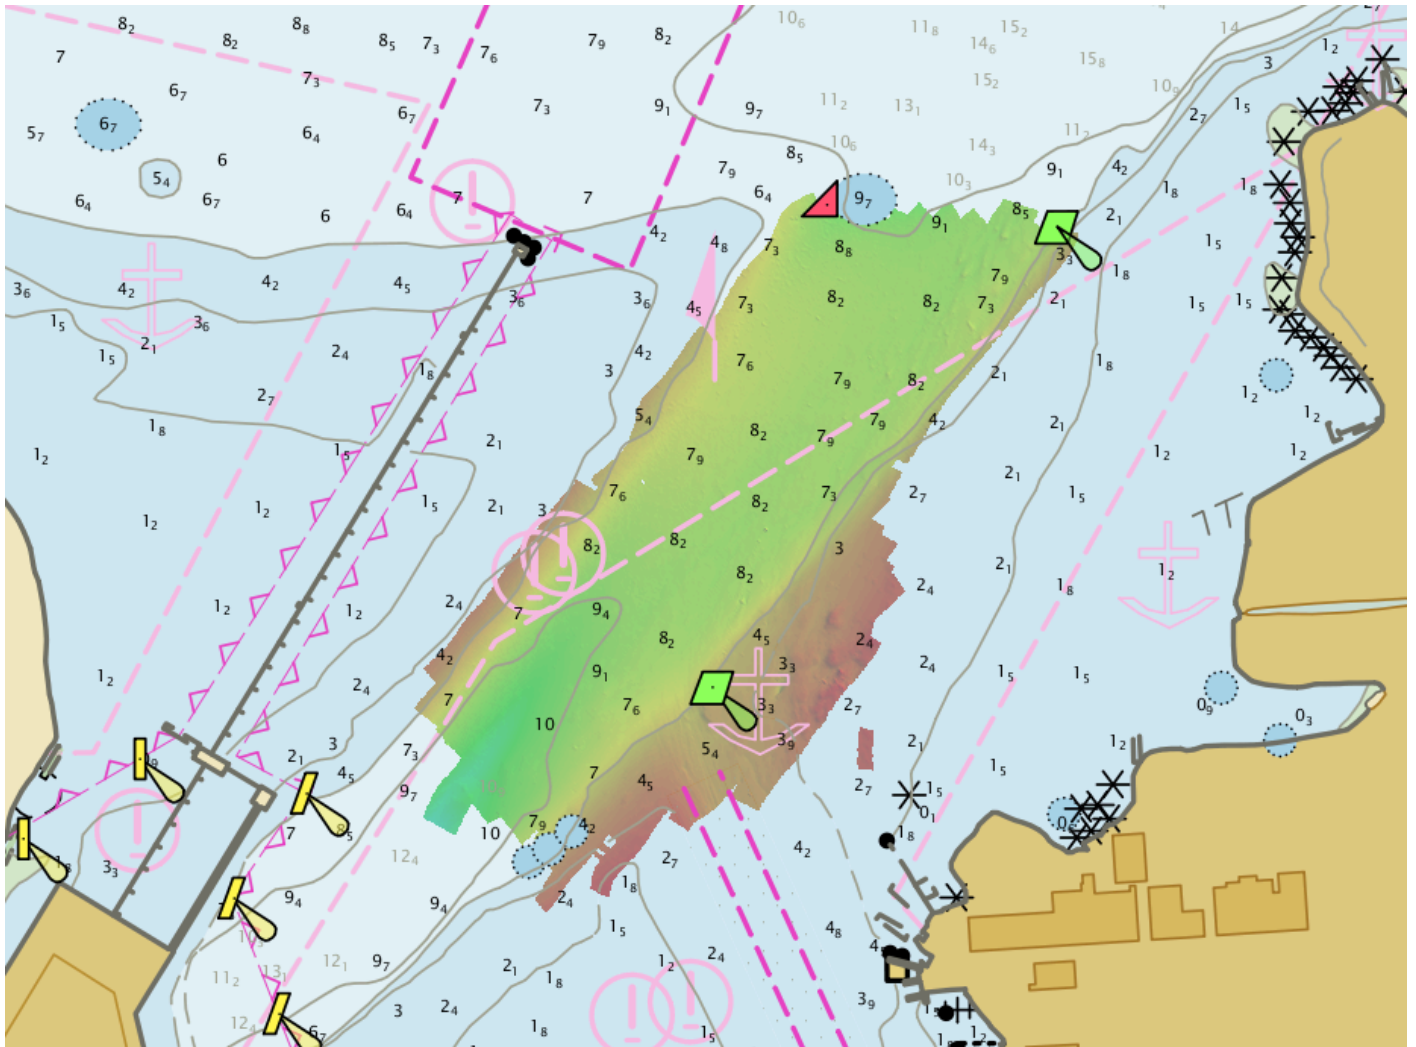
Survey coverage was in accordance with the requirements listed above and in the HSSD with some exceptions. There are three holidays located in the sheet, each was investigated and found to not be dangerous. Pydro Explorer's flier finder found one flier, which is on a buoy block for a charted buoy.

Figure 3: Survey Coverage of F00836 overlaid on ENC US5NY12M.

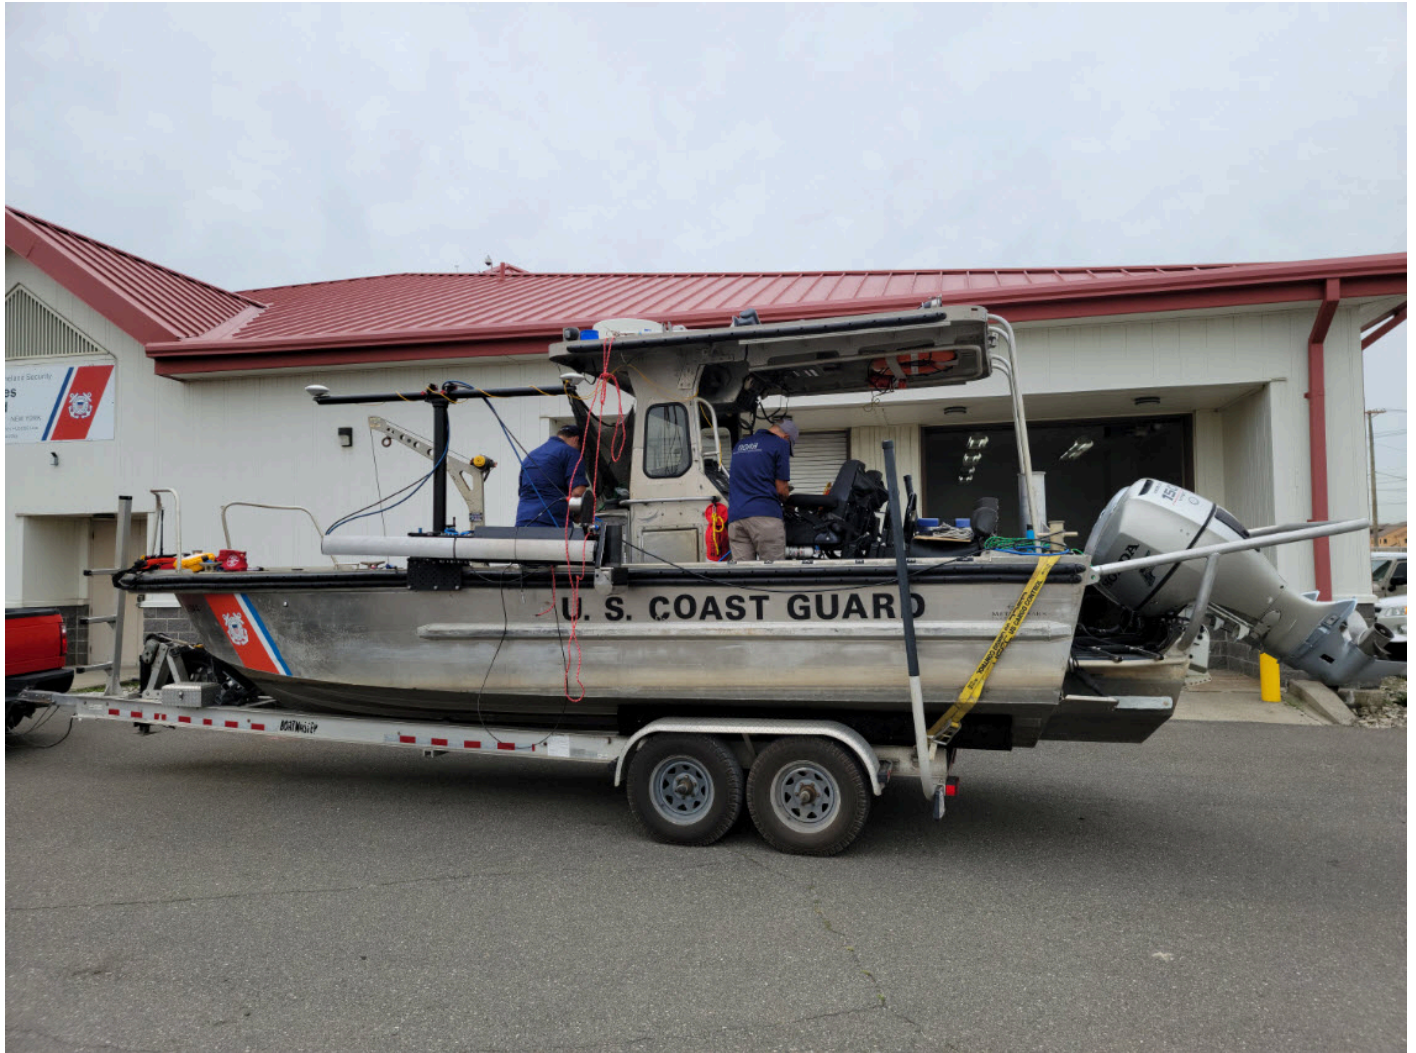
Figure 4: USCG TANB getting outfitted with MIST kit.

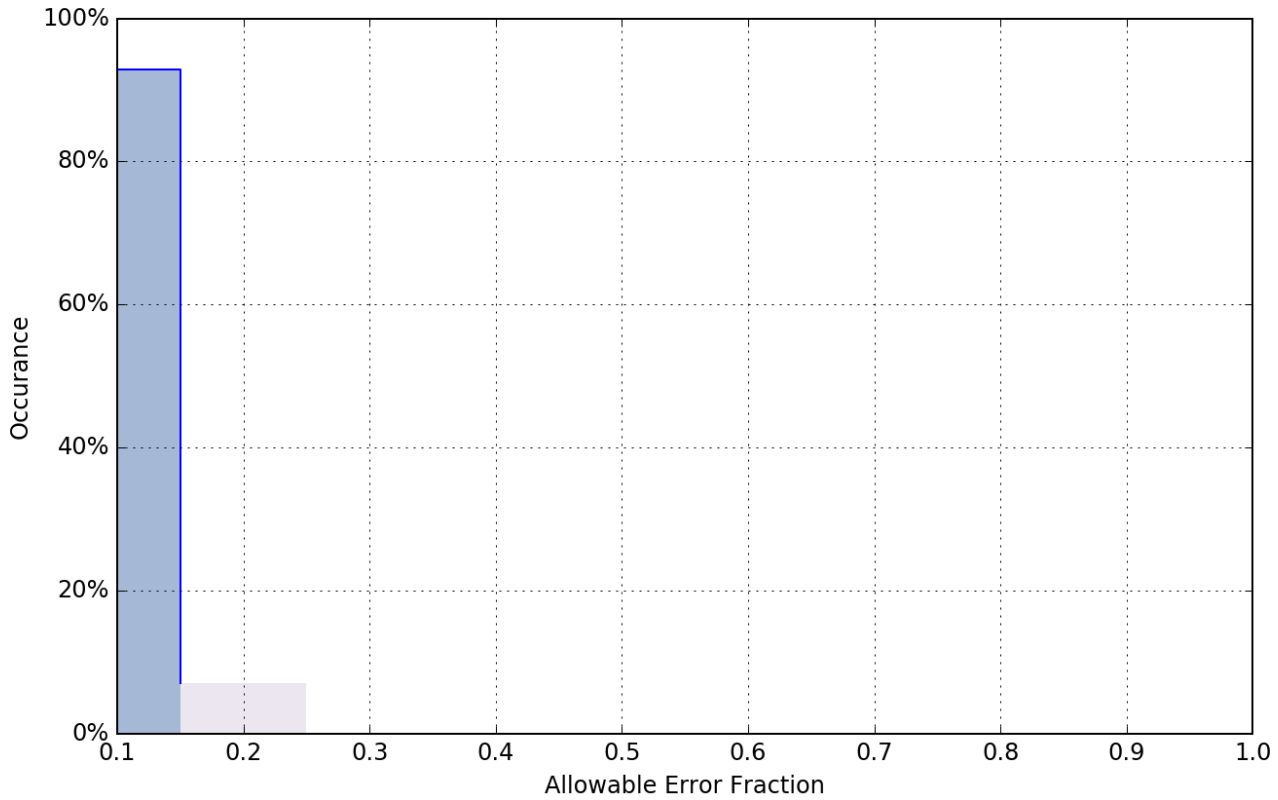
A 50cm CUBE surface was created using only mainscheme lines and a second 50cm CUBE surface was created using only crosslines. These surfaces were then input into the Pydro Tool "Compare Grids". The comparison passed HSSD specifications.

99.5+% nodes pass (216802), min=0.0, mode=0.1 mean=0.1 max=4.0

Figure 5: Pydro generated graph showing comparison between mainscheme and crosslines in F00836.

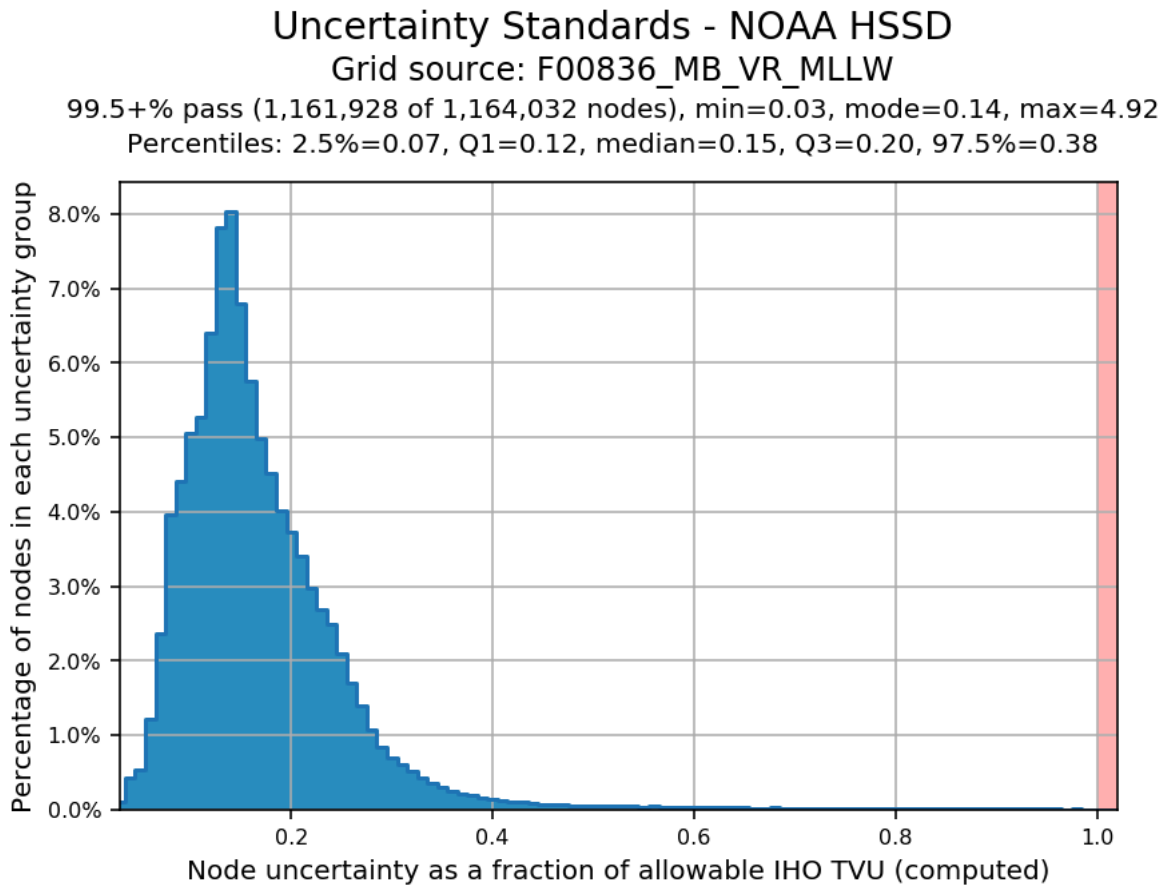
Total Propagated Uncertainty (TPU) values for F00836 were derived from a combination of fixed values for equipment and vessel characteristics, as well as field assigned values for sound speed uncertainties. The uncertainty for the VDatum model was provided to the field units in the Project Instructions. A visual inspection of the Uncertainty layer revealed the areas of higher uncertainty occur in the outer beams, and a visual inspection of the Density layer revealed the areas of lowest density are in the deepest areas of the survey. For F00836, 99.5+% of nodes passed NOAA uncertainty standards.

Figure 6: Pydro generated graph showing 99.5+% of nodes pass NOAA uncertainty standards within F00836 VR surface.

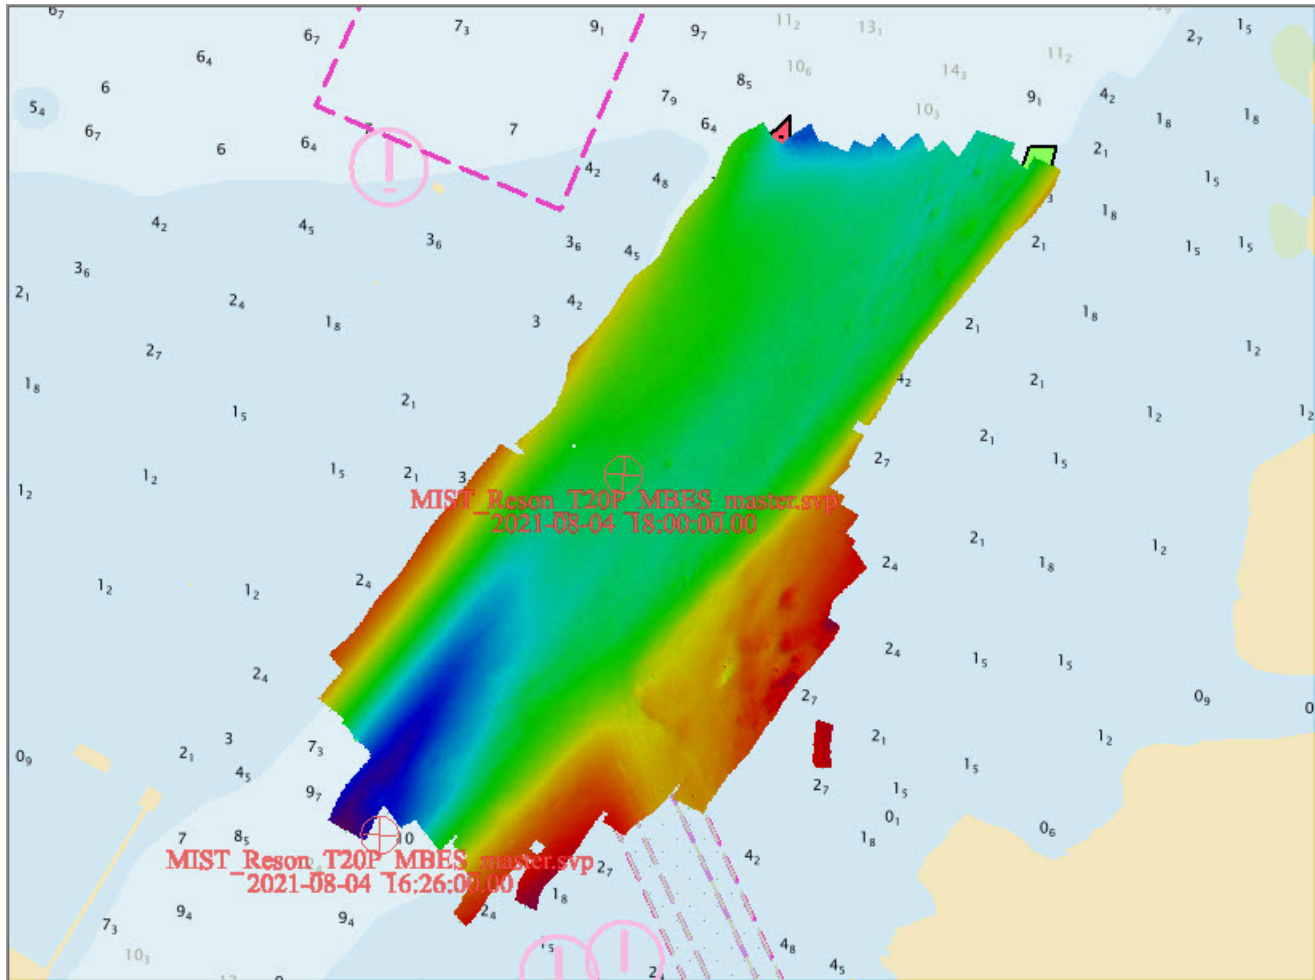
Two casts were taken at the search area, see figure below.

Figure 7: SVP locations in search area.

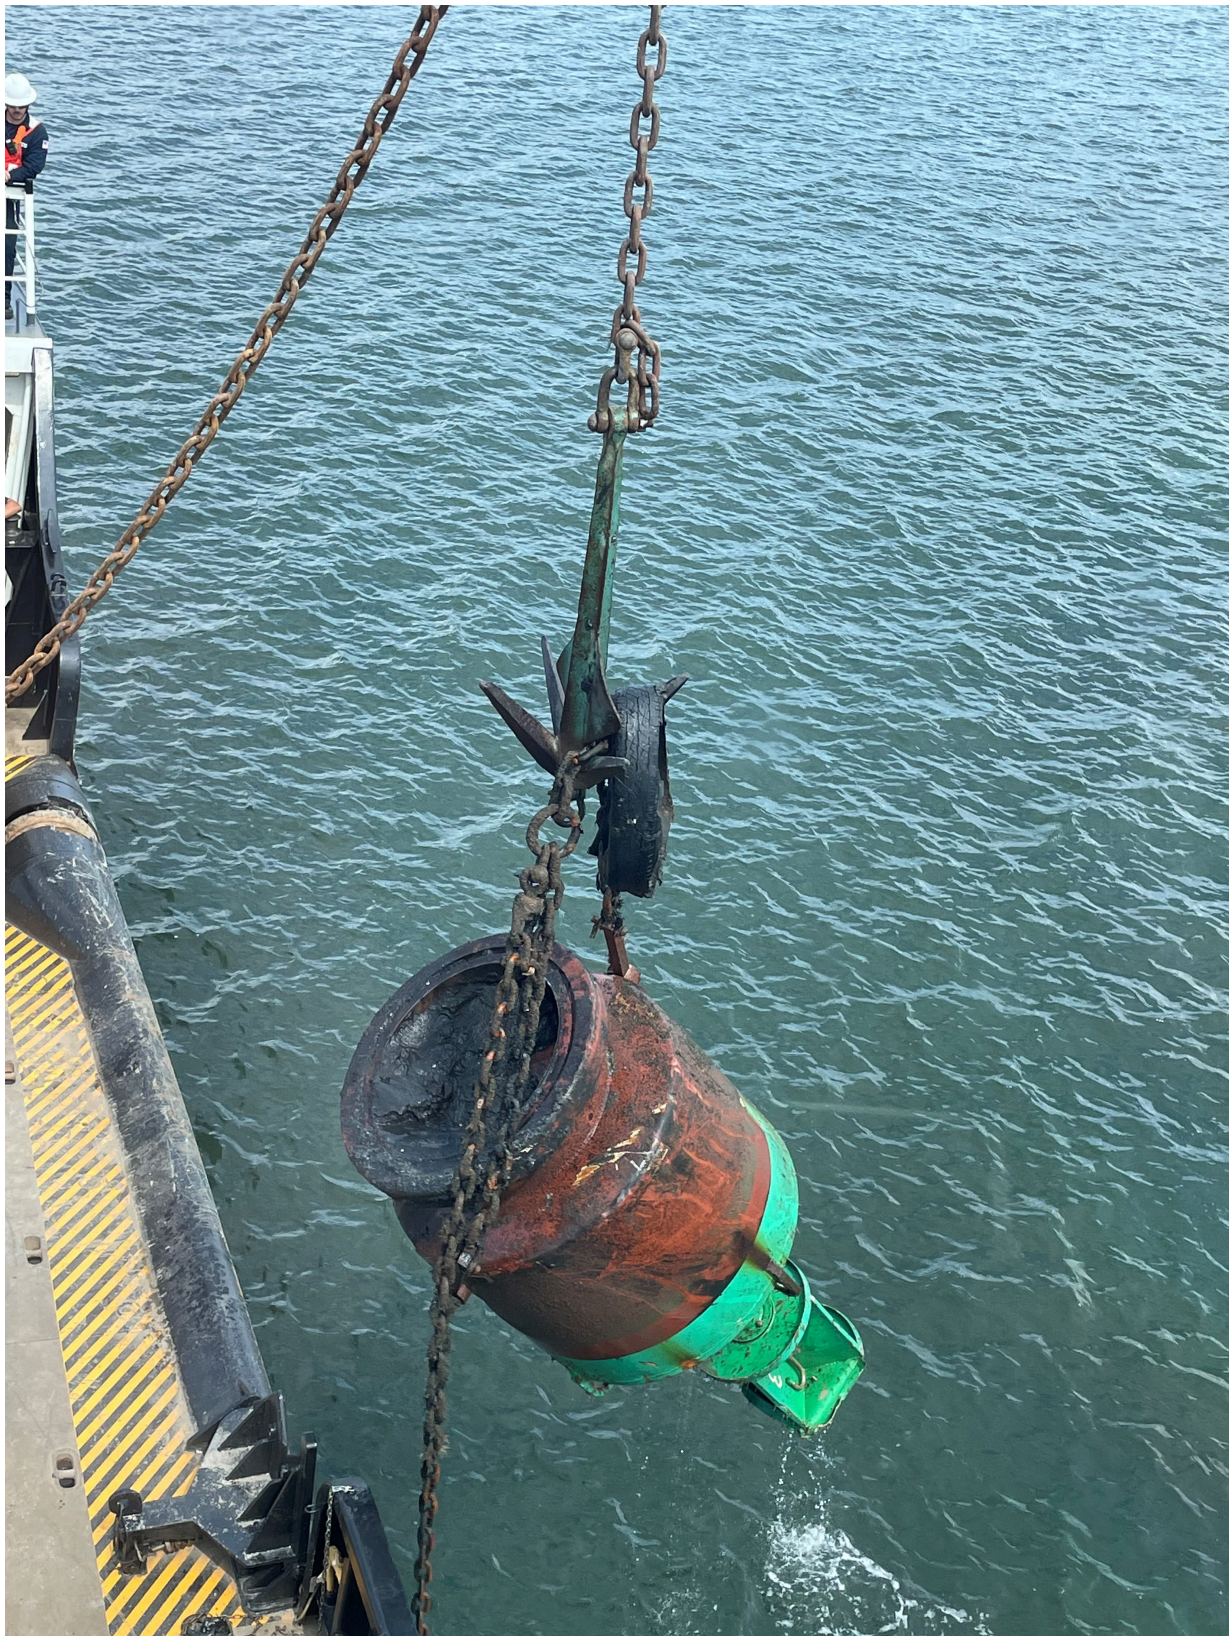
The MIST was sent to find a buoy that had sunk after being struck and determine if it got dragged into the shipping channel. The search was a success and the buoy was found to be located in the channel as feared. However, the USCG quickly removed the buoy from the channel, including its block and chain. For more information, please see the Supplemental Survey Records Correspondence folder.

Figure 8: Buoy being removed from the water.

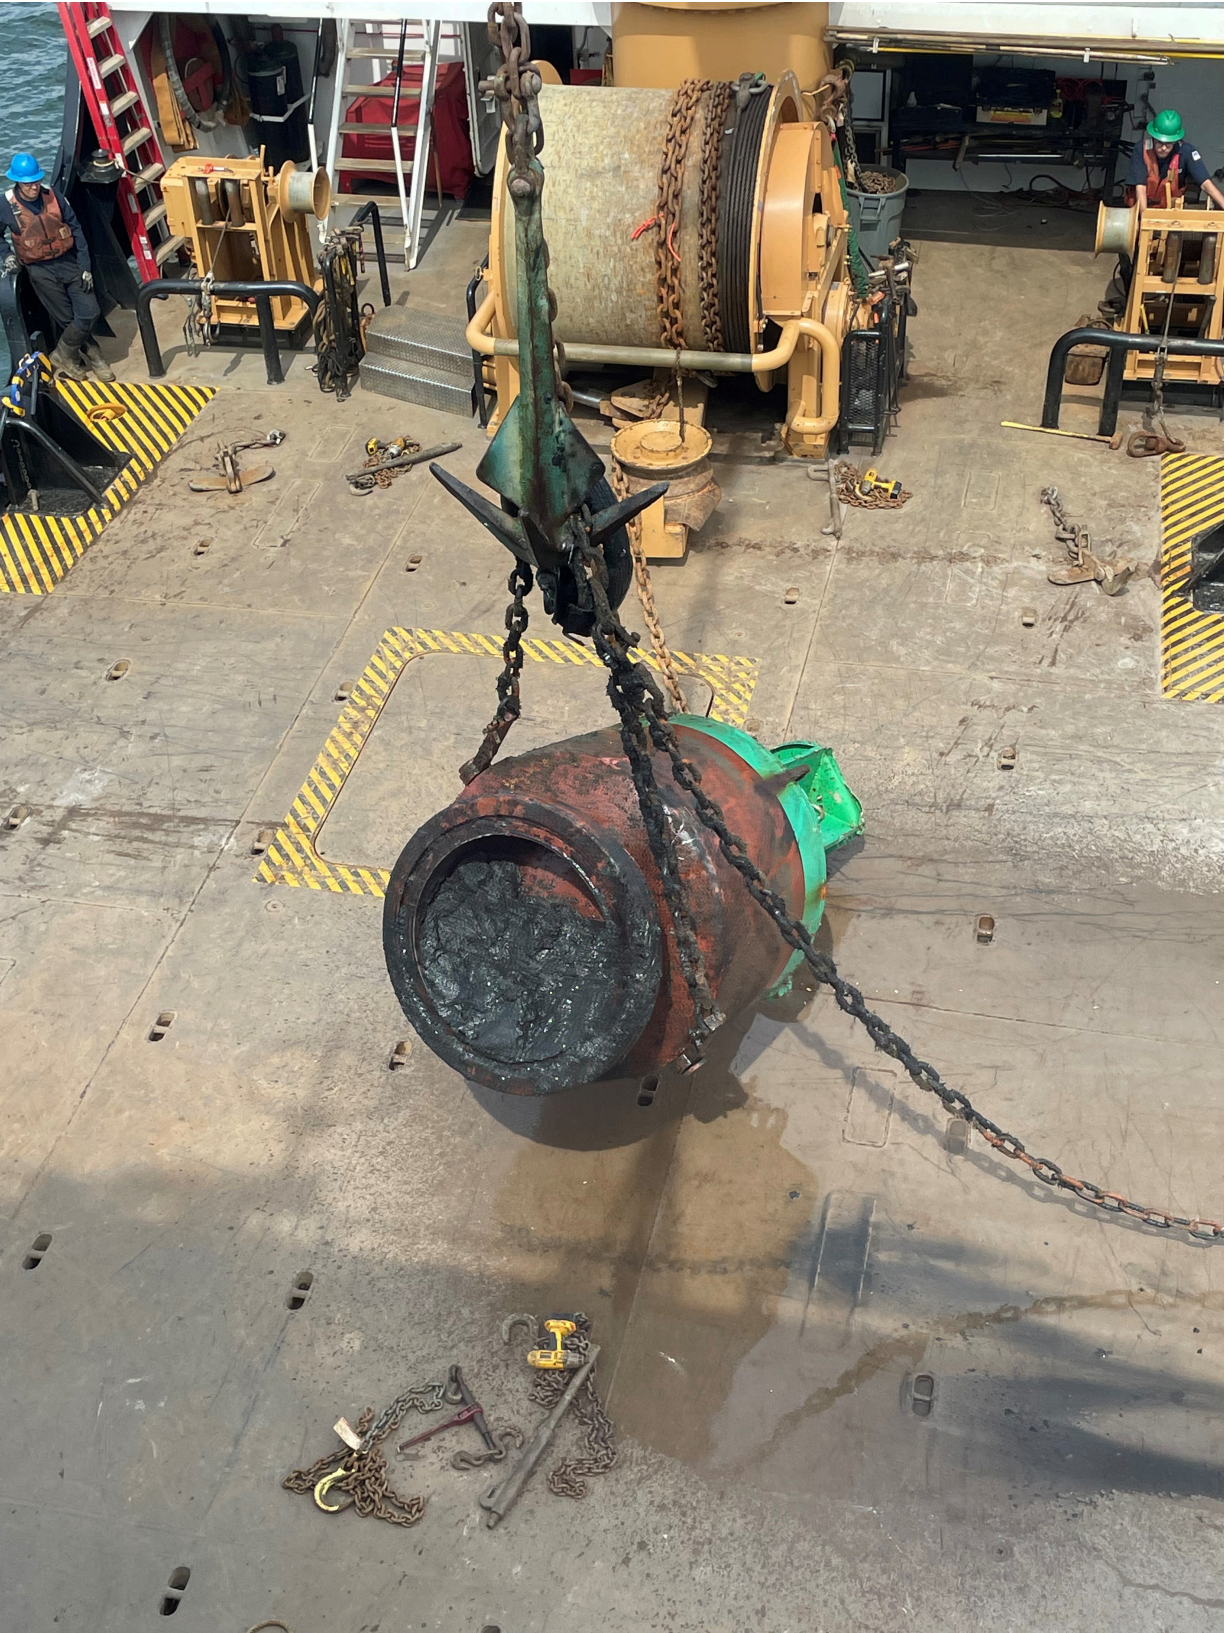
Figure 9: Buoy with chain being placed on deck after removal.
