DESCRIPTIVE REPORT

Type of Survey: Navigable Area

General Locality: Central Chesapeake Bay

Sub-locality: Cove Point

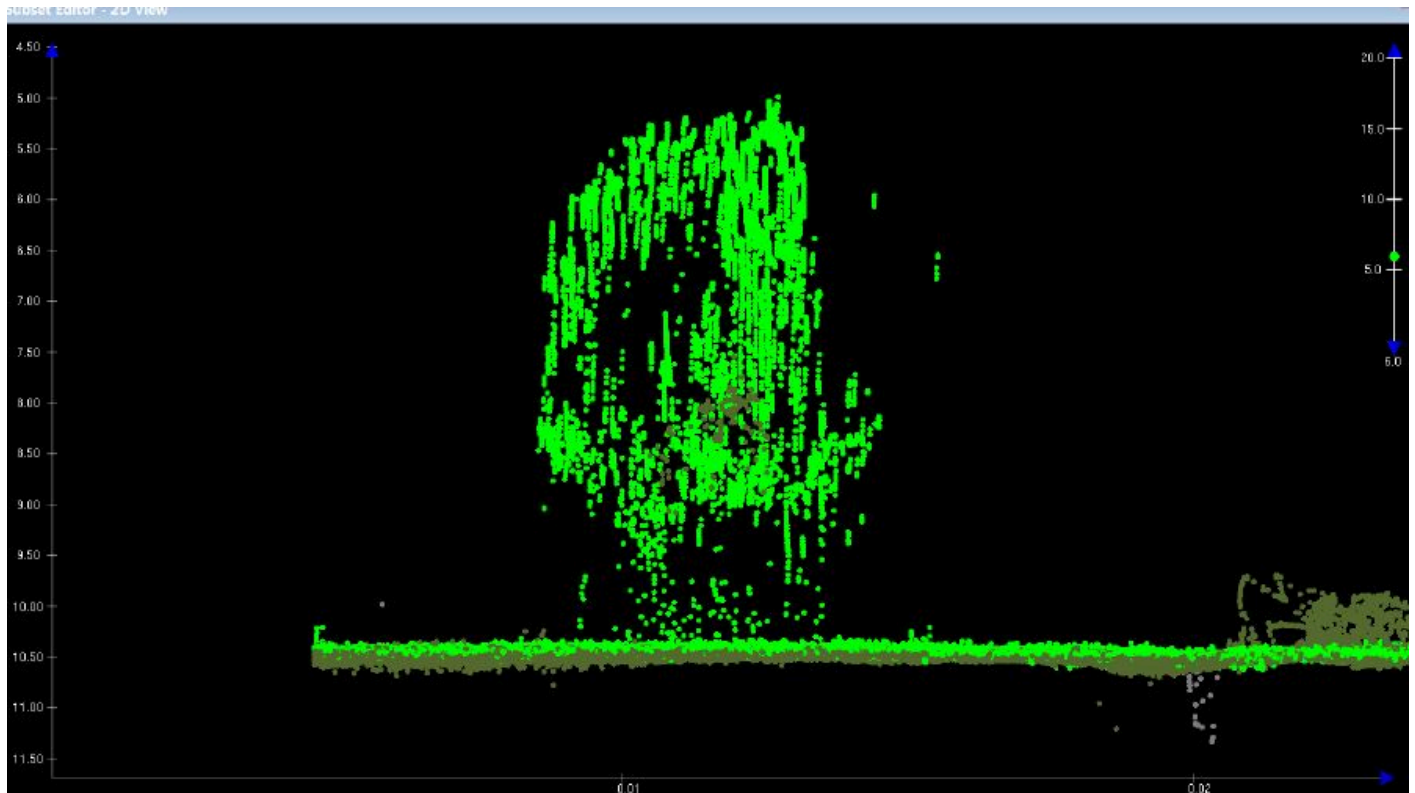
On several occasions, a large school of fish and/or other marine life prohibited the MBES from identifying the true seafloor. This interference resulted in artifacts in the processed data which did not accurately represent the seafloor (see Figure 8). In some cases, removal of these artifacts in the MBES surface introduced gaps in coverage. Each of these gaps in coverage were examined in CARIS HIPS and SIPS, Subset Editor and determined not to degrade the confidence in the quality of the survey. These data gaps do not limit the ability of adequately verify charted depths. See the F00853_Holiday.hob file in Appendices- II Supplemental_Records for the location of all of these gaps in coverage.

Figure 8: CARIS HIPS and SIPS Subset Editor image of marine life prohibiting the MBES from identifying the true seafloor.

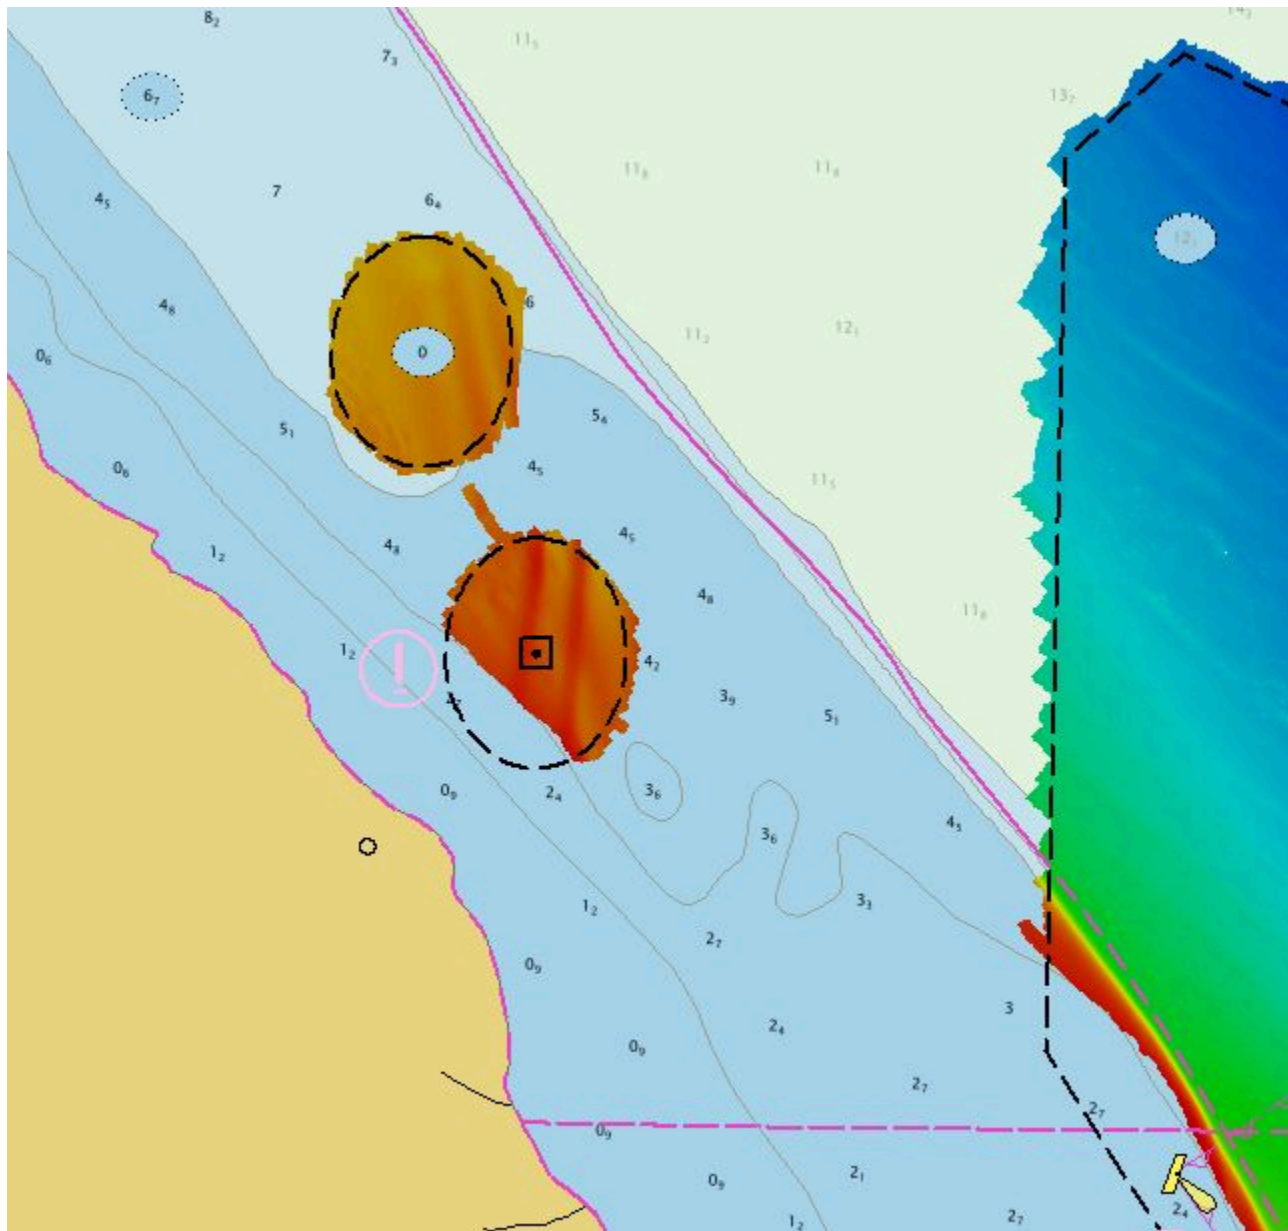
The assigned Unverified Charted Feature (UCF) at position 38.418614N by 076.41284W can not be considered disproved, due to R/V Bay Hydro II's inability to completely ensound the assigned search radius for safety reasons. Due to the extensive number of crab pots and the shallowness of the area, the shoreward 135 meters of the search radius was left unsurveyed (See figure 15).

Figure 15: F00853 survey data (in rainbow) overlaid onto the F00853 assigned UCF Search Radius (in black).

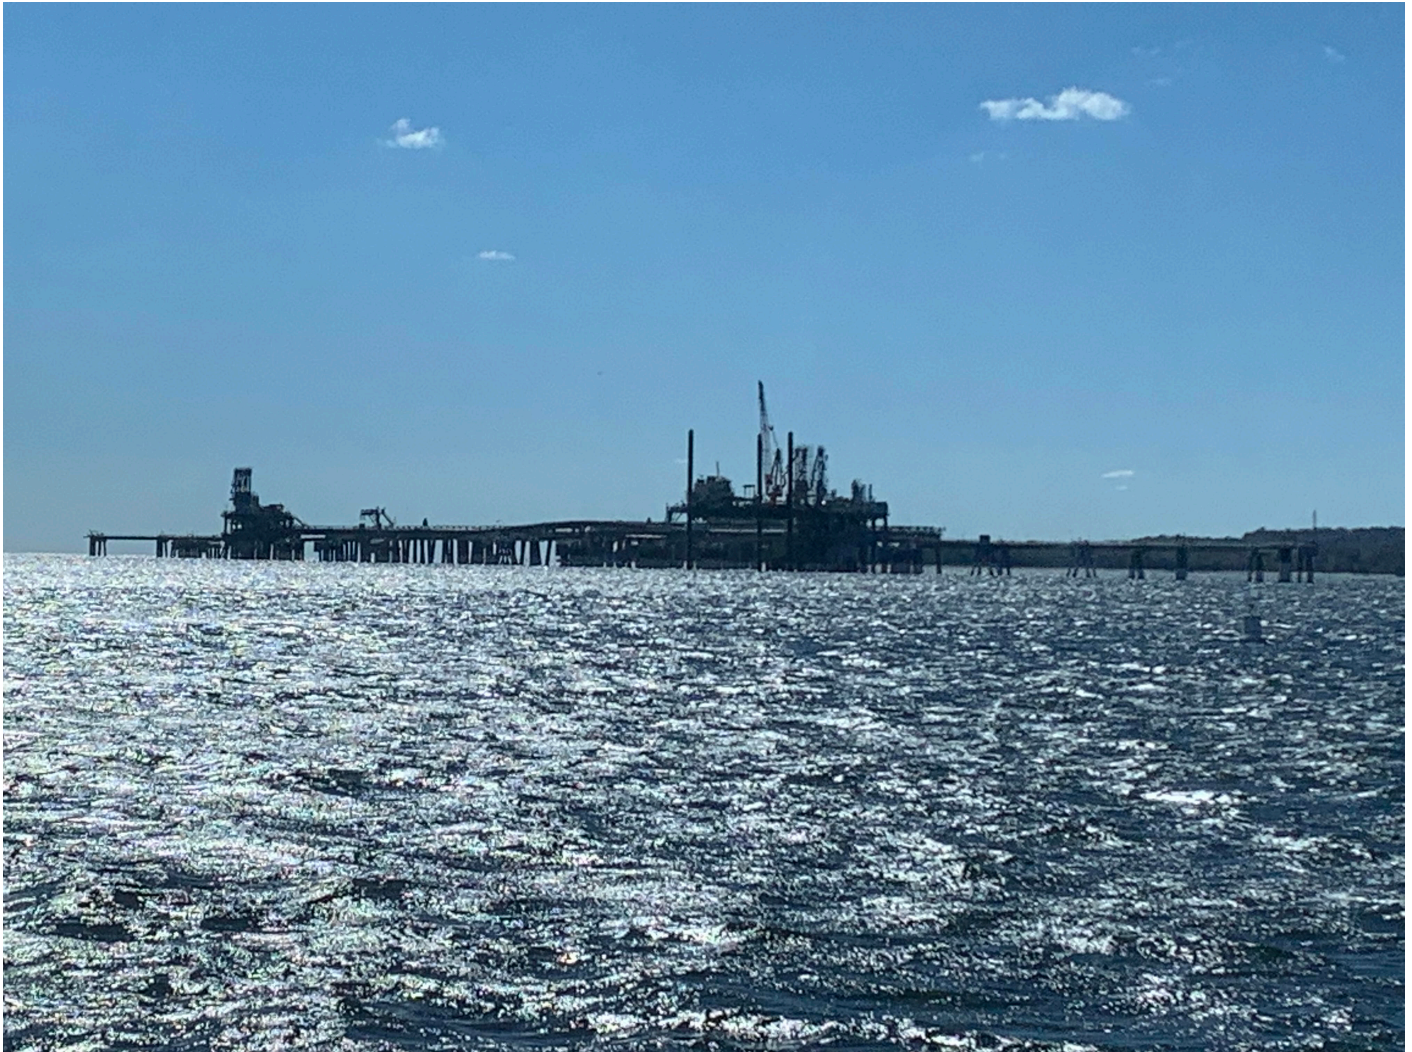
One platform feature was assigned to survey F00853, the Cove Point Liquid Natural Gas (LNG) platform (Figure 17). This platform was found to be correctly charted and operational, see the Final Feature File (F00853_FFF.000) for more details

Figure 17: Cove Point LNG Terminal platform.
