### DESCRIPTIVE REPORT

Type of Survey Hydrographic  
Field No. HSB-10-2-78  
Office No. H-9772

State Pennsylvania and New Jersey  
General Locality Delaware River  
Locality Trenton to Florence

DESCRIPTIVE REPORT  
To Accompany  
HYDROGRAPHIC SURVEY H-9772  
HSB-10-2-78

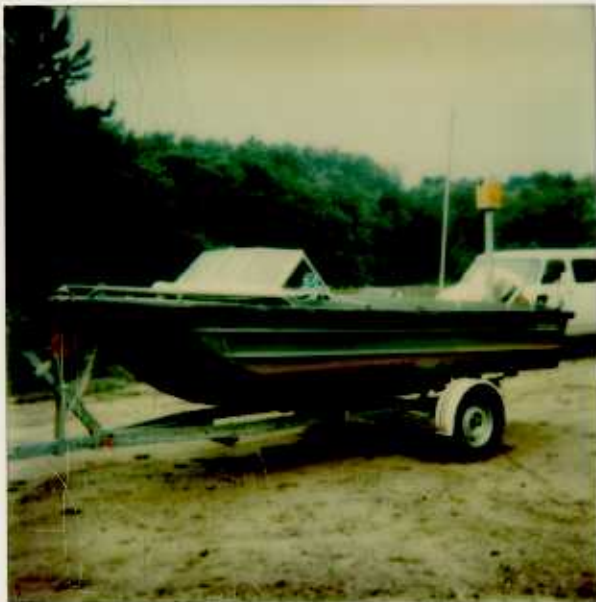
Photograph #1

All echo soundings were obtained using a Raytheon 719-B fathometer, SN 6211, with a calibrated velocity of sound through water of 800 fms/sec. The sounding transducer is mounted permanently through the hull of the sounding vessel. (See Photograph #2) No faults in the equipment were observed which might have affected the accuracy of sounding. A transducer draft correction of 1.0 feet and all fathometer initial trace corrections (generally maintained at zero on line) have

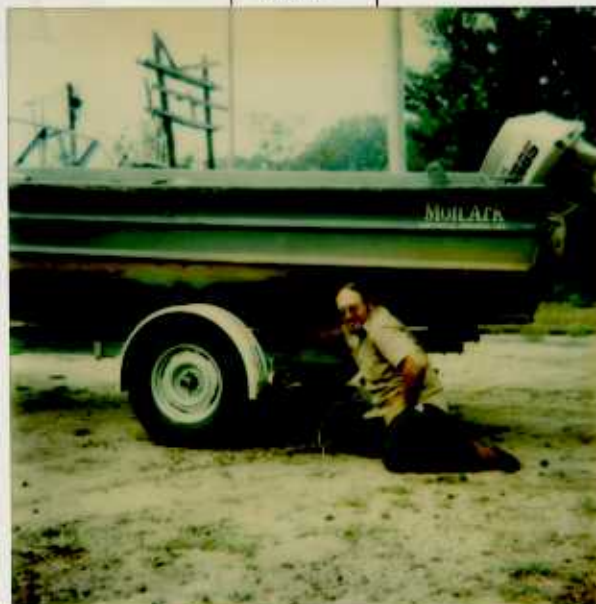
Photograph # 2  
Robert Snow pointing to transducer

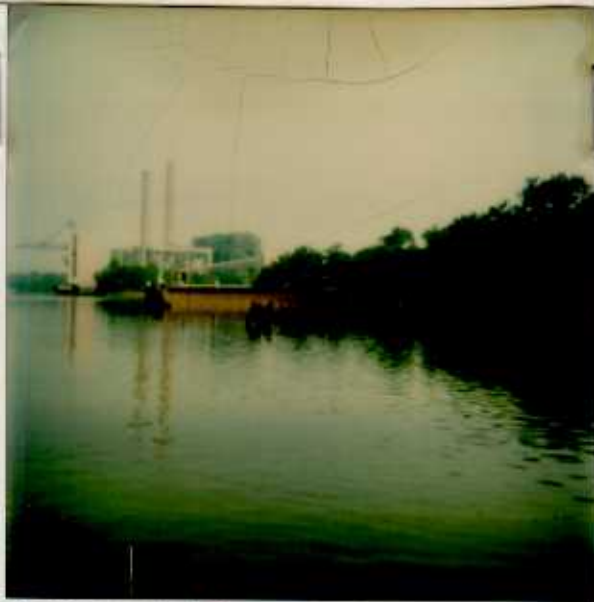
2. The dangerous sunken wreck, PA, charted at  $40^{\circ}10.4'$ ,  $74^{\circ}43.8'$  is not verified. A chain drag was attempted over the charted position on JD 255 but was aborted due to a rough bottom which made dragging impracticable. A group of 16 pilings, bare 8 ft. at the survey datum, was located at  $40^{\circ}10.42'$ ,  $74^{\circ}43.83'$  very near the charted position of this item (see Photograph #3). The hydrographer believes this group of pilings was mistaken for a wreck and reported as such. Recommend that the sunken wreck be deleted from the chart and that the group of pilings be charted. Recommend wreck be retained since pilings plot at approximate position of debris or piling on the chart.

Photograph # 3  
Vicinity PSR # 2

*Quality control agrees with hydrographer's recommendation.*

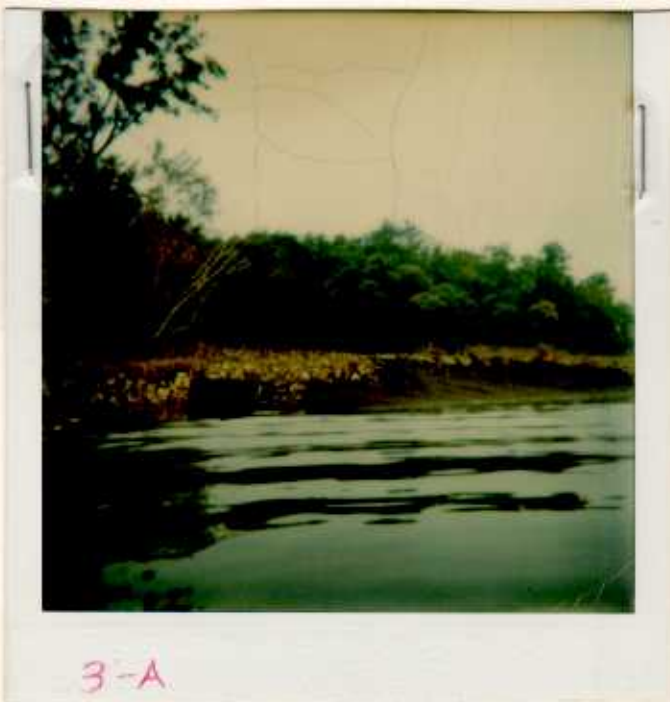
3-A

- ✓ 3. The dangerous sunken wreck charted at  $40^{\circ}10.25'$ ,  $74^{\circ}44.01'$  is verified and should be charted as partially submerged at  $40^{\circ}10.27'$ ,  $74^{\circ}44.01'$ . See Photo 3-A. *Concur, plotted as visible wreck* Wreck from T-8765 (1946-49)

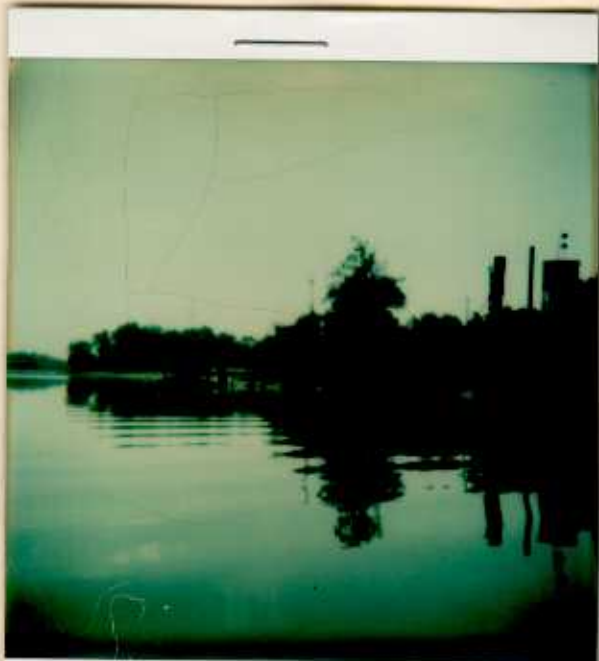
4

9. The wreckage <sup>present survey</sup> charted in the vicinity of 40°08.3', 74°45.86' still exists along with some additions which are shown on the field sheet, and should be charted as indicated. (See Photographs #4 thru 7 on page 9.) *Concur* - chart as shown on present survey <sup>from an unknown source</sup>

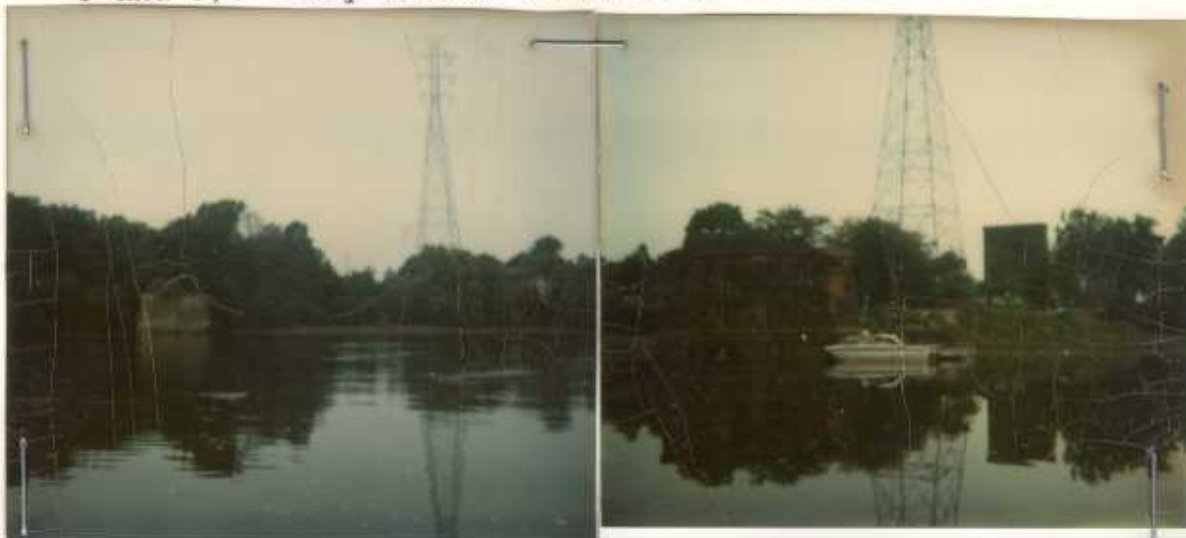
4. The charted structures <sup>*originating w/ T-8765 (1946-49)*</sup> in the water on each side of the river at approximate Latitude  $40^{\circ}11'$ , approximately 50 meters south of the overhead power cable, still exist. These are apparently old supports for a bridge and bare approximately 10 feet at MHW. These structures are good landmarks (see Photographs 8 and 9). They should continue to be charted. *✓*

Photograph # 8

Photograph # 9

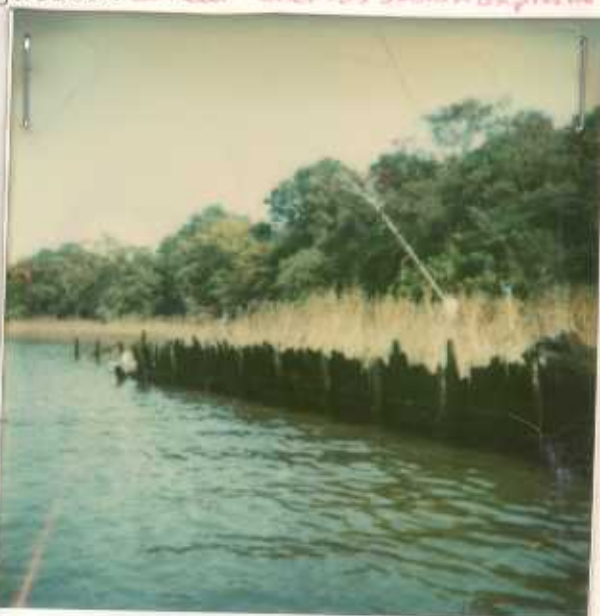
12

abandoned and overgrown Raritan River Canal. Similar bulkheading exists in varying degrees of ruin along the New Jersey bank of the Delaware River north of Crosswicks Creek. An example of this is in Photograph #12, near control station 004. This bulkheading was D.P.'d where the ruins falling into the river may be considered a hazard to navigation. *Concur - Chart as shown on present survey*

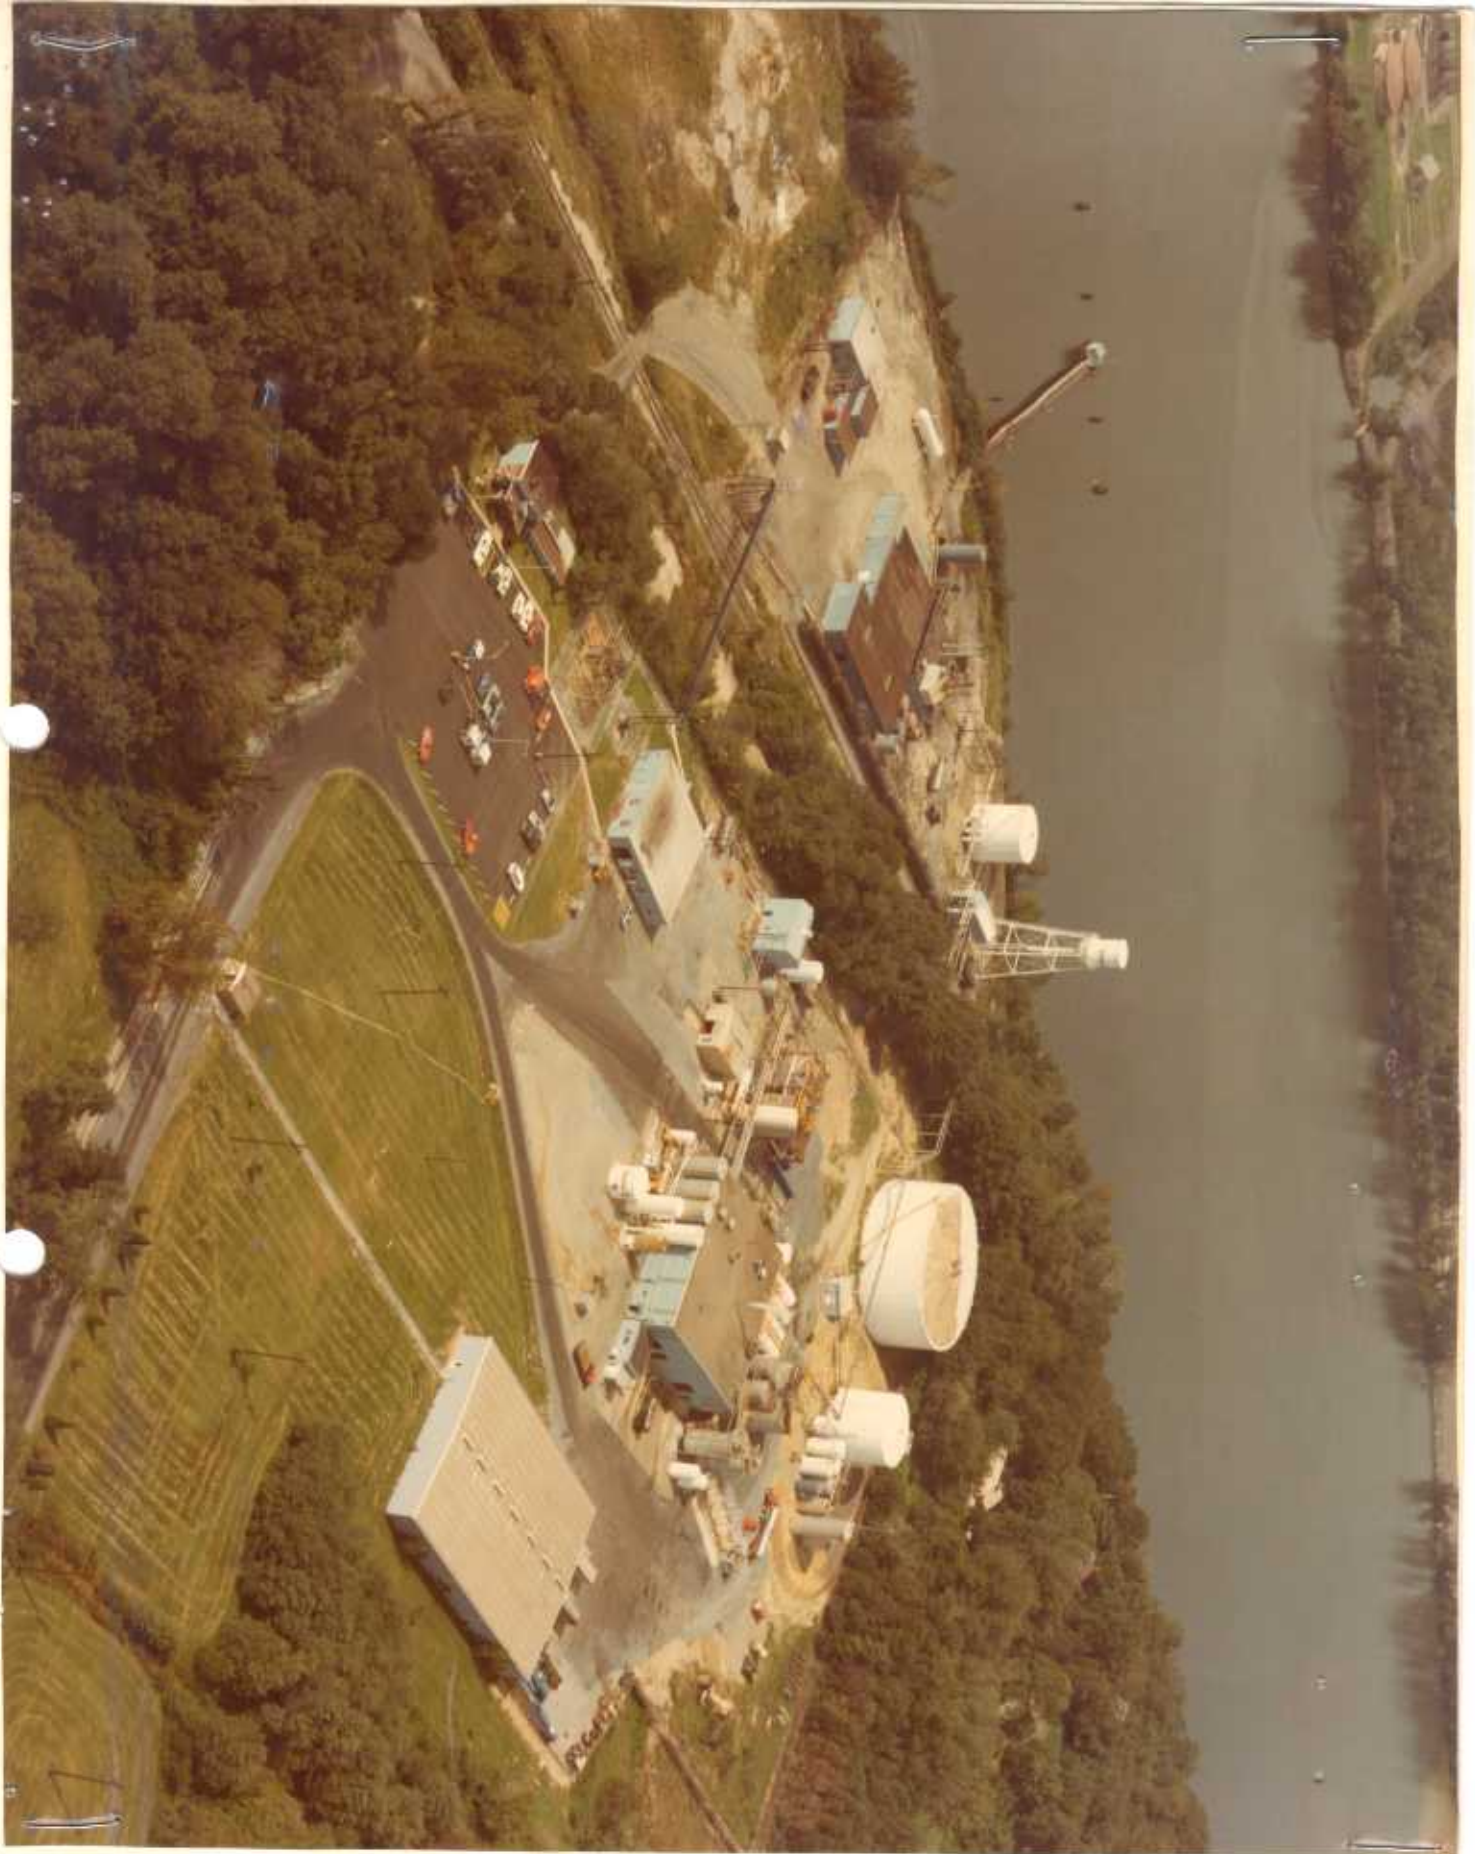
#13

7. There are two piers charted in the vicinity of  $40^{\circ}08.2'$ ,  $74^{\circ}44.2'$  where only one pier actually exists. This pier abuts the property of the Stepan Chemical Company. Mr. Don J. Supinski, manager of this plant (Telephone 609-298-1222), was visited on 19 September 1978. Mr. Supinski, who is a yachtsman, was familiar with the chart and had previously searched the plant records for anything which might explain the second pier and had found no indication that another pier had ever existed there. Of the two charted piers, the downstream position is correct, and the shape of the upstream pier is correct, including the relative position of four dolphins. (See Photograph #13, page 13. ) *Chart as shown on present survey*

This area was visited frequently by HFP-3 at all stages of the tide, including low tide, with no ruins ever appearing. On JD 257, Launch 1286 was drifted back and forth over the charted position of the second pier with still no evidence of ruins discovered. A telephone conversation with Mr. Max Rogers, C321, confirmed that the upstream pier was applied from a Corps of Engineers permit dated 1955. The pier was extended in 1960 to it's present length. The original position was apparently not very *Concur*

accurate. Later air photo revision showed the pier in the downstream position, and the cartographer, unable to conduct a field inspection, was obliged to leave the pier on the chart in the original position (in ruins since it did not show up on the photo), and chart a new pier in the correct downstream position. The hydrographer recommends the upstream pier in ruins be removed from the chart and the representation of the downstream pier be corrected to appear as it is shown in Photograph #13. ✓

- 2) The two piers shown at approximate position  $40^{\circ} 08'.15$ ,  $074^{\circ} 44'.25$  are in fact one and the same. The proper location is indicated by the downstream pier. The proper configuration, including the relative position of four dolphins, is indicated by the upstream pier. Recommend a local notice to mariners to delete the pier in ruins at position  $40^{\circ} 08'.2$ ,  $074^{\circ} 44'.2$ .

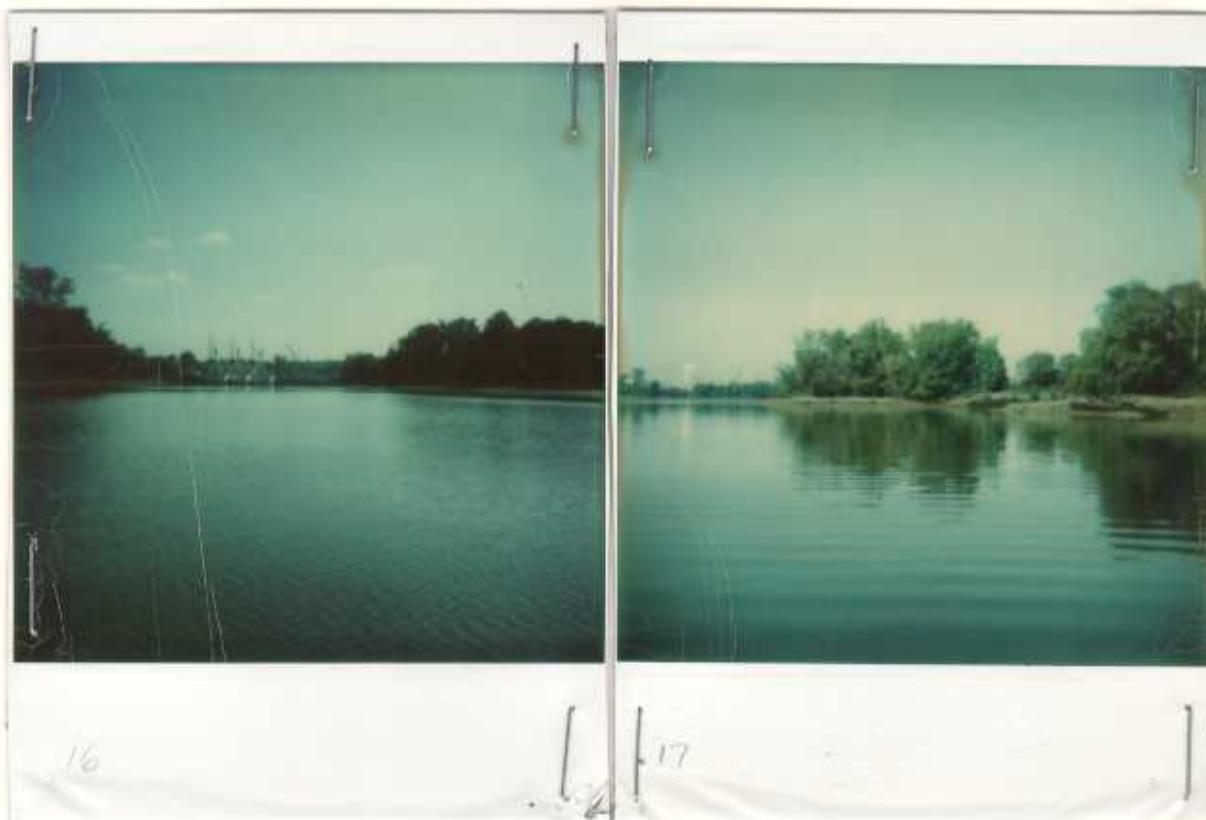
10. In the vicinity of  $40^{\circ}07.8'$ ,  $74^{\circ}44.5'$  there are no longer any docks or other features extending into the creek as presently shown on the chart. There exists a stranded barge, and near the bend in the creek, there is an extensive marine salvage operation with several large ships rafted out from the bulkhead, but no docks are evident. See ✓

Photographs #16 and #17. The manuscript is essentially correct here except for the single pier still shown extending from the bank that no longer exists. *Concur*

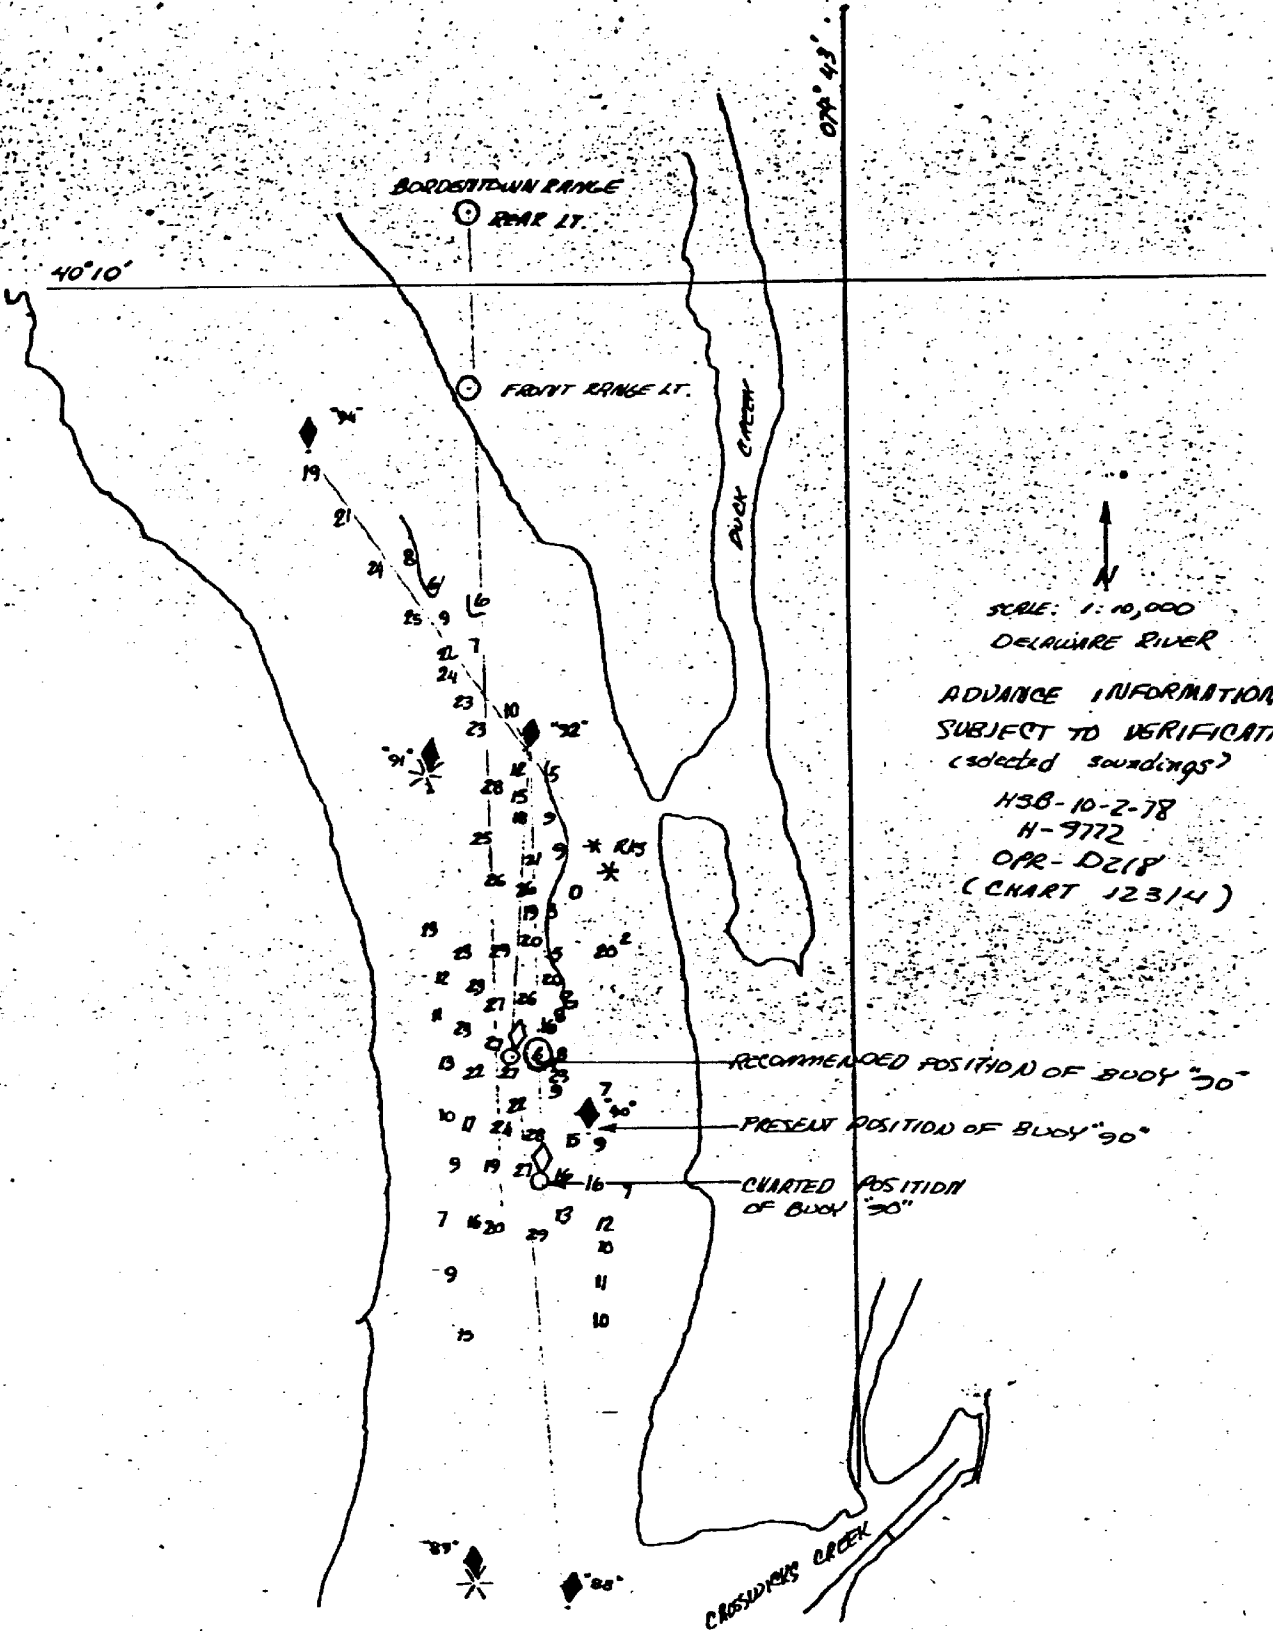
SCALE: 1:10,000  
DELAWARE RIVER

Red num buoy "90" is off station. Instead of returning it to its charted position it should be moved upstream to mark the six foot shoal presently extending into the marked channel.  
(see attached chartlet)

ADVANCE INFORMATION  
SUBJECT TO VERIFICATION  
(selected soundings)  
H38-10-2-78  
H-9772  
OPR-D218  
(CHART 12314)

- 1) Re my letter to you dated 5 September 1978, subject recommended relocation of buoy "90"; further investigation has shown the 6 ft. sounding extending into the channel to have been a spurious trace. The buoy, however, remains approximately 100 meters off station and does not accurately mark the channel. Recommend buoy "90" be returned to its charted position.
