DESCRIPTIVE REPORT

Type of Survey ... Hydrographic.....
Field No. HSB-10-4-81.....
Office No..... H-9989.....

State Florida.....
General Locality St. Joseph Bay.....
Locality Entrance to St. Joseph Bay.....

DESCRIPTIVE REPORT
TO ACCOMPANY
HYDROGRAPHIC SURVEY H-9989
HSB-10-4-81

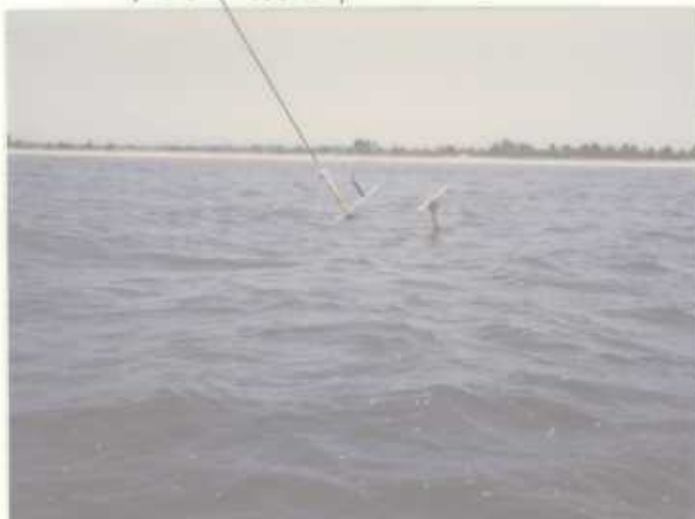
pos # 2384

DANGEROUS SUBM. WRECK
ST. JOSEPH BAY
FLORIDA

Latitude 29°51'29.52", Longitude 85°20'54.95" (Position #2384) is a detached position on a partially submerged wreck with ^{only} mast and net rigging exposed; not to be confused with PSR #8. It is recommended to chart the wreck at the above geographic position. The name of F/V is "Don't Cha Know". Chart as dangerous sunken wreck (mast). *logged and*

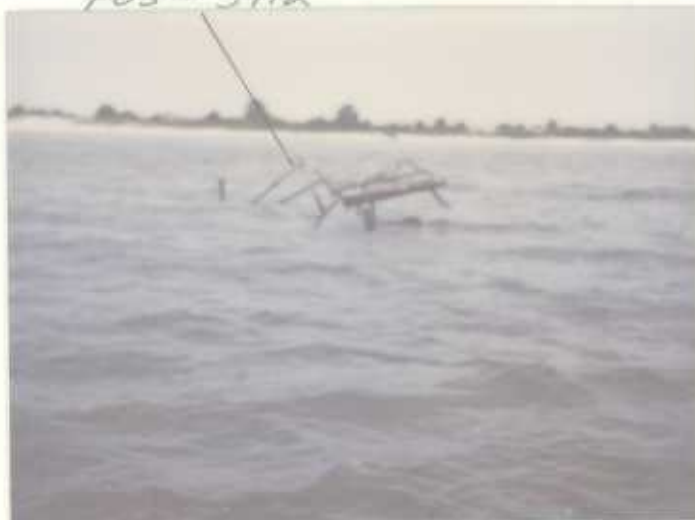
pos # 3412

DANGEROUS SUBM. WRECK
ST. JOSEPH BAY
FLORIDA

Estimated wreck - metal structure
per Sidg. Vol.

Latitude 29°52'02.213", Longitude 85°23'34.58" (Position #3412) is a D.P. on a dangerous ^{stranded} submerged wreck with net rigging exposed. It is recommended to chart the wreck at the above position as a visible wreck, *logged and* Sounding Volume No. 12 page 57 describes the wreck as a metal structure. 4 ft above MHW.

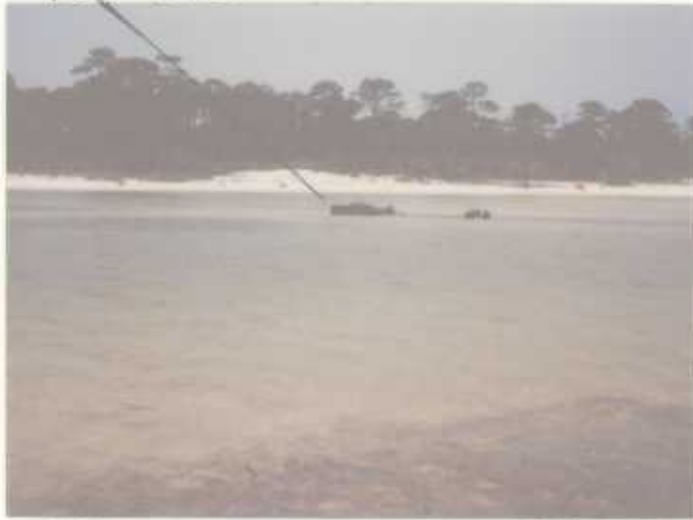
POS# 3413

PSR #9 was searched for and located on JD 125 (Position #3413). The dangerous submerged wreck charted at Lat. 29°51'14.685", Lon 85°23'53.624" originates with survey H-1265A (1875). The wreck (wooden hull ruins) was observed to be visible, bearing two feet above ^{mean} low water, in depths of ^{less than} one foot. The hydrographer recommends that the dangerous submerged wreck symbol be changed to a visible wreck symbol at the same position. Concur. RDS

PSA# 1
ST JOSEPH BAY
FLORIDA
