# DESCRIPTIVE REPORT

Registery No. H-10249

General Locality Togiak Bay

# Descriptive Report to Accompany Hydrographic Survey H-10249

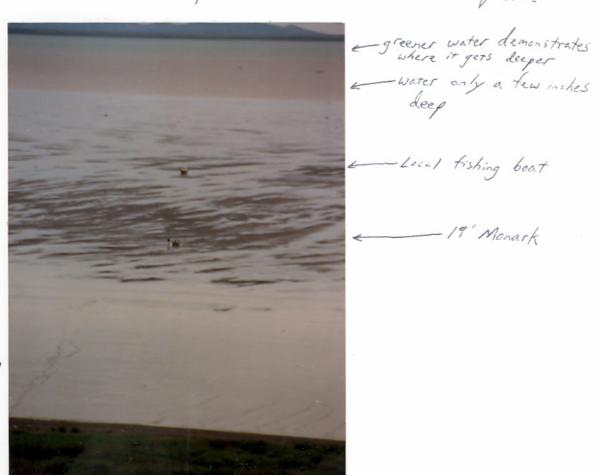
Tracks in mud

A large percentage of the survey area was found to have a muddy bottom. Heavy siltation from rivers has most likely deposited this mud over the years. Aerial photography shows extensive mud flats, especially along the northwest shoreline. Our survey of that area demonstrated extremely shallow depths. At times it was difficult to obtain an acceptable fathogram trace due to the suspended mud in the shallow water. A trail of black was at many times seen following the launches while surveying. In order to tend station NEMESIS (signal 223), the mud was crossed on foot and found to be over waist deep in places (see Appendix XIII).

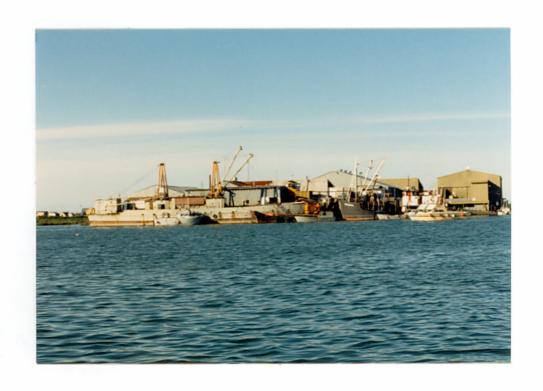
Photo showing the Wharf at Togiak Fisheries, Inc. of Twin Hills, Photo was taken Yooking Que south.

The hydrographer provides confusing information about the configuration of the berthing facilities at Togiak Fisheries, Inc., located at latitude 59°03'24"N, longitude 160°19'48"W. The raw data records clearly state that a pier was observed and due to the presence of a ship tied up to it the NE corner was located from "15 meters off". Scaling 15 meters from the fix places the end of the feature at the present HWL which conforms to the depiction on the shoreline map and the final field sheet, neither of which shows a pier. The hydrographer supplied a photograph of the facilities as viewed from seaward and there is no pier discernible. It is assumed the hydrographer located a wharf, not a pier. The smooth sheet depiction originates with shoreline map TP-01176.
