H-10987

DESCRIPTIVE REPORT

Type of Survey HYDROGRAPHIC

General Locality TONGASS NARROWS

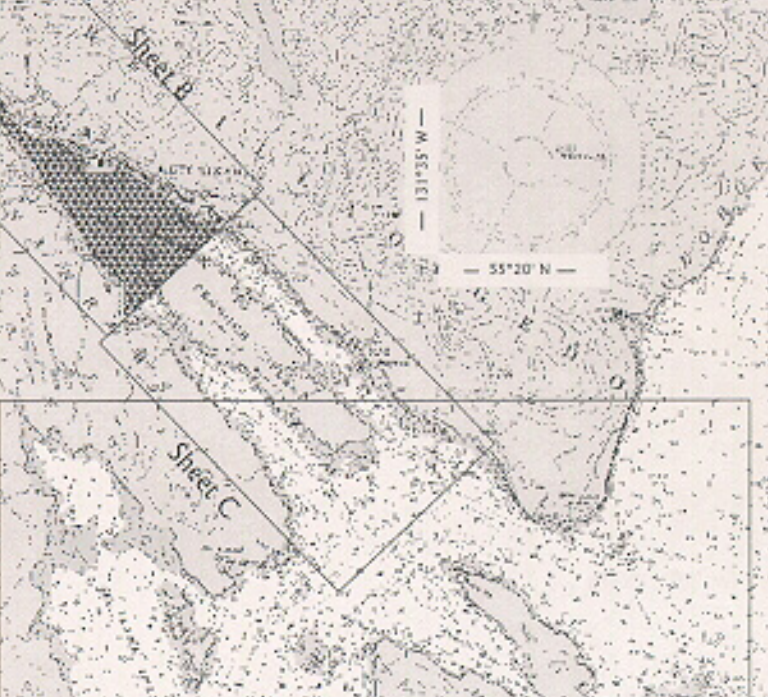
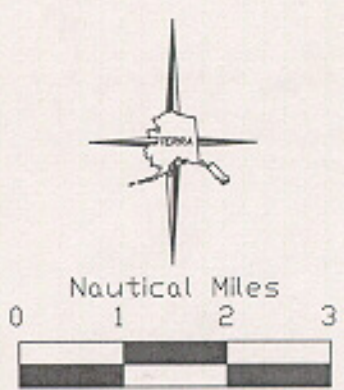
COVERAGE GRAPHIC
 OPR-O302-KR-00
 H-10987
 Hydrographic Survey of the
 Tongass Narrows, AK.
 JULY-NOVEMBER 2000
 Terra Surveys, LLC
 Gerald Douthit,
 Lead Hydrographer
 Vessels: Zeus/Jolly Pickle/Ducer
 Chart 17428

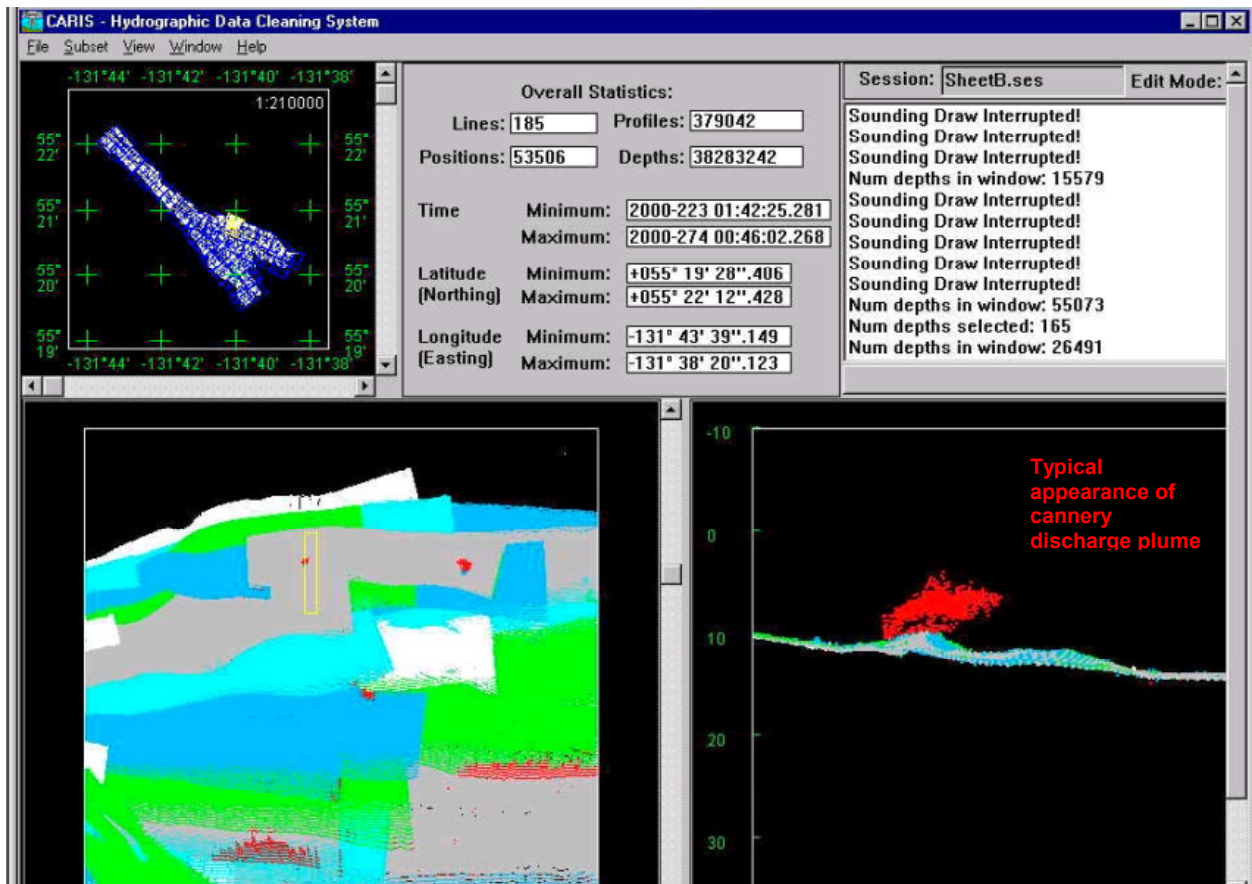
Caris screenshot showing typical plume of material from cannery discharge

A number of uncharted items were discovered during the Shoreline Verification of the area, including new floating docks and other structures of practical value to mariners. New features are discussed above and in detail in the table later in this section.⁴⁴ No new information of significant scientific value resulted from the survey. Anomalous tidal conditions were not encountered. Environmental conditions bearing directly on the hydrographic data included the presence of bull kelp throughout many areas shoreward of the four-meter curve, as well as some areas seaward of the four-meter curve. Kelp beneath the sonar head may have caused occasional interference in bottom acquisition; however, in general such interference is readily detectable in processing. In some areas, discharge from cannery outflows created plumes of material in the water column. Investigation of plumes with multibeam and side scan led project hydrographers to conclude that the material load in these areas was transitory, rather than an indicator of true seafloor bottom. However, “mounds” at the same locations are assumed to be accumulated cannery discharge that may remain on the seafloor for an indefinite time.⁴⁵

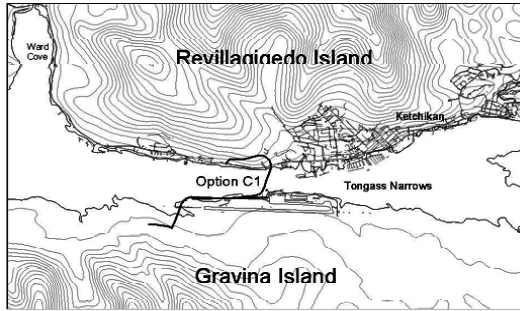
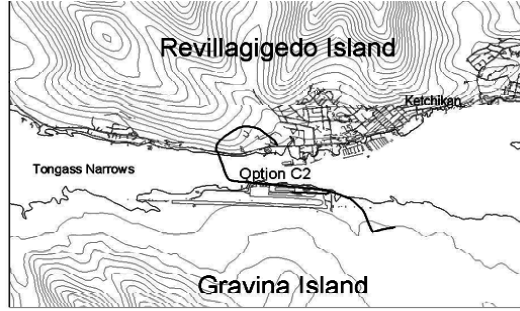
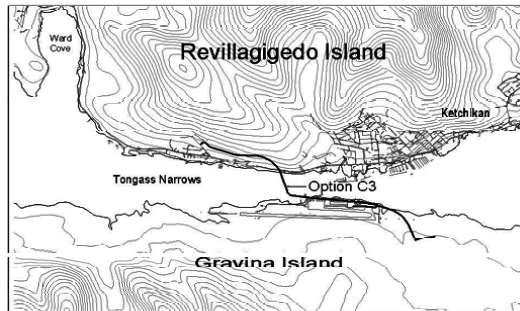
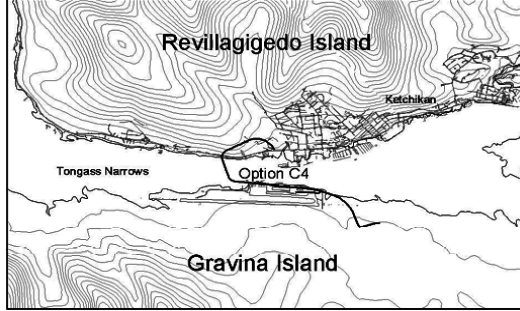
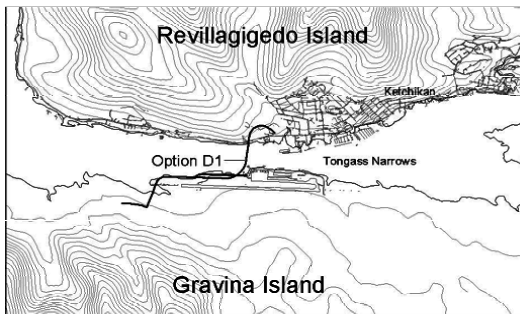
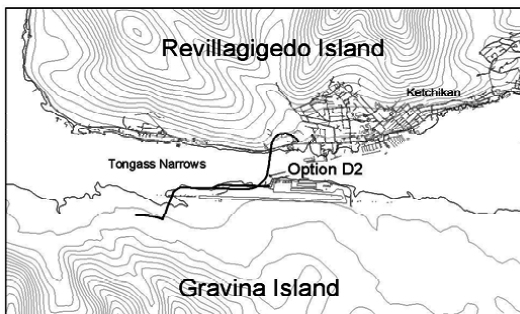
Proposed Bridge, Tunnel and Ferry Routes Potentially Affecting Surveyed Area

Option C1: Proposed Bridge; Option C2: Proposed Bridge; Option C3: Proposed Bridge; Option C4: Proposed Bridge; Option D1: Proposed Bridge; Option D2: Proposed Bridge

The survey area comprised the central section of Tongass Narrows, a busy waterway used by AMHS ferries, cruise ships, fishing vessels, float planes, timber interests, and private watercraft. In addition, the shorelines of Revillagigedo, Gravina, and other adjacent islands are frequently impacted by private, commercial, and public development. A significant activity which may indicate the need for new survey of the area in the near future is the proposed Gravina Access Project.⁴⁶ The Gravina Access Project (State of Alaska Department of Transportation and Public Facilities Project #67698, Federal Project #ACHP-0922(5)) includes twelve options for bridges, tunnels, or new ferry terminals which, if constructed, would directly impact the survey area.

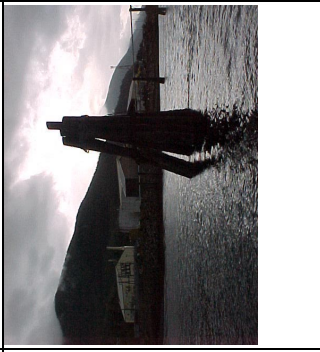
No.	Subsheet	Description	Latitude	Longitude	Photo File Directory	Image
B8	BSL-2	Dolphin near Carlanna Creek ⁵⁷ Depth MLLW: -9.383m Height MLLW: 5.617m	55° 21' 25.0" N	131° 42' 00.8" W	B8.jpg

- ⁵⁵ Chart as cable crossing sign at the survey position.
- ⁵⁶ Retain charted *Cable and Pipeline Area*.
- ⁵⁷ Chart as High Water dolphin at survey position.

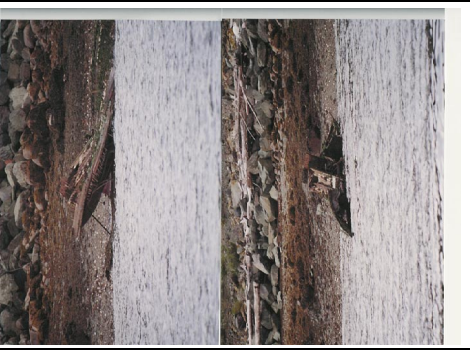
B9	BSL-9	Sunken boat wreck ⁵⁸ Depth MLLW: +0.722m Height MLLW: 5.022m	55° 21' 01.961" N	131° 41' 53.889" W	ITBI_6A_220.jpg

- ⁵⁸ Chart visible wreck at survey position.
- ⁵⁹ Chart as float, see smooth sheet for the depiction of the area.
- ⁶⁰ Chart as floating pier at survey position.

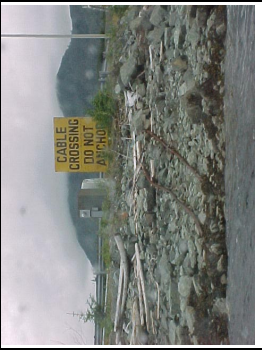
No.	Subsheet	Description	Latitude	Longitude	Photo File Directory	Image
B22	BSL-2	Cable Crossing Sign ⁶⁹	55° 21' 18.05" N	131° 42' 18.61" W	ITBI_5A_232.jpg
