H11032

Type of Survey Side Scan Sonar and  
Vertical Beam Hydrographic  
Field No. OPR-F336-KR-01 Sheet A  
Registry No. H11032

State North Carolina  
General Locality Pamlico & Croatan Sounds  
Sub locality Weir Point to Stumpy Point

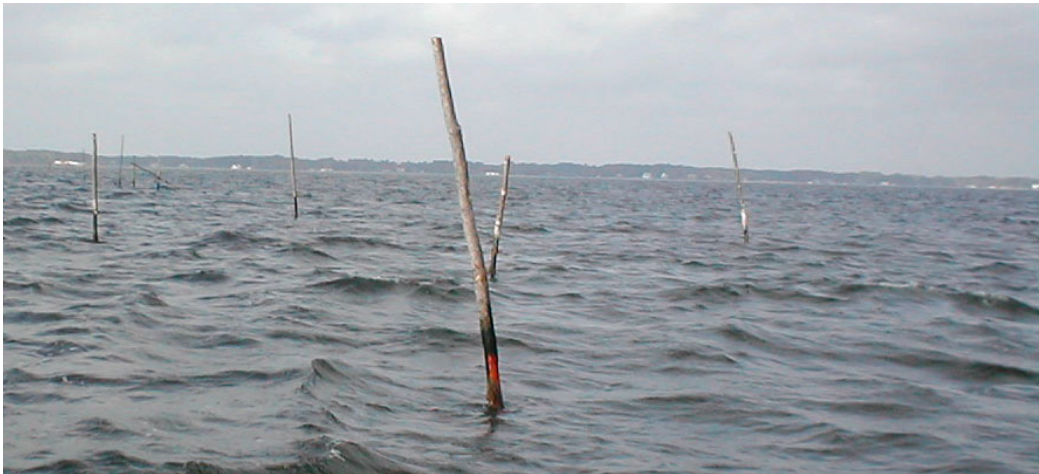
<p><b>Picture 1</b> - Fish trap stakes approximately 800 meters north of Croatan Sound bridge</p>	
<p>Pound net area with sign labeled "W.L. Craddock PN617167" located on the west shore above Roanoke Marshes Light and south of Daymarker "SC1"- stakes extend from shore out approximately 200 meters - width is widest at the eastern end, approx. 35 meters, with the spacing of approx. 20 meters (see Picture 2)</p>	<p>Approximate centerline (E-W):  N 35° 49' 30.23"  W 075° 43' 33.68"  to  N 35° 49' 28.05"  W 075° 43' 41.18"  <i>Concur.</i></p>

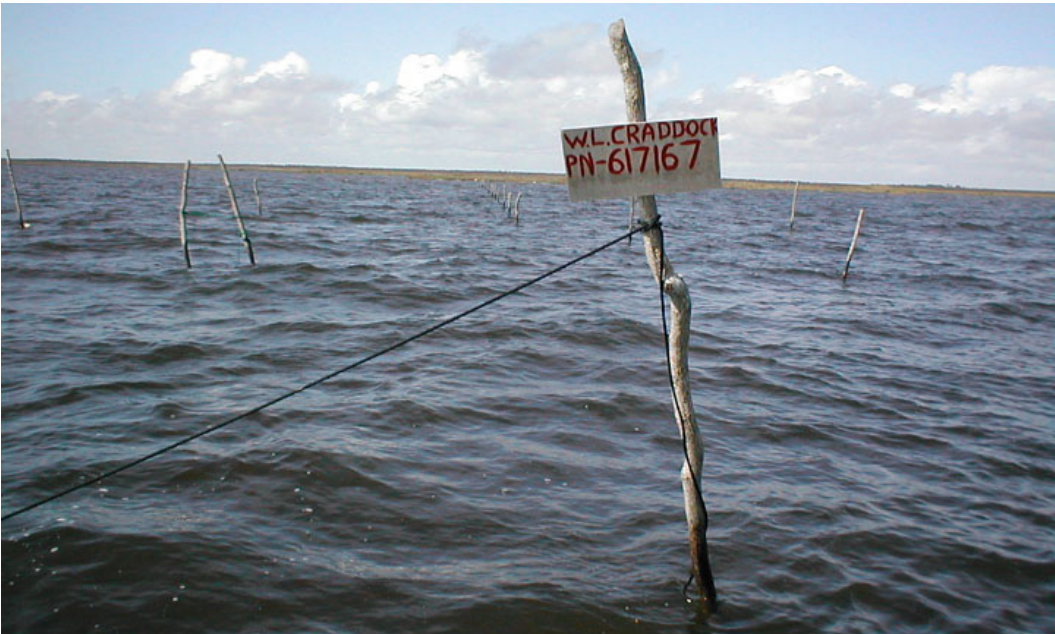
<p><b>Picture 2</b> - Pound net area located on west shore above Roanoke Marshes Light</p>

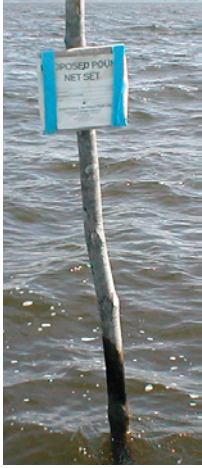
Description	Location (NAD83)
Single stake marked "Proposed Pound Net Set" 375 meters east-northeast of "W.L. Craddock PN617167" pound net area (see Picture 3)	N 35° 49' 32.61" W 075° 43' 18.67" <i>Concur.</i>

<p><b>Picture 3</b> - Single stake east of "W.L. Craddock PN617167"</p>	
North-south oriented line of fish trap stakes below Roanoke Island, approx. 3600 meters southeast of Roanoke Island West Side Light 2  - stakes extend south from shore approx. 200 meters	Approximate centerline (N-S): N 35° 48' 59.42" W 075° 38' 30.51" to N 35° 48' 52.57" W 075° 38' 30.41" <i>Concur.</i>
Pound net area with sign labeled "W.L. Craddock P.NO. 03612" located on the west shore approximately 3300 meters southwest of Roanoke Marshes Light  - stakes extend from shore approx. 650 meters - most of the width is 1-10 meters wide, with a 45x45 meter area on the eastern most end (see Picture 4)	Approximate centerline (E-W): N 35° 47' 18.06" W 075° 43' 25.65" to N 35° 47' 15.55" W 075° 43' 38.01" to N 35° 47' 11.42" W 075° 43' 50.59" <i>Concur.</i>

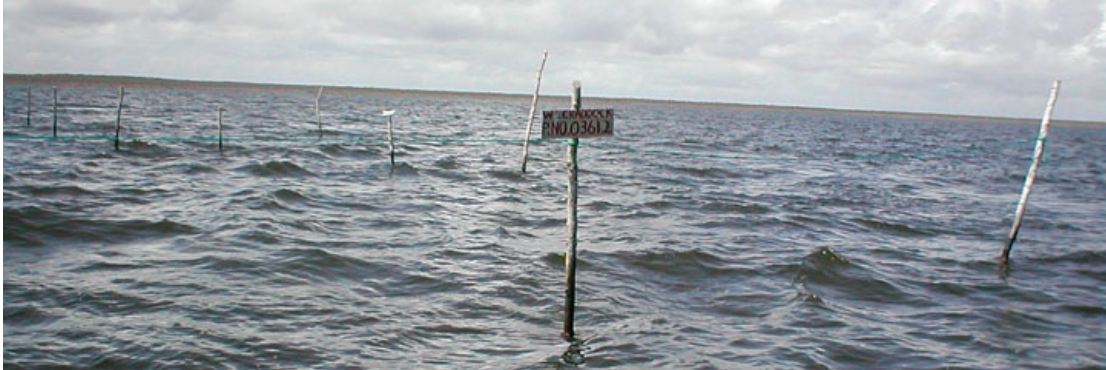
<p><b>Picture 4</b> - Pound net area on the west shore southwest of Roanoke Marshes Light</p>	
<p>Fish trap area of stakes, nets, and wires located on the west shore approximately 5600 meters southwest of Roanoke Marshes Light and 2500 meters south of "W.L. Craddock P.NO. 03612"</p> <ul style="list-style-type: none"> <li>- stakes extend from shore approx. 850 meters</li> <li>- north-south width varies from 45-80 meters (see Picture 5) <i>Concur.</i></li> </ul>	<p>Polygon bounded as follows:</p> <p>N 35° 45' 48.75" W 075° 43' 57.84" to N 35° 45' 51.65" W 075° 43' 42.84" to N 35° 45' 53.54" W 075° 43' 31.12" to N 35° 45' 51.99" W 075° 43' 30.73" to N 35° 45' 49.35" W 075° 43' 47.12" to N 35° 45' 45.95" W 075° 43' 57.95"</p>

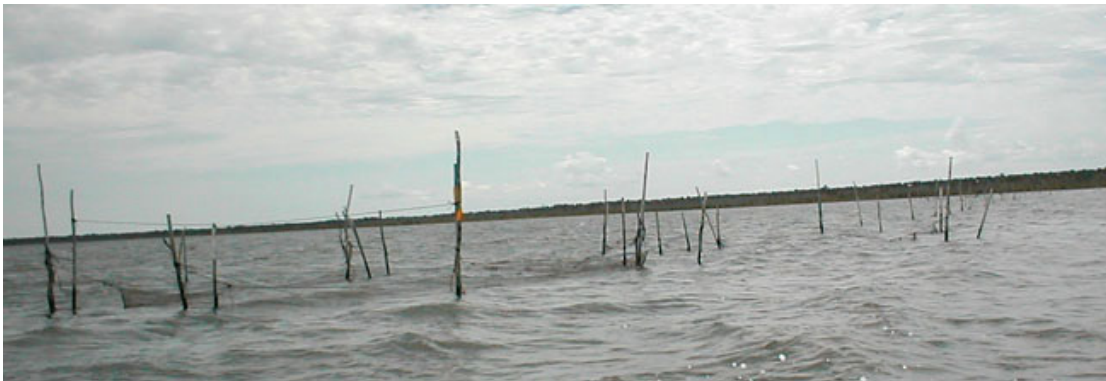
<p><b>Picture 5</b> - Fish trap area of stakes, nets, and wires on the west shore</p>

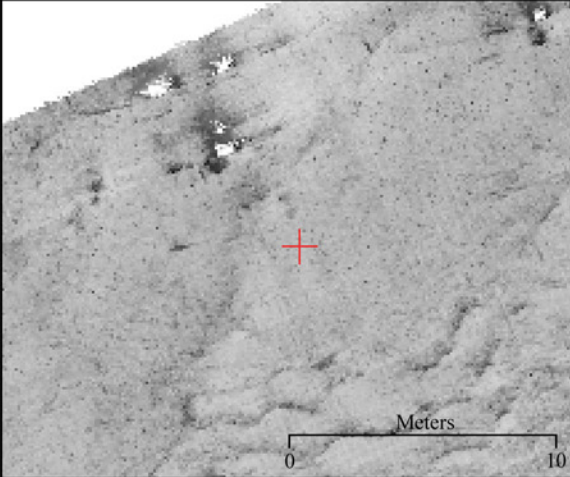
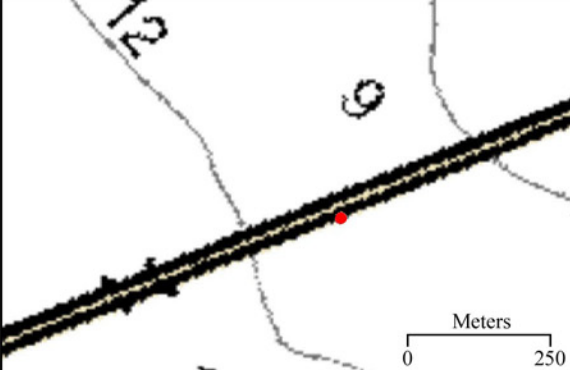
## FC197 Item Investigation Report

**Investigation Summary:** Side scan sonar data acquired along 4 tracklines oriented in a box pattern, no target observed in area. This item investigation is resolved and requires no further study.

<p> <b>Least Depth:</b> n/a  <b>Least Depth (sounding):</b> n/a  <b>Line:</b> n/a <b>Ping:</b> n/a  <b>LD Lat:</b> n/a  <b>LD Lon:</b> n/a         </p>	<p>Contact was not observed in side scan item investigation data. Further Echo Sounder information was not warranted.</p>
	<p>Contact was not observed in side scan item investigation data. Further Echo Sounder information was not warranted.</p>
<p> <b>Chart Recommendations:</b>            N/A - no objects or features observed.         </p>

N/A – no objects or features observed.

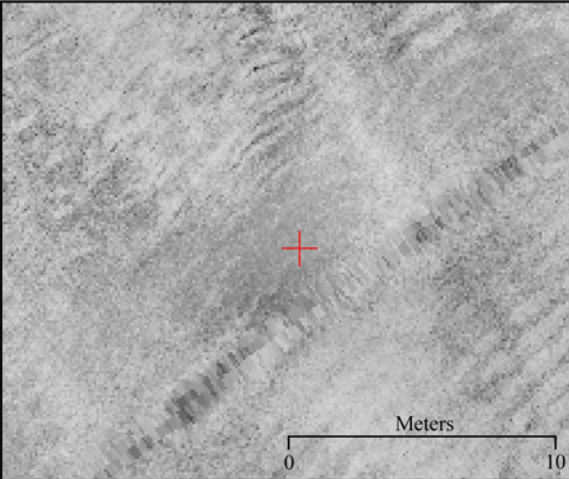
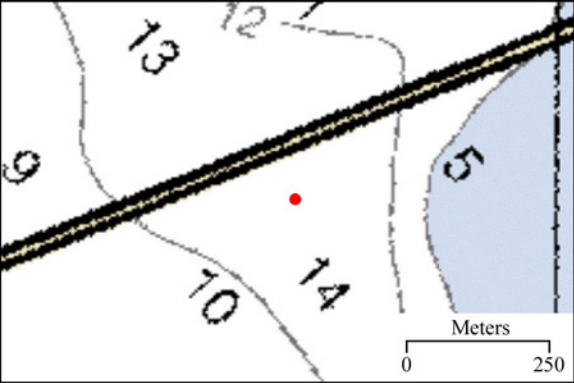
## FC273 Item Investigation Report

**Investigation Summary:** Side scan sonar data acquired along 4 tracklines oriented in a box pattern no target observed in area. This item investigation is resolved and requires no further study.

<p> <b>Least Depth:</b> n/a  <b>Least Depth (sounding):</b> n/a  <b>Line:</b> n/a <b>Ping:</b> n/a  <b>LD Lat:</b> n/a  <b>LD Lon:</b> n/a         </p>	<p>Contact was not observed in side scan item investigation data. Further Echo Sounder information was not warranted.</p>
	<p>Contact was not observed in side scan item investigation data. Further Echo Sounder information was not warranted.</p>
<p> <b>Chart Recommendations:</b>            N/A - no objects or features observed.         </p>

N/A – no objects or features observed.

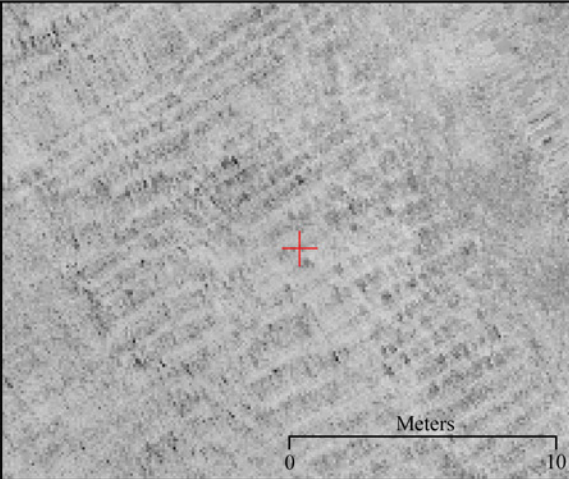
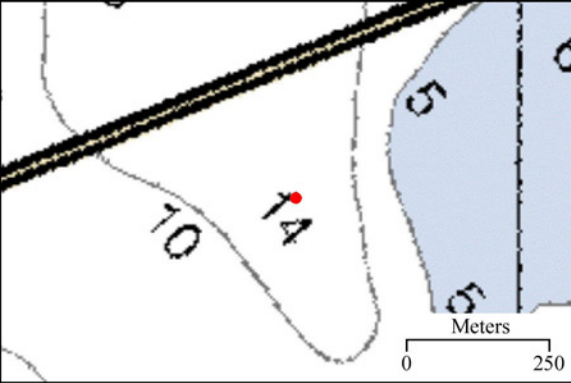
## FC284 Item Investigation Report

**Investigation Summary:** Side scan sonar data acquired along 4 tracklines oriented in a box pattern, no target observed in area. This item investigation is resolved and requires no further study.

<p> <b>Least Depth:</b> n/a  <b>Least Depth (sounding):</b> n/a  <b>Line:</b> n/a <b>Ping:</b> n/a  <b>LD Lat:</b> n/a  <b>LD Lon:</b> n/a         </p>	<p>Contact was not observed in side scan item investigation data. Further Echo Sounder information was not warranted.</p>
	<p>Contact was not observed in side scan item investigation data. Further Echo Sounder information was not warranted.</p>
<p> <b>Chart Recommendations:</b>            N/A - no objects or features observed.         </p>

N/A – no objects or features observed.

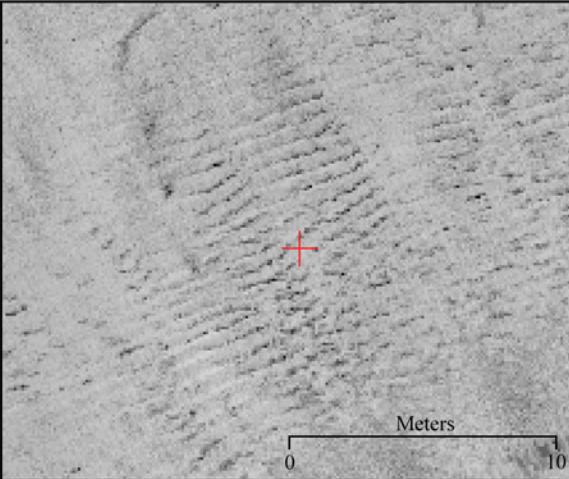
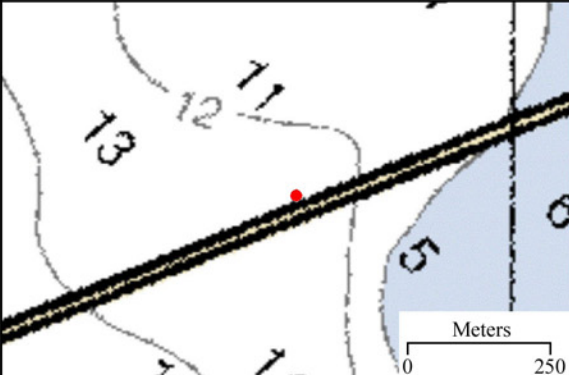
## OC11 Item Investigation Report

**Investigation Summary:** Side scan sonar data acquired along 4 tracklines oriented in a box pattern, no target observed in area. This item investigation is resolved and requires no further study.

<p> <b>Least Depth:</b> n/a  <b>Least Depth (sounding):</b> n/a  <b>Line:</b> n/a <b>Ping:</b> n/a  <b>LD Lat:</b> n/a  <b>LD Lon:</b> n/a         </p>	<p>Contact was not observed in side scan item investigation data. Further Echo Sounder information was not warranted.</p>
	<p>Contact was not observed in side scan item investigation data. Further Echo Sounder information was not warranted.</p>
<p> <b>Chart Recommendations:</b>            N/A - no objects or features observed.         </p>

N/A – no objects or features observed.

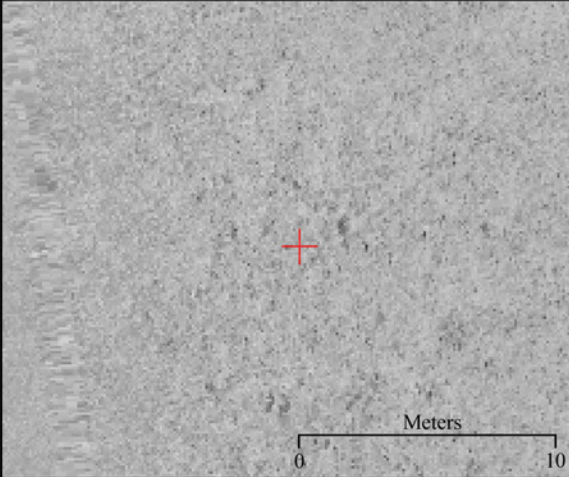
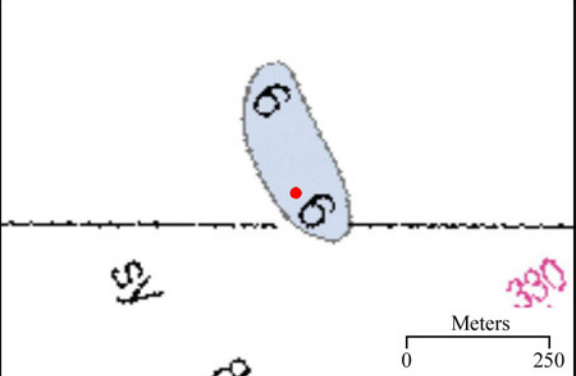
## FC356

**Investigation Summary:** Side scan sonar data acquired along 4 tracklines oriented in a box pattern, no target observed in area. This item investigation is resolved and requires no further study.

<p> <b>Least Depth:</b> n/a  <b>Least Depth (sounding):</b> n/a  <b>Line:</b> n/a <b>Ping:</b> n/a  <b>LD Lat:</b> n/a  <b>LD Lon:</b> n/a         </p>	<p>Contact was not observed in side scan item investigation data. Further Echo Sounder information was not warranted.</p>
	<p>Contact was not observed in side scan item investigation data. Further Echo Sounder information was not warranted.</p>
<p> <b>Chart Recommendations:</b>            N/A no objects or features observed.         </p>

N/A – no objects or features observed.

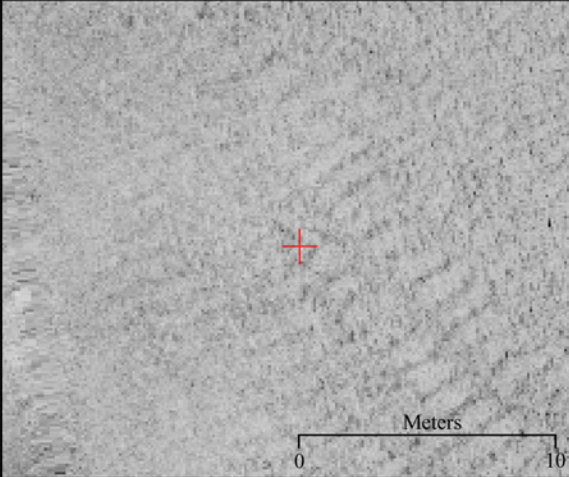
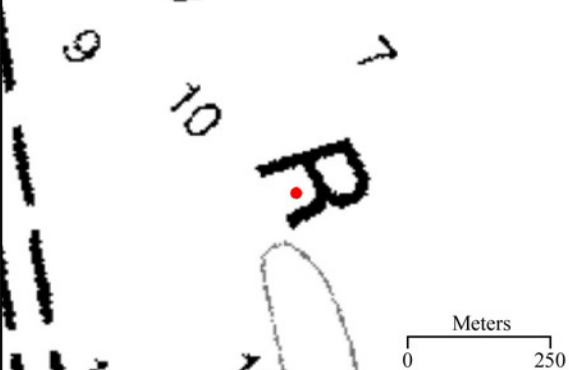
## OC18/OC19 Item Investigation Report

**Investigation Summary:** Side scan sonar data acquired along 4 tracklines oriented in a box pattern, no target observed in area. This item investigation is resolved and requires no further study.

<p> <b>Least Depth:</b> n/a  <b>Least Depth (sounding):</b> n/a  <b>Line:</b> n/a <b>Ping:</b> n/a  <b>LD Lat:</b> n/a  <b>LD Lon:</b> n/a         </p>	<p>Contact was not observed in side scan item investigation data. Further Echo Sounder information was not warranted.</p>
	<p>Contact was not observed in side scan item investigation data. Further Echo Sounder information was not warranted.</p>
<p> <b>Chart Recommendations:</b>            N/A - no objects or features observed.         </p>

N/A – no objects or features observed.

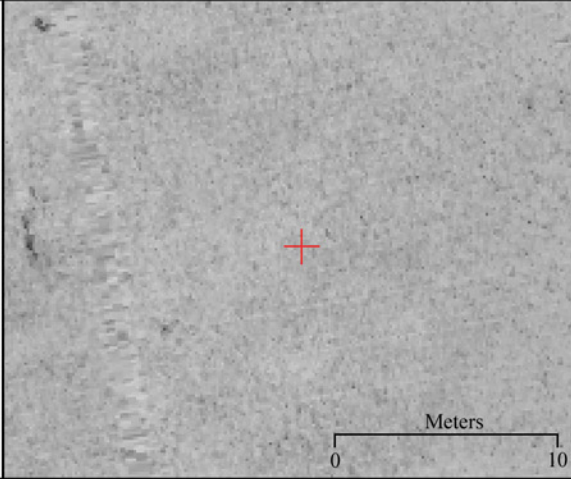
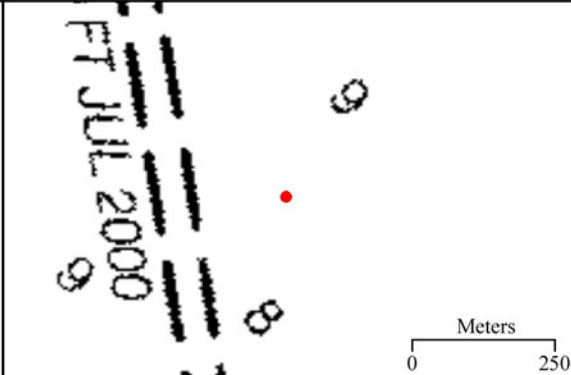
## FC379

<p><b>Line:</b> S25620256425  <b>Ping:</b> n/a  <b>Lat:</b> N 35° 51' 03.03"  <b>Lon:</b> W 075° 42' 27.55"  <b>Contact Dimensions (m):</b>  <b>H:</b> n/a <b>W:</b> n/a <b>L:</b> n/a  <b>Correlating Contacts:</b>  <b>Line:</b> S25620396427 <b>Ping:</b> n/a  <b>Line:</b> S25620436428 <b>Ping:</b> n/a  <b>Line:</b> S25620476426 <b>Ping:</b> n/a</p>

<p><b>Least Depth:</b> n/a  <b>Least Depth (sounding):</b> n/a  <b>Line:</b> n/a <b>Ping:</b> n/a  <b>LD Lat:</b> n/a  <b>LD Lon:</b> n/a</p>	<p>Contact was not observed in side scan item investigation data. Further Echo Sounder information was not warranted.</p>
	<p>Contact was not observed in side scan item investigation data. Further Echo Sounder information was not warranted.</p>
<p><b>Chart Recommendations:</b>  N/A - no objects or features observed.</p>

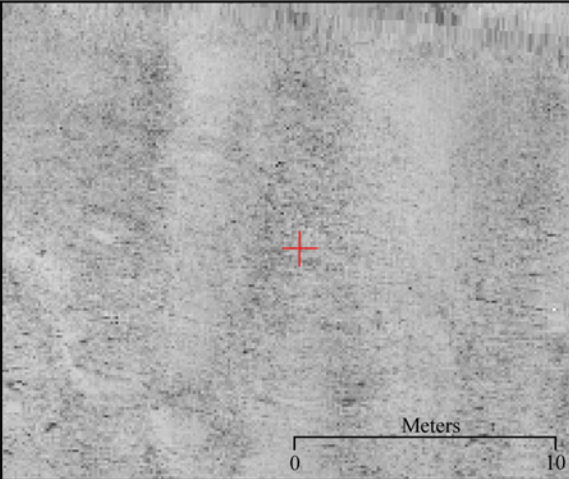
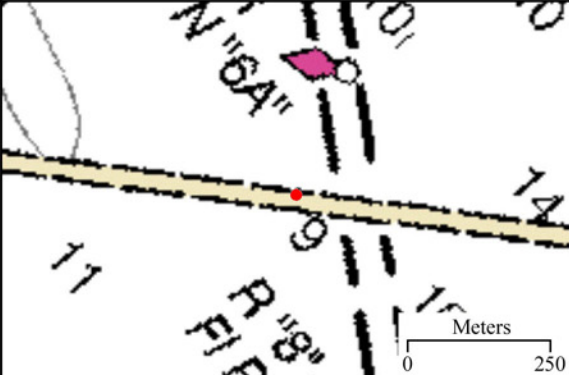
## OC23 Item Investigation Report

<p> <b>Line:</b> S25913176328  <b>Ping:</b> n/a  <b>Lat:</b> N 35° 53' 08.30"  <b>Lon:</b> W 075° 43' 07.14"  <b>Contact Dimensions (m):</b>  <b>H:</b> n/a <b>W:</b> n/a <b>L:</b> n/a  <b>Correlating Contacts:</b>  <b>Line:</b> S25912506325 <b>Ping:</b> n/a  <b>Line:</b> S25912586326 <b>Ping:</b> n/a  <b>Line:</b> S25913056326 <b>Ping:</b> n/a  <b>Line:</b> S25913226327 <b>Ping:</b> n/a         </p>

<p> <b>Least Depth:</b> n/a  <b>Least Depth (sounding):</b> n/a  <b>Line:</b> n/a <b>Ping:</b> n/a  <b>LD Lat:</b> n/a  <b>LD Lon:</b> n/a         </p>	<p>Contact was not observed in side scan item investigation data. Further Echo Sounder information was not warranted.</p>
	<p>Contact was not observed in side scan item investigation data. Further Echo Sounder information was not warranted.</p>
<p> <b>Chart Recommendations:</b>            N/A - no objects or features observed.         </p>

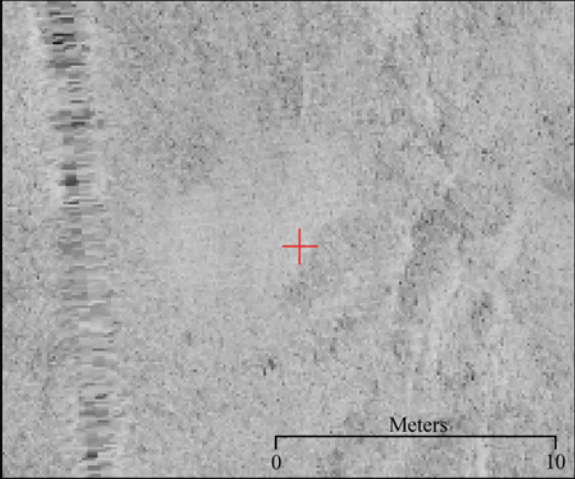
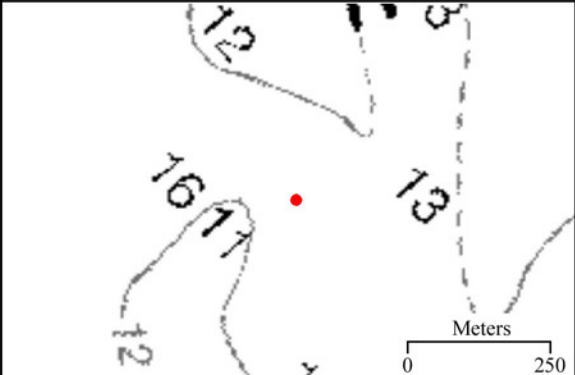
## OC25 Item Investigation Report

<p> <b>Line:</b> S25619556450  <b>Ping:</b> n/a  <b>Lat:</b> N 35° 49' 22.49"  <b>Lon:</b> W 075° 42' 21.44"  <b>Contact Dimensions (m):</b>  <b>H:</b> n/a <b>W:</b> n/a <b>L:</b> n/a  <b>Correlating Contacts:</b>  <b>Line:</b> S25620006451 <b>Ping:</b> n/a  <b>Line:</b> S25620056452 <b>Ping:</b> n/a  <b>Line:</b> S25620086453 <b>Ping:</b> n/a         </p>

<p> <b>Least Depth:</b> n/a  <b>Least Depth (sounding):</b> n/a  <b>Line:</b> n/a <b>Ping:</b> n/a  <b>LD Lat:</b> n/a  <b>LD Lon:</b> n/a         </p>	<p>Contact was not observed in side scan item investigation data. Further Echo Sounder information was not warranted.</p>
	<p>Contact was not observed in side scan item investigation data. Further Echo Sounder information was not warranted.</p>
<p> <b>Chart Recommendations:</b>            N/A -no objects or features observed.         </p>

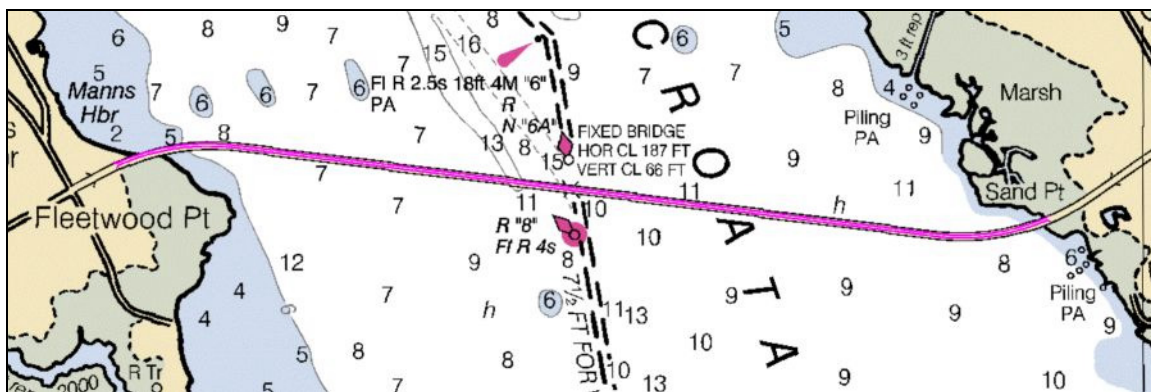
**Surveyed position of newly constructed Bridge (magenta)  
Chart 12204 35<sup>th</sup> Ed., in background**
