H11093

DESCRIPTIVE REPORT

Type of Survey HYDROGRAPHIC

General Locality Bering Sea, Pribilof Islands

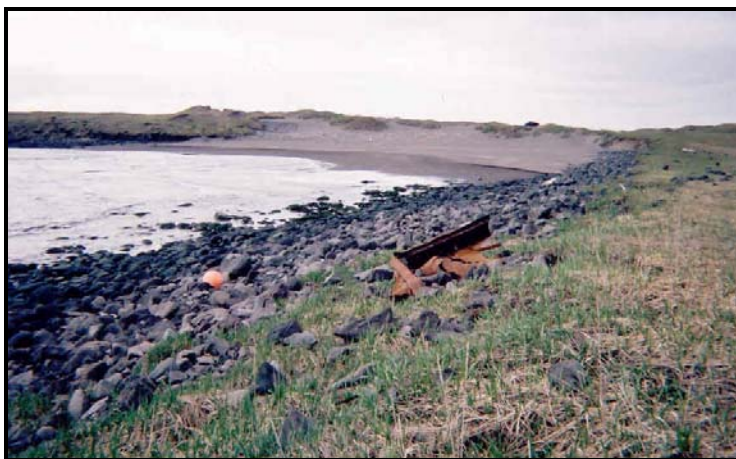
Figure 7 Chunk of Metal on Zolotoi Sands

- The wreck located on the chart on the beach of Zolotoi Bay at 57 07 0.79 N, 170 16 44.06 W was not observed in LIDAR nor was it observed upon a visit to the spot with a handheld GPS. A small chunk of metal was observed but it no longer had any semblance to a shipwreck and was well above MHHW. Local harbormaster has no recollection of a wreck on that spot. This symbol should be removed from Chart 16382.²¹

²¹ Concur, remove charted wreck.

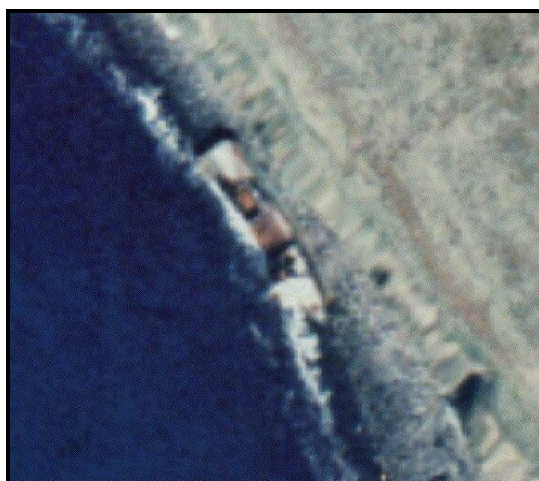
Figure 8 SAT Photo of Wreck “Terminator” prior to removal

- The wreck located on the chart at 31 06 58.74 N, 157 27 29.00 W²² was not observed in LIDAR nor was it observed upon a visit to the spot with a handheld GPS. The local harbormaster stated that this vessels name was “Terminator” and was removed in the past. This symbol should be removed from Chart 16382 and Chart 16380.²³

²³ Concur, remove charted wreck.
