DESCRIPTIVE REPORT

Type of Survey HYDROGRAPHIC

General Locality Twelve Mile Arm

Sublocality Outer Point to Cat Island

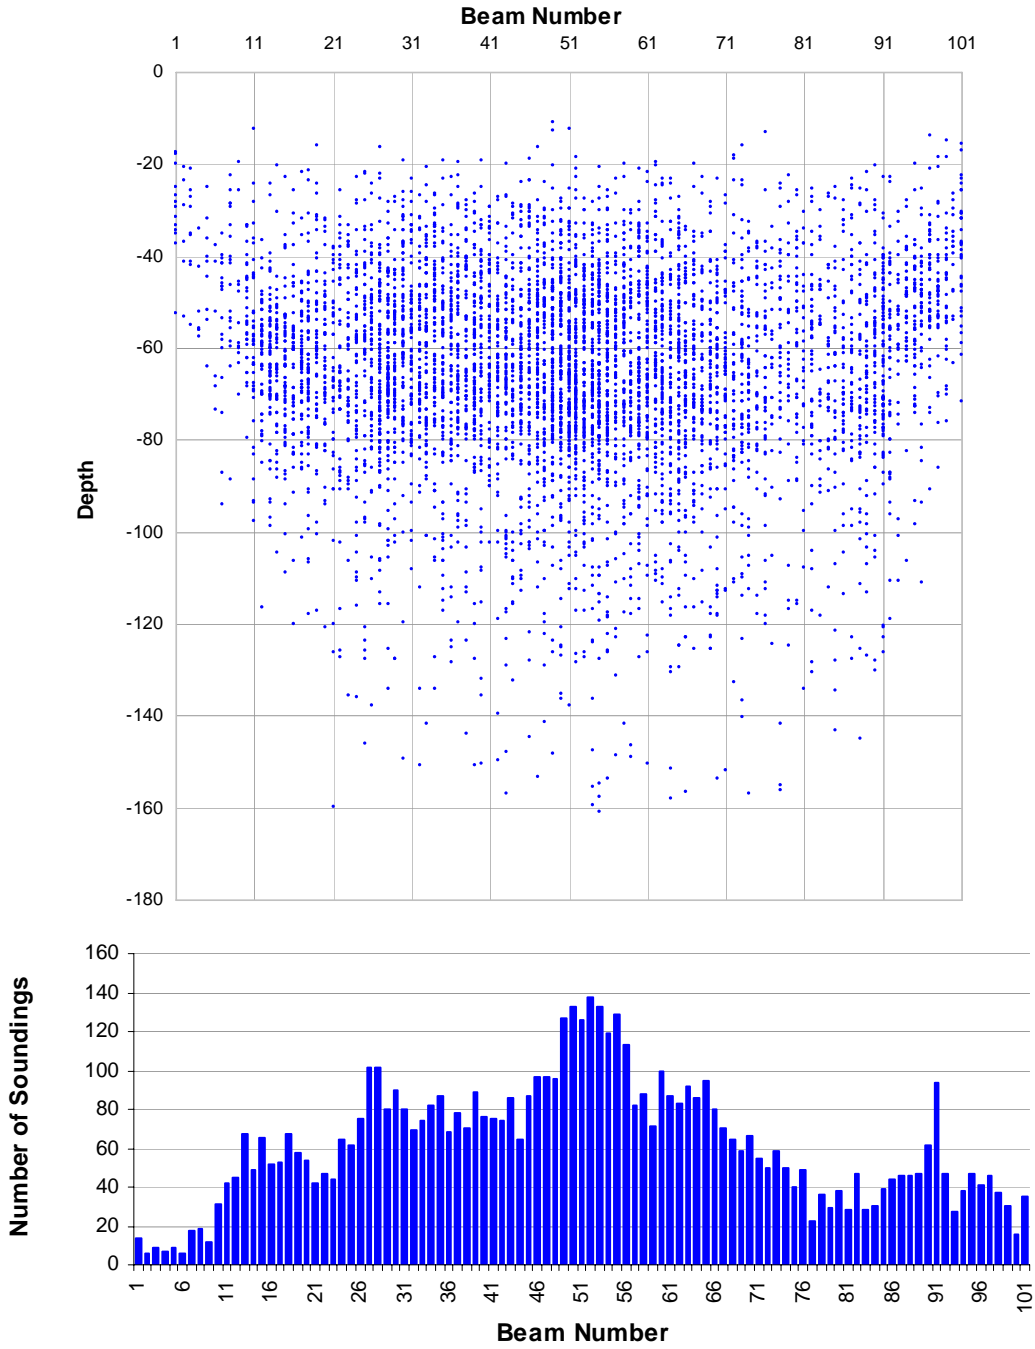
Sheet E Smooth Sheet Sounding Distribution Luna Sea

This chart shows large spikes in the outer beams on the port and starboard sides. The *Royal Fish* was used almost exclusively to survey along the shore. The outermost beam on the shore side was typically the most shoal for any given ping. A review of the smoothsheet verified that most shoreline soundings were from the 8124's outer beams.

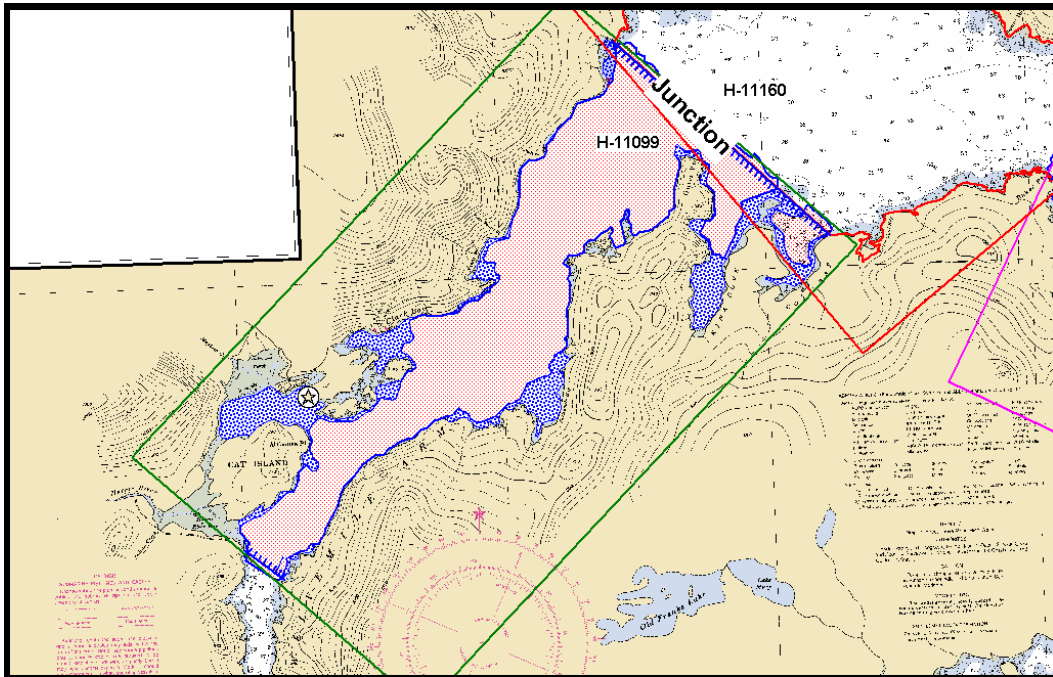
The northern limits of this survey¹⁰ junctions¹¹ H-11160 (2002, Scale 1:10,000) along it's southwesterly limits. The smoothsheet for H-11160 was plotted at the same scale as this survey and the soundings for both surveys agreed well.¹² There are no recommendations and no adjustments were made.

The junction location of H-11099 and H-11160

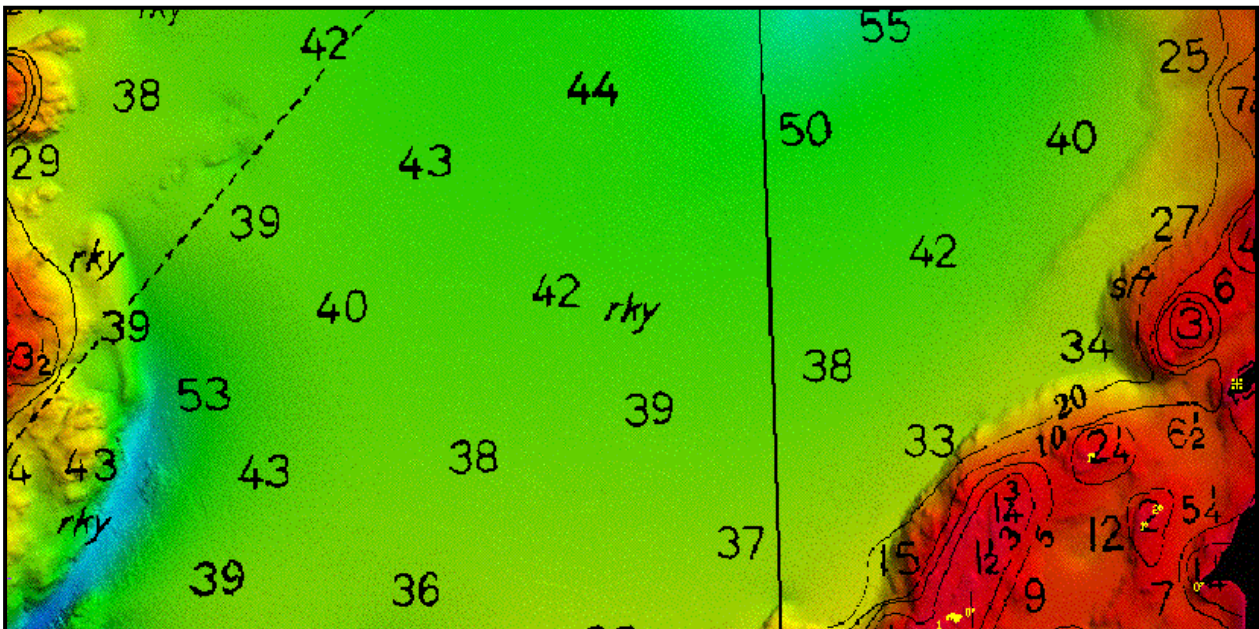
Figure 1.0

Vicinity	Comment
55°29'06" N and 132°35'18" W	An area marked as rky. This location has least depths ranging from 39 to 42 fathoms, and is generally featureless.

The following chartlet shows the area marked as 'rky'. Areas determined to contain rocks (small soundings in yellow) have been superimposed on a digital terrain map and monochrome chart for review.

Based on the results of survey H-11099, the Hydrographer recommends removal of the *rky* symbol on the affected charts.²⁴

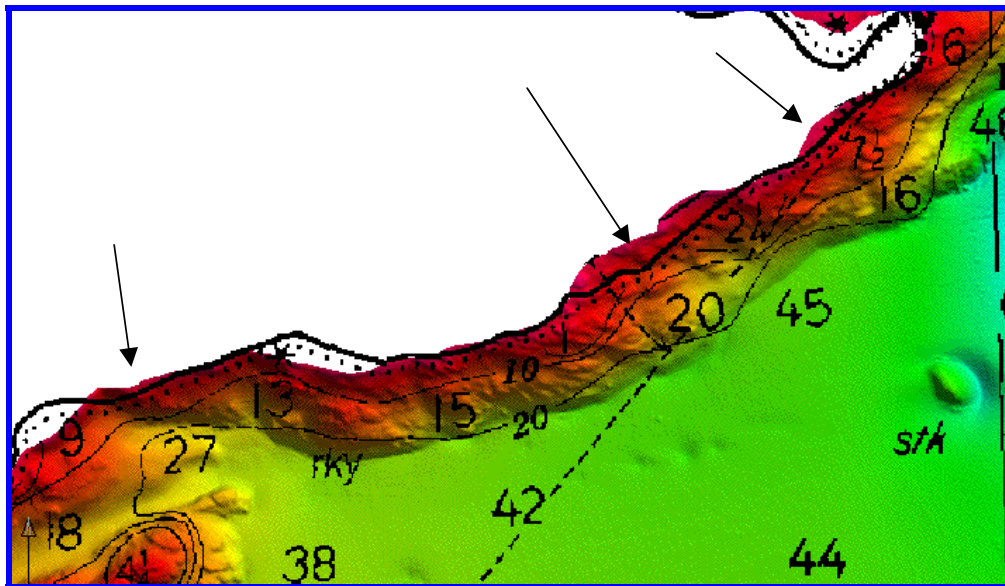
Vicinity	Comment
55°29'34" N and 132°35'06" W ³¹	Shoreline changed by Bathymetry ³²

The following chartlet shows the shoreline indicated on chart 17426 has changed. A digital terrain map has been superimposed on a monochrome chart for review.

Based on the results of this survey the Hydrographer recommends updating the chart with the shoreline changes from the 2002 bathymetry. The new shoreline has migrated to the north by as much as 35 meters in this area.³³

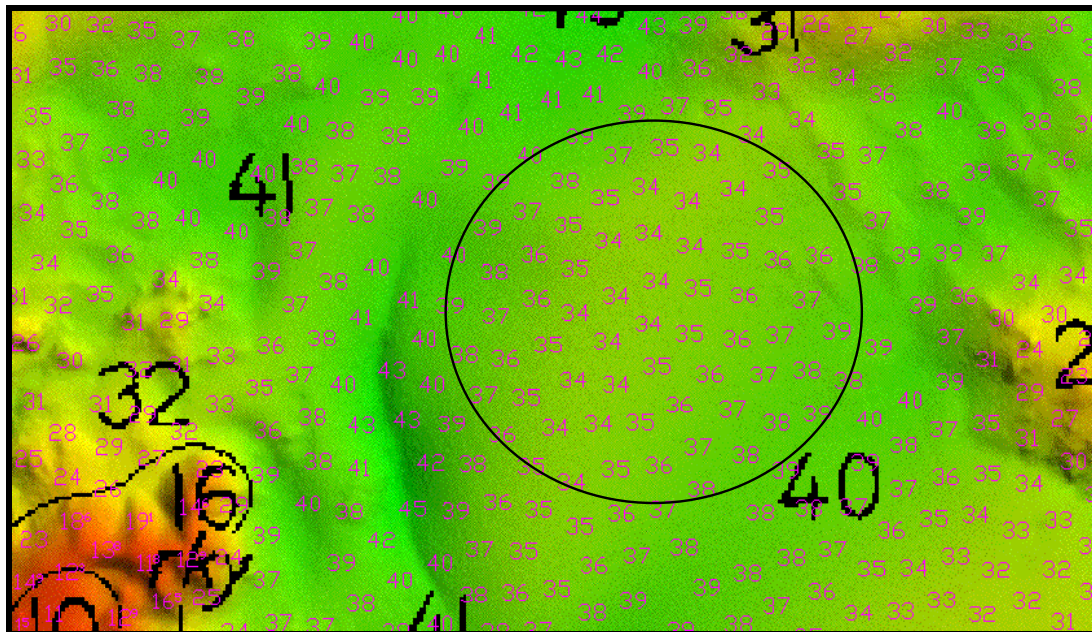
Vicinity	Comment
55°31'31" N and 132°32'40" W	Area of shoaling

The following chartlet shows an area of shoaling. Smoothsheet soundings have been superimposed on a digital terrain map and a monochrome chart for review.

Based on the results of this survey the Hydrographer recommends adding a 34-fathom sounding at the position of 55°31'31" N and 132°32'40" W.

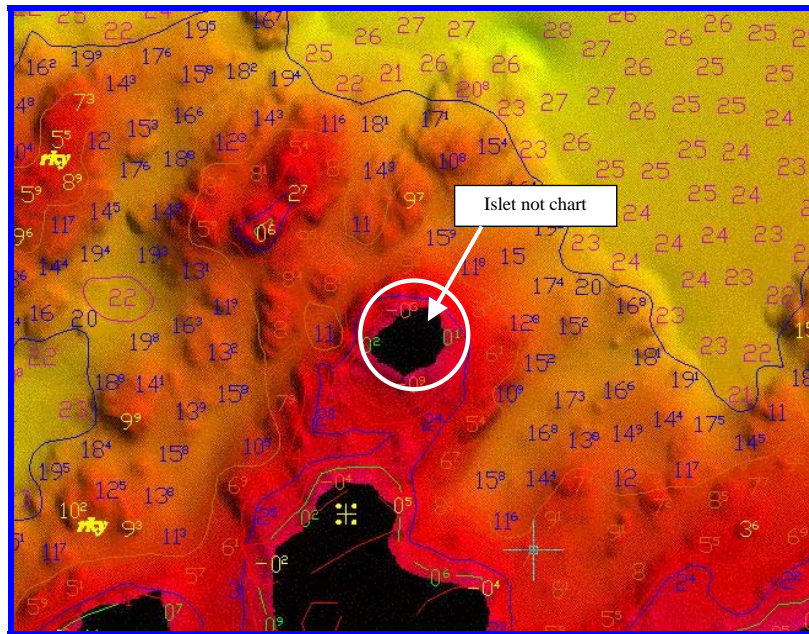
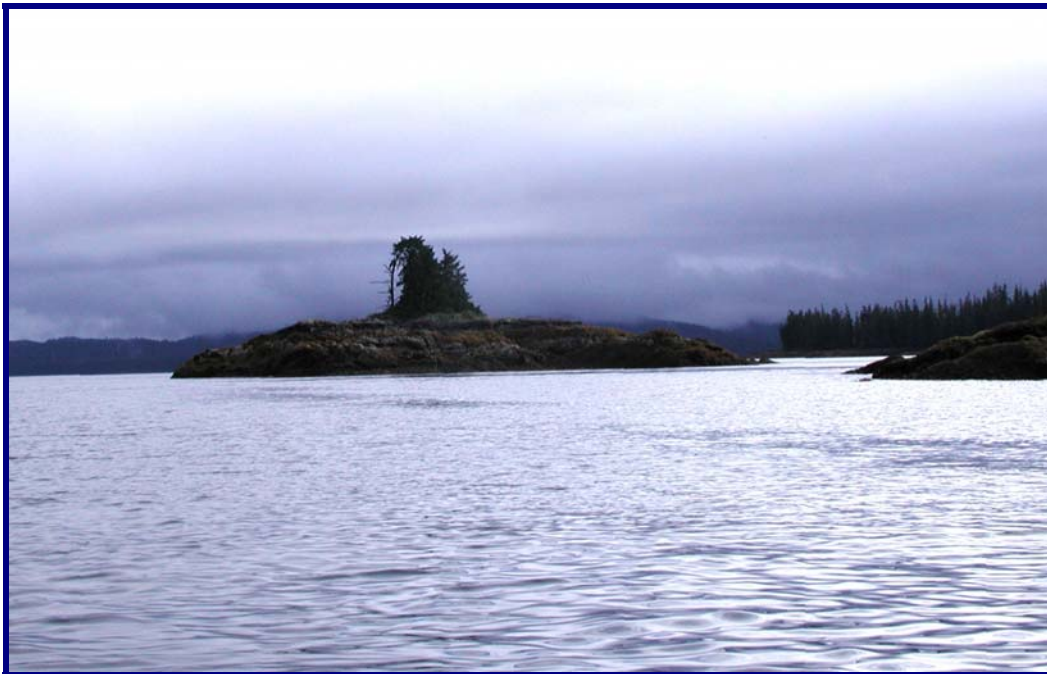
Bathymetry and traditional shoreline verification revealed an Islet not charted.³⁸ The image below shows the 2002 soundings and contours as they compare to Chart 17426. The chart does show a symbol that could represent a land mass although the charted contours indicate more of an extension of the Islet to the south. The remote sensing data lists a rock at this position. However, ground truthing reported trees growing on this mass which measures approximately 90 meters across, and is 16-feet above MLLW.

Symbol on Chart 17426 where Islet was found

2002 soundings overlaid on the digital terrain model

2002 shoreline verification photo of Islet not charted

Based on the results of this survey the Hydrographer recommends changing the charted symbol at the position of 55°30'39" N and 132°32'36" W³⁹ to an Islet

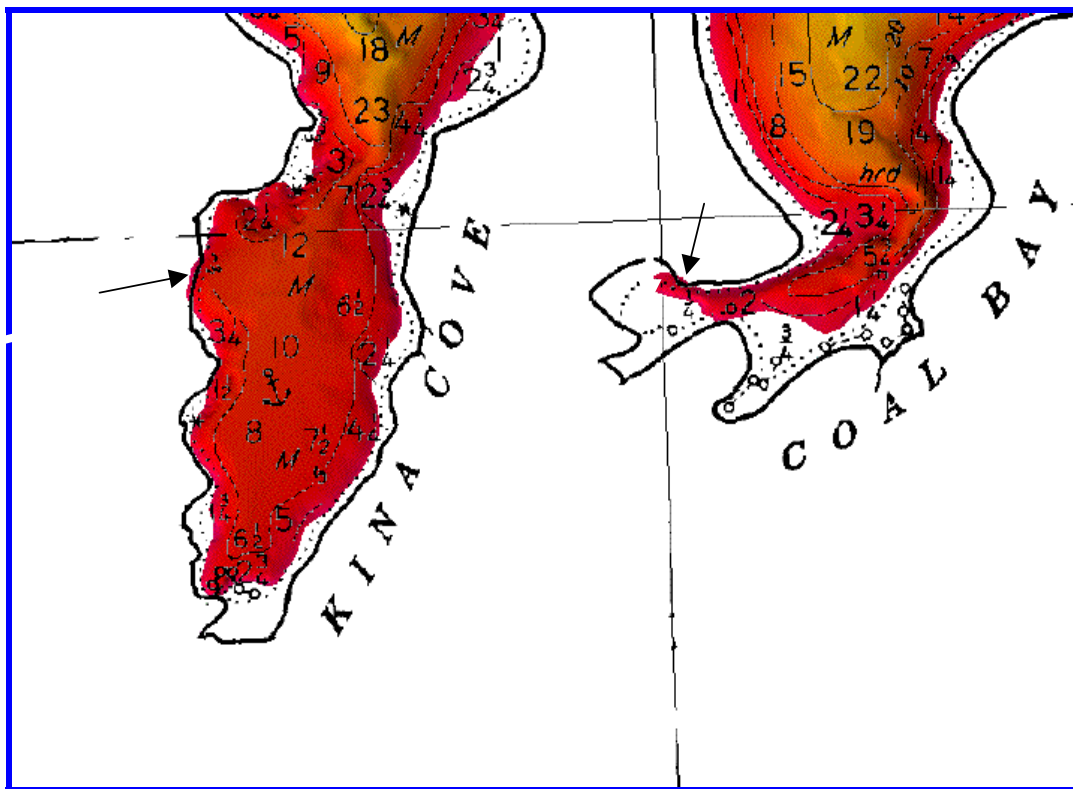
Vicinity	Comment
Kina Cove, Coal Bay	Shoreline changed by Bathymetry ⁴⁰

The following chartlet shows the shoreline indicated on chart 17426 has changed.⁴¹ A digital terrain map has been superimposed on a monochrome chart for review.

Based on the results of this survey the Hydrographer recommends updating the chart with the shoreline changes from the 2002 bathymetry.

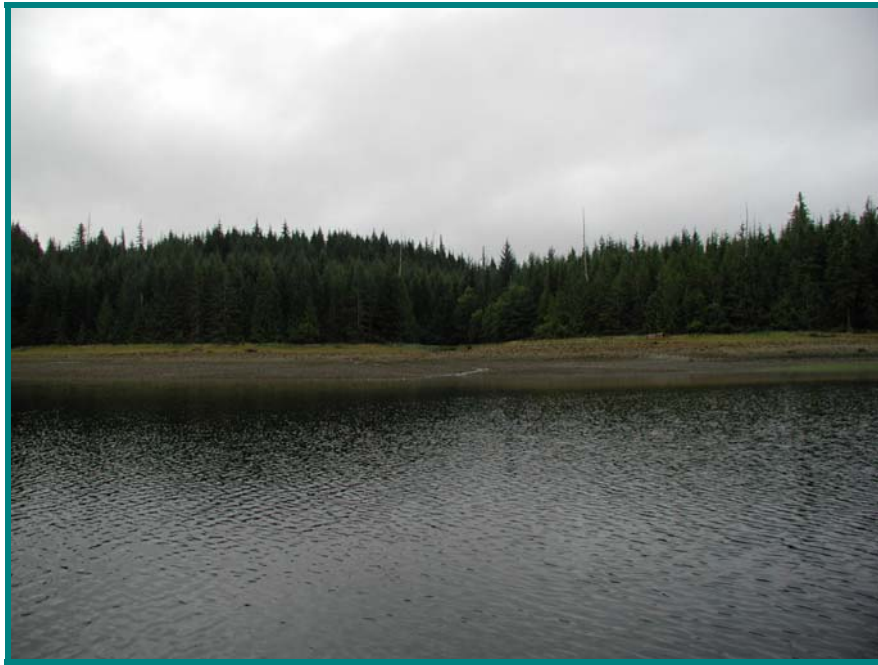
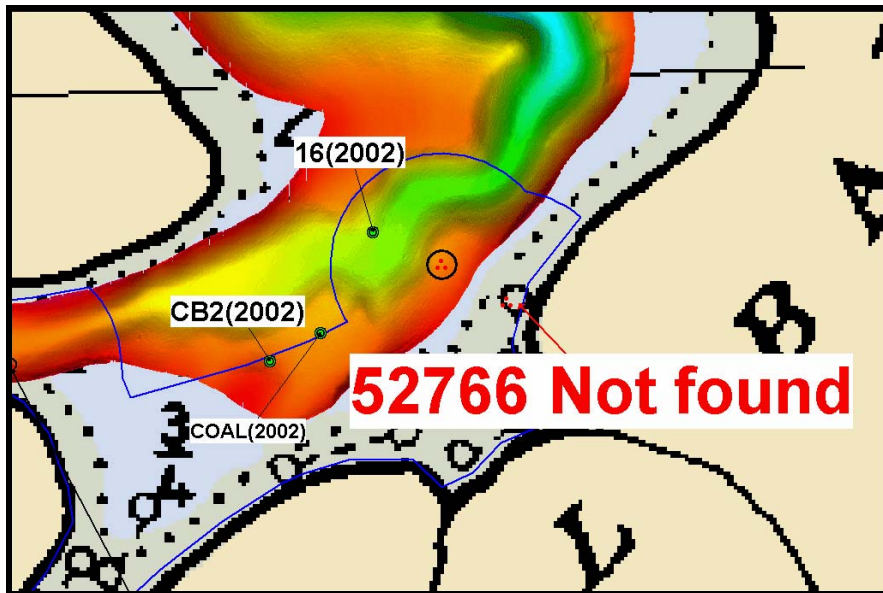
Investigation Summary: This item fell outside the limits of hydrography. A 700-meter, visual shoreline investigation was done for one hour at low tide. The AWOIS radius was totally exposed during this search. Any remnants, if they existed, would have been visible. No dolphins were found. The AWOIS history lists this area as the most seaward location of a group of dolphins. Refer to the following photos, images and plotted field positions for more details on this item.

Seaward extents of AWOIS item 52766 search area

AWOIS item 52766 and the 2002 search positions, Chart 17426

Based on the results of survey H-11099, the Hydrographer recommends removal of the Submerged piles symbols from the chart and removal of the AWOIS item.⁴⁴

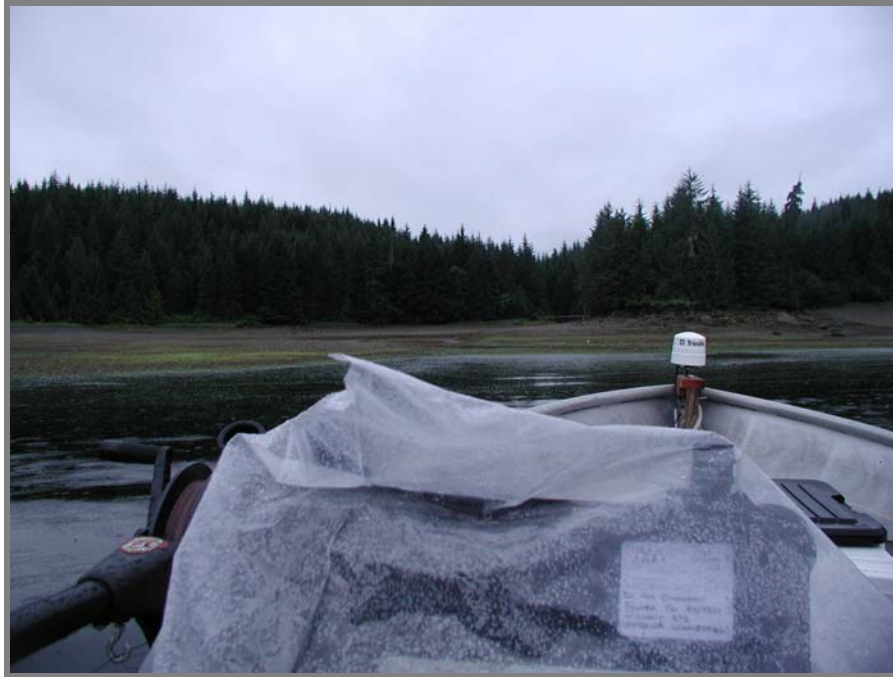
Investigation Summary: A 200-meter radius area was searched for two hours in addition to investigation in the office. The position for this item falls outside the limits of hydrography. The northern half of the search area has full coverage. The southern half was searched visually during shoreline verification at low tide. The AWOIS history lists log storage dolphins at this location. No Dolphins were found. Refer to the following photos, images and plotted field positions for more details on this item.

AWOIS item 52767 search area looking North

AWOIS item 52767 search area, Chart 17426

Based on the results of survey H-11099, the Hydrographer recommends removal of the dolphin symbol on the affected charts. ⁴⁵

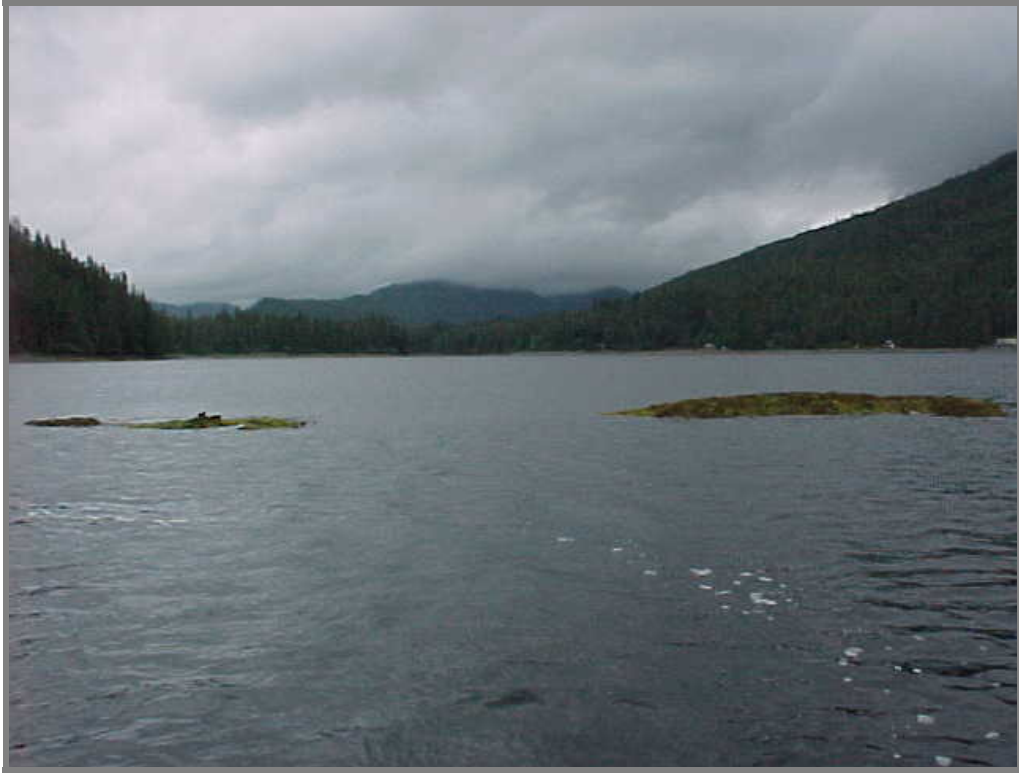
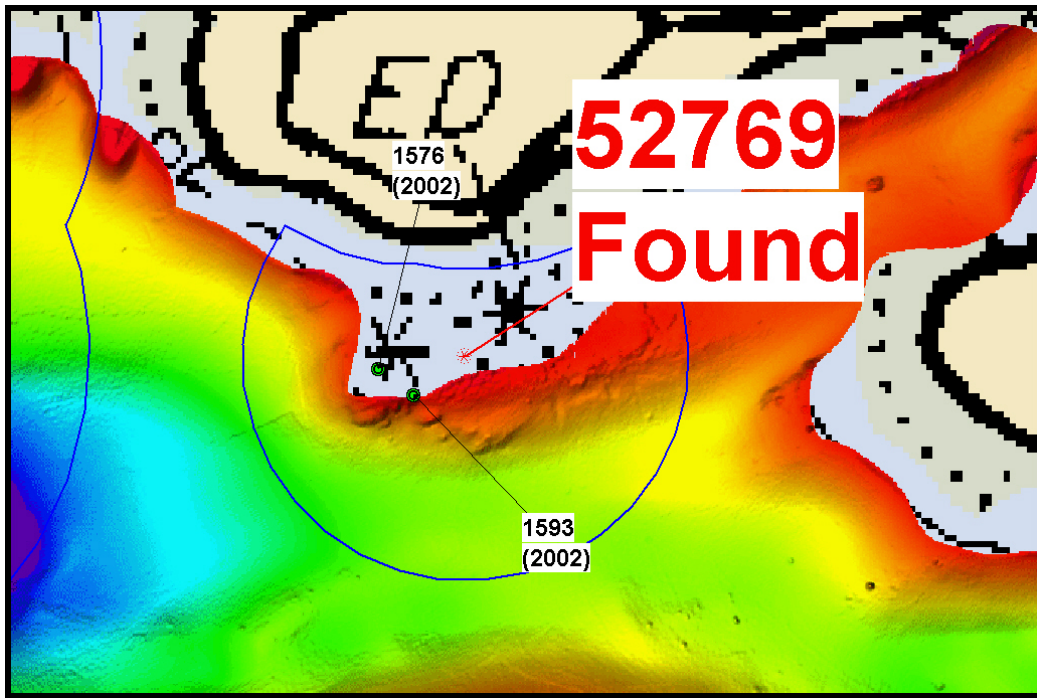
Investigation Summary: A 150-meter radius was searched. A rock awash was found and positioned 50 meters from the historical position. The charted rock symbol agrees with the 2002 surveyed position. The area has full SWMB coverage on the seaward side, defining the shape of this item. Refer to the following photos, images and plotted field positions for more details on this item.

AWOIS item 52769, looking North

AWOIS item 52769, 2002 bathymetry, and 2002 positions; Chart 17426

Based on the results of survey H-11099, the Hydrographer recommends retention of the charted rock symbol for the item. The AWOIS position of this item should be updated to the 2002 surveyed position, Lat 55° 28' 48" N and Long 132° 39' 11"W(average of extent surveyed position above).⁴⁶

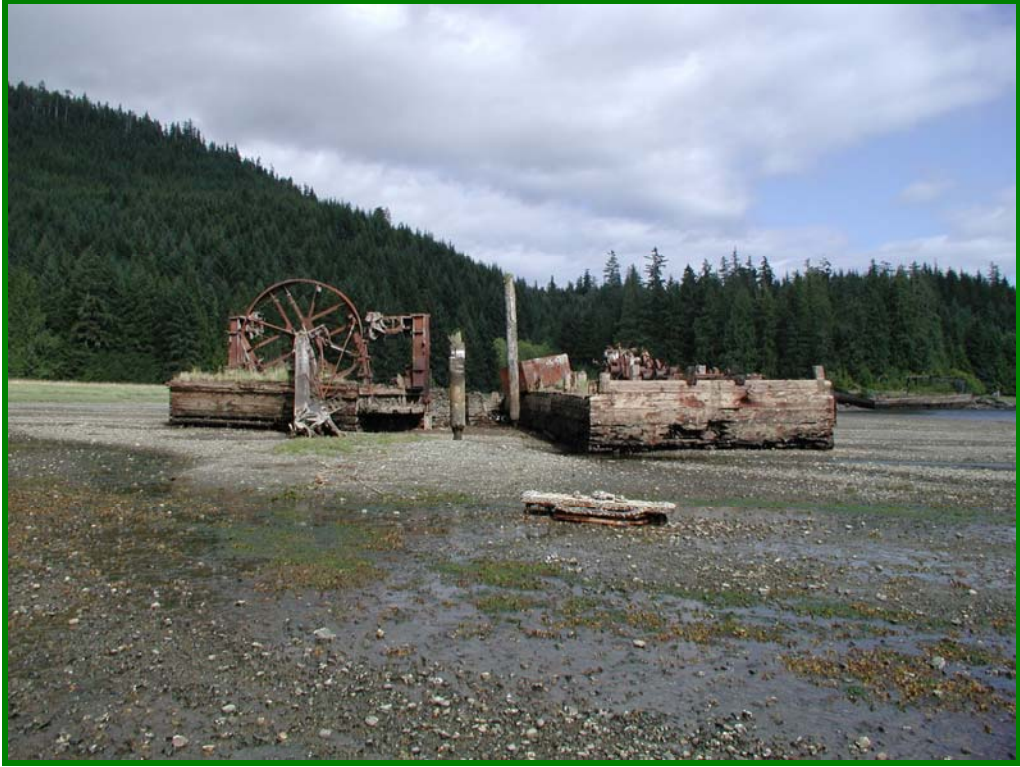
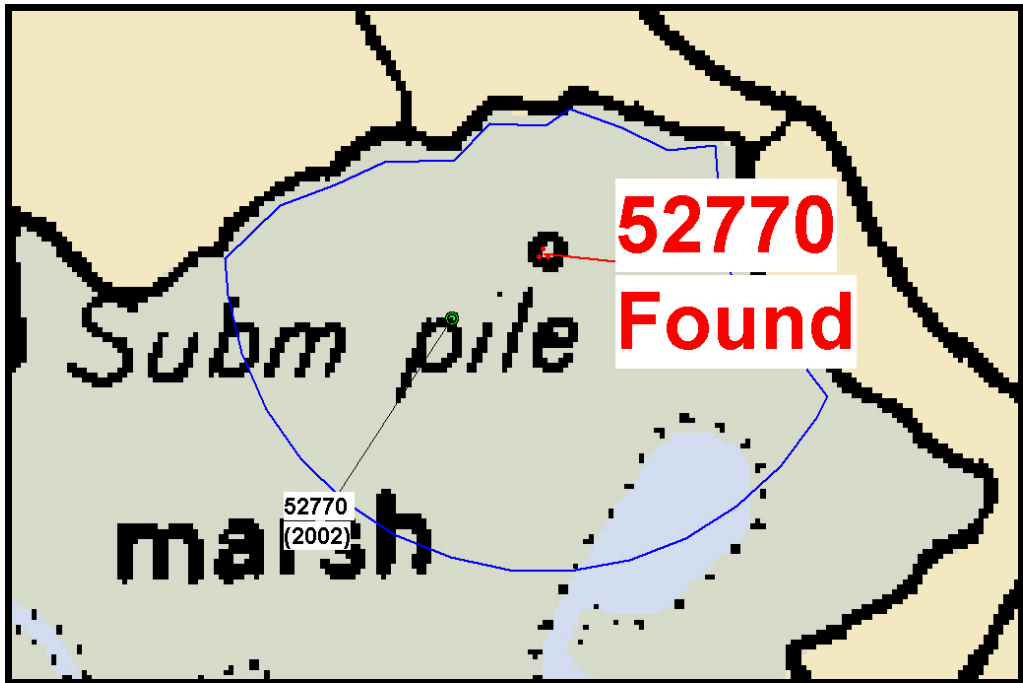
AWOIS item 52770 looking North

AWOIS item 52770 and 2002 position, Chart 17426

Recommendations: Based on the results of survey H-11099, the Hydrographer recommends updating the charted submerged pile symbol to a visible ruins symbol and adding a wreck symbol. The position should also be updated to the 2002 position, Lat 55° 29' 14.28" N Long 132° 39' 26.26" W⁴⁷

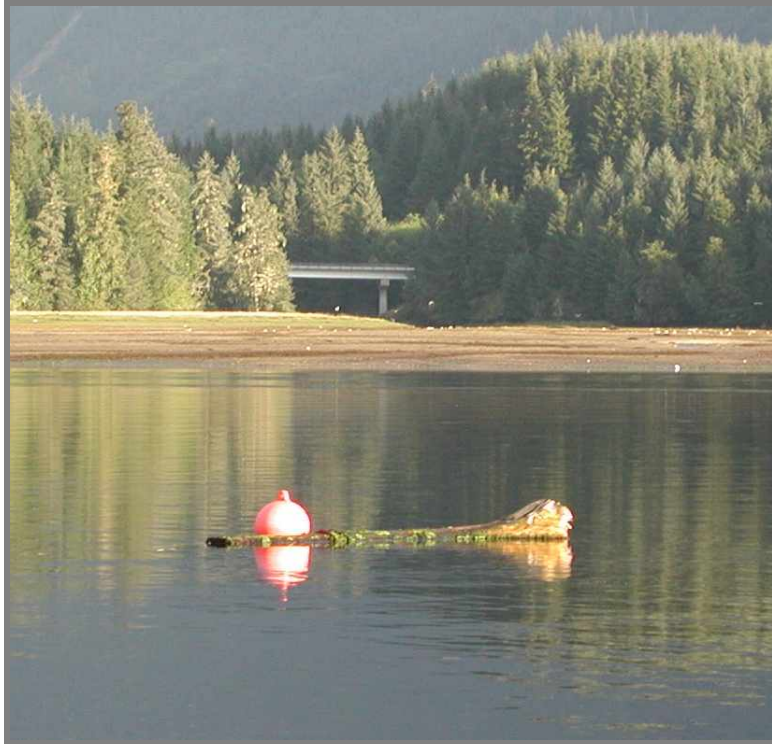
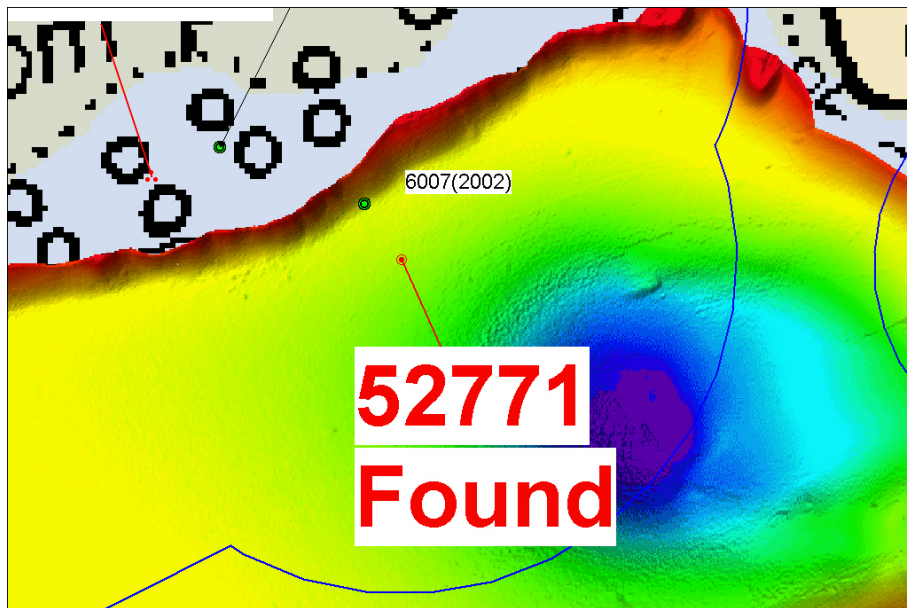
AWOIS item 52771, looking Northwest

AWOIS item 52771, 2002 bathymetry and 2002 position; Chart 17426

Recommendations: Based on the results of survey H-11099, the Hydrographer recommends retention of the log symbol. This log is floating at Lat 55°28'50.51" N Long 132°39'38.44" W.⁴⁸

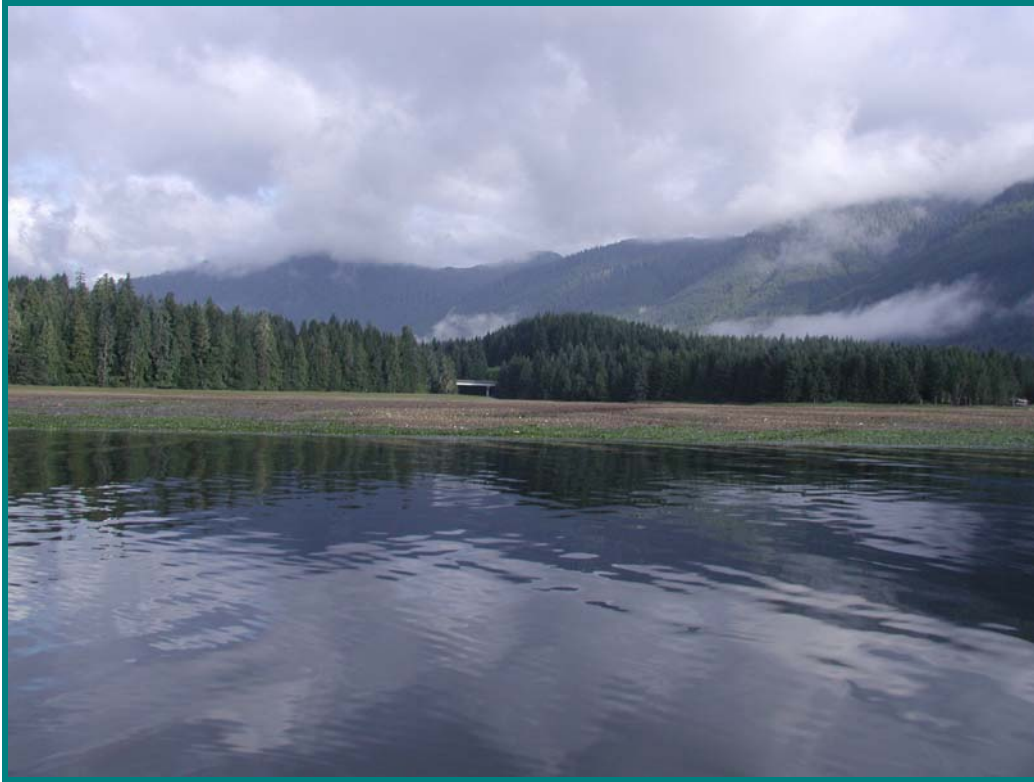
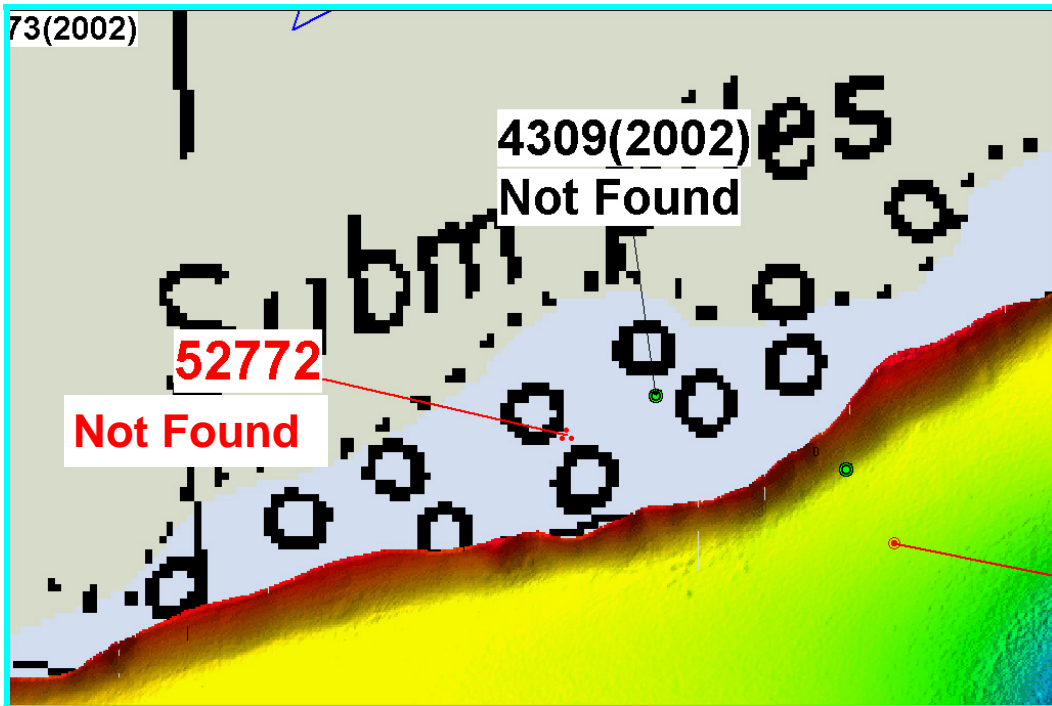
Investigation Summary: A two-hour 510-meter by 80-meter corridor was searched, in addition to office investigation. This item falls outside the limits of hydrography, a search position was obtain during shoreline verification. Water clarity was good; the bottom was visible during the search. There are submerged piles symbols on the chart in this search corridor. No dolphins or piles were found anywhere within the search corridor.

AWOIS 52772 search area, looking Northwest

AWOIS 52772 search position, Chart 17426

Based on the results of survey H-11099, the Hydrographer recommends removal of the Submerged piles symbols from the chart and removal of the AWOIS item.⁴⁹

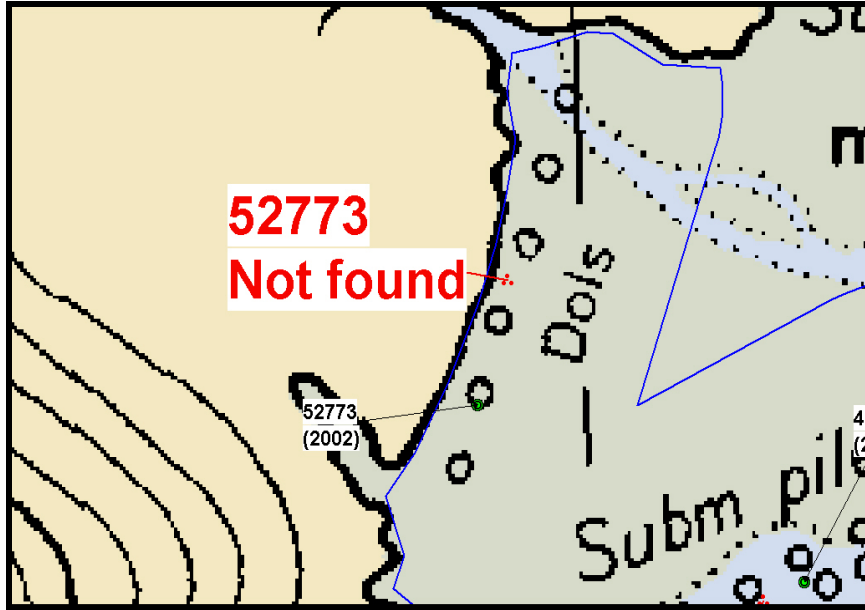
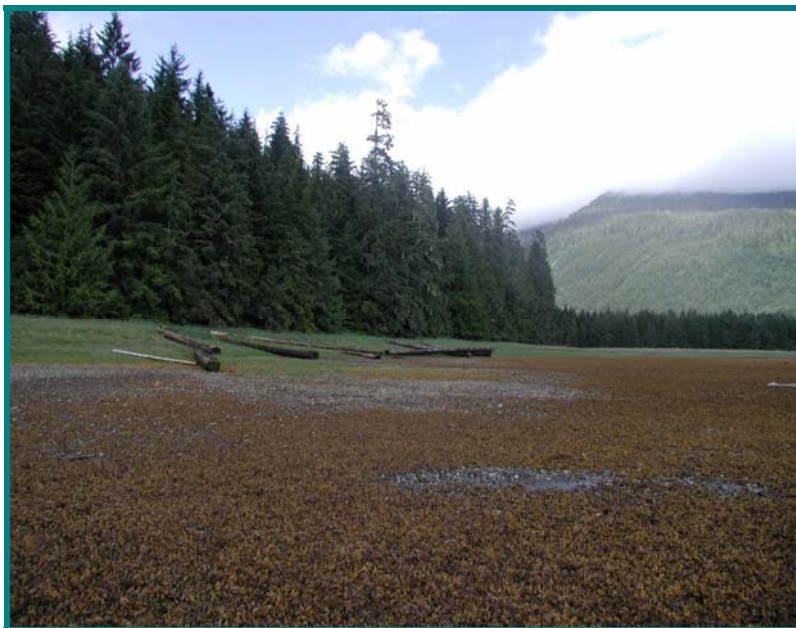
Investigation Summary: This item fell outside the limits of hydrography. A two hour search on foot was conducted along a corridor 500-meters long and 50-meters wide along the shoreline where the charted dolphins are supposed to be located. The entire search corridor was exposed and visible. No dolphins were found in the search area. There was approximately 20 logs lying down above the high tide line in this area. These may be left over from the log storage area the dolphins once supported.

AWOIS 52773 search position, Chart 17426

Logs in AWOIS 52773 search area, looking North

Based on the results of survey H-11099, the Hydrographer recommends removal of the dolphin symbols .⁵⁰

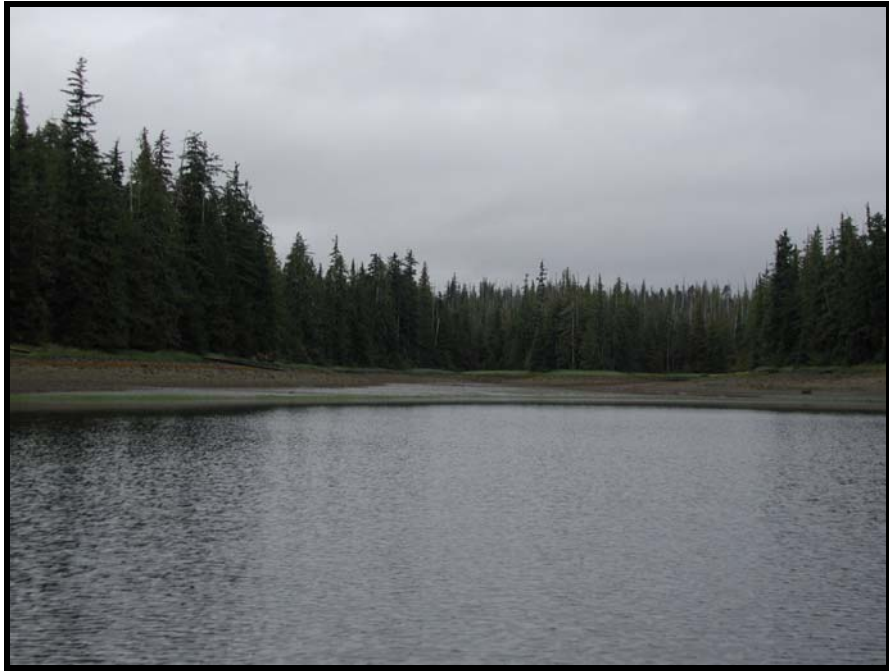
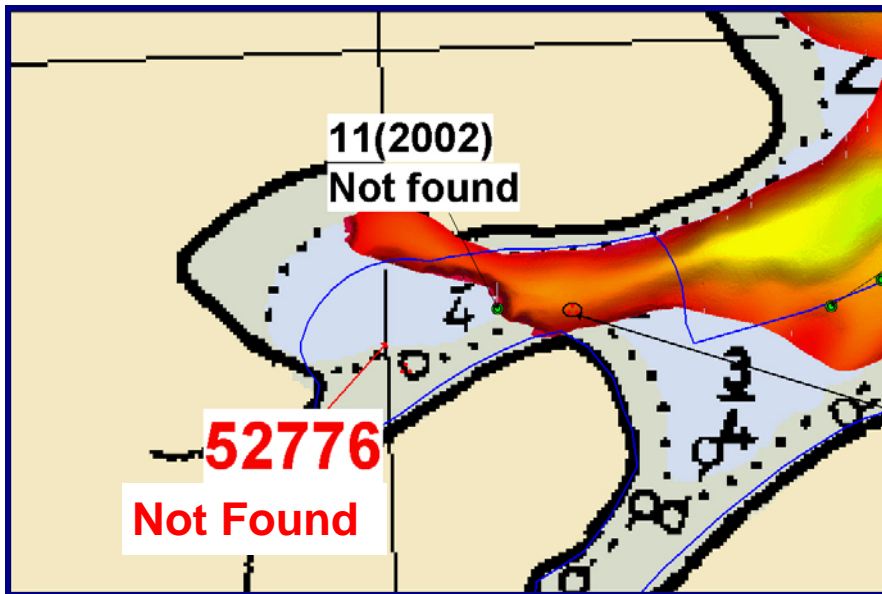
Investigation Summary: A 100-meter swath was searched for two hours in addition to investigation in the office. The position for this item falls outside the limits of hydrography. The Eastern portion of the search area has full coverage. The Western portion was searched visually during shoreline verification at low tide. The AWOIS history lists a dolphin used as a hydrographic control station at this location. No dolphins were found.

AWOIS item 52776 search area

AWOIS item 52776, 2002 bathymetry and 2002 position; Chart 17426

Based on the results of survey H-11099, the Hydrographer recommends removal of the dolphin symbols.⁵¹

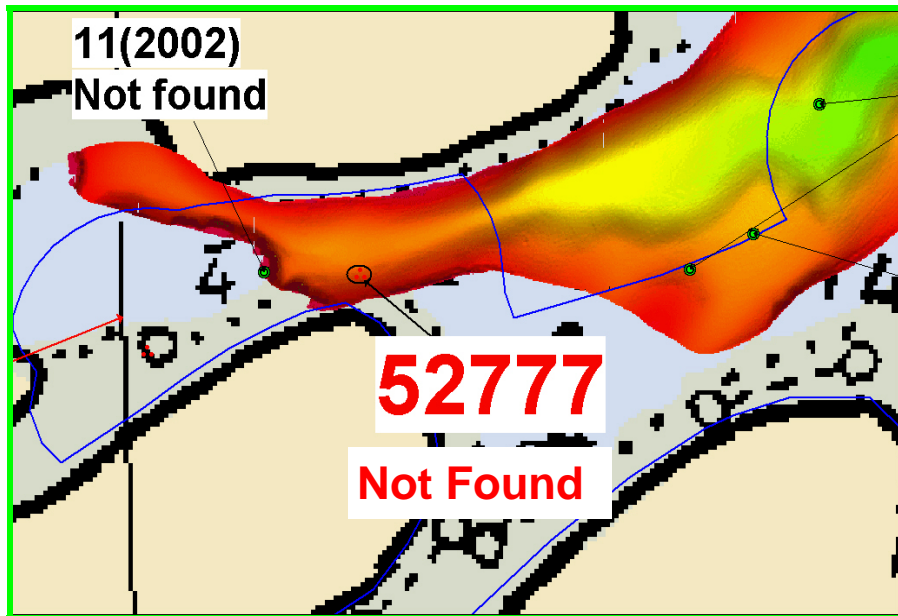
Investigation Summary: A 100-meter swath was searched for two hours with bathymetry, shoreline verification, and office investigation. This area has 200% SWMB coverage. It has been the hydrographer's experience, this coverage would show a pile if it was there. The AWOIS history lists two pilings charted as one at this location. No pilings were found.

SWMB coverage over AWOIS item 52777 as viewed in CARIS HIPS

AWOIS item 52777, 2002 bathymetry and 2002 position; Chart 17426

Based on the results of survey H-11099, the Hydrographer recommends removal of the pile symbol.⁵²

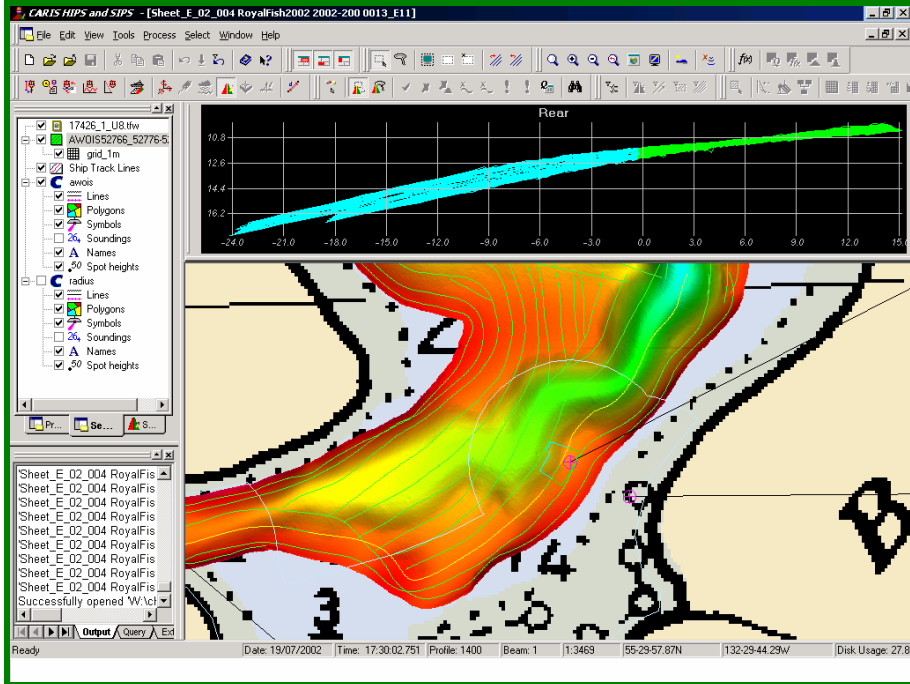
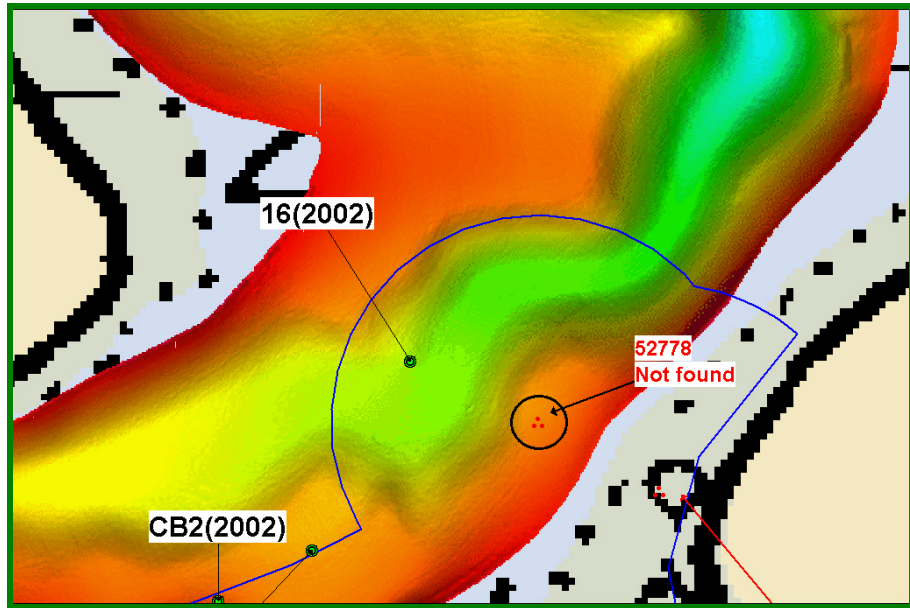
Investigation Summary: A 150-meter swath was searched for two hours in addition to office investigation. This area has 200% SWMB coverage. It has been the hydrographer's experience, this coverage would show a pile if it was there. The AWOIS history lists two pilings charted as one at this location. No pilings were found.

SWMB coverage over AWOIS item 52778 as viewed in CARIS HIPS

AWOIS item 52778, 2002 bathymetry and 2002 search position; Chart 17426

Based on the results of survey H-11099, the Hydrographer recommends removal of the pile symbol.⁵³

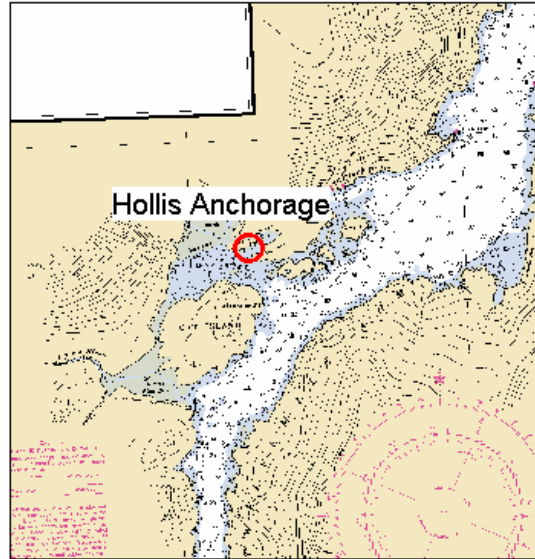
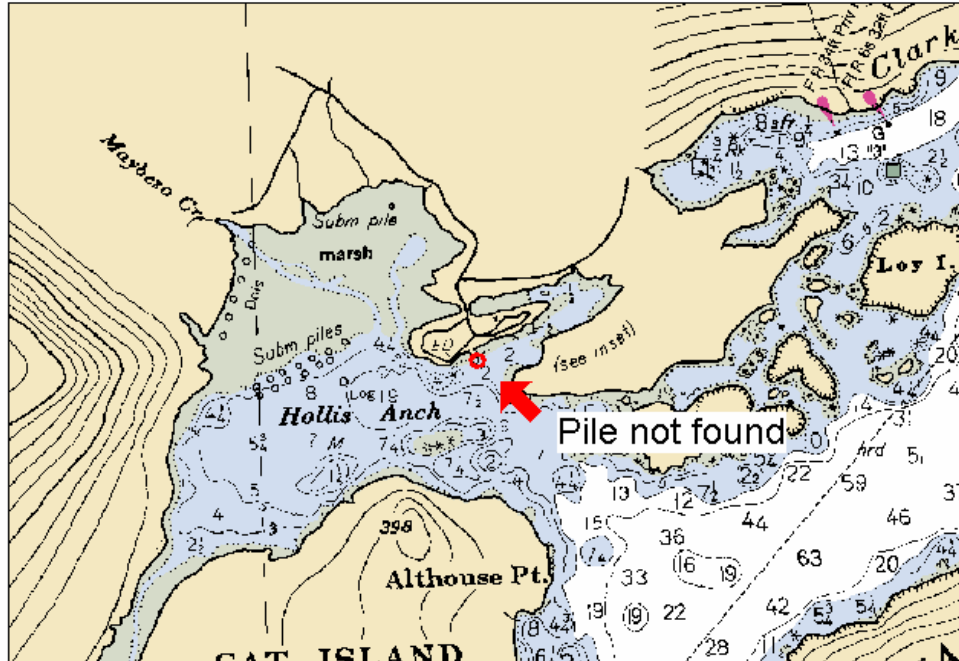
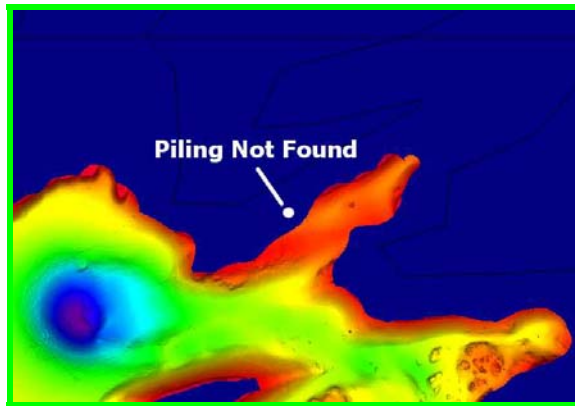
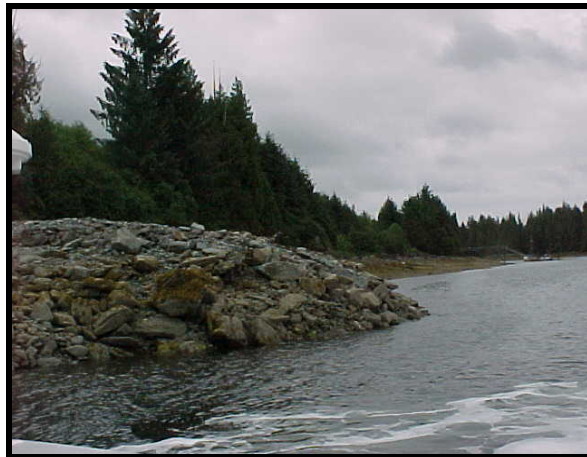
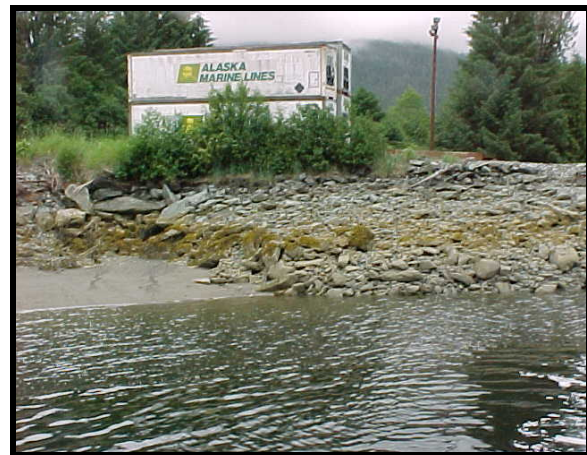
Disproval item #1

Disproval #1: Hollis Anchorage pile not found

Shoreline verification crews were unable to locate a pile and historical ferry dock in Hollis Anchorage on DN 179. The crew diligently searched the area. The area was not covered with multibeam data. Local knowledge confirmed that the dock and piling have been removed.⁵⁷ The following page shows photos and multibeam images of the area.

Limits of bathymetry and photos of piling not found
