DESCRIPTIVE REPORT

Type of Survey HYDROGRAPHIC

General Locality Twelve Mile Arm

Sublocality Outer Point to Cat Island

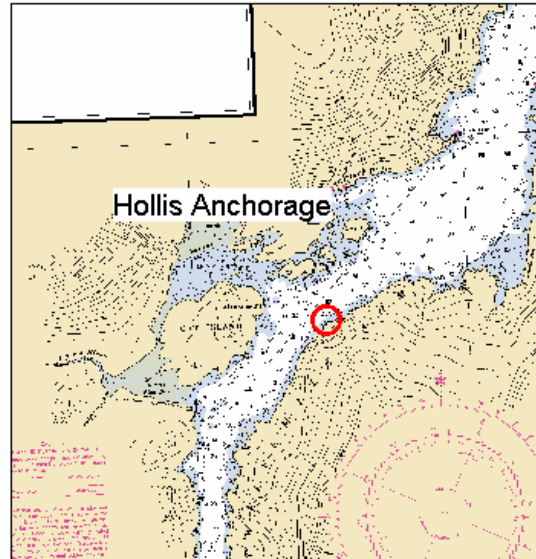
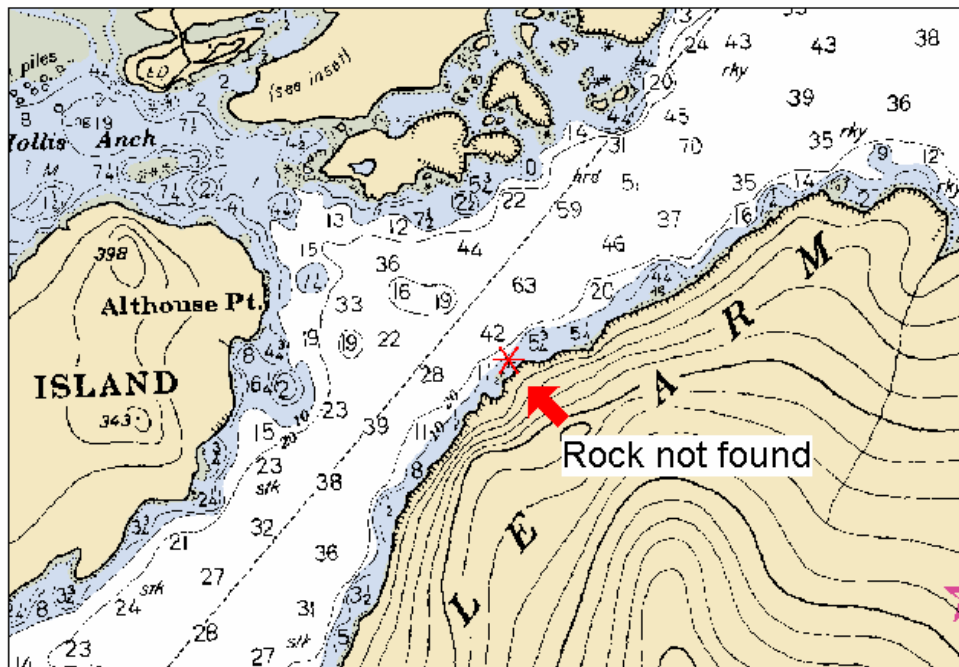
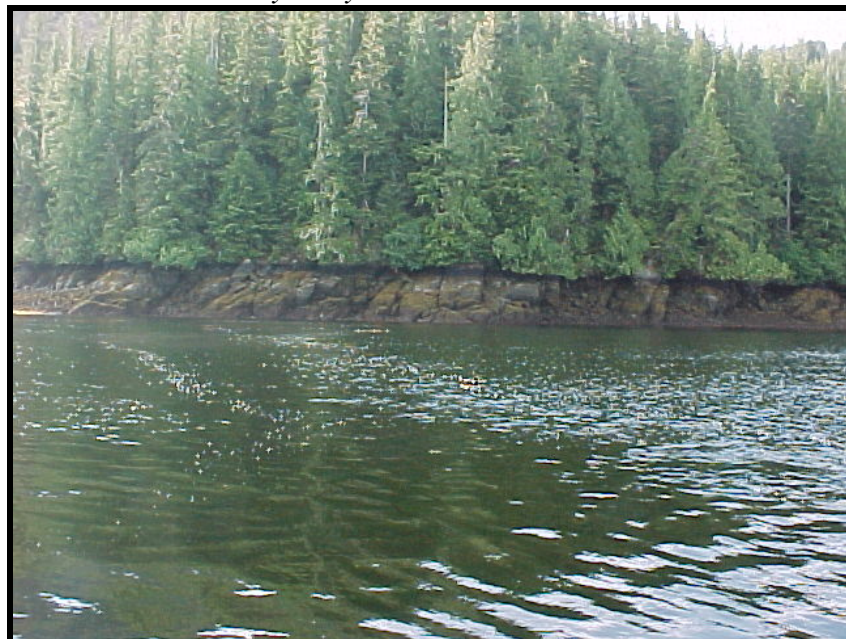
Disproval # 2: Rock not found

The shoreline verification crews were unable to locate a rock near the 4-meter curve after a diligent 20-minute search on DN 222. The area has 200% multibeam coverage, and no rock was found in the data.⁵⁸ The digital terrain image does show covered rocks in the vicinity.

Bathymetry over rock search area

Disproval #2 Rock search area

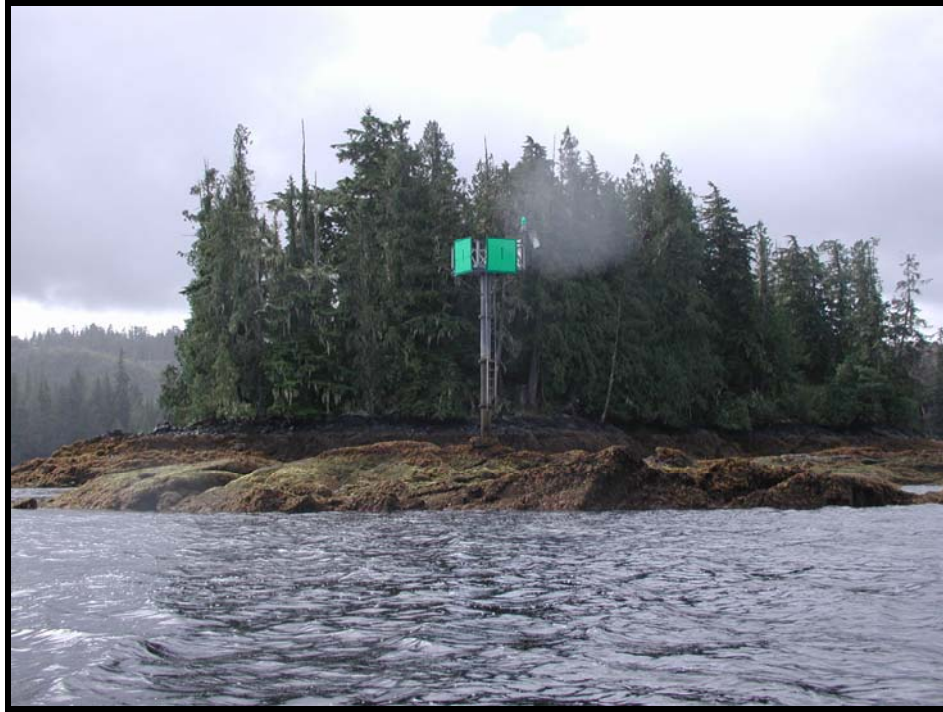
Jarvis Island Light 1 (22401)

Jarvis Island Light 1 was found in good condition and appears to serve its intended purpose.

Surveyed position, 9:35:51 ADT, August 09, 2002:
55° 30' 24.2" N, 132° 33' 36.2" W

Position comparison with nautical chart 17426

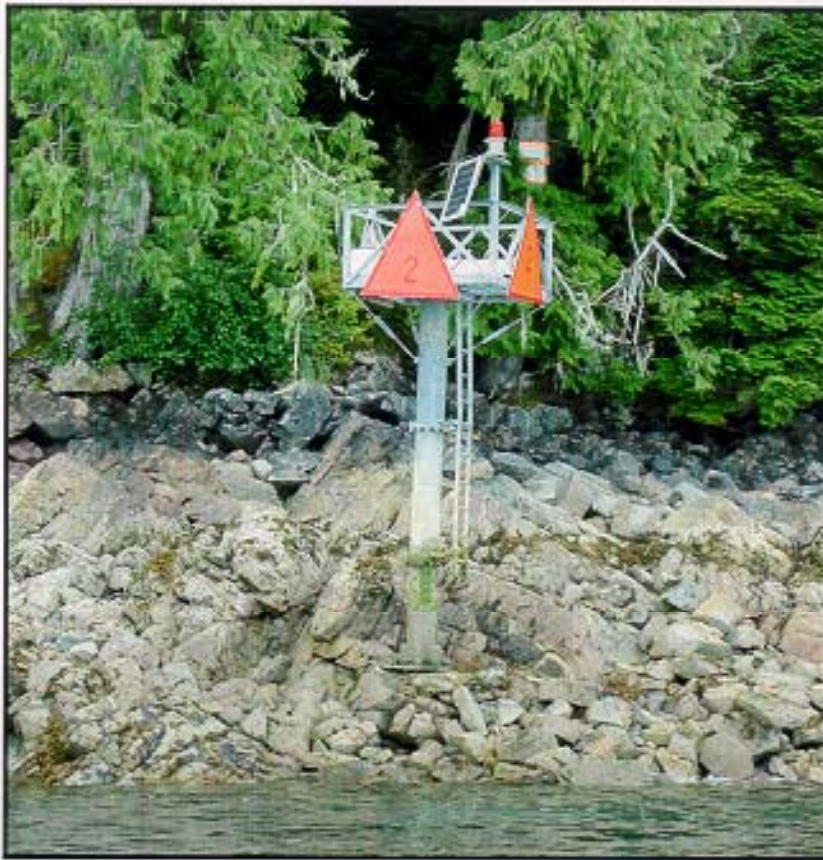
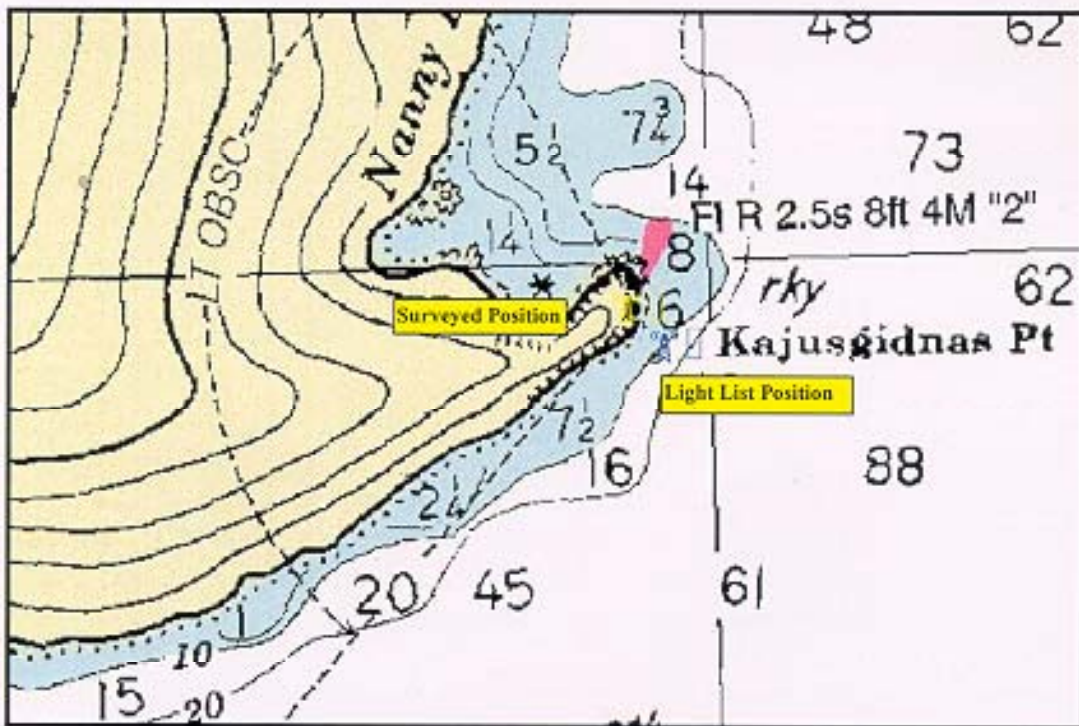
Clark Bay Light 2 (22403)

Clark Bay Light 2 was found in good condition and appears to serve its intended purpose.

Surveyed position, 15:05:43 ADT, July 18, 2002:
55° 29' 56.4" N, 132° 35' 8.6" W
