DESCRIPTIVE REPORT

Type of Survey HYDROGRAPHIC
Field No. OPR-0331-KR
Registry No. H-11236

State ALASKA
General Locality Kasaan Bay
Sublocality Twenty Fathom Bank to Skowl Point

Descriptive Report to Accompany Hydrographic Survey H-11236

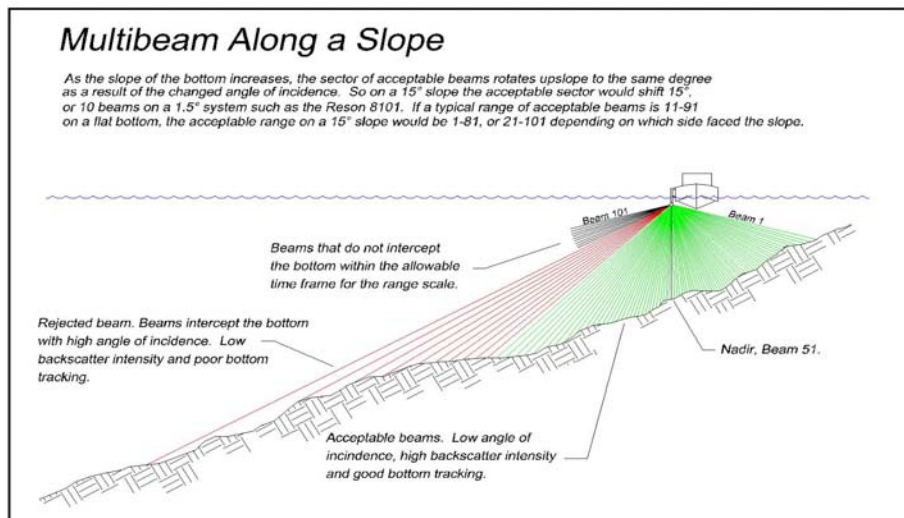
An estimated 95% confidence level generated from crossline analysis was used as a guide in determining data acceptability. In practice, the subjective nature of multibeam data cleaning resulted in a slight variance of final smooth sheet soundings from the estimated 95% confidence level. This is represented by the overlay in the Smoothsheet Sounding Distribution graph on the following page.⁶ Conditions warranting accepting data from outer beams occurred along steep terrain where the outermost beams had a better angle of incidence on the up-hill side. This was often the case, due to the steep slopes encountered through most of the survey. This effect is shown in the following figure.

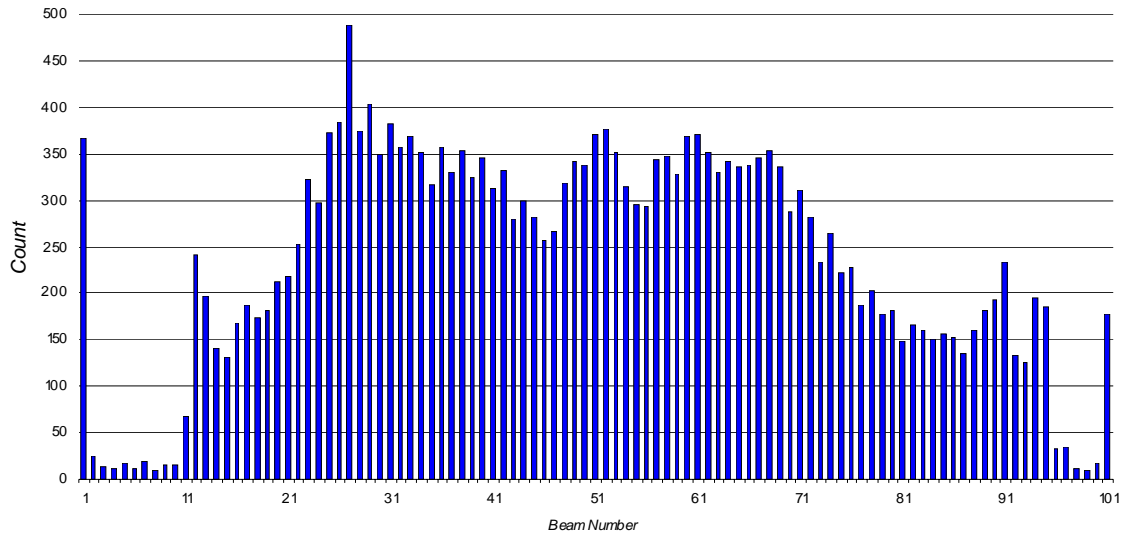
Figure 2.

Final smooth sheet soundings were compiled into a spreadsheet and plotted. Figure 2 contains two charts, one showing the distribution of soundings by beam number and depth⁷, and below it a histogram depicting the number of soundings per beam on the smooth sheet. The green line represents the 95% confidence level based on the crossline analysis. Tabular results are presented in Table 1. The Reson 8101 multi-beam echo sounder has 101 beams and is numbered from port to starboard, 1-101 with beam 51 representing the nadir beam.

The histogram brings to attention a few anomalies in the distribution of soundings by beam. The first is the large number of soundings from beam 1 and beam 101. Typically, soundings from outer beams were filtered out during line cleaning. On shallow, near shore lines this filter was not applied to aid in the attainment of soundings at the 4 meter curve. To protect the sounder, mounted on the starboard side of the vessel, shore lines were usually run with the port side to the beach, resulting in a larger number of soundings from beam 1.

The sector of beams from 2-10 and 96-100 shows a very small occurrence of soundings on the smooth sheet. This is a result of a standard practice of filtering out the outer beams. Soundings from these beams were used in the rare occurrence of sparse data density from the central portion of the swath or in areas of excellent data quality.

The distribution through the remainder of the swath is variable but with a slight increase in the number of soundings from the outer beams to the central portion of the swath. Local variances are likely attributable to small biases from beam to beam in the sonar. The increase in soundings towards the center of the swath is likely due to the stronger return signal strength of the near nadir beams, improving data quality and resulting in slightly more accepted soundings than the outer beams.

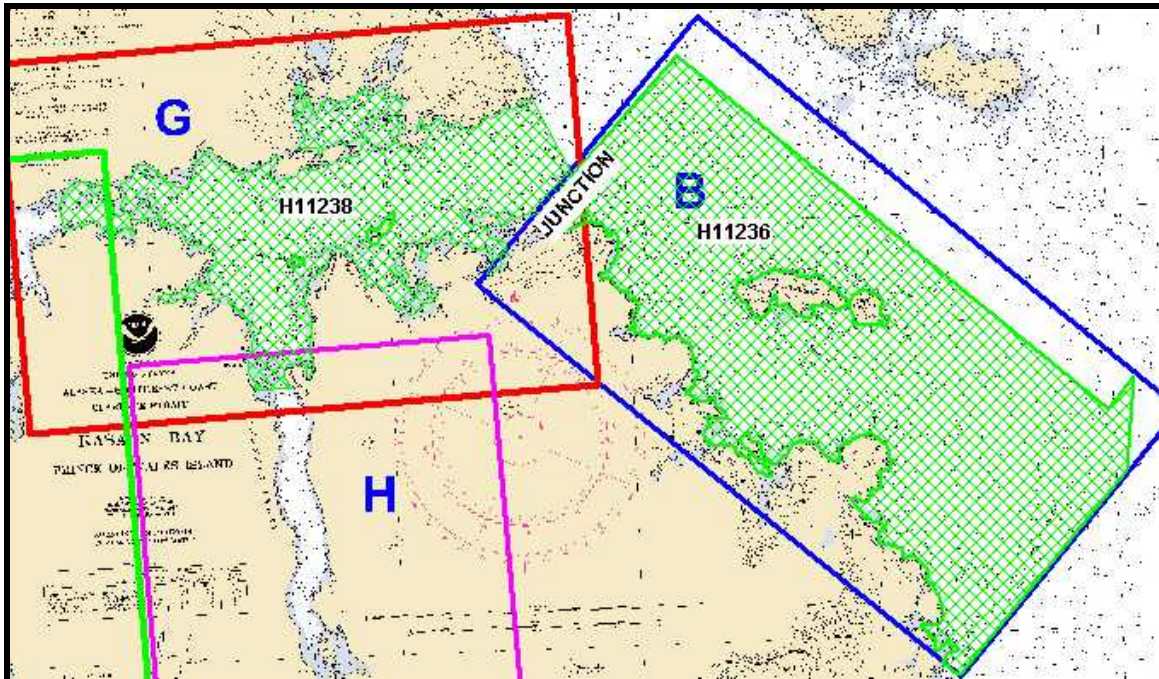
Figure 3.

The northwest limits of this survey⁸ junctions⁹ the easterly limits of H11238 (2003, Scale 1:10,000). Both of the smoothsheets for H11236 and H11238 were plotted at the same scale and the soundings for both surveys agreed well.¹⁰ There are no recommendations and no adjustments were made.

The junction locations of H11236 and H11238

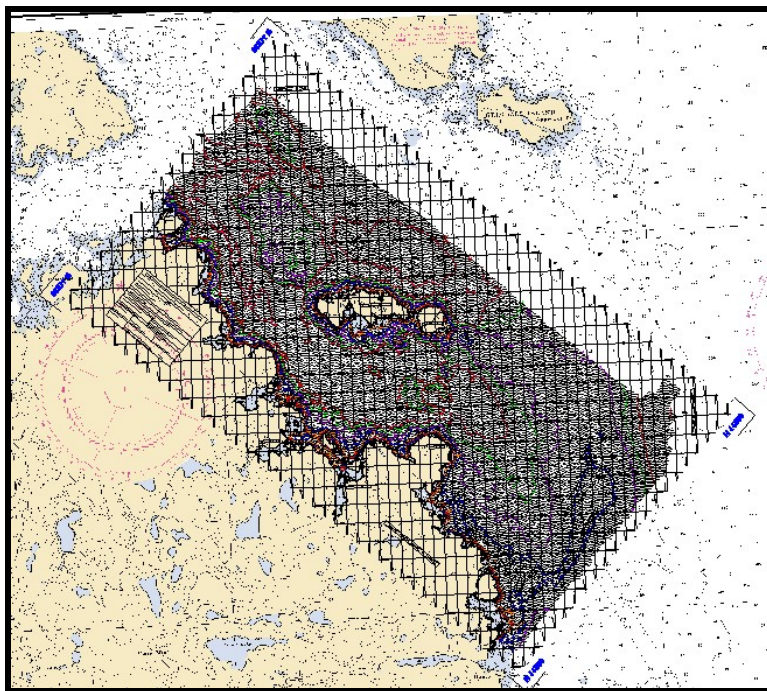
This survey generally agreed well with the charts. Occasionally, minor disagreements with the curves or soundings were noted.¹⁸ Charted and remote sensing features that differed significantly are discussed on the following pages.¹⁹ Refer to “Section D2 Additional Results” for shoreline investigation results affecting this chart.

Smooth sheet H-11236 overlaid on Chart 17420 for comparison

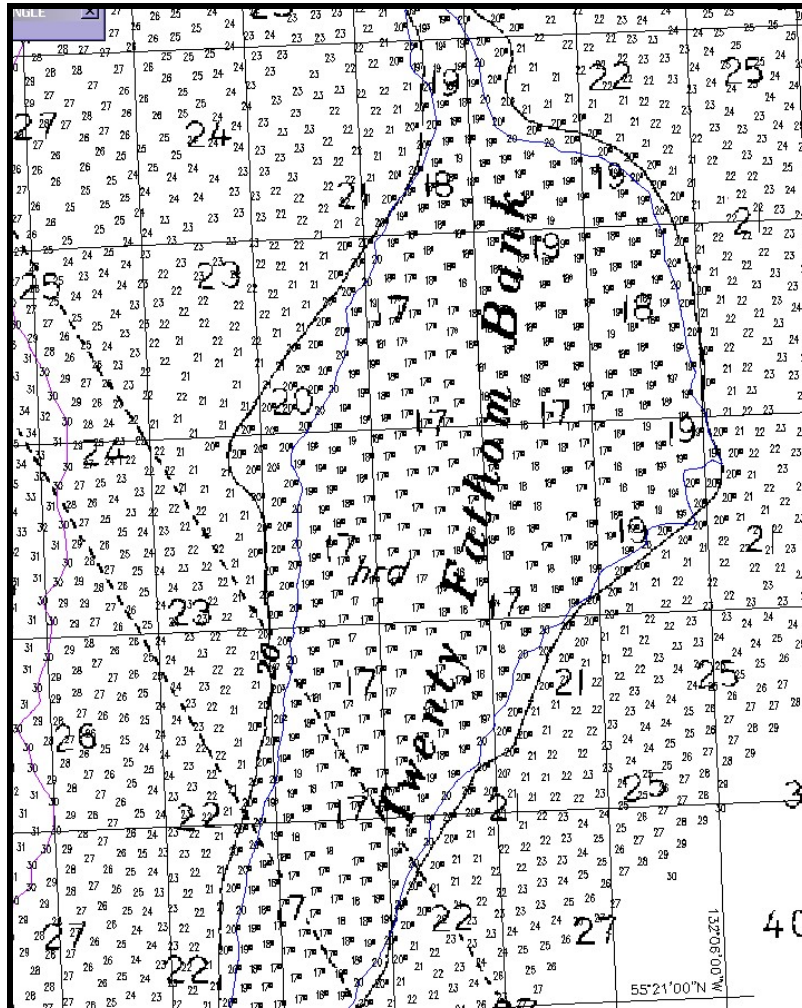
Twenty Fathom Bank is the only charted shoal in this survey. The survey agrees with the chart.²⁰

Chart 17426 Overlaid with 2003 soundings and curves

There are no recommendations affecting Twenty Fathom Bank.²¹

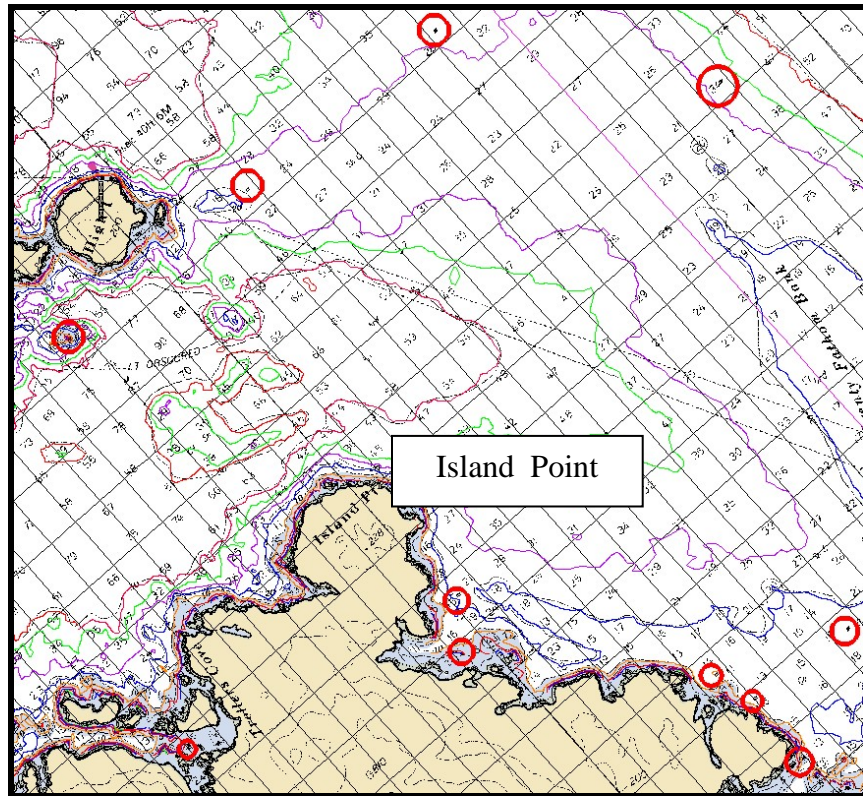
There were 11 new rocks identified in this survey from bathymetry. The following is a list of their positions and depths.²²

Chart 17426 with new rock positions circled red

Based on the results of survey H-11236, the Hydrographer recommends updating the next editions with the rocks listed.³³

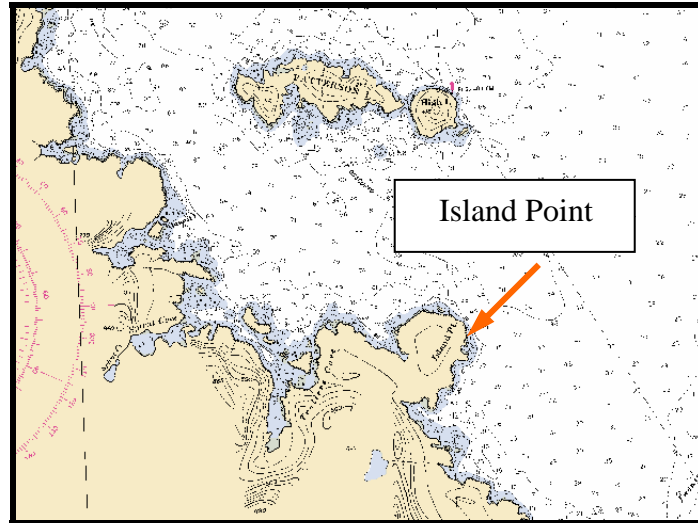
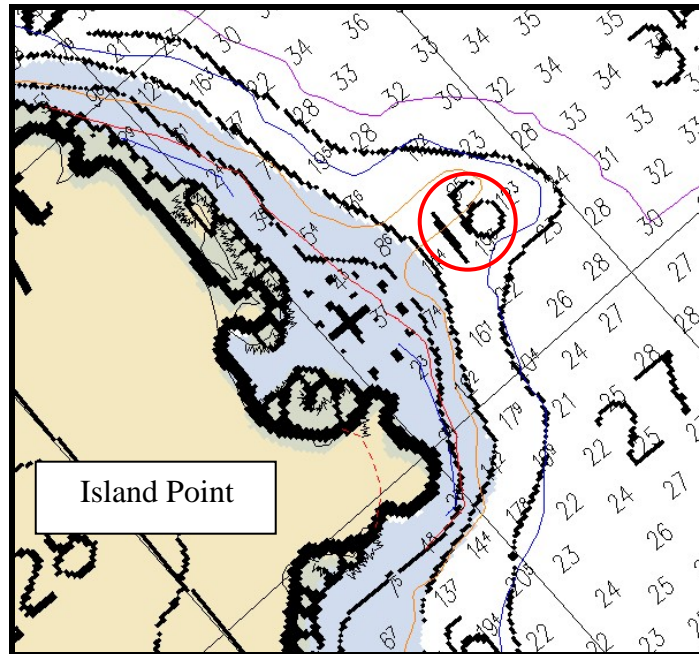
A review of the soundings and chart shows a 9.5-fathom³⁵ near a ³⁶16-fathom sounding.

Chart 17426 Location Map³⁷

Detail of Chart 17426 with 2003 soundings

Based on the results of survey H-11236, the Hydrographer recommends replacing the 16-fathom sounding at 55° 22' 05.561"N and 132° 09' 34.401 "W with a 9.5- fathom sounding.³⁸

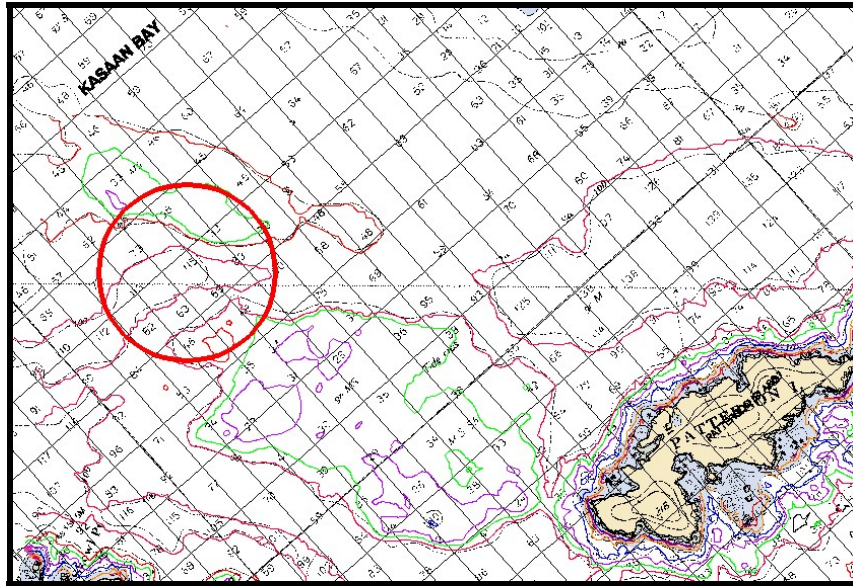
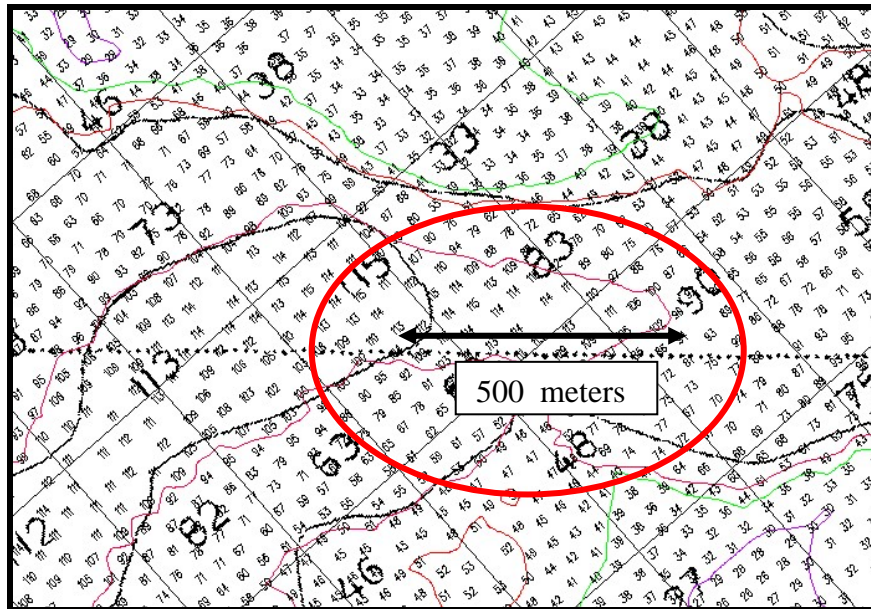
A review of the soundings and chart shows a deepening trend in the circled 100-fathom curve below.³⁹

Chart 17426, Location of 100 fathom curve deepening trend

Detail of 100-fathom curve deepening trend

Based on the results of survey H-11236, the Hydrographer recommends updating the next editions using the 2003 soundings to extend the 100-fathom curve at the above location 500 meters southeast.

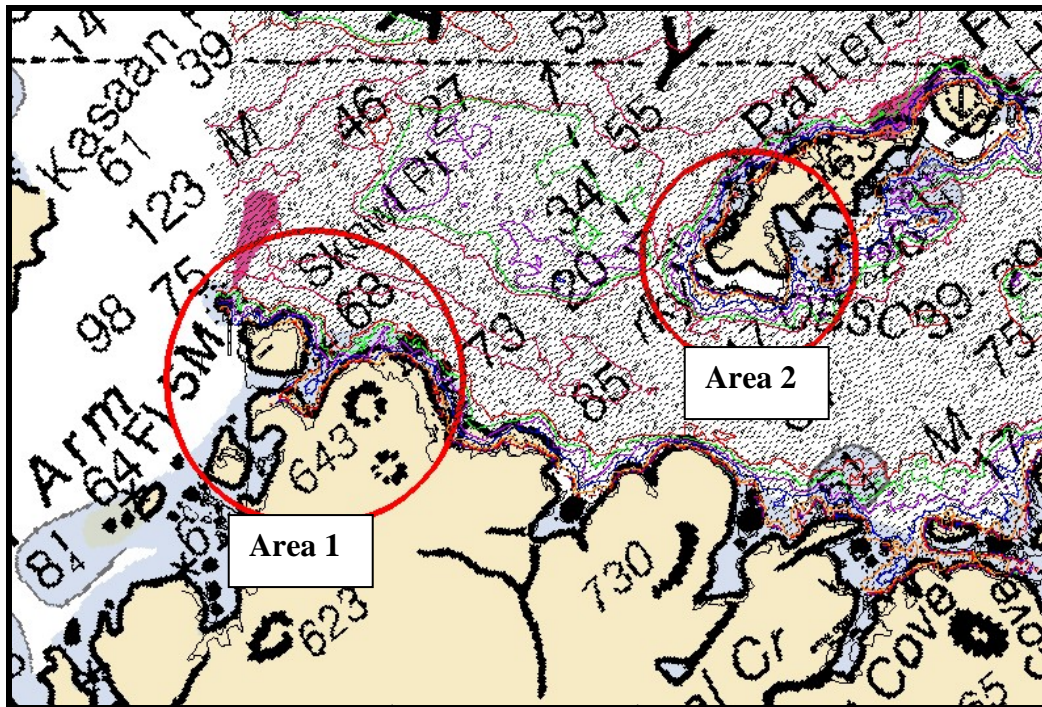
This survey generally agreed well with the chart. There were no outstanding disagreements with the depth curves or soundings. A comparison of the chart and remote sensing data shows a discrepancy of two areas in excess of 200 meters. These areas show the charted shoreline shifted to the east of the remote sensing data. The remote sensing data was verified through traditional and limited methods during this survey and was found to be accurate.⁴⁰

Location of shoreline discrepancy (circled) on Chart 17420 with 2003 soundings

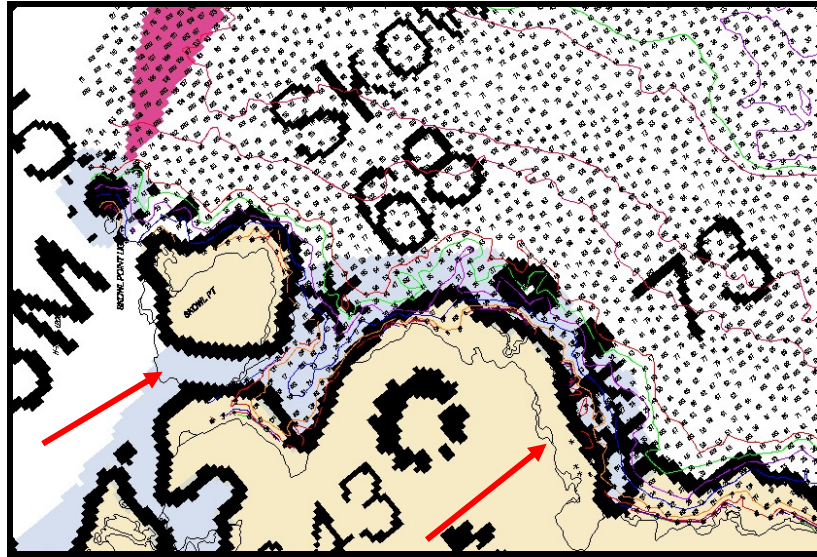
Chart 17420 Area 1

Chart 17420 and 2003 soundings showing remote sensing data shoreline discrepancy

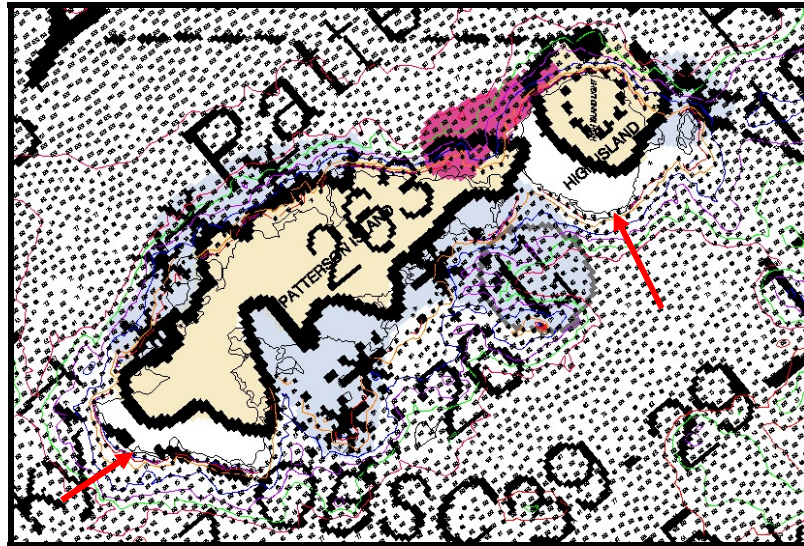
Chart 17420 Area 2

Chart 17420 and 2003 soundings showing remote sensing data shoreline discrepancy

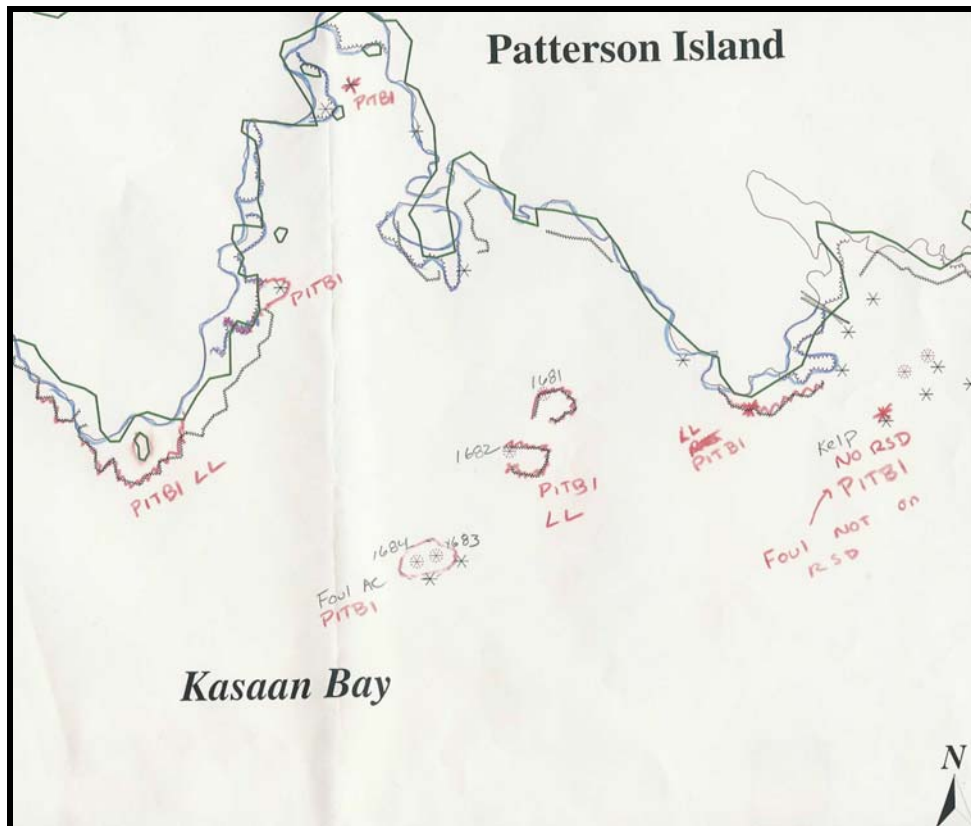
Shoreline and near-shore investigation were required for this contract. The ground truth observations agreed well with the remote sensing data (RSD). The field crews worked with shoreline maps showing RSD and charted shoreline, ledge line, islets and rocks. The crews noted agreements, disagreements and sketched any ground-truth changes onto these maps. ⁴² Navigation was achieved through HYPACK software showing the position of the boat in its relationship to both sets of data simultaneously. If a feature was not represented in the RSD or disagreed with the RSD position by more than 20 meters, it was noted as a “Potential Item To Be Investigated” (PITBI) in accordance with SOW 3.4.2.1. The survey also found features that were charted, but not represented on the RSD. Those features were noted as PITBI if they were navigationally significant. ⁴³ The field maps with notes were scanned into jpeg format. The scanned maps were then uploaded via file transfer protocol to the COTR for review.

Typical Field Notes from Shoreline Investigation

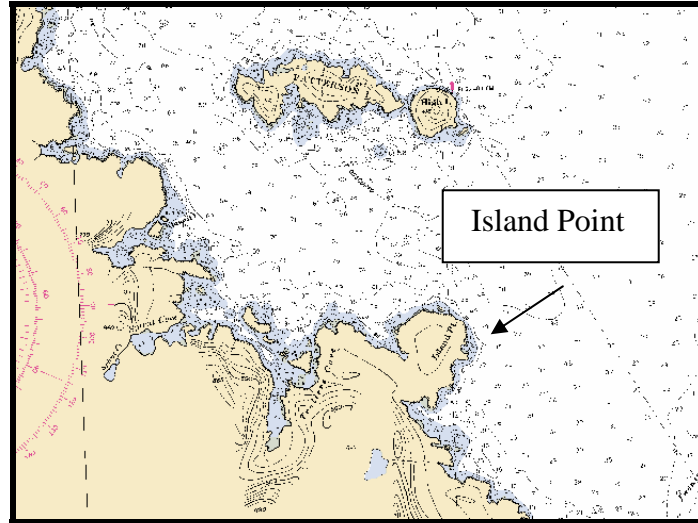
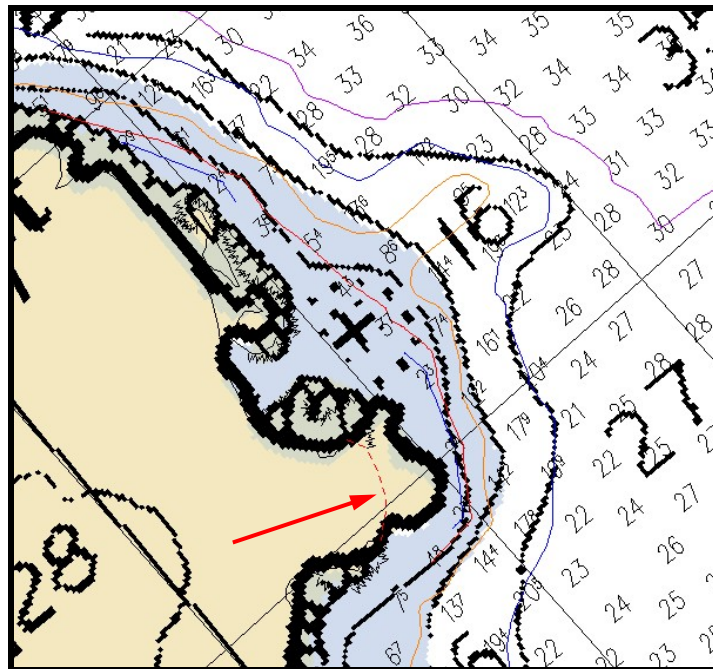
The survey identified a portion of shoreline that did not agree with the chart or the RSD. This was discovered during limited verification and is shown as a dashed red line on the smooth sheet.⁴⁴

Chart 17426 Location Map

Detail of shoreline change on Chart 17420

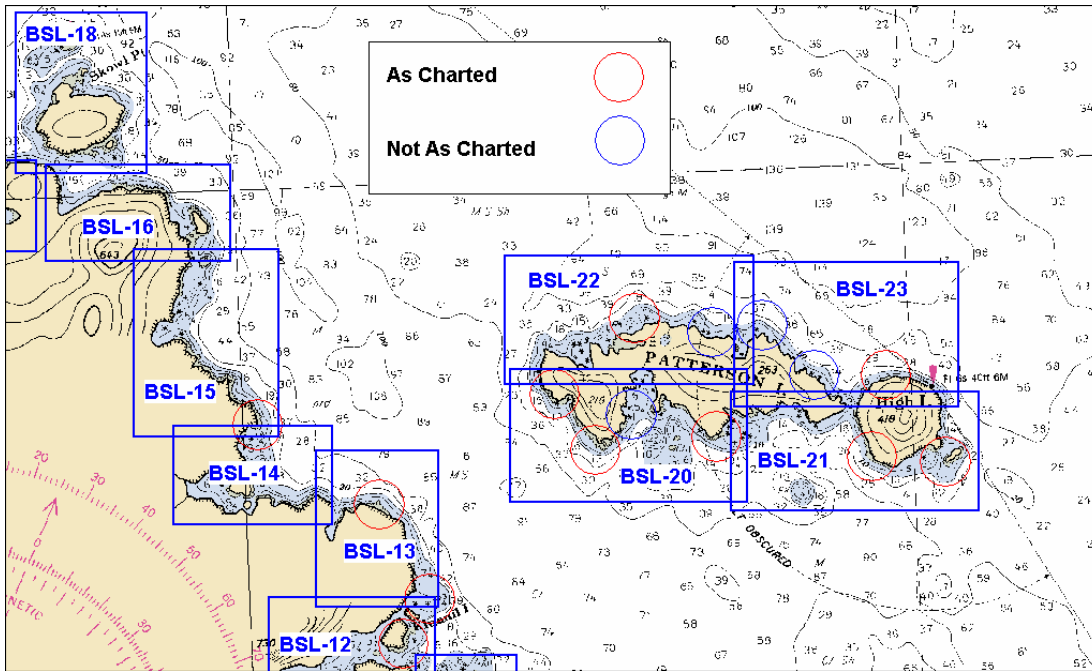
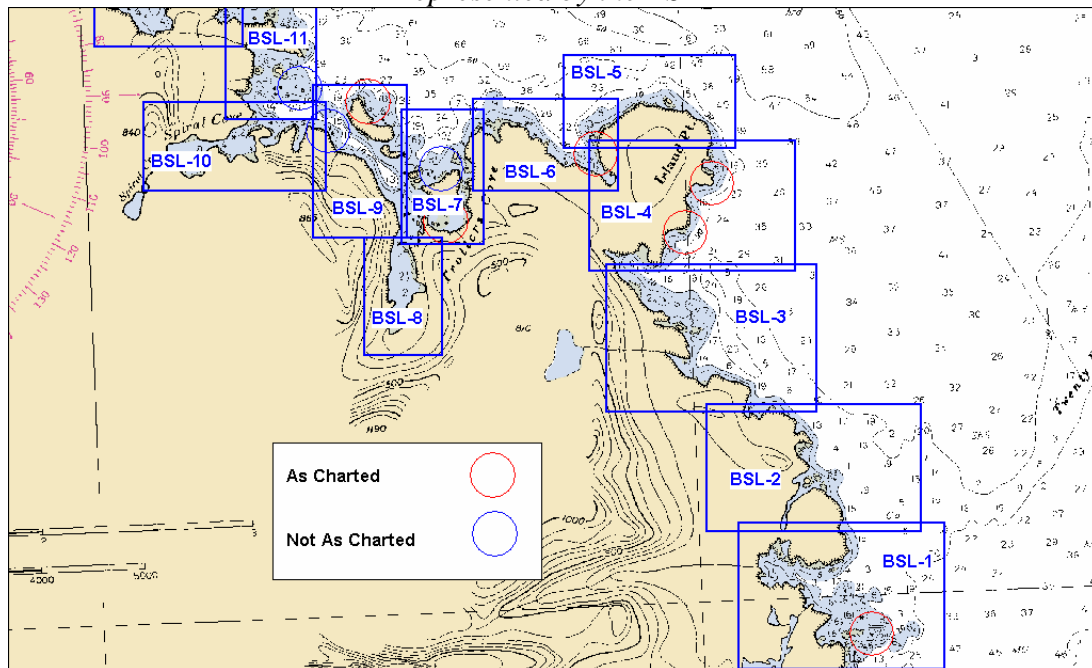
This survey identified foul areas⁴⁵ and ledge lines that were not represented on the RSD. Refer to the images below for location maps of these areas.⁴⁶

Chart 17426 with charted areas (circled red) and not charted (circled blue) areas not represented by the RSD

Based on the results of survey H-11236, the Hydrographer recommends retaining charted foul and ledge lines not represented by the RSD.⁴⁷ The hydrographer also recommends further investigation into the features not charted that were discovered through shoreline verification.⁴⁸

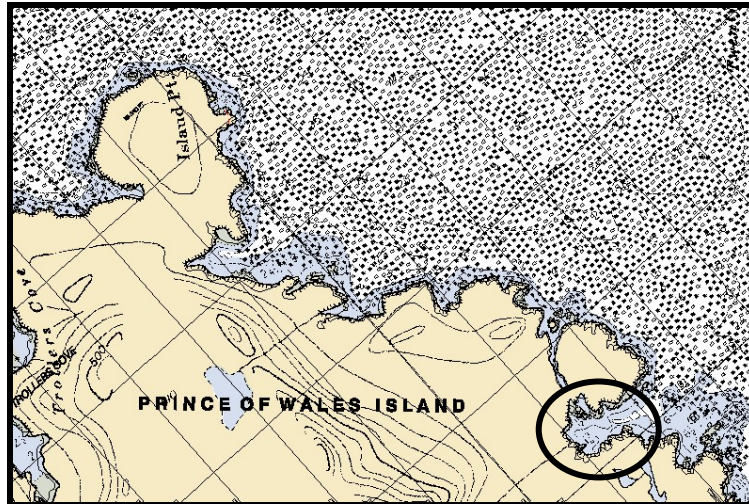
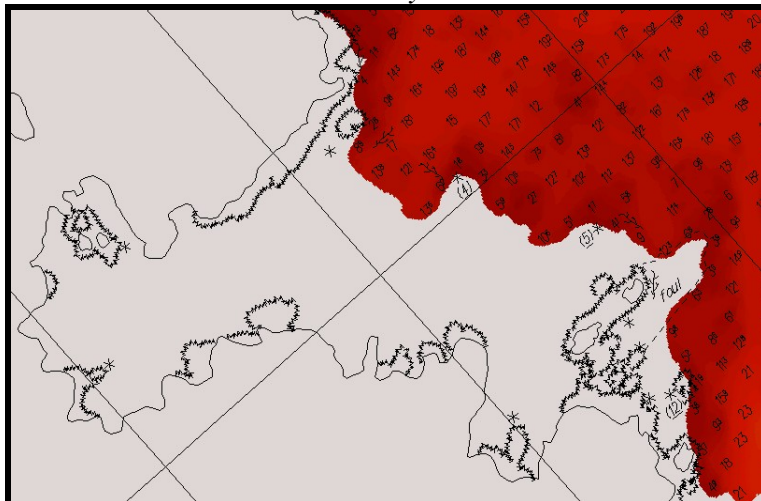
There is a small bay in the southern portion of the survey where data does not extend to the 4-meter curve. The hydrographer determined that navigation to the 4-meter curve was not prudent here due to a charted rock and copious amounts of kelp at the entrance of the bay.

Chart 17426 with bay location circled

Close up of bay with digital terrain model, soundings and kelp symbols

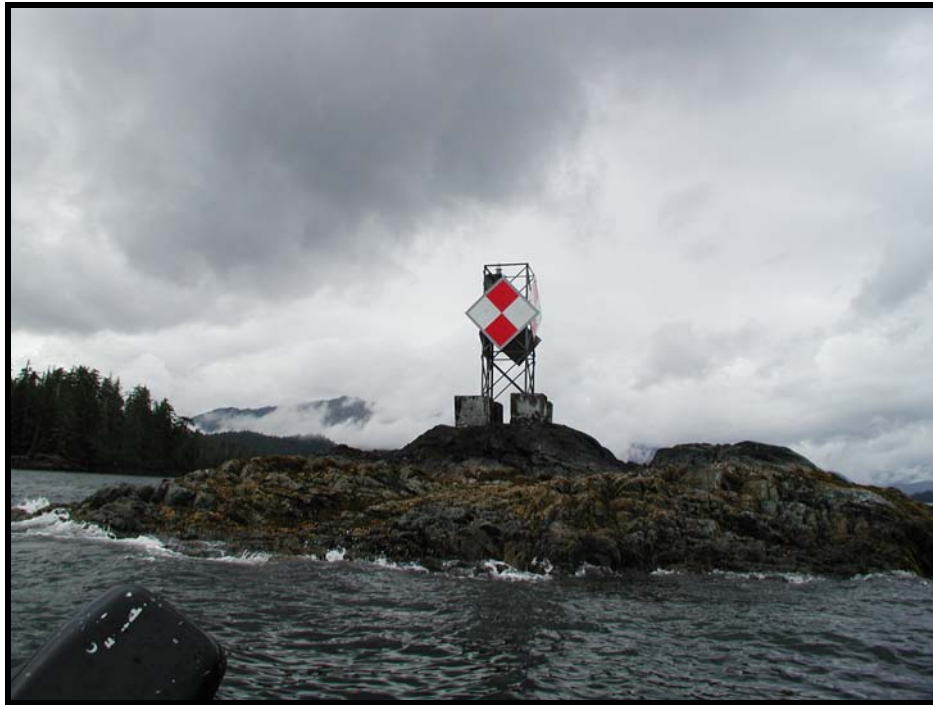
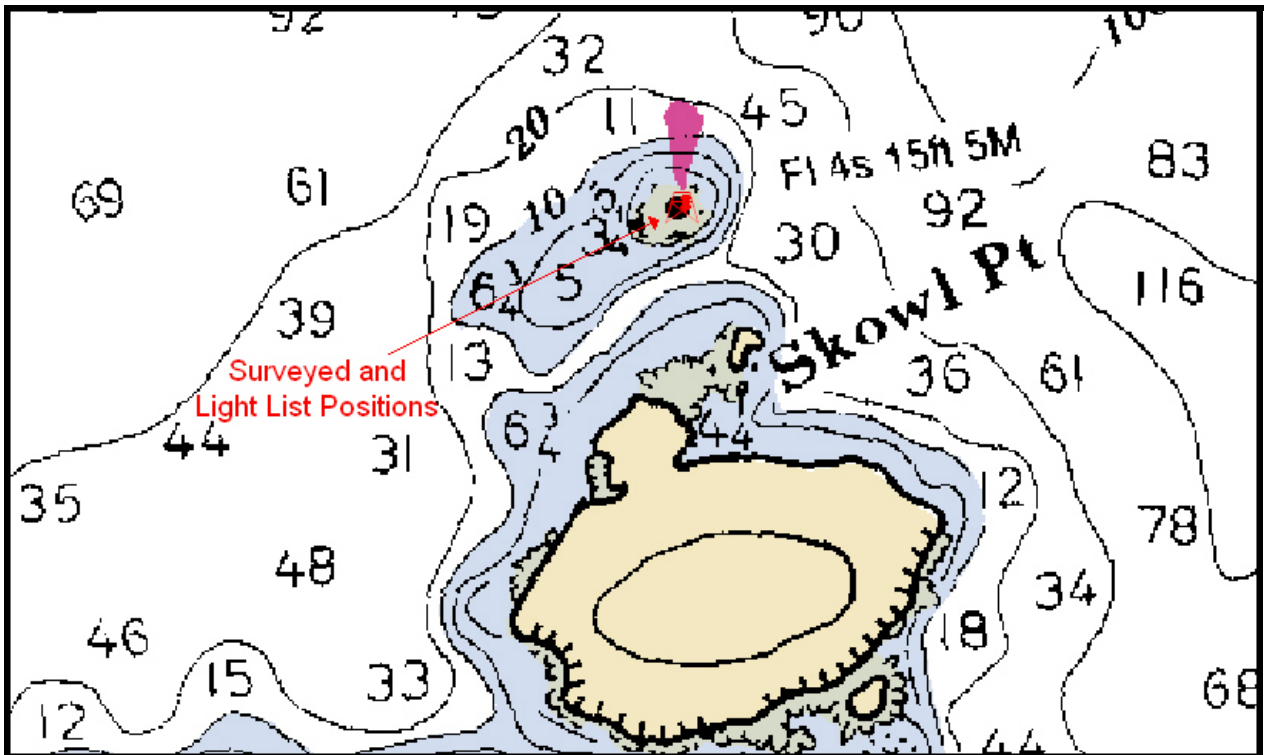
Skowl Point Light (22380)

Skowl Point Light was found in good condition and appears to serve its intended purpose.

Structure: NR on skeleton tower

2003 Surveyed position: Lat 55°25'39.4"N Long 132°16'08.4"W

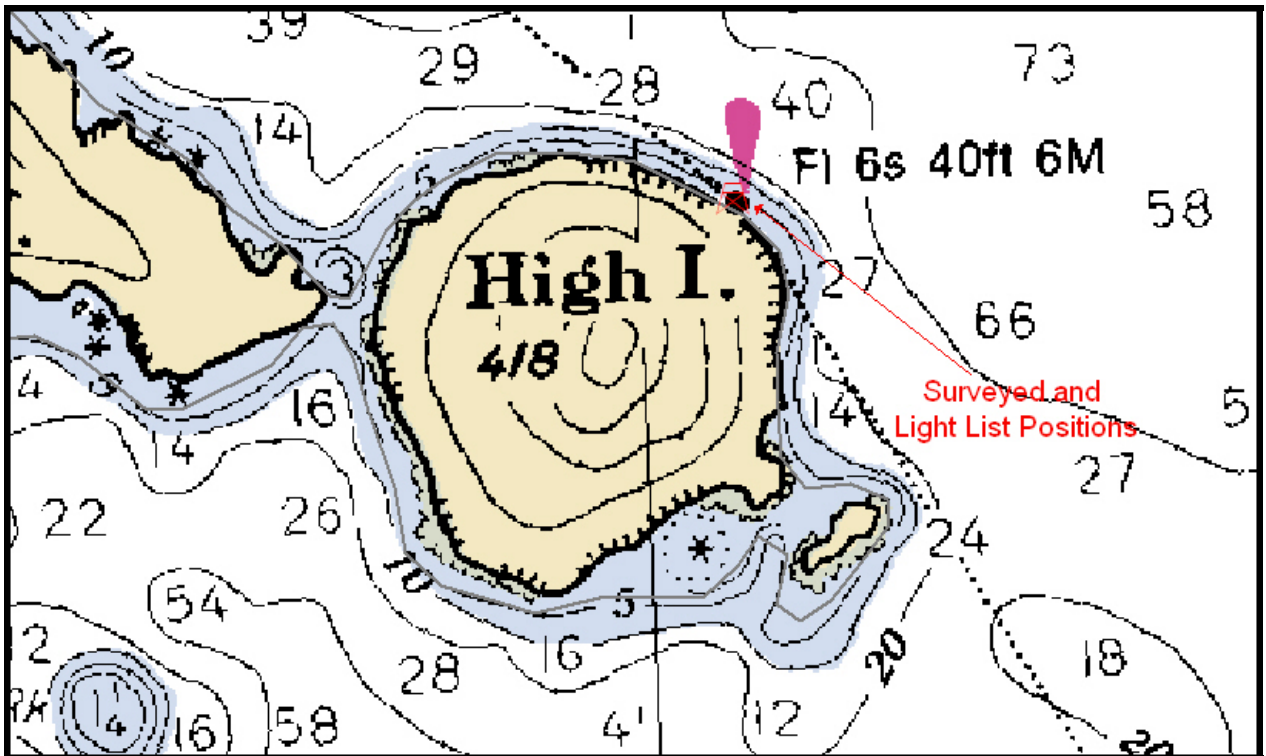
High Island Light (22375)

High Island Light was found in good condition and appears to serve its intended purpose.

Structure: NR on skeleton tower

2003 Surveyed position: Lat 55°24'03.2"N Long 132°09'50.4"W

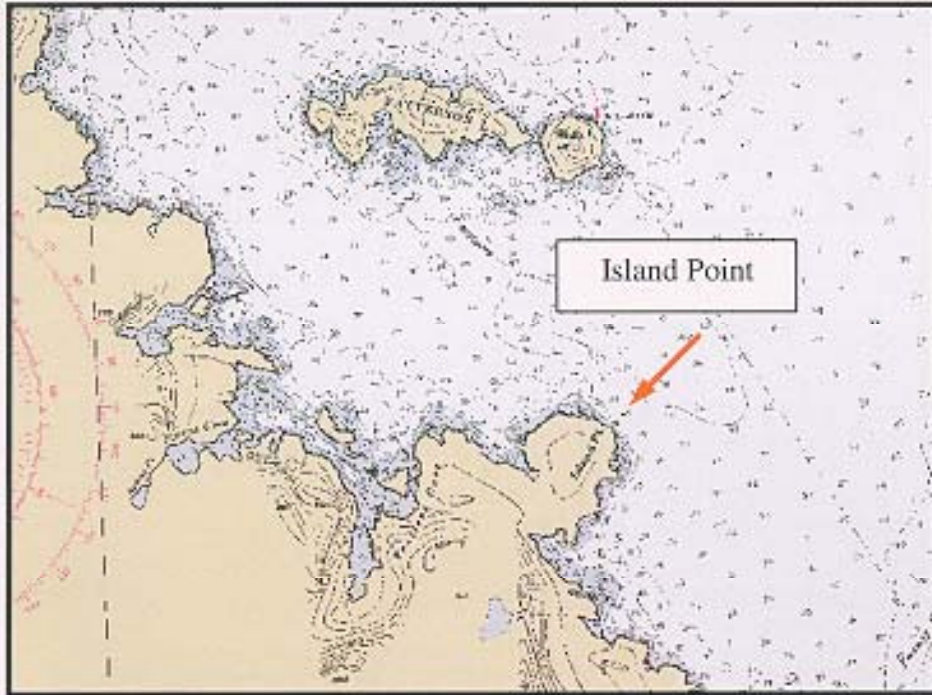
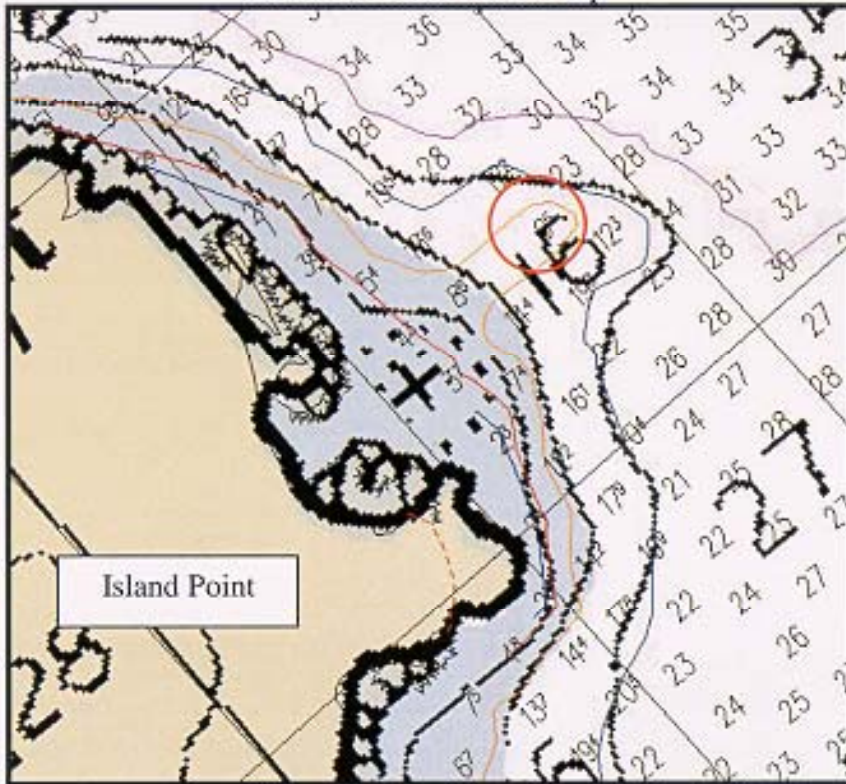
Feature	Depth(ft or fms)	Latitude	Longitude
Sounding	9 fms 3 ft	55° 22' 05.6" N	132° 09' 34.4" W ⁵⁸

Chart 17426 Location Map

Detail of Chart 17426 with 2003 soundings
