DESCRIPTIVE REPORT

Type of Survey HYDROGRAPHIC

Registry No. H-11237

General Locality Twelve Mile Arm

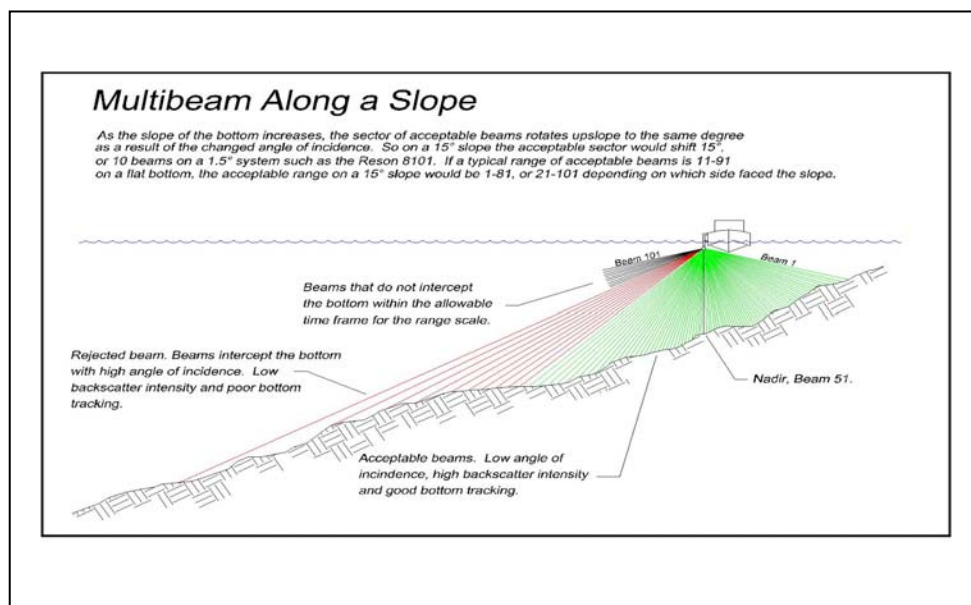
Figure 1

An estimated 95% confidence level generated from crossline analysis was used as a guide in determining data acceptability. In practice, the subjective nature of multibeam data cleaning resulted in a slight variance of final smooth sheet soundings from the estimated 95% confidence level. This is represented by the overlay in the Smoothsheet Sounding Distribution graph that follows. Conditions warranting accepting data from outer beams occurred along steep terrain where the outermost beams had a better angle of incidence on the up-hill side. This was often the case, due to the steep slopes encountered through most of the survey. This effect is shown in figure 1.

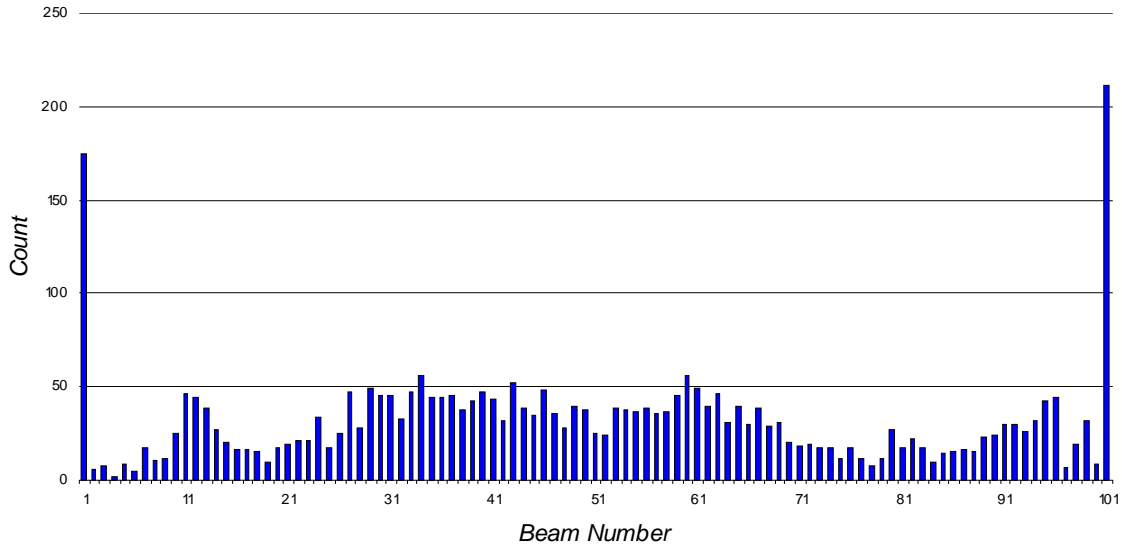
Figure 2. Smoothsheet Sounding Distribution

Final smooth sheet soundings were compiled into a spreadsheet and plotted. Figure 2 shows a histogram depicting the number of soundings per beam on the smooth sheet. Tabular results are presented in Table 1. The Reson 8101 multi-beam echo sounder has 101 beams and is numbered from port to starboard, 1-101 with beam 51 representing the nadir beam.

The histogram brings to attention the large number of soundings from beam 1 and beam 101. Typically, soundings from outer beams were filtered out during line cleaning. On shallow, near shore lines this filter was not applied to aid in the attainment of soundings at the 4 meter curve. As a result, depending on which side of the sonar was oriented towards the shore, soundings from beam 1 or 101 were the outermost, and on an upwardly sloping bottom, shoalest soundings of a shore buffer line. This manifested itself as a rim of soundings from beams 1 and 101 along the shoreline in the shoal biased smoothsheet. The tables below show the distribution of soundings by depth for beams 1 and 101.

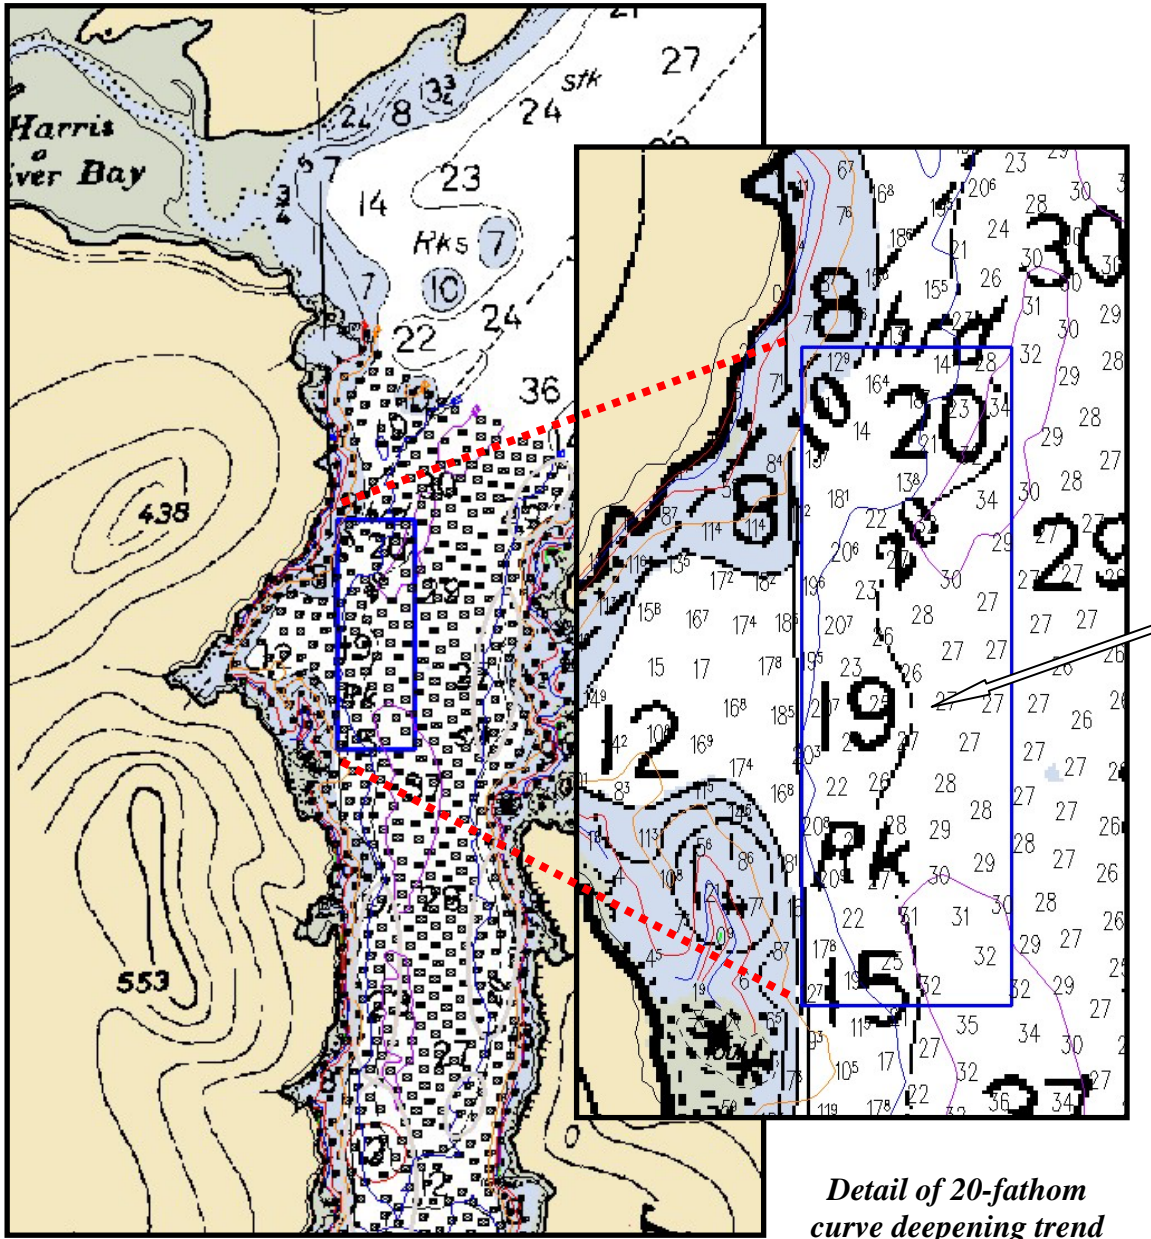
A review of the soundings and chart shows a deepening area in the¹⁶ 20-fathom curve below. A charted depth of 19-fathoms falls outside the 2003 20-fathom curve.

Chart 17426, Location of 20- fathom curve deepening trend

Based on the results of survey H-11237, the Hydrographer recommends updating the next editions using the 2003 soundings to adjust the 20-fathom curve at the above location.

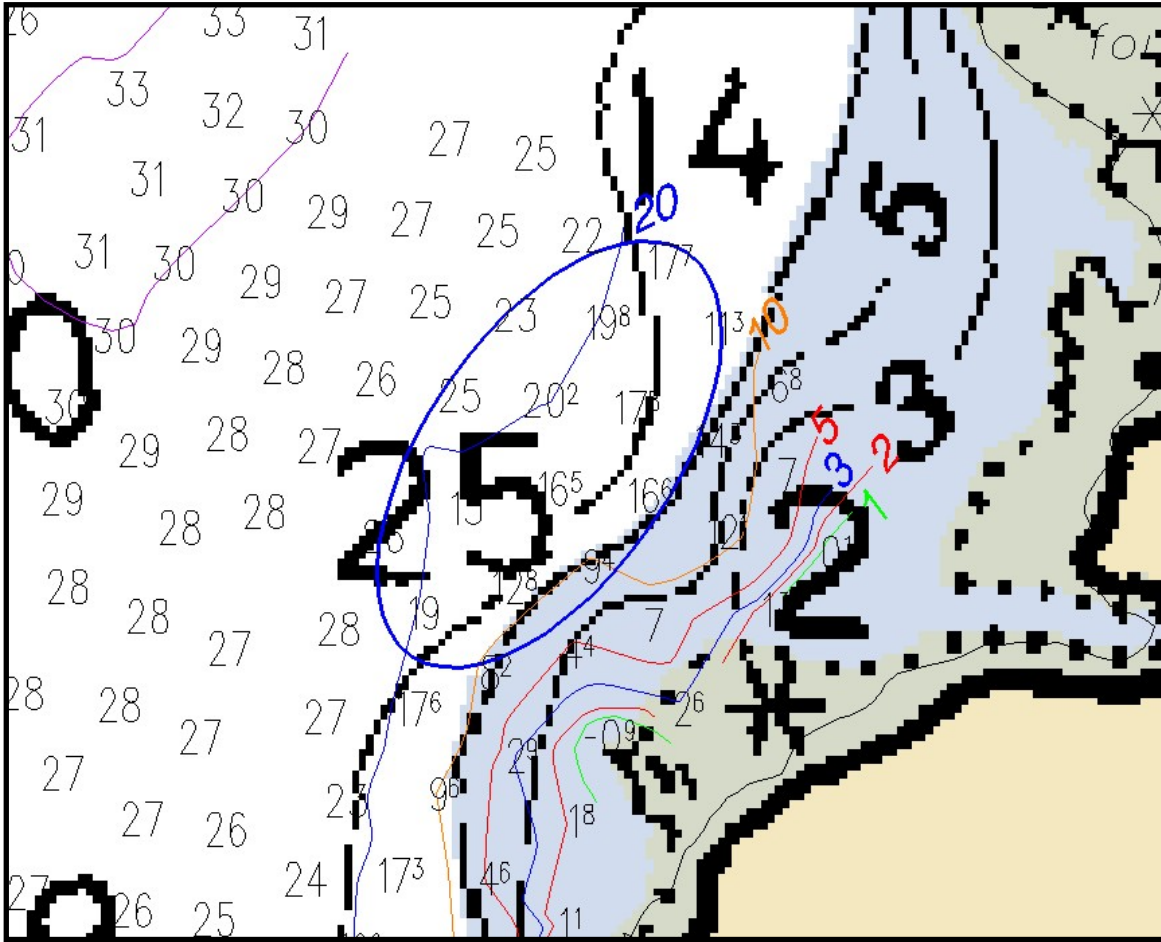
A review of the soundings and chart shows a shoal area in the¹⁷ 20-fathom curve located at the northeasterly end of the survey limits.

Chart 17426, Location of 20- fathom curve shoaling trend

Based on the results of survey H-11237, the Hydrographer recommends updating the next editions using the 2003 soundings to adjust the 20-fathom curve at the above location.

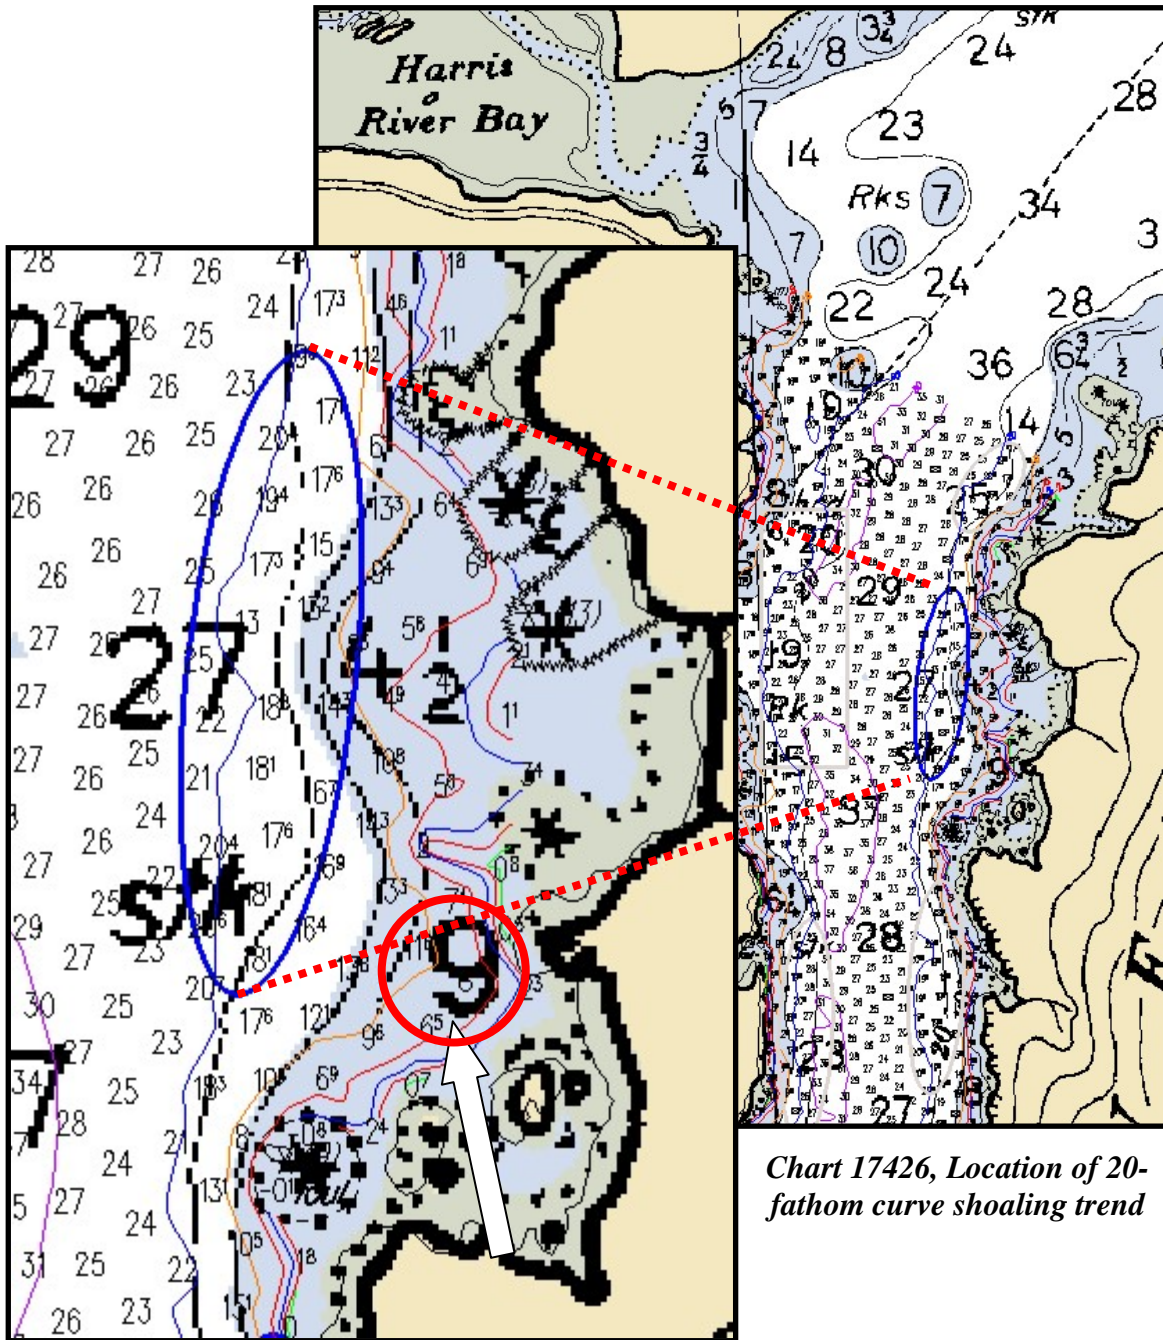
A review of the soundings and chart shows a shoal area in the¹⁸ 20-fathom¹⁹ below. Also noted is a charted 9-fathom depth inside the charted 5-fathom curve.

Chart 17426, Location of 20-fathom curve shoaling trend

Detail of 9-fathom charted depth inside the 5- and 10-fathom curve and 20-fathom curve shoaling trend

Based on the results of survey H-11237, the Hydrographer recommends updating the next editions using the 2003 soundings to adjust the 5 ,10 and 20-fathom curves at the location above.

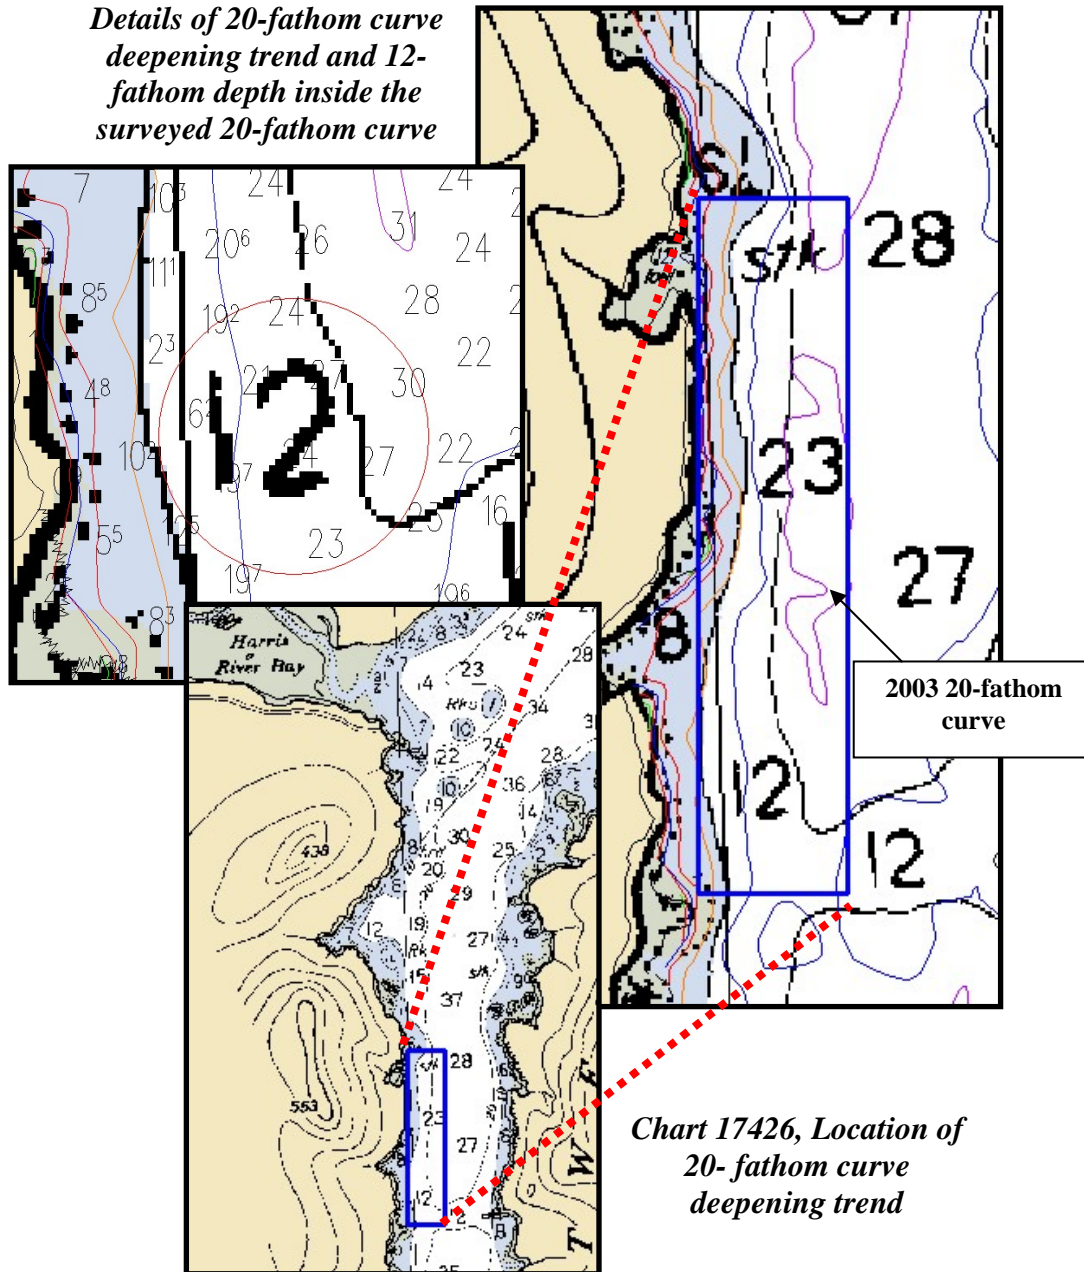
A review of the soundings and chart shows a deepening area in the²⁰ 20-fathom curve below. A charted depth of 12-fathoms falls outside the current 20-fathom curve.²¹

Based on the results of survey H-11237, the Hydrographer recommends updating the next editions using the 2003 soundings to adjust the 20-fathom curve, as well as updating the charted 12-fathom sounding with a 16 fathom sounding at the location above.

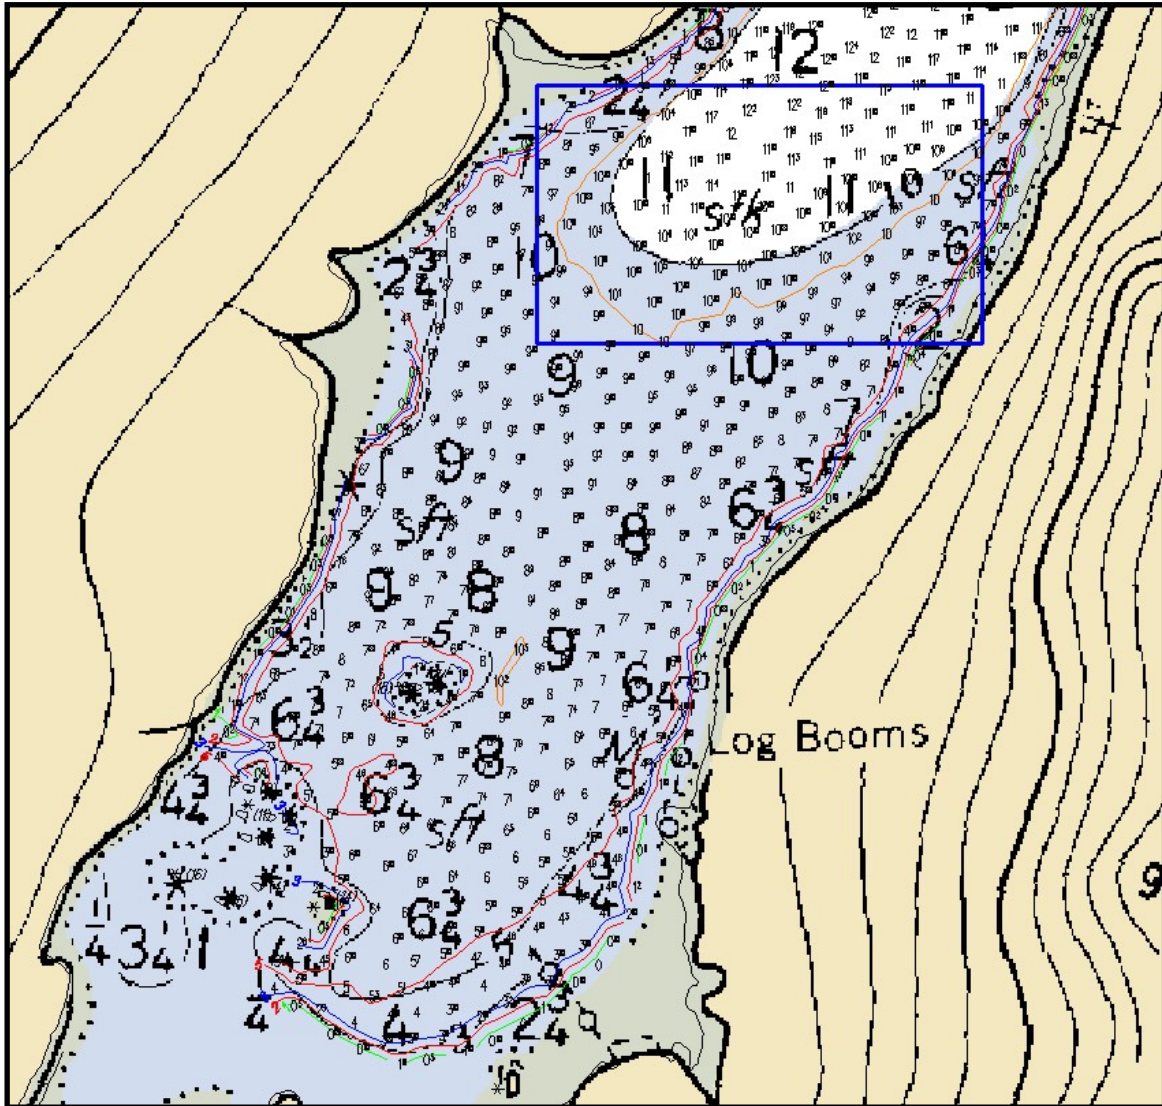
A review of the soundings and chart shows a deepening trend of the 10-fathom curve at the south end of the survey area shown below.

Based on the results of survey H-11237, the Hydrographer recommends updating the next editions using the 2003 soundings to adjust the 10-fathom curve in the above area.

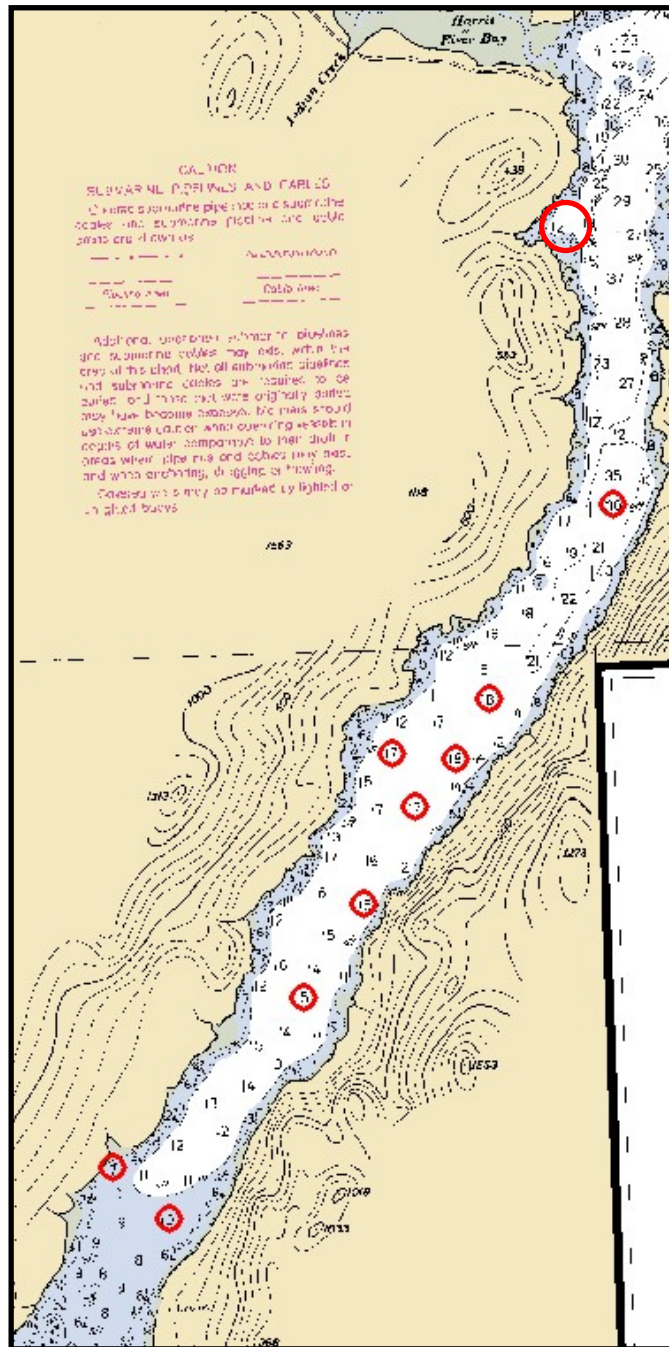
Chart 17426

A review of the soundings and chart shows several charted values that differ from the soundings. These locations are circled in the detail below and described on the following pages.²²

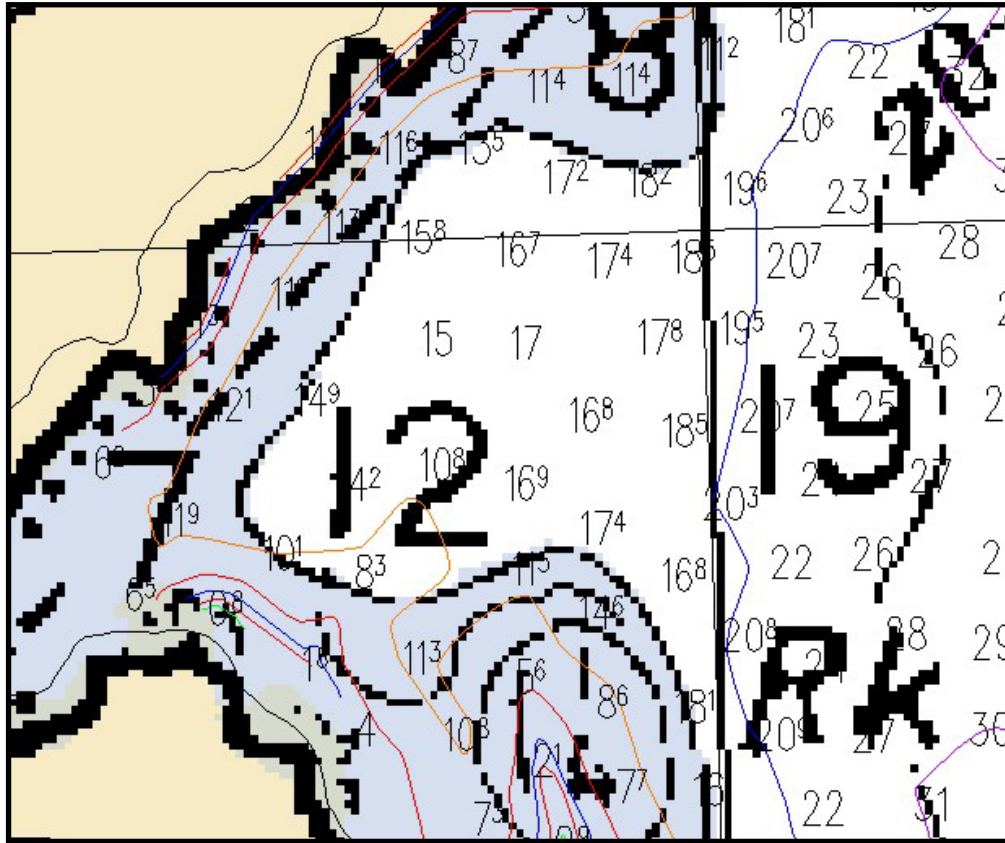
A review of the soundings and chart shows a 2003 10.8-fathom near a charted 12-fathom sounding.

Based on the results of survey H-11237, the Hydrographer recommends replacing the 12-fathom sounding at 55° 26' 41"N and 132° 40' 09 "W with a 10-fathom 5-foot sounding.

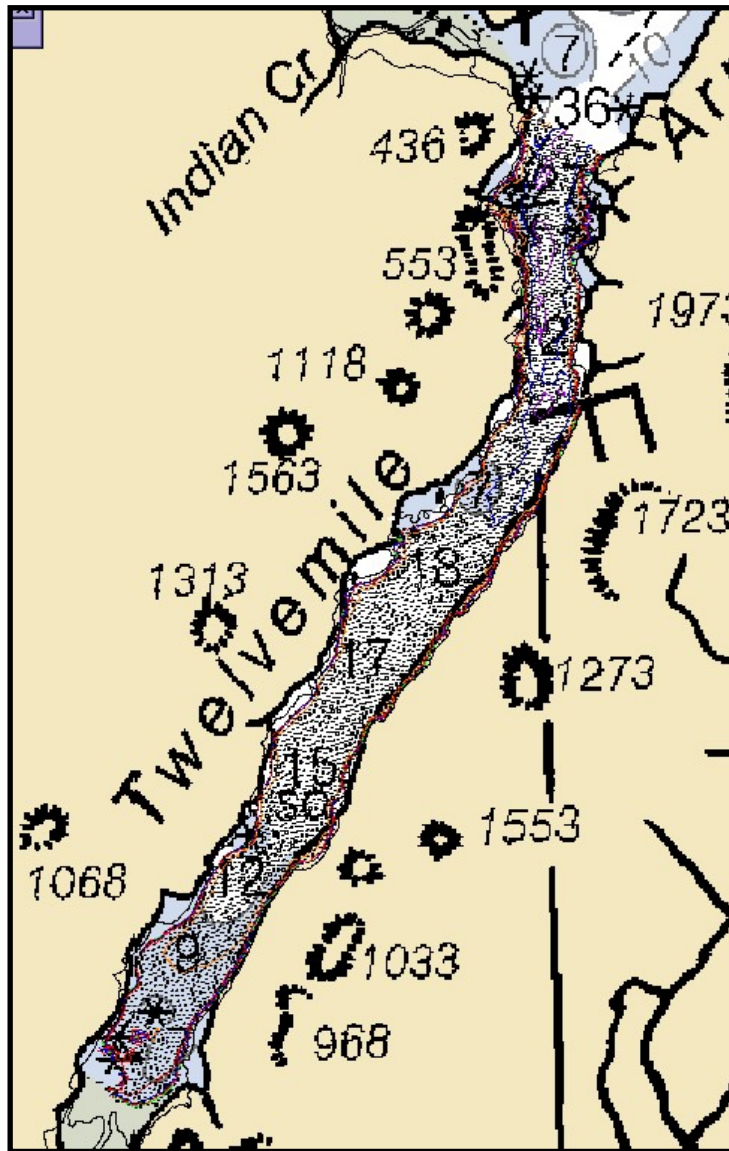
This survey generally agreed well with the chart. There were no outstanding disagreements with the depth curves or soundings. A comparison of the chart and remote sensing data does reveal a general discrepancy in the form of a shift in the shoreline. The charted shoreline is shifted overall to the north of the remote sensing data. The remote sensing data was verified through traditional and limited methods during this survey and was found to be accurate.

A portion of Chart 17420 showing the charted versus RSD shoreline discrepancy

Based on the results of survey H-11237, the Hydrographer recommends updating the next editions should be adjusted to²⁴ the 2003 RSD shoreline data.²⁵

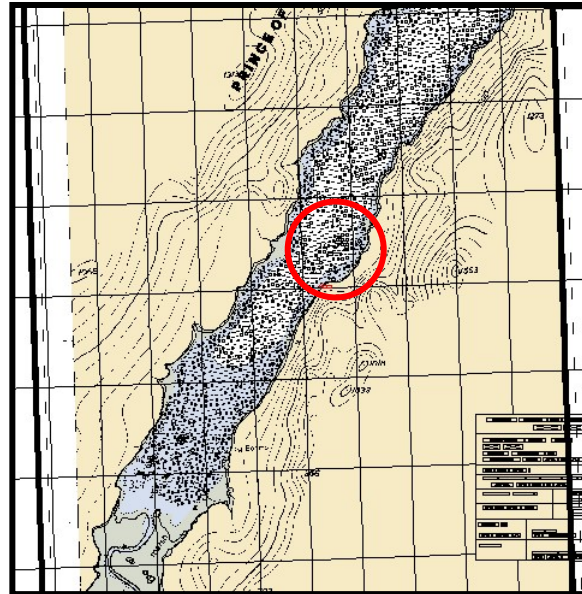
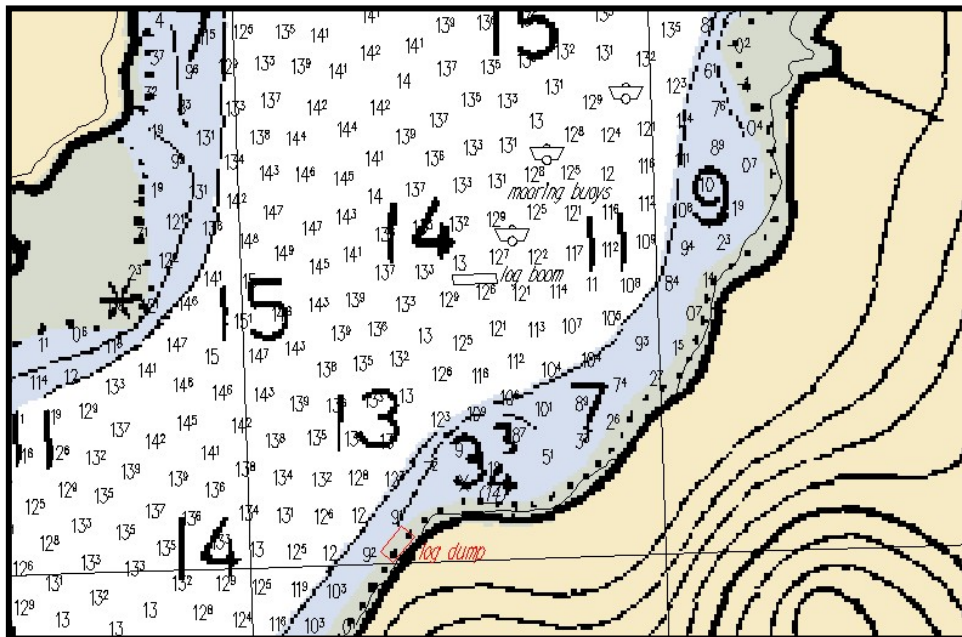
This survey identified a logging site not currently on the chart. A log boom, three mooring bouys, and a log dump site were all positioned and included in the detached position log. They are also shown on the smoothsheet.³⁶

Chart 17426 with logging activity area circled

Detail of Chart 17426 with logging activity area circled

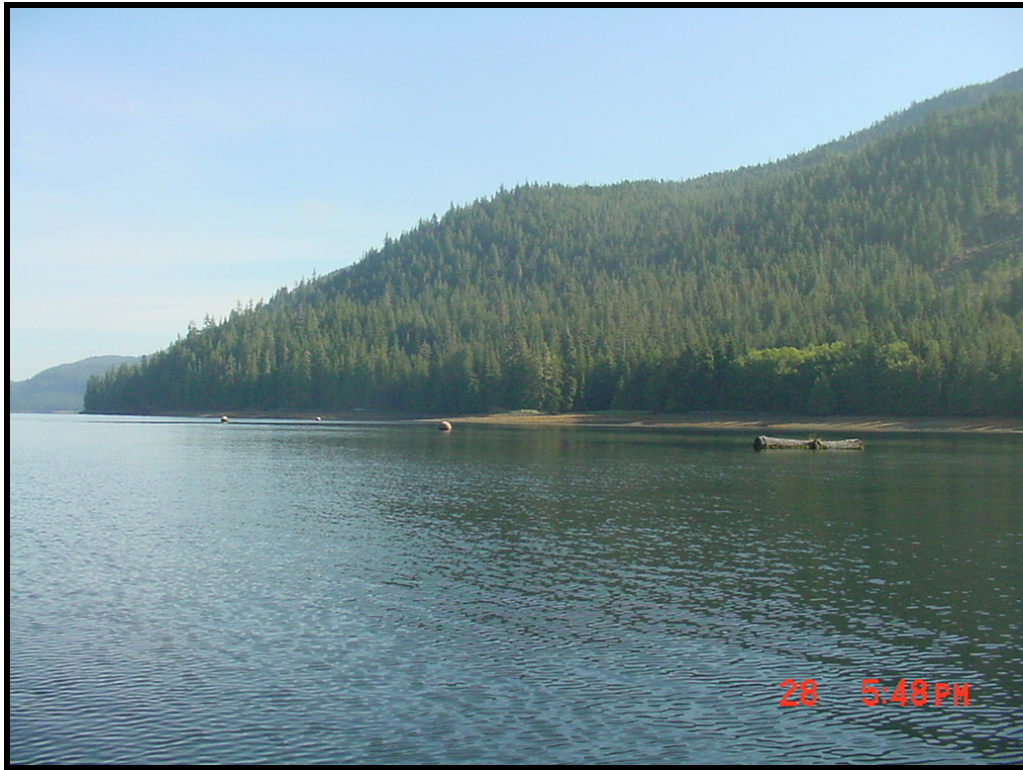
Mooring bouys and log boom

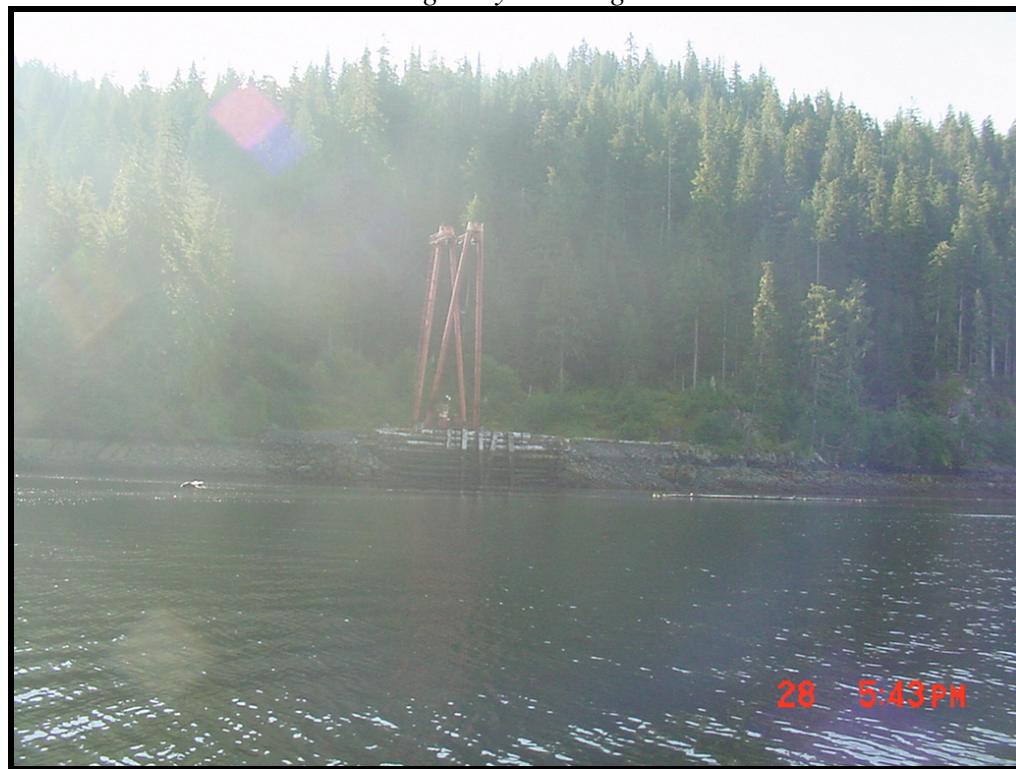
Log dump site

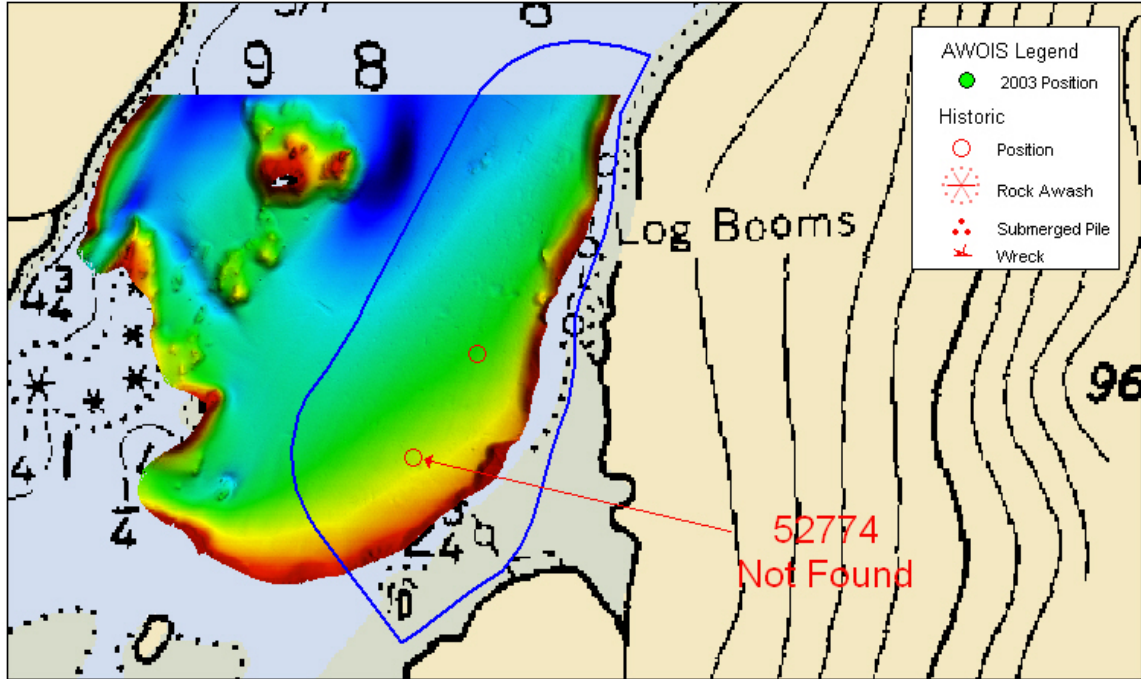
Date(s)/Day Number(s): 08/28/2003 / DN240
Survey Vessel Name: Skiff
Position Numbers/Time: 2071/09:17:52
Investigation Method: Shoreline Verification
Surveyed Position (NAD83): Lat 55° 22' 13.08"N Long 132° 43' 35.49"W
Position Determined By: Differential GPS
Investigation Summary: The charted position of this item fell outside the limits of hydrography.³⁸ The AWOIS radius was fully investigated by a combination of 200% SWMB coverage and visual shoreline investigation. A review of the digital terrain model detected no topographic relief. Remains of the log dump were found on the shore east of the AWOIS position.

AWOIS item 52774, radius, 2003 bathymetry, Chart 17426

Based on the results of survey H-11237, the hydrographer recommends the log boom symbol and notation be removed from the chart and database.³⁹

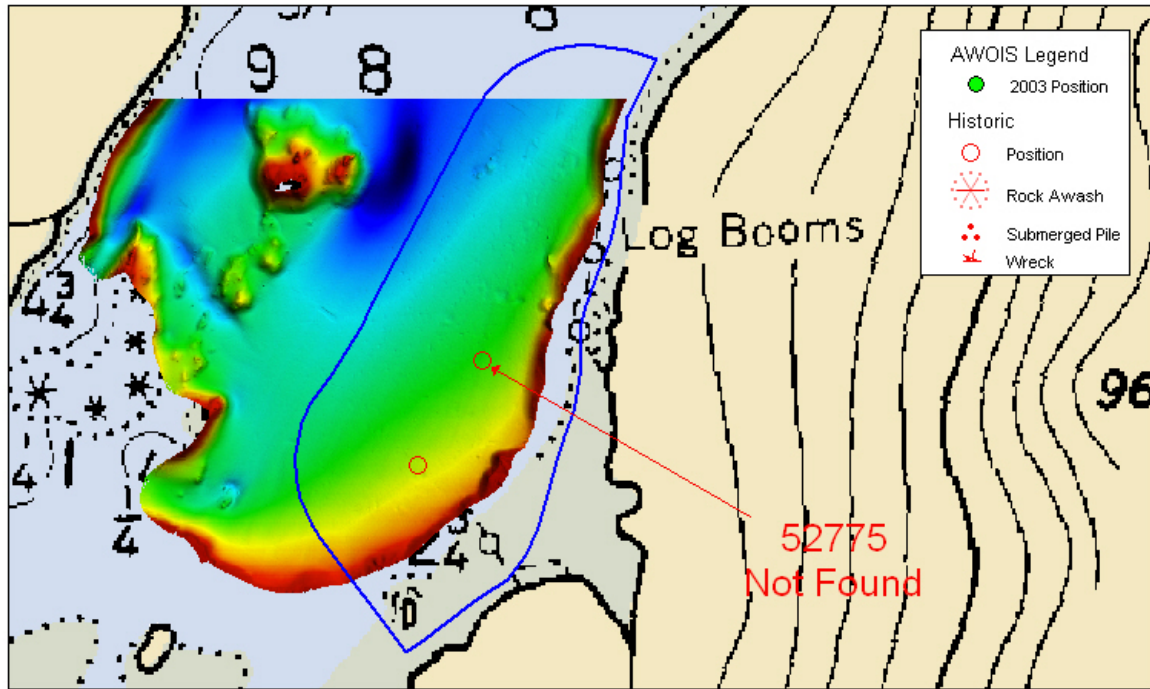
Date(s)/Day Number(s): 08/28/2003 / DN 240
Survey Vessel Name: Skiff
Position Numbers/Time: 2072/09:22:02
Investigation Method: Shoreline Verification and 200% SWMB coverage
Surveyed Position (NAD83): Lat 55° 22' 19.76"N Long 132° 43' 28.74"W
Position Determined By: Differential GPS
Investigation Summary: The charted position of this item fell outside the limits of hydrography.⁴⁰ The AWOIS radius was fully investigated by a combination of 200% SWMB coverage and visual shoreline investigation. Remains of the log dump were found on the shore east of the AWOIS position.

AWOIS item 52775, radius, 2003 bathymetry, Chart 17426

Based on the results of survey H-11237, the hydrographer recommends the log boom symbol and notation be removed from the chart and database.⁴¹
