DESCRIPTIVE REPORT

Type of Survey HYDROGRAPHIC

Registry No. H-11278

Sublocality Korovin Strait

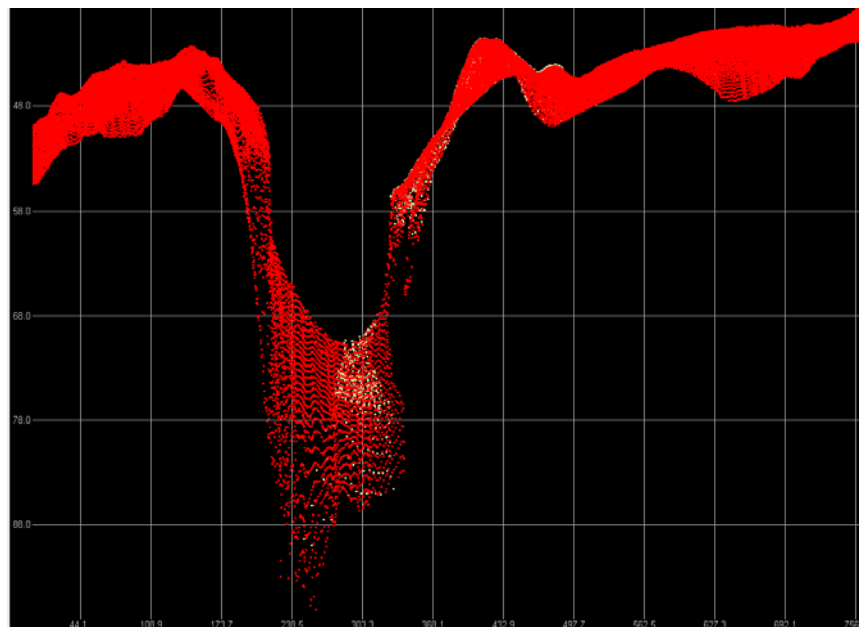
Figure 2: Profile of B02-QC004

- The majority of beams that fell outside of the 95 percent confidence level were located in areas having extreme steep slopes and/or rocks. The figures below show a few examples of this.

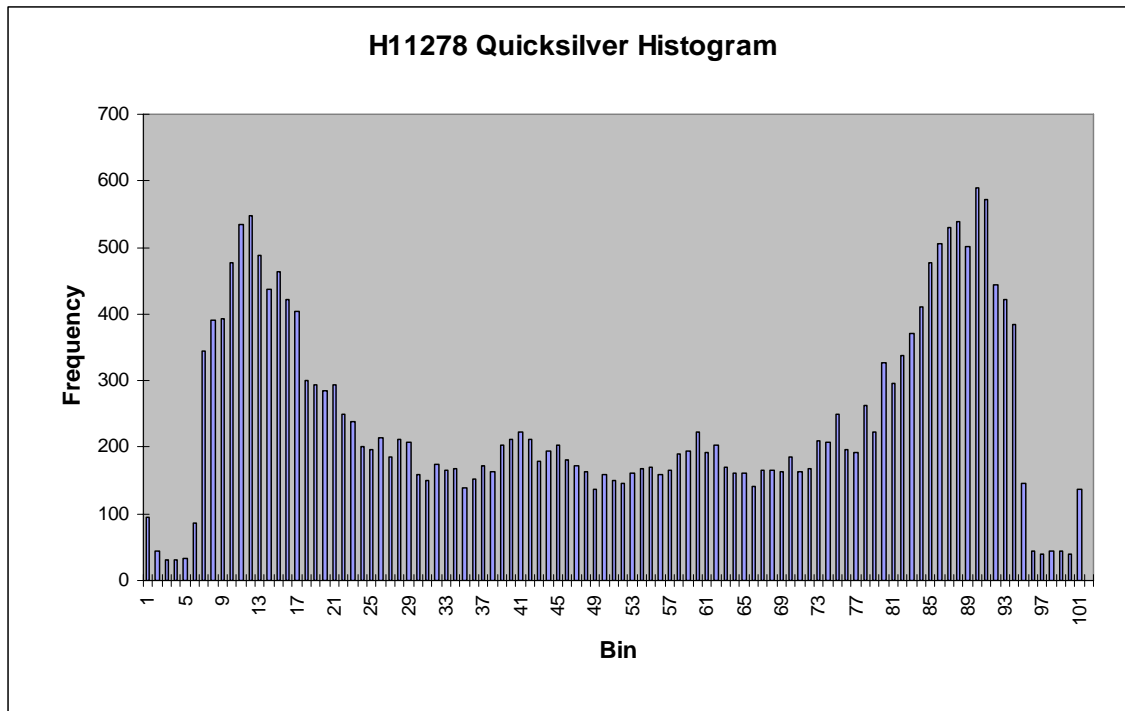
Figure 5 Histogram for 8101 (Quicksilver)

Figure 5 Histogram is for the Reson 8101 data collected from May 4, 2004 to June 8, 2004 on the Quicksilver. The histogram shows an increase of selected soundings from the outer beams. This is the result of surveying near the shoreline where the outer beams are mapping the shallowest areas. Also the majority of adjacent lines were run¹⁰, port beams overlapped with port beams and starboard beams overlapped with starboard beams. This makes it possible to have higher density data per square meter on the outer edges, leading to a higher chance of sounding selection on the smooth sheet. It is also apparent on these examinations the transition from phase to amplitude detection method of the sonar (around beams 37 and 65).¹¹

¹¹ ~~Strikethrough It is also apparent on these examinations the transition from phase to amplitude detection method of the sonar (around beams 37 and 65).~~, replace with “The transition in sonar detection method from phase to amplitude (around beams 37 and 65) is also apparent in the histogram.”

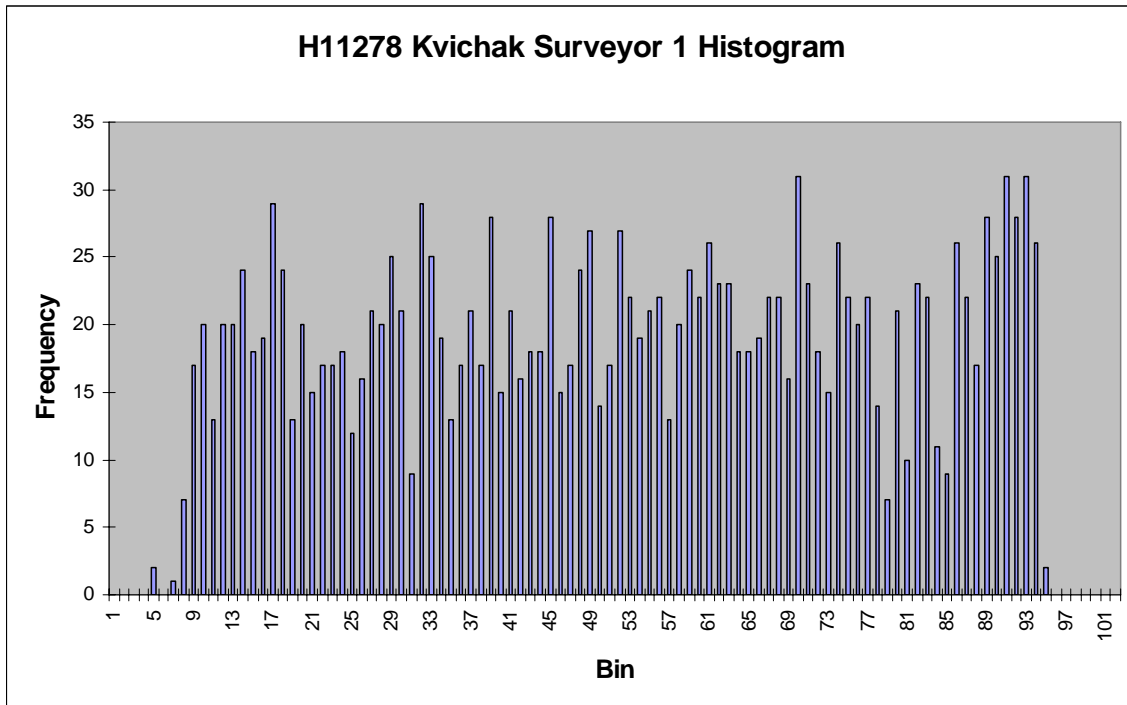
Figure 6 Histogram for 8111 (Kvichak Surveyor 1)

Figure 6 Histogram is for the Reson 8111 data, collected on June 2, 2004 on the Kvichak Surveyor 1. The Surveyor 1 was utilized to conduct the deep water portion of the sheet which consisted of three lines; hence the low number of selected soundings on the smooth sheet. The histogram is somewhat evenly distributed, but due to the lack of soundings¹², no trends can be identified.

¹² ~~Strikethrough lack of soundings~~, replace with “small number of soundings”.

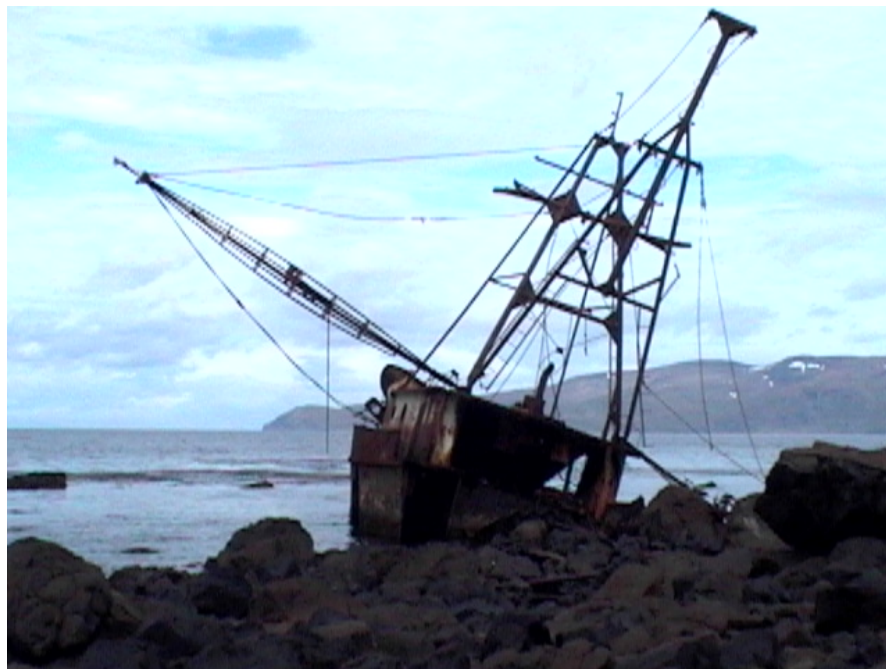
Figure 8 Bow section of the Ray Mar Houston

The AWOIS item was not found at the assigned position, but rather 0.67 NM northwest of the charted or assigned position. The vessel name is the "Ray Mar Houston" and ²⁹is broken into two major pieces (noted as bow and stern) with debris scattered between the two sections. The bow position is located at 55°21'26" N 160°28'20" W and the stern at 55°21'25" N 160°28'23" W. Note: To disprove the assigned position the DP Skiff and Quicksilver visited the charted location and collected video and photos.

Fieldnote POSITION DETERMINED BY: MAGELLAN MERIDIAN HANDHELD GPS WITH WAAS.
INVESTIGATION SUMMARY: THE VESSEL NAME IS THE "RAY MAR HOUSTON" AND IS BROKEN INTO TWO MAJOR PIECES WITH DEBRIS SCATTERED BETWEEN THE TWO SECTIONS. THE ITEM IS ACTUALLY LOCATED APPROXIMATLY 0.67 NM NORTHWEST OF THE CHARTED POSITION. THE DP SKIFF AND R/V QUICKSILVER VISITED THE CHARTED POSITION AND COLLECTED VIDEO AND PICTURES TO DISPROVE THE CHARTED LOCATION.
CHARTING RECOMMENDATION (HYDROGRAPHER): THE CURRENT WRECK SYMBOL SHOULD BE REMOVED AND PLACED AT THE BOWS SURVEYED POSITION.
EVALUATOR COMMENTS: Concur with clarification. Delete wreck PA and chart visible wreck as found by the present survey."/>

It's the hydrographers' recommendation that the charted wreck symbol be removed and charted at the bows surveyed position of 55°21'26" N 160°28'20" W.³⁰ It is represented this way on the H11278 smooth sheet. Refer to Appendix E³¹ for AWOIS form.

³⁰ Concur with clarification. Remove charted wreck and "PA" notation at approximately Lat 55/20/54N and Lon 160/27/36W and chart visible wreck as found by the present survey..

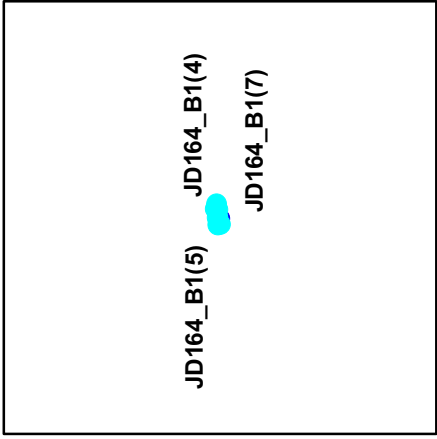
MB Coverage With Smooth Sheet Soundings
 200m x 200m

LIDAR Rk not found at 55 20 59.52 N 160 27 33.65 W. Investigated by the DP skiff on Julian day 164. Seven lead line measurements were taken at and in the vicinity of the 1.8 fm Rk LIDAR sounding and the shoalest depth found was 3.3 fms. Recommend do not chart the 1.8 fm LIDAR Rk.³⁹ DP form JD164_B1.

Remarks/Recommendations:
 Multiple fixes taken. 1.8 fm Rk not confirmed. Recommend do not chart lidar soundings and Rk.
 Chart: 16553_1 Topo: Carto Code: None

³⁹ Concur. Kelp noted in the area on both H11330 and H11147b may account for the inaccurate LIDAR sounding. Chart this area based on the survey findings.

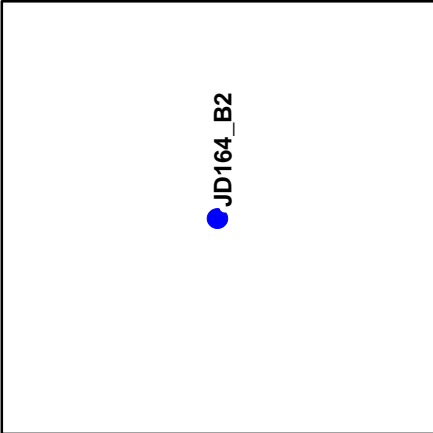
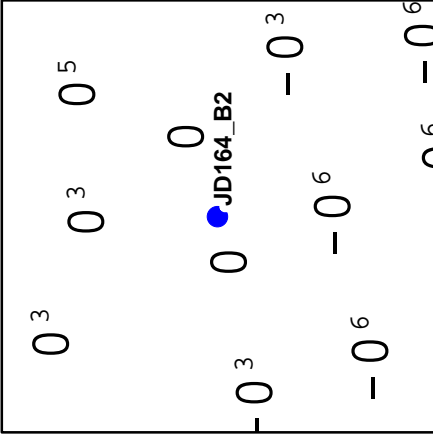
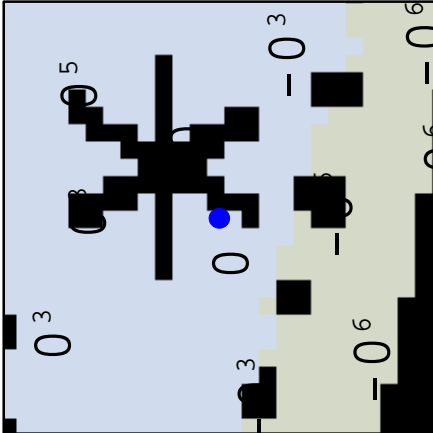
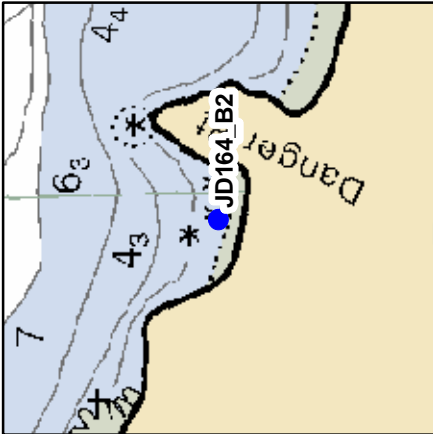
Charted rock observed. Investigated by skiff on Julian day 164; rock found with height of 2 ft MLLW. Recommend charting rock at DP position 55 20 35.26 N 160 26 29.58 W with a height of 2 ft MLLW. Appears on smooth sheet at DP position. DP form JD164_B2. Other charted rocks in the vicinity of Item 2 were not investigated and it's the hydrographers' recommendation that they should remain on the chart.⁴⁰

Remarks/Recommendations:
 Charted rock confirmed; retain as charted with height of 2 ft MLLW.
 Chart: 16553_1 Topo: Carto Code: None

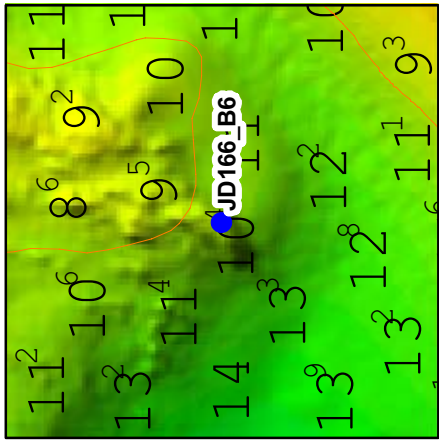
MB Coverage With Smooth Sheet Soundings Lidar Smooth Sheet with Neighboring DP's
 200m x 200m

7.8 fm LIDAR Rk positioned at 55 21 41.78 N 160 22 24.22 W was not located. The area was surveyed with 100% multibeam coverage. The shoalest depth in the area is 10.4 fms and is represented as such on the H11278 smooth sheet at 55 21 41.599 N 160 22 24.806 W. Recommend do not chart LIDAR 7.8 fm Rk. DP form JD166_B6.⁴²

Remarks/Recommendations:
 7.8 fm lidar Rk not found by full multibeam coverage. Recommend do not chart lidar 7.8 fm Rk.
 Chart: 16553_1 Topo: Carto Code: None

⁴² Concur. Refer to endnotes 44 and 45 for charting recommendations.

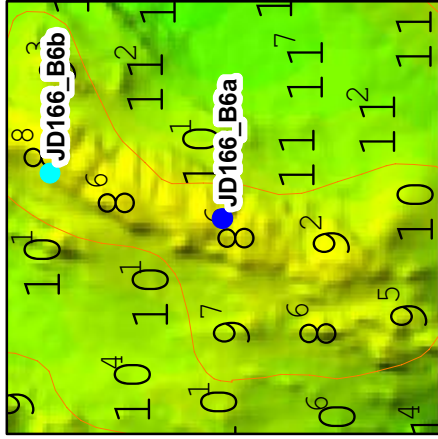
MB Coverage With Smooth Sheet Soundings Lidar Smooth Sheet with Neighboring DP's
 200m x 200m

8.3 fm LIDAR Rk located just north of the 7.8 fathom sounding above was confirmed by full multibeam coverage, but with depth of 8.6 fms having a position of 55 21 45.373 N 160 22 21.449 W. Recommend chart 8.6 fm Rk at multibeam location.⁴³ DP form JD166_B6a.

Remarks/Recommendations:
 Full MB coverage confirms Rk but with depth of 8.6 fms. Recommend chart 8.6 f m Rk at multibeam location.
 Chart: 16553_1 Topo: Carto Code: None

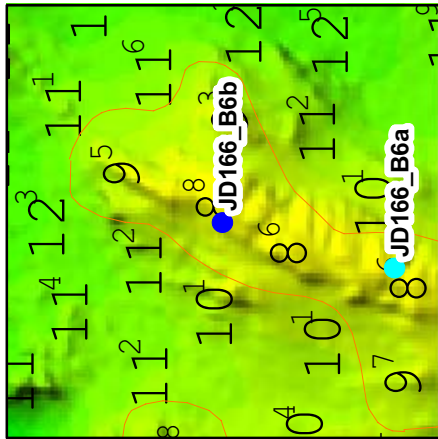
8.7 fm LIDAR Rk located just north of the 7.8⁴⁴ fathom sounding above was confirmed by full multibeam coverage, but with depth of 8.8 fms having a position of 55 21 48.292 N 160 22 19.429 W. Recommend chart 8.8 fm Rk at multibeam location.⁴⁵ DP form JD166_B6b.

Remarks/Recommendations:
 Full MB coverage confirms Rk but with depth of 8.8 fms. Recommend chart 8.8 f m Rk at multibeam location.
 Chart: 16553_1 Topo: Carto Code: None

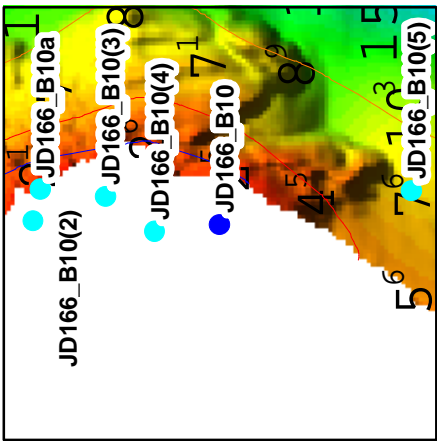
0.1 fm LIDAR Rk positioned at 55 21 01.08 N 160 19 27.76 W was confirmed, but with height of 4 ft MLLW. Recommend charting rock at seaward-most extent with height of 4 ft MLLW. Appears on smooth sheet at seaward-most extent as defined by skiff investigation at 55 21 00.84 N 160 19 27.73 W. DP form JD166_B10.⁴⁶

Remarks/Recommendations:
 Lidar Rk confirmed but with height of 4 ft MLLW. Chart rock (4 ft MLLW) at seaward-most extent position JD166_B10(3) is seaward most extent.
 Chart: 16553_1 Topo: Carto Code: 089

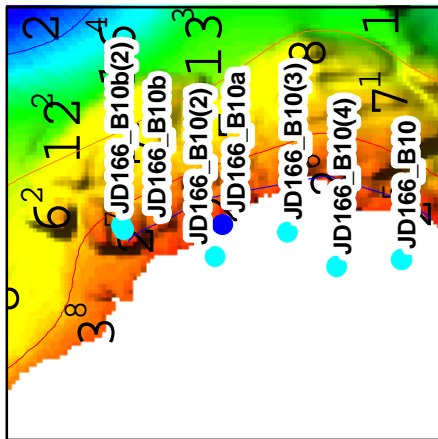
0.7 fm LIDAR Rk located just north of the 0.1 fathom sounding above confirmed. Recommend charting as reported by LIDAR.⁴⁷ DP form JD166_B10a.

Remarks/Recommendations:
 0.7 fm lidar Rk confirmed. Recommend chart as reported by lidar.
 Chart: 16553_1 Topo: Carto Code: None

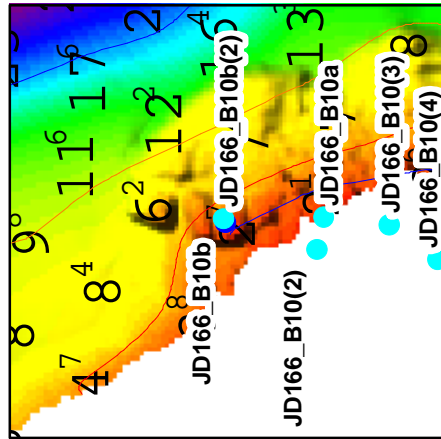
1.7 fm LIDAR Rk located just north of the 0.1 fathom sounding above was confirmed but with depth of 2.7 fms. Skiff visited area, noted dense kelp, and could not locate the rock. Multibeam coverage, however, confirmed a rock at the LIDAR position but with a depth of 2.7 fms. Recommend do not chart LIDAR 1.7 fm Rk – chart multibeam 2.7 fm Rk located at 55 21 04.865 N 160 19 27.363 W.⁴⁸ Also chart kelp. DP form JD166_B10b.

Remarks/Recommendations:
 1.7 fm lidar Rk confirmed with MB coverage but with depth of 2.7 fms. Chart with MB Rk position and depth. Skiff observed dense kelp; chart kelp.
 Chart: 16553_1 Topo: Carto Code: None

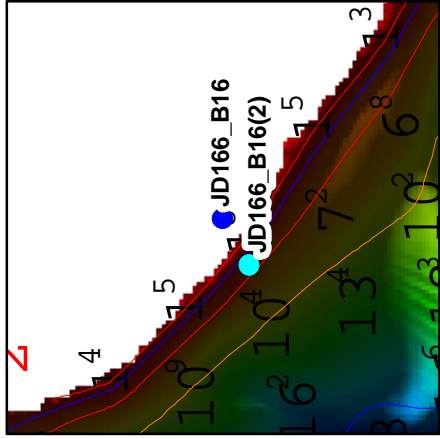
Drying LIDAR rock located at 55 23 41.03 N 160 19 30.16 W was confirmed but with a height of 7 ft MLLW. Recommend chart with height of 7 ft MLLW. Appears on smooth sheet at DP position 55 23 41.08 N 160 19 30.28 W with DP height. DP form JD166_B16.⁴⁹

Remarks/Recommendations:
 Drying lidar rock confirmed but with height of 7 ft MLLW. Chart at DP position with DP height.
 Chart: 16553_1 Topo: Carto Code: 089
