DESCRIPTIVE REPORT

Type of Survey HYDROGRAPHIC

Registry No. H-11354

Sublocality Approaches to Sitka

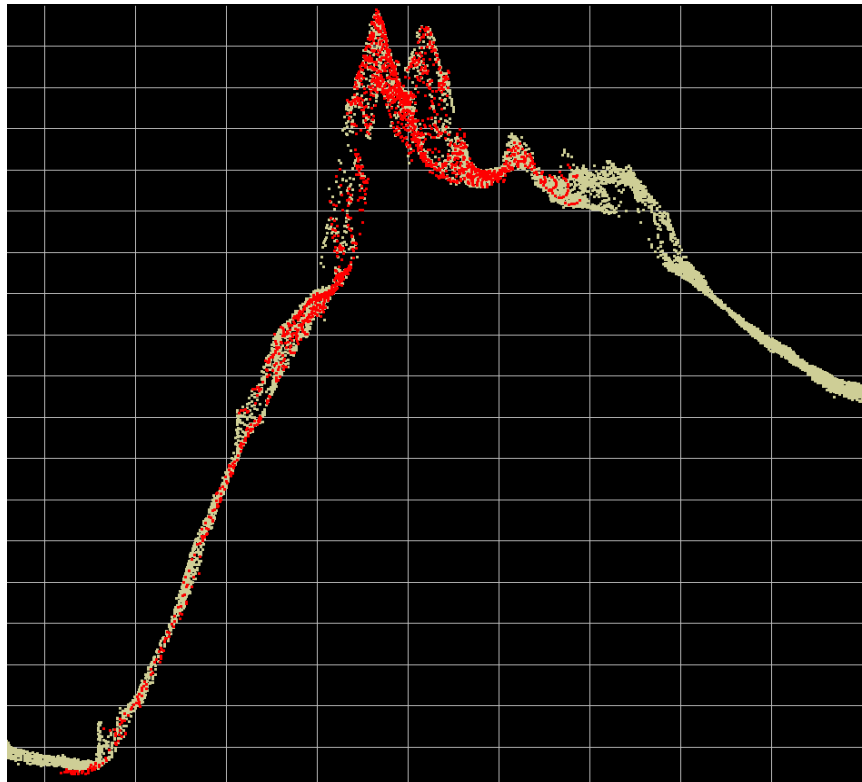
Figure 2: Profile of U02-QC008

- The majority of beams that fell outside of the 95 percent confidence level were located in areas having extreme steep slopes and/or rocks. The figures below show a few examples of this.

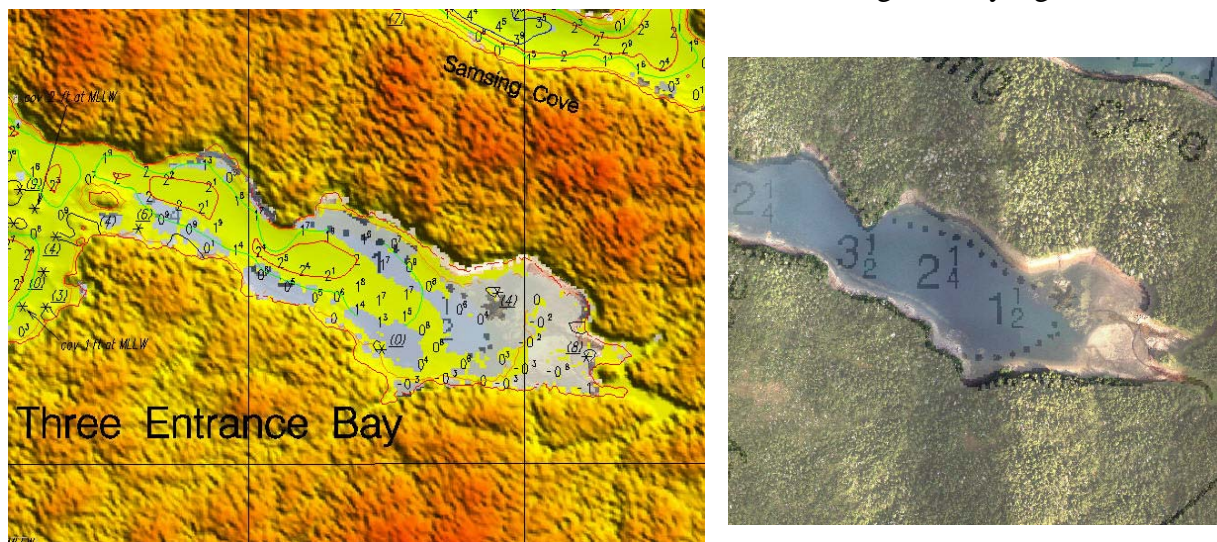
Figure 4: LIDAR Coverage (Three Entrance Bay)

- Due to water clarity and bottom type (evident from the orthomosaic below on the right) there were sections of Three Entrance Bay that had sparse LIDAR coverage. It should be noted that these areas are not considered to be navigationally significant.

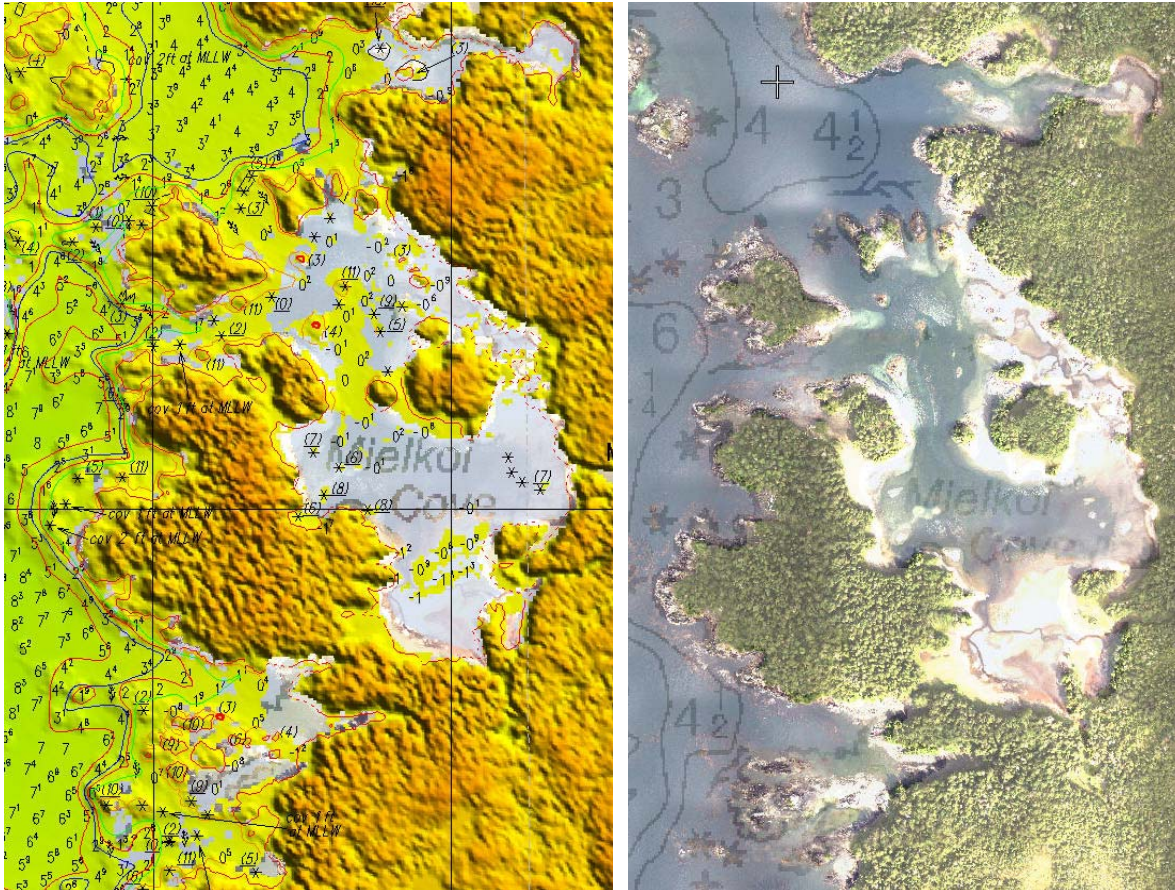
Figure 5: LIDAR Coverage (Mielkoi Cove)

- LIDAR data was limited in Mielkoi Cove because of the bottom type. It is evident from the orthomosaic below on the right that the bottom consists of mud. As stated above the area is not considered to be navigationally significant. In this area, the sea to land or transition zone was not mapped fully, hence the broken MHW line.

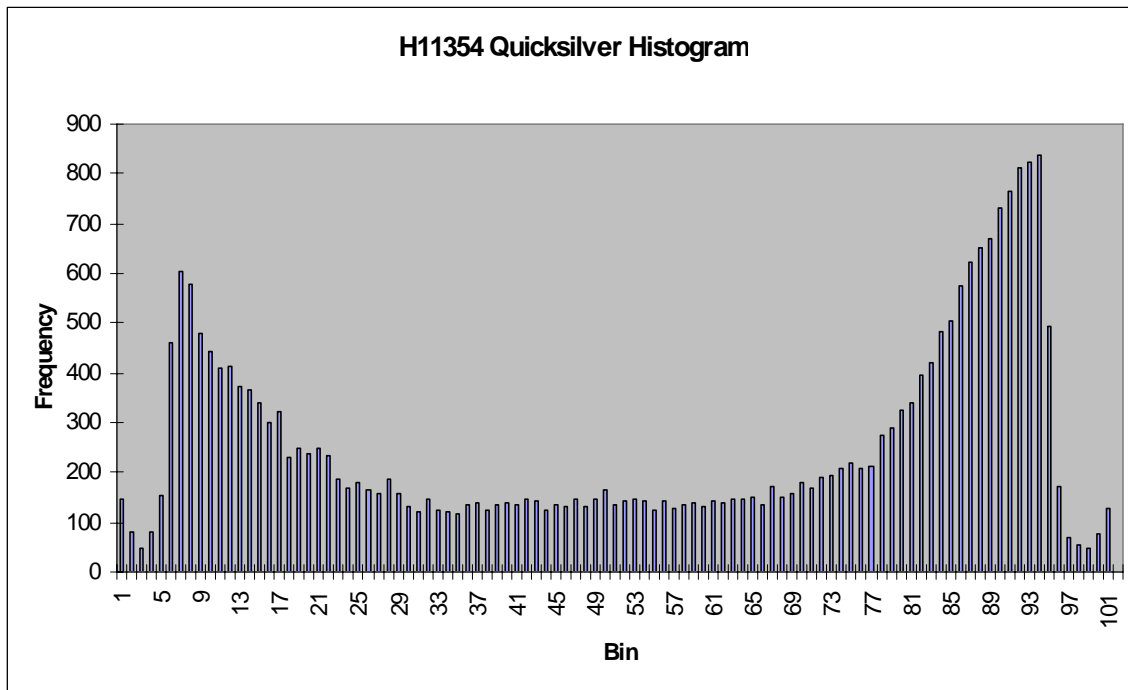
Figure 6 Histogram for 8101 (Quicksilver)

Figure 6 Histogram is for the Reson 8101 data collected from August 17, 2004 to September 15, 2004 on the Quicksilver. The histogram shows an increase on selected soundings from the outer beams (around beams 5 - 25 and 81 - 95). This is the result of surveying near the shoreline where the outer beams are mapping the shallowest areas. Also, in the majority of adjacent lines that were run, port beams overlapped with port beams and starboard beams overlapped with starboard beams. This makes it possible to have higher density data per square meter on the outer edges, leading to a higher chance of sounding selection on the smooth sheet.

The decrease or lack of selected soundings on the outer beams is the result of deterioration of data quality on the outer beams. In most cases set filters were used to flag the outer beams as rejected, but in other cases, additional cleaning or filters were used on a line by line basis resulting in fewer selected soundings.

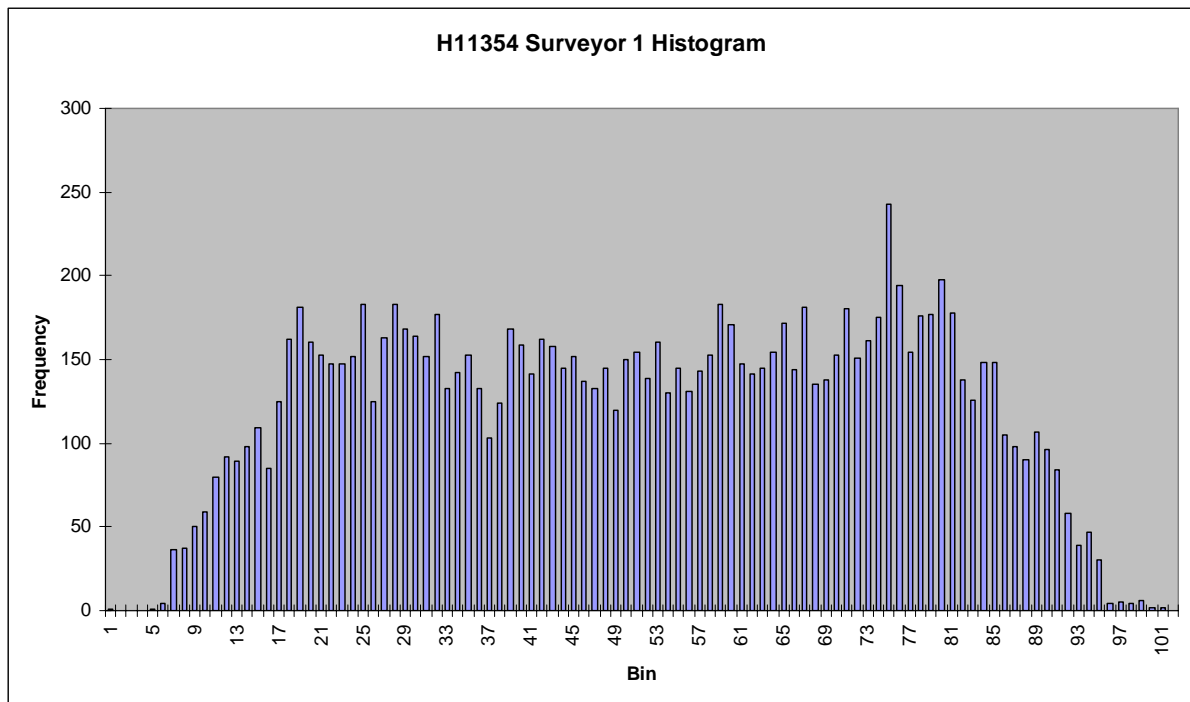
Figure 7 Histogram for 8111 Surveyor 1

Figure 7 Histogram is for the Reson 8111 data, collected on July 26, 2004 to July 28, 2004 on the Kvichak Surveyor 1. The Surveyor 1 was utilized to conduct the deep-water portion of the sheet. The histogram is evenly distributed between beams 17 to 81, it is somewhat apparent on these examinations the transition from phase to amplitude detection method of the sonar (around beams 37 and 69).

The decrease or lack of selected soundings on the outer beams is the result of deterioration of data quality on the outer beams, especially in deep water. In most cases set filters were used to flag the outer beams were rejected, but in other cases additional cleaning or filters were used on a line by line bases resulting in fewer selected soundings.

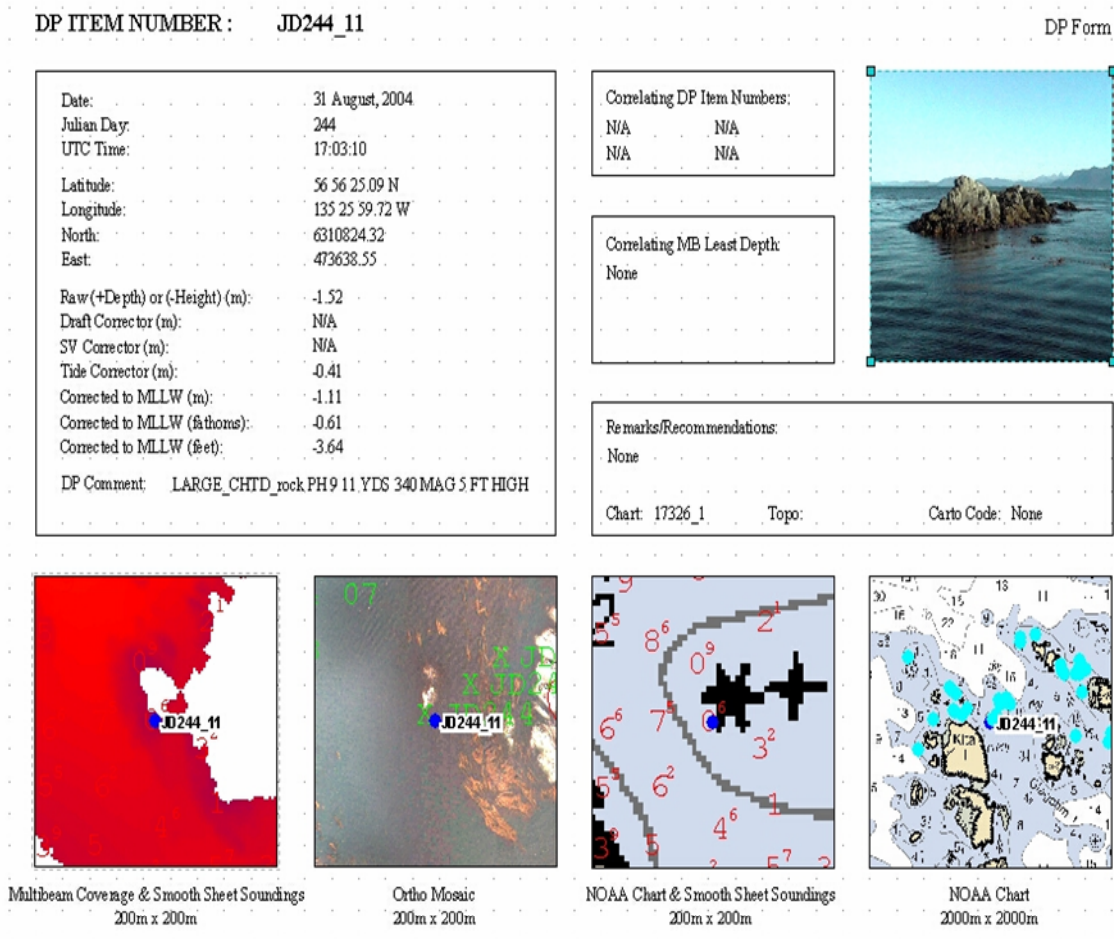
Figure 9 DP Correlator Sheet

ArcMap v9.0 with the Shoreline Correlator add-on, written by the Fugro Pelagos Inc. GIS department, aided in the processing of the investigation results. The correlator utilized the Winfrog Log files to create an individual DP form for all acquired DP's. The correlator was mapped to the Log, Tide, Photos, NOAA Chart (largest scale available), LIDAR Data, Smooth Sheet Soundings, Multibeam Coverage and Ortho Mosaic files to calculate and display the desired information for each DP. Figure 9 shows an example of a DP form produced from the Correlator. The DP forms and the raw field notes can be found in Appendix F. ⁶⁰

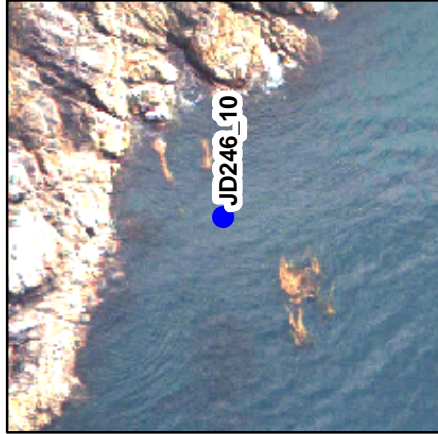
Orthomosaic
 100m x 100m

Remarks/Recommendations:
 New Rk (57 01 53.55 N, 135 22 34.09 W) with Skiff Ht and ortho position.
 Chart: 17326 Topo: N/A Carto Code: 089

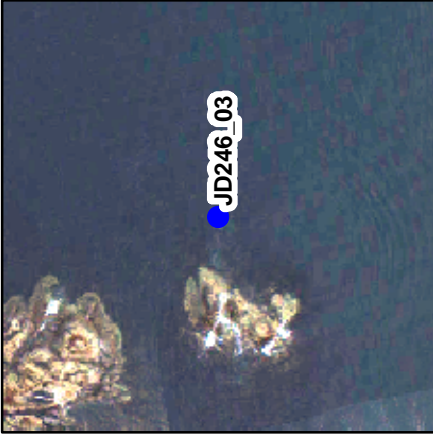
Orthomosaic
 100m x 100m

Remarks/Recommendations:
 Chrt'd Rk (57 01 57.49 N, 135 22 35.51 W) Appears on SS at ortho position and Skiff Ht.
 Chart: 17326 Topo: N/A Carto Code: 089

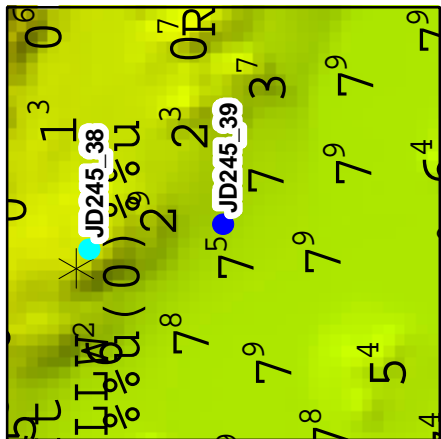
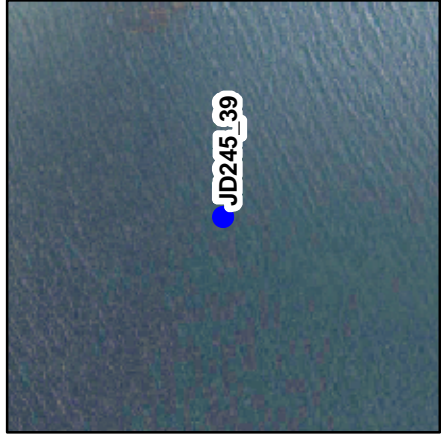
Remarks/Recommendations:
 Chrt'd Rk (56 56 31.33 N, 135 23 18.75 W) not found. Area had full multibeam & LIDAR coverage and was investigated by the Skiff. Recommend removal.
 Chart: 17326 Topo: N/A Carto Code: None

- Charted rock at 56 56 31.33 N, 135 23 18.75 W was not found during this survey. The rock received full multibeam and LIDAR coverage and was visited by the skiff. Recommend removal. See DP form JD245_39.²⁶

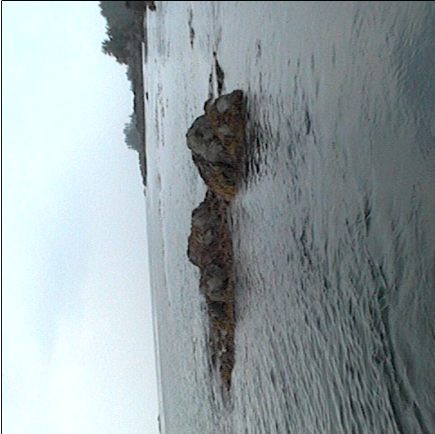
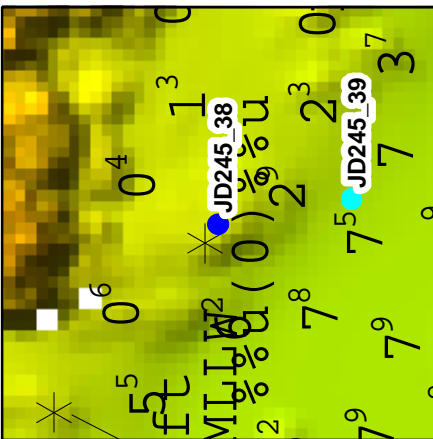
Remarks/Recommendations:
 New Rk (56 56 33.33 N, 135 23 19.47 W). Charted with Skiff position and ht.
 Chart: 17326 Topo: N/A Carto Code: 089

- New rock at 56 56 33.33 N, 135 23 19.47 W was located by LIDAR with height of 0 ft above MLLW but skiff obtained a shoaler height of 4 ft above MLLW. Orthomosaic also indicates that skiff positioning of rock is more accurate. Recommend charting at skiff position (56 56 33.33 N, 135 23 19.47 W) with skiff height and appears as such on smooth sheet. See DP form JD245_38.²⁷

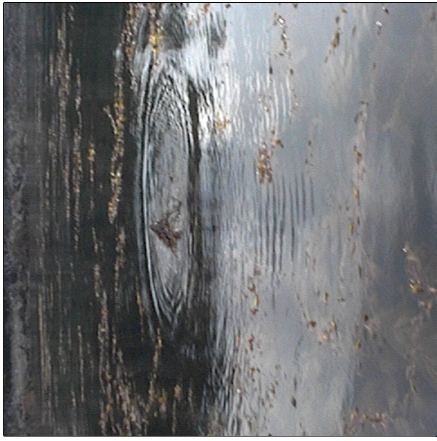
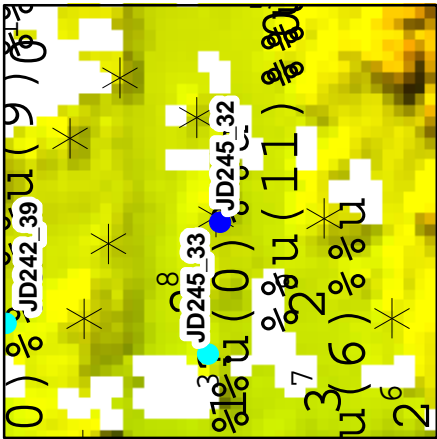
Remarks/Recommendations:
 New Rk (56 57 11.68 N, 135 22 58.45 W) found by Skiff.
 Chart: 17326 Topo: N/A Carto Code: 089

- New rock at 56 57 11.68 N, 135 22 58.45 W was located by LIDAR (0 ft above MLLW) and by skiff but skiff obtained a shoaler depth (2 ft above MLLW) at position 3m southwest. Possible LIDAR did not find shoalest point. Recommend charting at skiff position (56 57 11.68 N, 135 22 58.45 W) with skiff height, and appears as such on smooth sheet. See DP form JD245_32. ³⁷

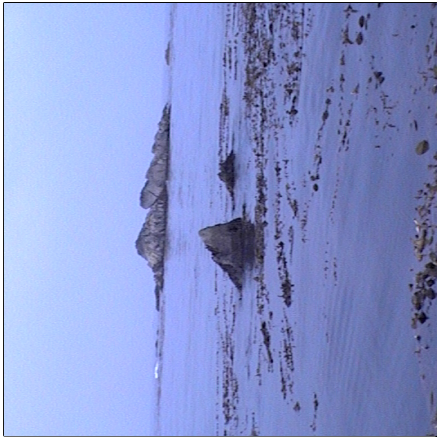
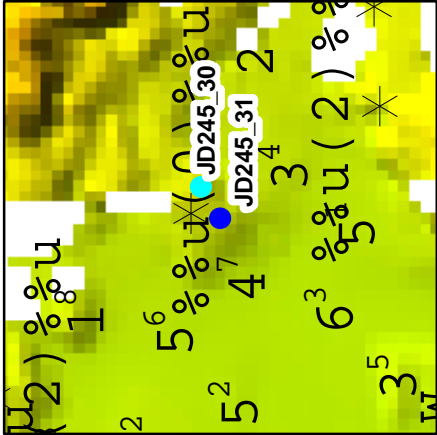
DP ITEM NUMBER : JD245_31

Remarks/Recommendations:
 New rock (56 57 41.33 N, 135 23 03.10 W) was observed by skiff.
 Chart: 17326 Topo: N/A Carto Code: 089

- New rock at 56 57 41.33 N, 135 23 03.10 W was observed by skiff (3 ft above MLLW) while LIDAR found the slightly deeper rock 13m north (0 ft above MLLW). Another skiff rock was located 13m northeast (DP form JD245_30) – recommend charting the seaward new rock (56 57 41.33 N, 135 23 03.10 W) and charting a ledge to include the two nearby rocks since at smooth sheet scale the three rocks cannot be portrayed. Appears as such on smooth sheet. See DP form JD245_31. ⁴¹

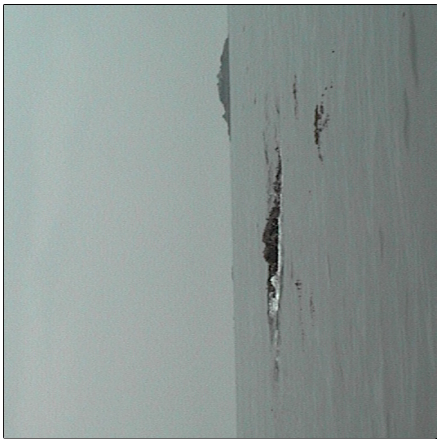
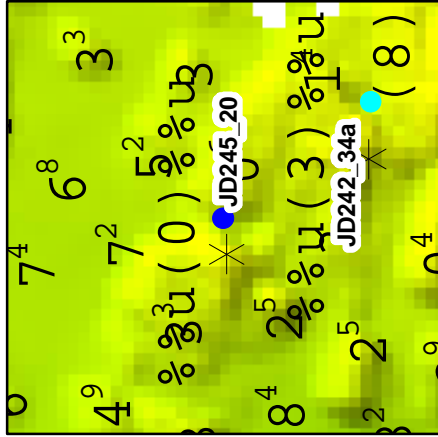
DP ITEM NUMBER : JD245_20

Remarks/Recommendations:
 Chrt'd Rk (56 57 44.50 N, 135 23 26.08 W) not found. Area had full multibeam coverage and was investigated by the Skiff. Recommend removal
 Chart: 17326 Topo: N/A Carto Code: None

- Charted rock at 56 57 44.50 N, 135 23 26.08 W was not found during this survey. Full multibeam coverage found a shoalest depth of 2.5 fms at the position. Recommend removal. See DP form JD245_20. ⁴⁰

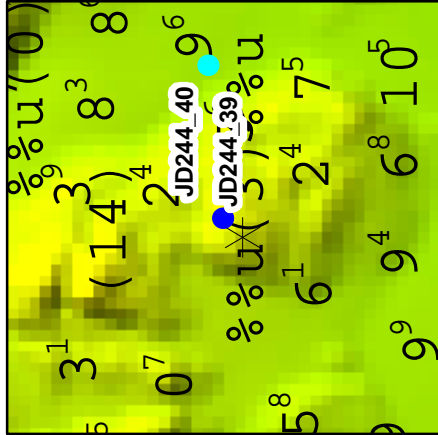
Remarks/Recommendations:
 Chrt'd Rk (56 56 34.41 N, 135 24 29.72 W) found. Chrt'd at Skiff position with Skiff Ht.
 Chart: 17326 Topo: N/A Carto Code: 089

- Charted rock at 56 56 34.41 N, 135 24 29.72 W was located by LIDAR and skiff, but skiff obtained shoaler height. Orthomosaic also indicates skiff positioning on rock is more accurate. Recommend charting at skiff position (56 56 34.41 N, 135 24 29.72) with skiff height, and appears as such on smooth sheet. See DP form JD244_39.²⁸

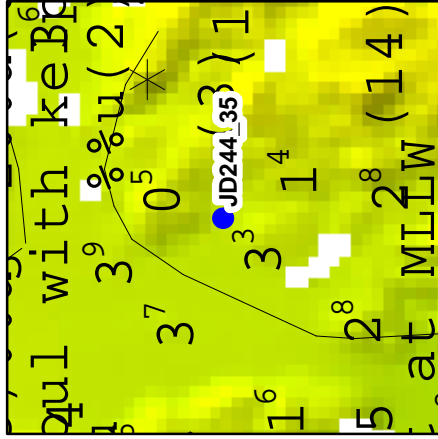
DP ITEM NUMBER: JD244_35

Remarks/Recommendations:
 Chrt'd Rk (56 56 17.45 N, 135 24 49.65 W) not found. Area had LIDAR coverage and was investigated by the Skiff. Recommend removal.
 Chart: 17326 Topo: N/A Carto Code: None

- Charted rock at 56 56 17.45 N, 135 24 49.65 W was not found during this survey. The rock received LIDAR coverage and was visited by the skiff. Skiff reported a depth of 3.8 fms at this position. Recommend removal. See DP form JD244_35.²⁵

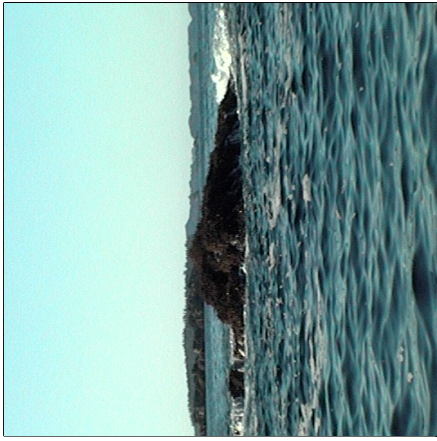
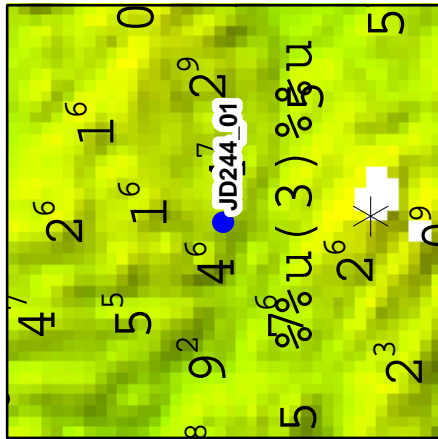
DP ITEM NUMBER : JD244_01

Remarks/Recommendations:
 Cht'd rk found, used ortho position and skiff height. Refer to the DR for a detailed description.
 Chart: 17326 Topo: N/A Carto Code: 089

- Charted rock at 56 56 36.57 N, 135 26 38.148 W was located, but a hole in combined multibeam / LIDAR coverage indicates shoalest point not located. Skiff visited rock and fixed its height at 3 ft above MLLW. As skiff could not safely approach rock its position was estimated. Position clearly visible on orthomosaic. Recommend charting at orthomosaic position (56 56 36.36 N, 135 26 36.30 W) using skiff height, and appears as such on smooth sheet. See DP form JD244_01.²⁴

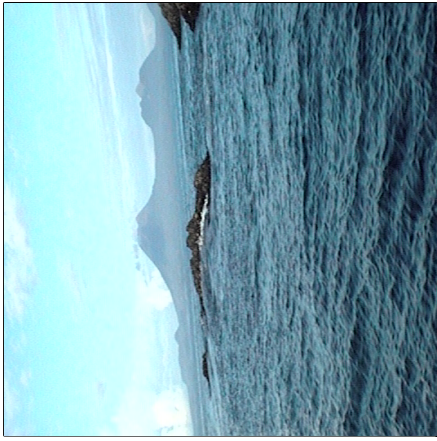
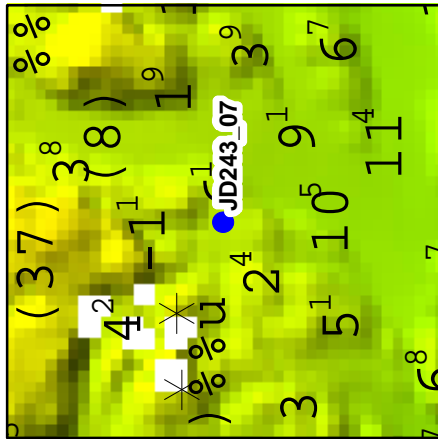
DP ITEM NUMBER : JD243_07

Remarks/Recommendations:
 Charted rock (56 57 42.15 N, 135 24 55.64 W) Recommend using the Skiff Ht and orthomosaic position.
 Chart: 17326 Topo: N/A Carto Code: 089

- Charted rock at 56 57 42.15 N, 135 24 55.64 W was located by skiff. Rock apparent in orthomosaic but height not obtained by LIDAR. Recommend using skiff height (2 ft above MLLW) at orthophoto position (56 57 42.50 N 135 24 56.30 W), and appears as such on smooth sheet. See DP form JD243_07. ³⁹

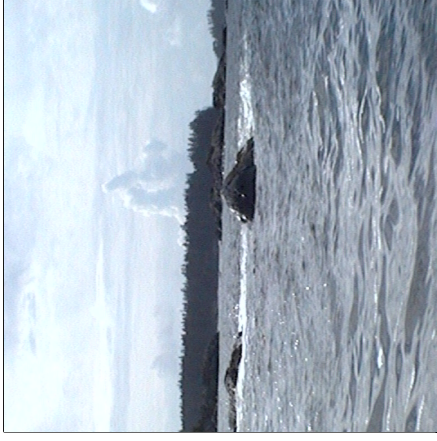
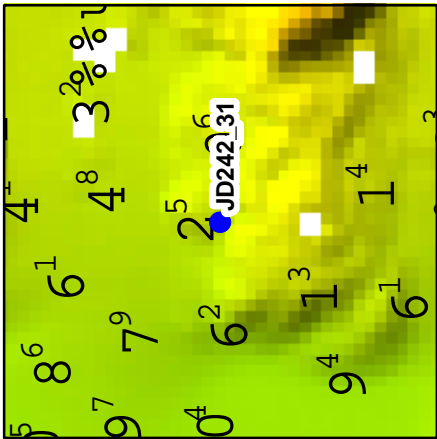
Remarks/Recommendations:
 Charted Rk (56 58 07.75 N, 135 22 58.68 W) was found and cht'ed with Skiff Ht and ortho position.
 Chart: 17326 Topo: N/A Carto Code: 089

- Charted rock at 56 58 07.75 N, 135 22 58.68 W was observed by the skiff (3 ft above MLLW). Rock is evident in orthomosaic. As skiff position was estimated it is recommended the rock be charted at orthomosaic position (56 58 07.75 N, 135 22 58.68 W) using skiff height, and appears as such on smooth sheet. See DP form JD242_31. ⁴³

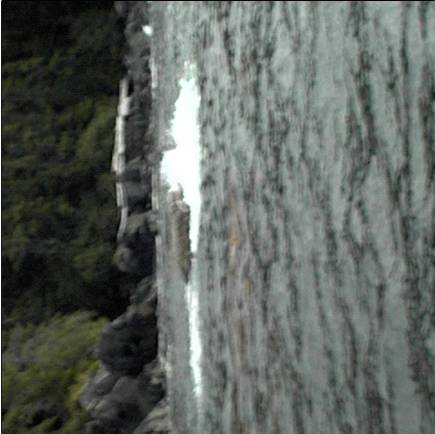
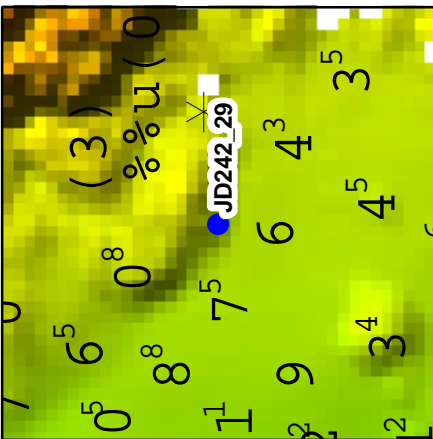
DP ITEM NUMBER : JD242_29

Remarks/Recommendations:
 Chtd Rk (56 58 21.04 N, 135 23 02.70 W) was found, recommend changing from rock to islet and charting at position from orthomosaic.
 Chart: 17326 Topo: N/A Carto Code: 089

- Charted rock at 56 58 21.04 N, 135 23 2.70 W was observed by skiff. Skiff obtained height of 3 ft above MHW. Recommend removing charted rock and charting islet at position from orthomosaic (56 58 21.04 N, 135 23 2.70 W), and appears as such on smooth sheet. See DP form JD242_29. ⁴⁴

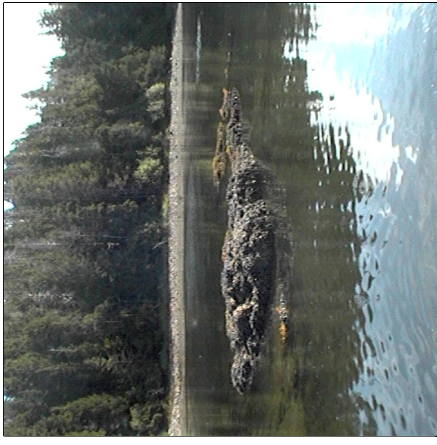
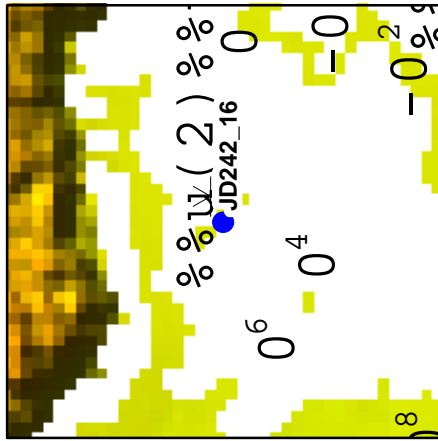
Remarks/Recommendations:
 Chtd Rk (56 58 39.32 N, 135 21 33.22 W) was found. Recommend charting at LIDAR position using skiff height.
 Chart: 17326 Topo: N/A Carto Code: 089

- Charted rock at 56 58 39.32 N, 135 21 33.22 W was observed by LIDAR (2 ft above MLLW) and skiff. Skiff obtained a shoaler height of 4 ft above MLLW. Rock is clear in orthomosaic; recommend charting at LIDAR position (56 58 40.14 N, 135 21 32.99 W) using skiff height, and appears as such on smooth sheet. See DP form JD242_16. ⁴⁵

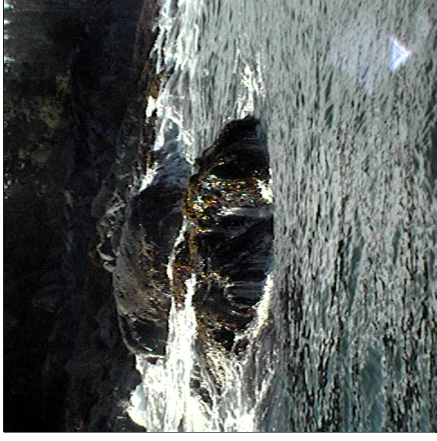
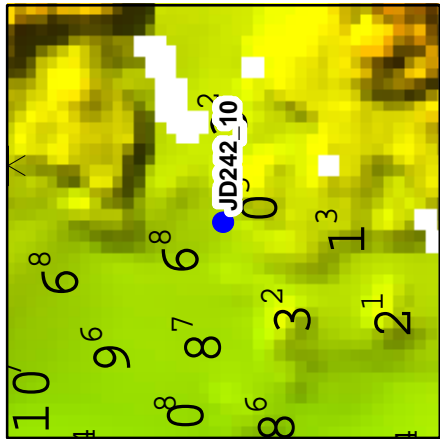
DP ITEM NUMBER : JD242_10

Remarks/Recommendations:
 Chtd Rk (56 58 39.78 N, 135 22 49.80 W) was observed by Skiff. Appears on SS at ortho position and Skiff Ht.
 Chart: 17326 Topo: N/A Carto Code: 089

-
- Charted rock at 56 58 39.78 N, 135 22 49.80 W was observed by skiff with a height of 3 ft above MLLW. Rock is evident on orthomosaic; as skiff position was estimated it is recommended that rock be charted at orthomosaic position (56 58 40.13 N, 135 22 48.61 W) with skiff height and is presented as such on smooth sheet. See DP form JD242_10. ⁴⁶

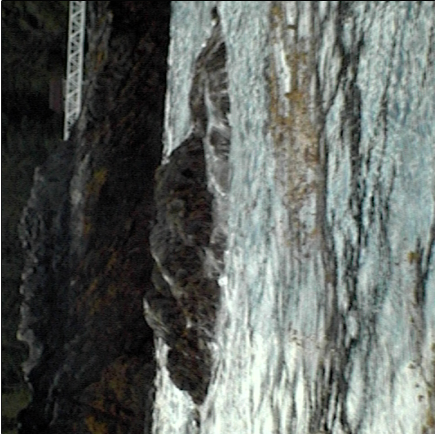
Remarks/Recommendations:
 Chrt'd Rk (57 00 04.78 N, 135 21 35.97 W) was located by the skiff. Appears on the SS at the ortho position and Skiff Ht.
 Chart: 17326 Topo: N/A Carto Code: 089
