DESCRIPTIVE REPORT

Type of Survey: **Hydrographic and
ENC Validation**

Registry Number: **H11400**

Sub-locality: Gravesend Bay

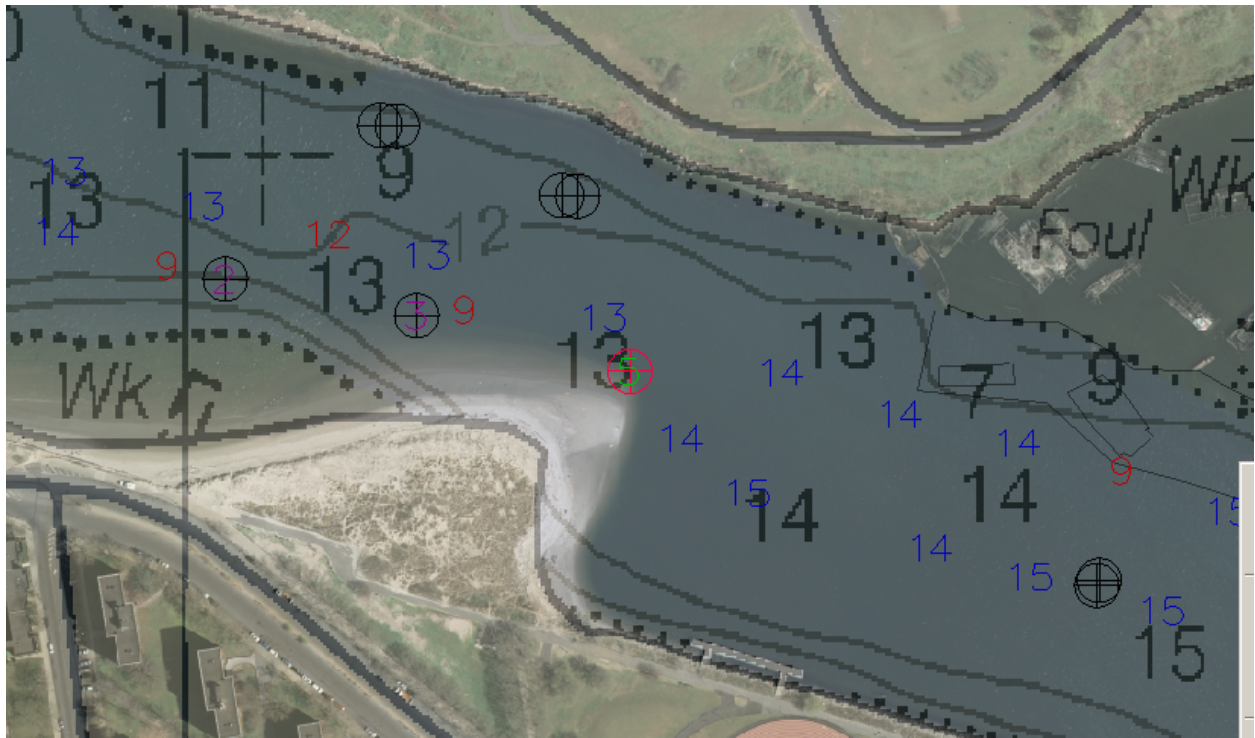
Figure 1.1.1

The feature is the least depth on an uncharted shoal. Chart a 5-ft depth at the feature position. The feature was submitted to MCD as a DtoN on 12/9/08. The MCD verification was received on 12/11/08.

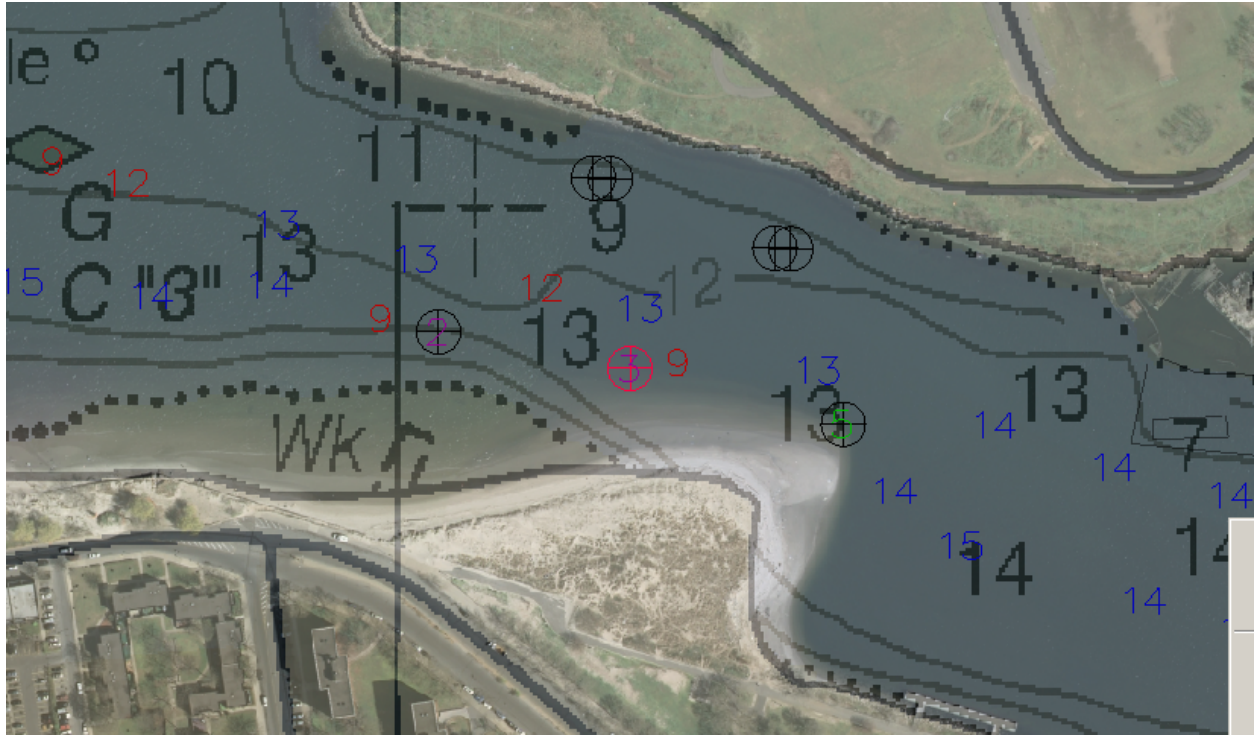
Figure 1.2.1

The feature is the least depth on an uncharted shoal. Chart a 3-ft depth at the feature position. The feature was submitted to MCD as a DtoN on 12/9/08. The MCD verification was received on 12/11/08.

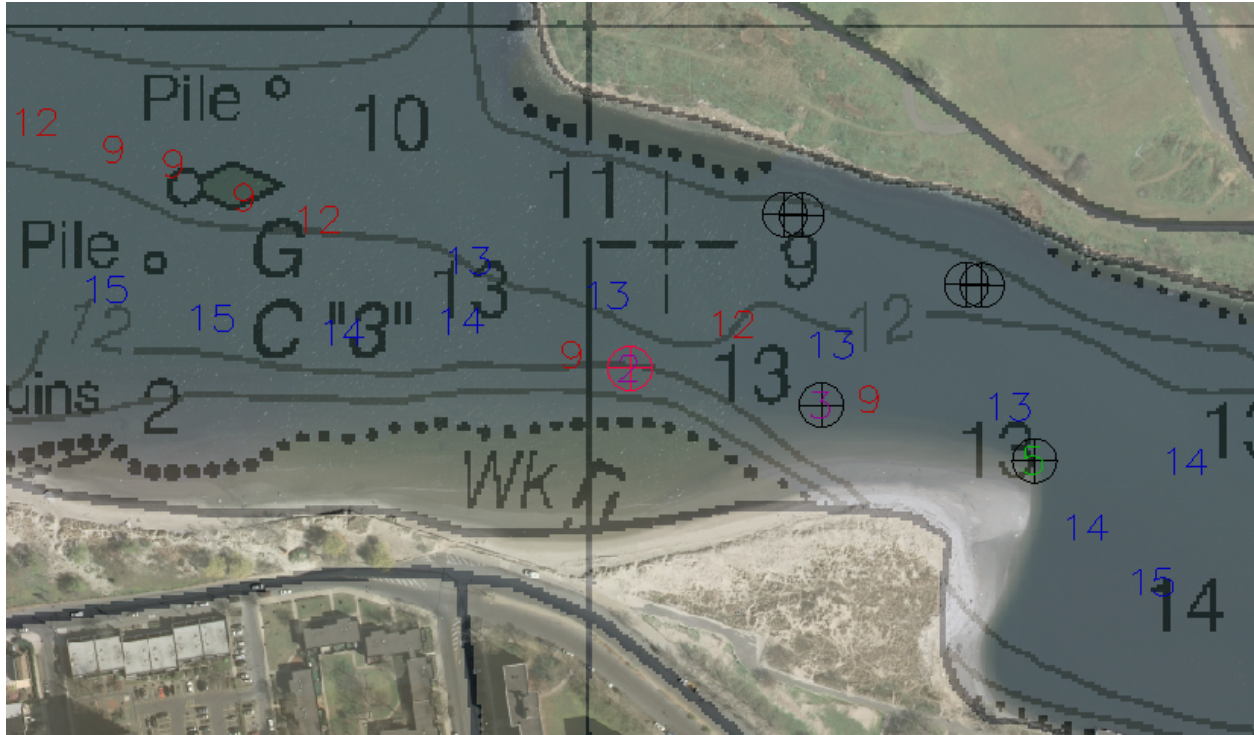
Figure 1.3.1

The feature is the least depth on an uncharted shoal. Chart a 2-ft depth at the feature position. The feature was submitted to MCD as a DtoN on 12/9/08. The MCD verification was received on 12/11/08.

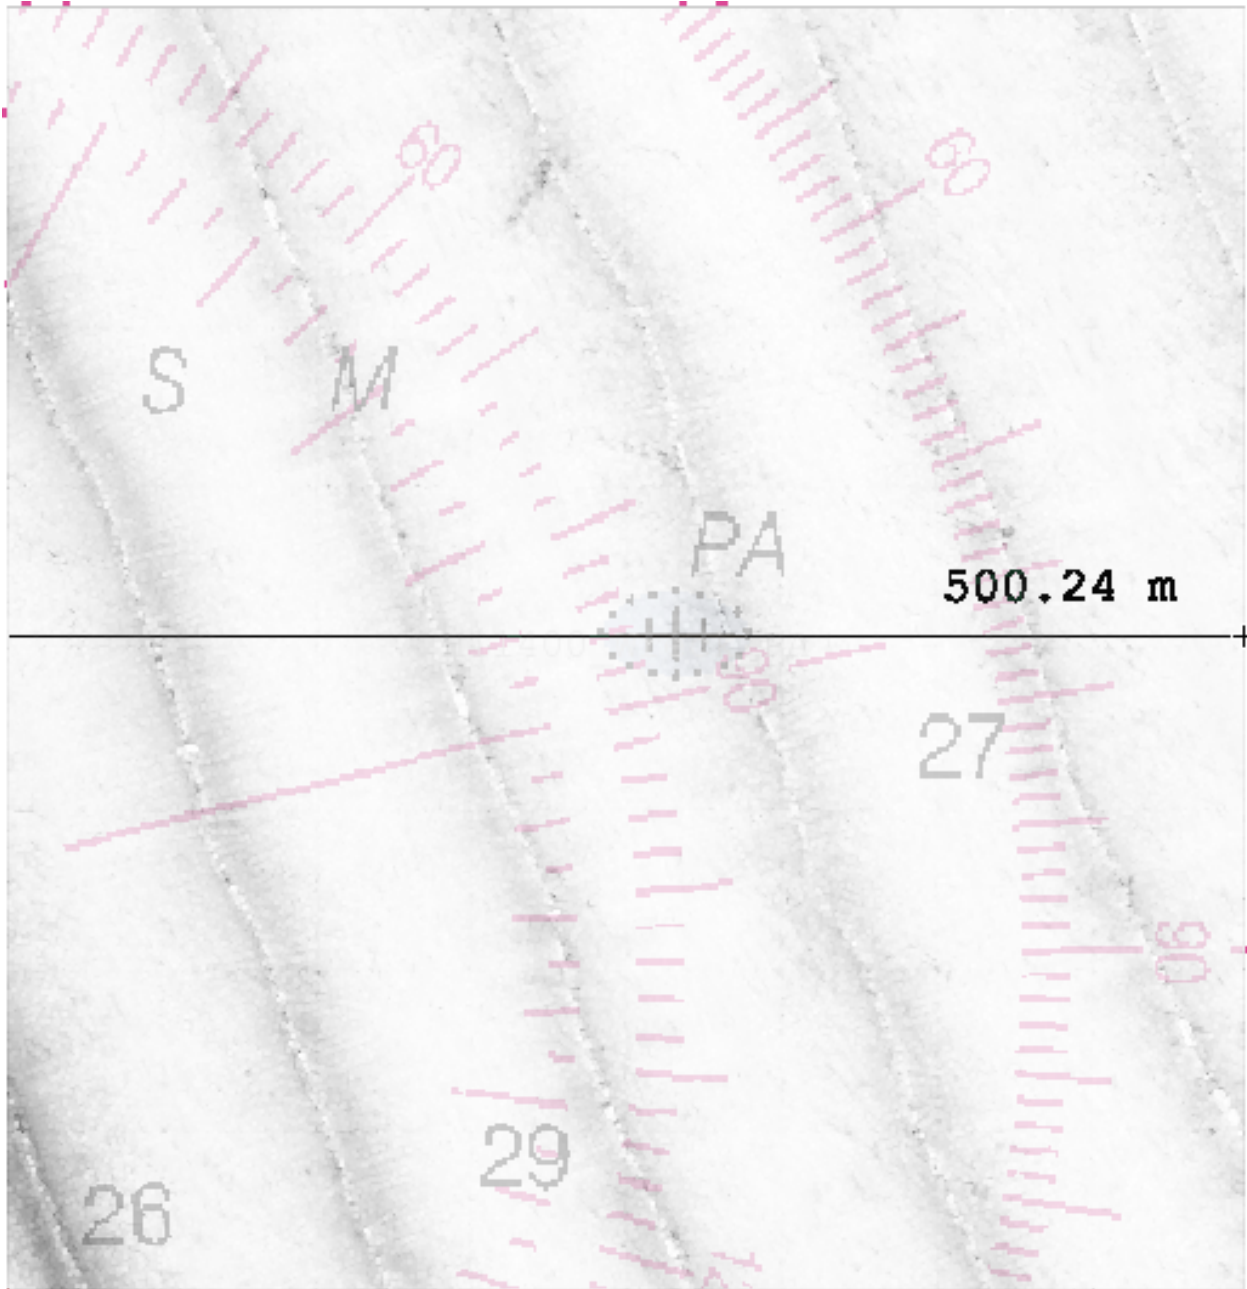
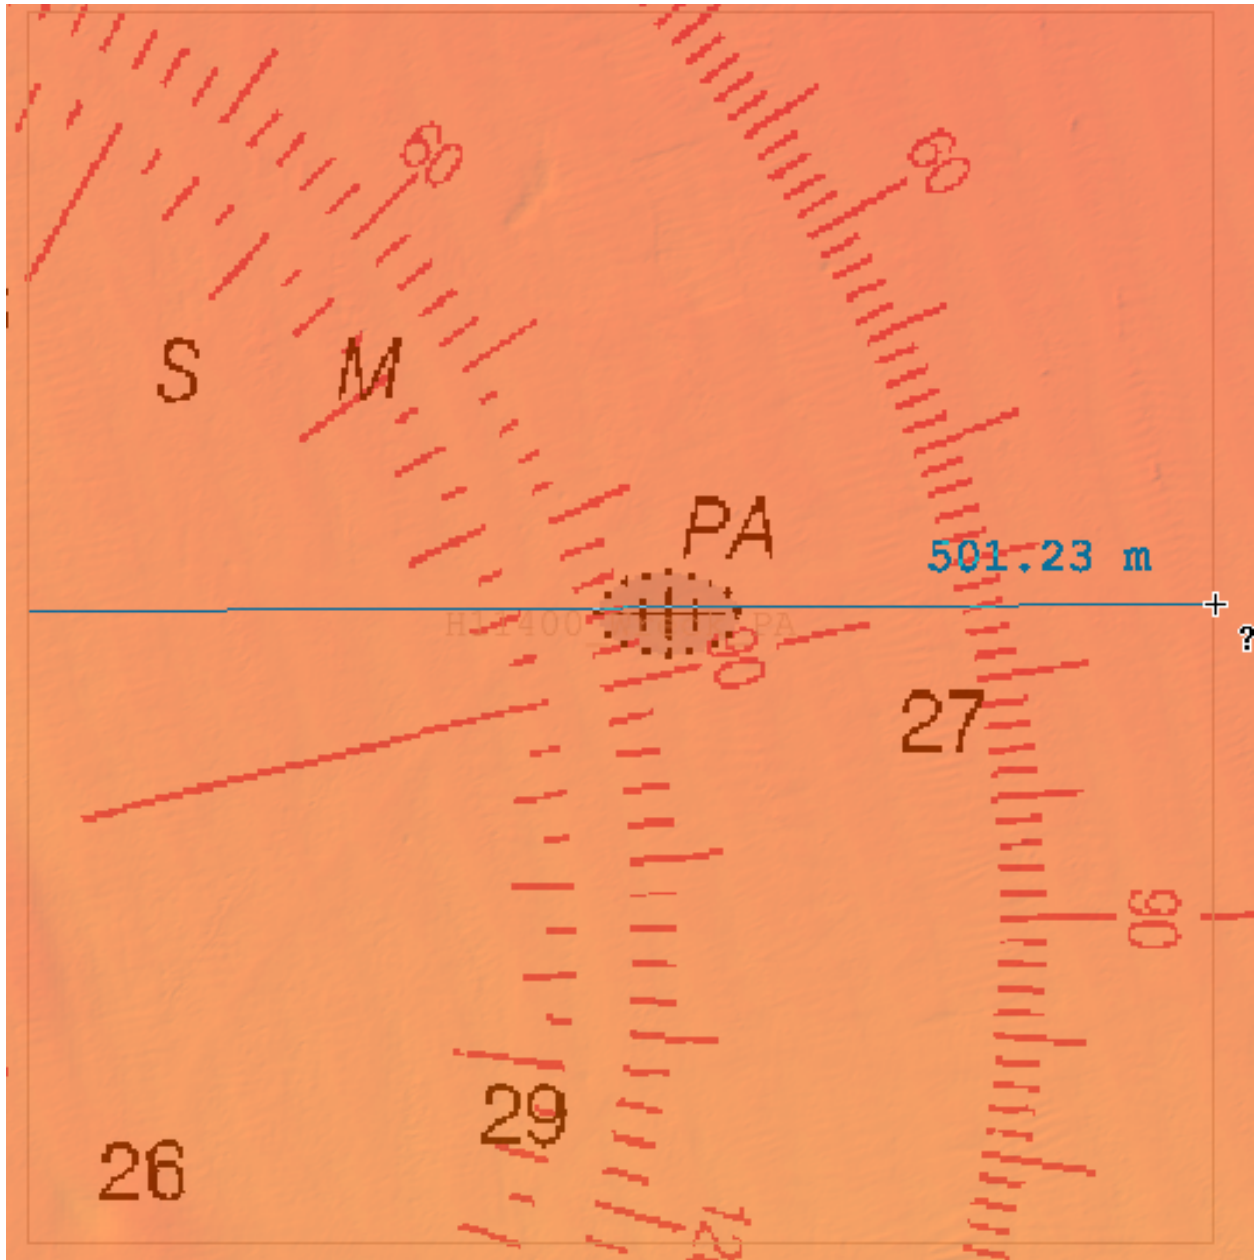
Figure 1.1.1

Area fully ensounded with Side Scan Sonar and MBES with no remnants of a wreck visible. Hydrographer recommends removing charted Wreck PA symbol.

Concur.

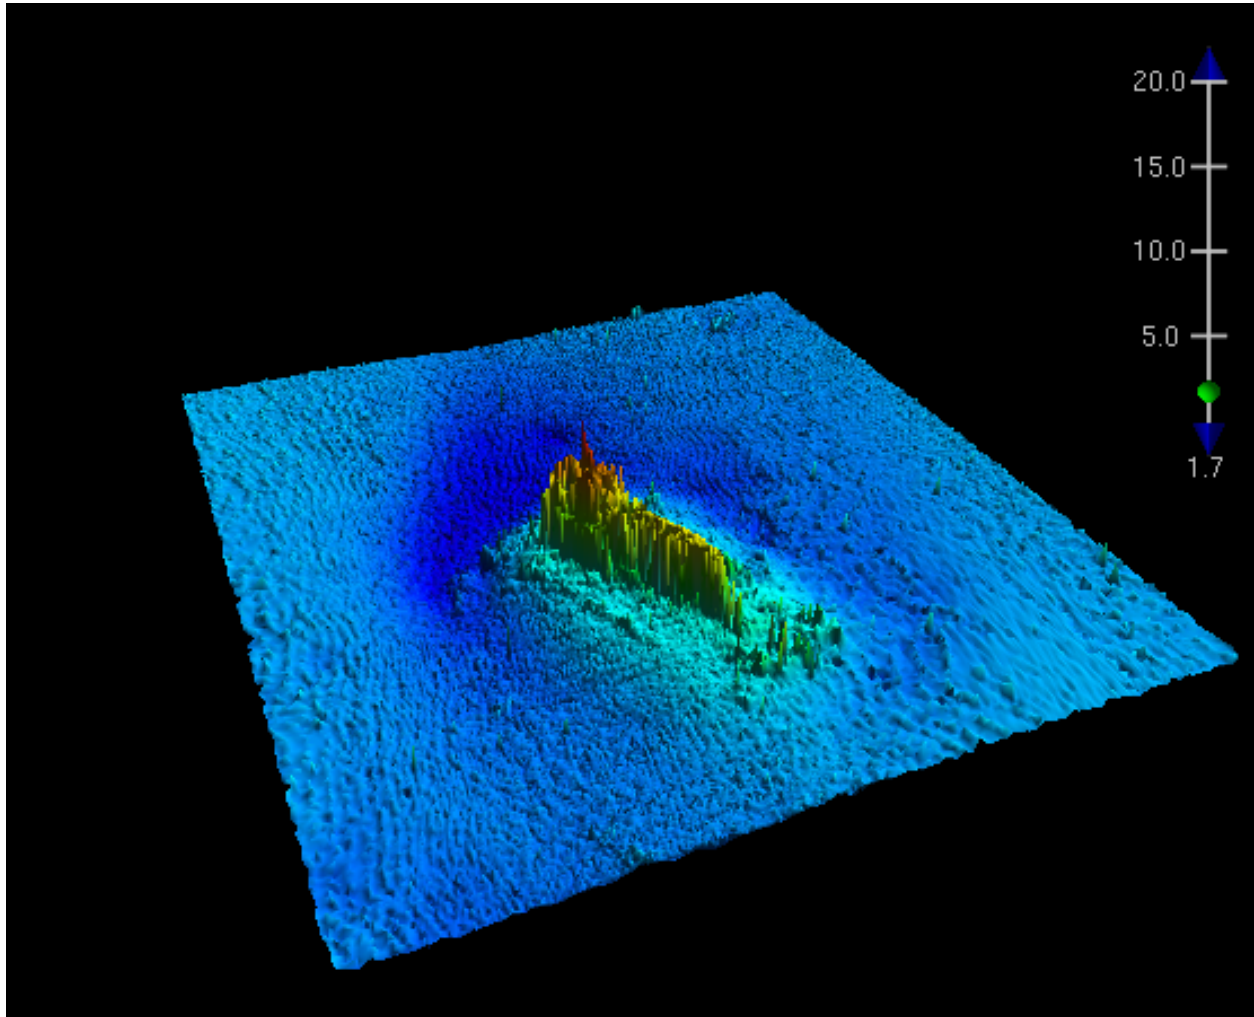
Figure 1.2.1

The hydrographer originally selected a different sounding as the feature's least depth (.../2005-305/013_1755 ping 5409, beam 4). The hydrographer's recommendation was the following: "Hydrographer recommends charting a least depth of 4.55 m at position 40.58863938N , 074.01687186W (583195.13E , 4493558.18N). See correlating AWOIS feature for further instruction."

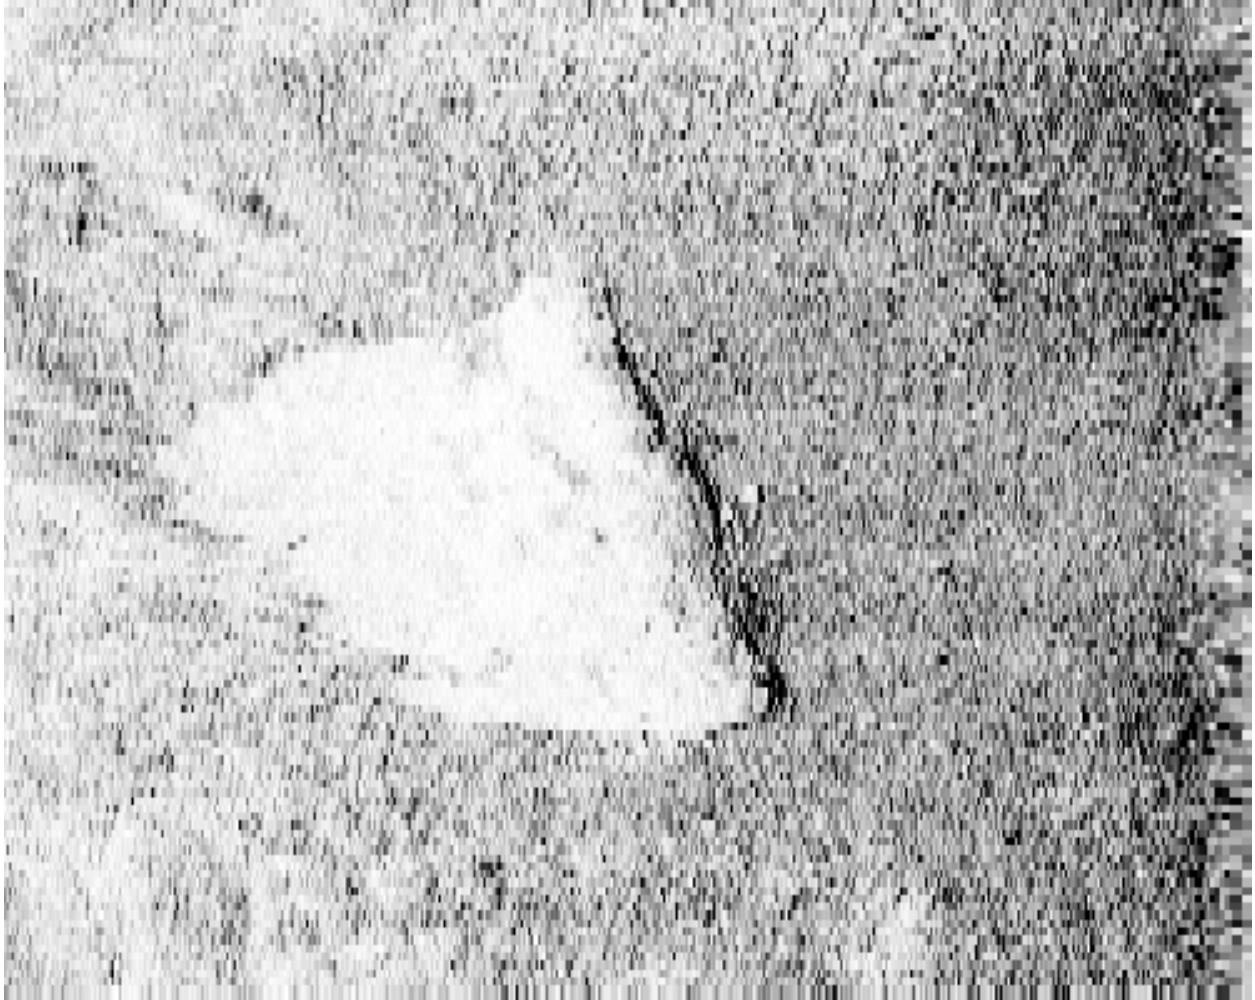
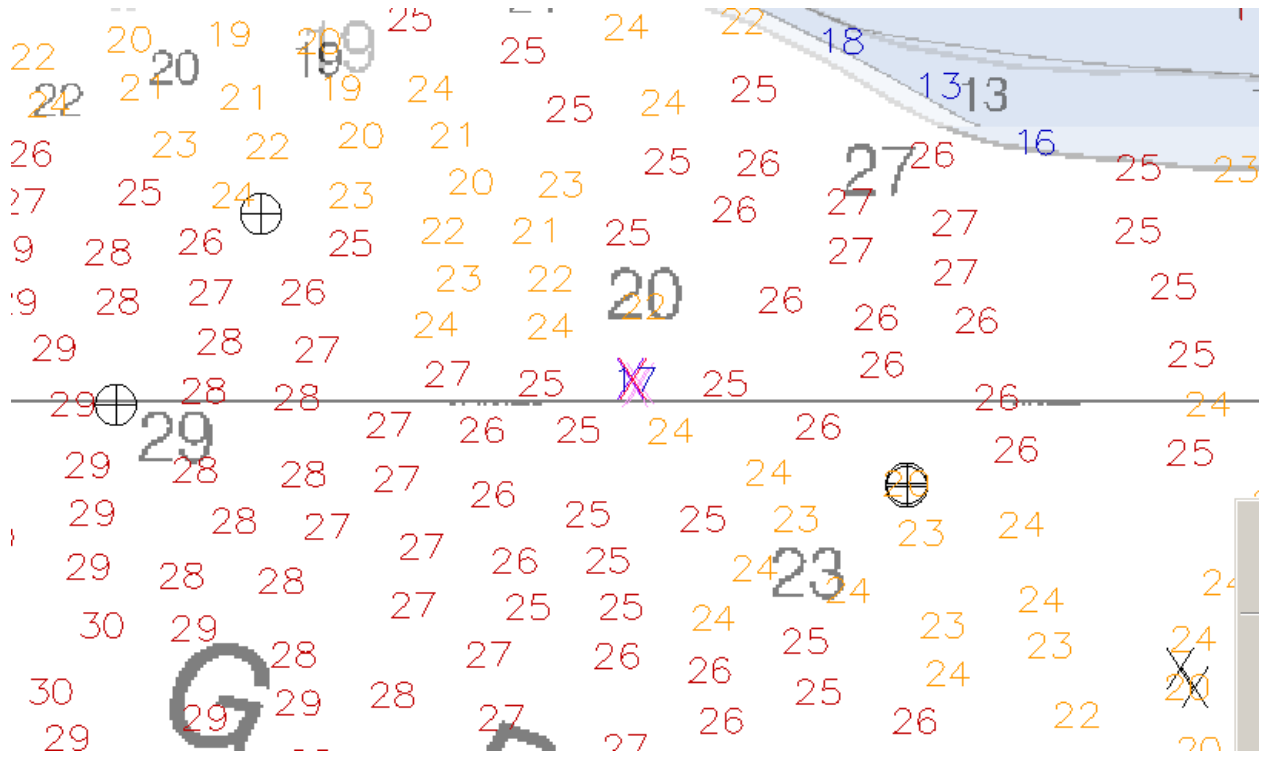
Figure 1.1.1

The hydrographer originally selected another sounding as the least depth and provided the following recommendation: "Chart least depth of contact of 16' in surrounding 23' at position 40.60007321N , 074.02113942W (582819.88E , 4494823.36N)."

Concur with clarification. Chart the current feature as an obstruction.

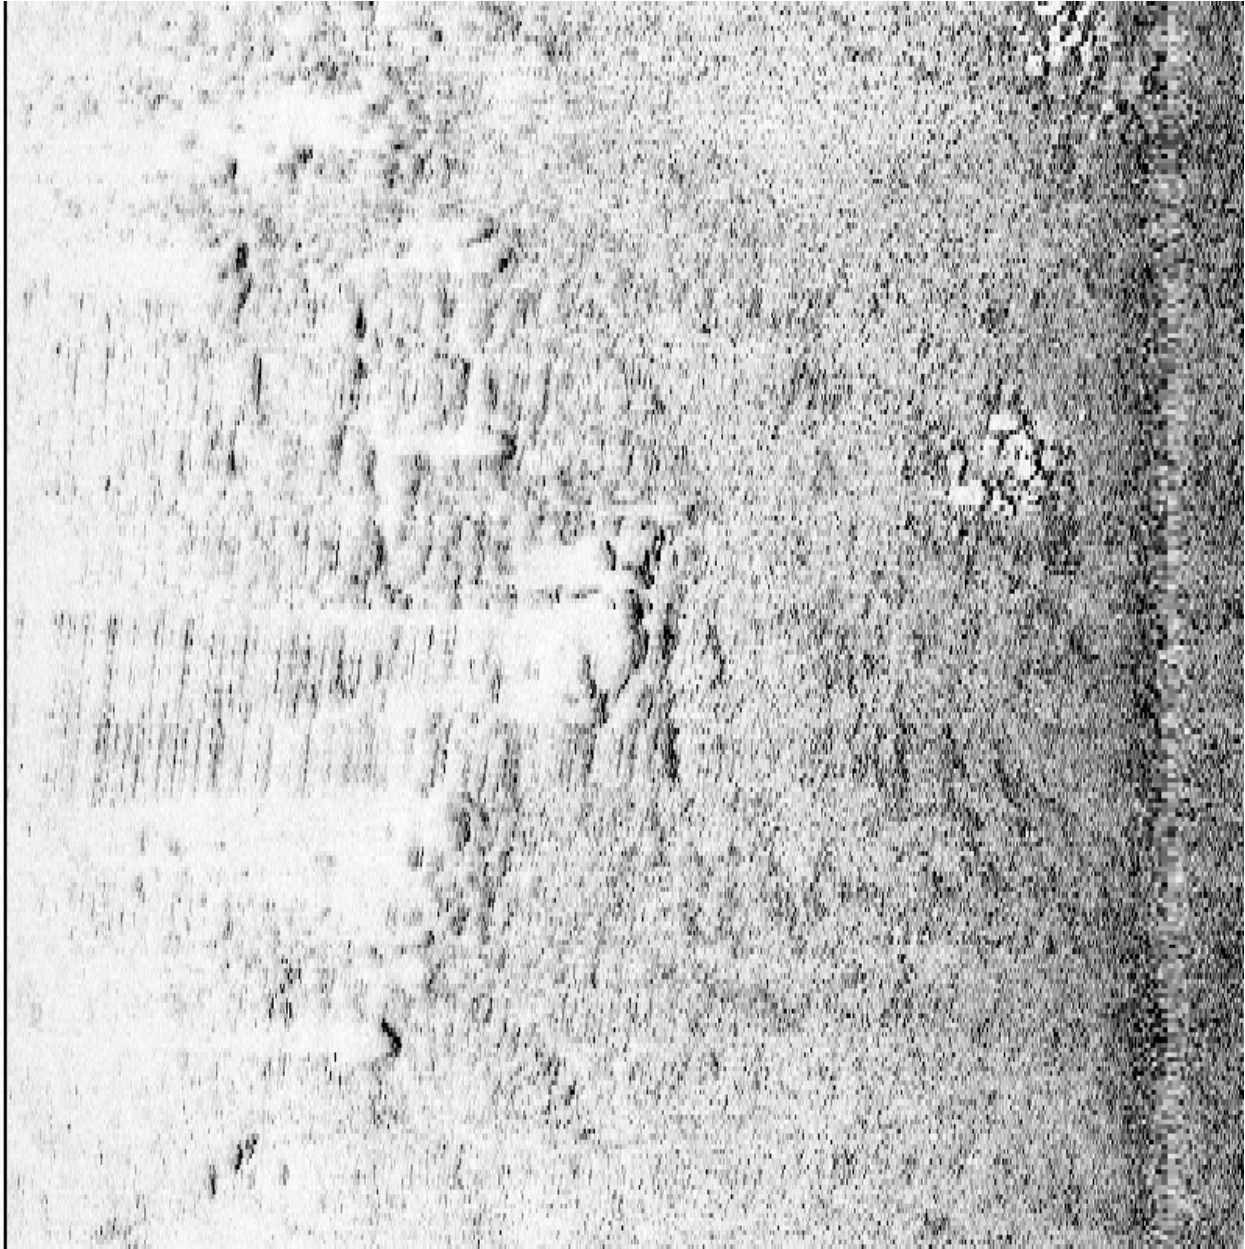
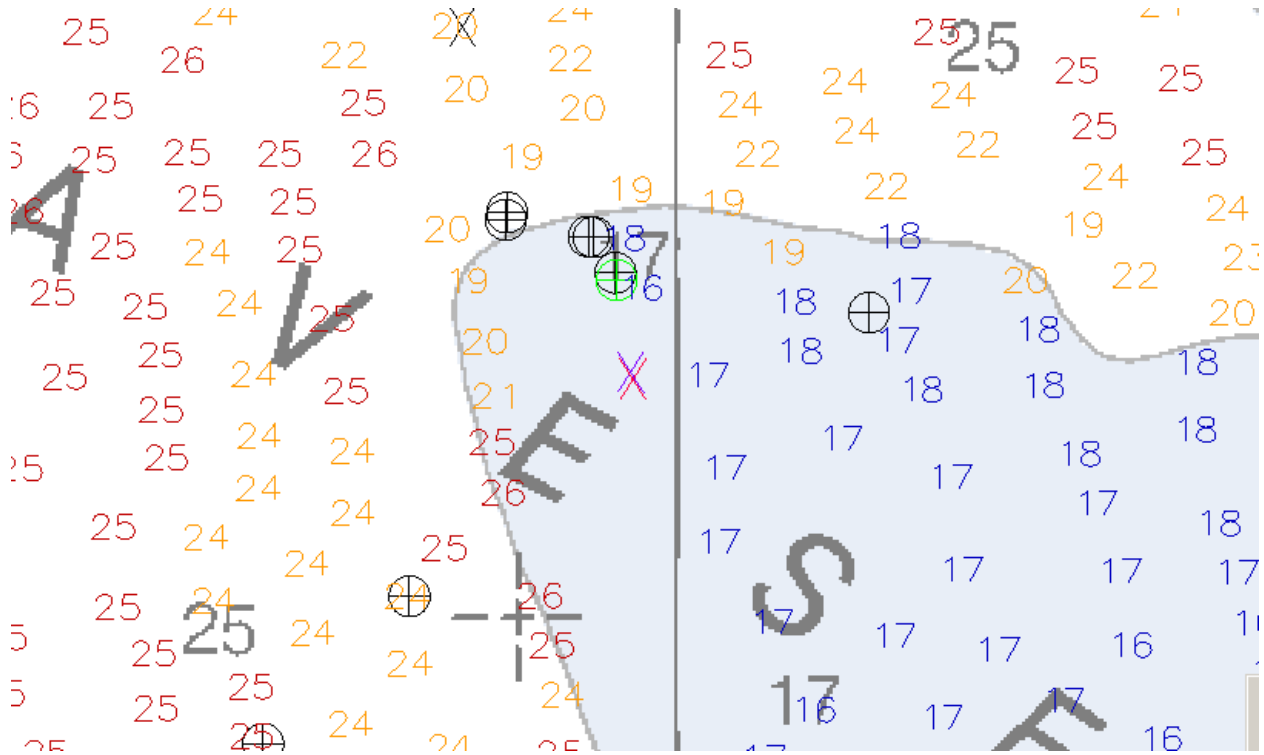
Figure 1.3.1

The contact is a rock in a cluster of uncharted rocks that were not developed with MBES or VBES data. The calculated shadow height is 1.2 meters, and the nearest survey sounding is 5.3 meters. Chart a reported depth of 4.1 meters (cartographically rounds to 13 ft) with the annotation 'Rks'.

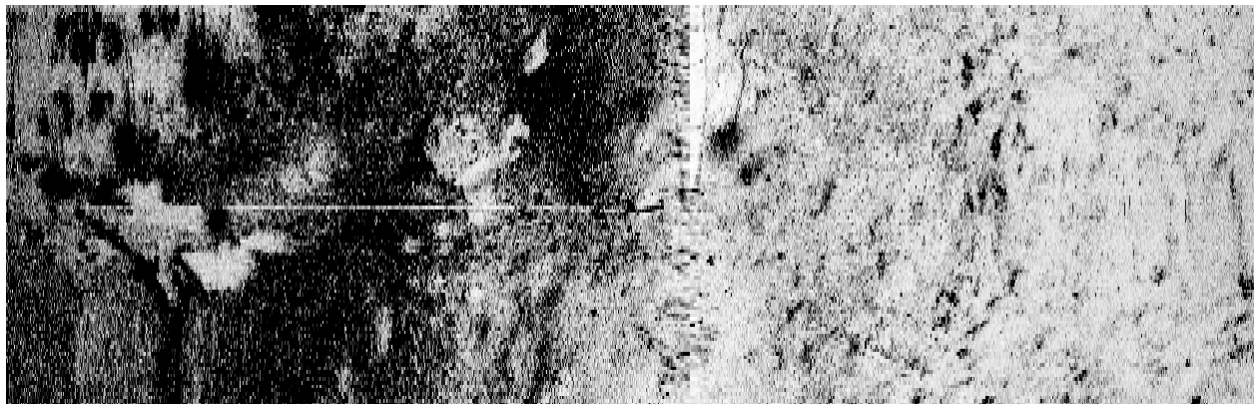
Figure 1.5.1

The feature is a SSS contact not addressed by the field. The contact has a long, very narrow shadow, suggesting a buoy cable or pile. The field did not document a buoy near this position. No other data are available. Chart a submerged pile.

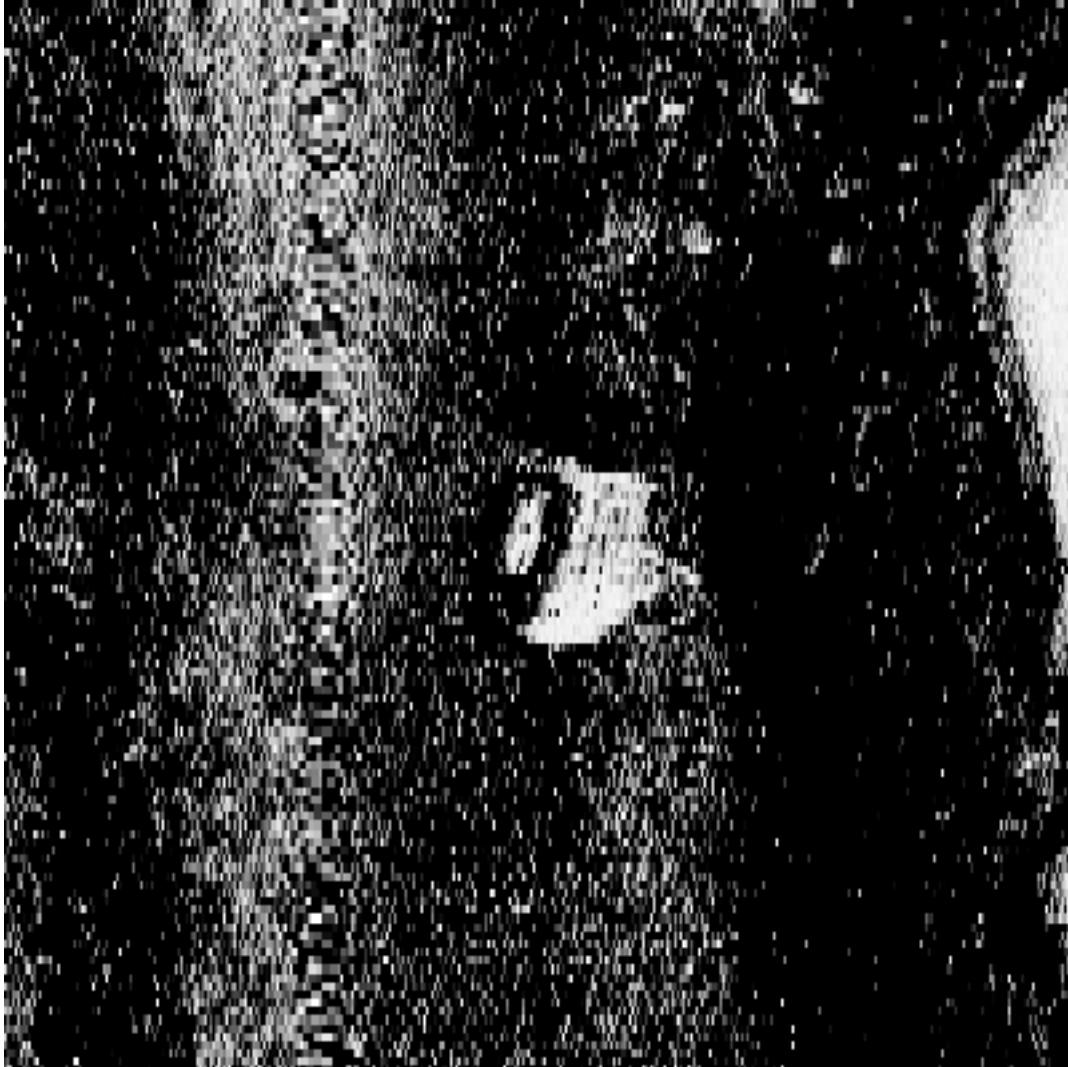
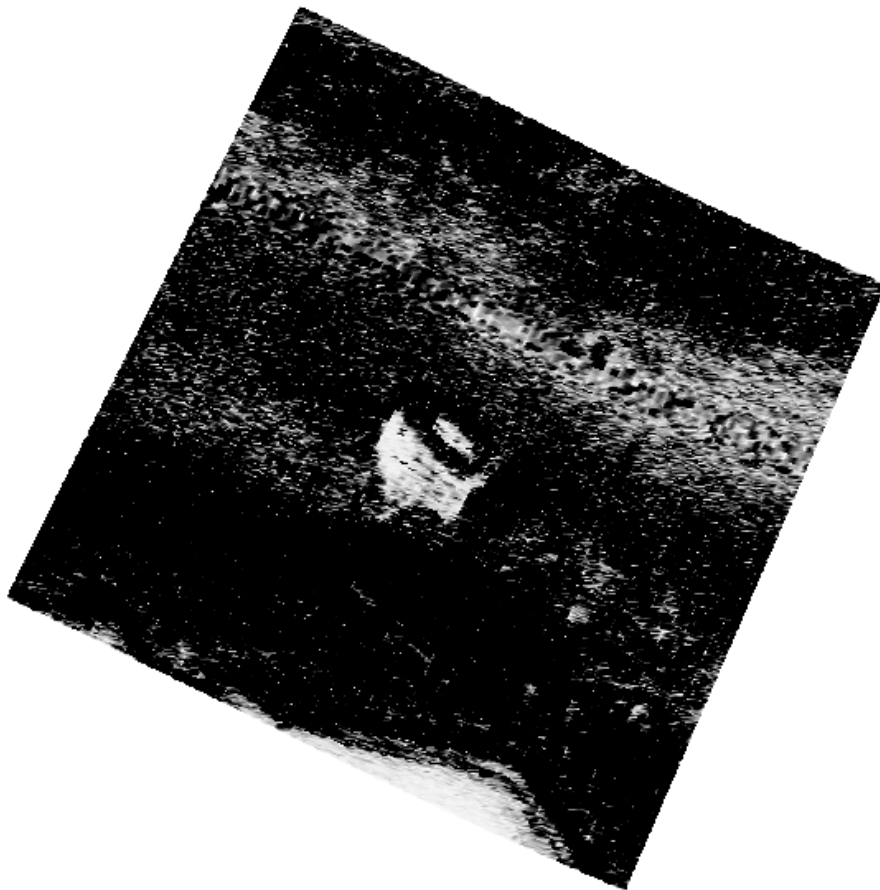
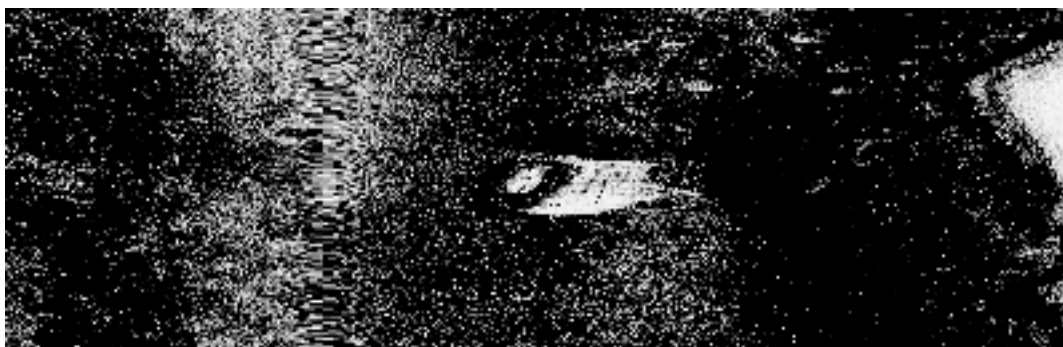
Figure 1.7.1

Boat shaped object detected 6m from towfish nadir. Depths were not attainable over these contacts due to unsafe conditions.-VP

Concur with clarification. Chart a dangerous wreck, least depth unknown.

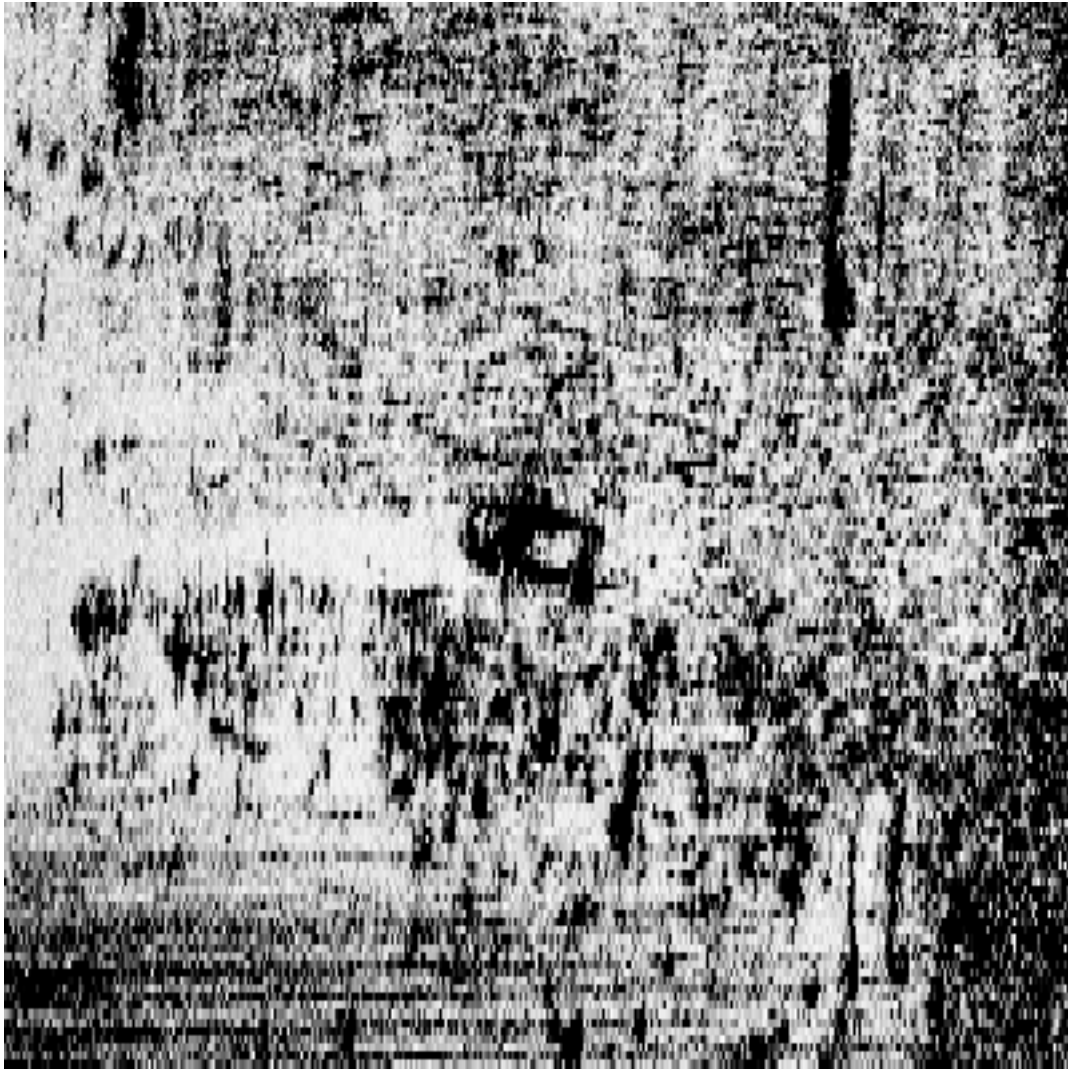
Figure 1.8.1

The feature is a 5-m long wreck that was not developed with MBES or VBES data. Modify the proximal wreckage area to encompass the current feature, and shorten the length of the proximal charted piers to accommodate the expanded wreckage area.

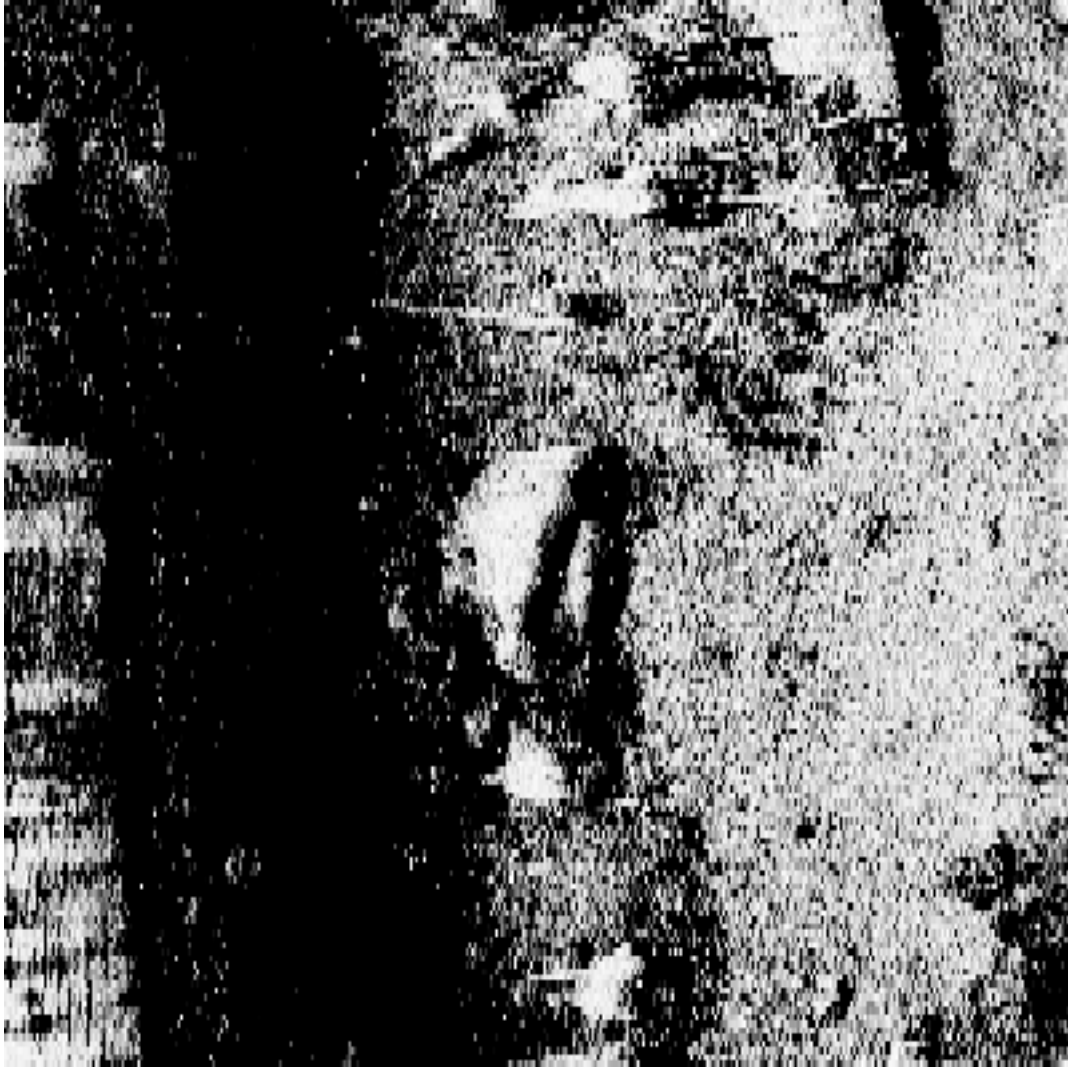
Figure 1.9.1

The SSS contact is a 10-m long uncharted wreck that is ~20 meters from a 40-m long charted wreck. Chart the feature as a dangerous wreck.

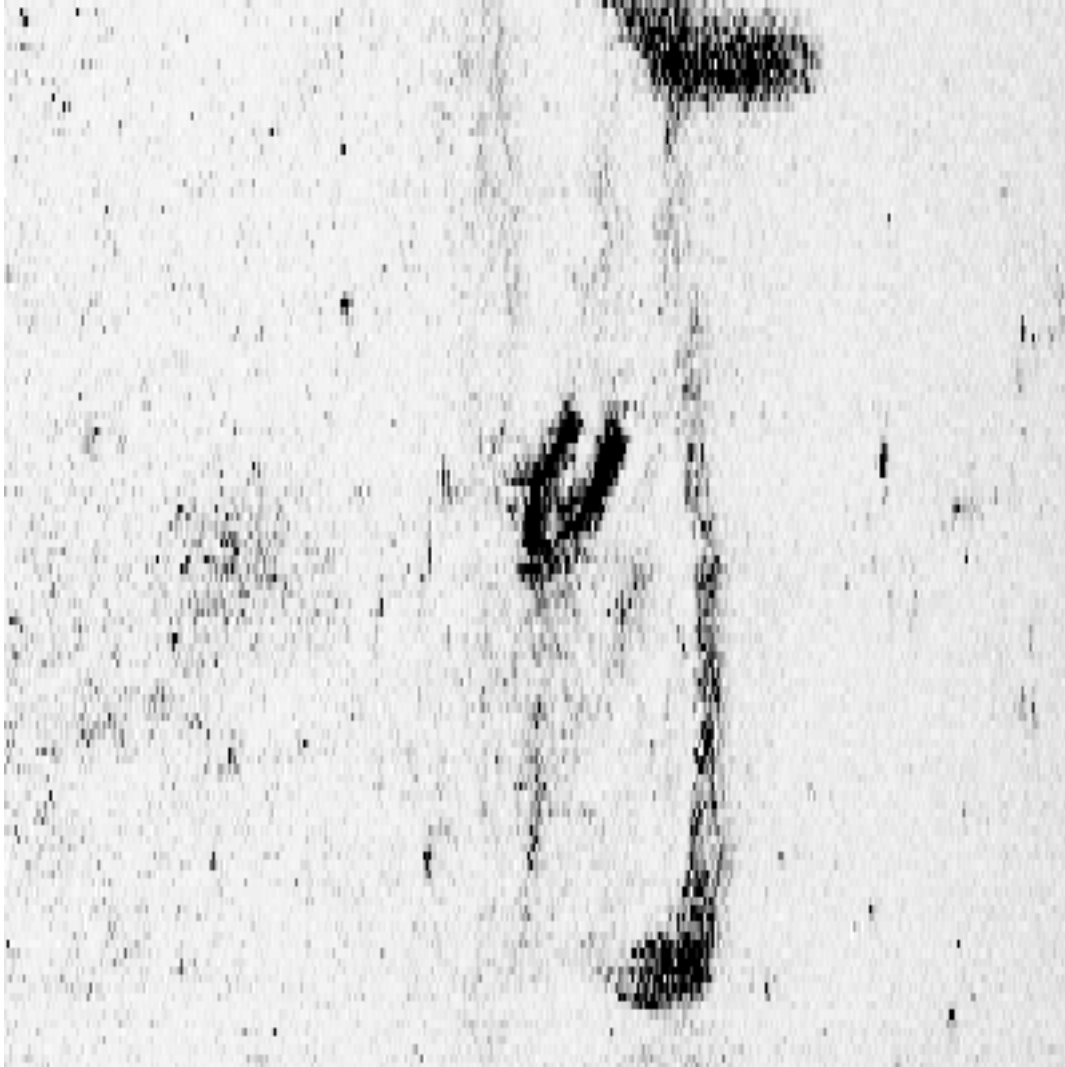
Figure 1.11.1

No recommendation made by hydrographer. The feature is a 6-m long wreck. Chart feature as wreck with a reported least depth of 10 ft (14 ft surrounding depth minus 3.6 ft shadow height).

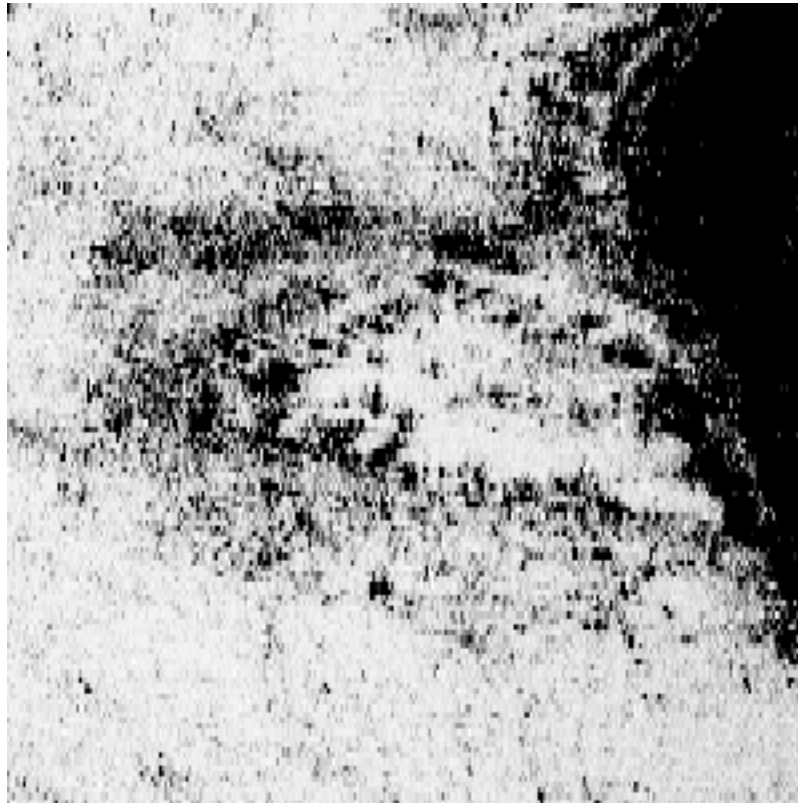
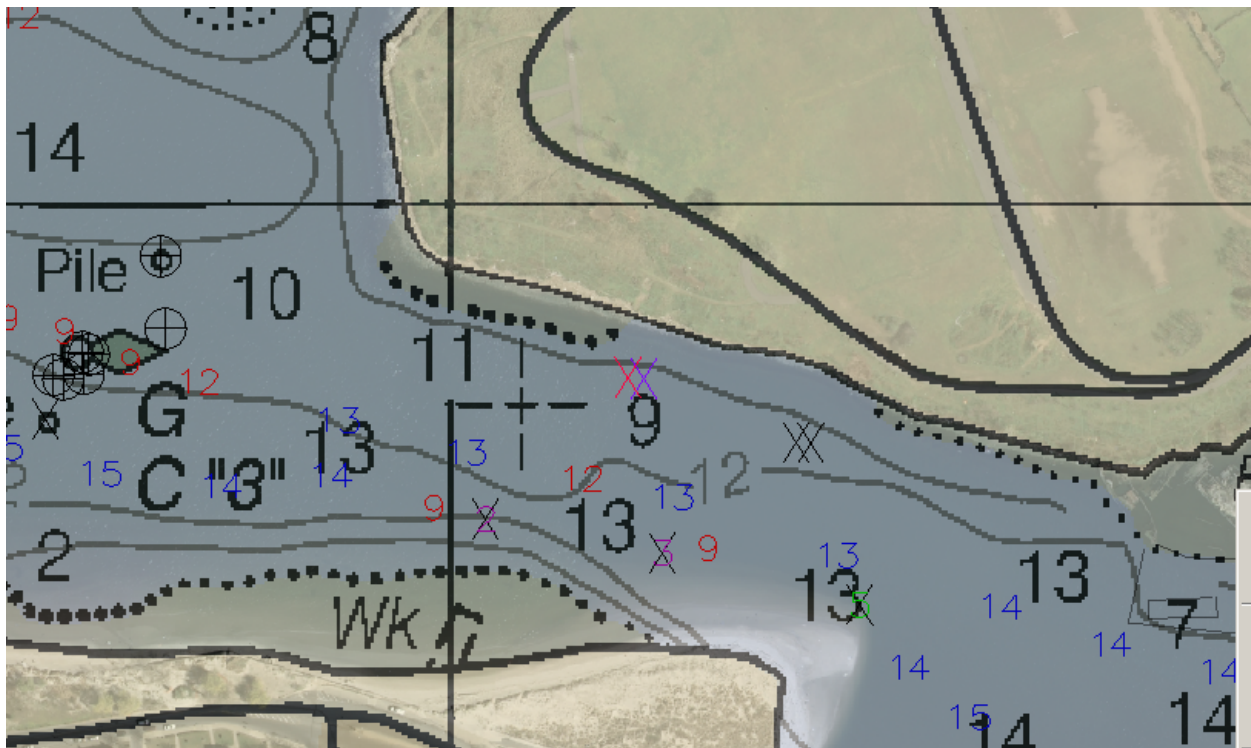
Figure 1.12.1

No recommendation made by hydrographer. Chart feature as a dangerous wreck, least depth unknown. (No surrounding bathymetry data were acquired to be able to calculated a reported depth.)

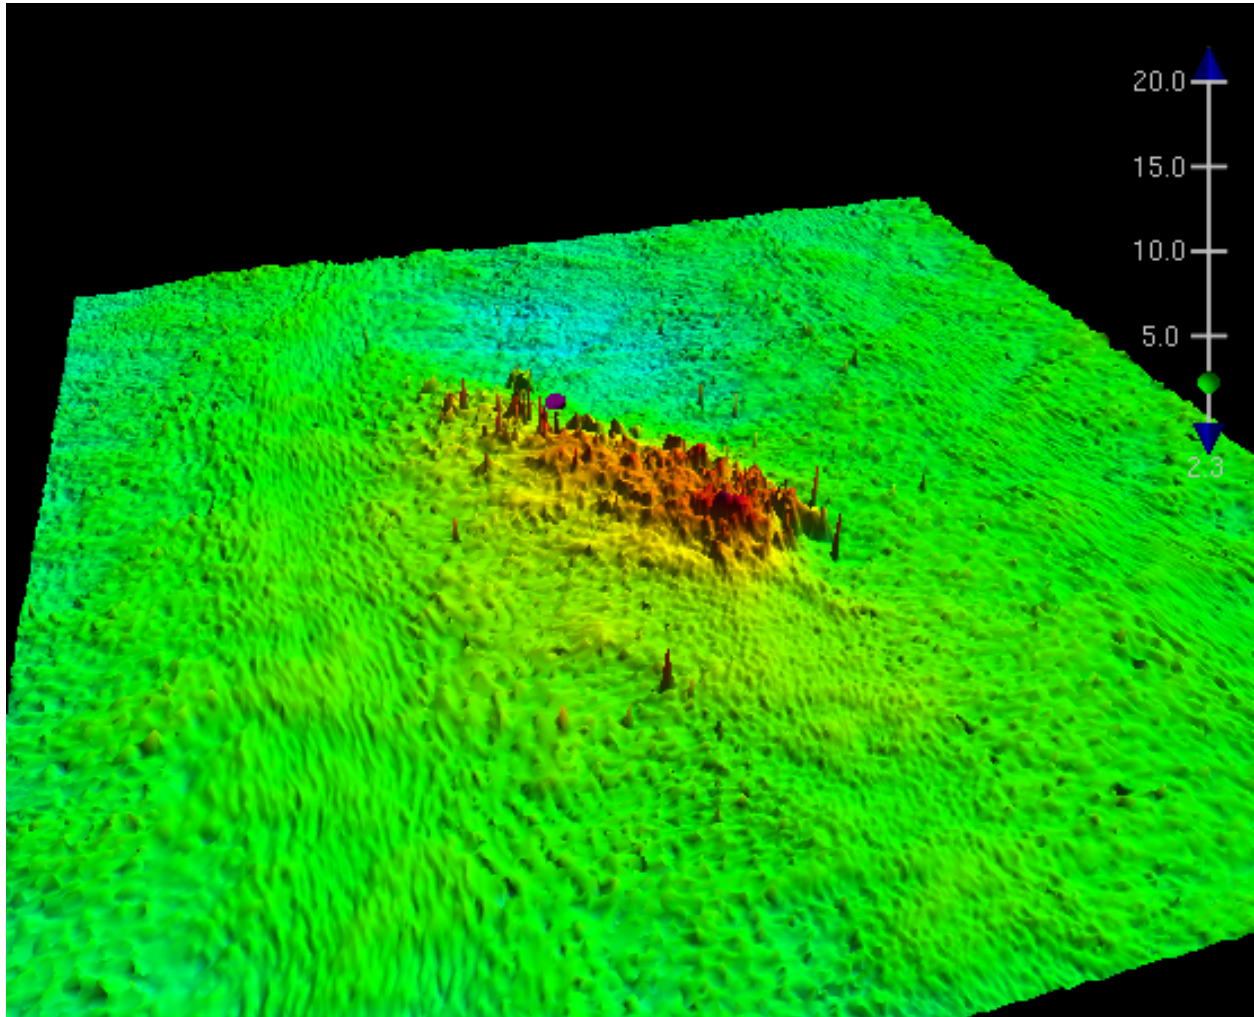
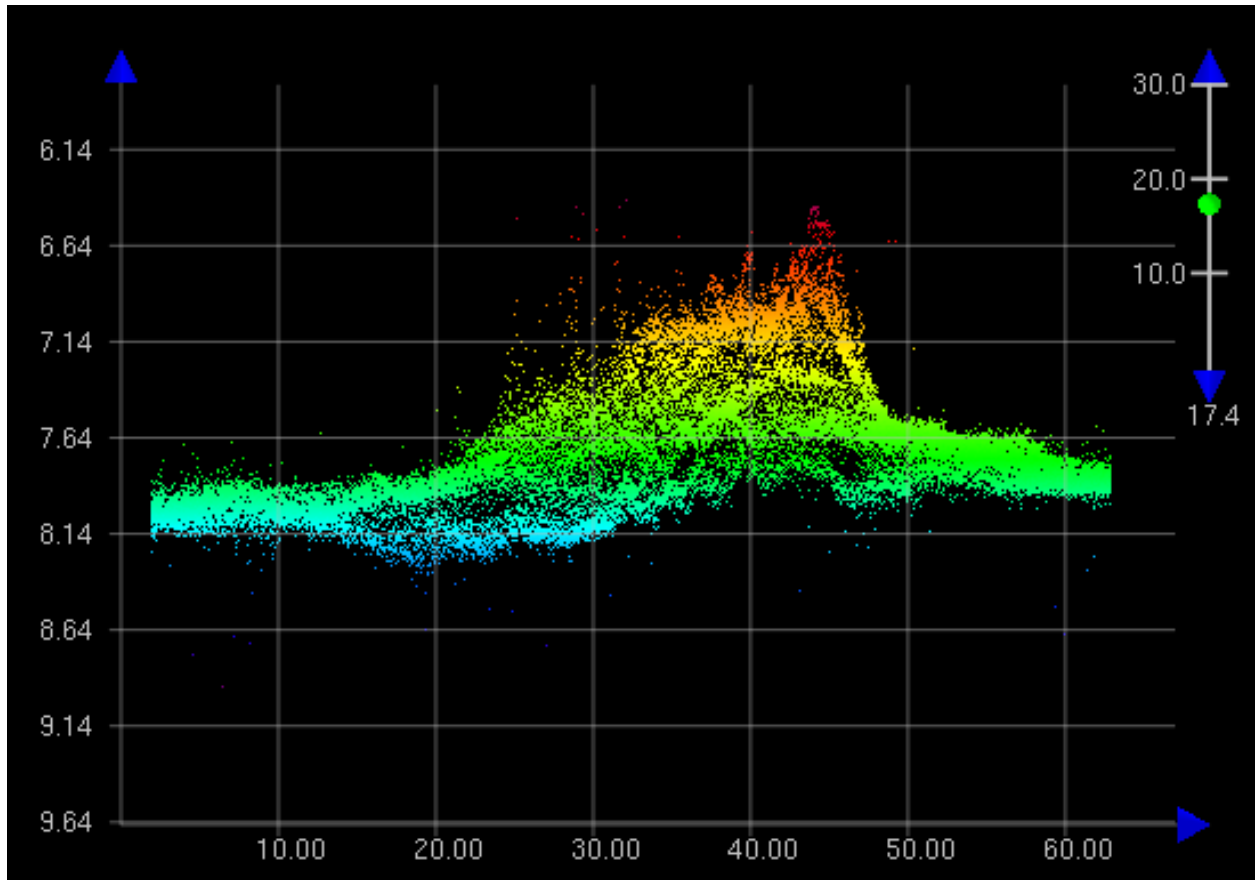
Figure 1.13.1

Gravel mound observed with MBES and SSS.-VP

Hydrographer recommends charting an obstruction with a 21 foot least depth at position 40°34'45.956"N, -074°01'10.984"W.

Concur.
