DESCRIPTIVE REPORT

Type of Survey: **Hydrographic and
ENC Validation**

Registry Number: **H11400**

Sub-locality: Gravesend Bay

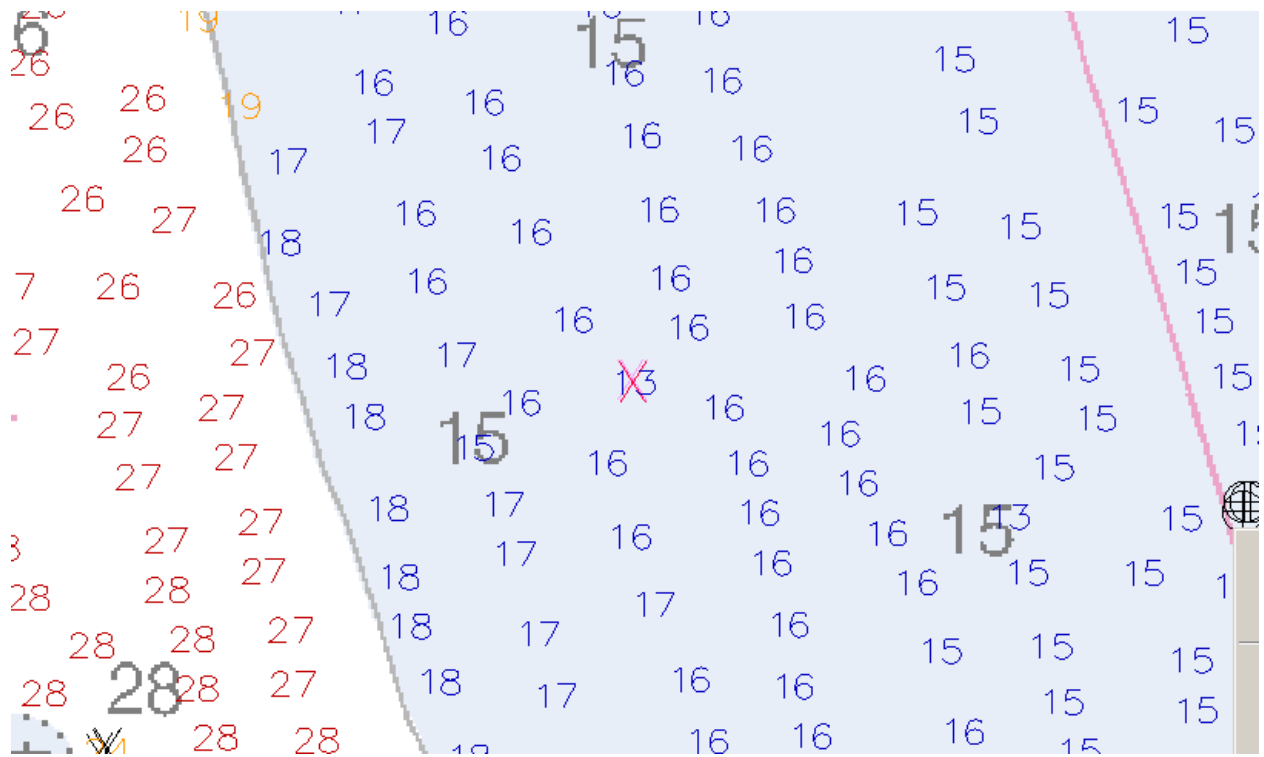
Figure 1.14.1

Hydrographer recommends charting Obstruction with least depth of 12.93 feet at position 40°35'26.006"N , -074°00'46.711"W.

Concur with clarification. Chart an obstruction with a least depth of 13.054 feet (cartographically rounded to 13 feet).

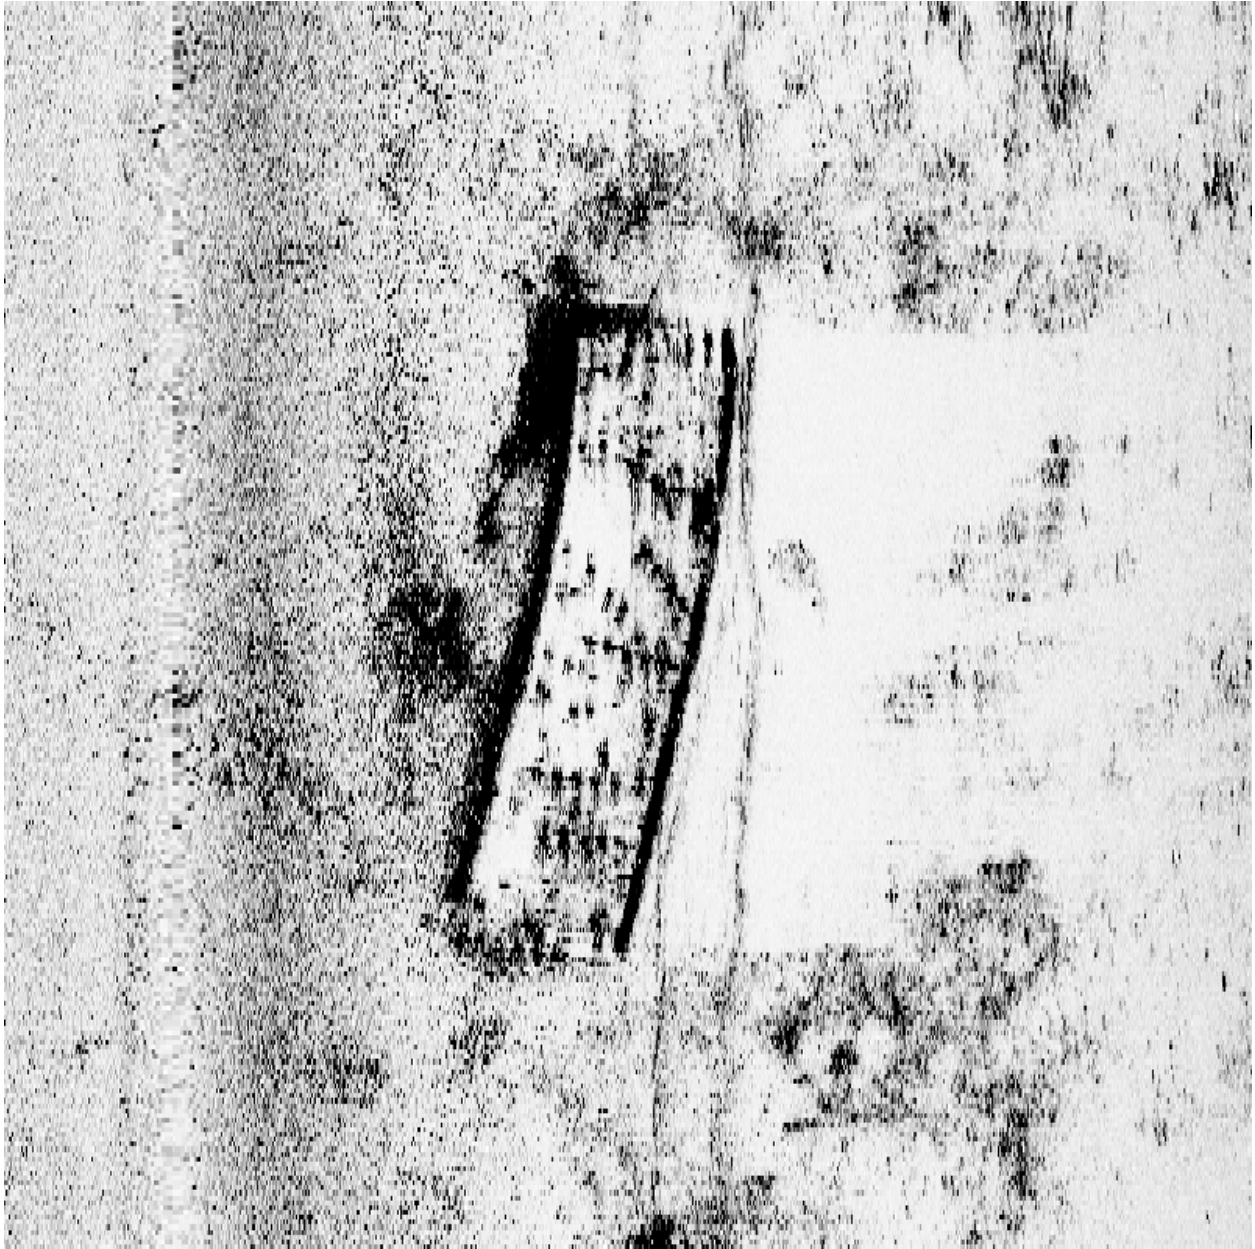
Figure 1.1.1

Charted Wreck verified with 200% Side Scan Sonar near other Obstrn PA's. Depths were not attainable over these contacts due to unsafe conditions.-VP

Concur with clarification. The wreck is deemed to be the charted dangerous wreck PA at 40°34'48.893" N, 073°59'30.095" W. Modify the charted dangerous wreck PA to reflect the current feature's surveyed position, and delete the 'PA' annotation. Chart with a reported least depth of 11 ft (surrounding depth of 15 minus shadow height of 4 feet).

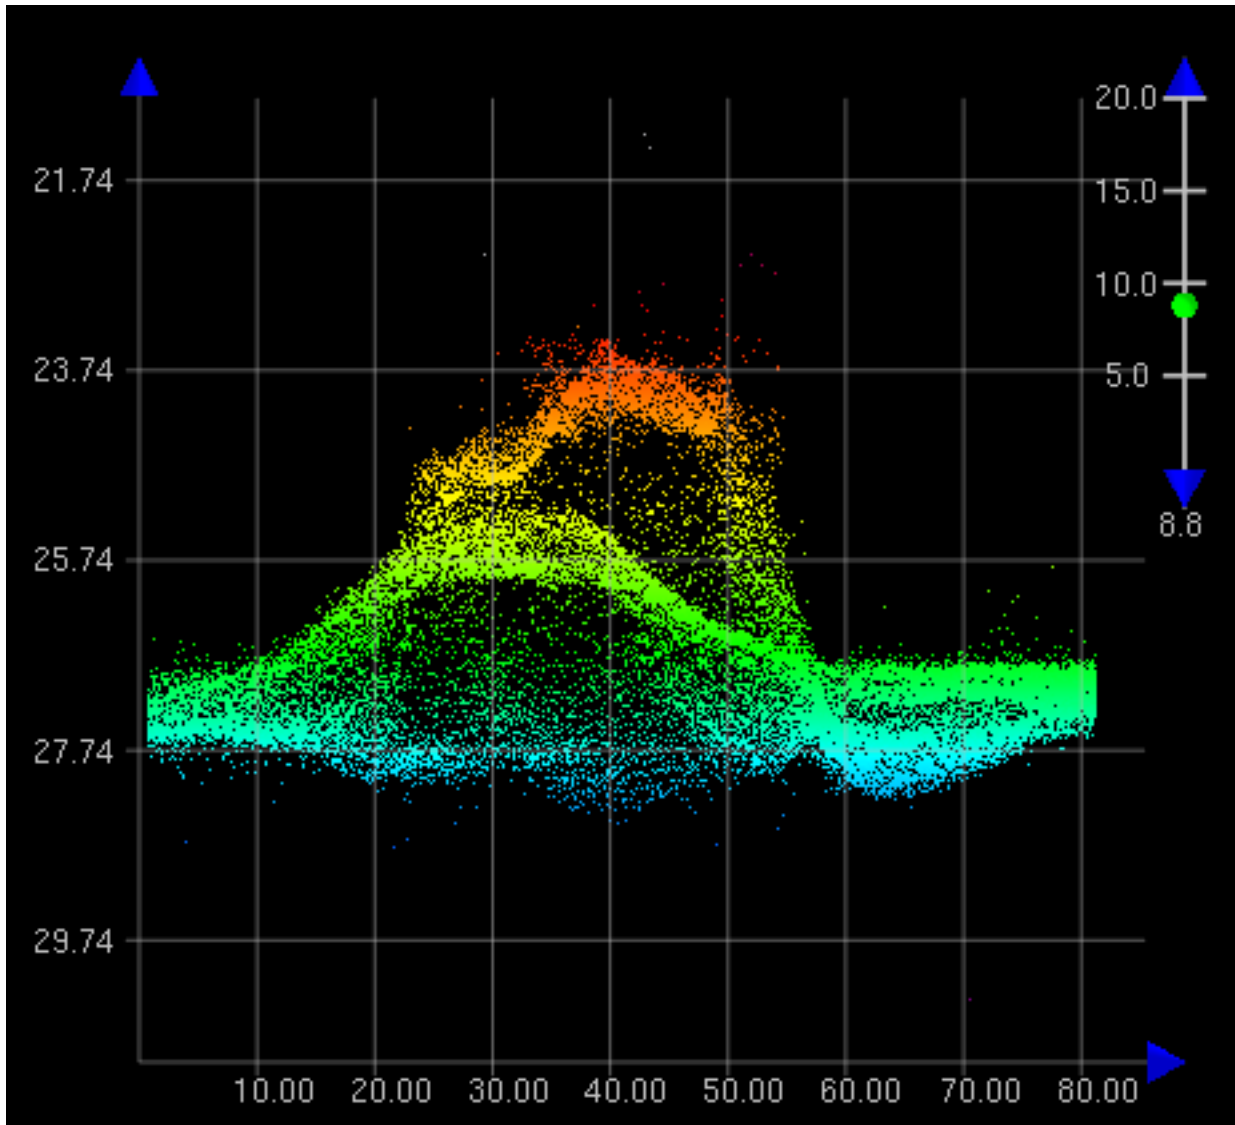
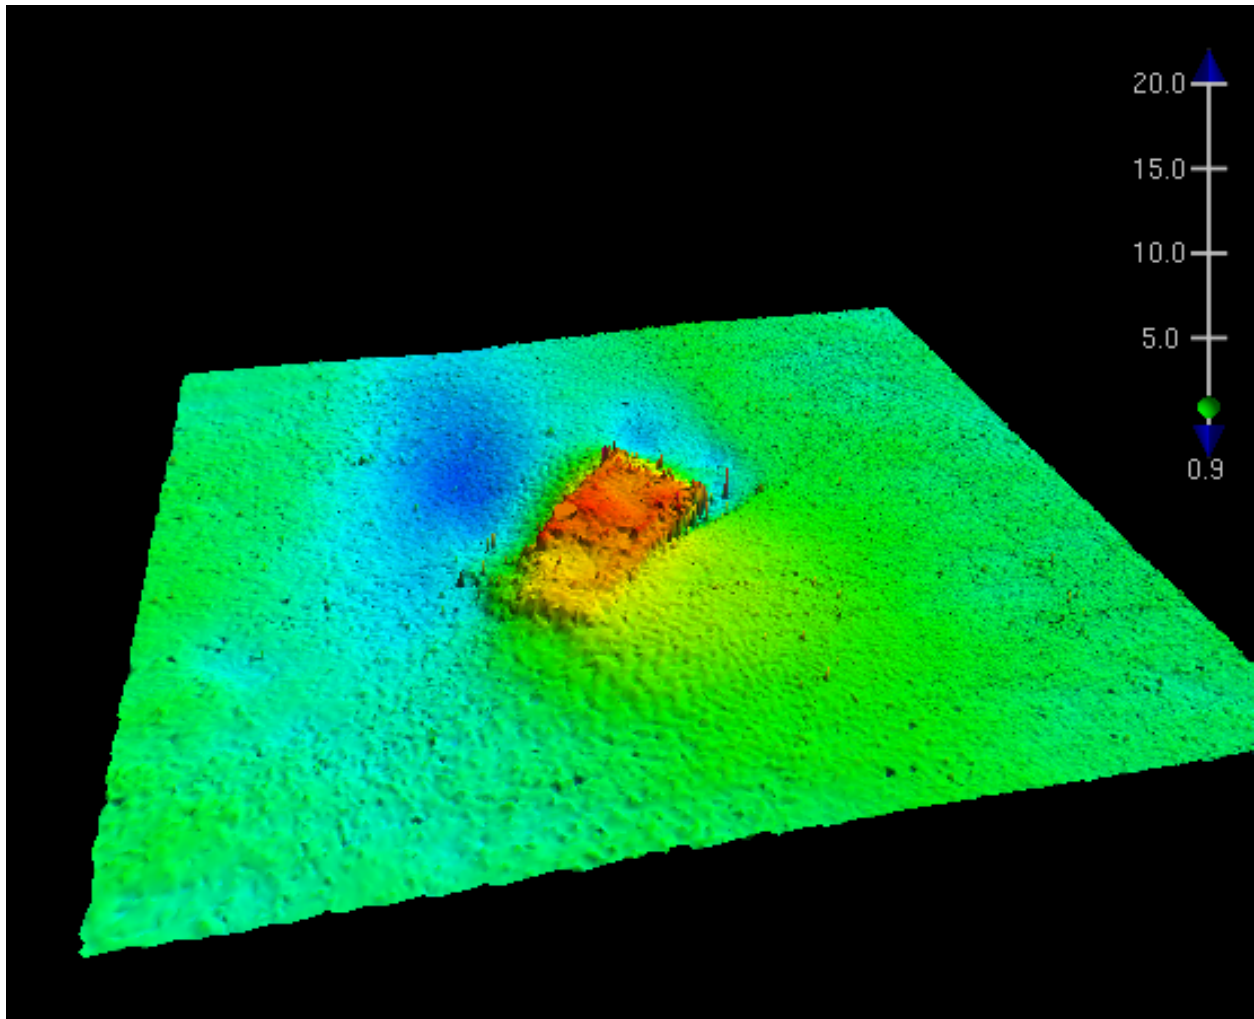
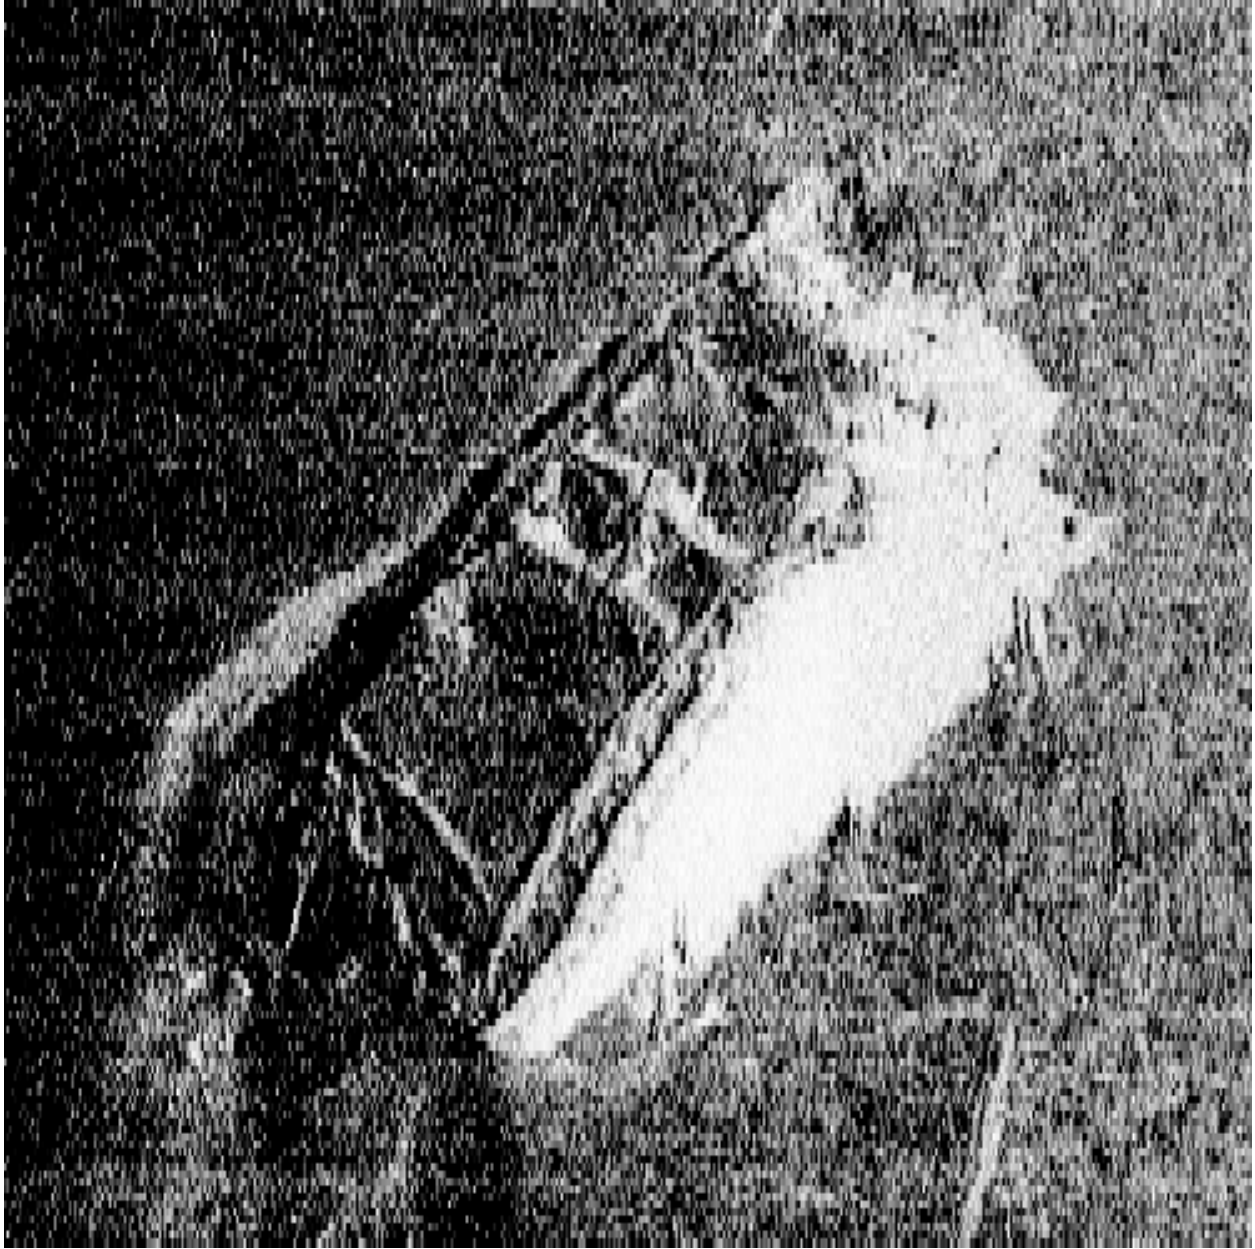
Figure 1.3.1

Hydrographer recommends charting wreck at position 40°35'30.553"N , -074°02'10.313"W, with a least depth of 76 feet.

A 76-ft wreck is already charted within 20 meters of this feature. Retain 76-ft wreck as charted.

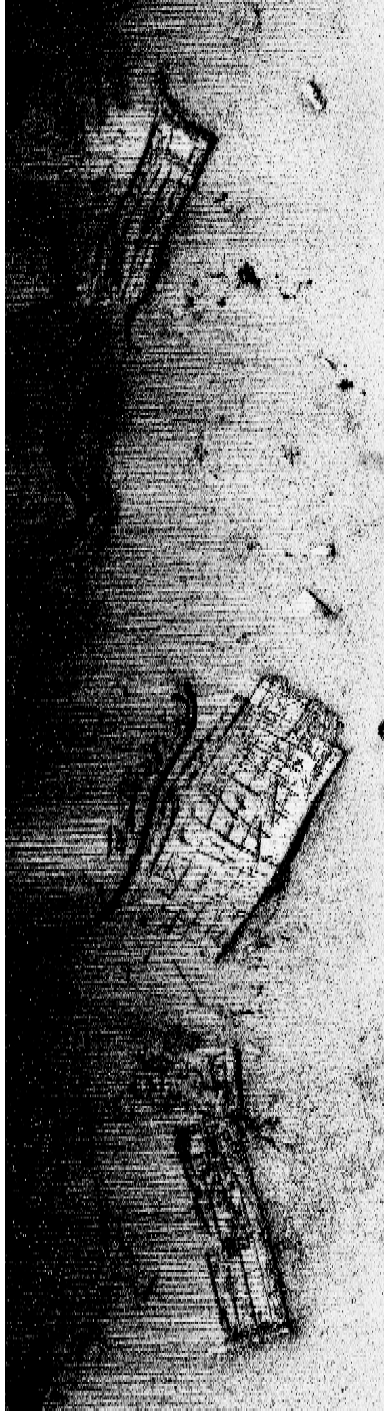
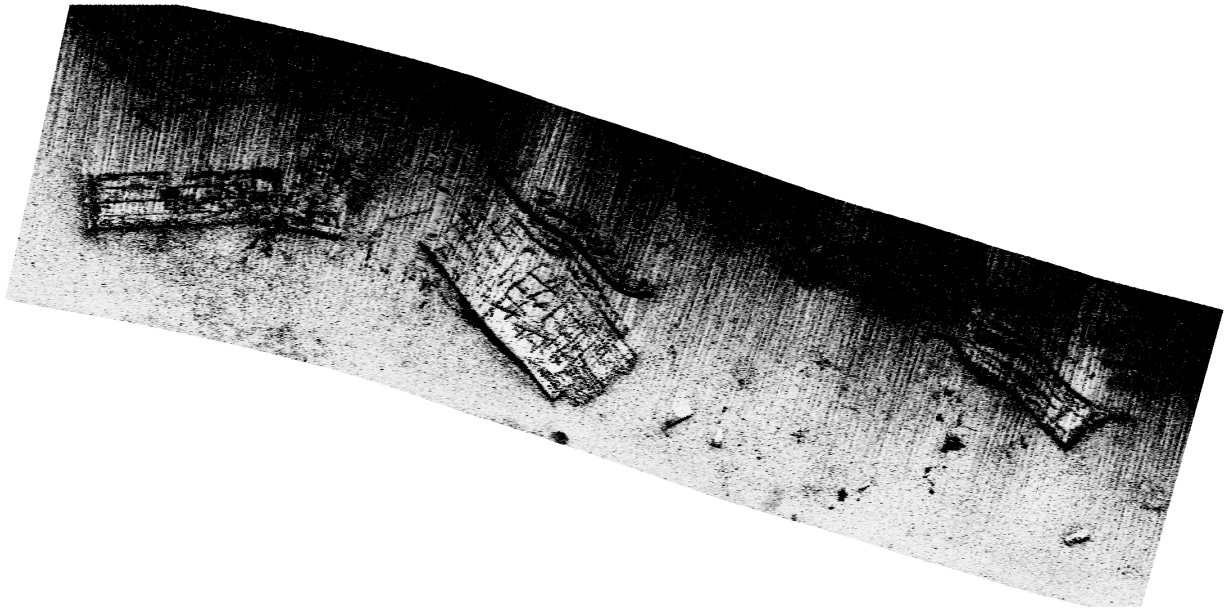
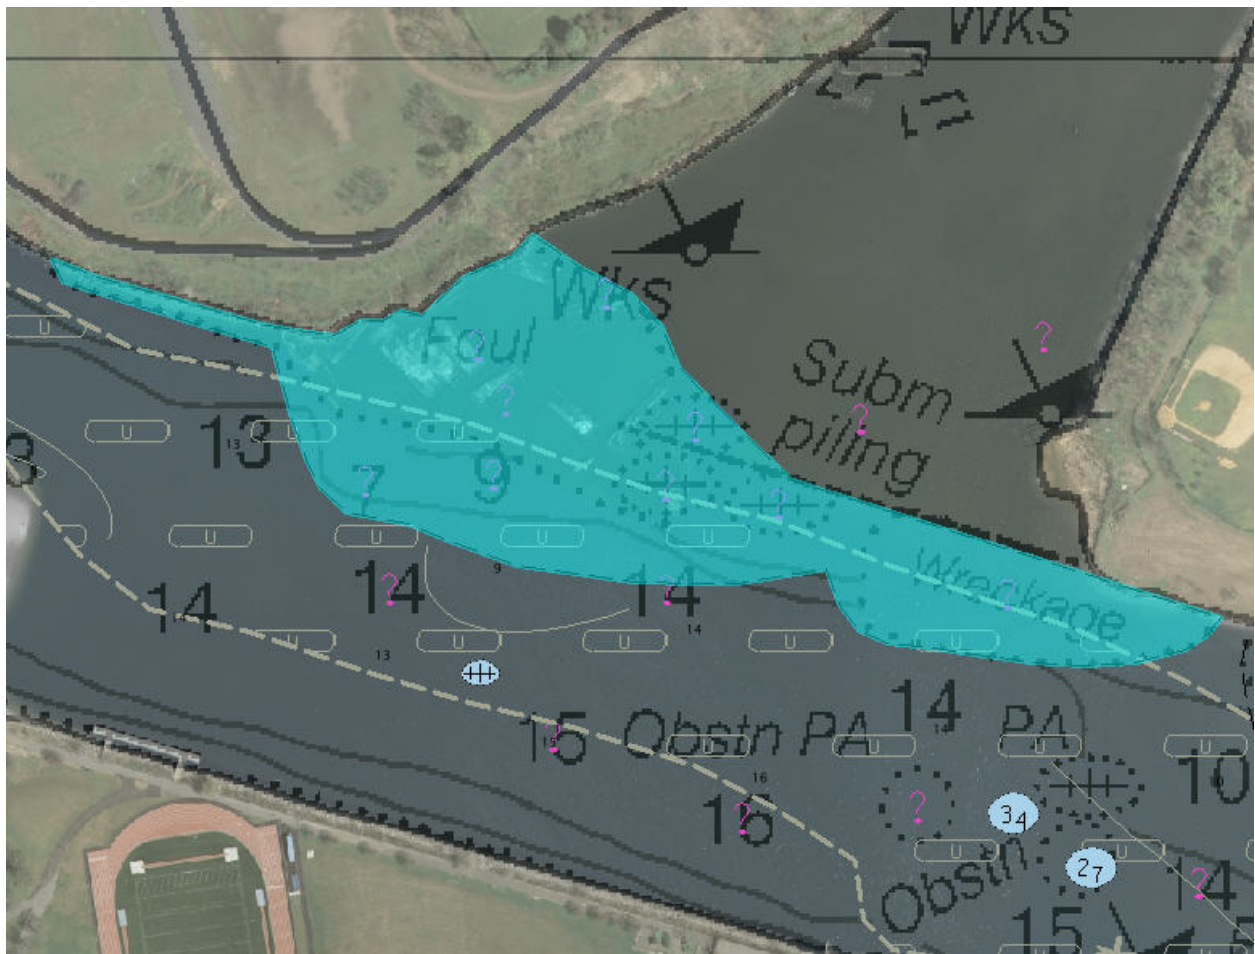
Figure 1.4.1

Multiple wreck(s) strewn about area. Depths were not attainable over these contacts due to unsafe conditions.- VP

Hydrographer recommends extending the charted foul area to the southwestern extent at position 40° 34' 53.4288"N, -73° 59' 45.78" and the southeastern extent at position 40° 34' 51.4272"N, -73° 59' 38.004"W.

Concur with clarification. Extend charted foul area, but delete annotation 'Foul' and add annotation 'Wreckage'.

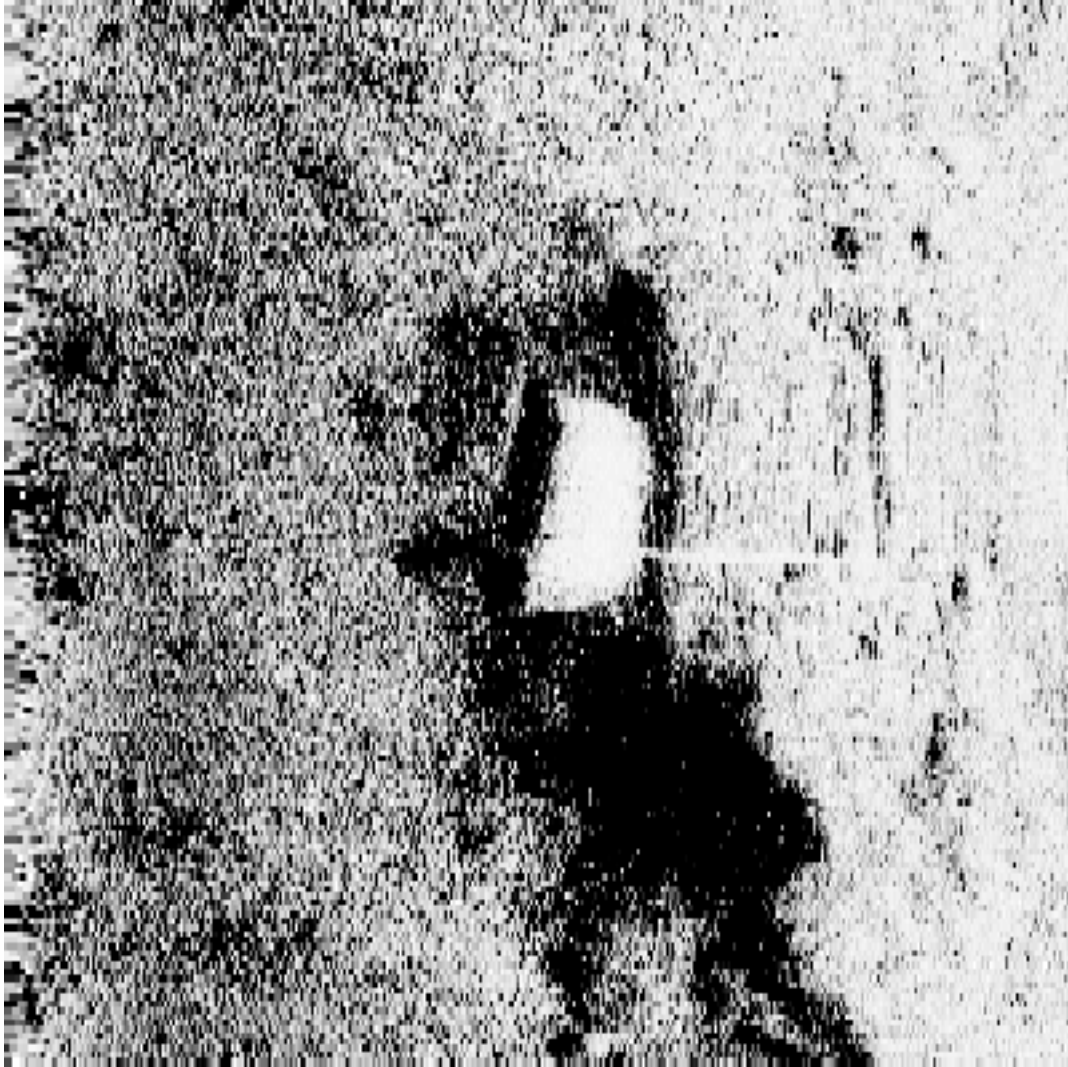
Figure 1.5.1

Obstruction observed within danger circle of charted obstruction. Modify charted obstruction to have a reported least depth of 9 feet (15-ft surrounding depth minus shadow height of 6 ft).

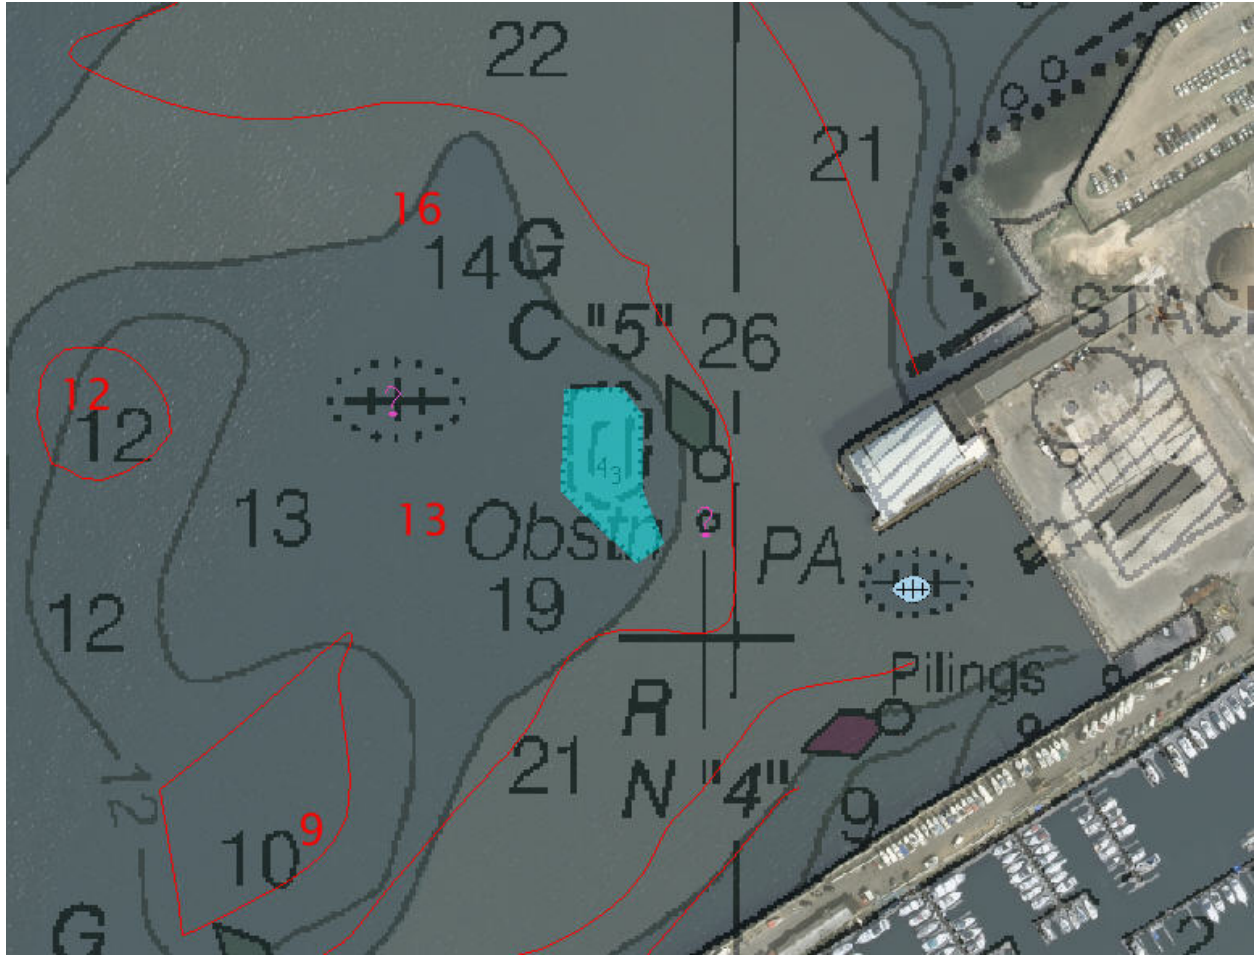
Figure 1.7.1

Concur with clarification. Debris is ~85 meters offshore wharf. Modify extents of charted obstruction area to encompass debris as observed in SSS data and add a reported depth of 10 feet (surrounding depth minus shadow height).

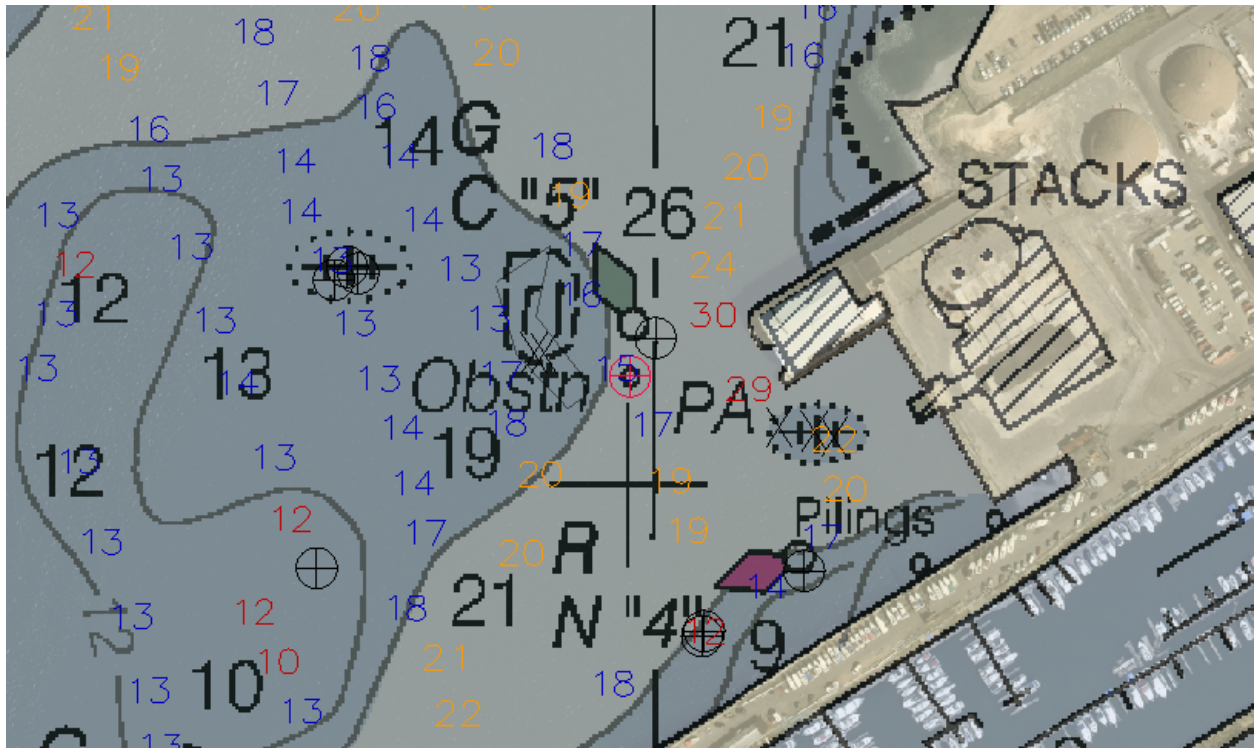
Figure 1.8.1

The feature is a charted visible pile not addressed by the hydrographer. The pile is not observed in two passes of SSS data. Office reviewer recommends deleting charted pile.

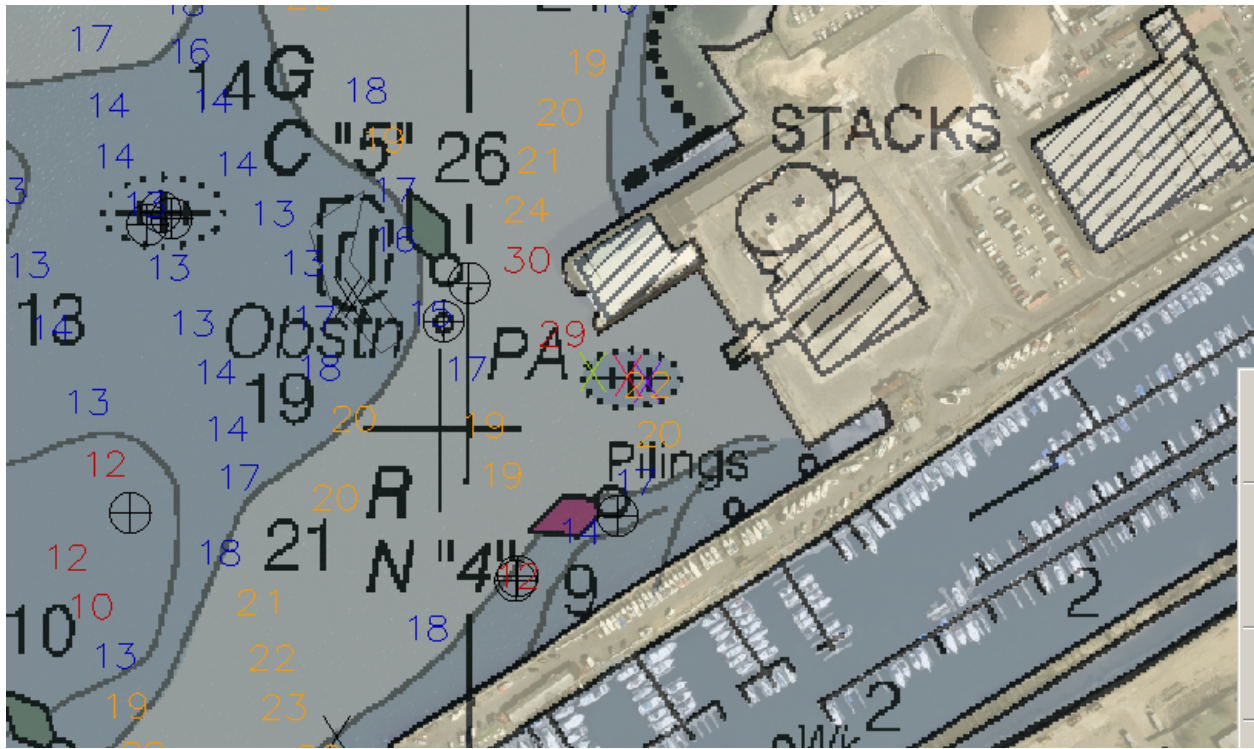
Figure 1.9.1

Charted Wreck PA not observed on SSS; 100x100 square meter radius image.-VP

Do not concur. Only 100% SSS data were acquired in the area, and the charted wreck PA is positioned at nadir. A narrow contact is observed sticking up into the water column at nadir in the SSS data near the charted. Retain the charted dangerous wreck PA.

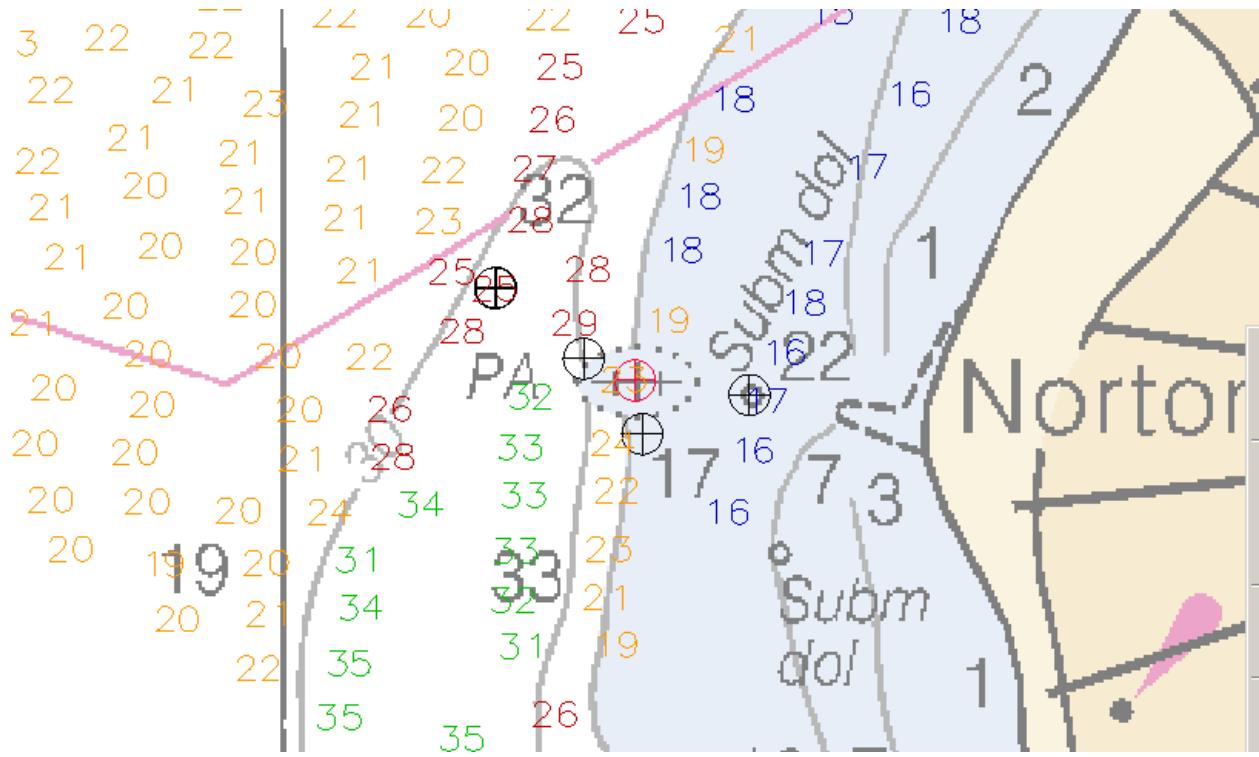
Figure 1.14.1

Retain as charted. Charted dangerous sunken wreck not addressed by the field. No wreck was observed in the immediate vicinity, but the data coverage and image quality are deemed insufficient to warrant feature disapproval.
