| DESCRIPTIVE REPORT |
| Type of Survey <u>Sidescan Sonar, Single Beam Sonar and Interferometric Sonar</u> |
| Registry No. <u>H11612</u> |
| General Locality <u>Lake Borgne</u> |

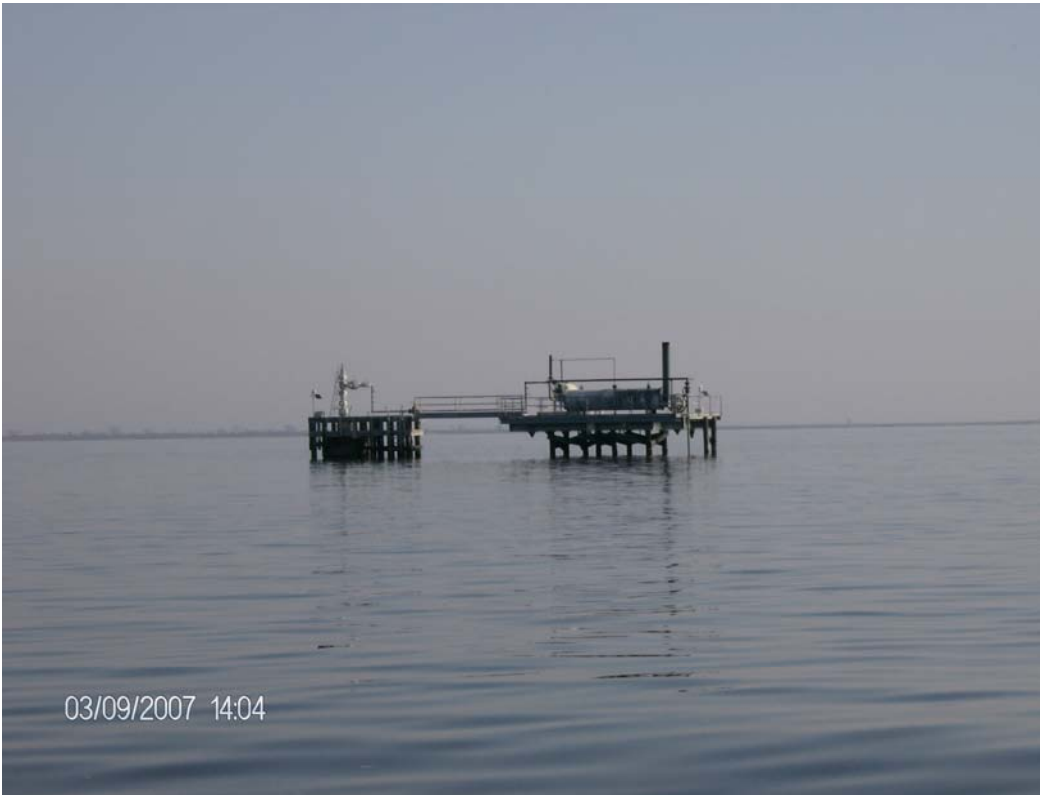
Figure 1. Photograph of platform within H11612.

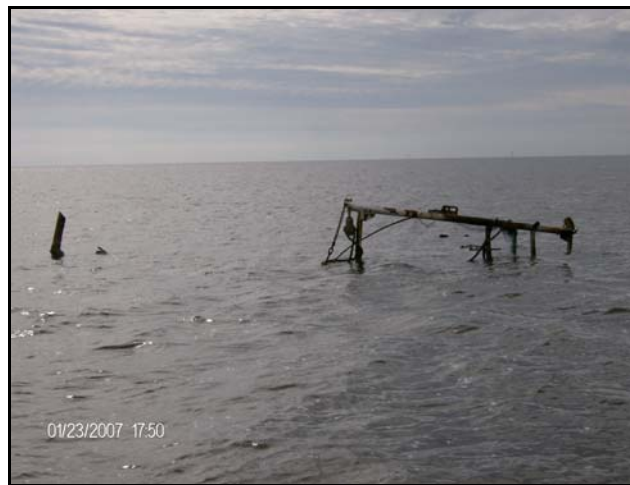
Figure 15. Photograph of wreck showing exposed masts within H11612.

Chart a wreck showing masts above chart datum (K25) with danger circle in 30° 10.72095' N 089° 31.06479' W

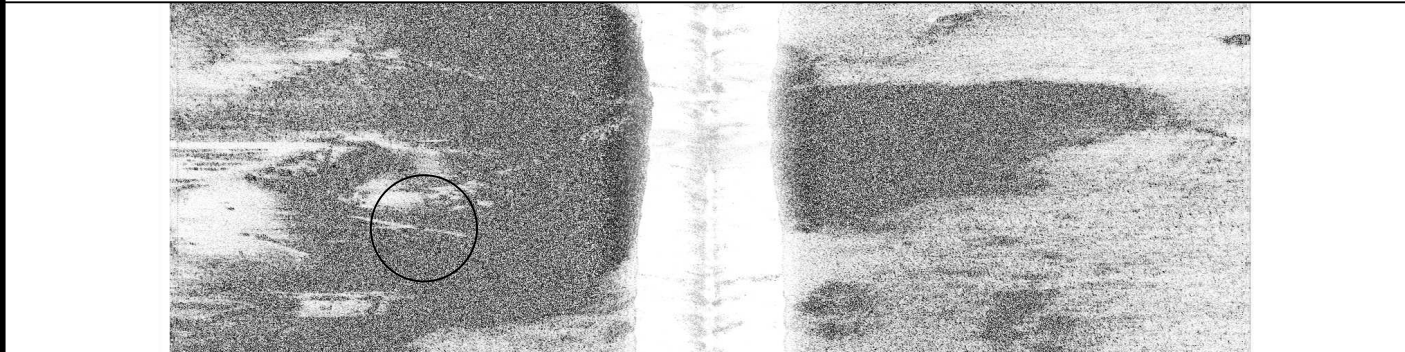
ID: 84 File: TD07029_070129203600.XTF 30 08 21.97N 089 36 29.65W RNG: -15.16 HGT: 1.02 HDG: 090

COMMENT:
PLATFORM Plot platform symbol

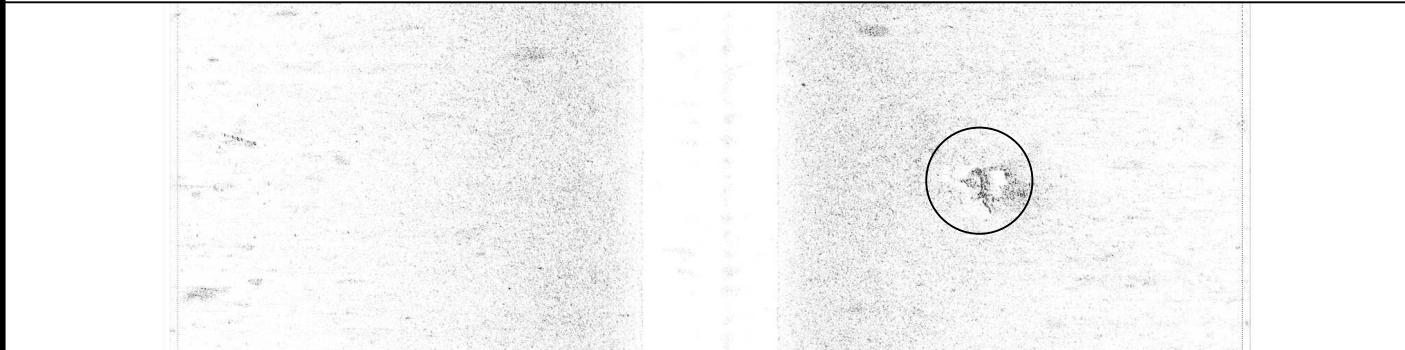
ID: 88 File: TD07029_070129214100.XTF 30 08 23.21N 089 30 47.88W RNG: -18.19 HGT: 0.69 HDG: 264

COMMENT:
OBSTR Plot sounding and
symbol Obstr (least depth
estimated from side scan)

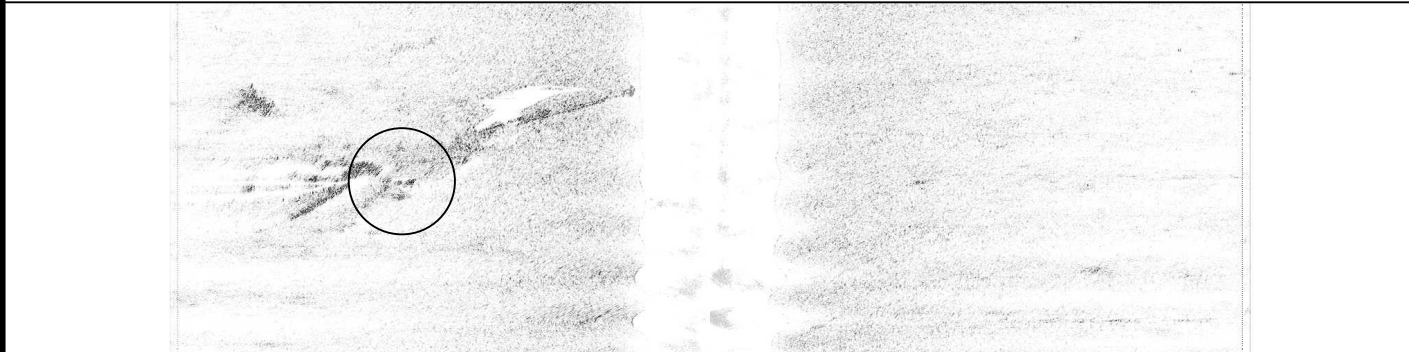
ID: 270 File: TD07141_070521202000.XTF 30 09 20.90N 089 31 29.67W RNG: -17.09 HGT: 0.76 HDG: 202

COMMENT:
OBSTRS Plot sounding and
symbol Obstrs
