**H11620 CARIS H-Cell final deliverables include the following products:**

**C. VERTICAL AND HORIZONTAL CONTROL**

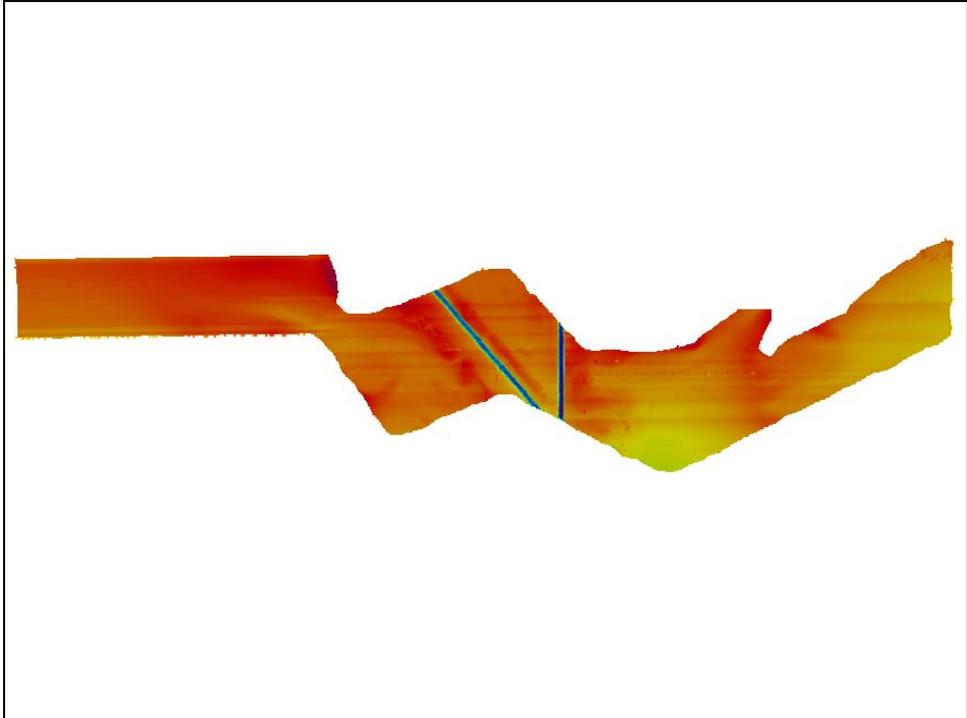
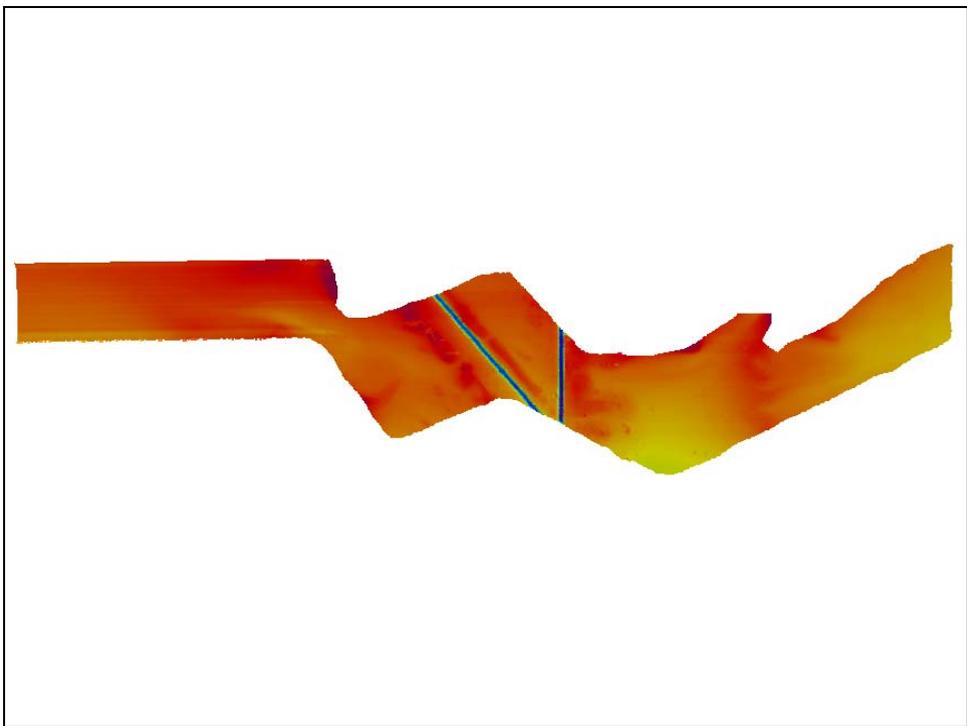
The two screen captures below show interpolated surfaces created from the dense sounding selections before tide correction, and after tide correction.

A known tide error existed in this survey of significant magnitude. Much of the error was previously attributed to meteorological effects. Further investigation revealed incorrect appending of Caris tide files—tide files in Local Standard Time (LST) were combined with files in GMT. The survey was conduct in LST, meaning all of the tide data appended in GMT had significant tide error.

Tide data was downloaded for each tide station in LST to encompass all survey times. The tide data was re-applied, and all the data was re-merged with the correct HVF’s. The surfaces were then recreated, and the results were favorable, as much of the observed tide error was removed. Tide error still exists in Area 4, and this error is evident in the depth curves.
