## DESCRIPTIVE REPORT

Registry No. H111 G

General Locality Keku Strait

Sublocality High Island to Southern Entrance of Keku

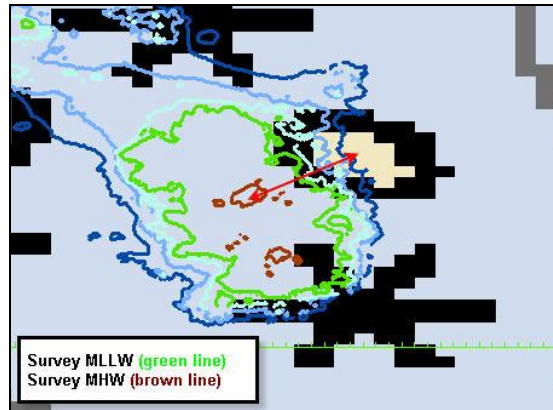
- Islet 165 m long and 120 m wide on Chart 17360 located at 56°30'46.789"N 133°45'23.276"W was found located 140 m off to the SW.

Figure 8 - Islet off charted position

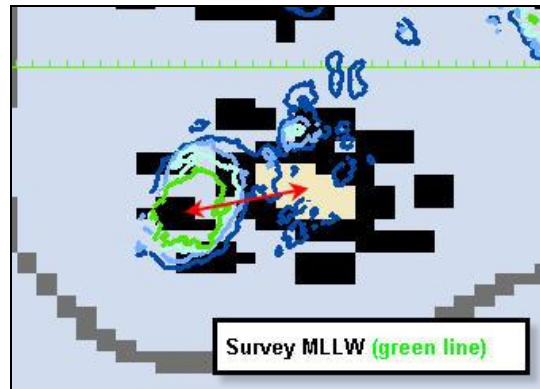
- Islet 185 m long by 128 m wide on Chart 17360 located at  $56^{\circ}30'25.924''\text{N}$   $133^{\circ}41'17.11''\text{W}$  was found located 131 m off to the W and under the MHW line.

Figure 10 - Islet not found; fesature off charted position

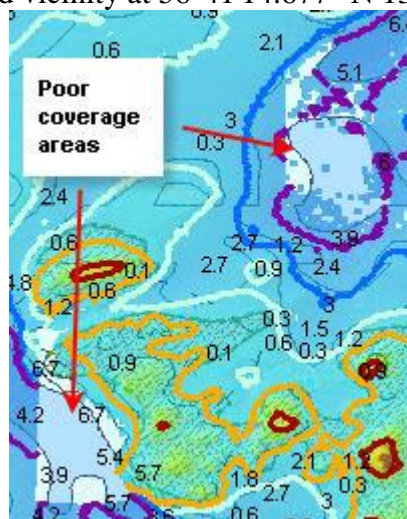
- Laser extinction around vicinity at 56°41'14.677" N 133°44'28.122"W.

**Figure 23 - Laser extinction; water quality.**

The following features require further investigation. These features were either not found with the LiDAR system or are additional features that were found and are of question. These areas described are recommended to be visited with a multibeam echo-sounder system or other techniques to verify no navigation hazards exist.

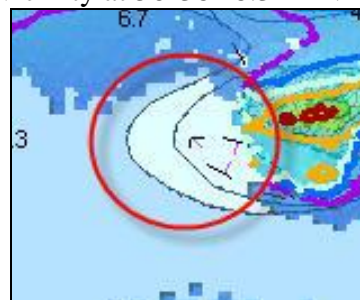
- Laser extinction around vicinity at 56°38'28.341"N 133°42'20.403"W.

**Figure 26 - Laser extinction; water quality.**
